Construction and Stormwater Inspection

Operator: PROVIDENCE OPERATING LLC DBA POCO -
10694

Location ID: 451646

Inspection Photos
Location Name: Brighton Lakes 20-17
Location ID: 451646

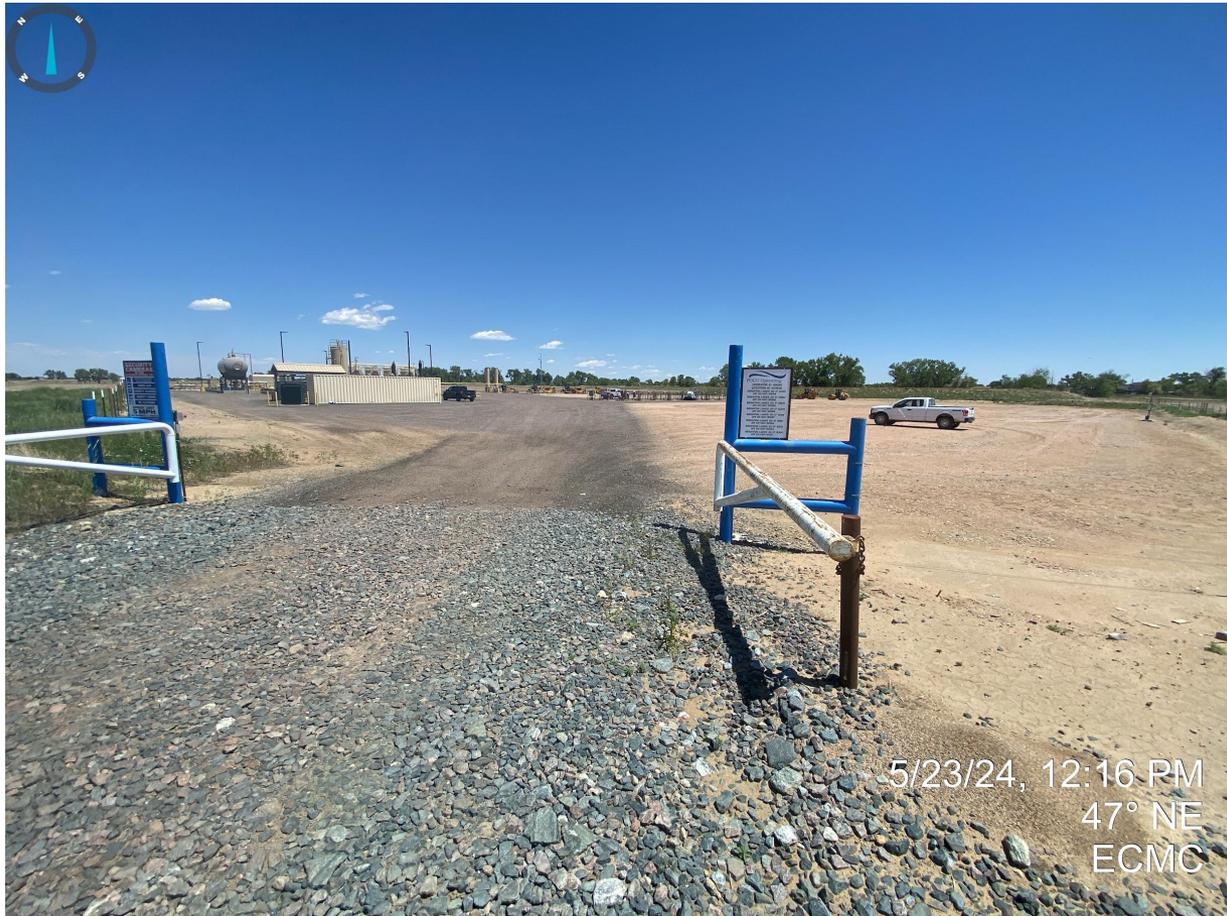
Photo 1. Form 2A was not posted on location at the time of this inspection.

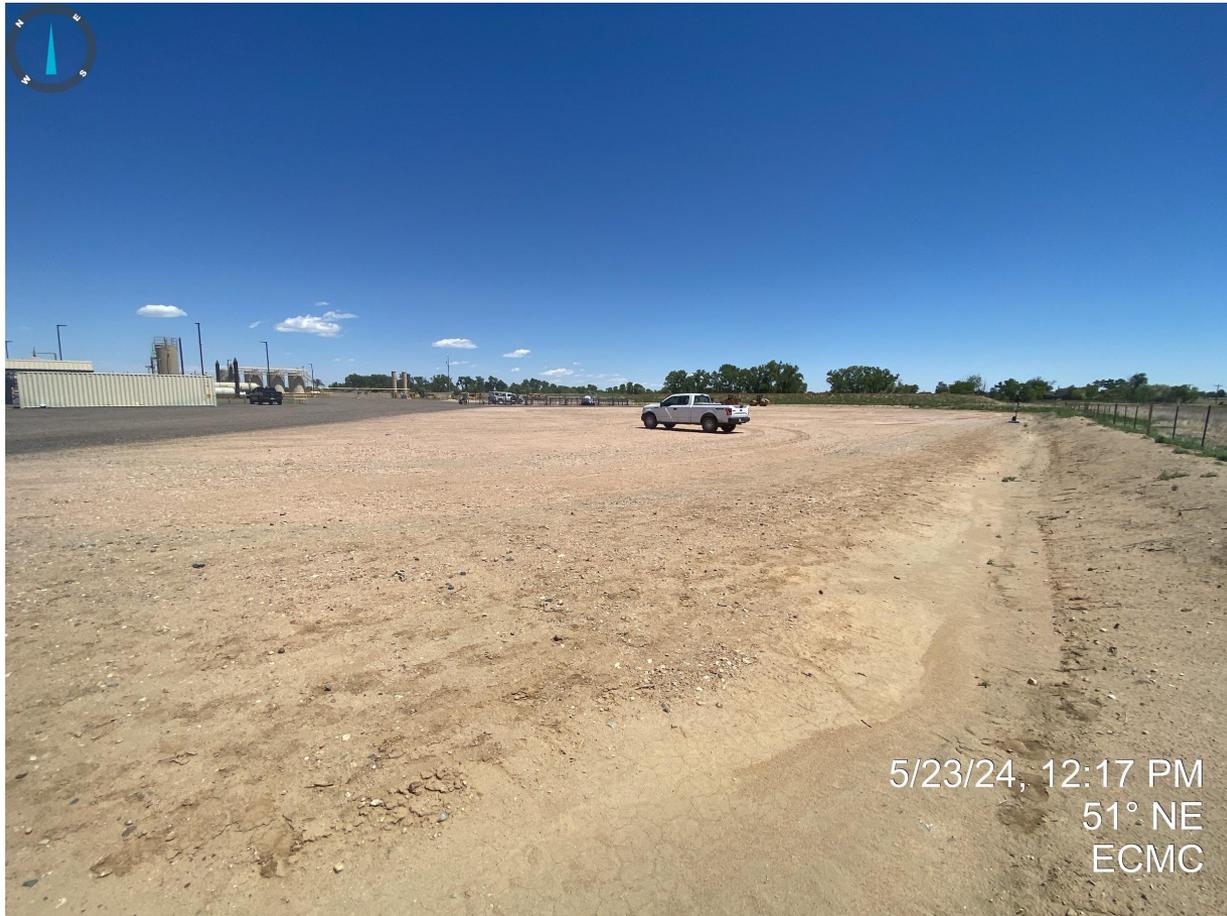
Photo 2. Southwest corner of the interim area. Interim reclamation does not appear to have been performed at the time of this inspection. Refer to FIR for additional information.

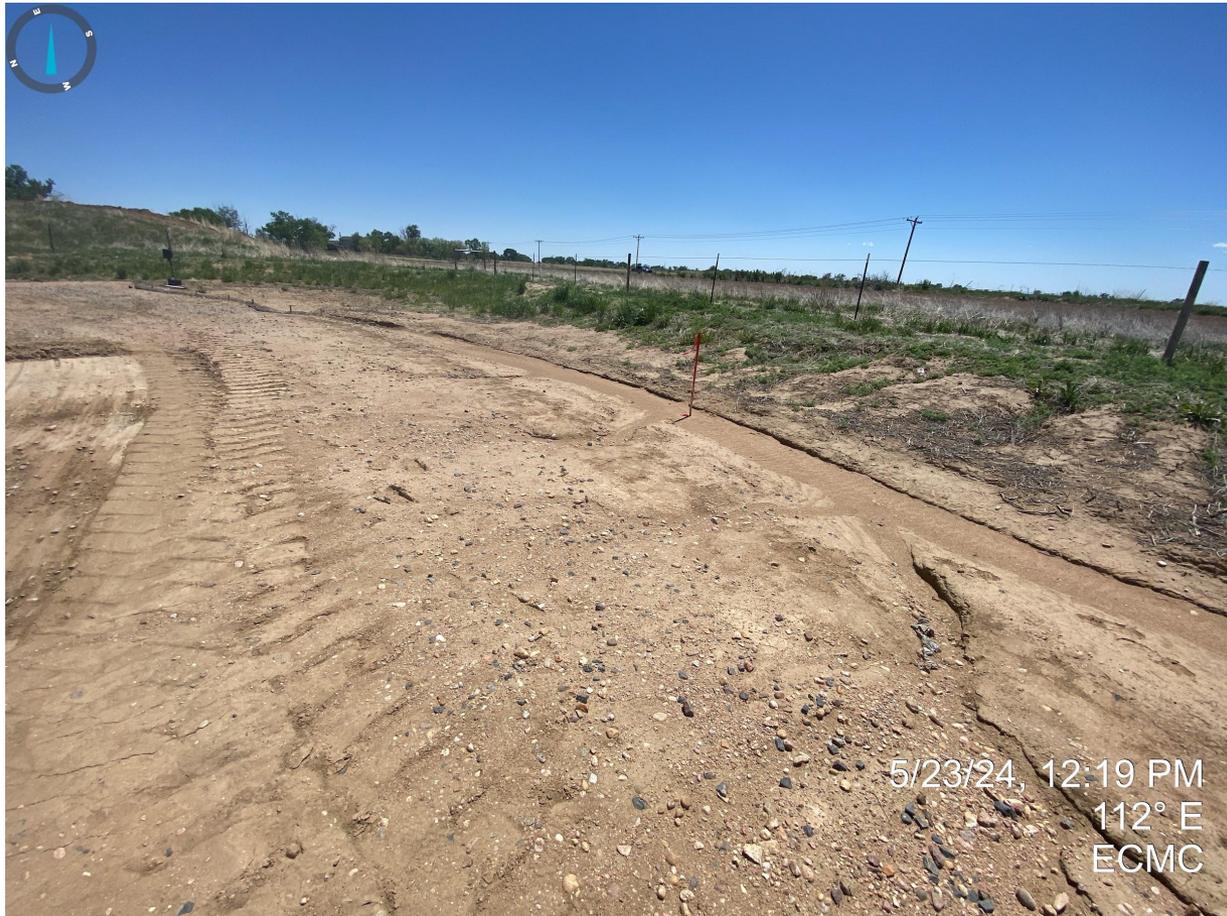
Photo 3. Southeast corner of the production area near the sediment trap. Erosion degradation observed at the time of this inspection.

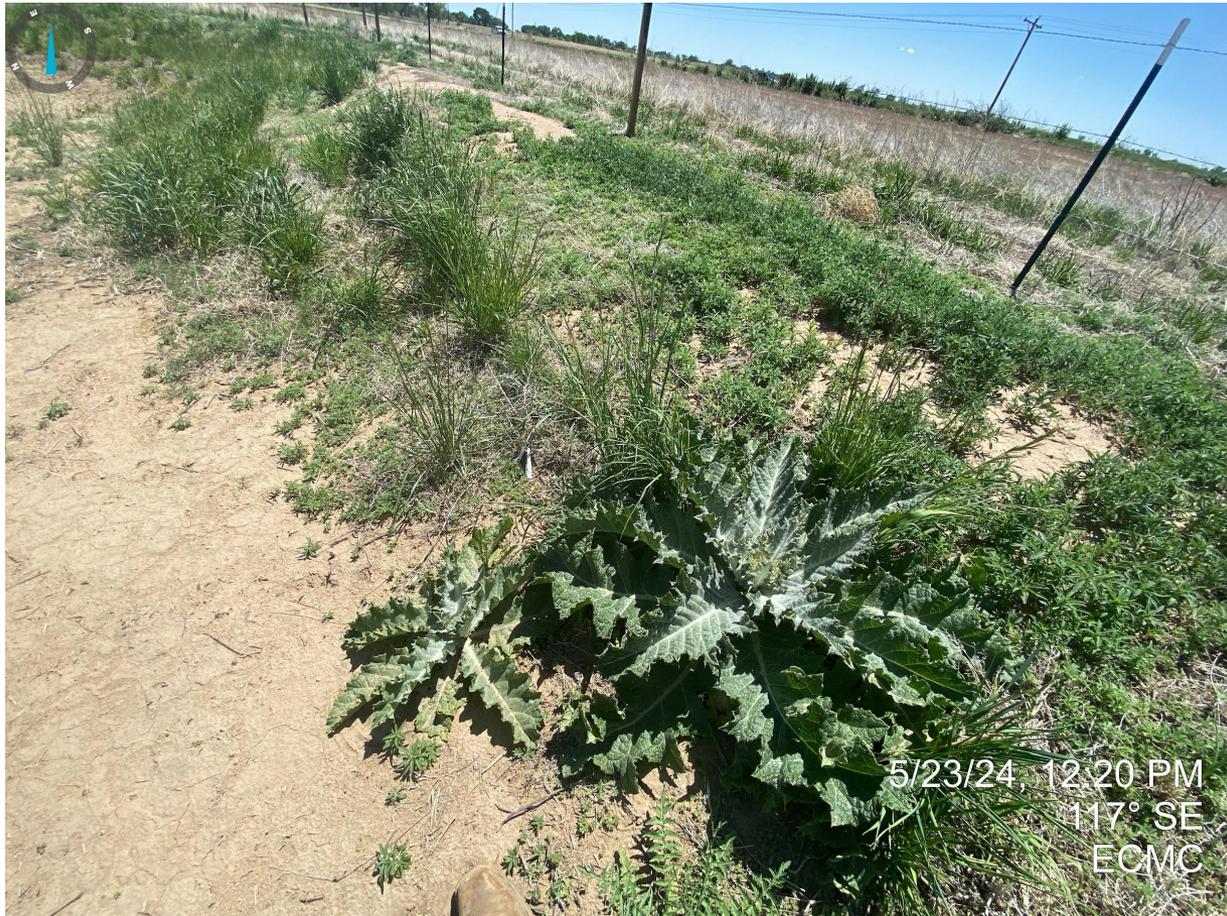
Photo 4. Example of CO Noxious Weed List B (scotch thistle) and undesirable vegetation (kochia) observed. Operator shall inspect the entire location and implement a weed management program.

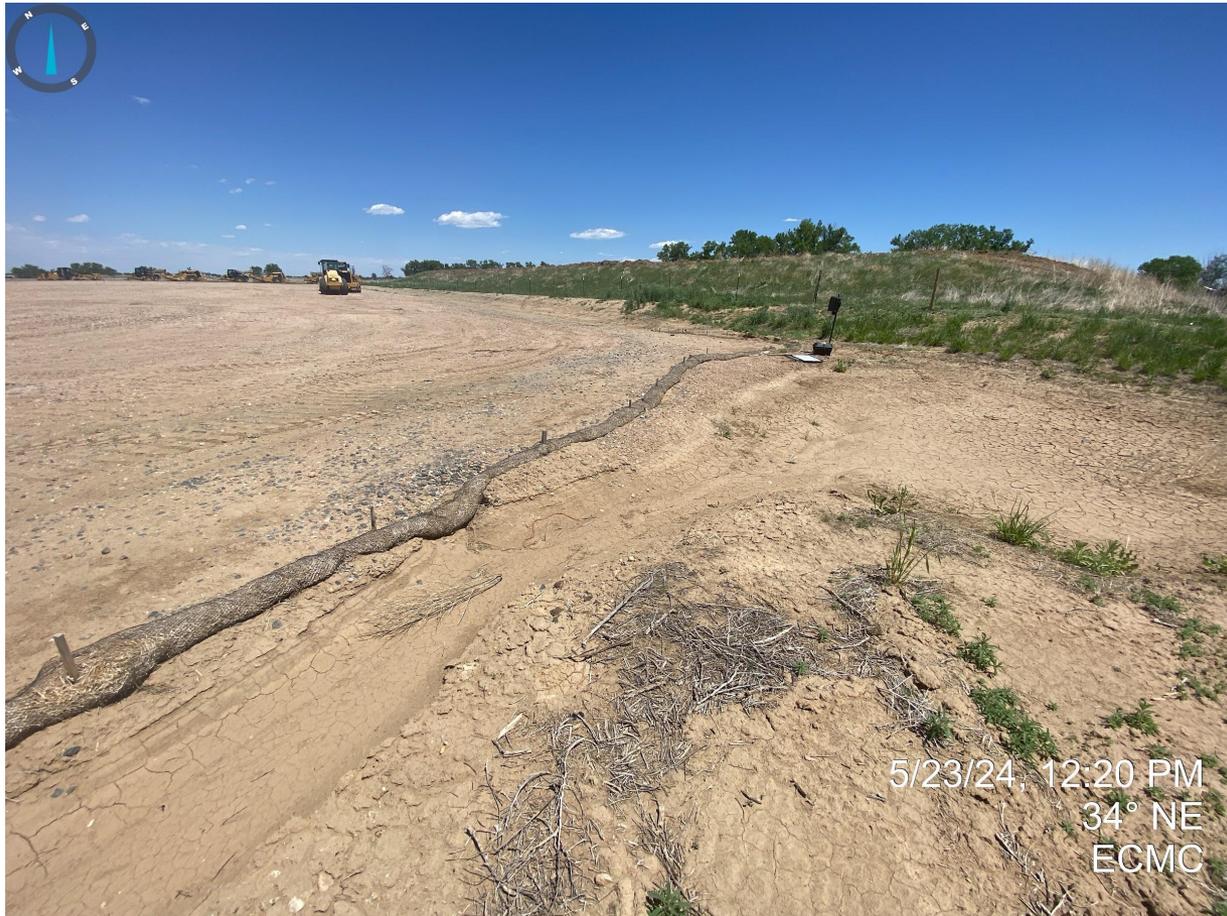
Photo 5. Sediment trap at the southeast corner of the location. Evidence of erosion degradation and inadequate BMPs (straw wattles).

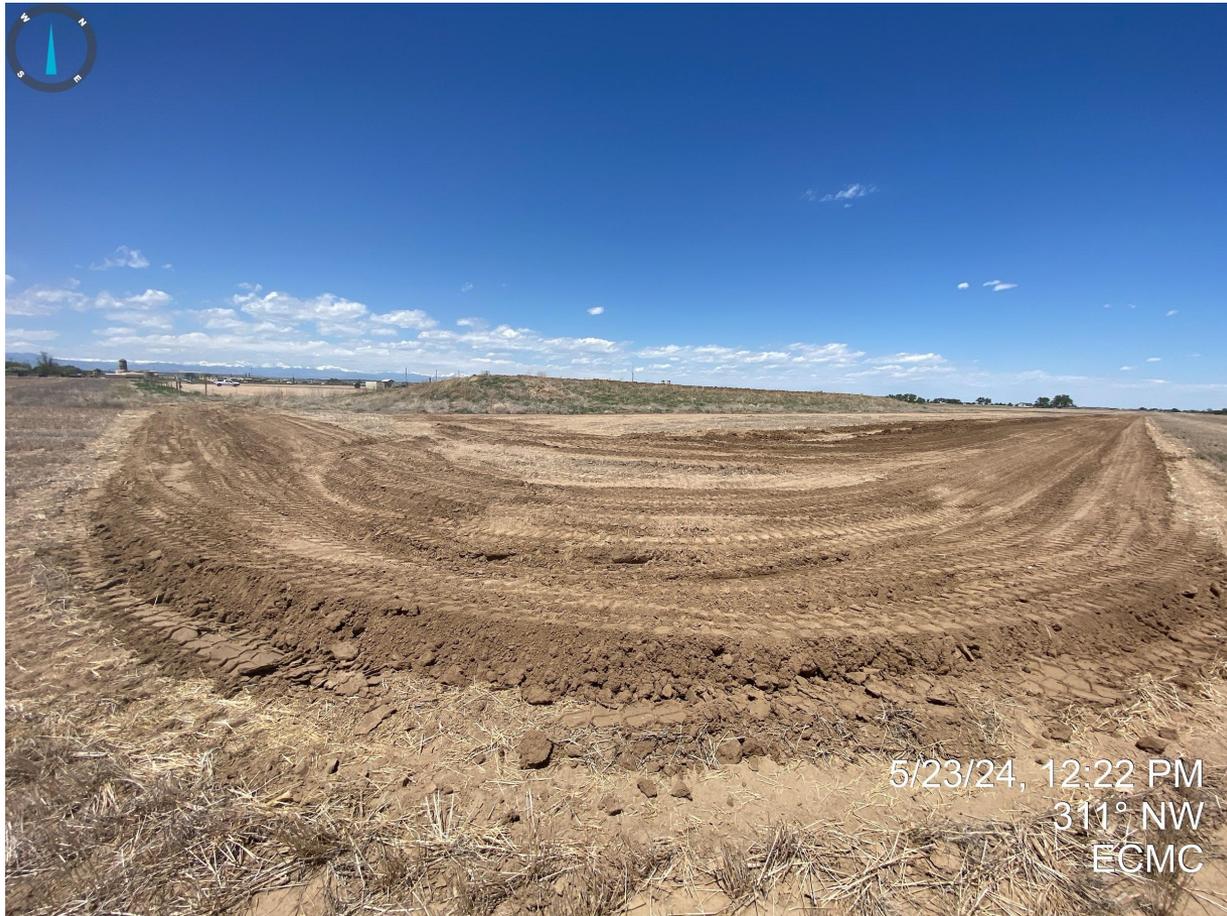
Photo 6. Southeast corner of pad expansion. Perimeter stormwater controls are still in process at the time of this inspection.

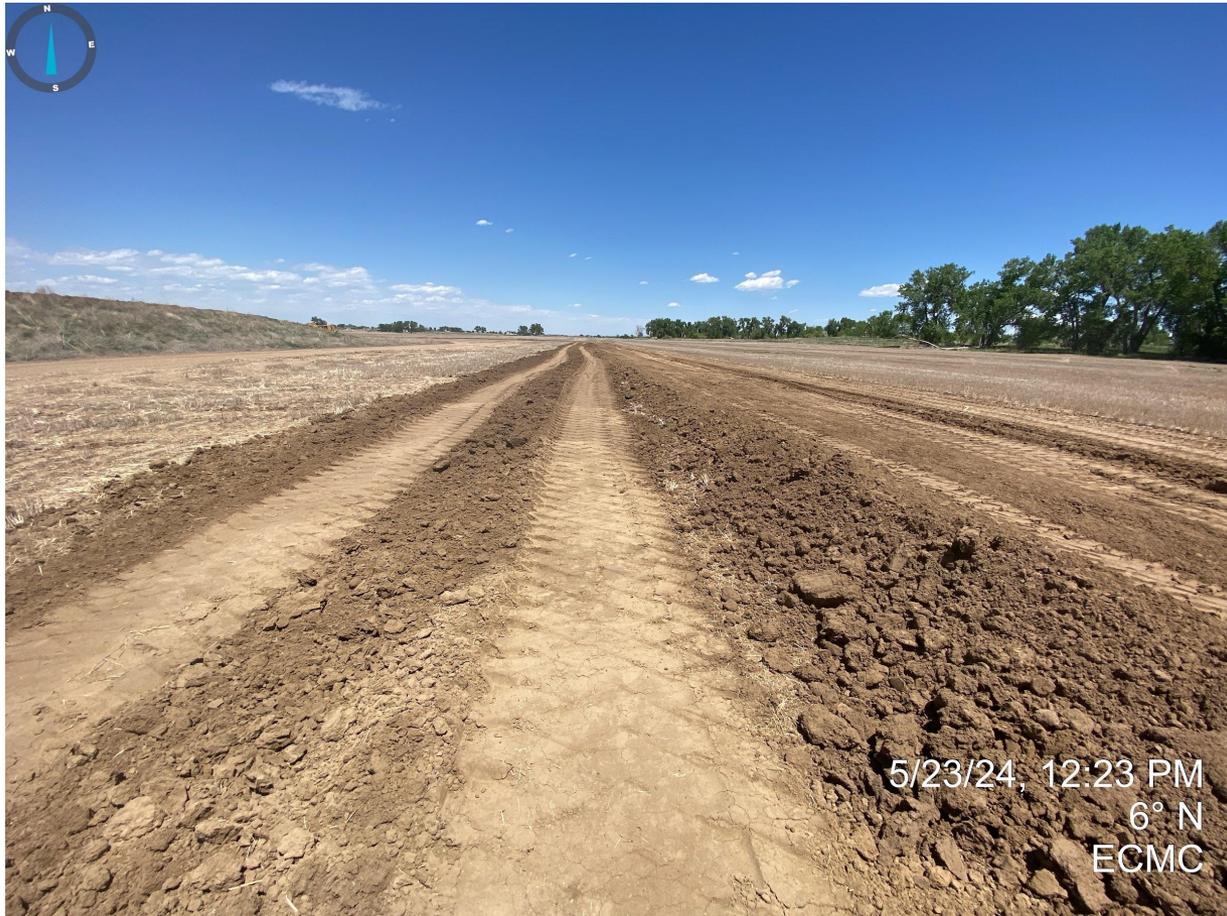
Photo 7. East side of pad expansion. It appears that the existing topsoil stockpile is being moved further east to the new DA limits. Operator shall ensure that all topsoil is salvaged in accordance with Rule 1002.b and that topsoil is not used as fill material.

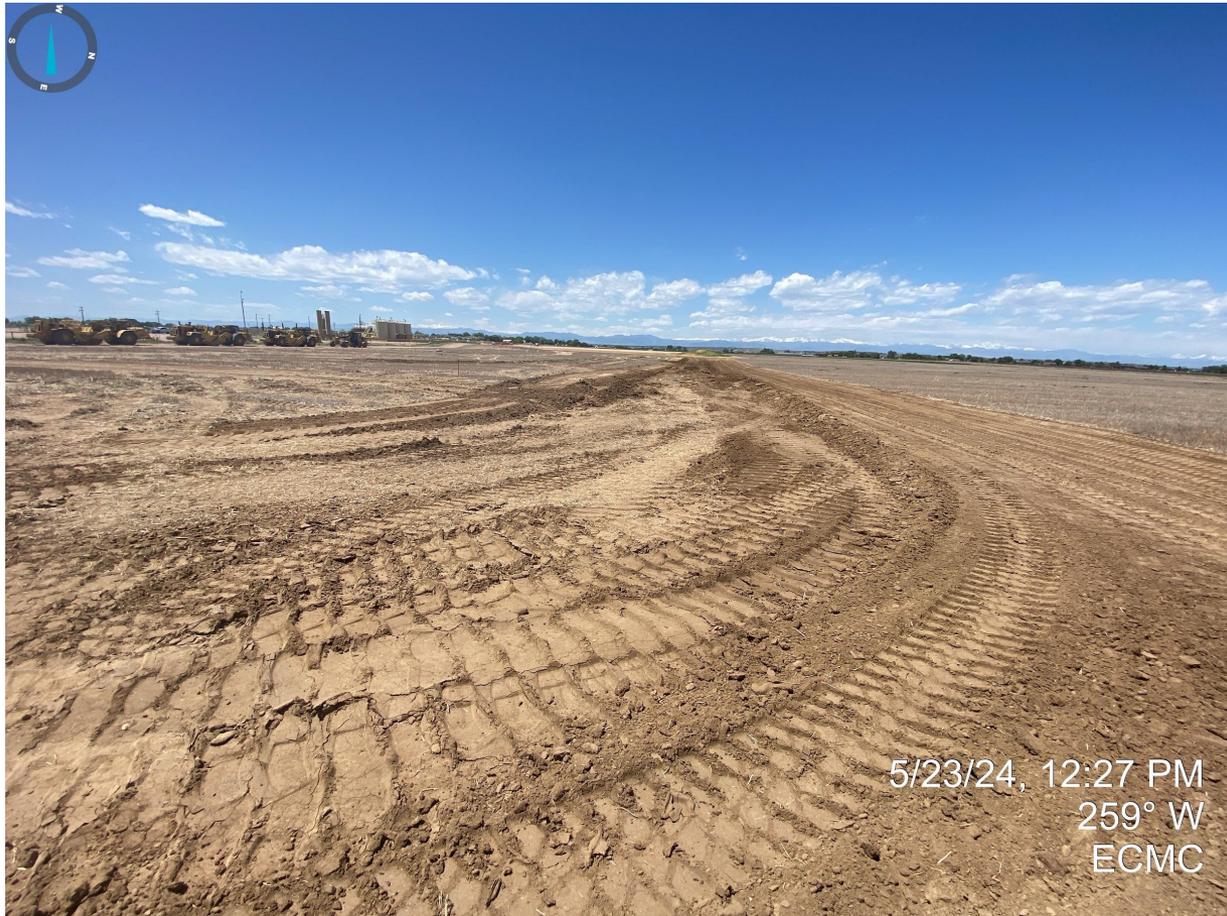
Photo 8. Northeast corner of pad expansion. Perimeter stormwater controls are still in process at the time of this inspection.

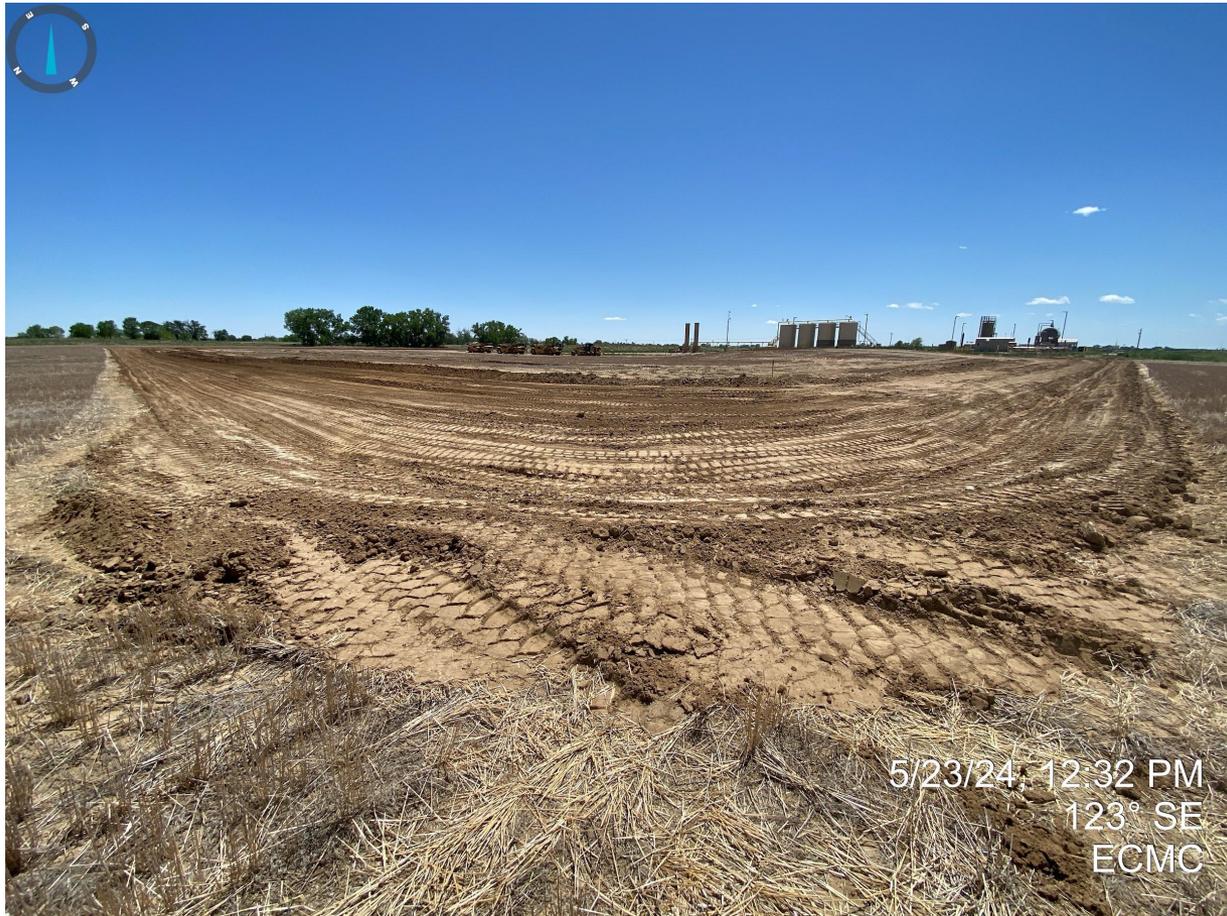
Photo 9. Northwest corner of pad expansion. Perimeter stormwater controls are still in process at the time of this inspection.

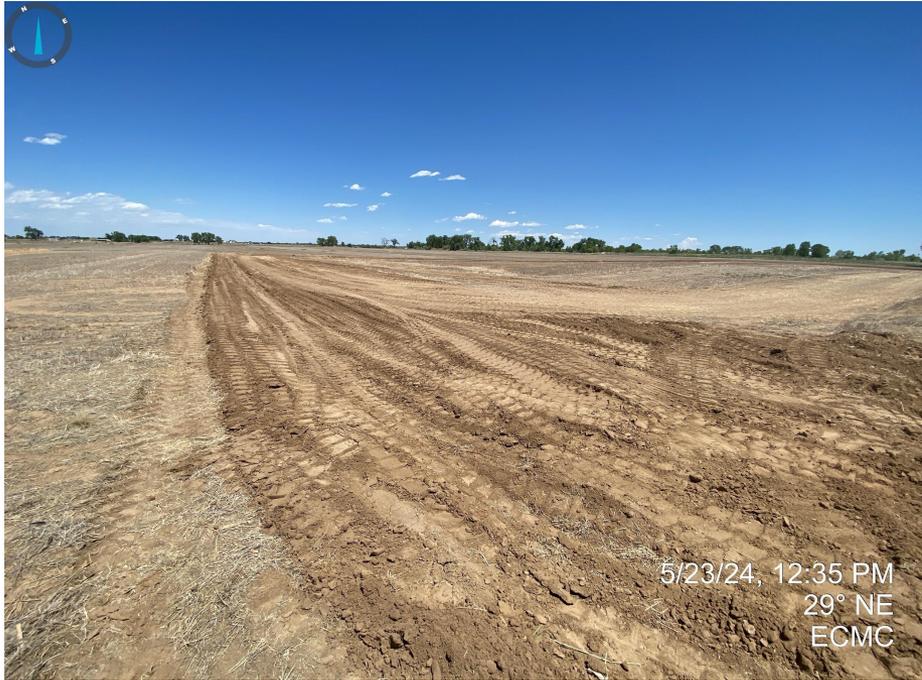
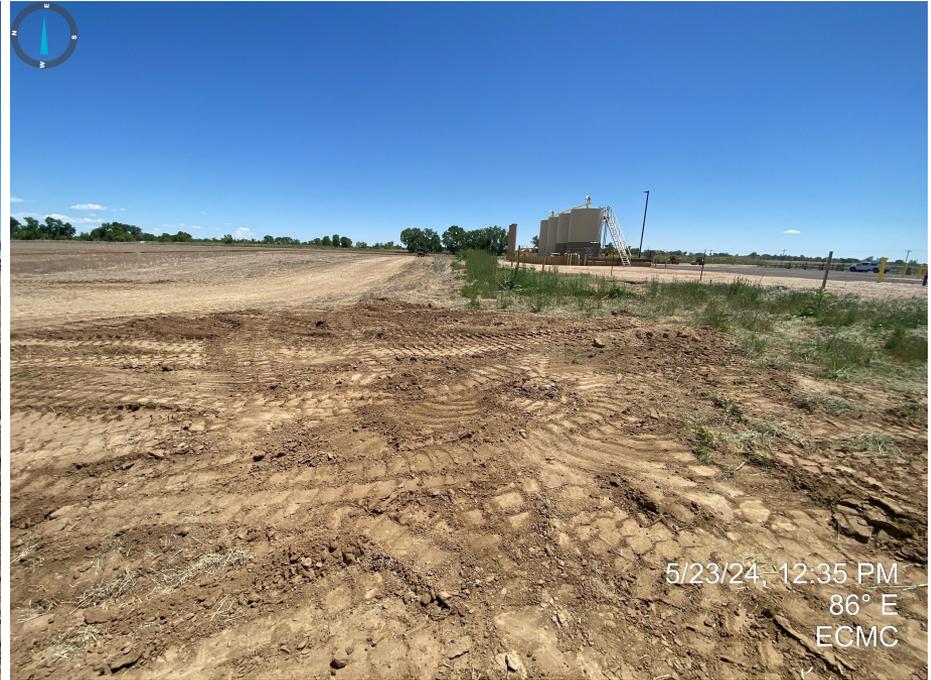
Photo 10. Southwest corner of pad expansion. Perimeter stormwater controls are still in process at the time of this inspection.

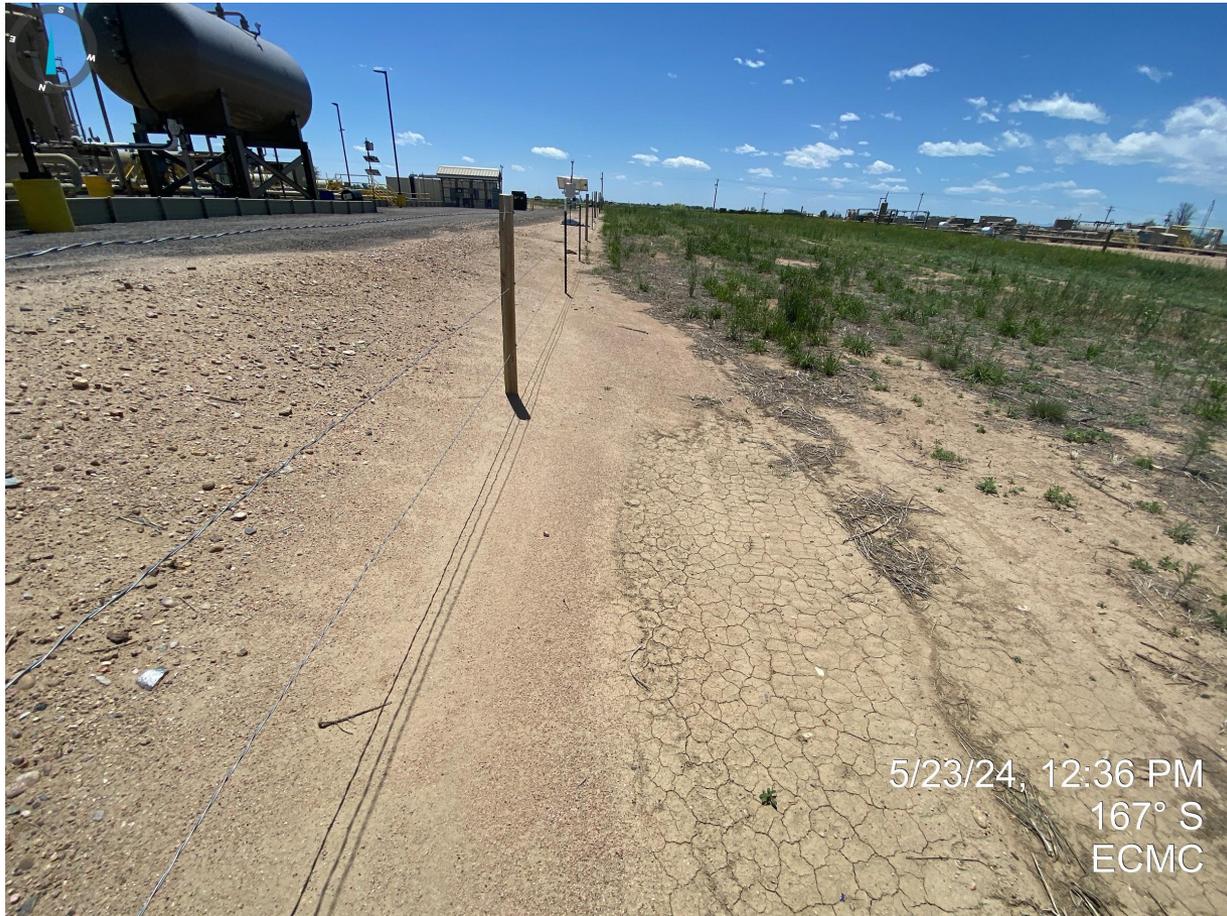
Photo 11. Northwest production areas do not appear to be properly stabilized with erosion degradation evident.

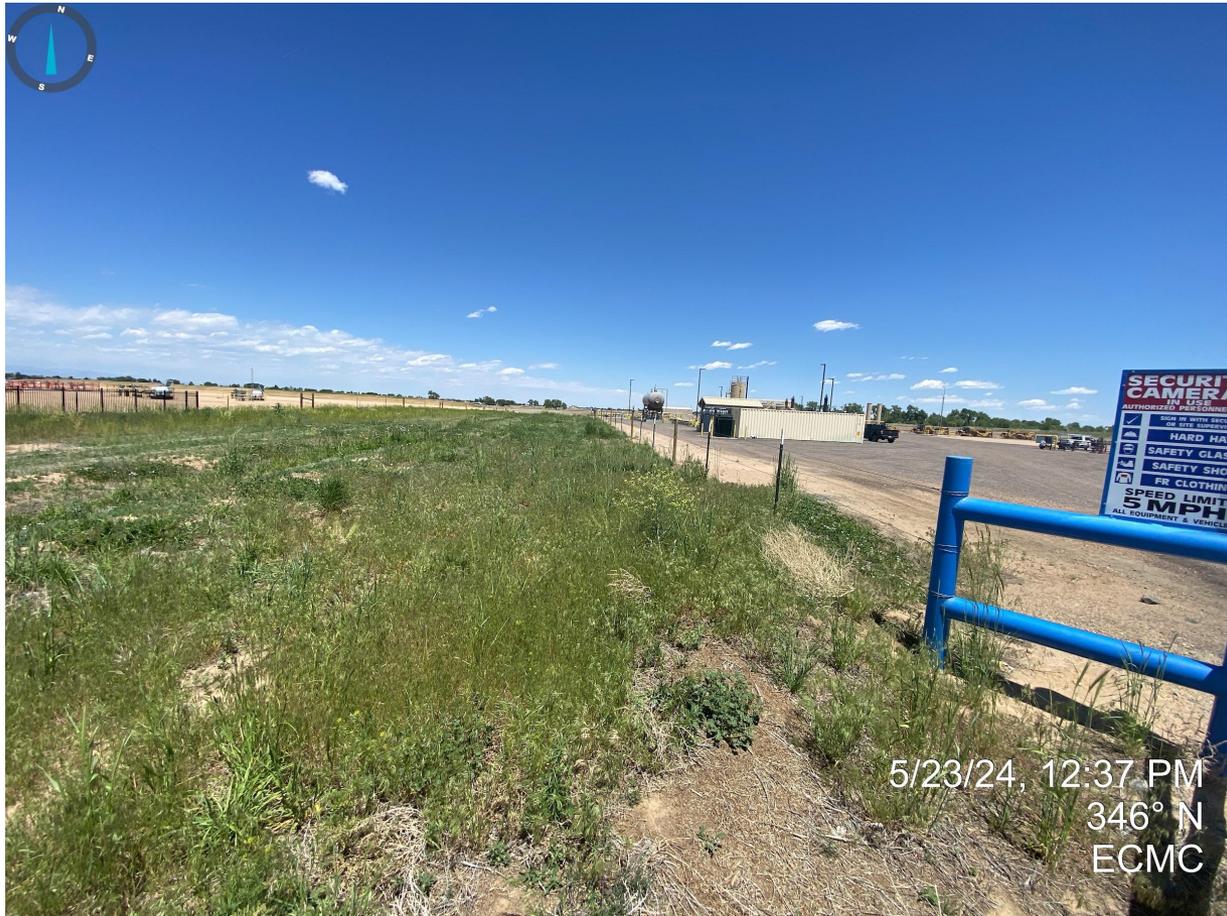
Photo 12. CO List C Noxious Weed (downy brome) and undesirable vegetation (kochia) observed on the western portion of the production area.

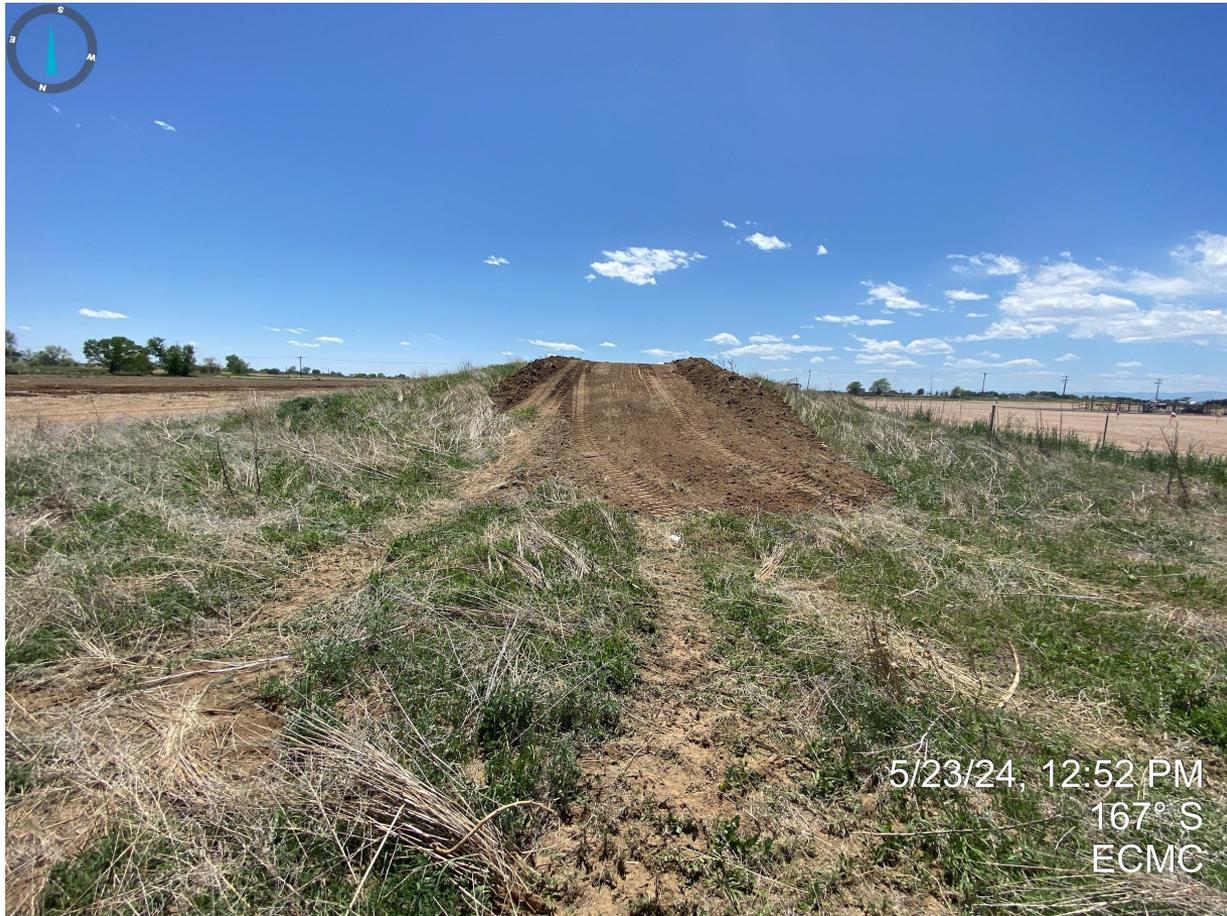
Photo 13. North side of existing topsoil stockpile. It appears that topsoil is in the process of being moved further east due to pad expansion. CO List C Noxious Weed (field bindweed and downy brome) are the predominant vegetation cover on the topsoil stockpile at the time of this inspection.

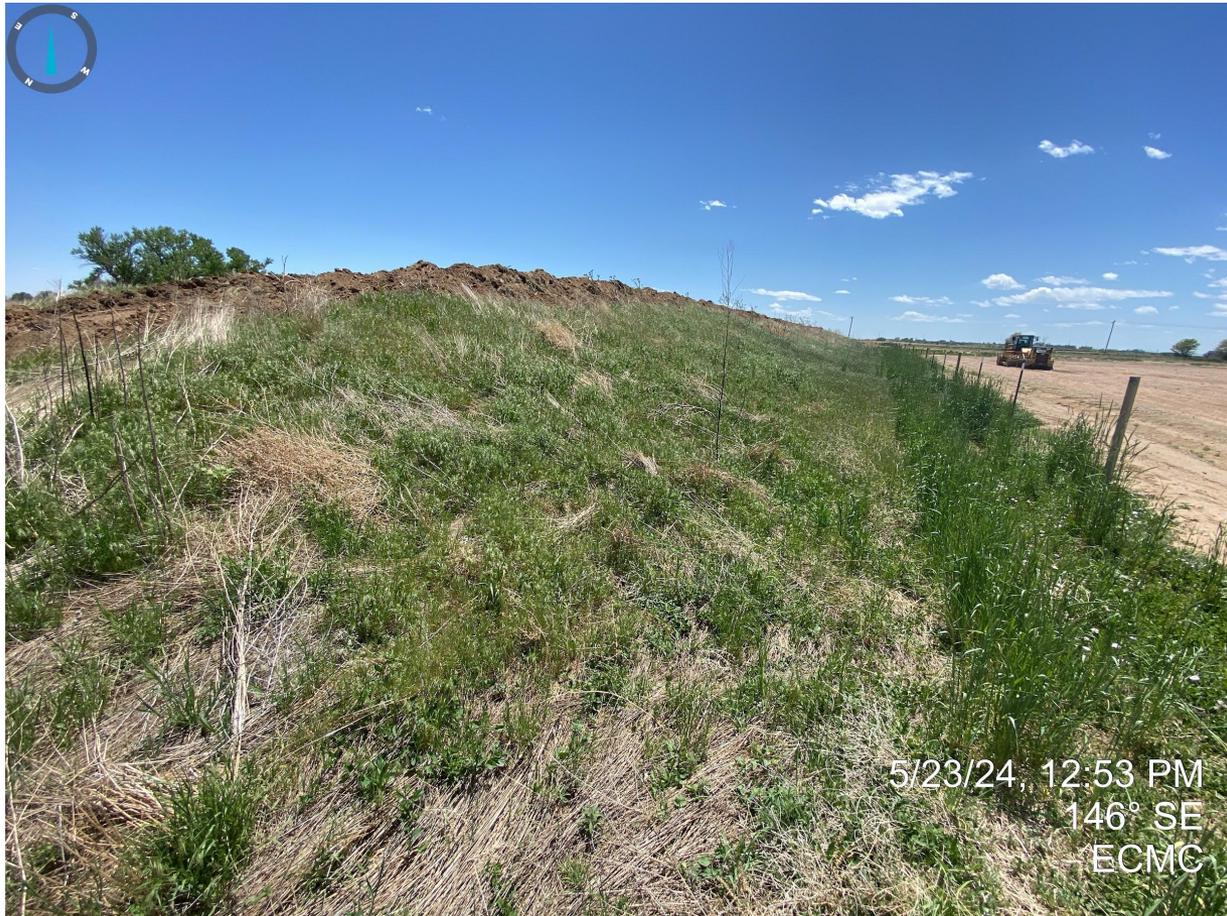
Photo 14. Northeast corner of topsoil stockpile; see comments in Photo 13.

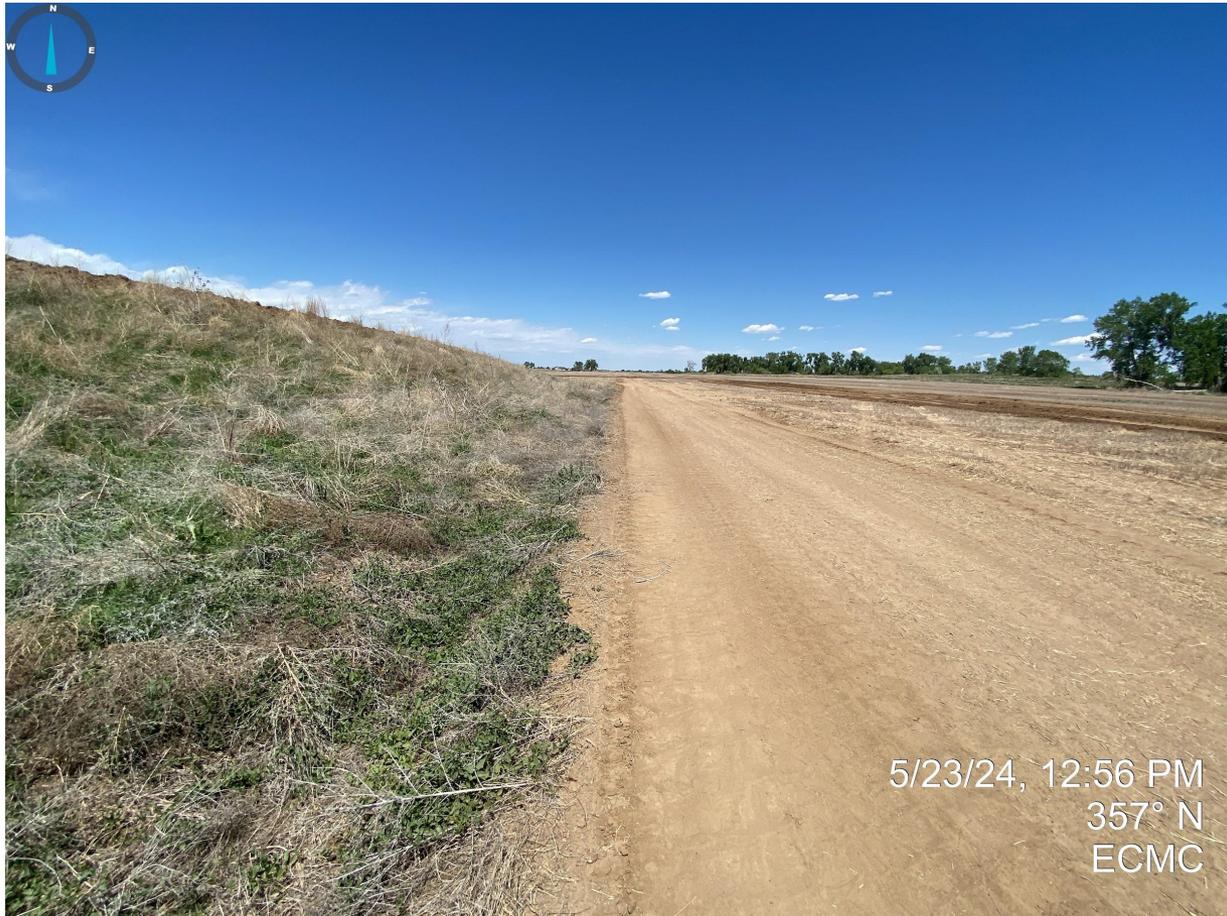
Photo 15. Southeast corner of topsoil stockpile; see comments in Photo 13.

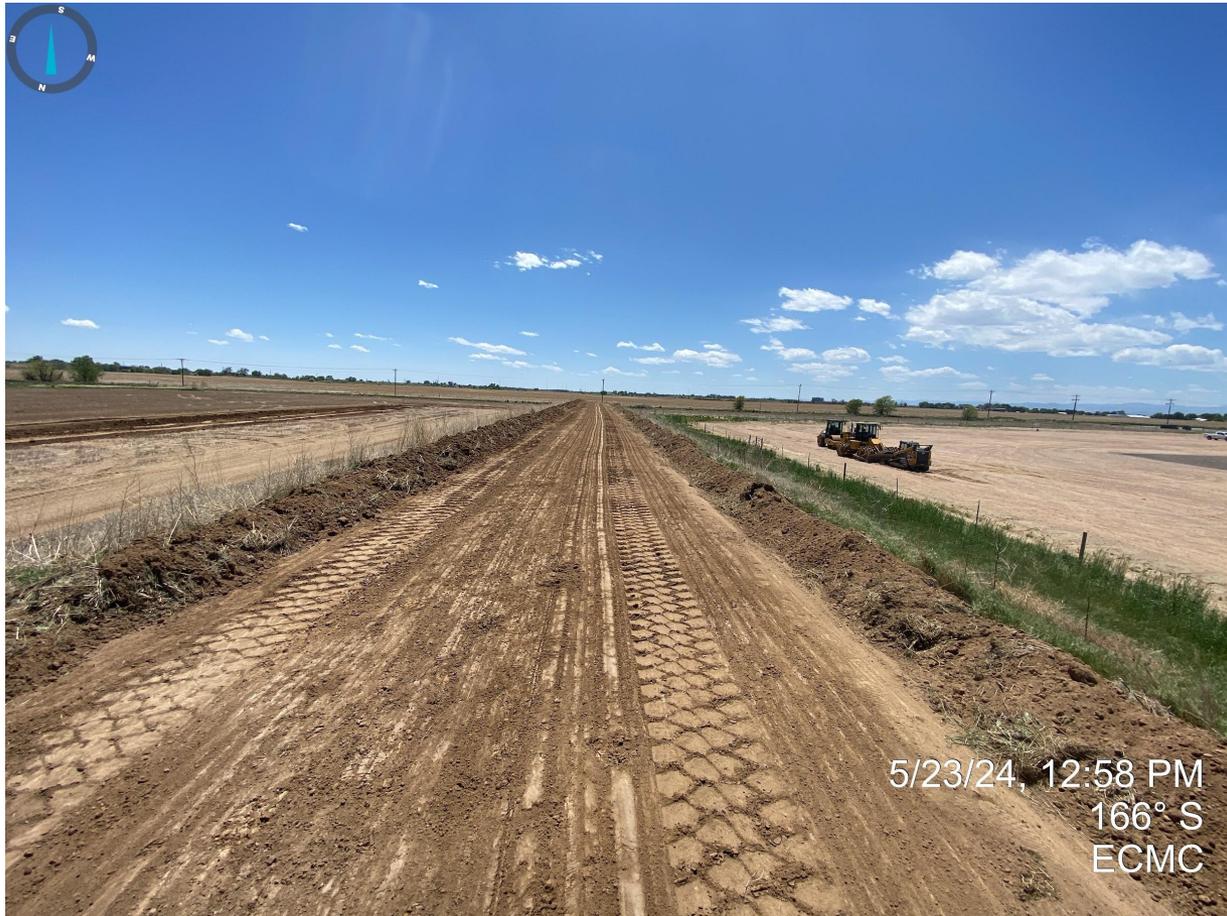
Photo 16. Top/upper portion of the topsoil stockpile; see comments in Photo 13.

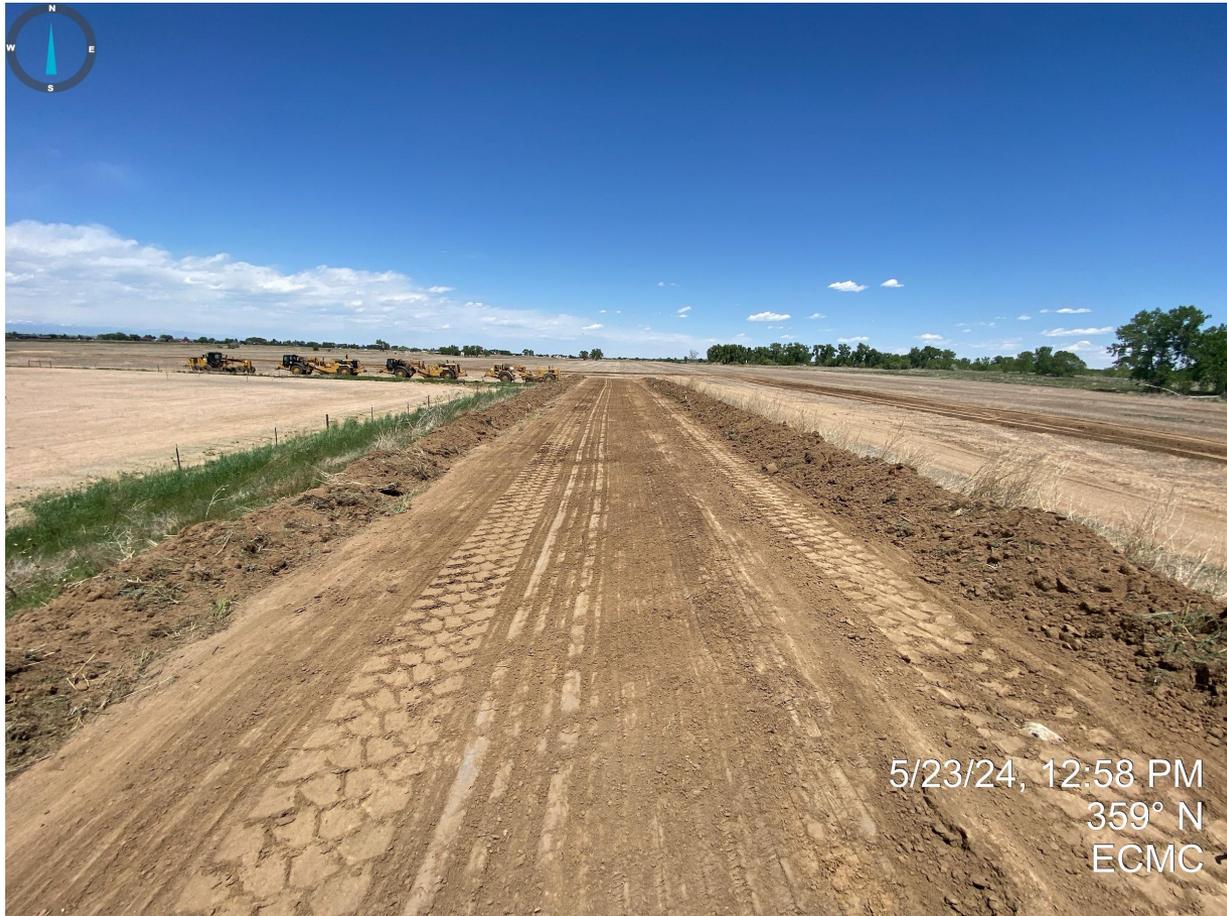
Photo 17. Top/upper portion of the topsoil stockpile; see comments in Photo 13.

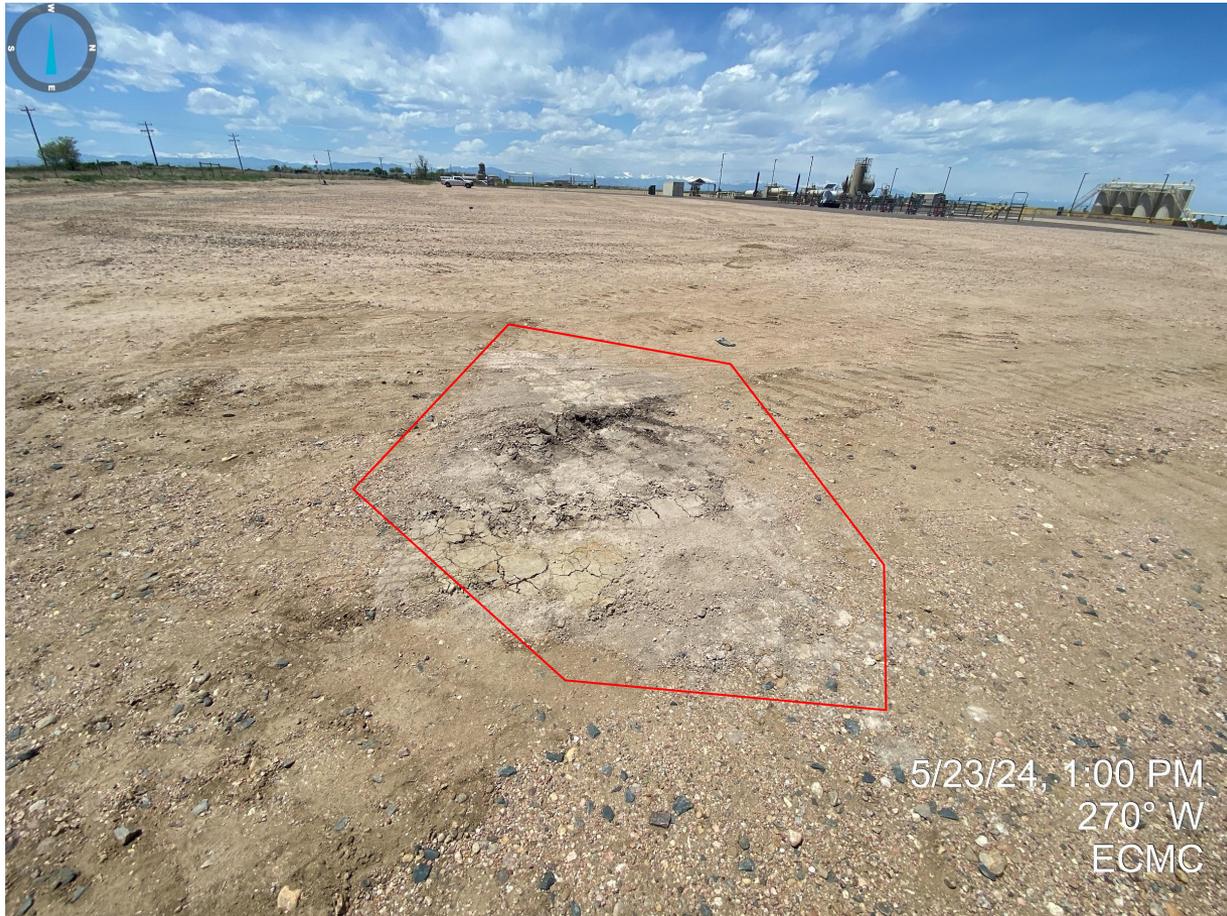
Photo 18. Unmixed concrete debris is a potential stormwater pollutant source and needs to be removed and disposed of.

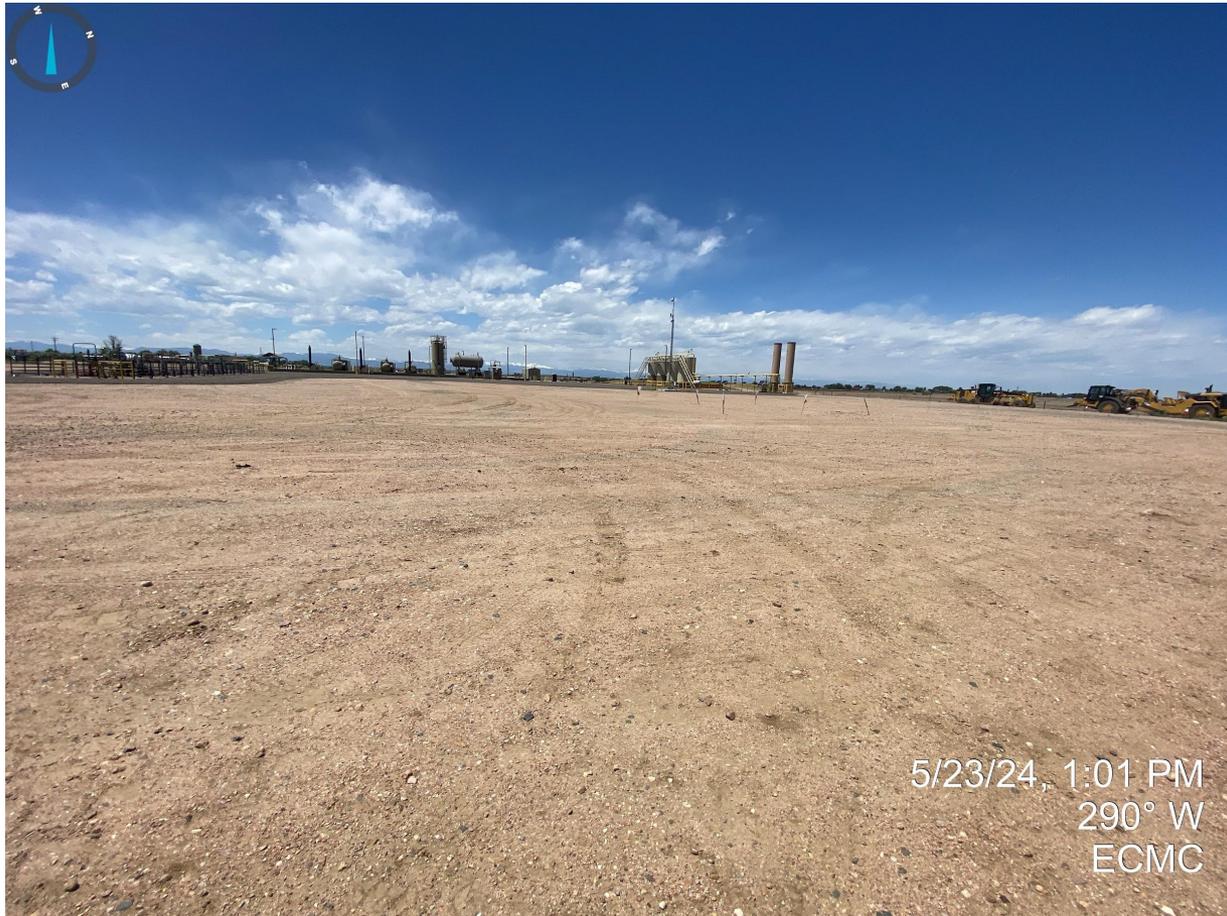
Photo 19. Overview of eastern interim areas; Interim reclamation does not appear to have been performed at the time of this inspection. Refer to FIR for additional information.
