Construction and Stormwater Inspection

Operator: PROVIDENCE OPERATING LLC DBA POCO -
10694

Location ID: 451646

Inspection Photos
Location Name: Brighton Lakes 20-17
Location ID: 451646

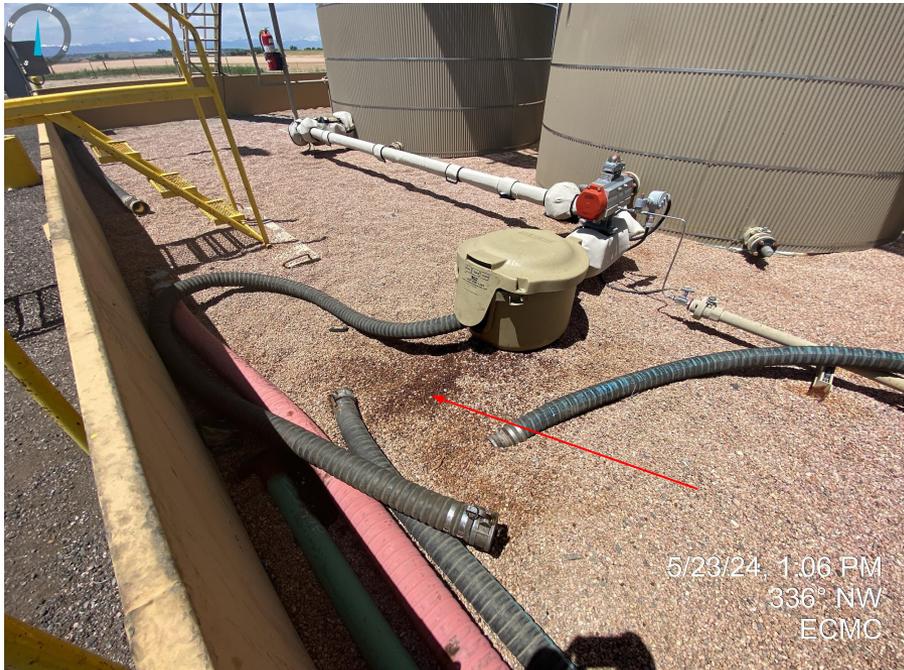
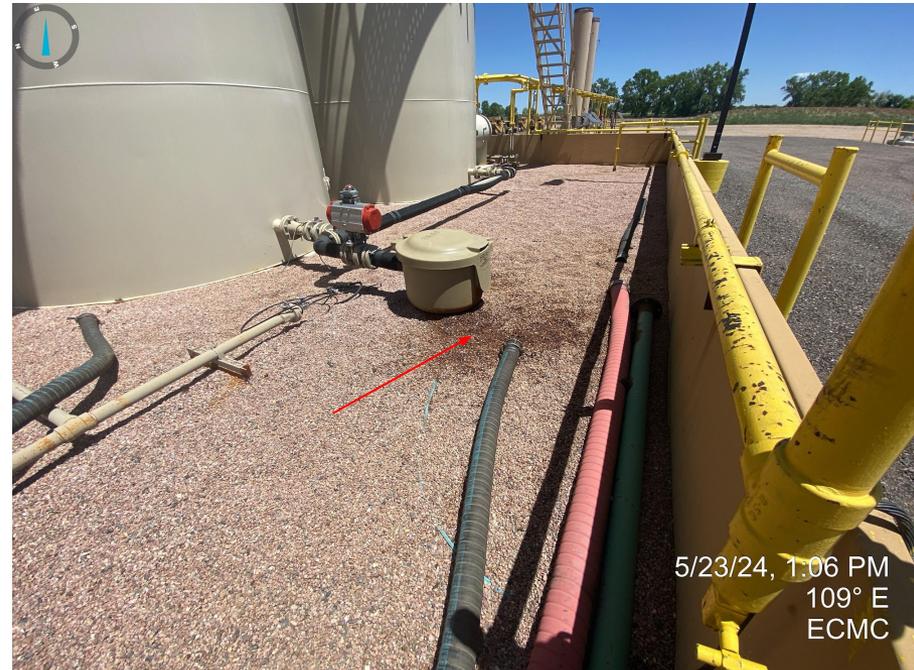
Photos 20 & 21. Stained soil observed within secondary containment at tank battery.

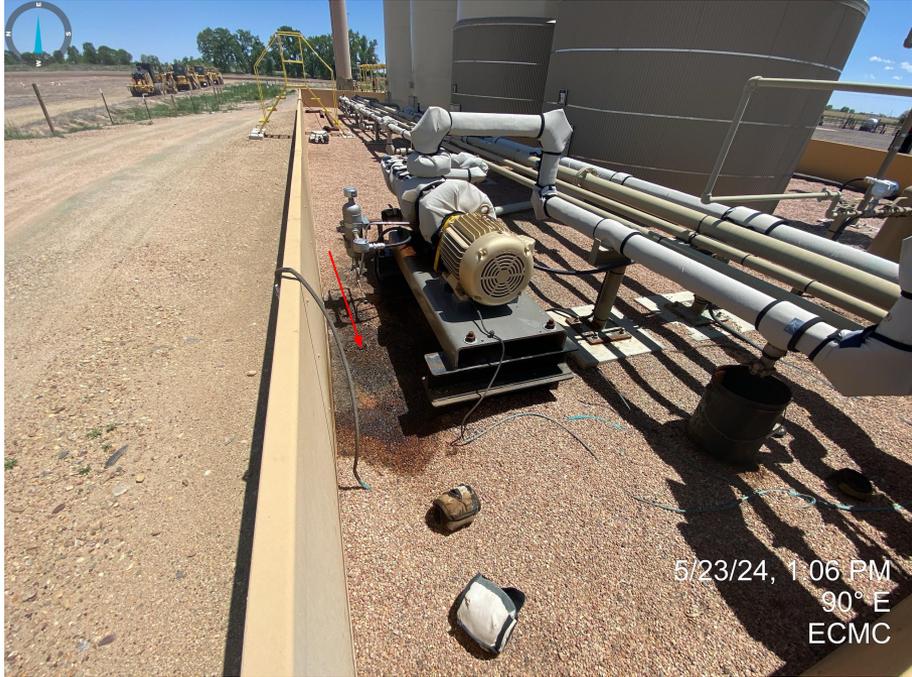
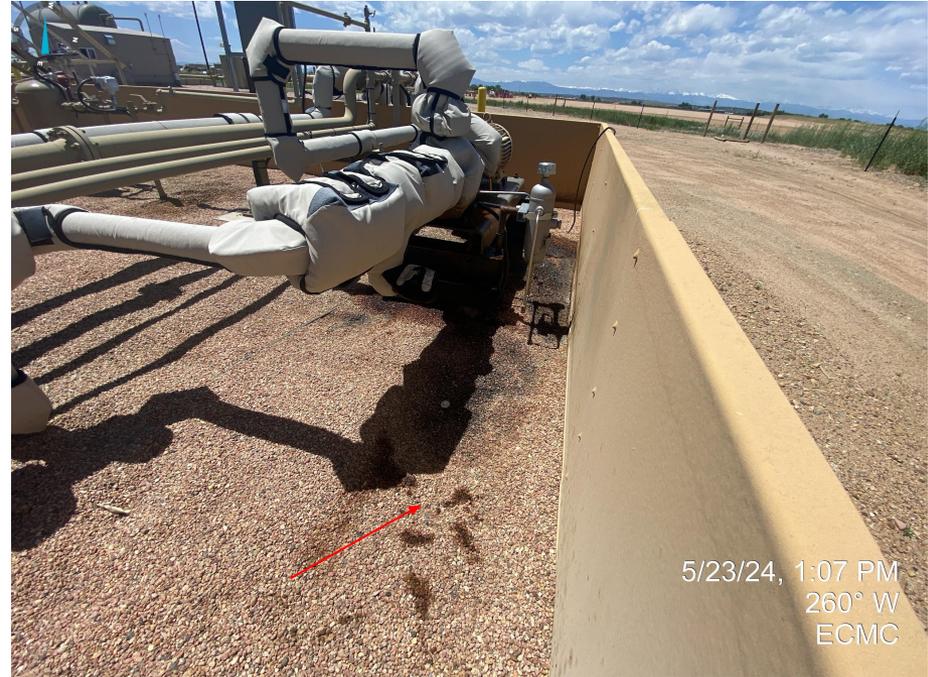
Photos 22 & 23. Stained soils observed near equipment in tank battery secondary containment.

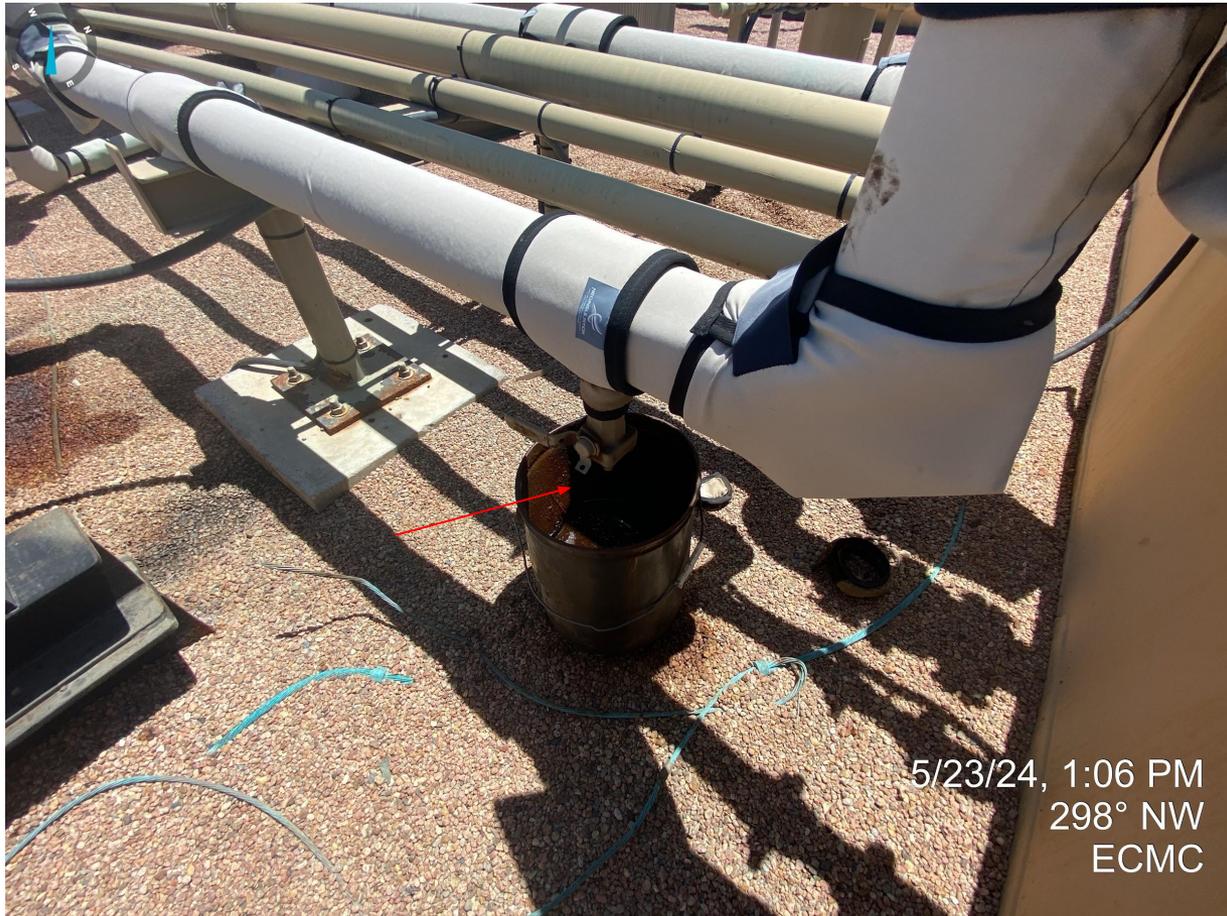
Photo 24. No wildlife protection equipment observed on bucket.

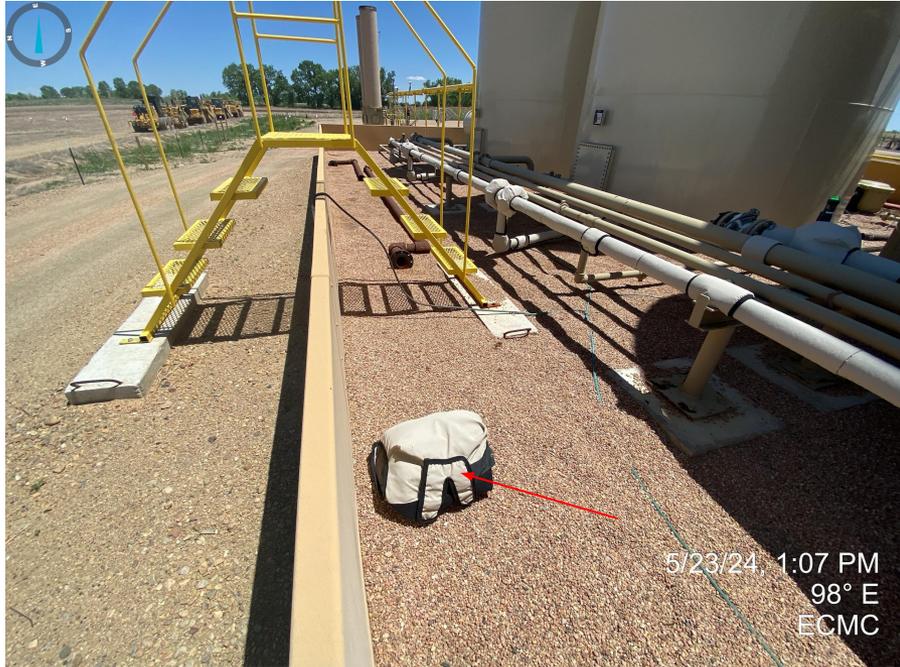
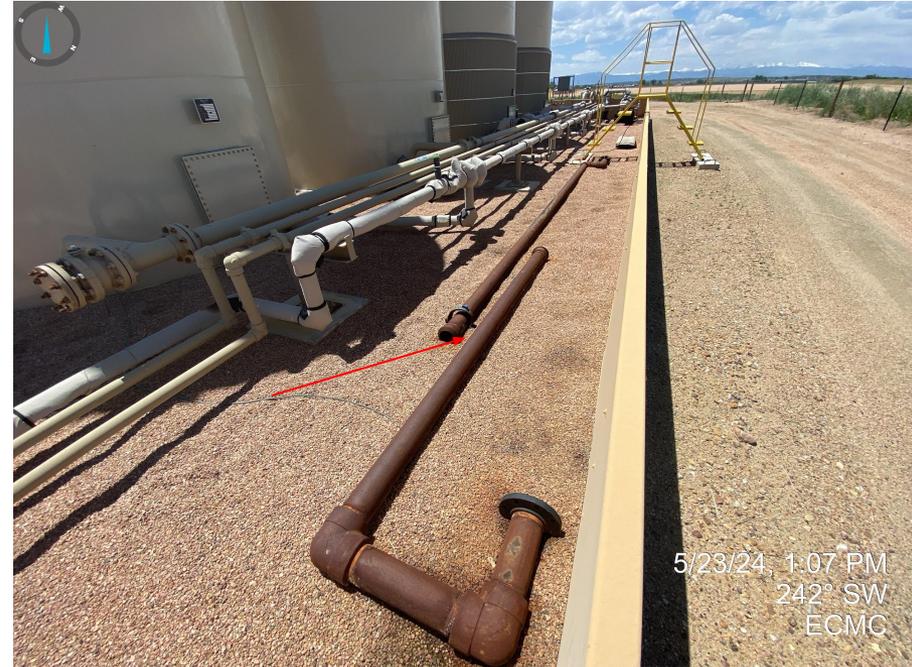
Photos 25 & 26. Unused equipment needs to be removed or returned to service.

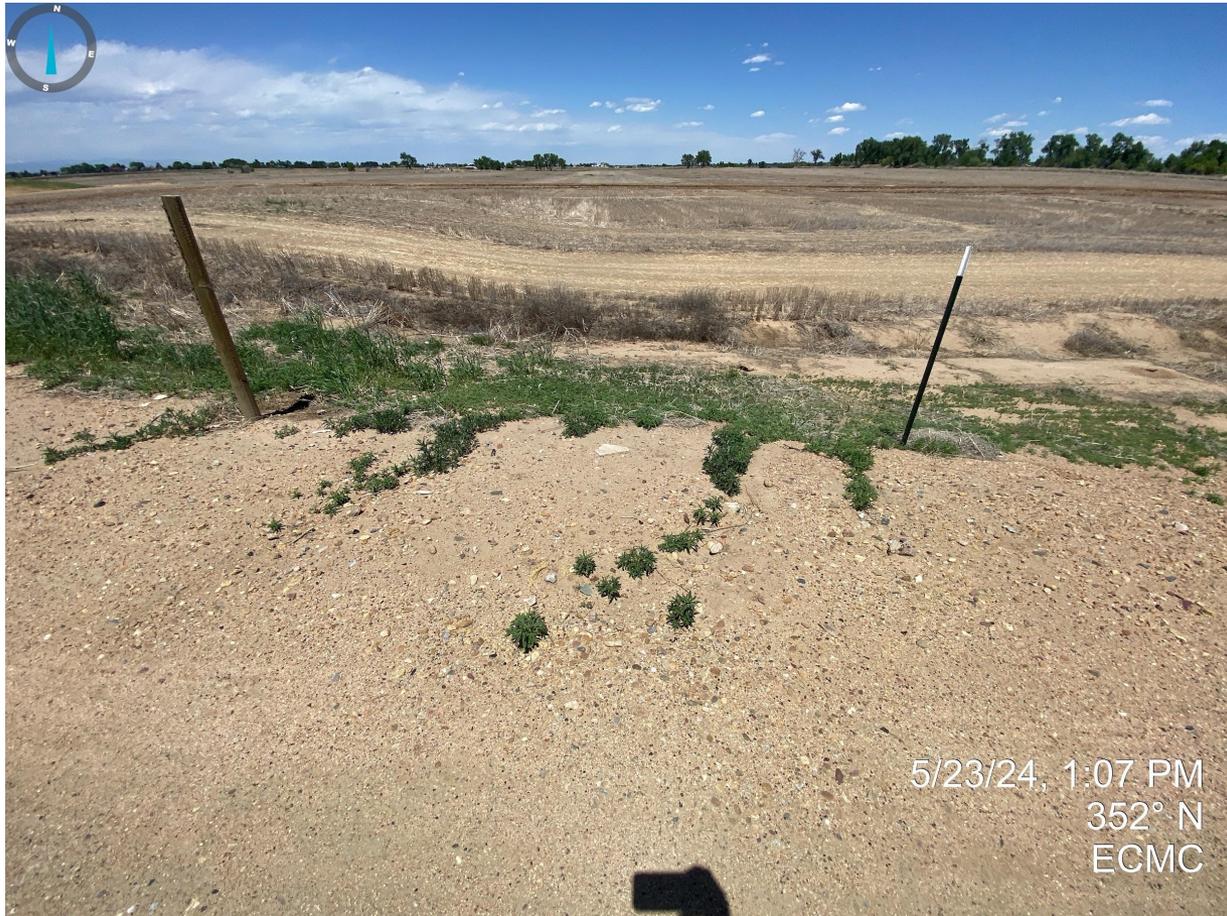
Photo 27. Erosion degradation and undesirable vegetation observed north of tank battery.

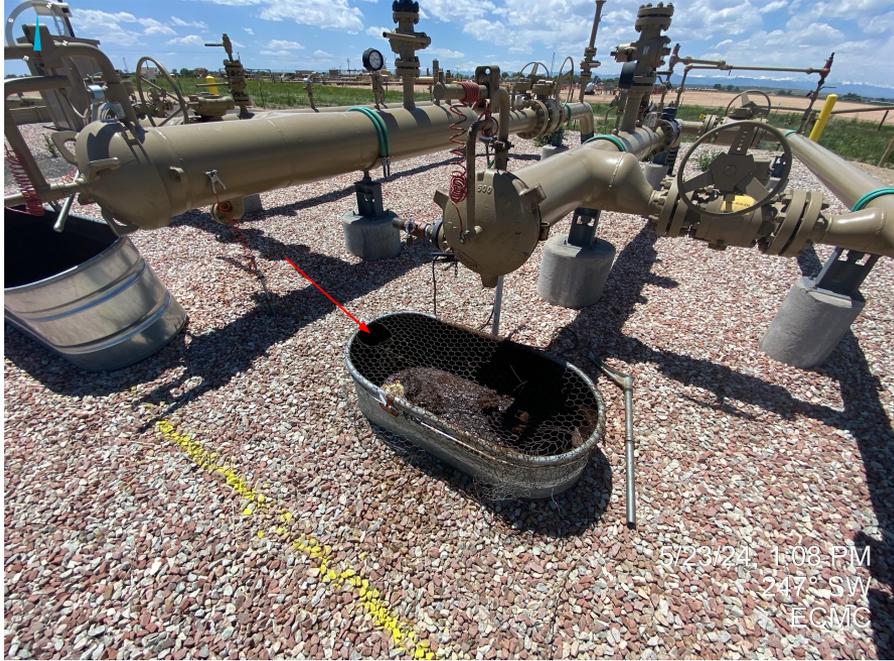
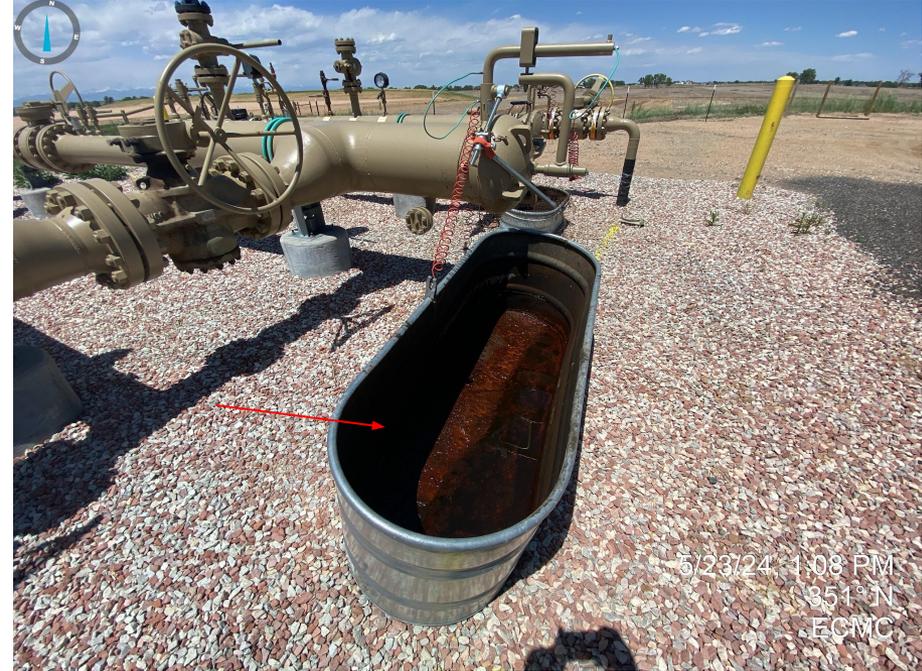
Photos 28 & 29. Wildlife protection equipment is not adequate (torn or not installed). Free fluids need to be removed per Rule 905.e

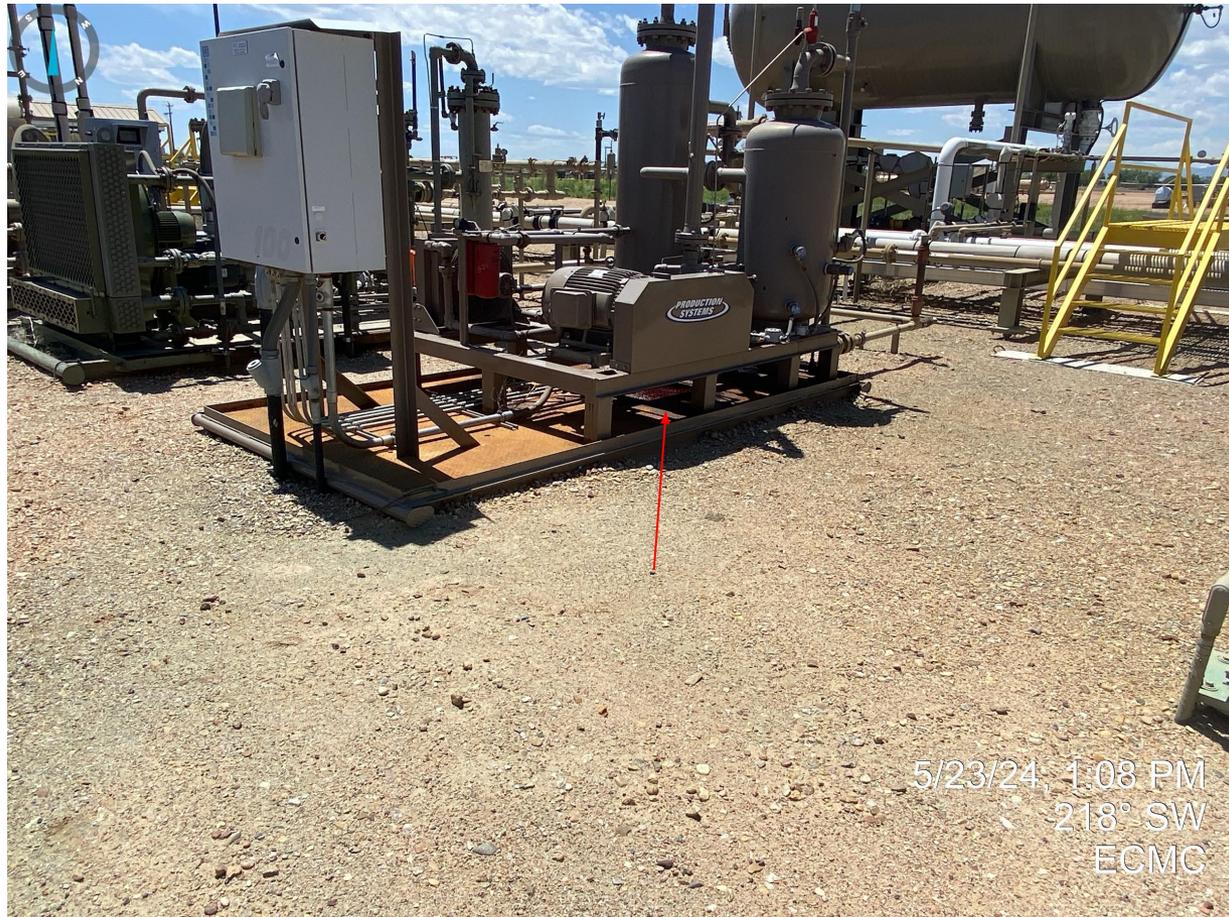
Photo 30. Free fluids observed on skid need to be properly disposed of per Rule 905.e.

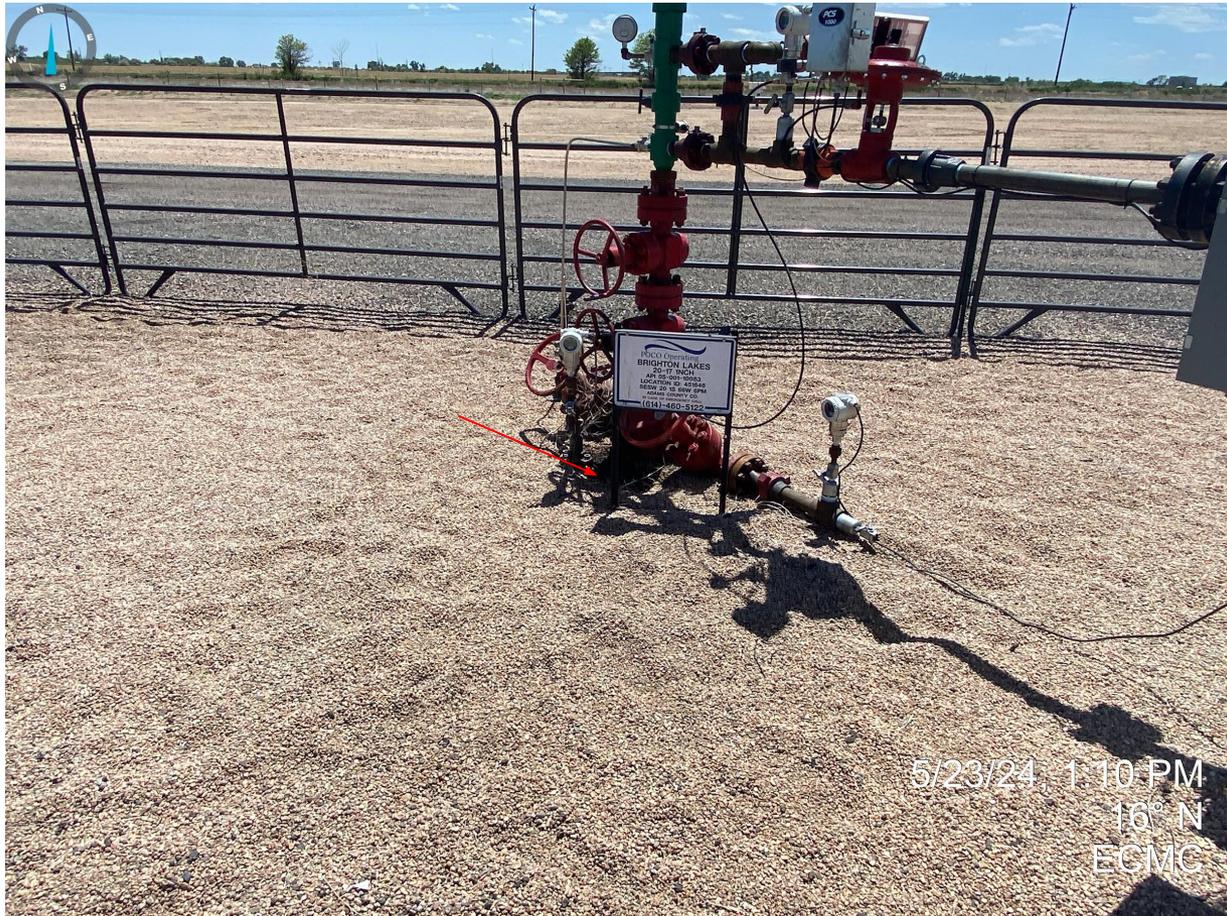
Photo 31. Stained soil observed near wellhead need to be properly disposed of per Rule 905.e.

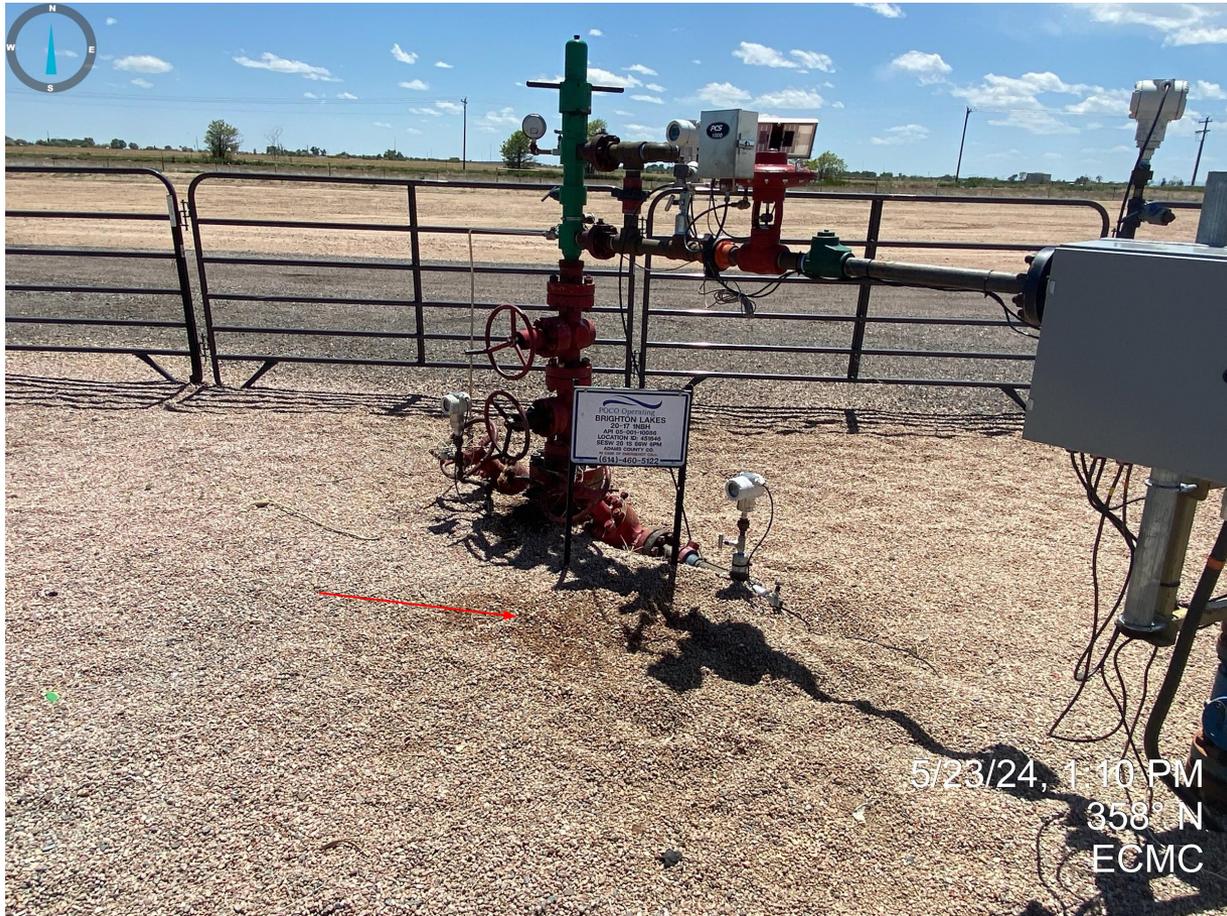
Photo 32. Stained soil observed near wellhead need to be properly disposed of per Rule 905.e.

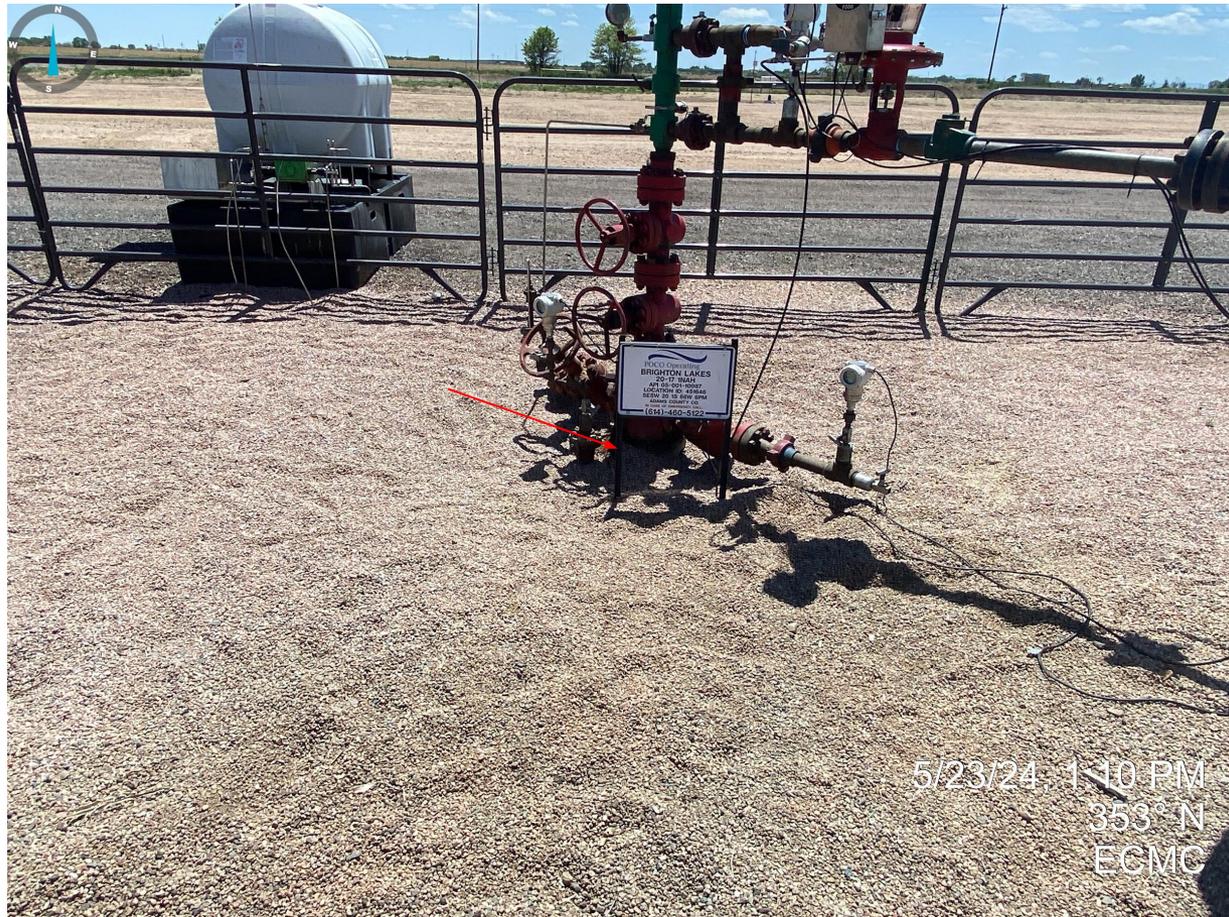
Photo 33. Stained soil observed near wellhead need to be properly disposed of per Rule 905.e.

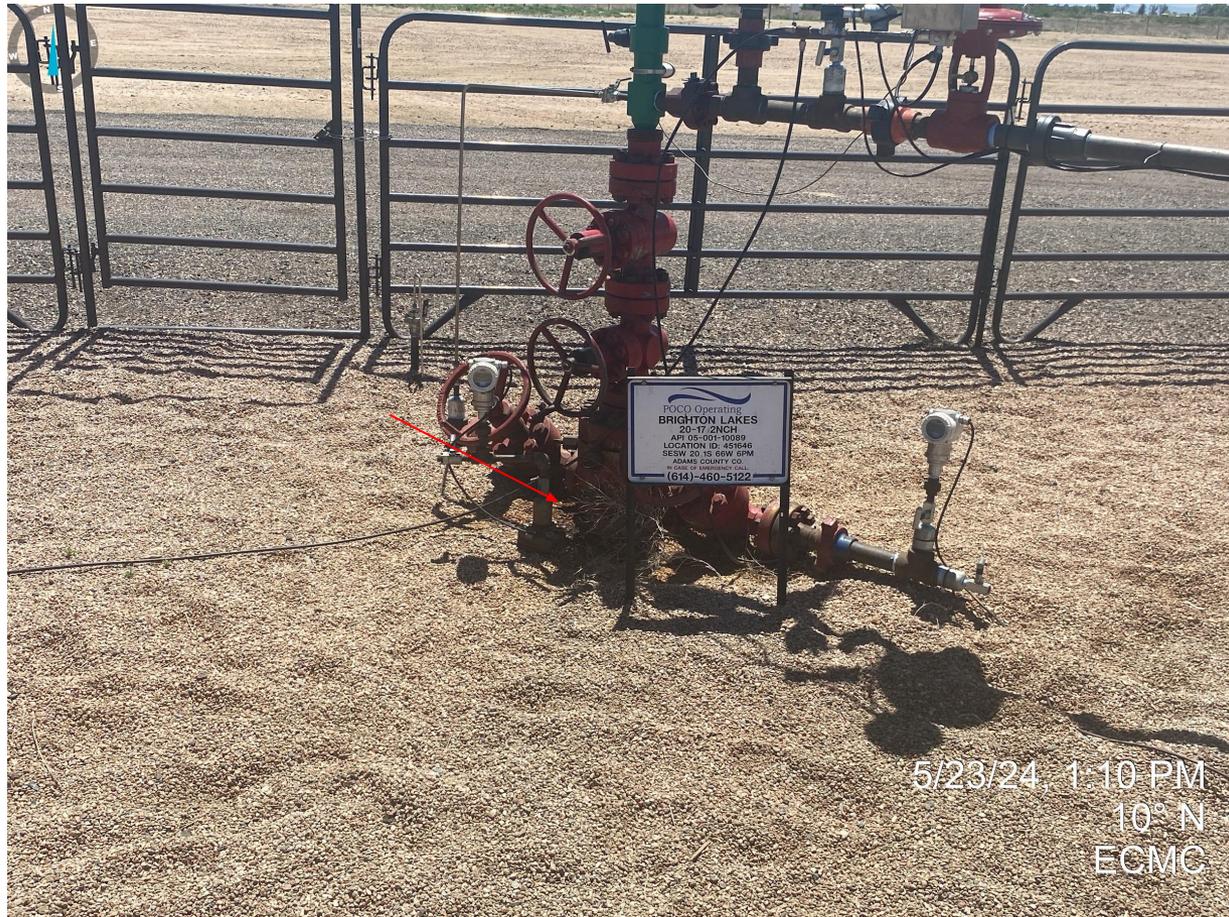
Photo 34. Stained soil observed near wellhead need to be properly disposed of per Rule 905.e.

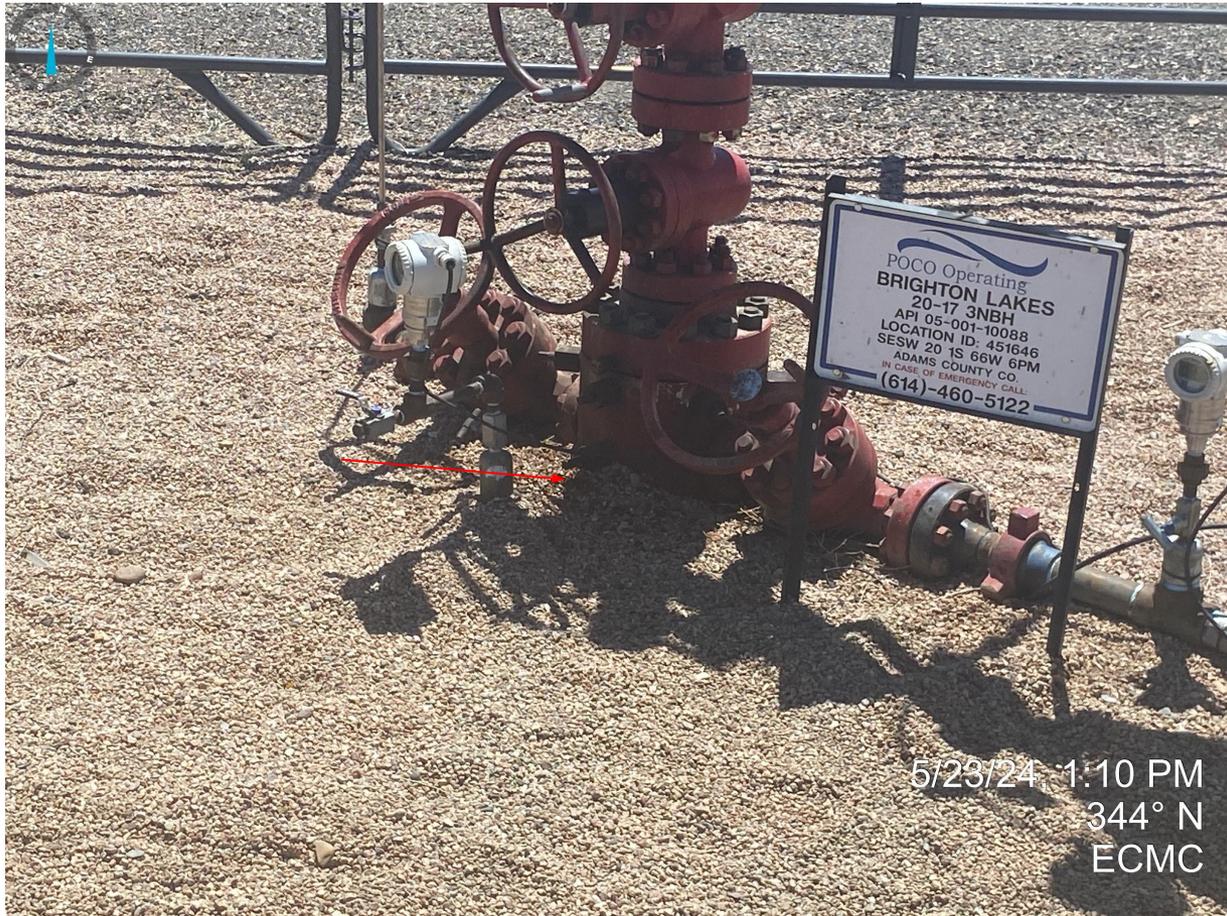
Photo 35. Stained soil observed near wellhead need to be properly disposed of per Rule 905.e.

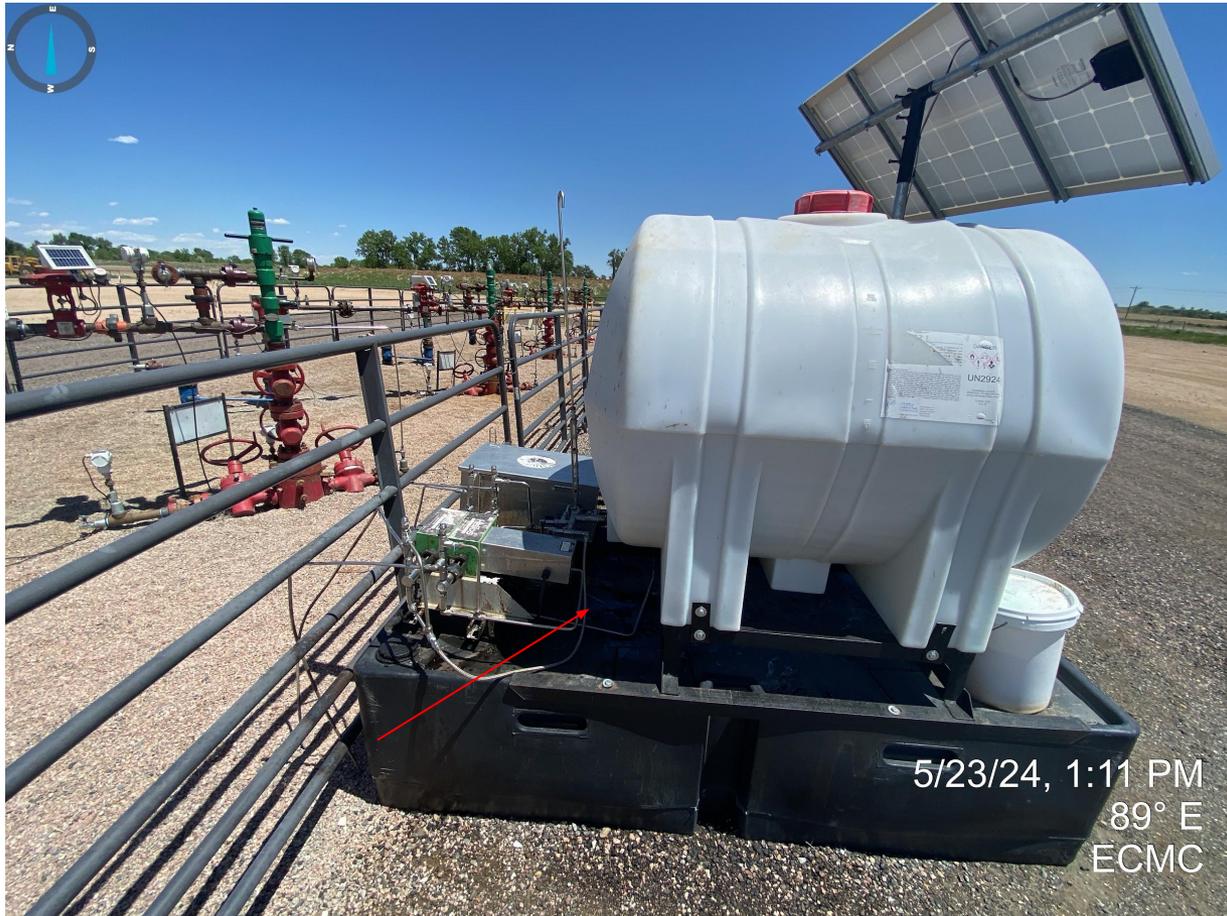
Photo 36. Free fluids observed within secondary containment need to be properly disposed of.
