Inspection Photos

Location Name: TEP ROCKY MOUNTAIN LLC Wasatch Compressor Station

Facility # 467146

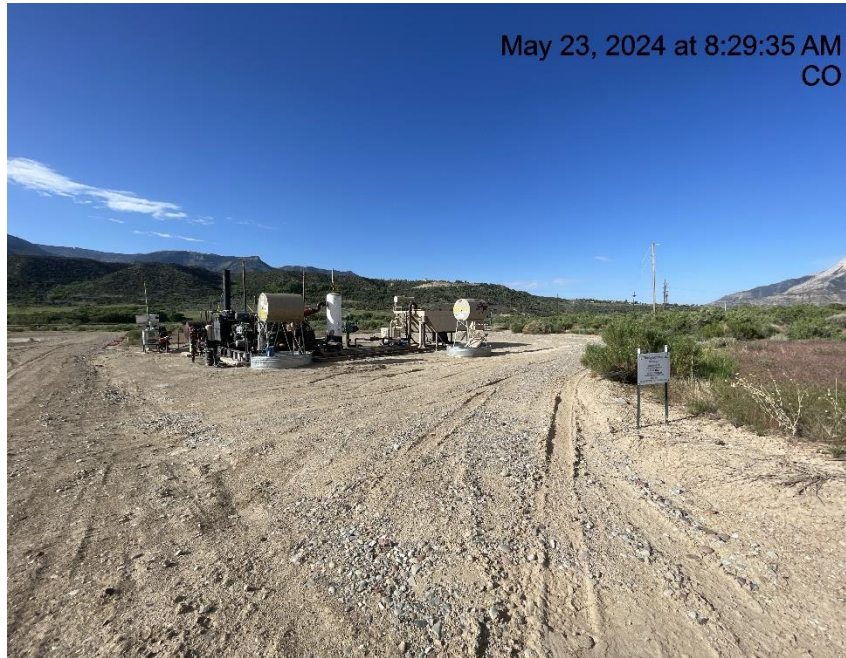
Photo # 8051 From entrance to location

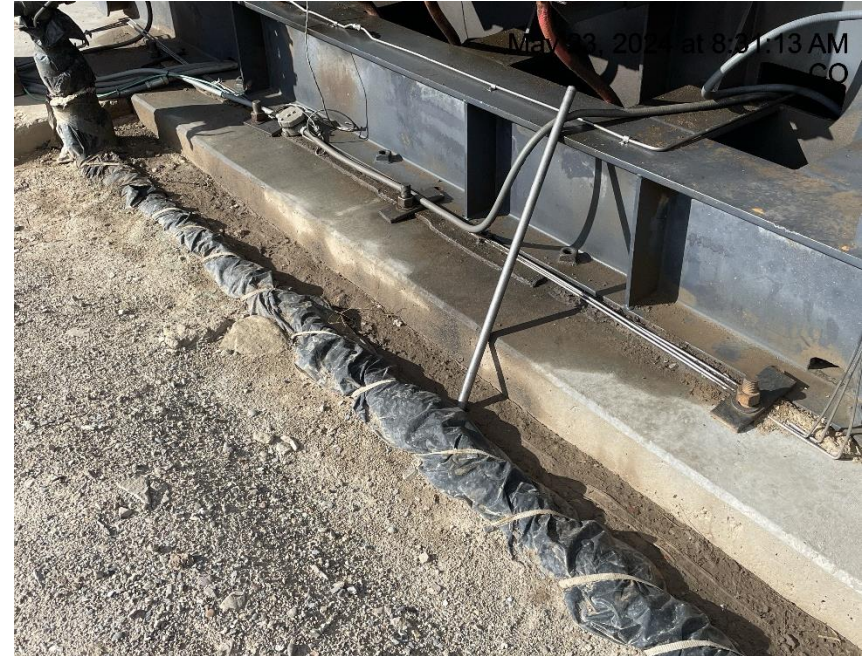
Photo # 8058 Staining near compressor

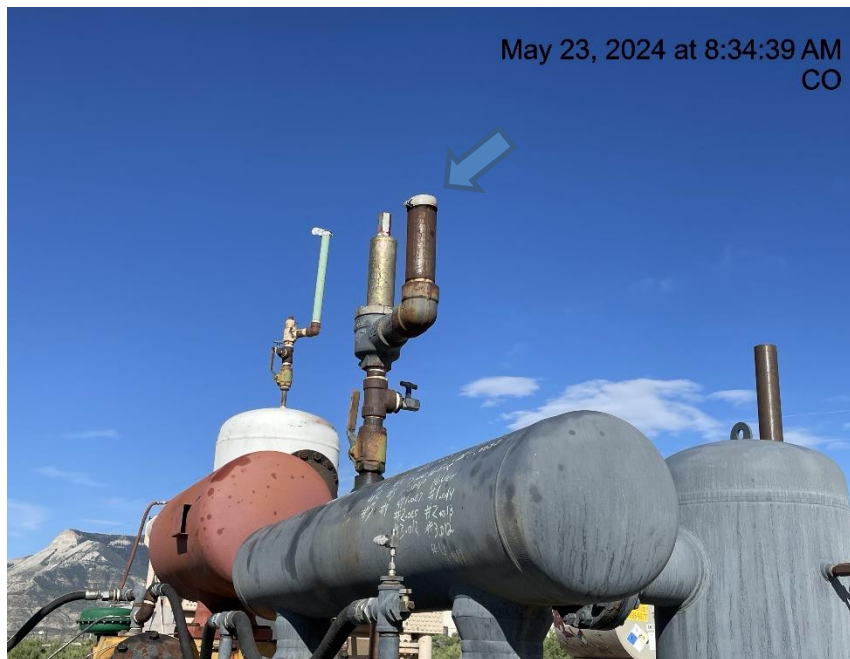
Photo # 8059 PRV vent line lacks cap/does not comply with CECMC pressure safety device rules

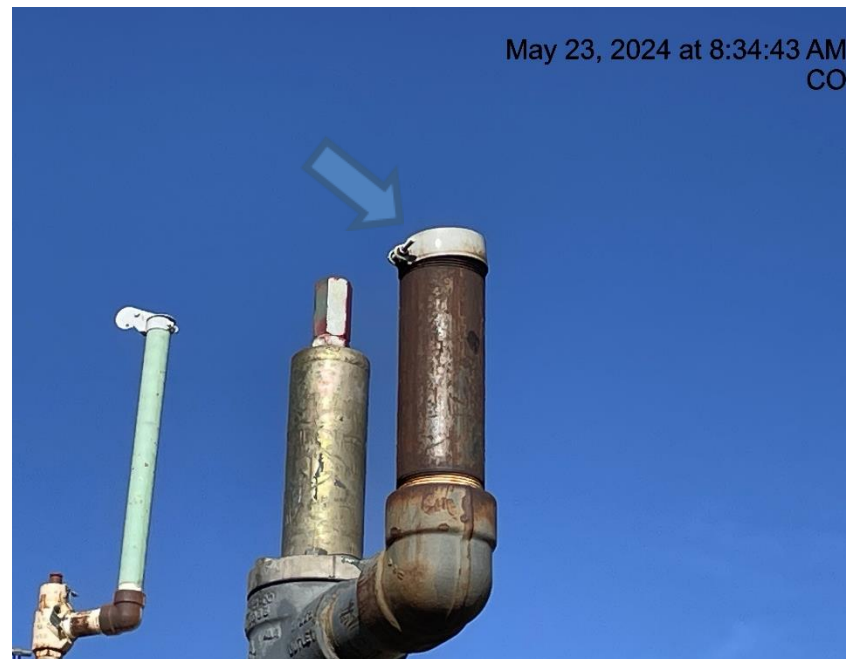
Photo # 8060 PRV vent line lacks cap/does not comply with CECMC pressure safety device rules

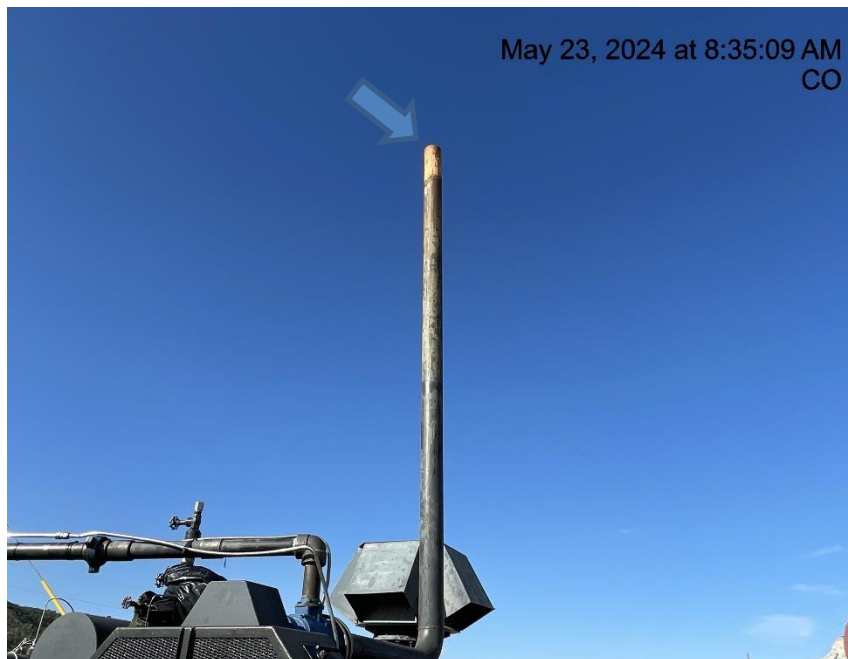
Photo # 8061 Stack/piping lacks wildlife protection/does not comply with CECMC wildlife rules

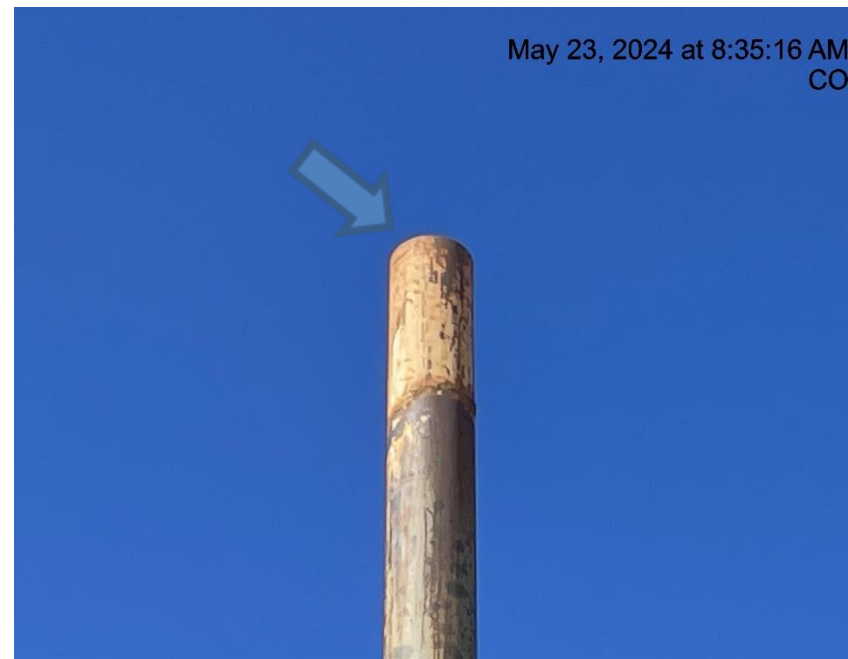
Photo # 8062 Stack/piping lacks wildlife protection/does not comply with CECMC wildlife rules

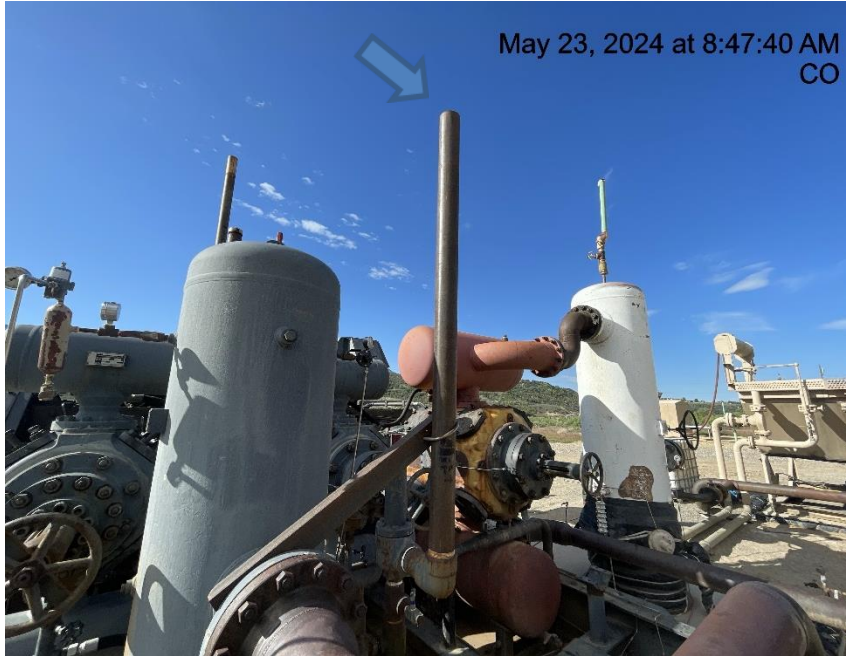
Photo # 8063 PRV vent line lacks cap/does not comply with CECMC pressure safety device rules

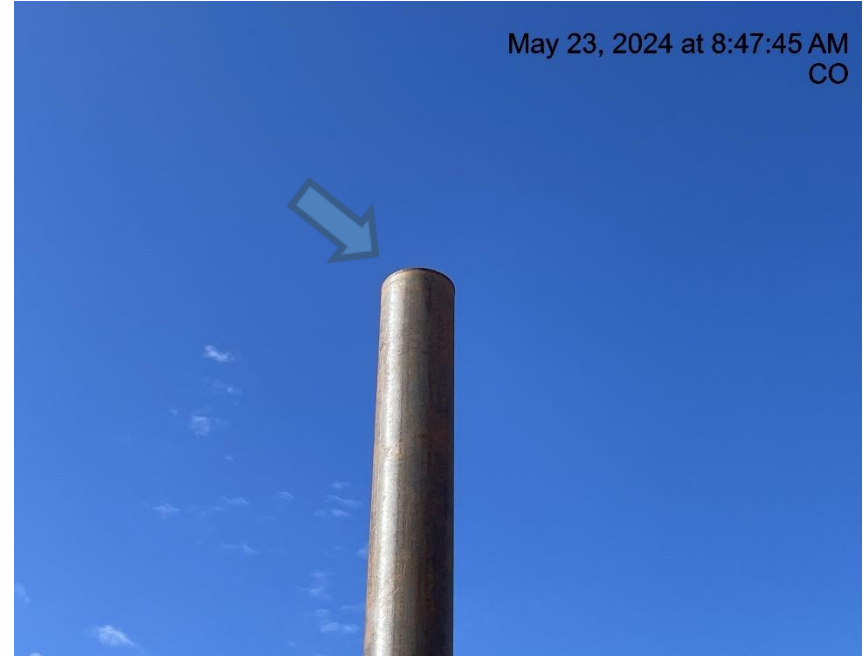
Photo # 8064 PRV vent line lacks cap/does not comply with CECMC pressure safety device rules
