Storm Water Management and Erosion control
Location Name: TEP ROCKY MOUNTAIN LLC CLOUGH RMV 232-28 Pad
Location ID: 324163

Section/Township/Range: 28 6S94W

COLORADO
Energy & Carbon Management
Commission
Department of Natural Resources

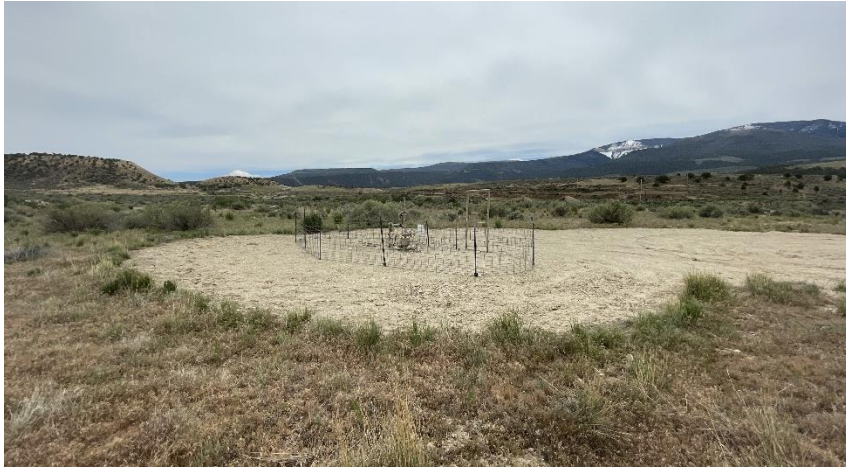
North West corner of location.

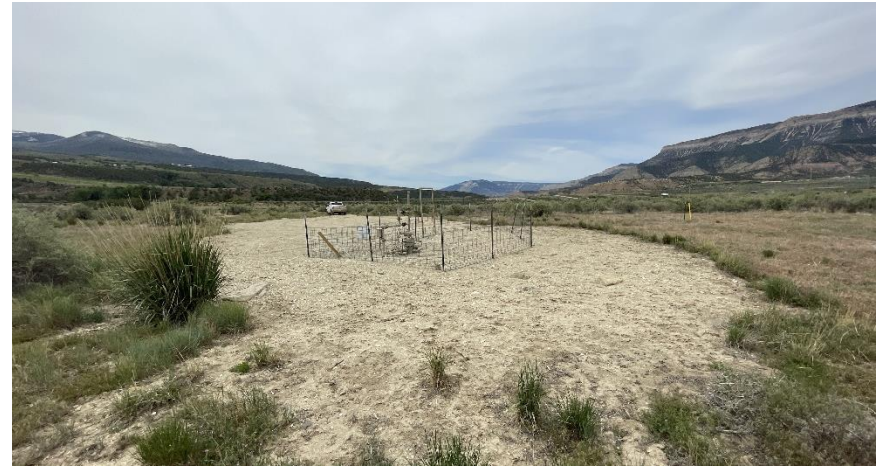
North East corner of location.

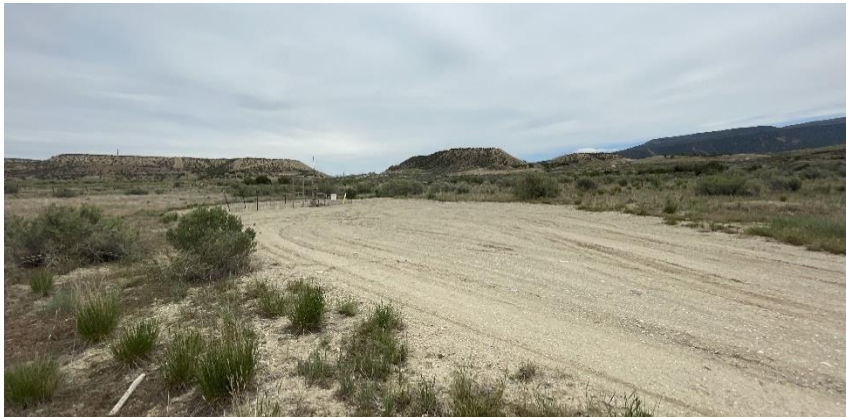
South West corner of location.

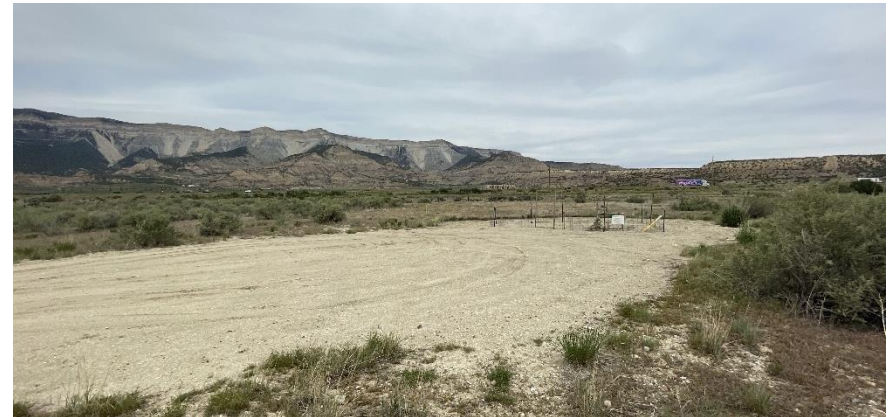
South East corner of location.

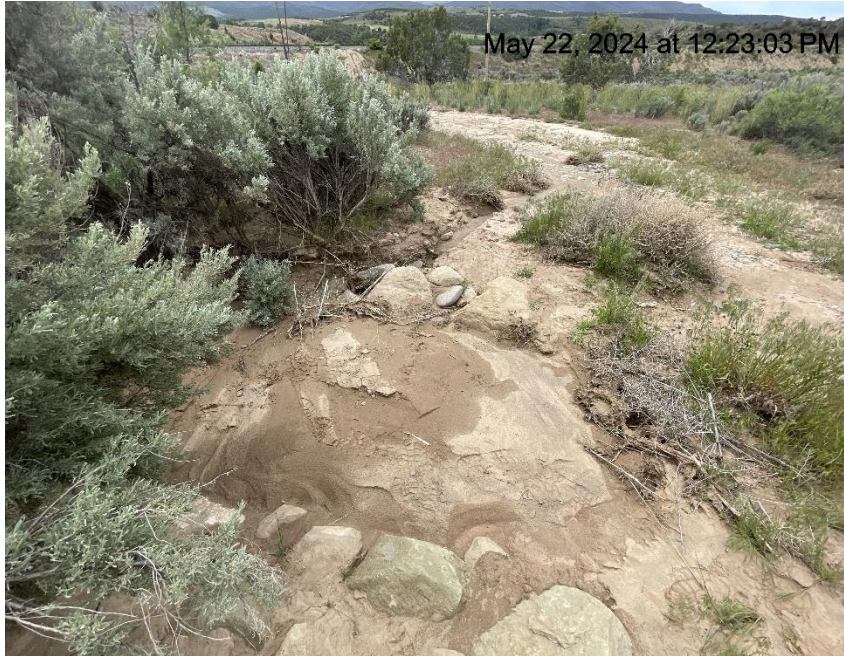
Photo # 7891 Ditch & Culvert need maintenance/erosion & transport of sediment onto lease road

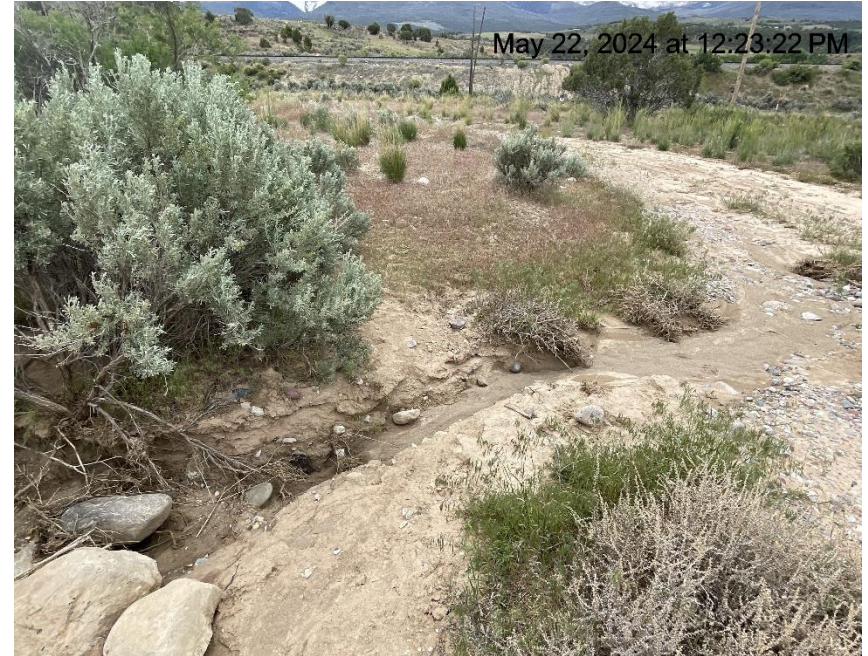
Photo # 7892 Erosion & transport of sediment onto lease road

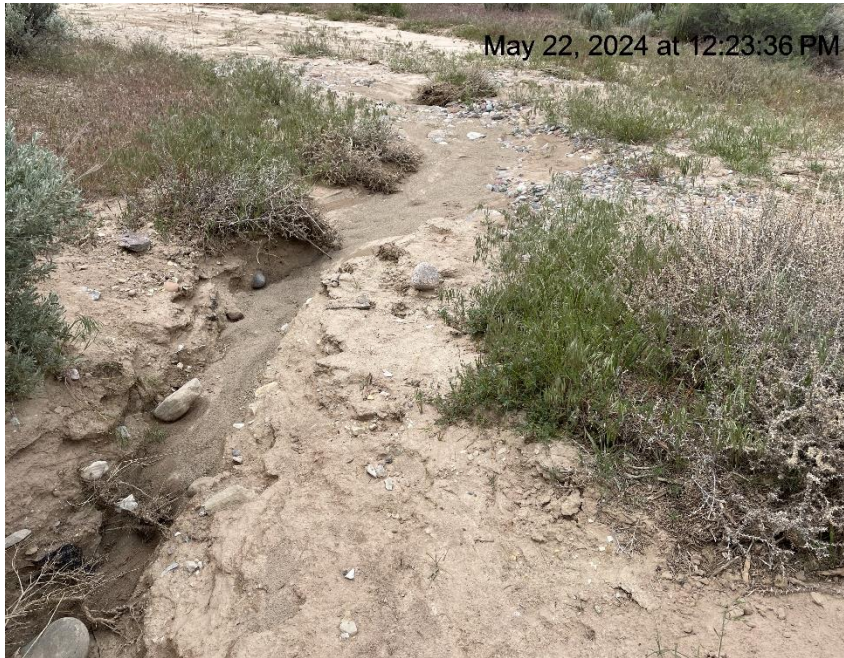
Photo # 7893 Erosion & transport of sediment onto lease road

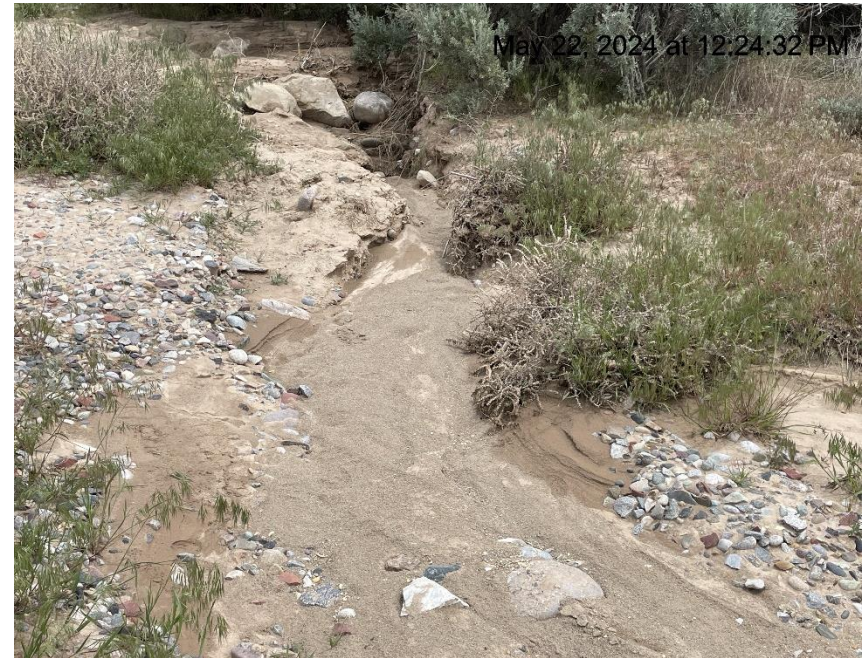
Photo # 7894 Erosion & transport of sediment onto lease road

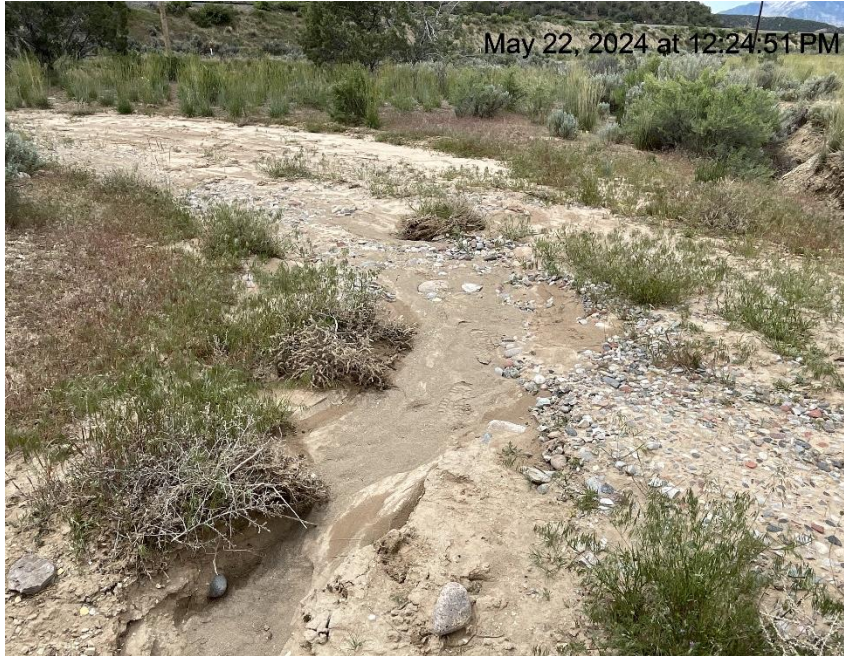
Photo # 7895 Erosion & transport of sediment onto lease road

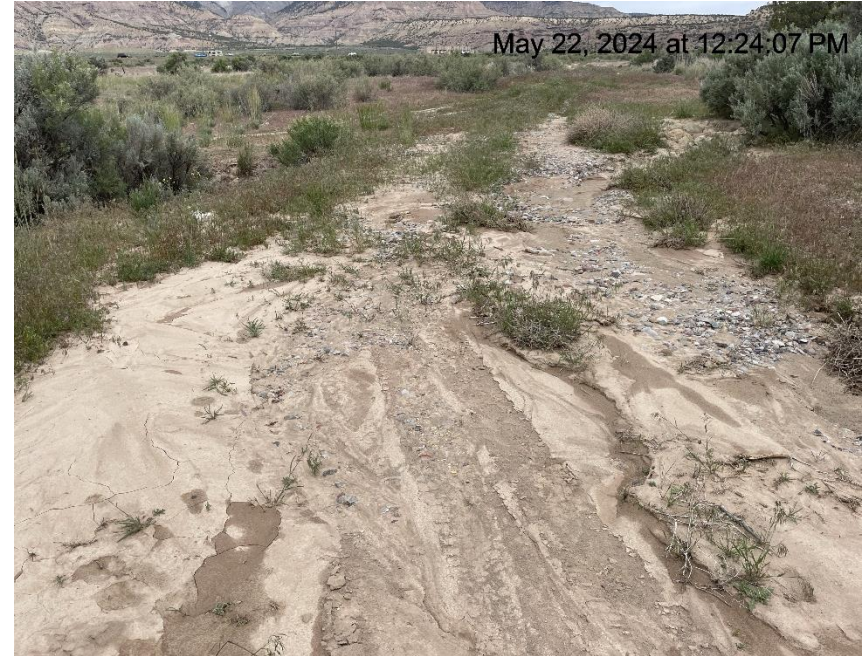
Photo # 7896 Erosion & transport of sediment onto lease road
