Final Reclamation Inspection

Operator: NEWPEK LLC #10484

Location ID: 445039

Inspection Photos
Location Name: Fauver #1-20
Location ID: 445039

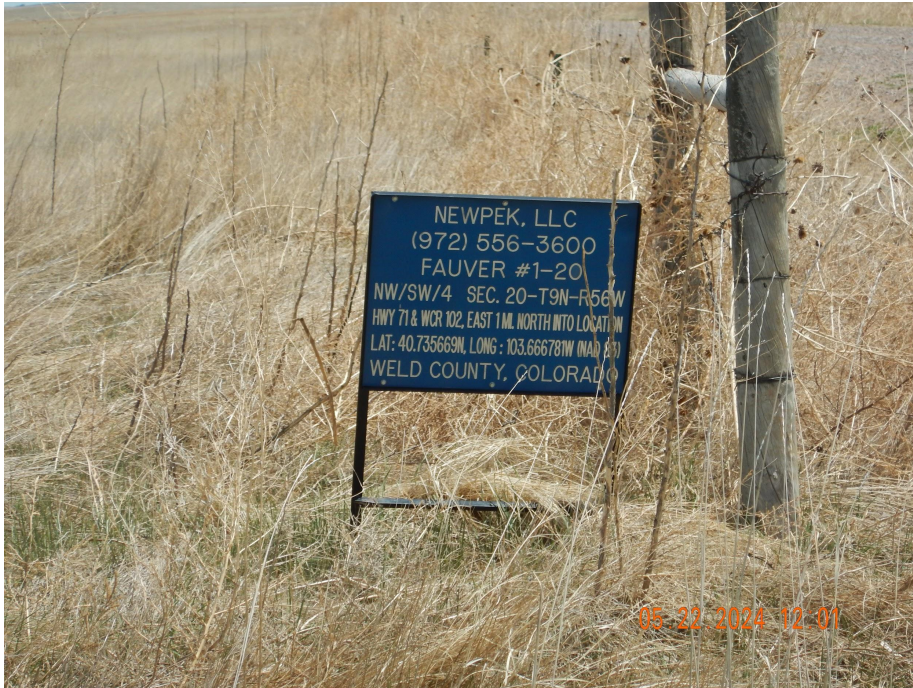
Photo 1. Photo taken from the well location entrance off CR 102, facing East. Photo illustrates the Operator well sign.

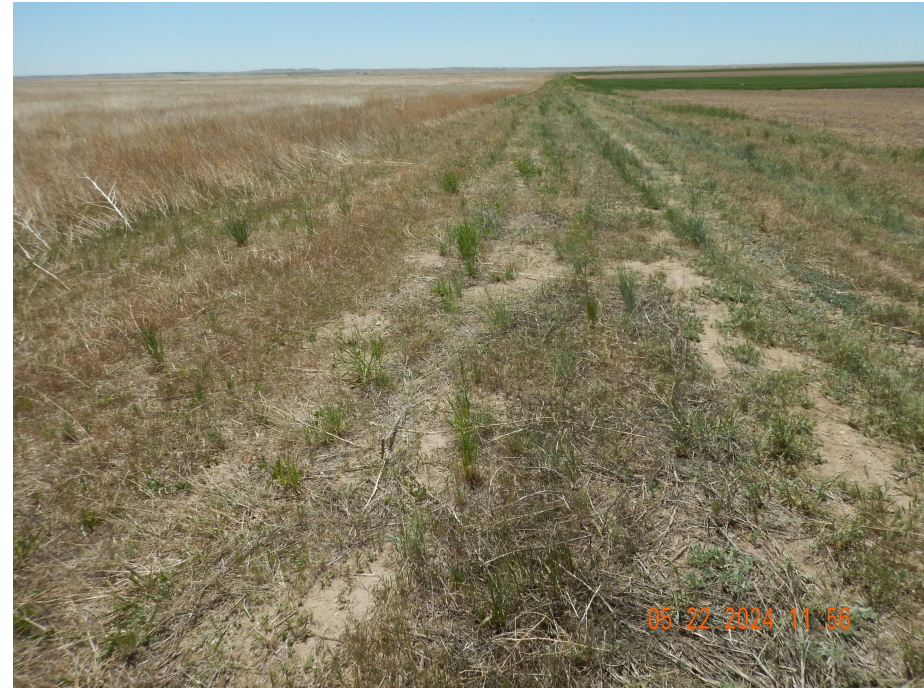
Photo 2. Photo taken from the northern section of the well location access road, facing South. Photo illustrates the establishment of grass species but it is not uniform or reflective of reference area vegetative levels. The access road has a high density of cheatgrass and annual vegetation. There is evidence of mowing with remnant annual stocks.

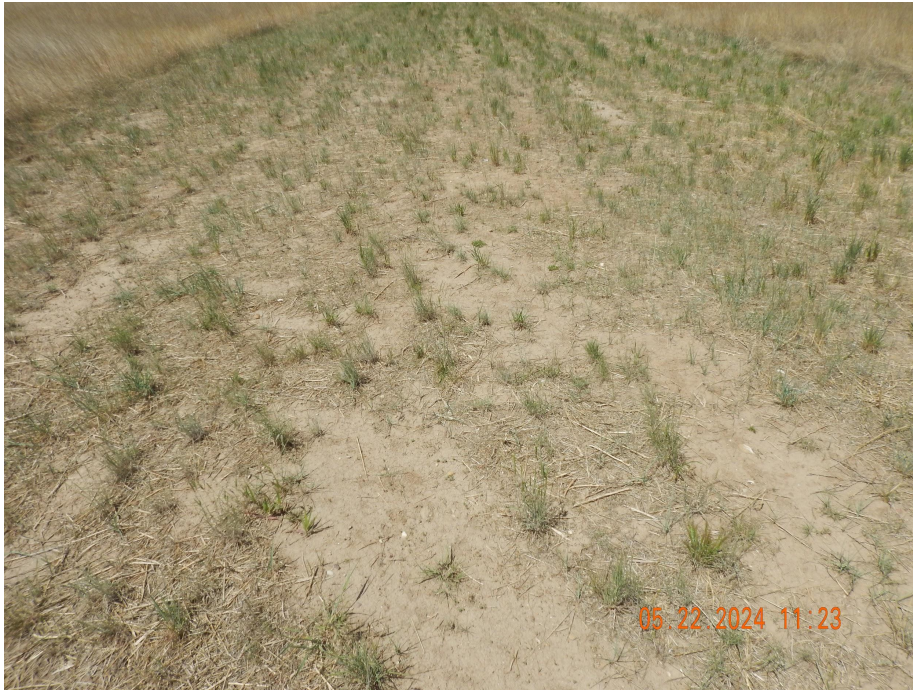
Photo 3. Photo taken just west of the location along the west-east access road section, facing West. Photo illustrates the establishment of grass species but it is not uniform or reflective of reference area vegetative levels.

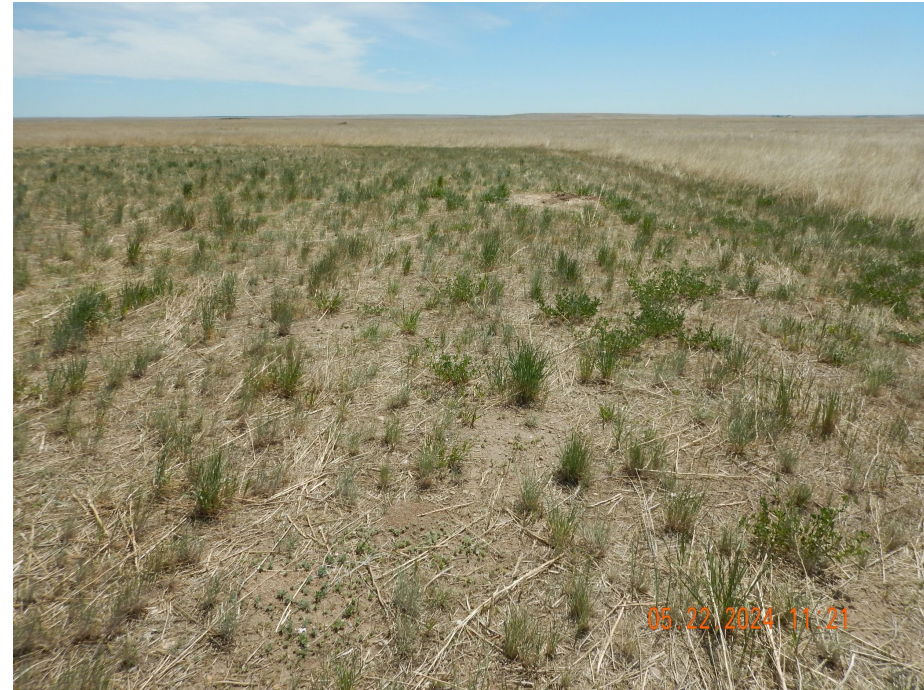
Photo 4. Photo taken from the southern location, facing East. See comments under Photo 2 and 3.

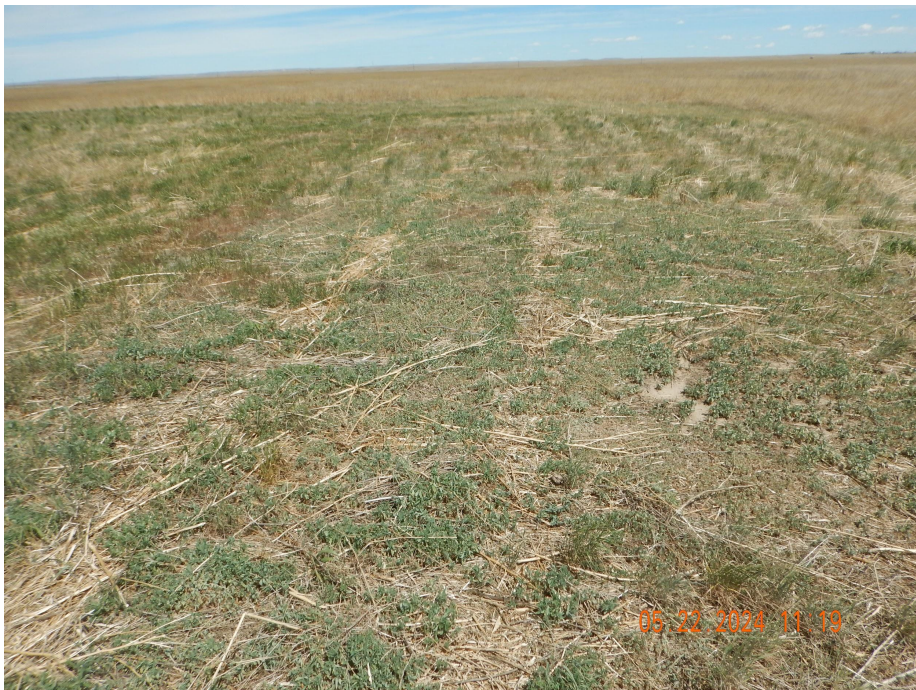
Photo 5. Photo taken from the eastern location, facing North. Photo illustrates a section that is dominated by annual, weedy Kochia vegetation.

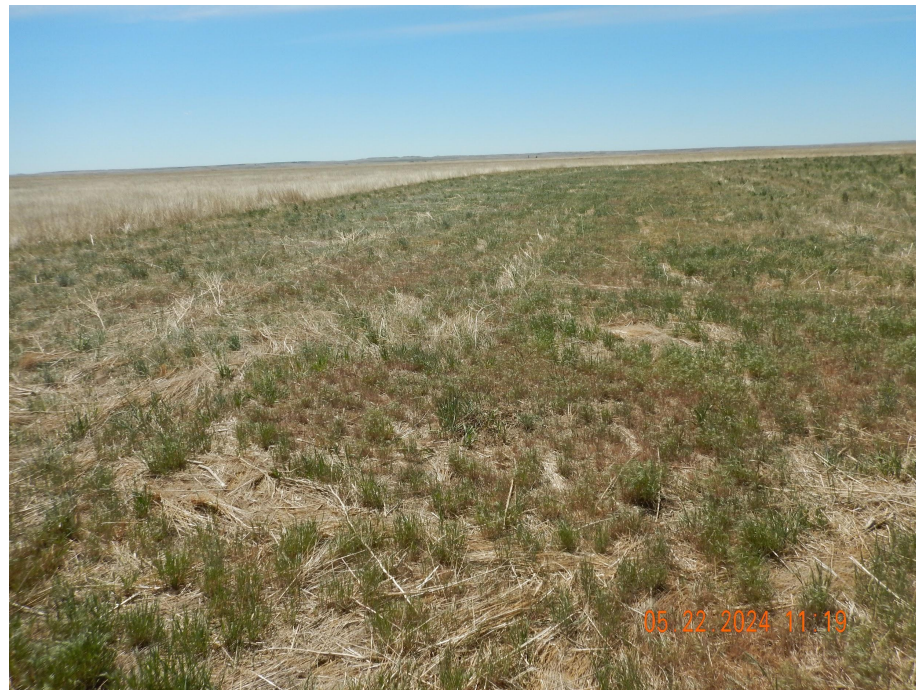
Photo 6. Photo taken from the northern location, facing East. See comments under Photo 2 and 3.

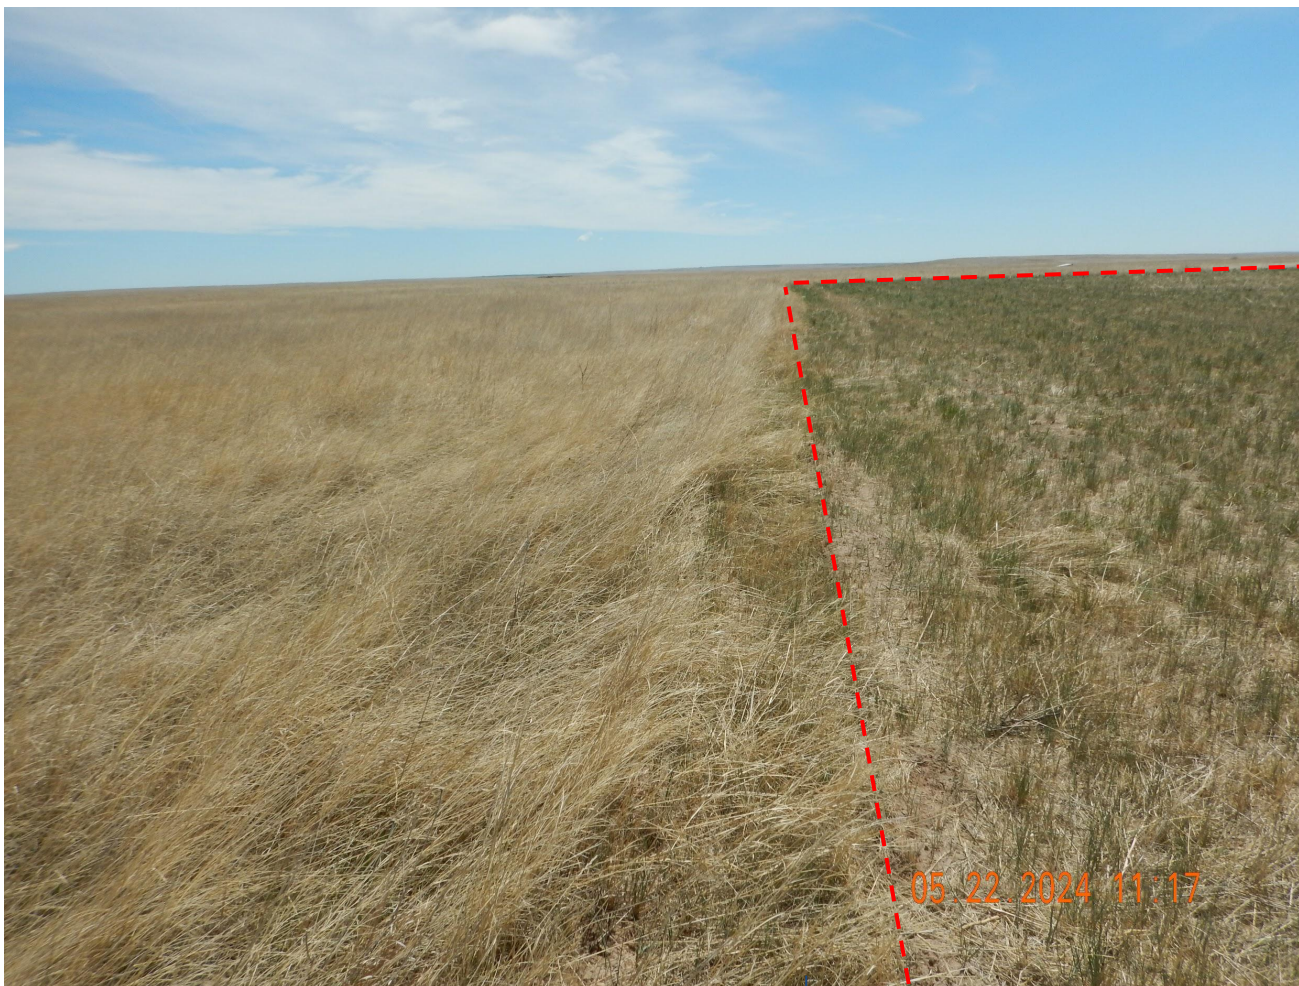
Photo 7. Photo taken from the western location, facing North. Photo illustrates the reference area vegetation in comparison to the location.

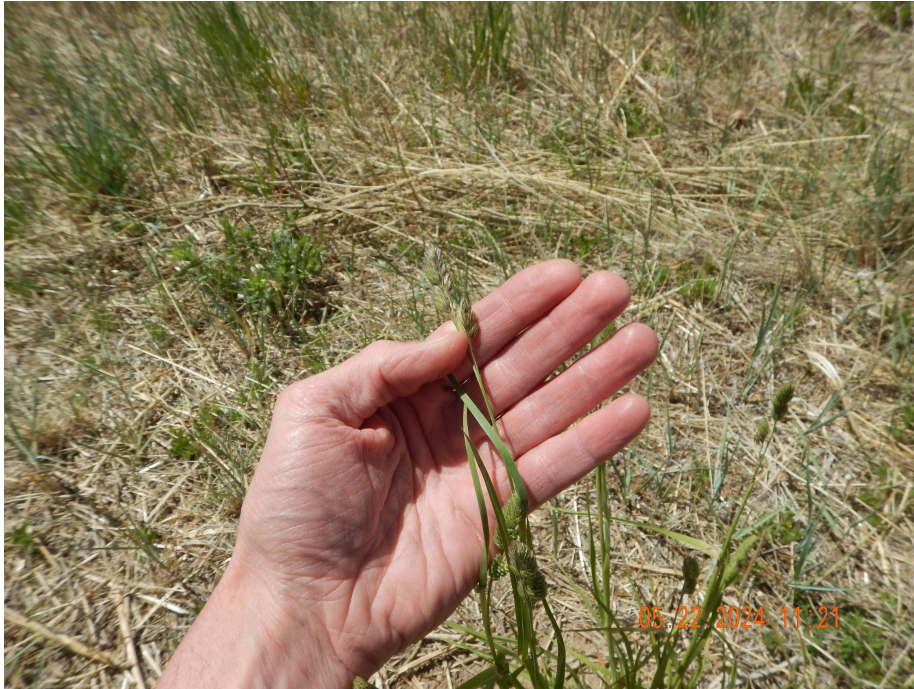
Photo 8. Photo taken from the location. Photo illustrates Orchardgrass, which is an introduced grass species that is not reflective of reference area vegetation.

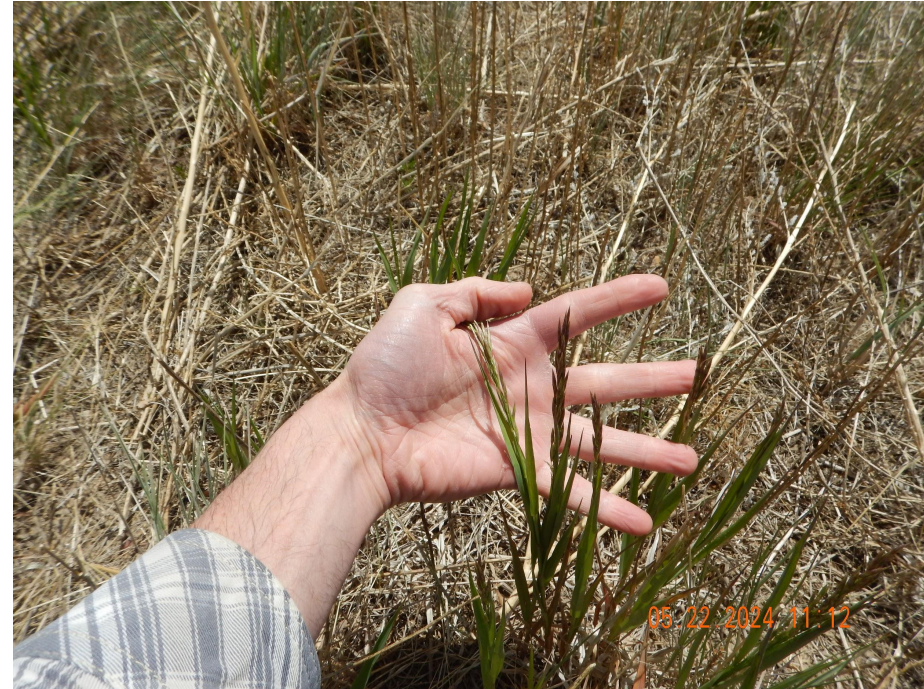
Photo 9. Photo taken from the location. Photo illustrates Smooth brome grass, which is an introduced grass species that is not reflective of reference area vegetation.

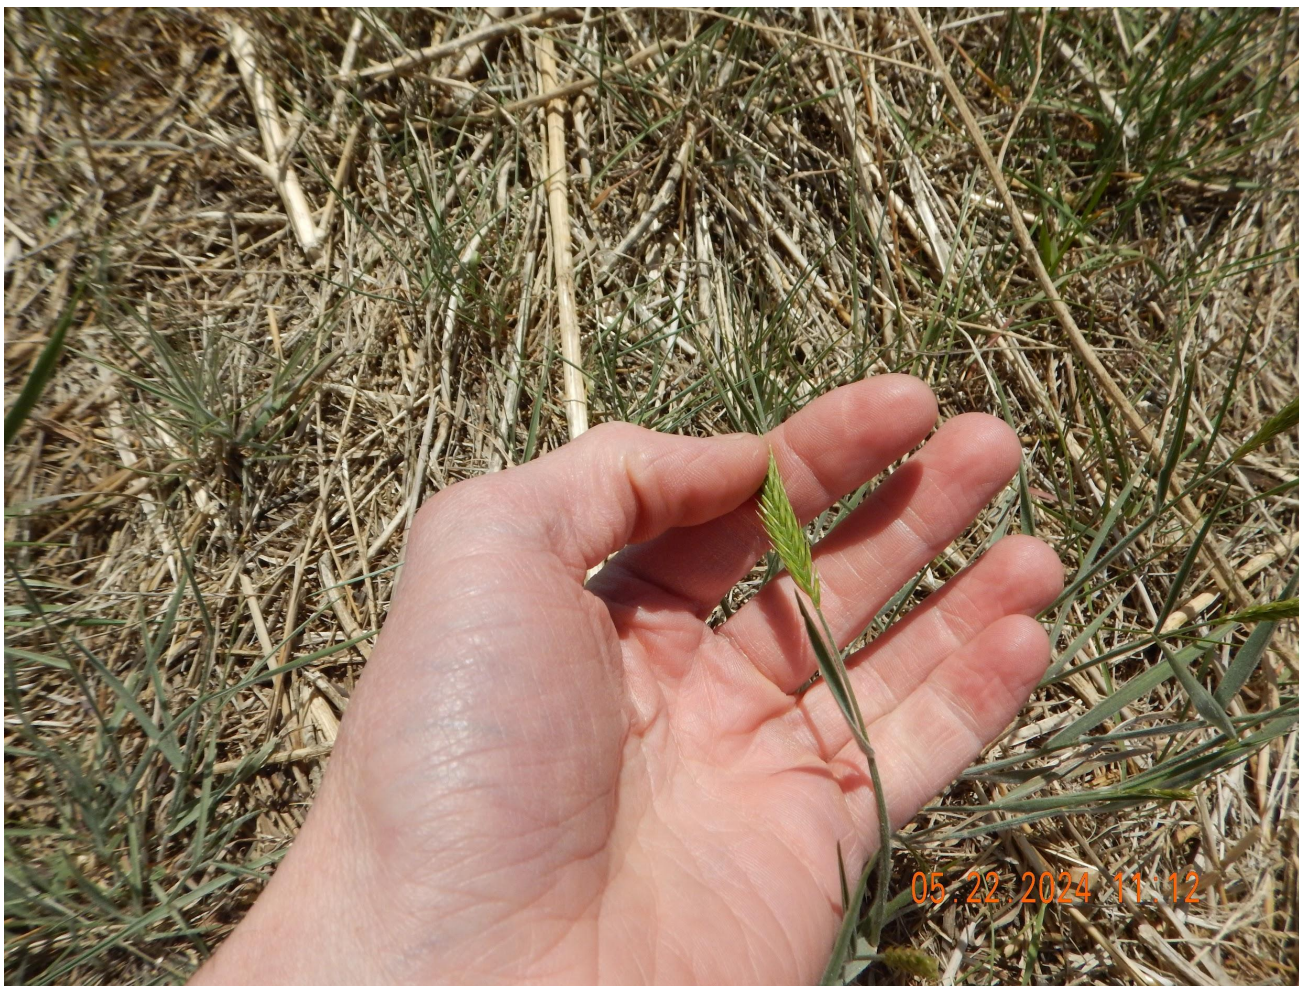
Photo 10. Photo taken from the location. Photo illustrates Siberian wheatgrass, which is an introduced grass species that is not reflective of reference area vegetation.
