Inspection Photos

Location Name: TEP ROCKY MOUNTAIN LLC SNYDER A10 well

Location ID: 311651

API # 045-12398

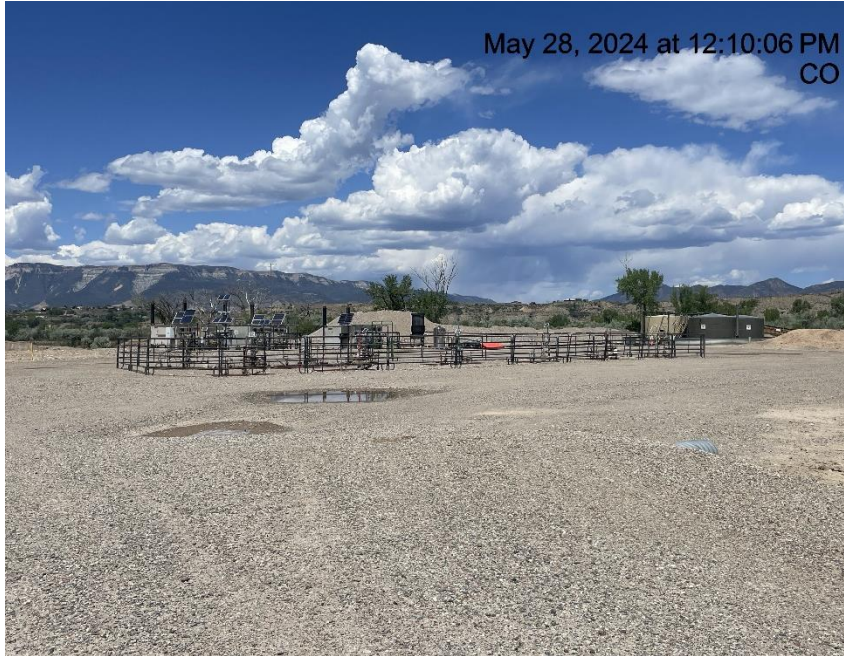
Photo # 8467 From entrance to location

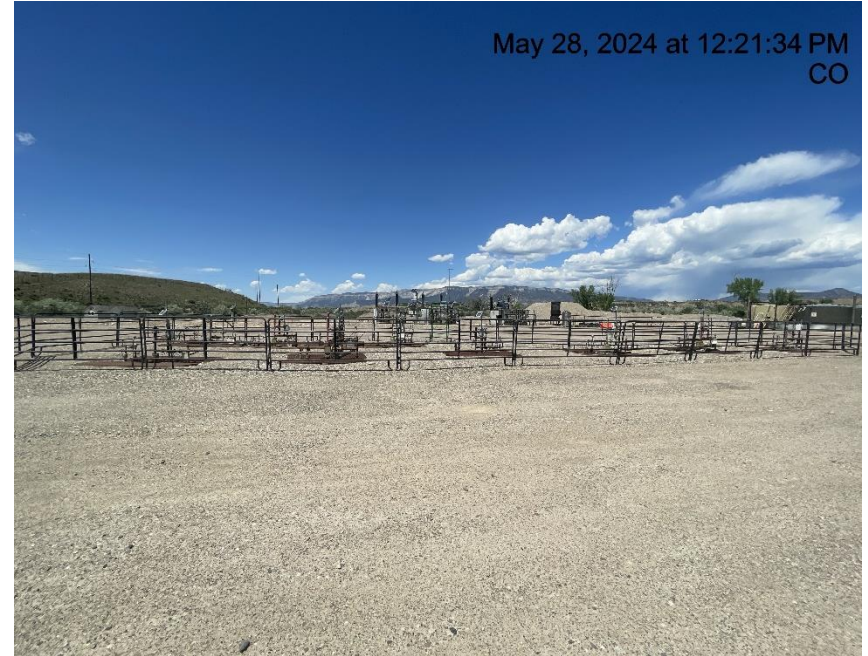
Photo # 8468 Location

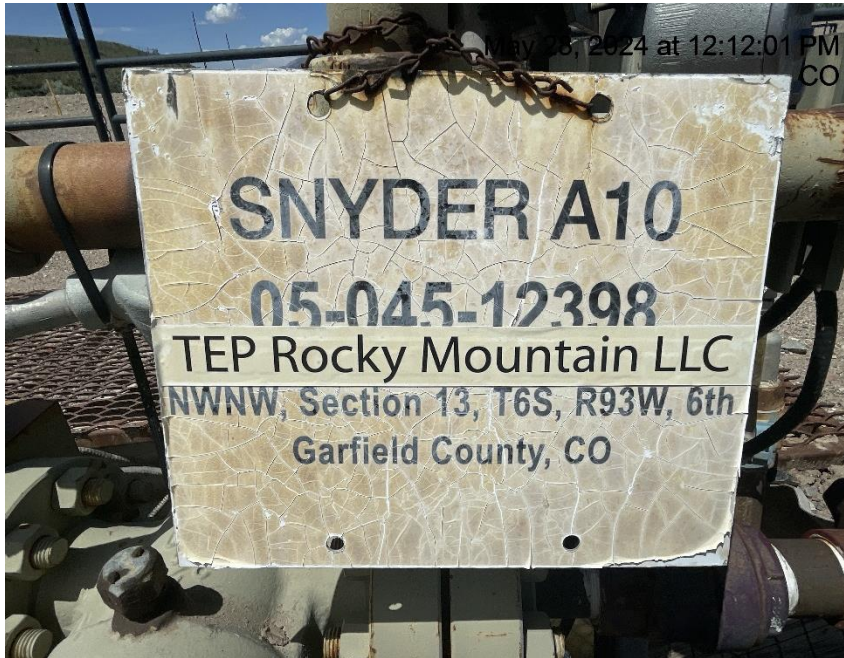
Photo # 8469 Location

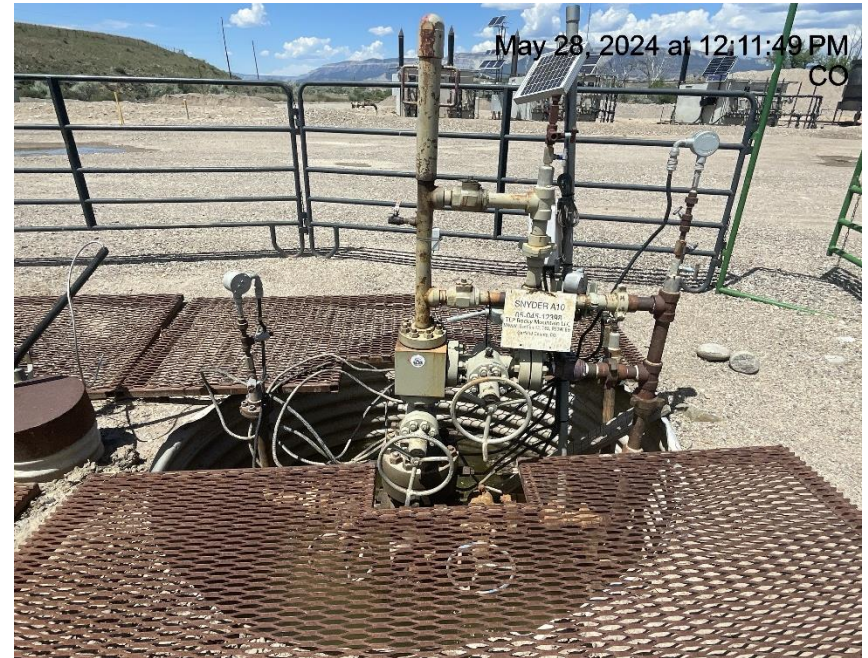
Photo # 8470 Location

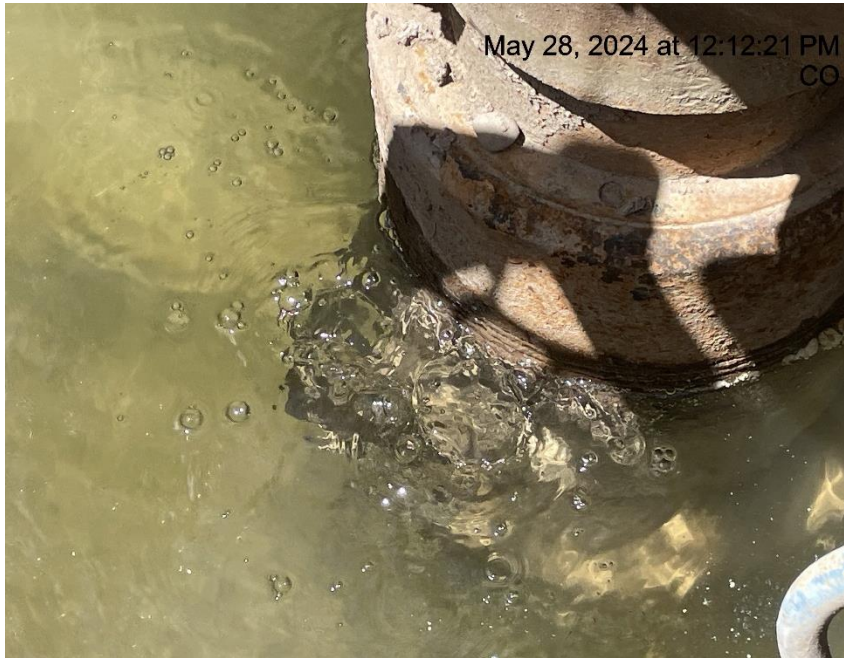
Photo # 8471 Possible wellhead leak/gas bubbling up around wellhead through water in cellar

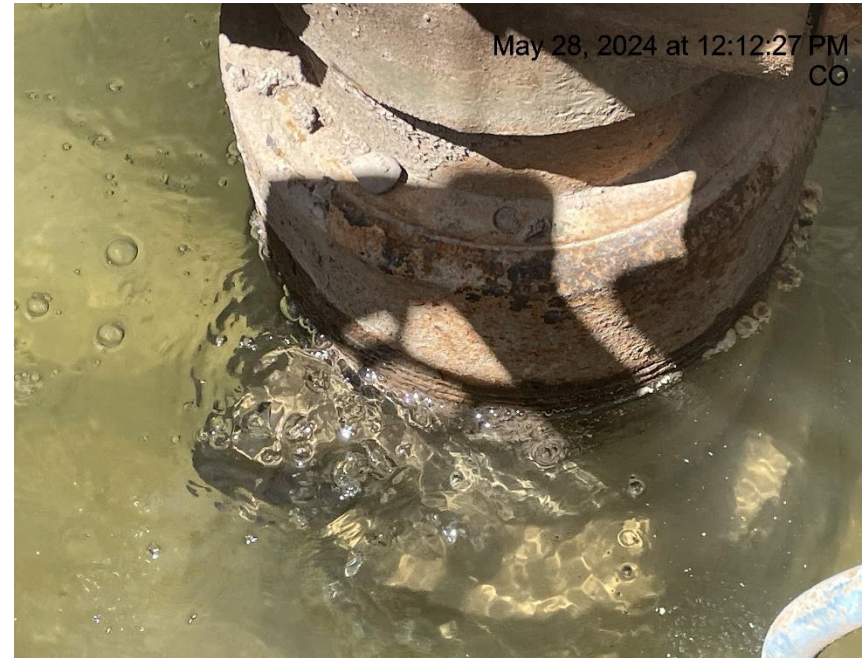
Photo # 8472 Possible wellhead leak/gas bubbling up around wellhead through water in cellar

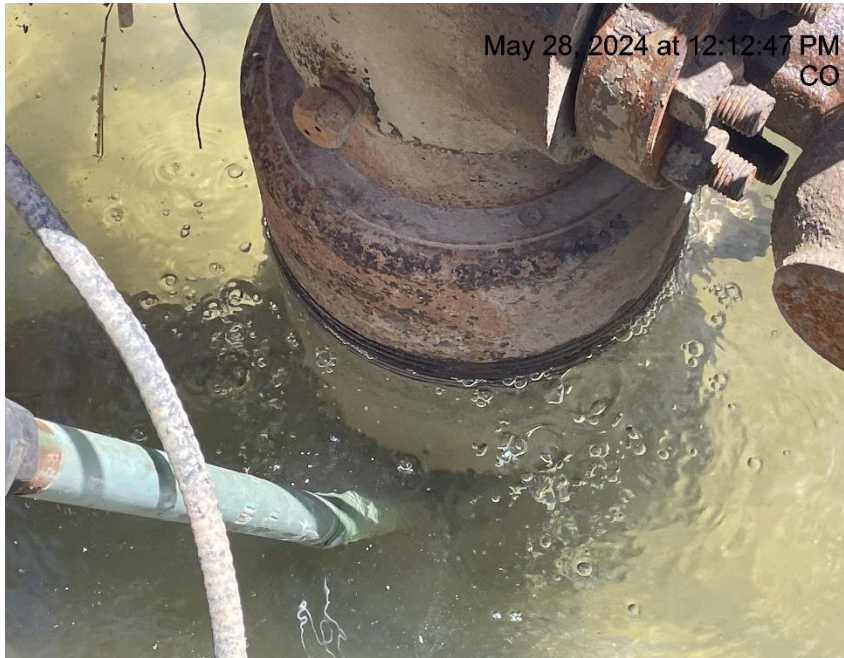
Photo # 8473 Possible wellhead leak/gas bubbling up around wellhead through water in cellar

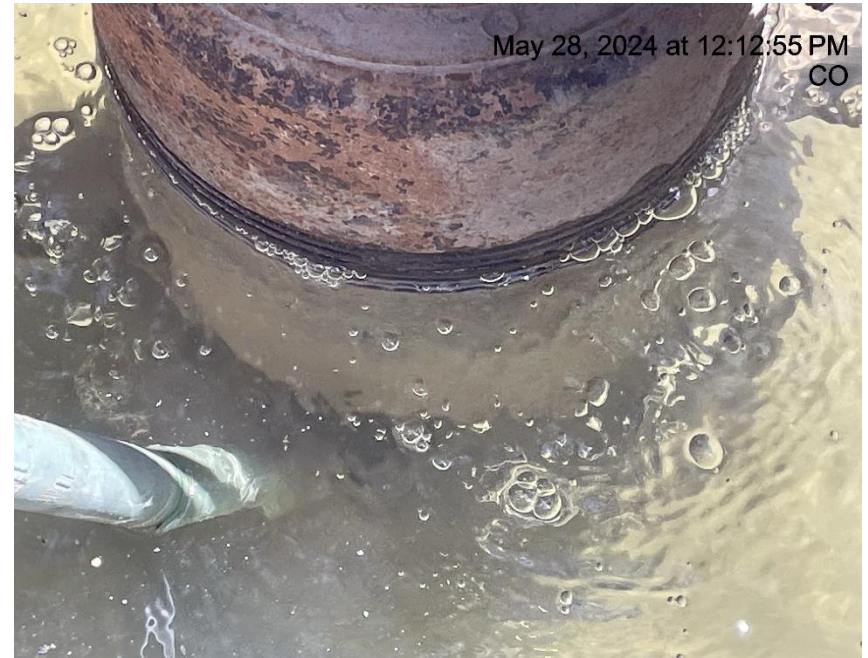
Photo # 8474 Possible wellhead leak/gas bubbling up around wellhead through water in cellar

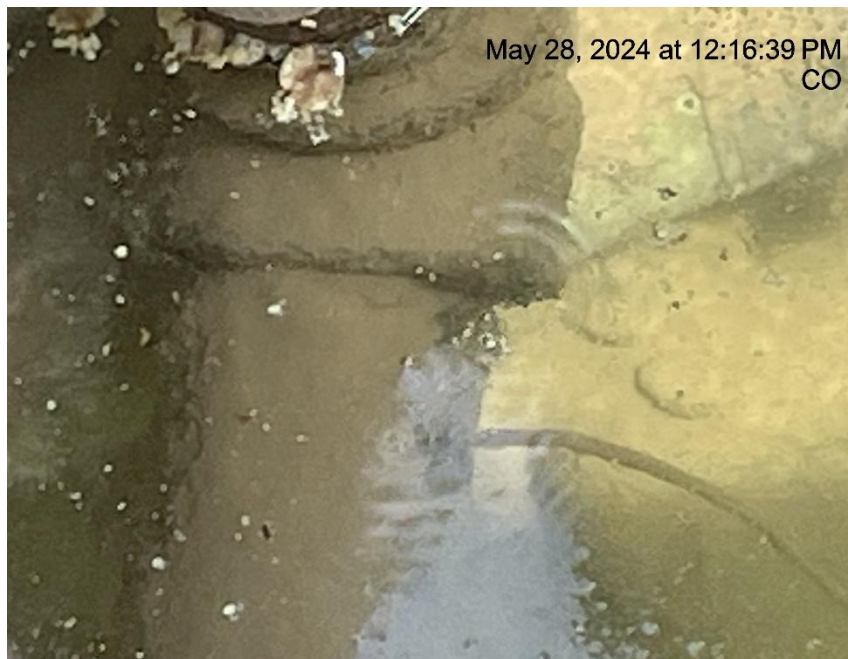
Photo # 8475 Possible leak/gas bubbling up through water in cellar around bradenhead line

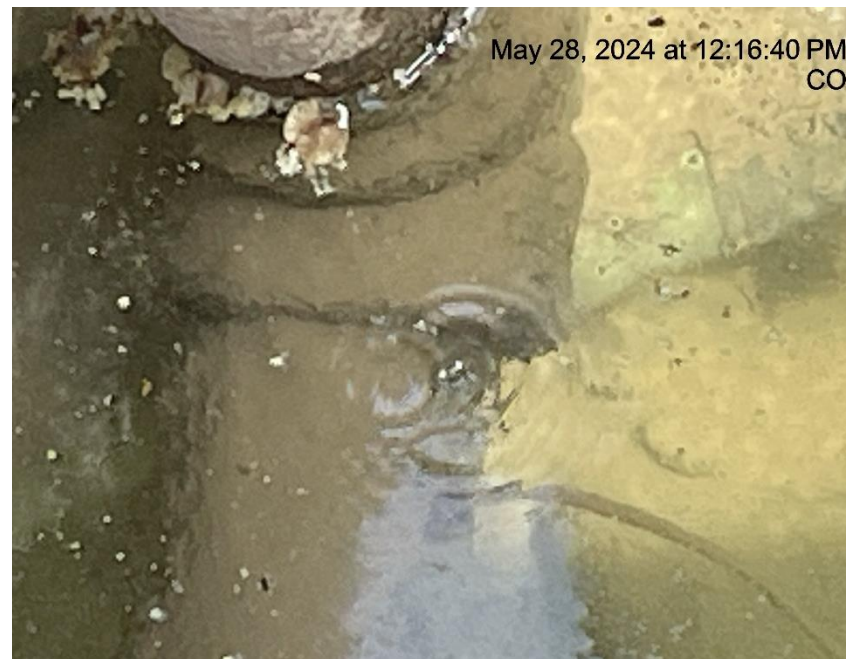
Photo # 8476 Possible leak/gas bubbling up through water in cellar around bradenhead line
