Storm Water Management and Erosion control
Location Name: TEP ROCKY MOUNTAIN LLC FEDERAL RWF 11-19 Pad
Location ID: 335448

Location Overview: Location is within High Priority/Density Habitat areas. Location is approximately 315 yards from a creek/drainage that contributes to the Colorado River.

Section/Township/Range: 18 6S94W

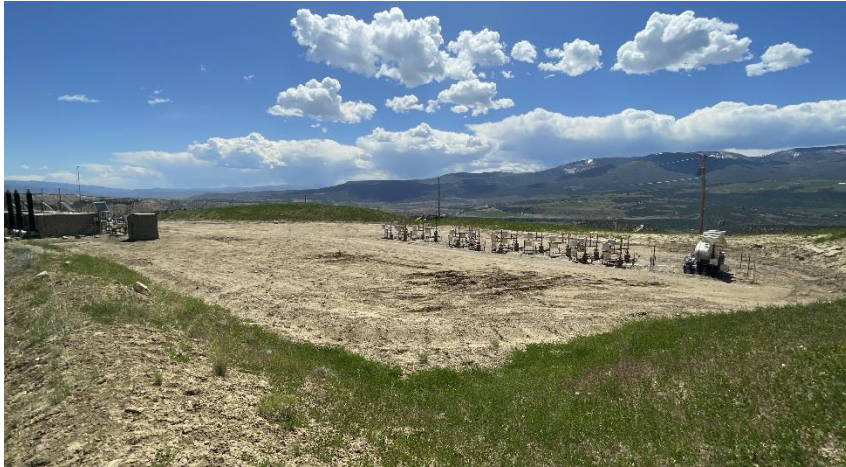
North West corner of location.

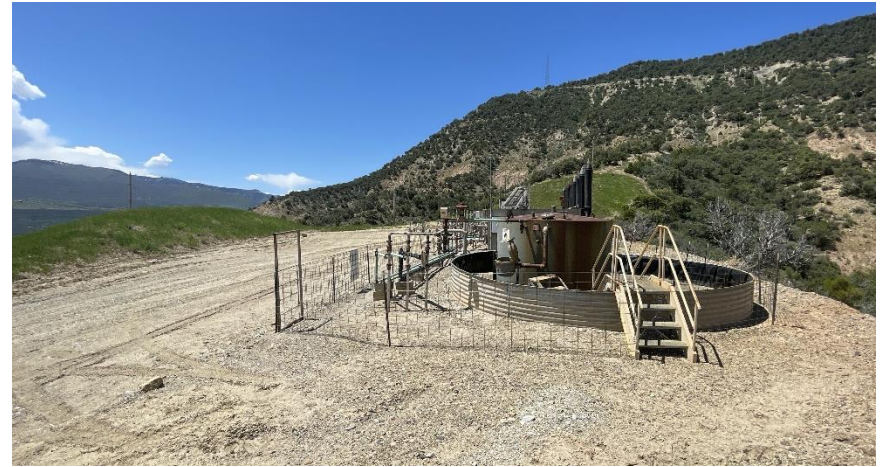
North East corner of location.

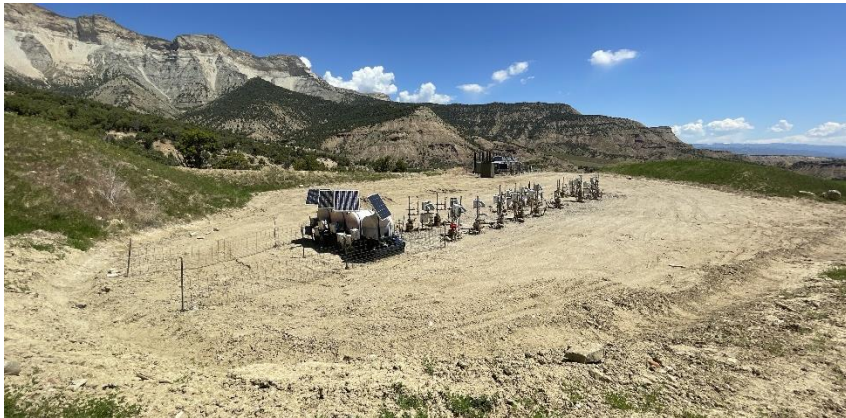
South West corner of location.

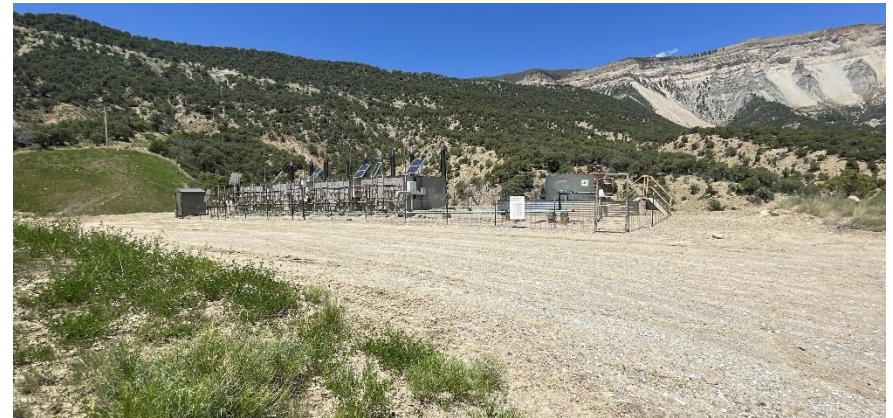
South East corner of location.

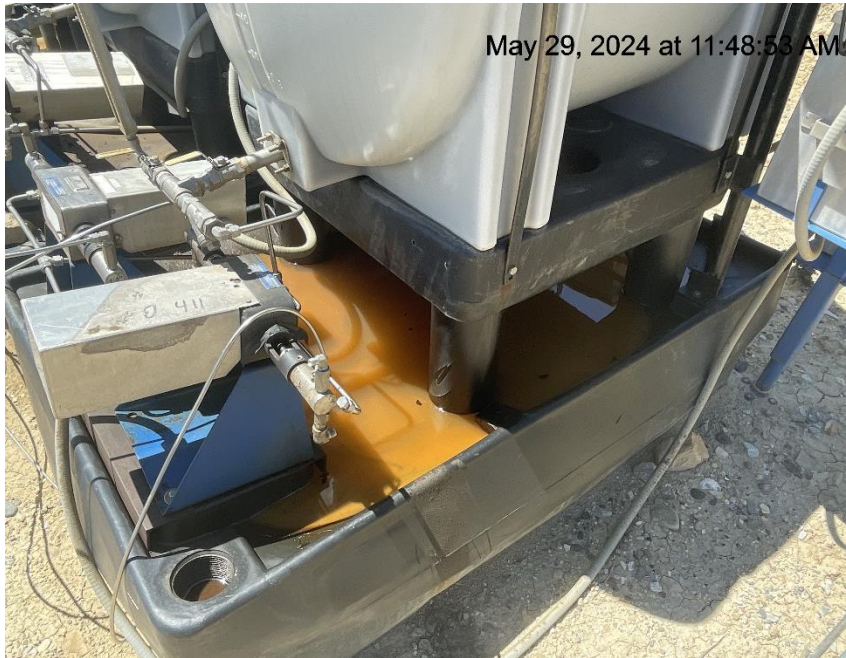
Photo # 8667 Failure to maintain chemical BMP/chemical containment full of fluid & not sufficient to contain possible spill

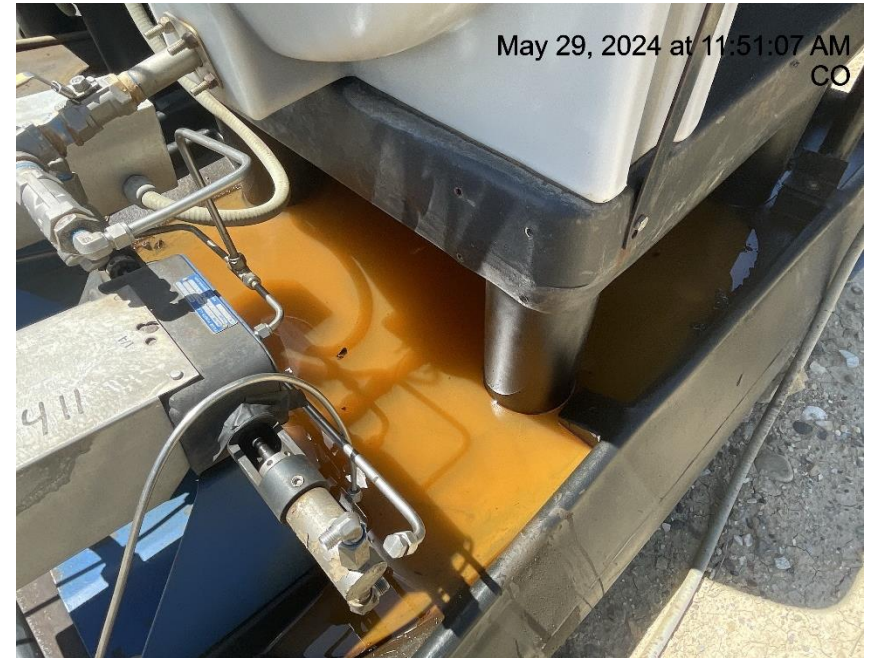
Photo # 8668 Failure to maintain chemical BMP/chemical containment full of fluid & not sufficient to contain possible spill

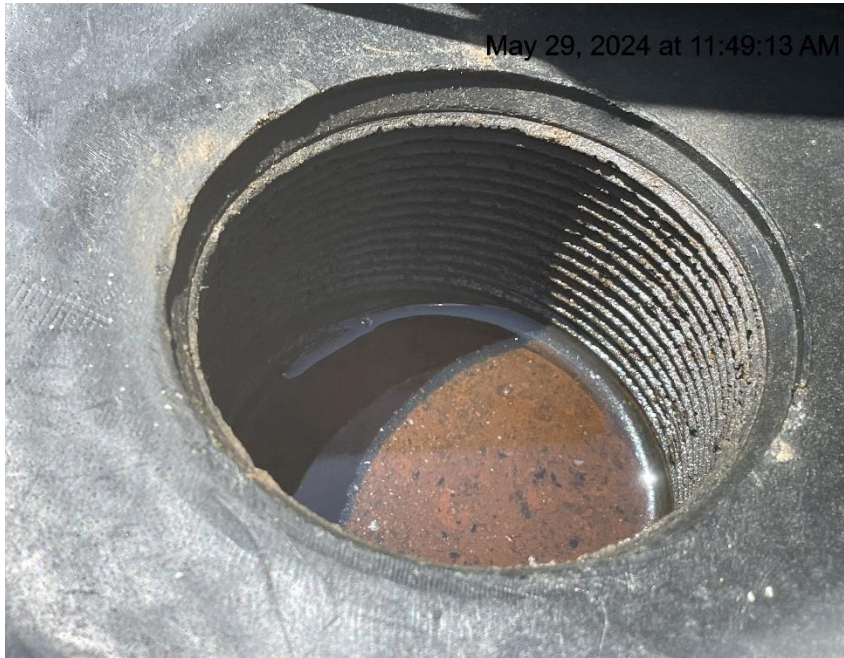
Photo # 8669 Failure to maintain chemical BMP/chemical containment full of fluid & not sufficient to contain possible spill

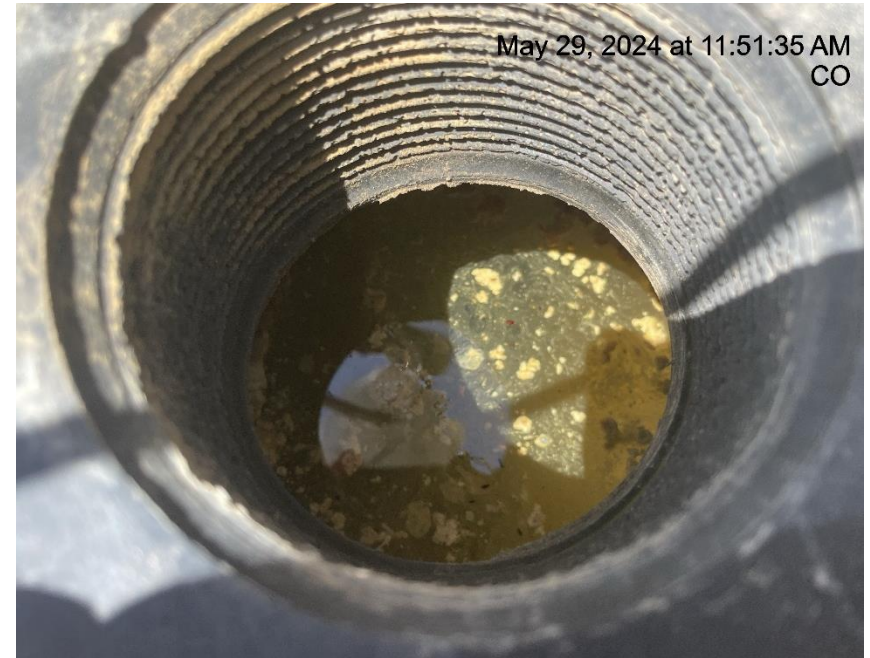
Photo # 8670 Failure to maintain chemical BMP/chemical containment full of fluid & not sufficient to contain possible spill

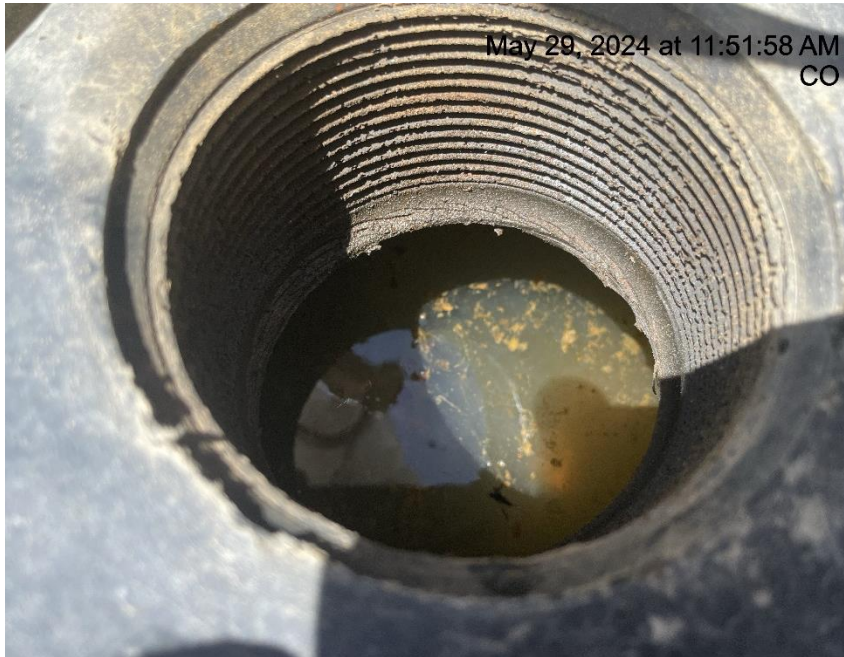
Photo # 8671 Failure to maintain chemical BMP/chemical containment full of fluid & not sufficient to contain possible spill

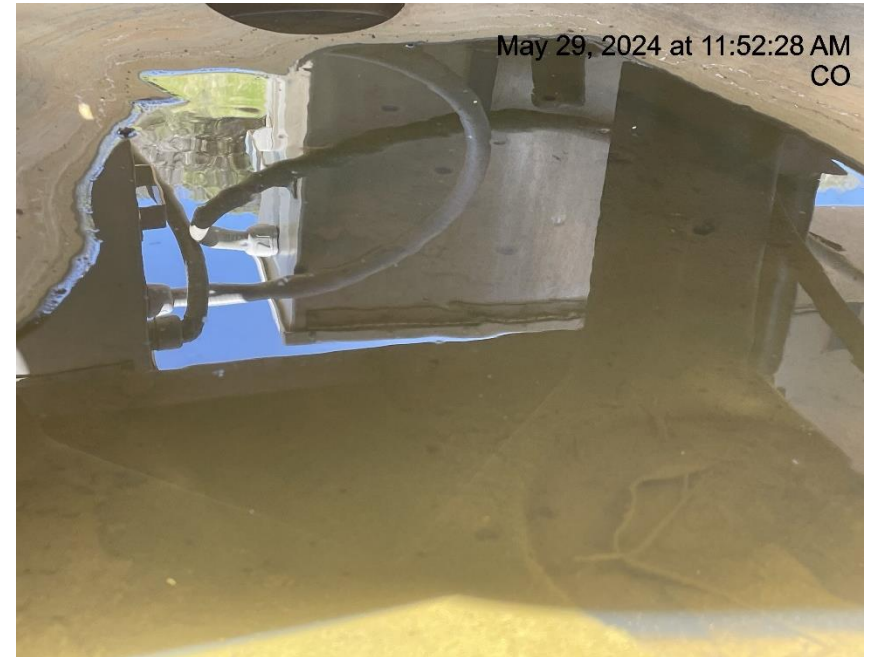
Photo # 8672 Failure to maintain chemical BMP/chemical containment full of fluid & not sufficient to contain possible spill

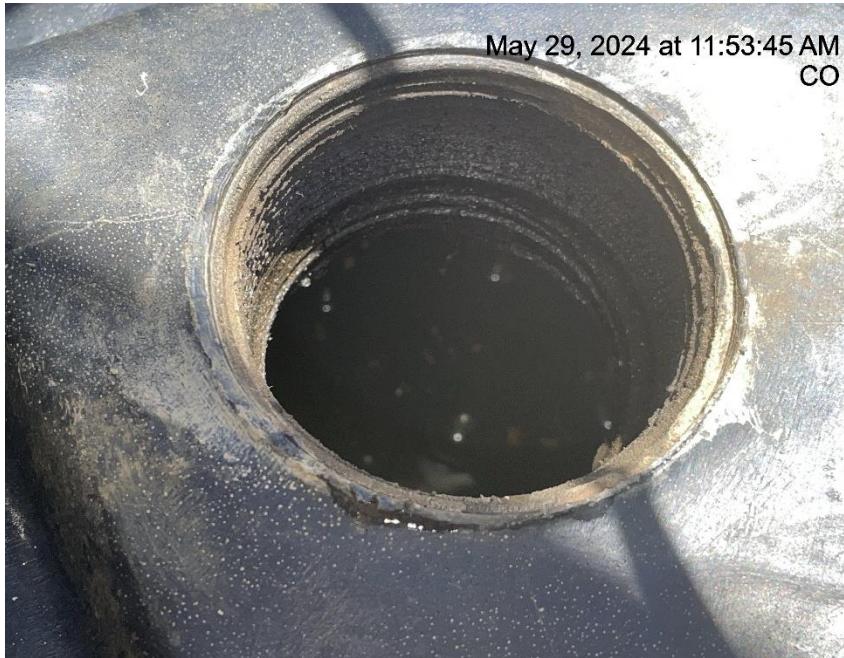
Photo # 8673 Failure to maintain chemical BMP/chemical containment 7/8th full of fluid & not sufficient to contain possible spill

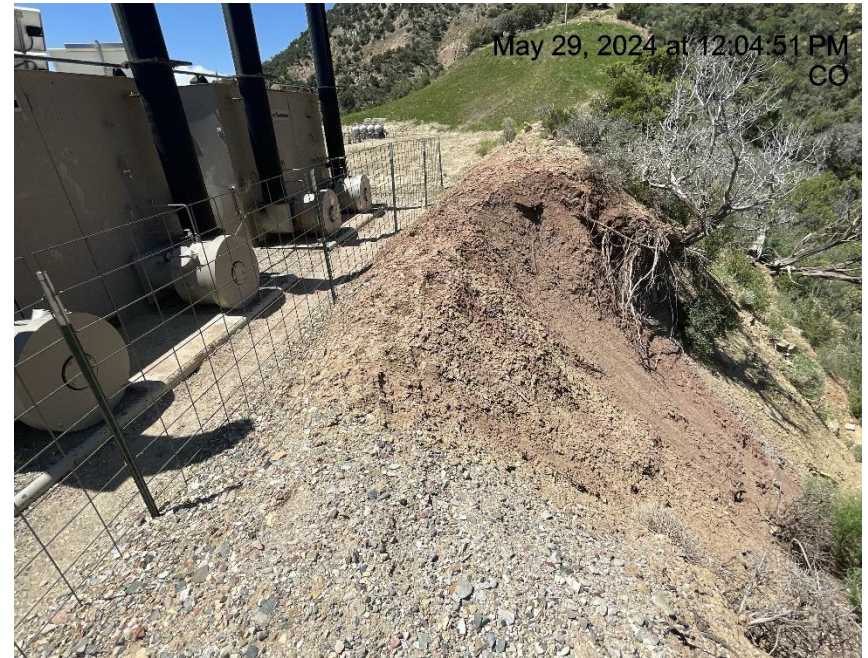
Photo # 8674 Edge of pad has started to slough & started to damage berm/BMP (N/NE area of pad behind production units)

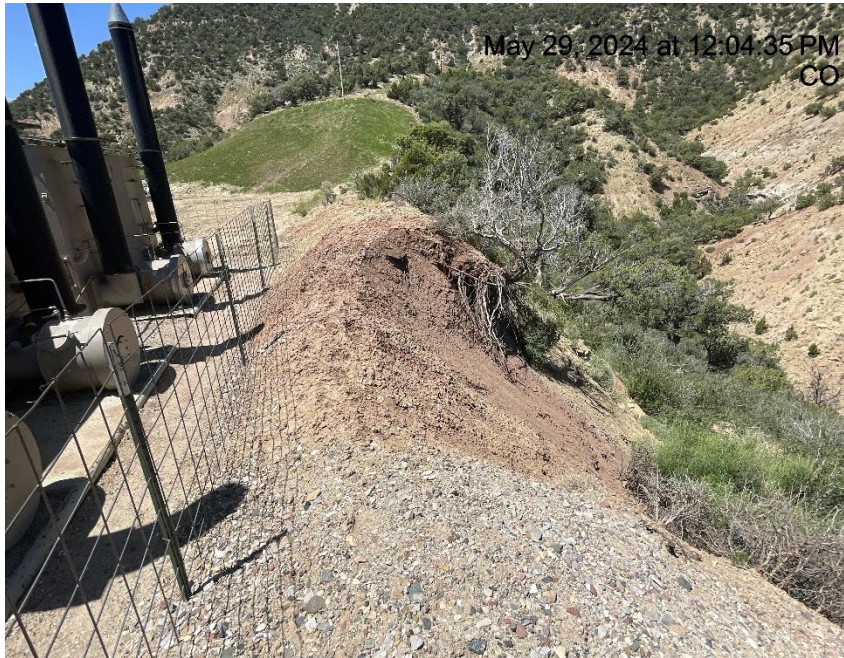
Photo # 8675 Edge of pad has started to slough & started to damage berm/BMP (N/NE area of pad behind production units)

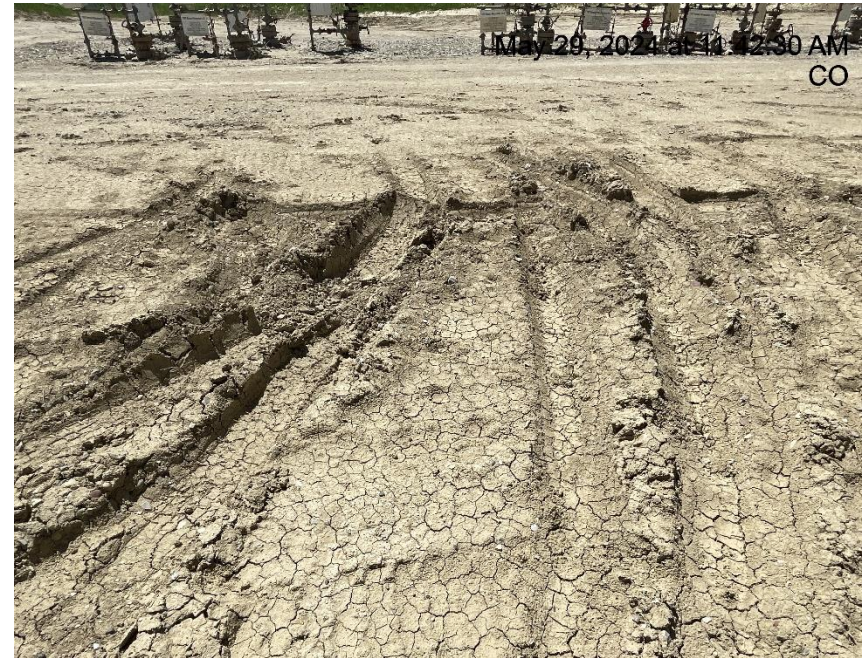
Photo # 8676 Lack of stabilization/compaction

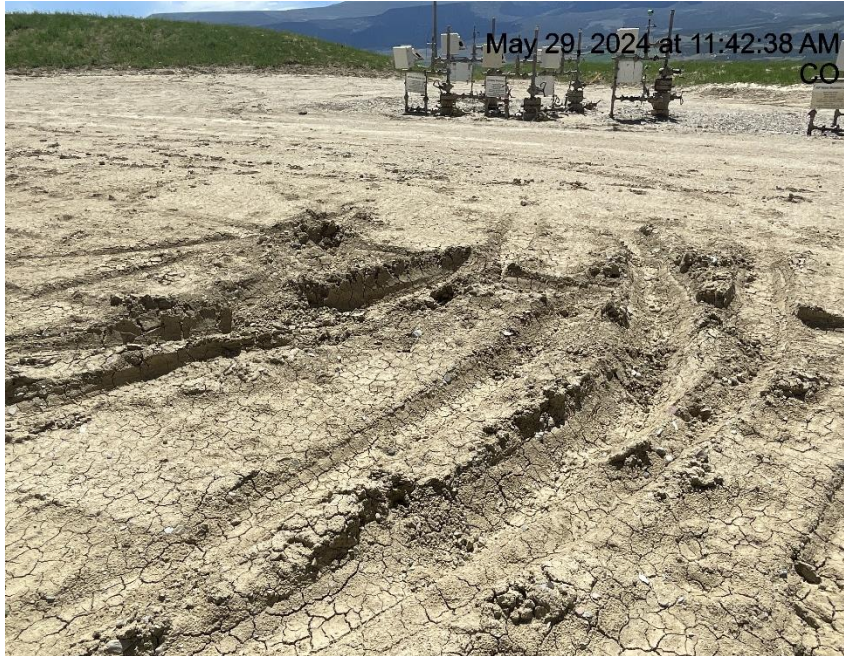
Photo # 8677 Lack of stabilization/compaction

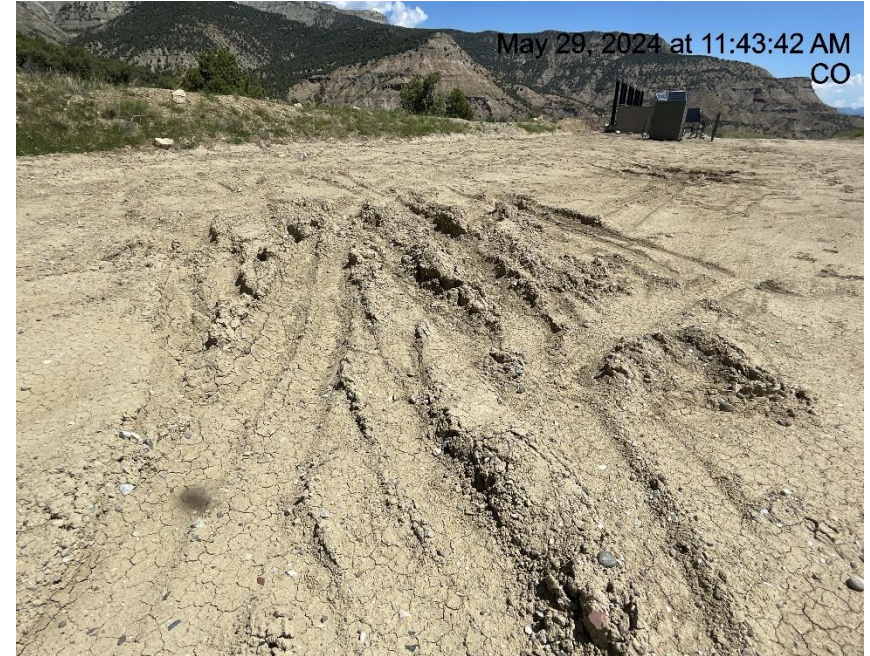
Photo # 8678 Lack of stabilization/compaction

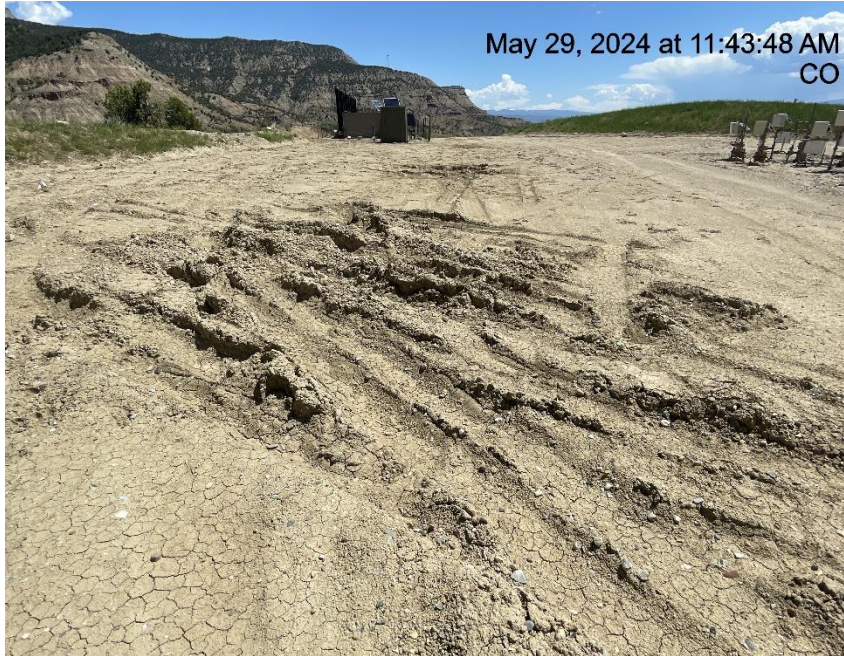
Photo # 8679 Lack of stabilization/compaction

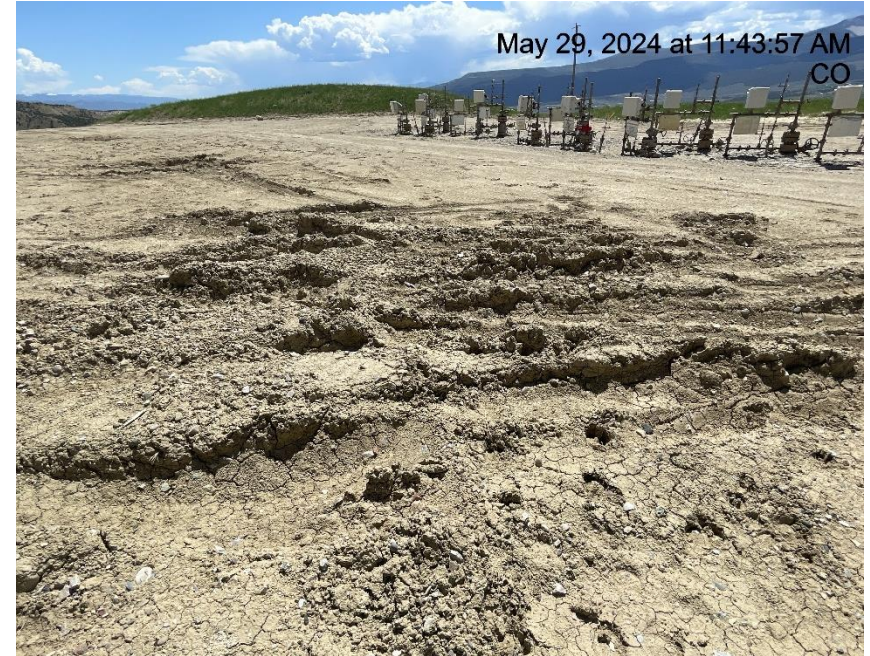
Photo # 8680 Lack of stabilization/compaction

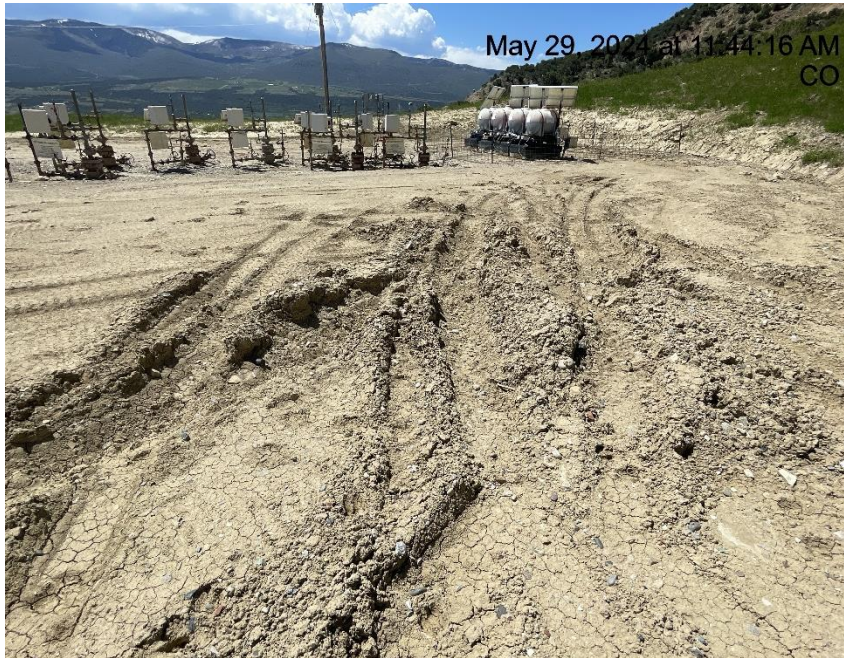
Photo # 8681 Lack of stabilization/compaction
