Inspection Photos

Location Name: TEP ROCKY MOUNTAIN LLC FEDERAL RWF 11-19 Pad

Location ID: 335448

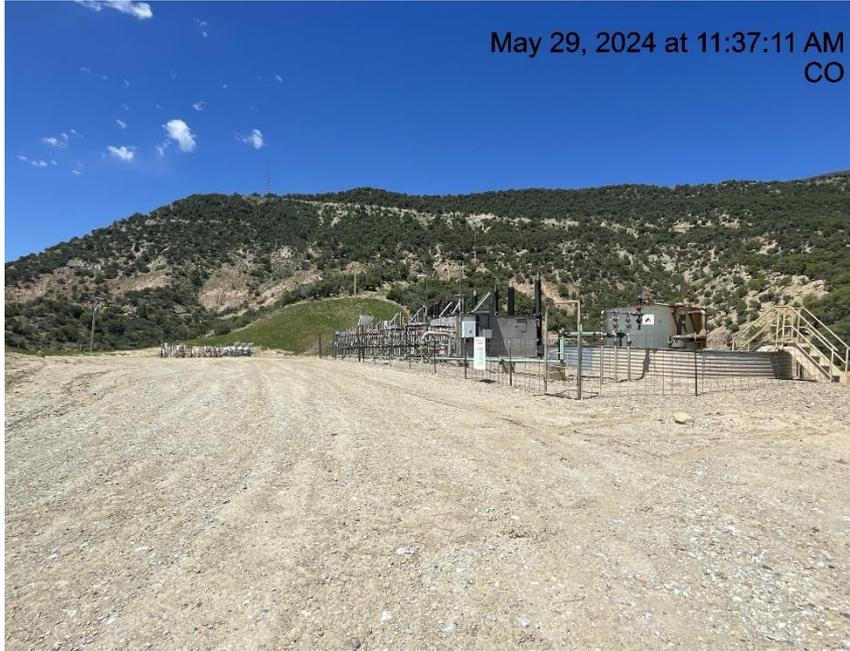
Photo # 8640 From entrance to location

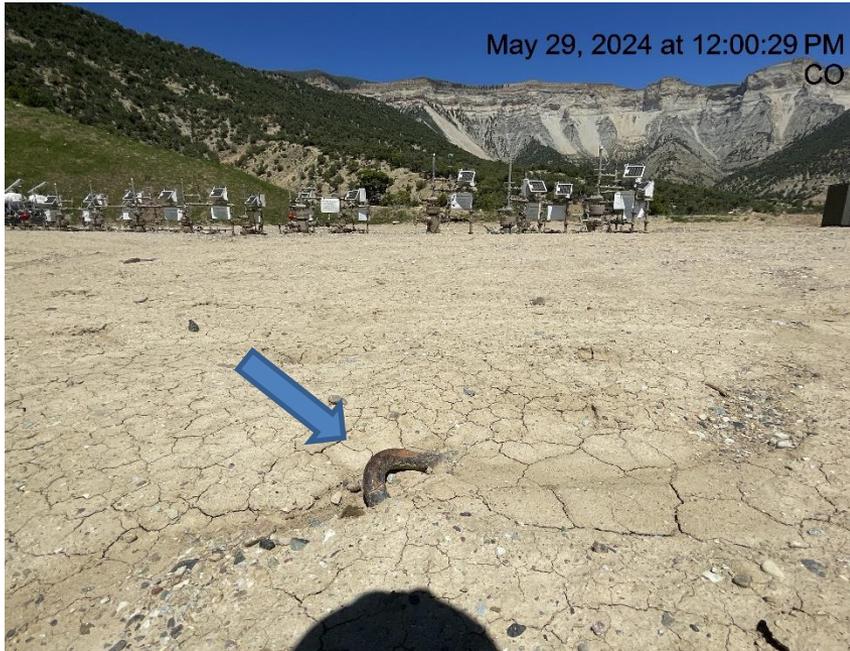
Photo # 8648 Unmarked deadman

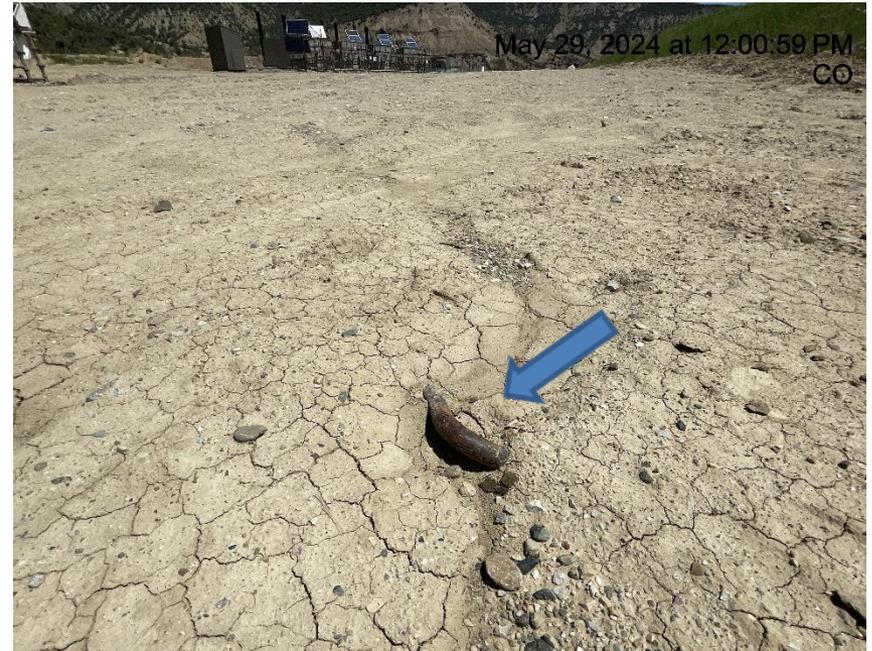
Photo # 8649 Same unmarked deadman from different angle

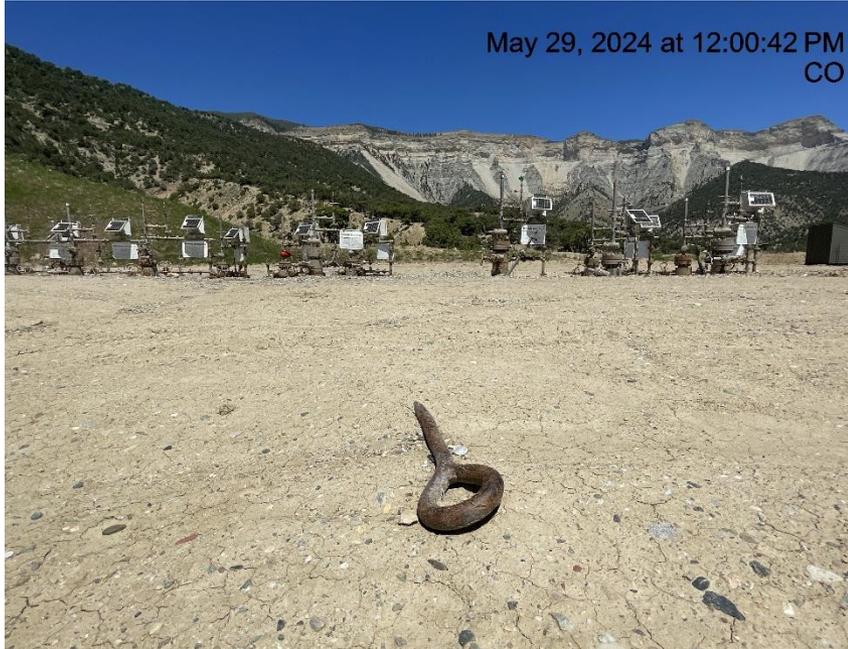
Photo # 8650 Unmarked deadman

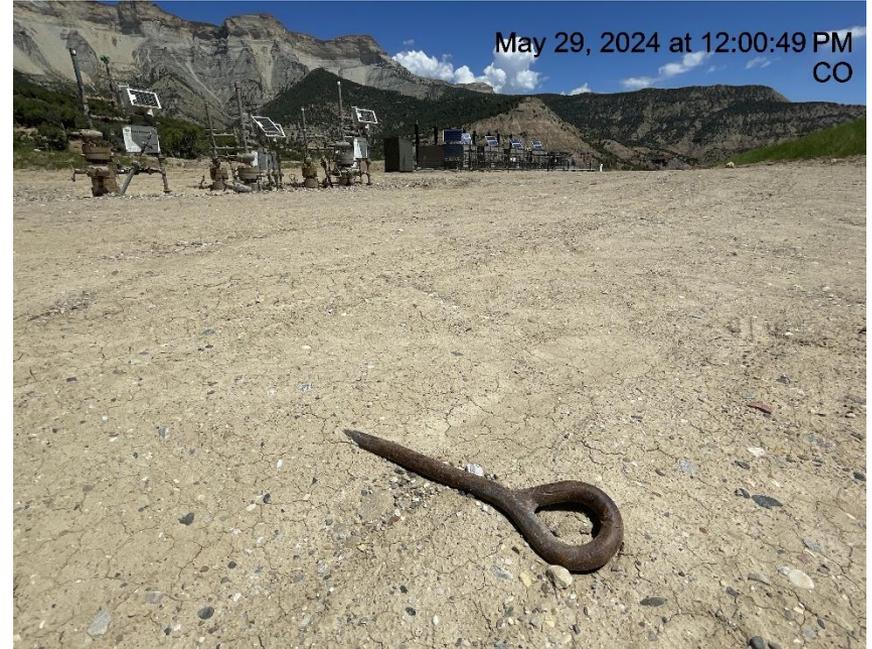
Photo # 8651 Same unmarked deadman from different angle

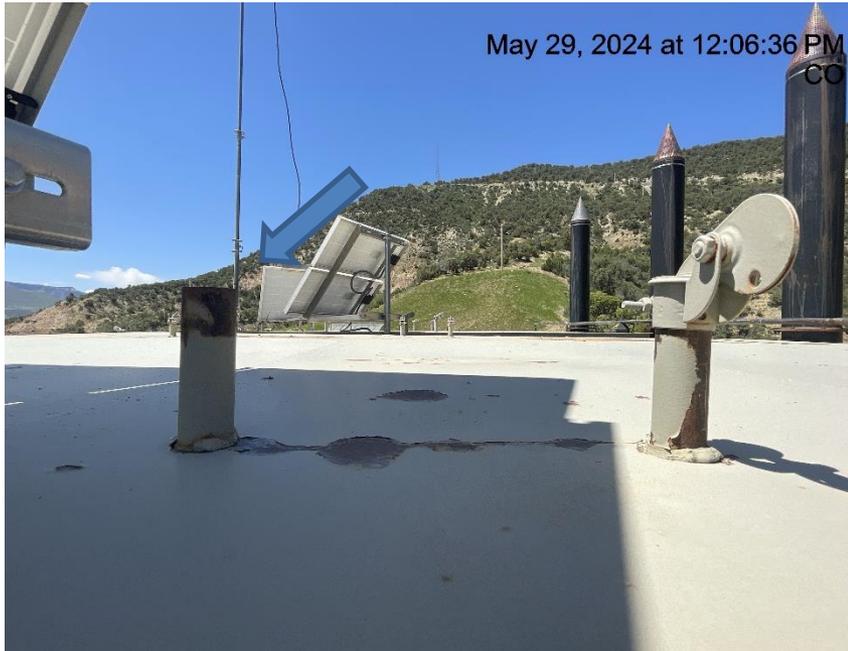
Photo # 8652 Rupture disc vent line does not comply with CECMC pressure safety device rules

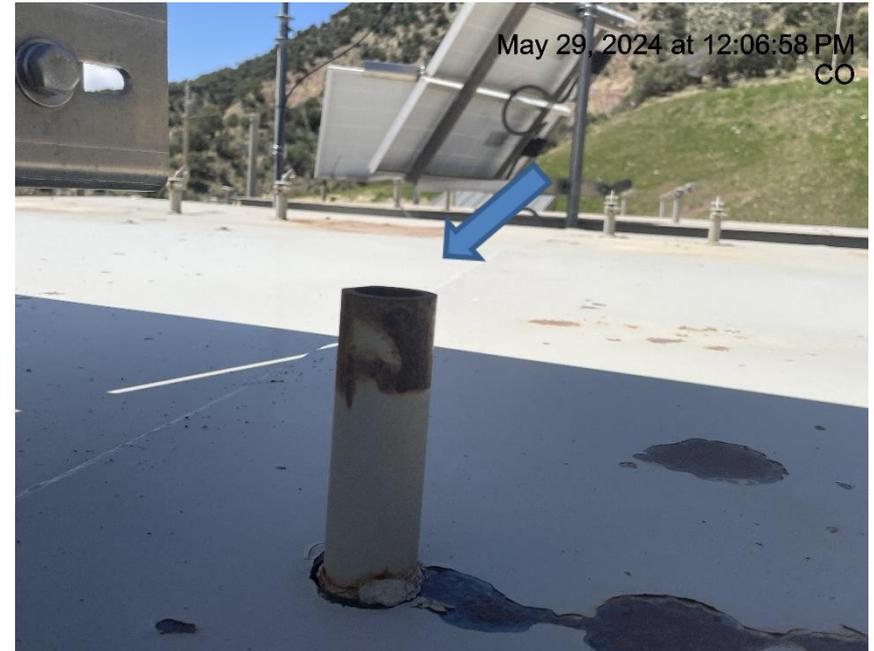
Photo # 8653 Rupture disc vent line does not comply with CECMC pressure safety device rules

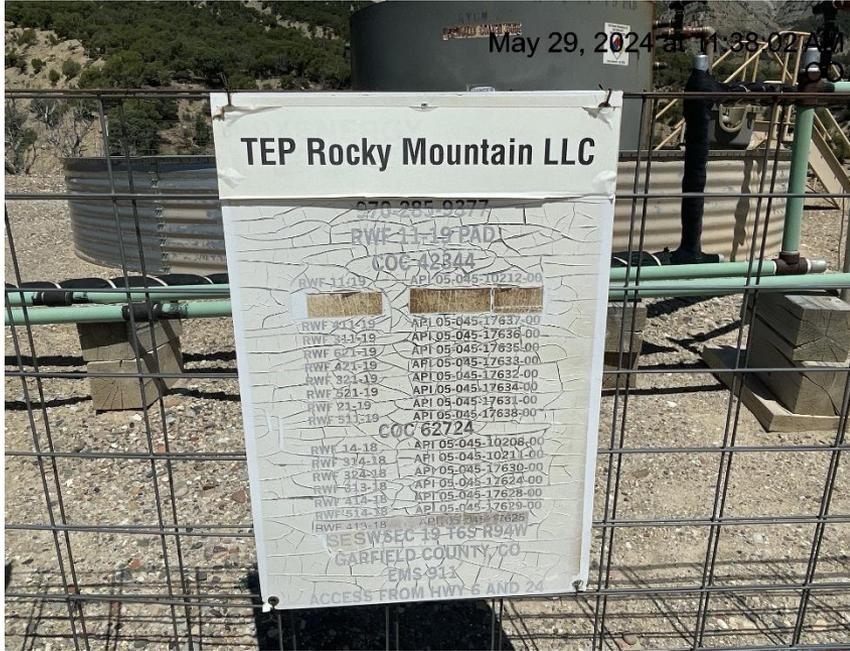
Photo # 8654 Battery sign weathered/faded/cracking/
becoming illegible & does not comply with CECMC rules

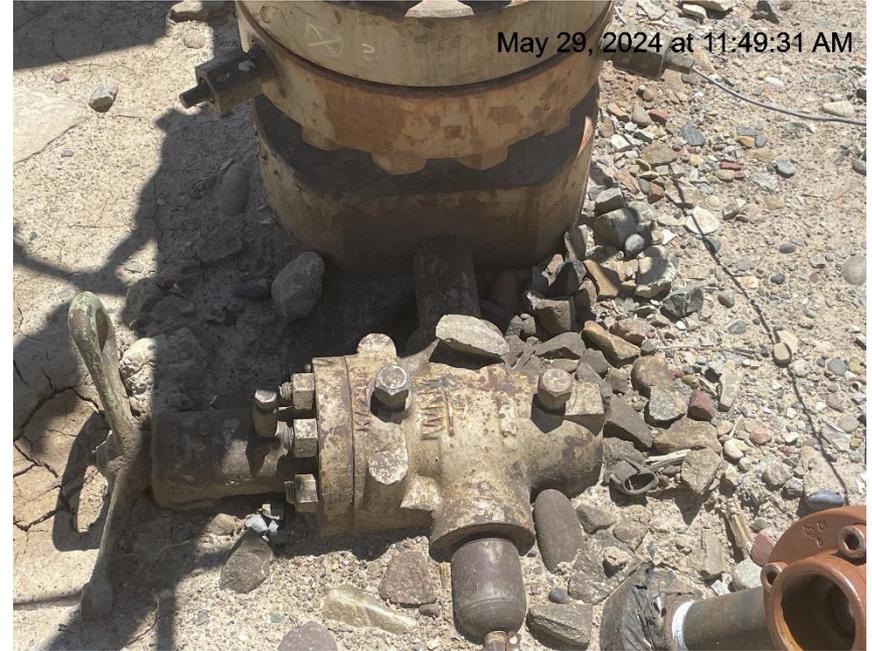
Photo # 8655 Stained soils & gravel

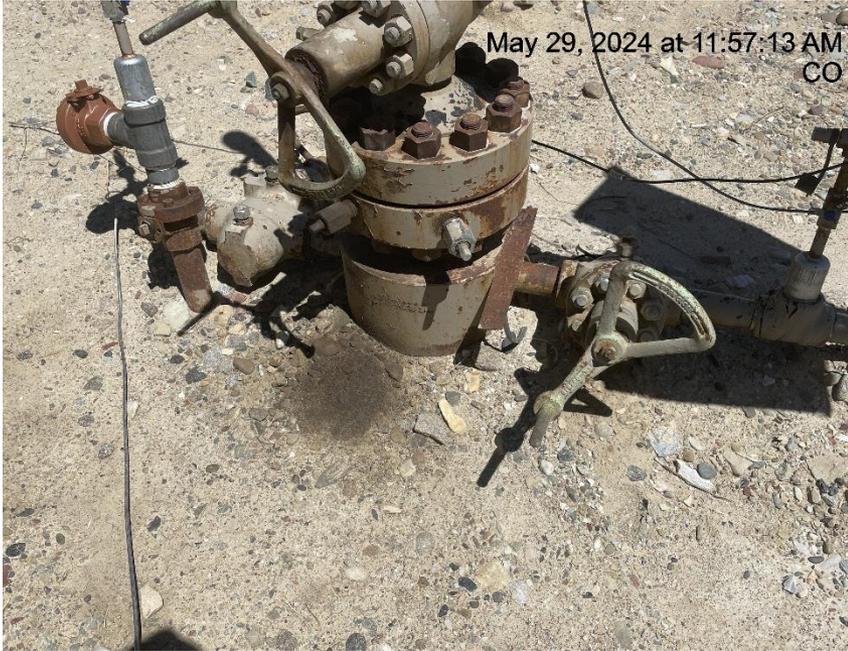
Photo # 8656 Stained soils & gravel

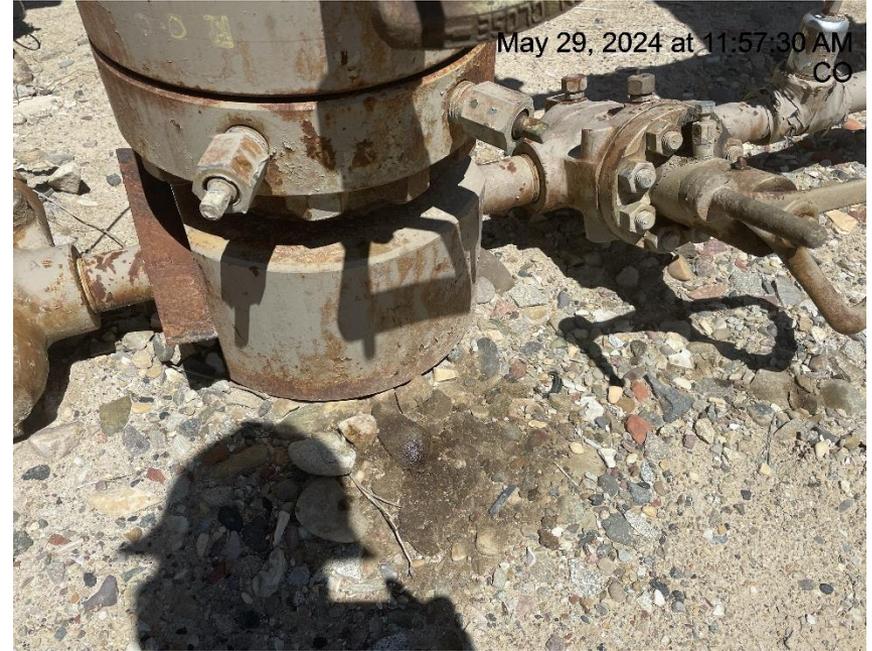
Photo # 8657 Stained soils & gravel

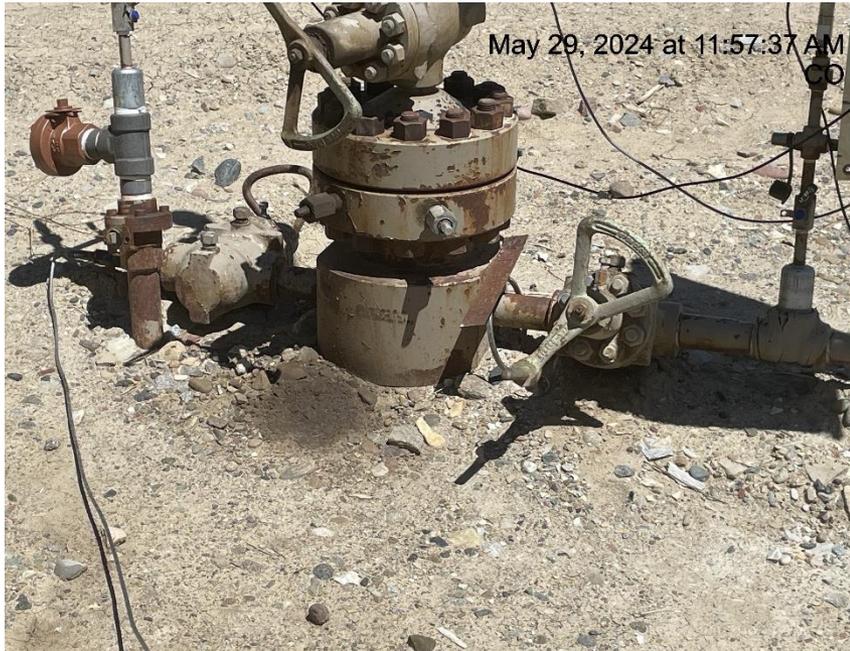
Photo # 8658 Stained soils & gravel

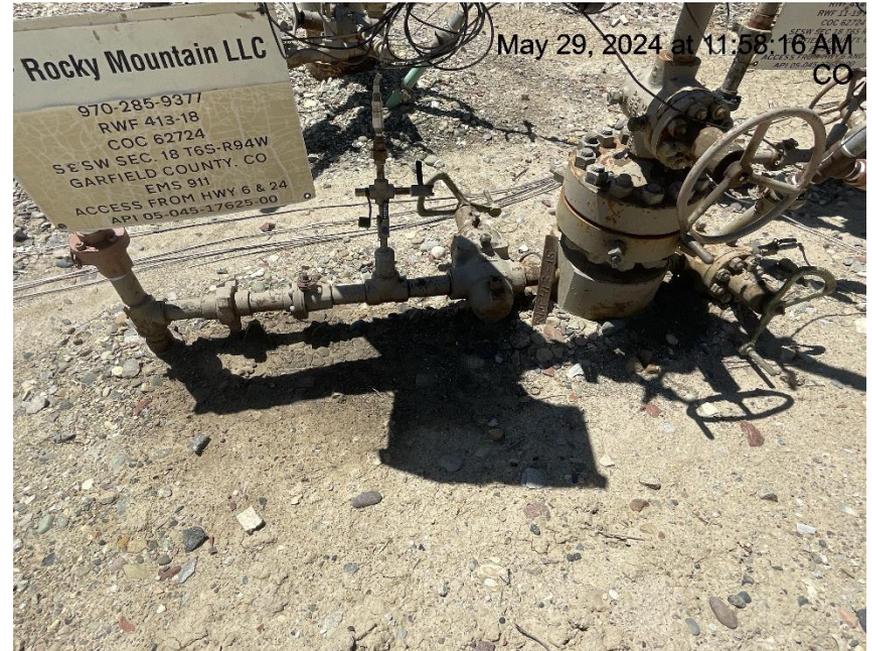
Photo # 8659 Stained soils & gravel

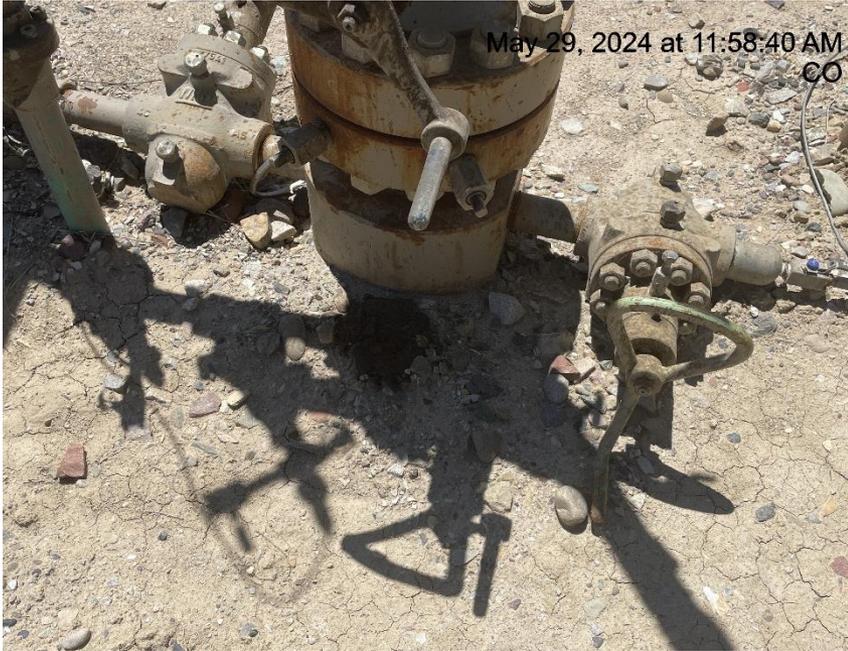
Photo # 8660 Stained soils & gravel

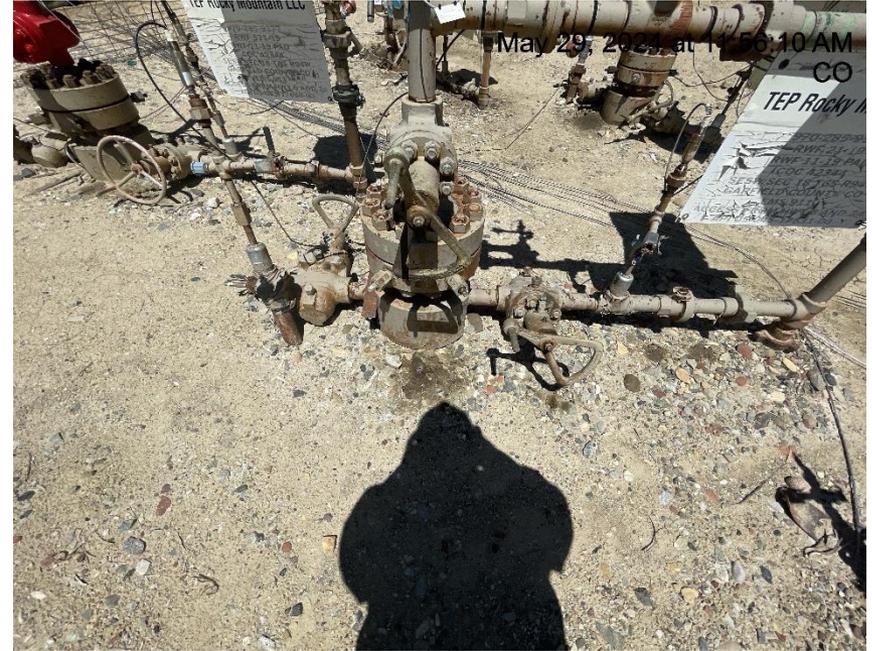
Photo # 8661 Stained soils & gravel

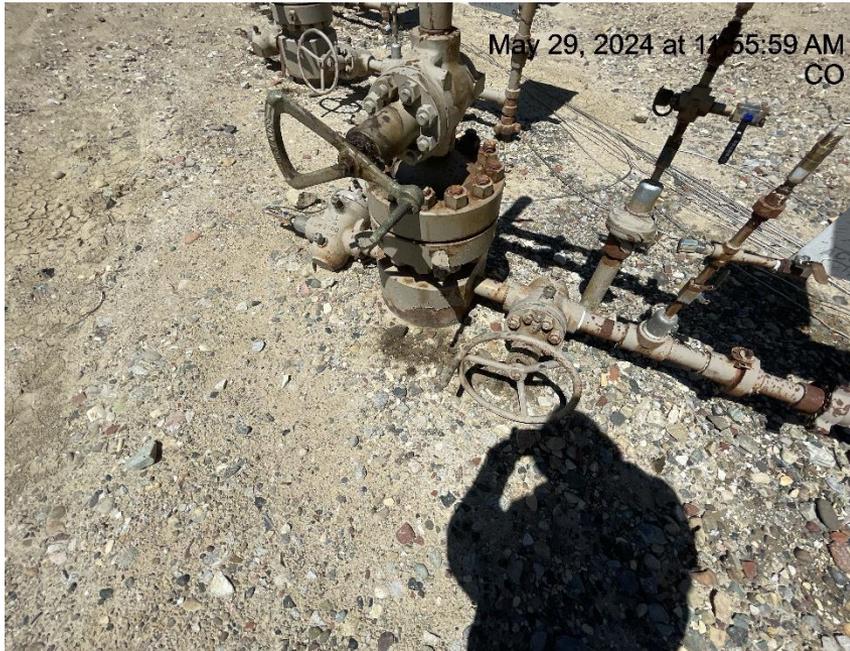
Photo # 8662 Stained soils & gravel

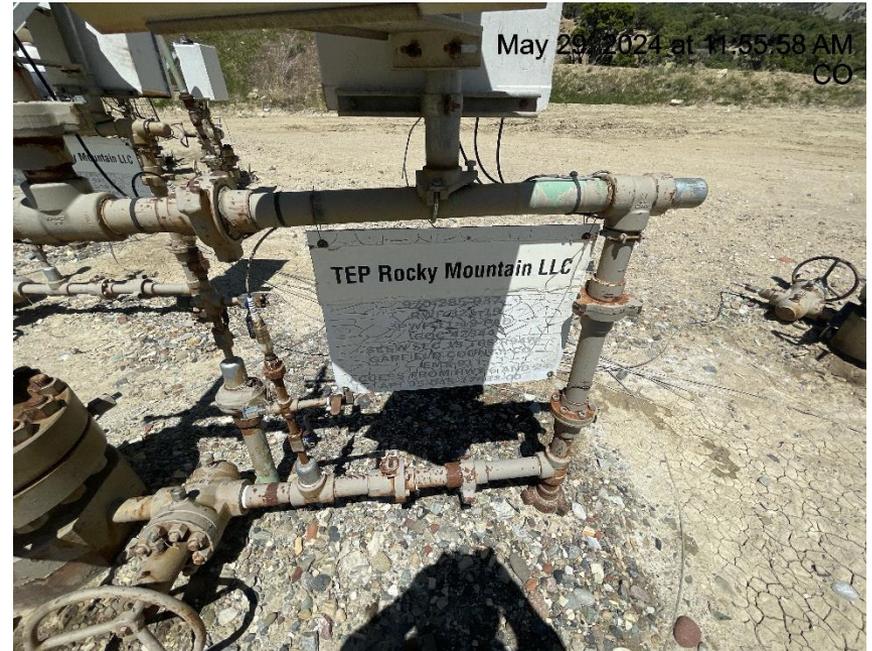
Photo # 8663 Multiple wellhead signs weathered/fading & cracking & starting to become illegible

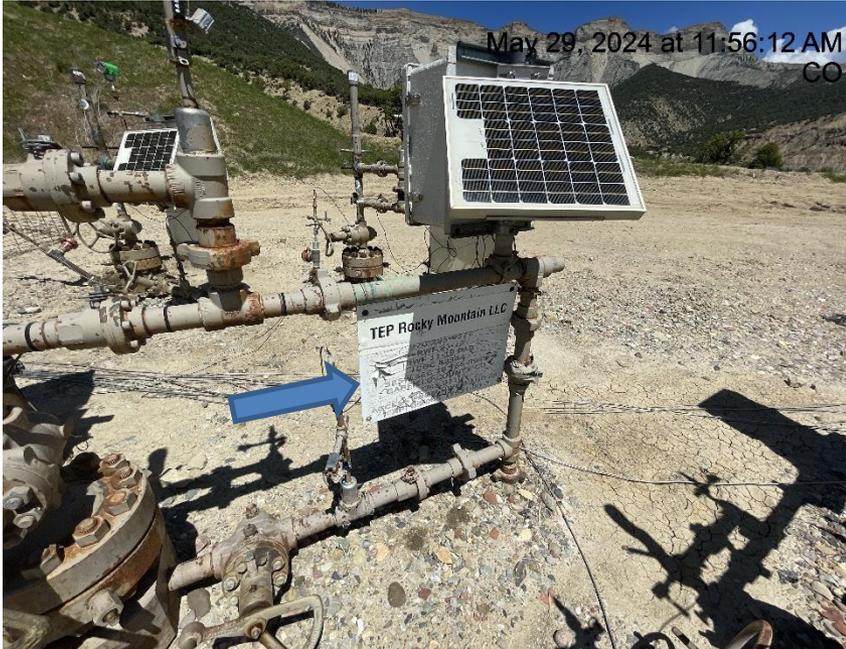
Photo # 8664 Multiple wellhead signs weathered/fading & cracking & starting to become illegible

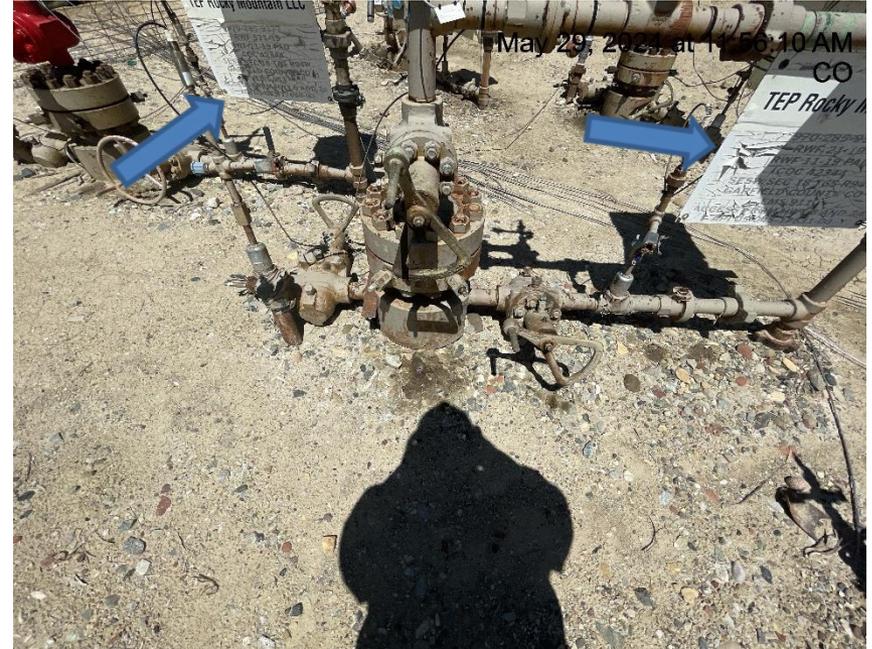
Photo # 8665 Multiple wellhead signs weathered/fading & cracking & starting to become illegible
