Construction and Stormwater Inspection

Operator: Crestone Peak Resources Operating LLC -
10633

Location ID: 486500

Inspection Photos
Location Name: Lussing Trust 4-64/19-20 North
Location ID: 486500

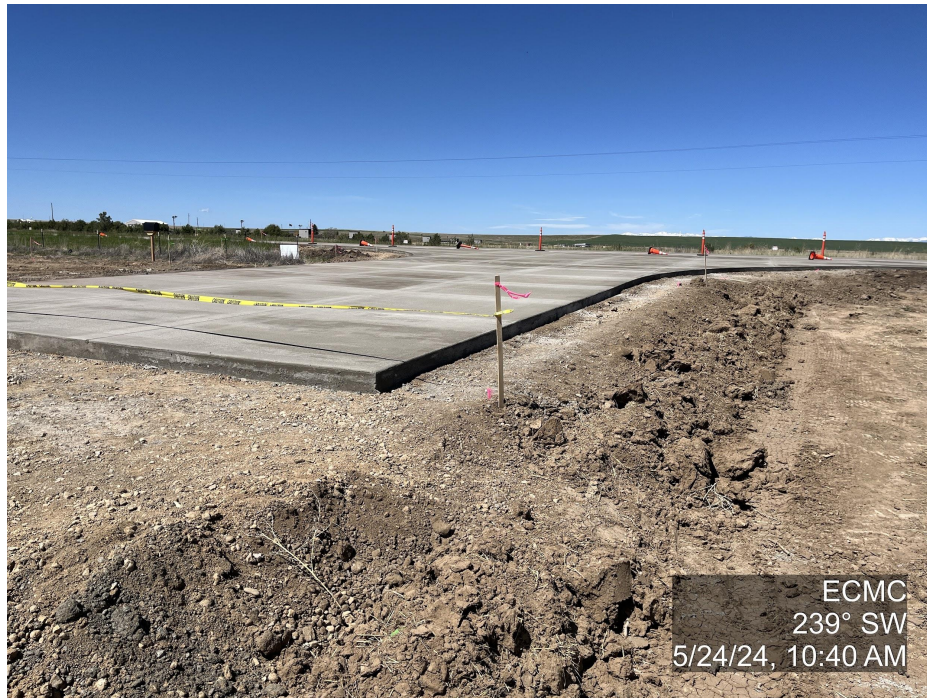
Photo 1. The photo was taken at the entrance to the well location facing Southwest. The photo illustrates the newly poured concrete entrance skirt.

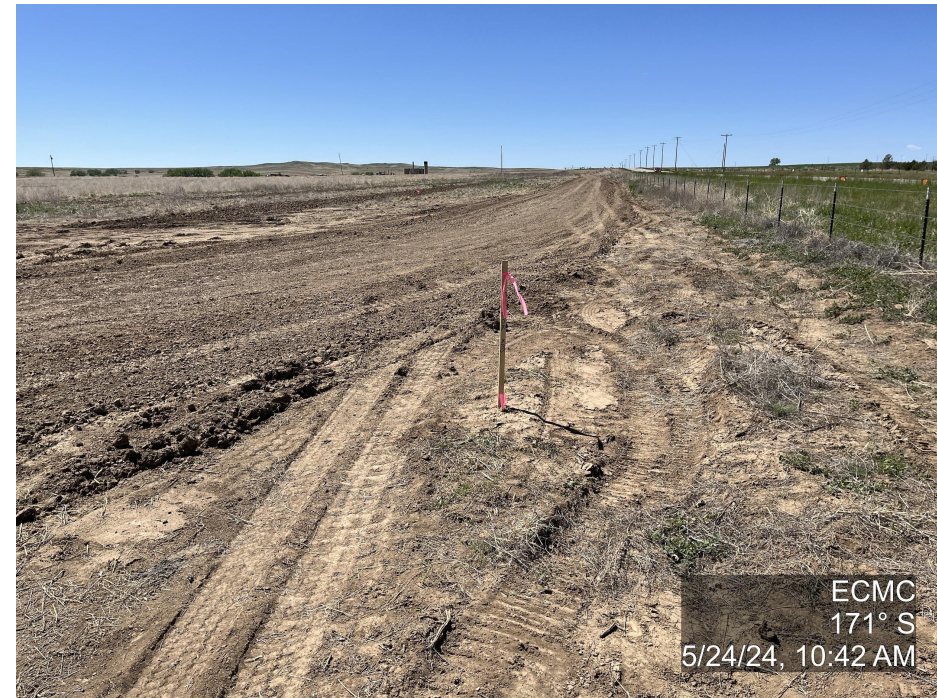
Photo 2. The photo was taken at the entrance to the well location facing South. The photo illustrates the initial access road used while the concrete entrance sets.

Note - this access road will need reclaimed.

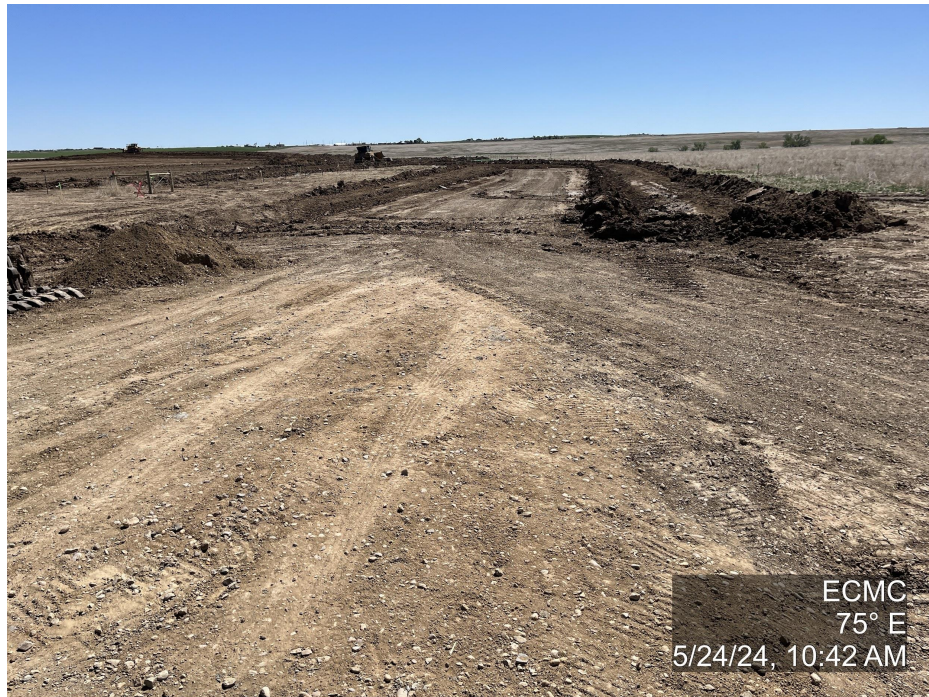
Photo 3. The photo was taken at the well location facing East. The photo illustrates the access road topsoil has been salvaged to either side and is still in the process of being stabilized.

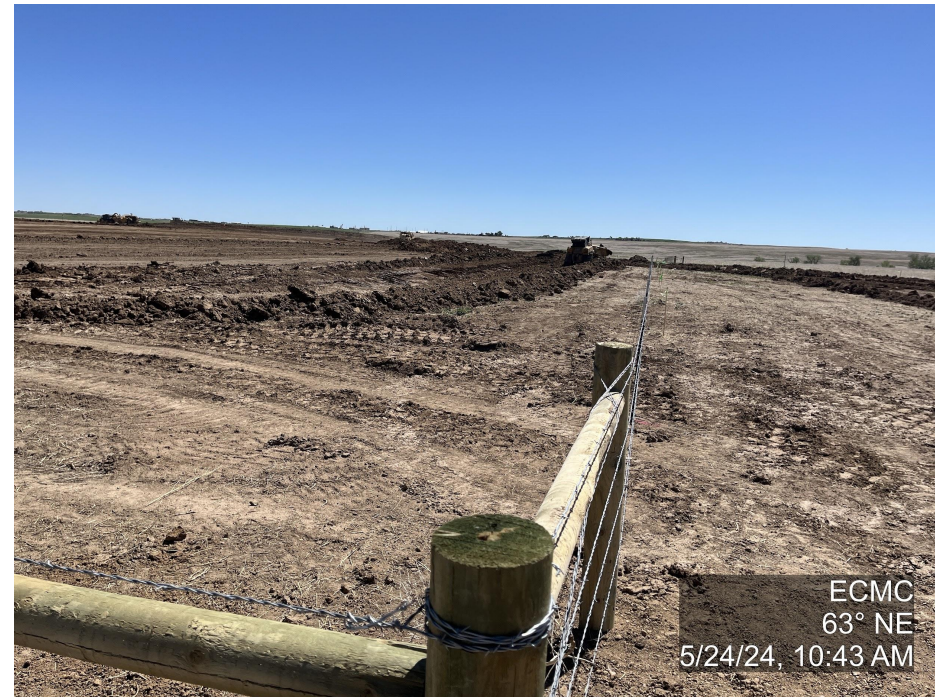
Photo 4. The photo was taken at the well location facing Northeast. The photo illustrates the disturbance area boundary fencing and topsoil removal in process.

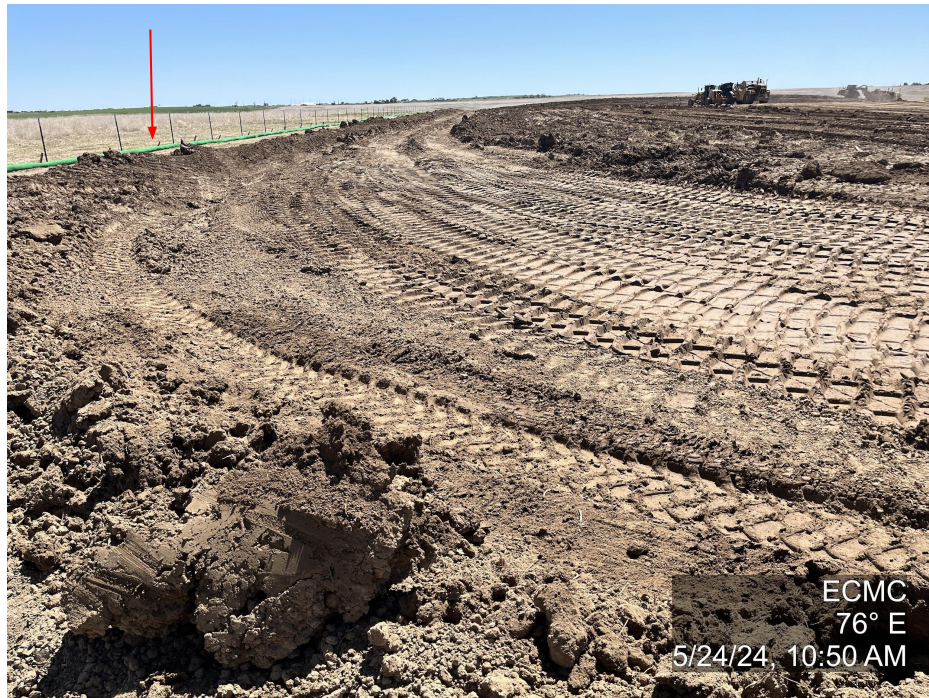
Photo 5. The photo was taken at the well location facing East. The photo illustrates topsoil removal in process as well as perimeter erosion control.

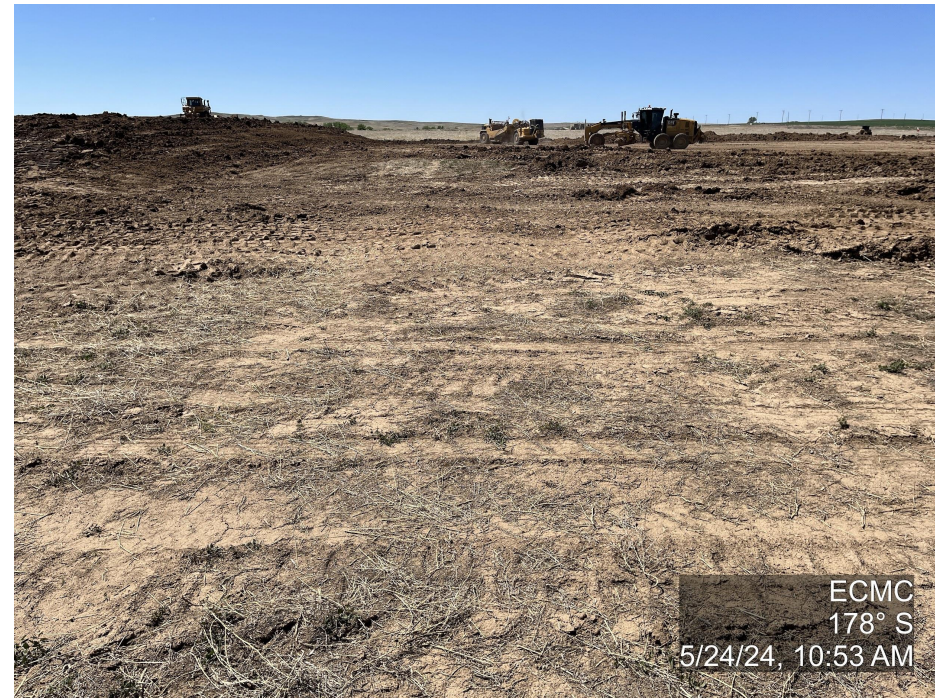
Photo 6. The photo was taken at the well location facing South. The photo illustrates the topsoil being stockpiled.
