**Antler Energy LLC
Federal-Chamberlin 22-1
Location ID: 312863**

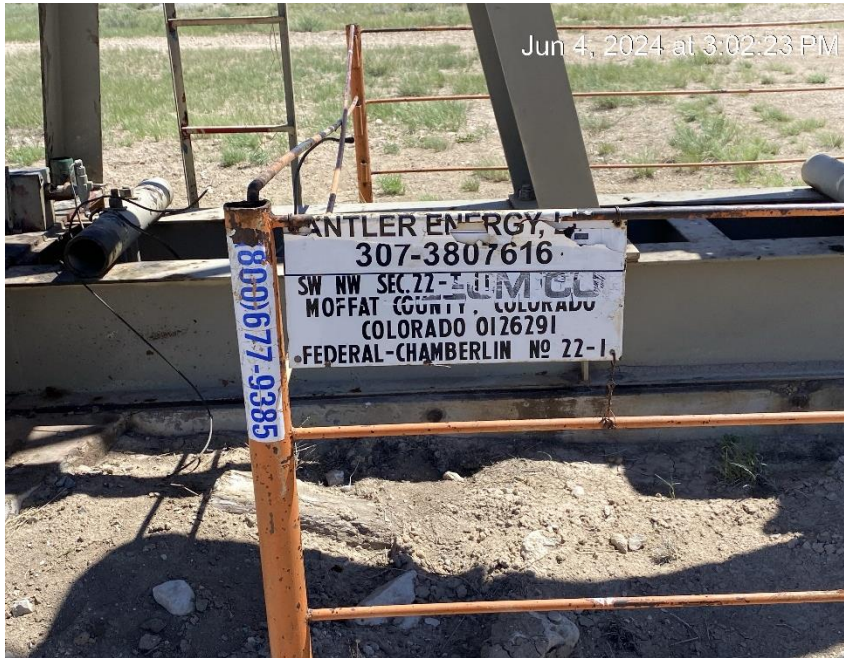
When replaced additional information will be required

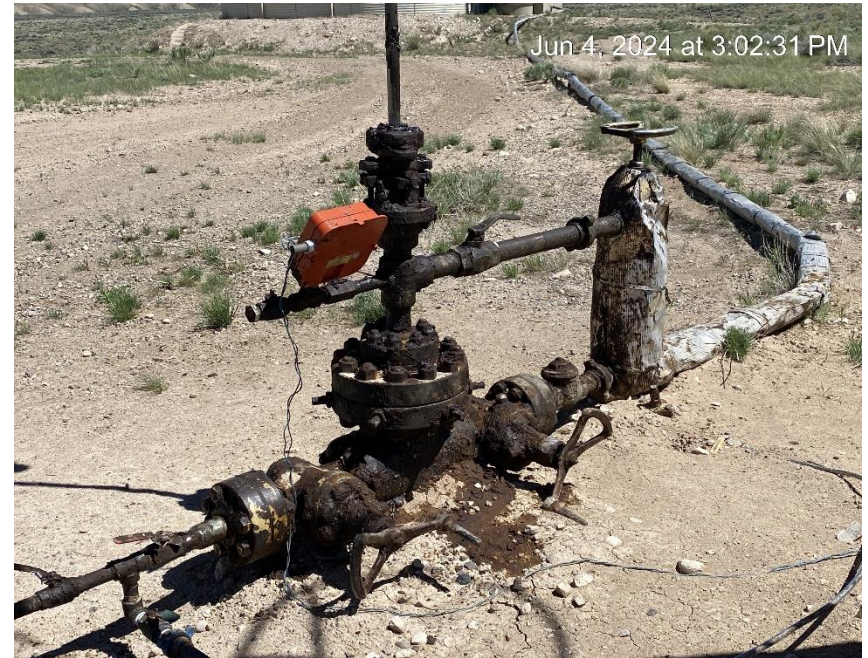
Oily waste. Stained soil.

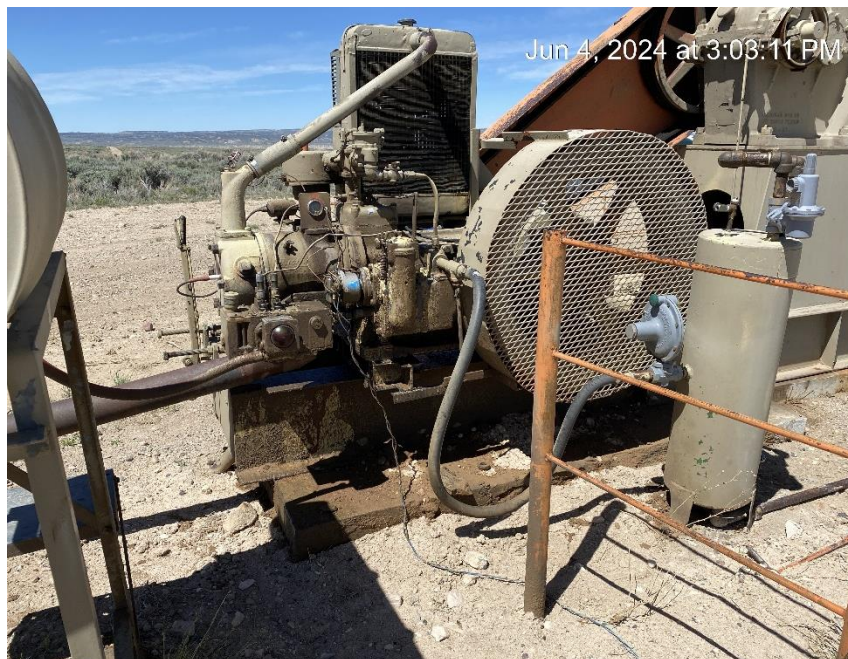
Oily waste. Covered staining?

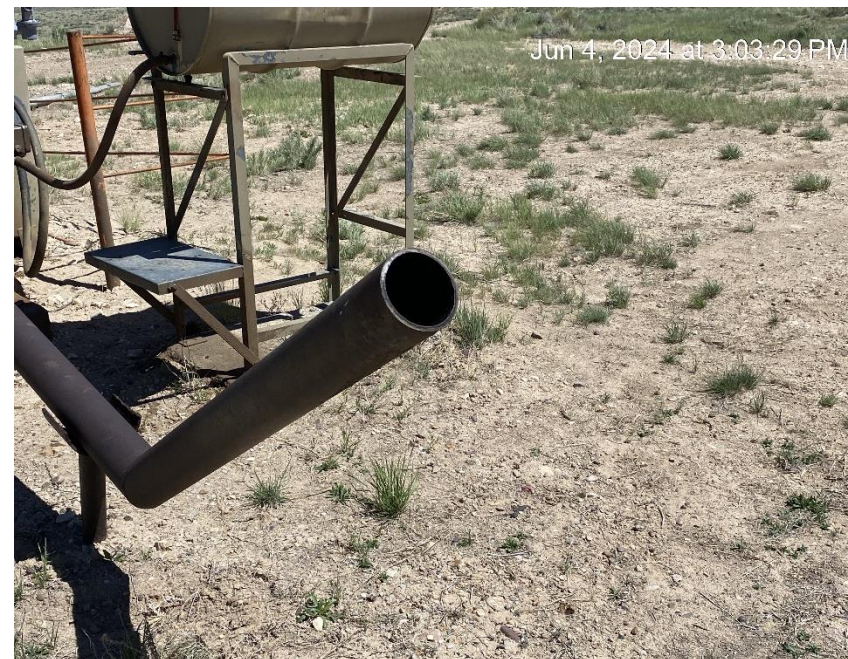
Open to wildlife

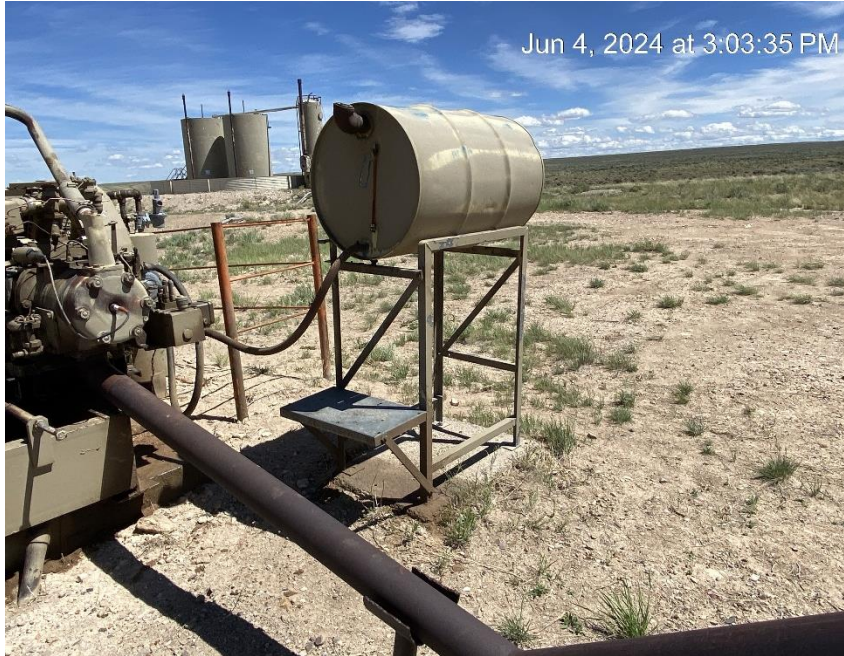
No containment or contents label.

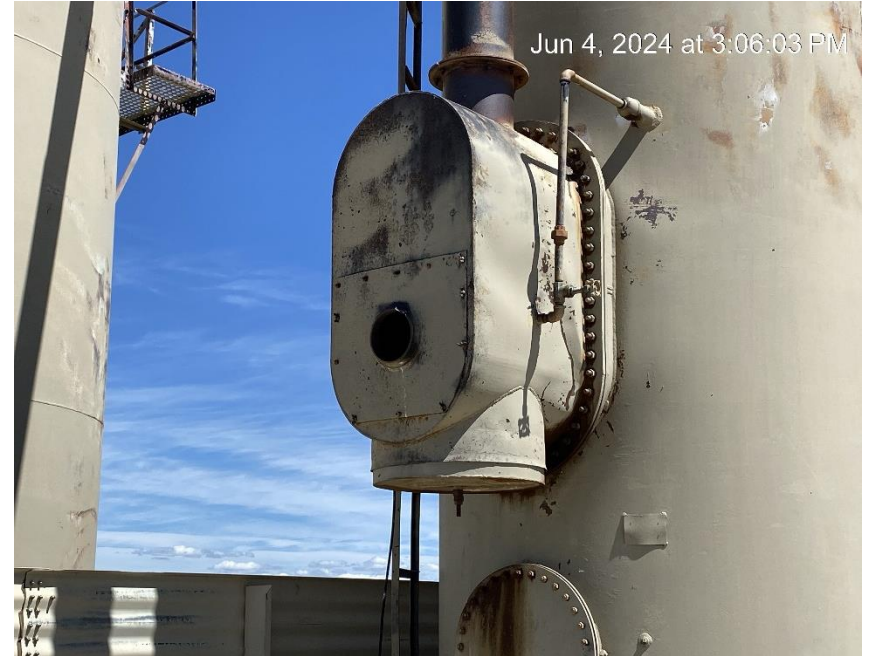
Open to wildlife.

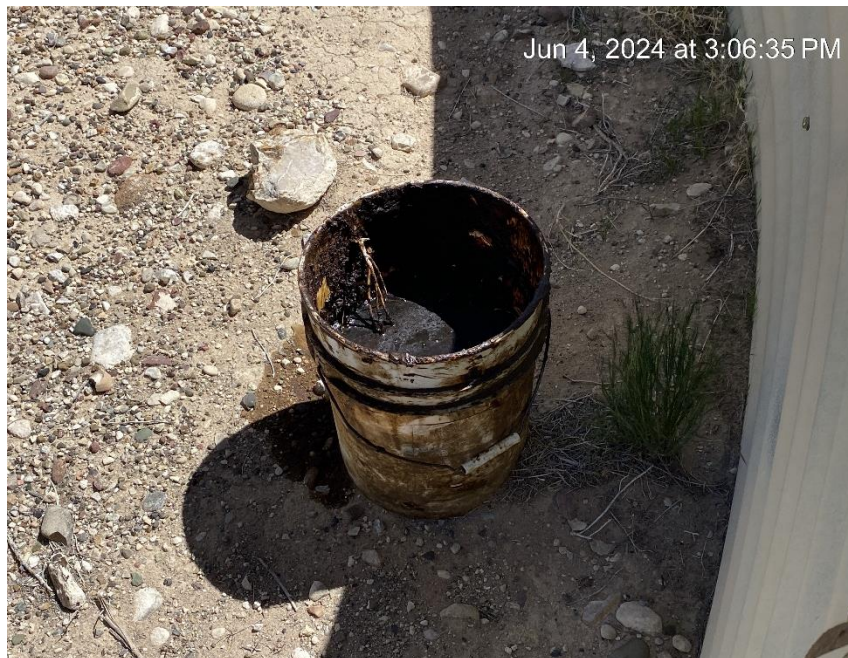
Oily waste. Open to wildlife.

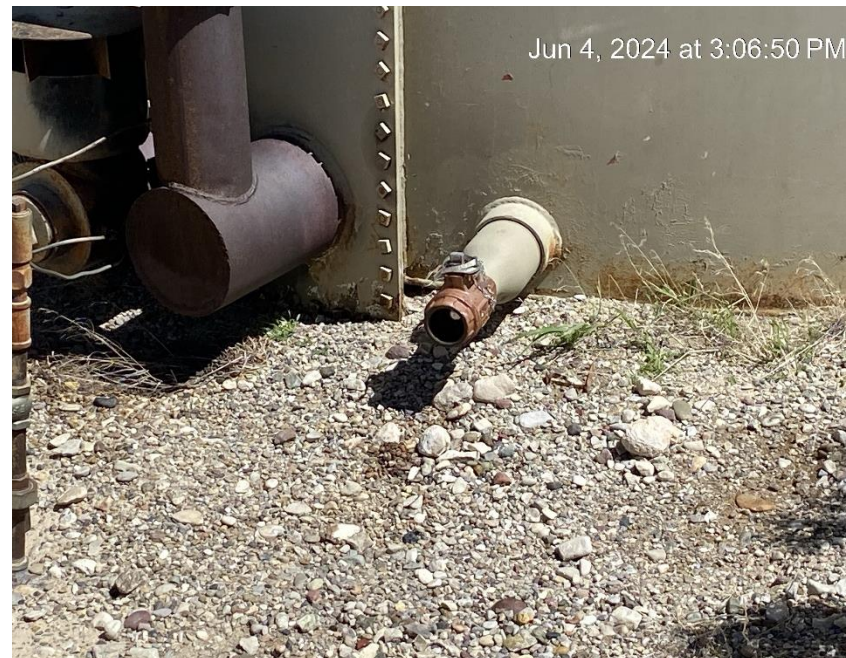
Open end tank valve. Stained soil.

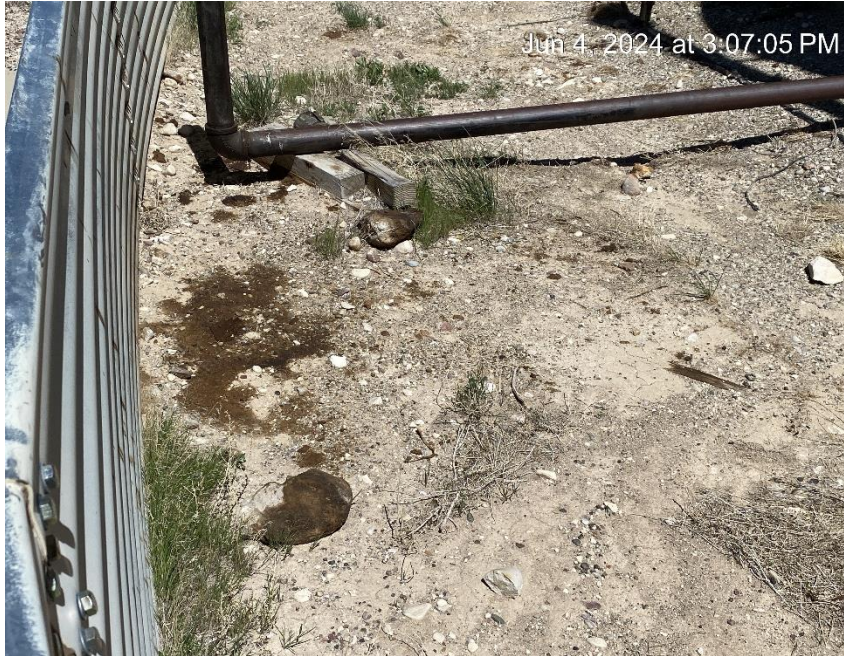
Debris. Stained soil.

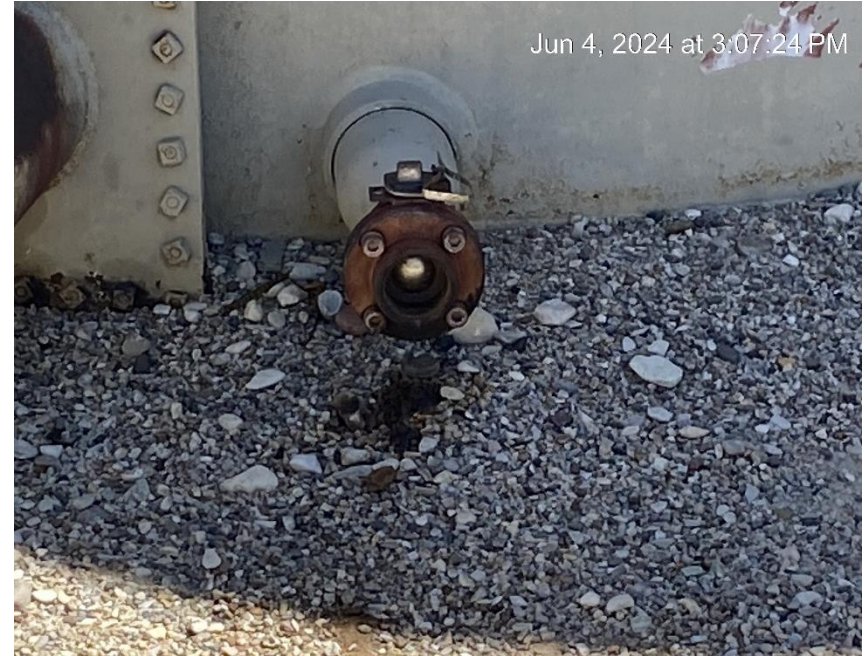
Open end tank valve. Oily waste. Stained soil.

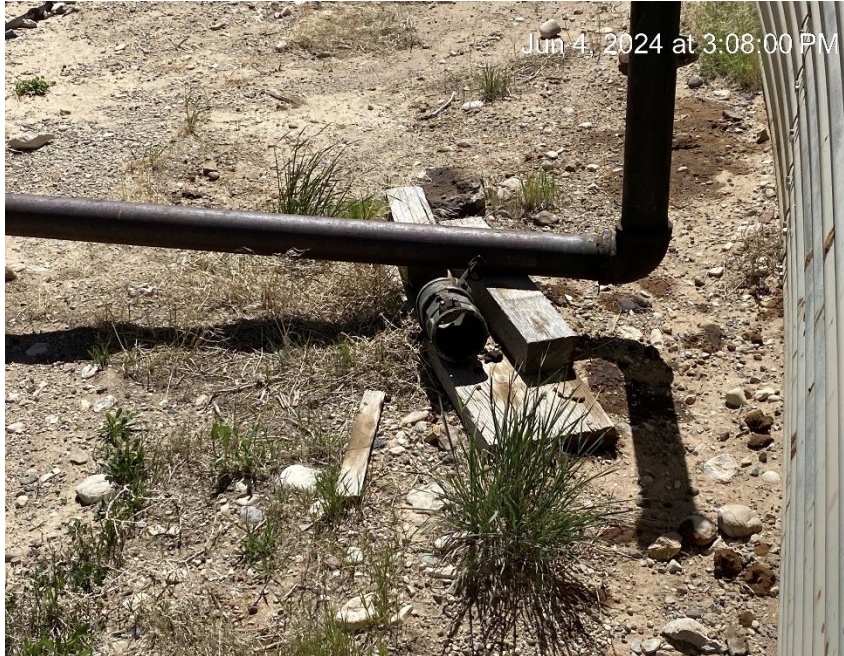
Debris. Stained soil.

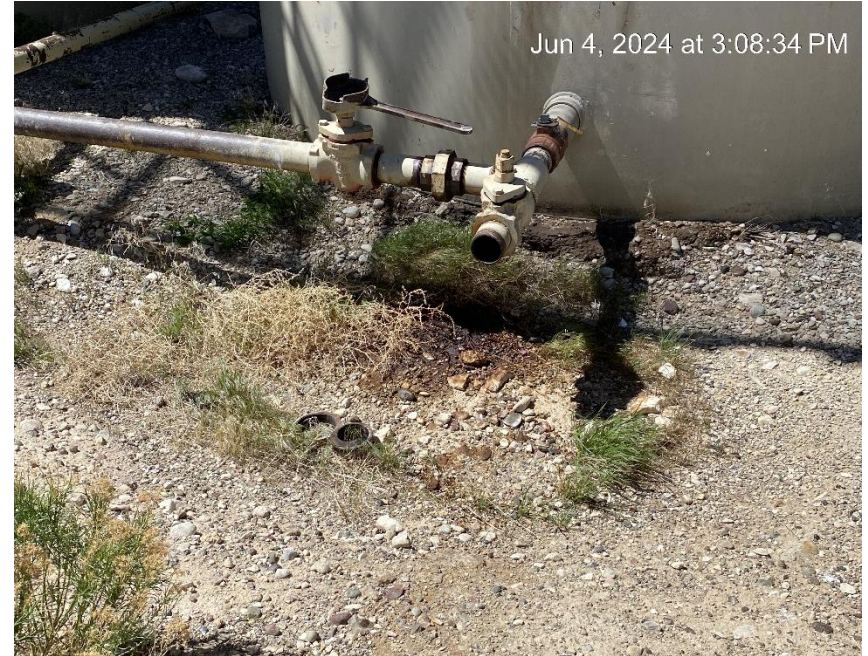
Oily waste. Open end tank valve

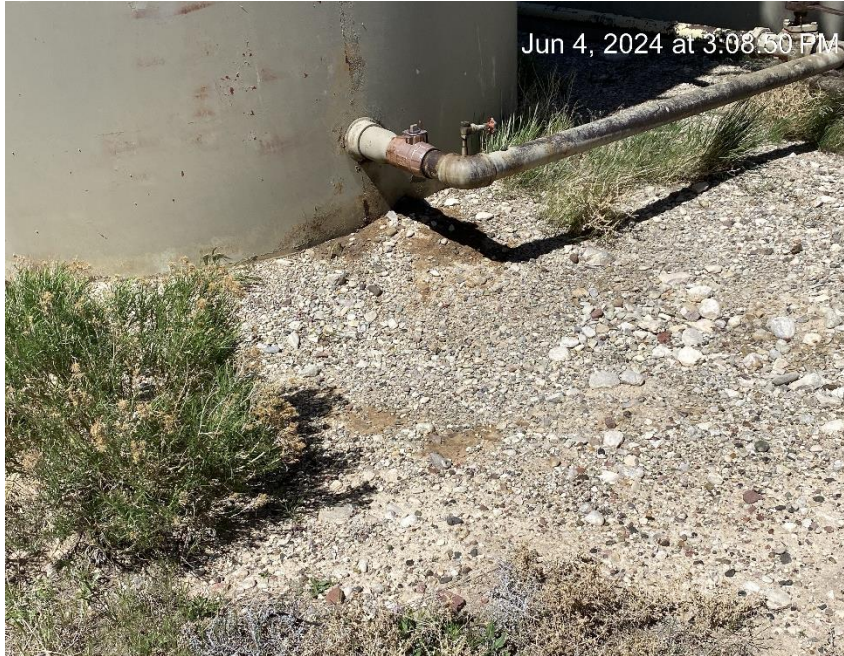
Oily waste. Open end tank valve.

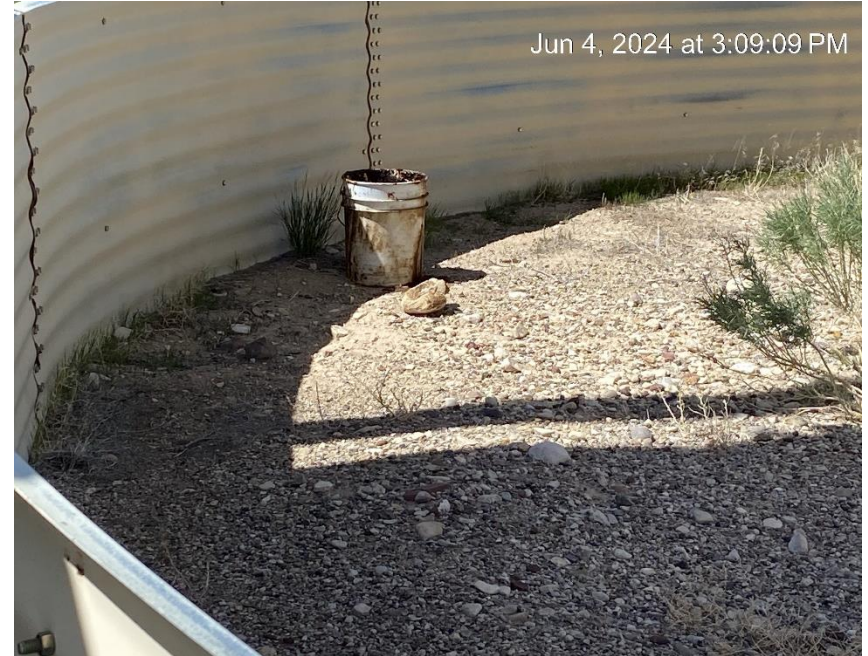
Debris

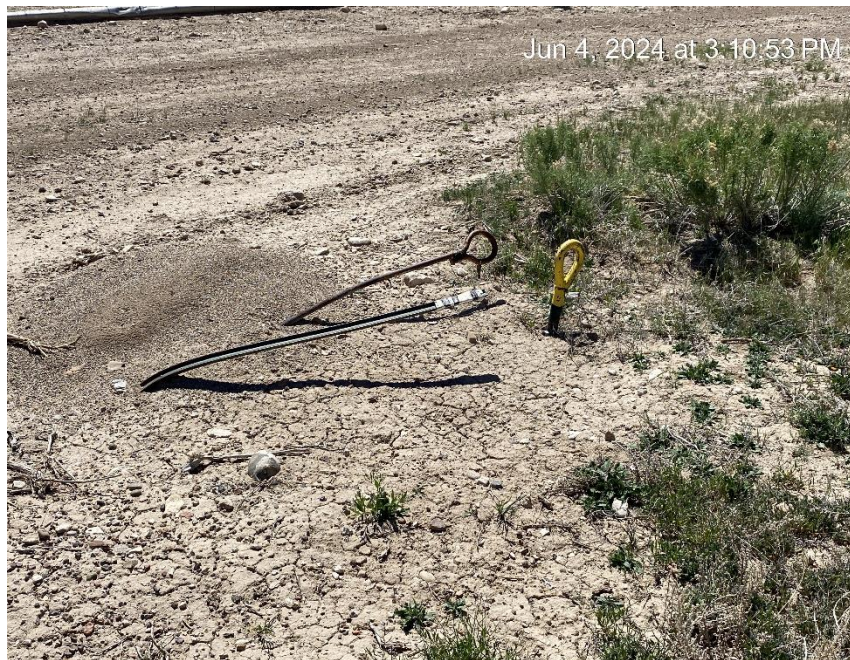
Unmarked anchors

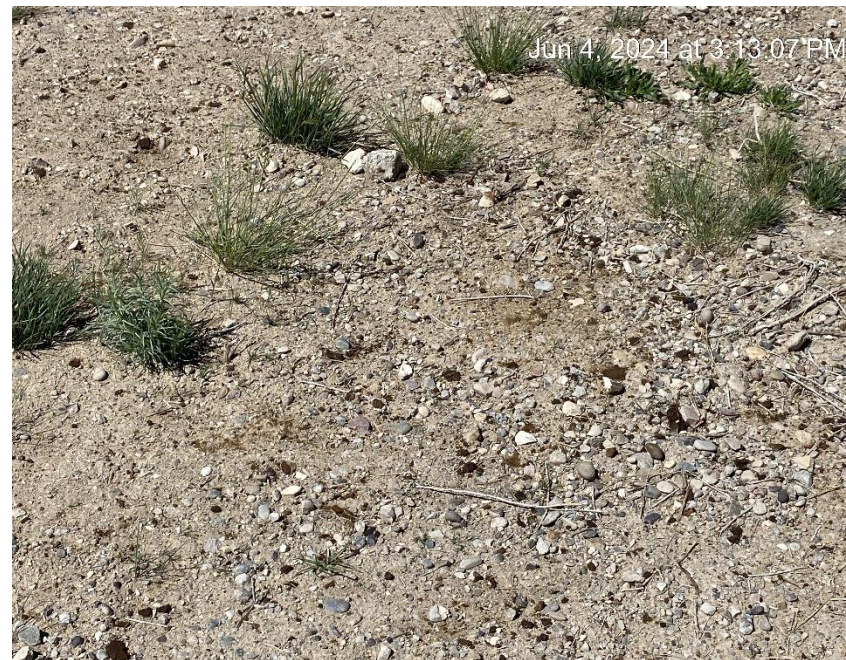
Oily waste around wellhead
