# Inspection Photos

API: 017-06625

Operator: **WILLIFORD ENERGY COMPANY**

Inspection Date: 5/30/2024

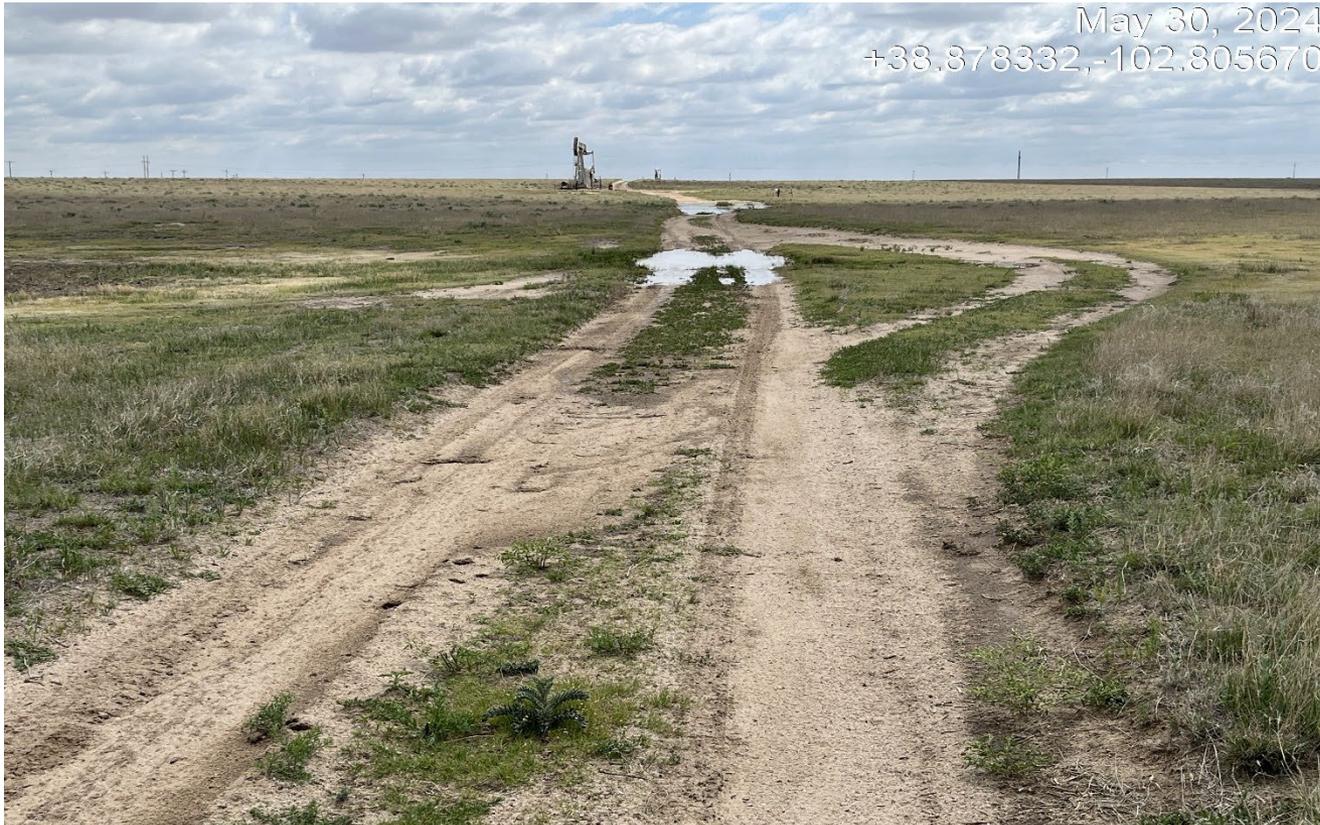
**Photo 1.** Facing east along the access road. Vehicles are causing unnecessary disturbance driving outside of the access road due to stormwater pooling on the road. The access road must be maintained and shall not drive outside of the access road boundary.

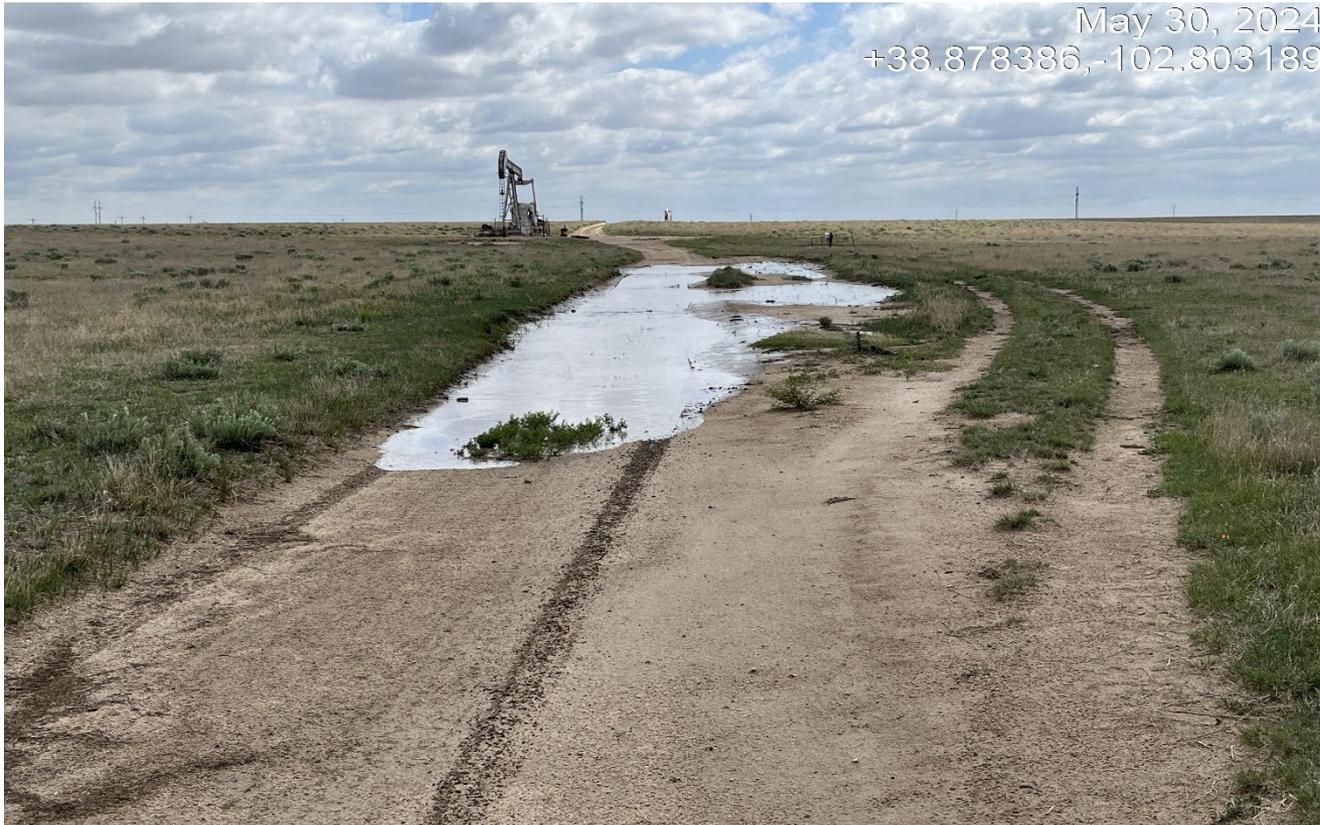
**Photo 2.** Facing east along the access road. Vehicles are causing unnecessary disturbance driving outside of the access road due to stormwater pooling on the road. The access road must be maintained and shall not drive outside of the access road boundary.

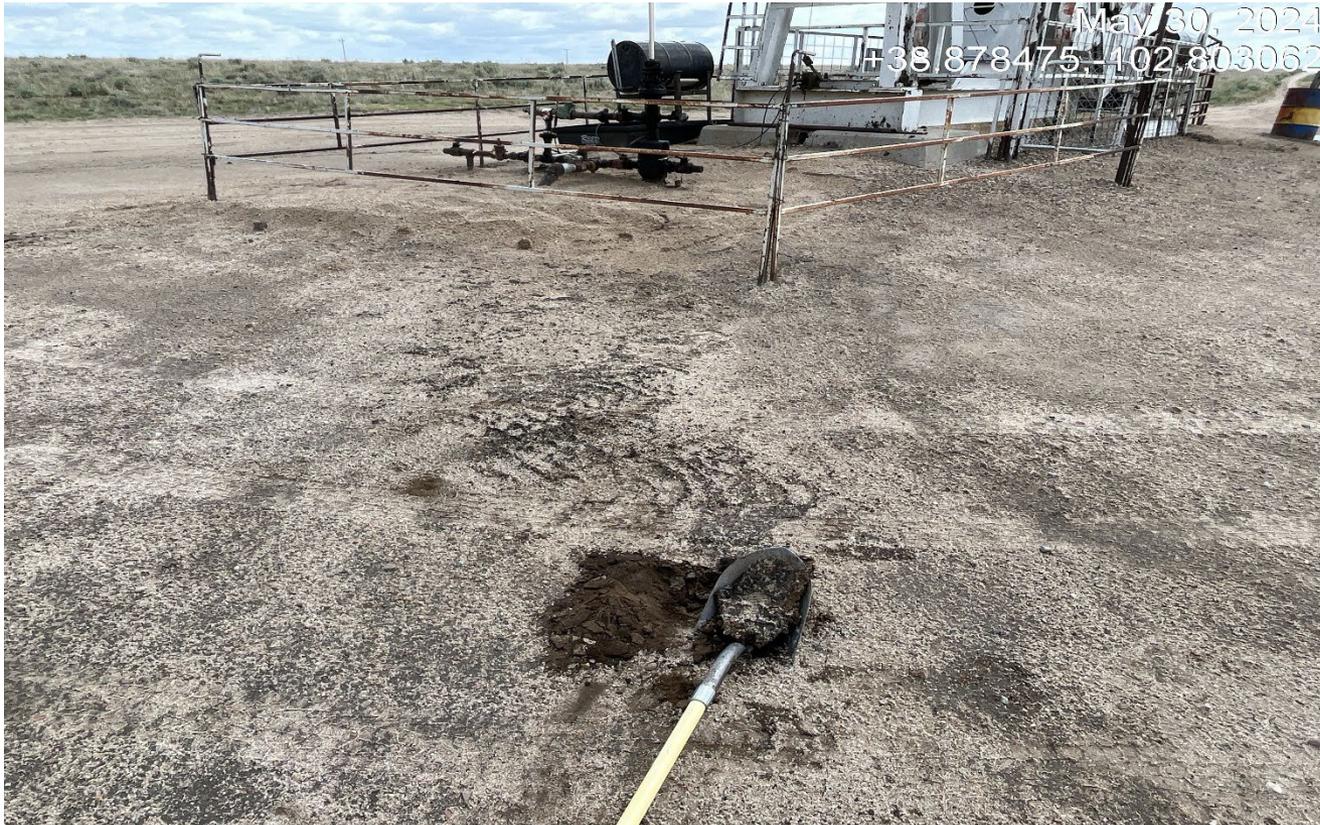
**Photo 3.** Facing northeast toward the wellsite. There is impacted soils from the previous spill that were not cleaned up.

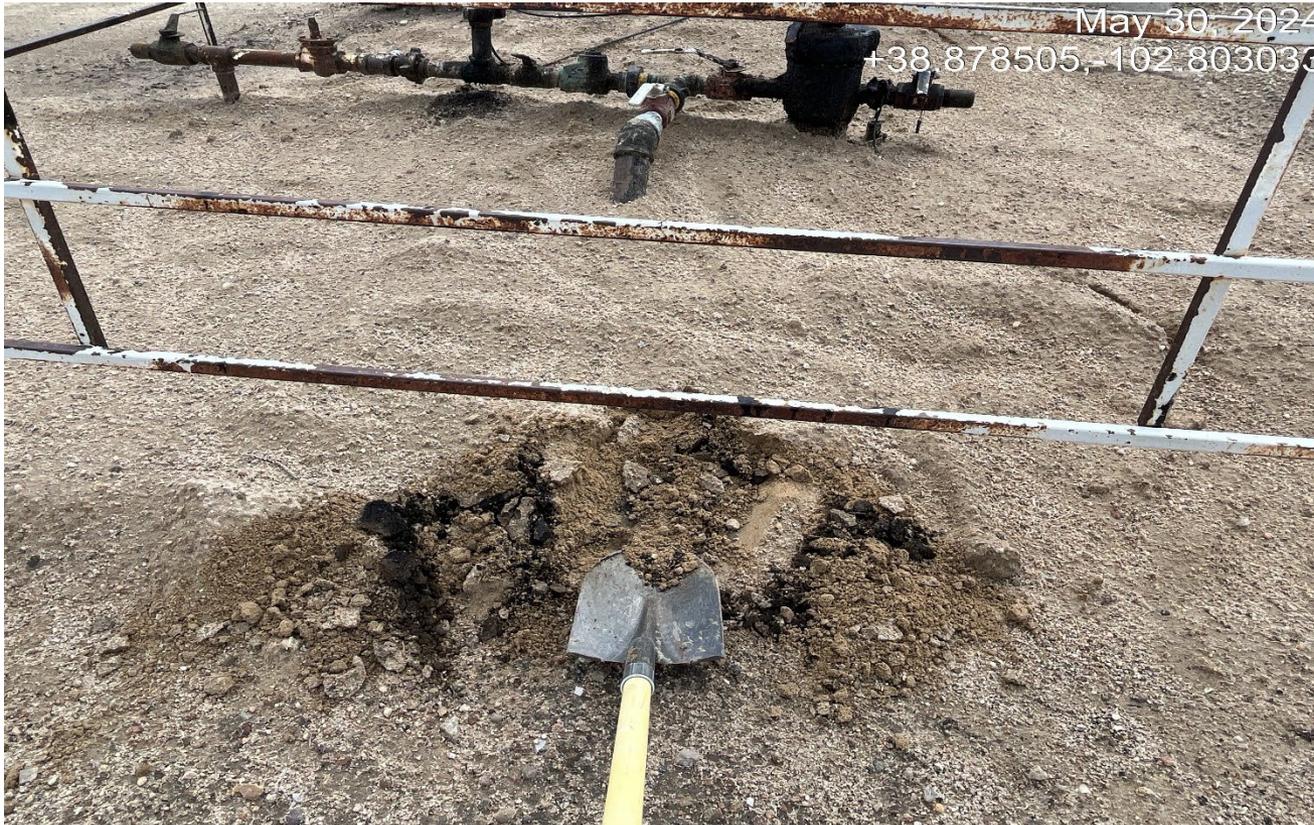
**Photo 4.** It appears there was sand spread on top of the spill which was not cleaned up per the rules.

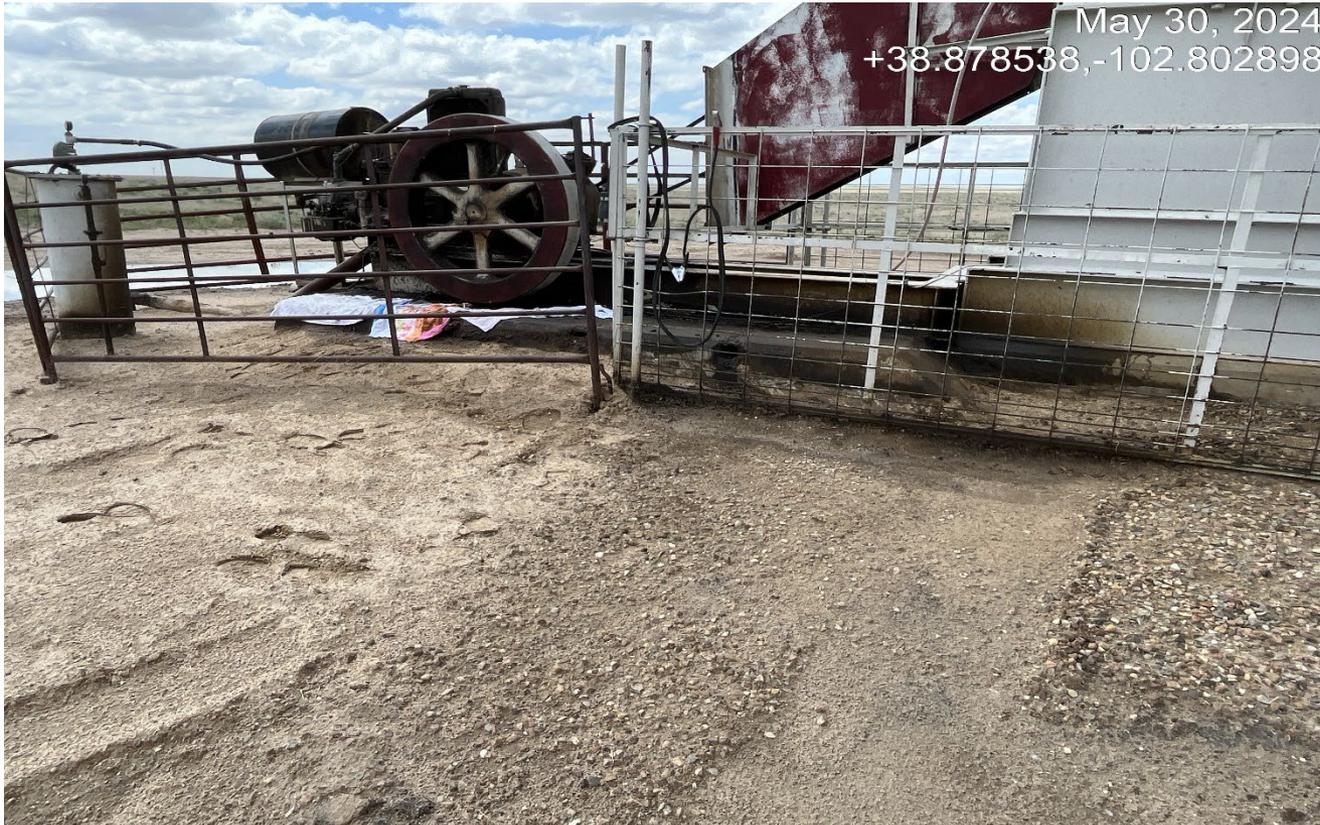
**Photo 5.** The pumpjack engine is still leaking oil and there

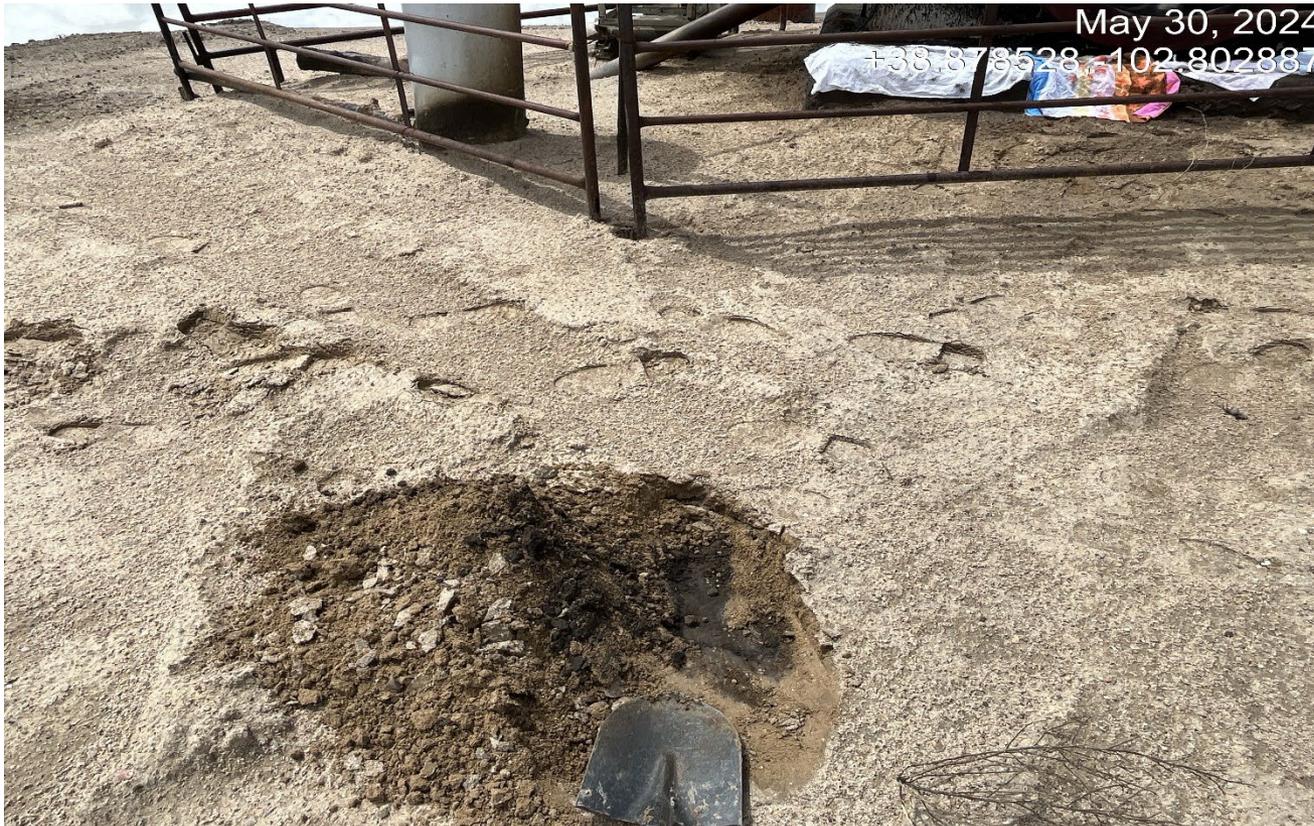
**Photo 6.** It appears there was sand spread on top of the spill which was not cleaned up per the rules.

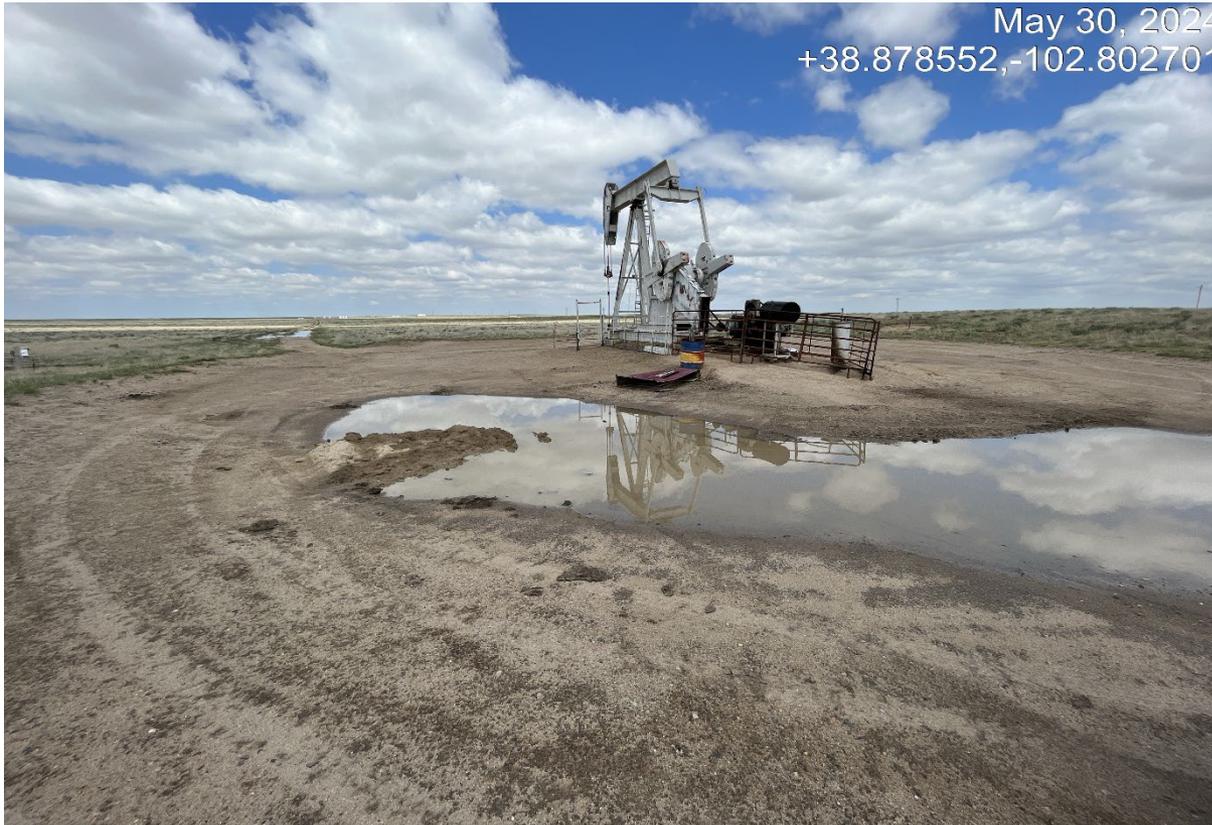
**Photo 7.** Facing west toward the location. There is water pooling at the east side of the location..
