# Inspection Photos

API: 017-06636

Operator: **WILLIFORD ENERGY COMPANY**

Inspection Date: 5/30/2024

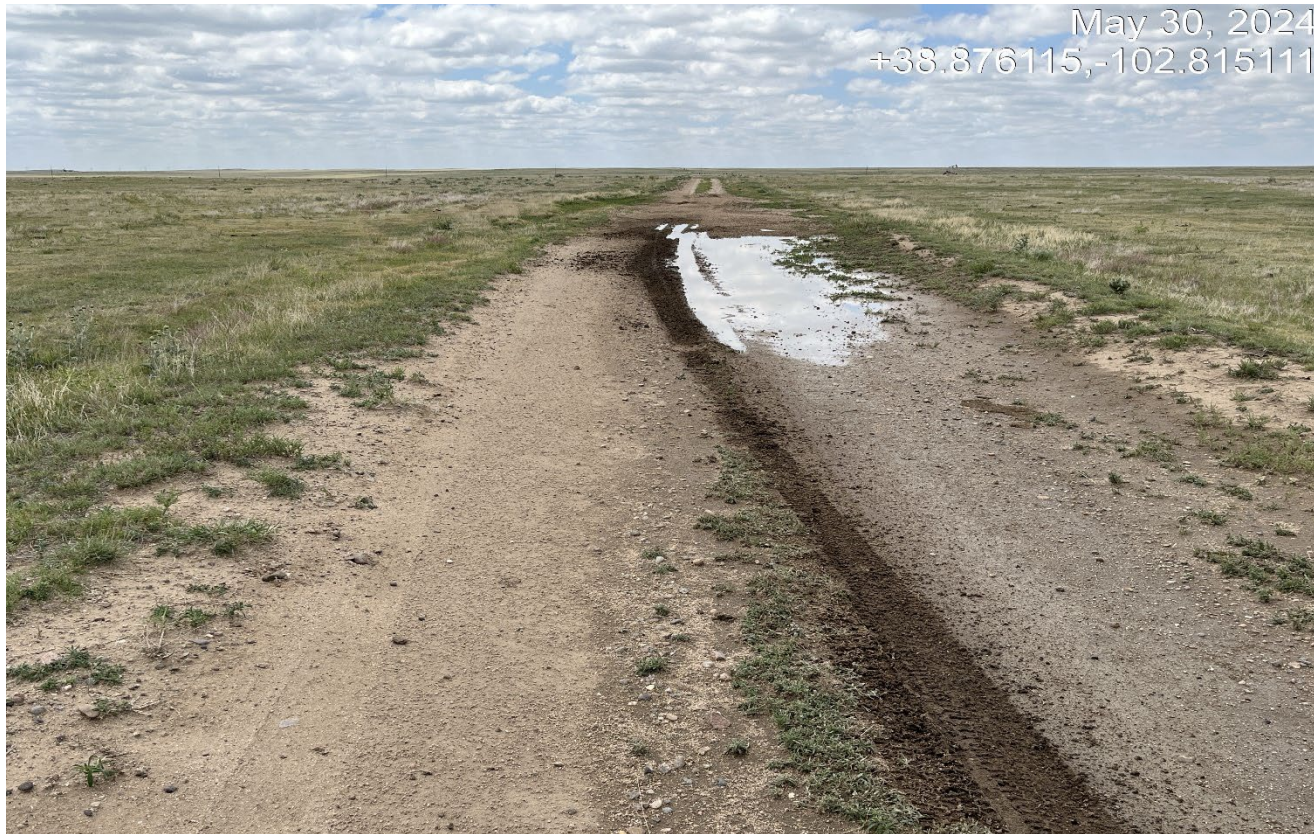
**Photo 1.** Facing south along the access road. Vehicles are causing unnecessary disturbance driving outside of the access road due to stormwater pooling on the road. The access road must be maintained and vehicles shall not drive outside of the access road boundary. Previous corrective action was not completed.

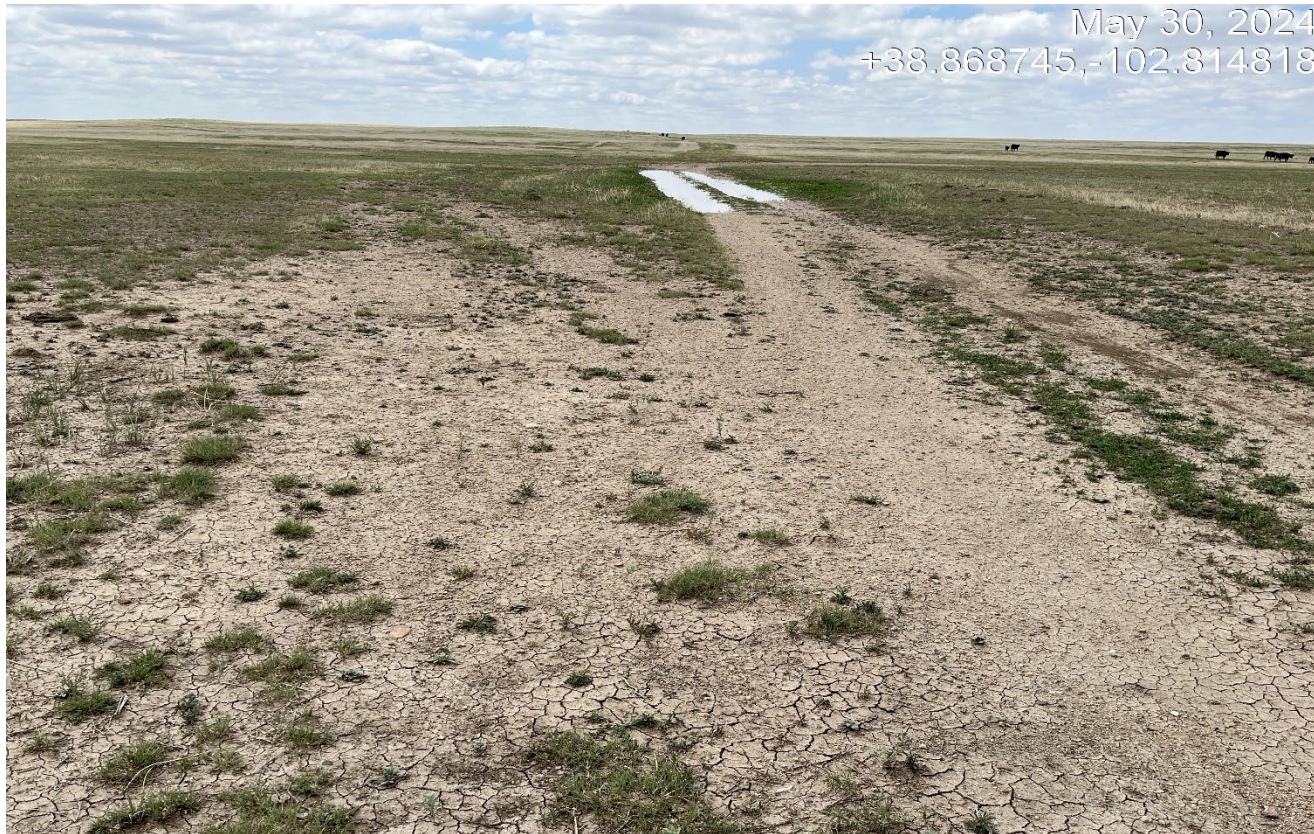
**Photo 2.** Facing south along the access road. Vehicles are causing unnecessary disturbance driving outside of the access road due to stormwater pooling on the road. The access road must be maintained and vehicles shall not drive outside of the access road boundary. Previous corrective action was not completed.

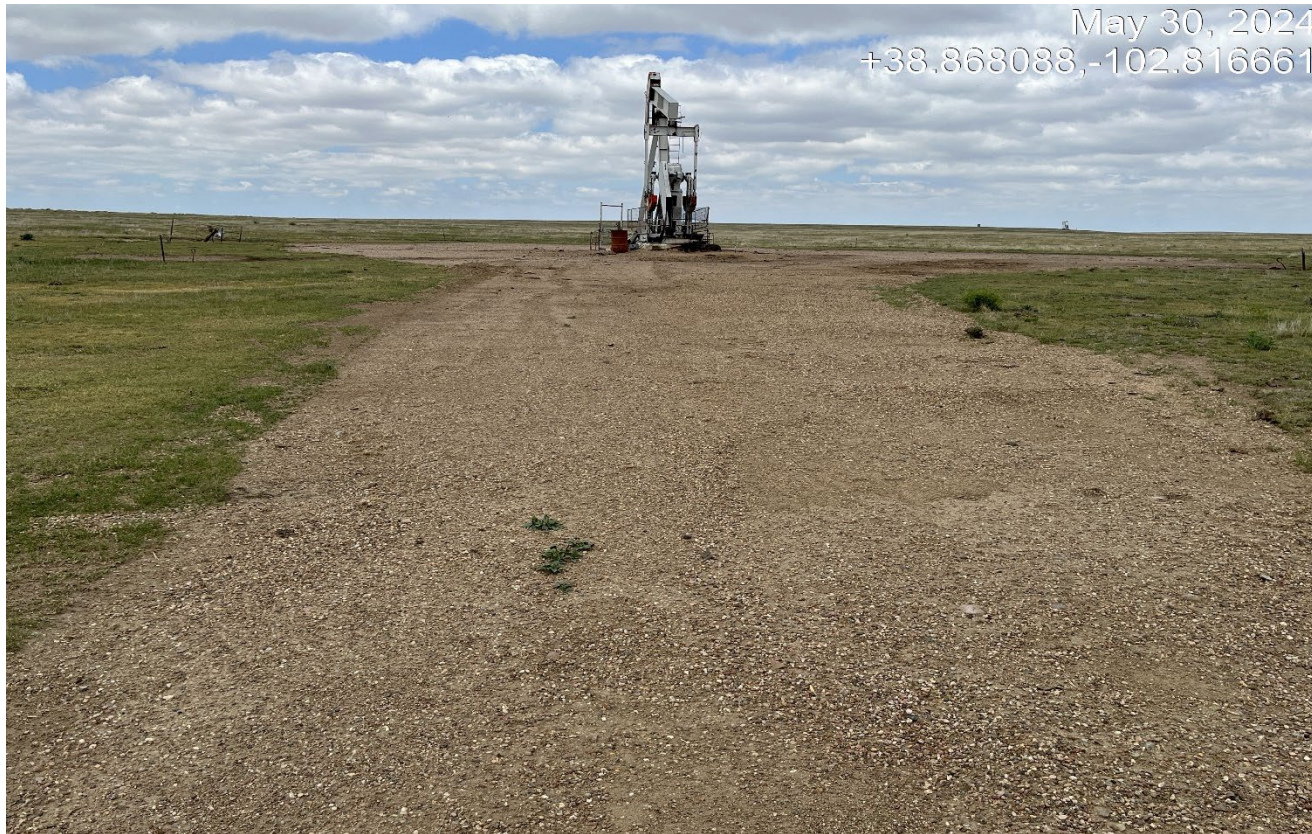
**Photo 3.** Facing west along the road toward the wellsite. There has been gravel spread along the area where erosion channel was previously observed.

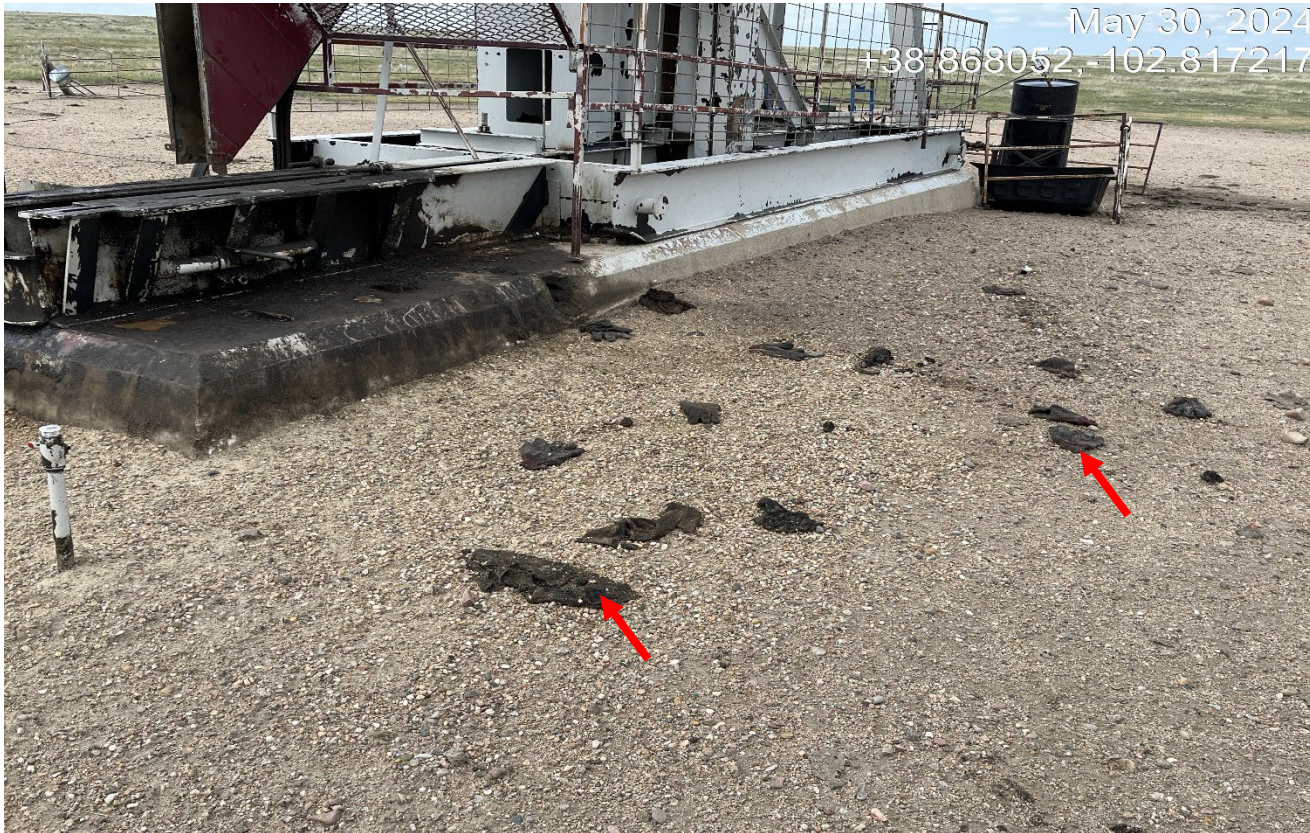
**Photo 5.** There are oily rags in this are that must be disposed.

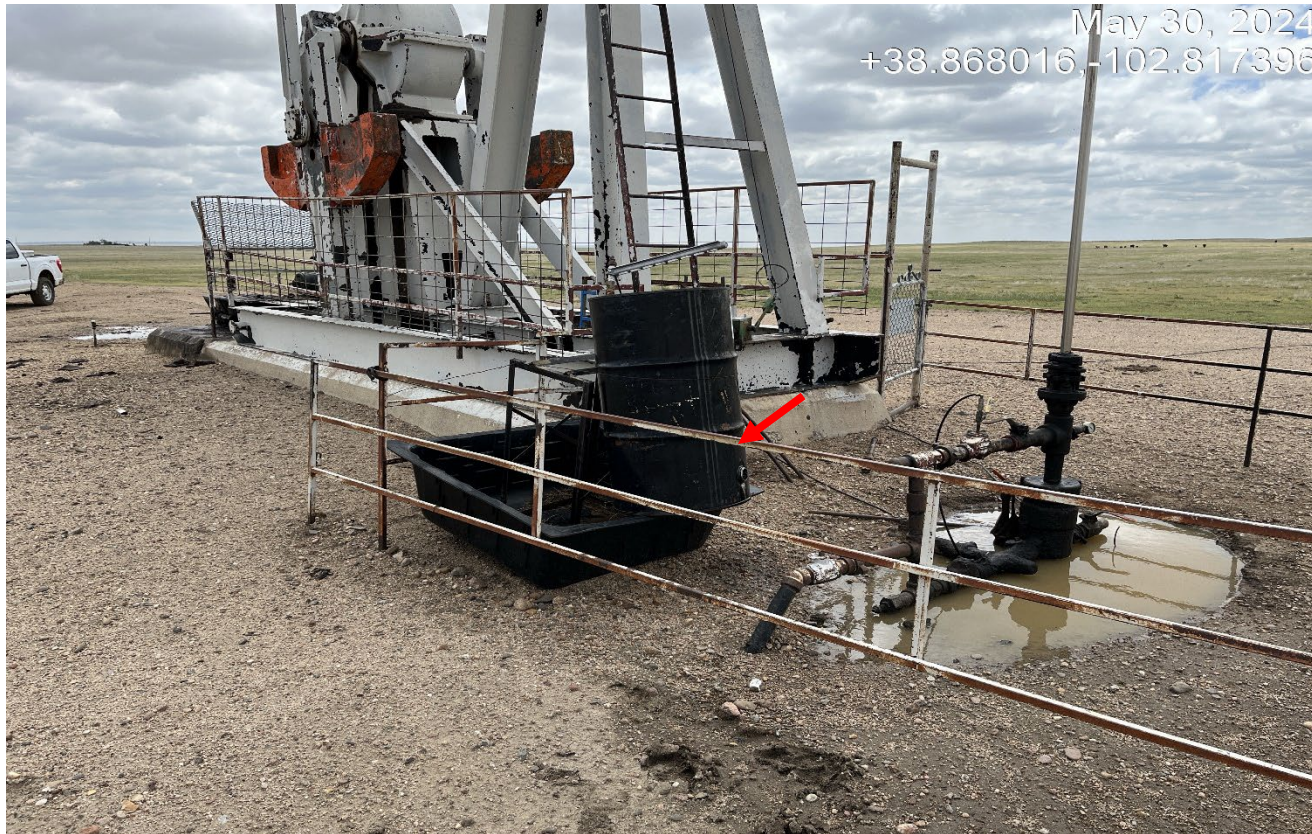
**Photo 6.** Facing toward the wellhead. The barrel is not properly set in the containment and there is no netting on the secondary containment..

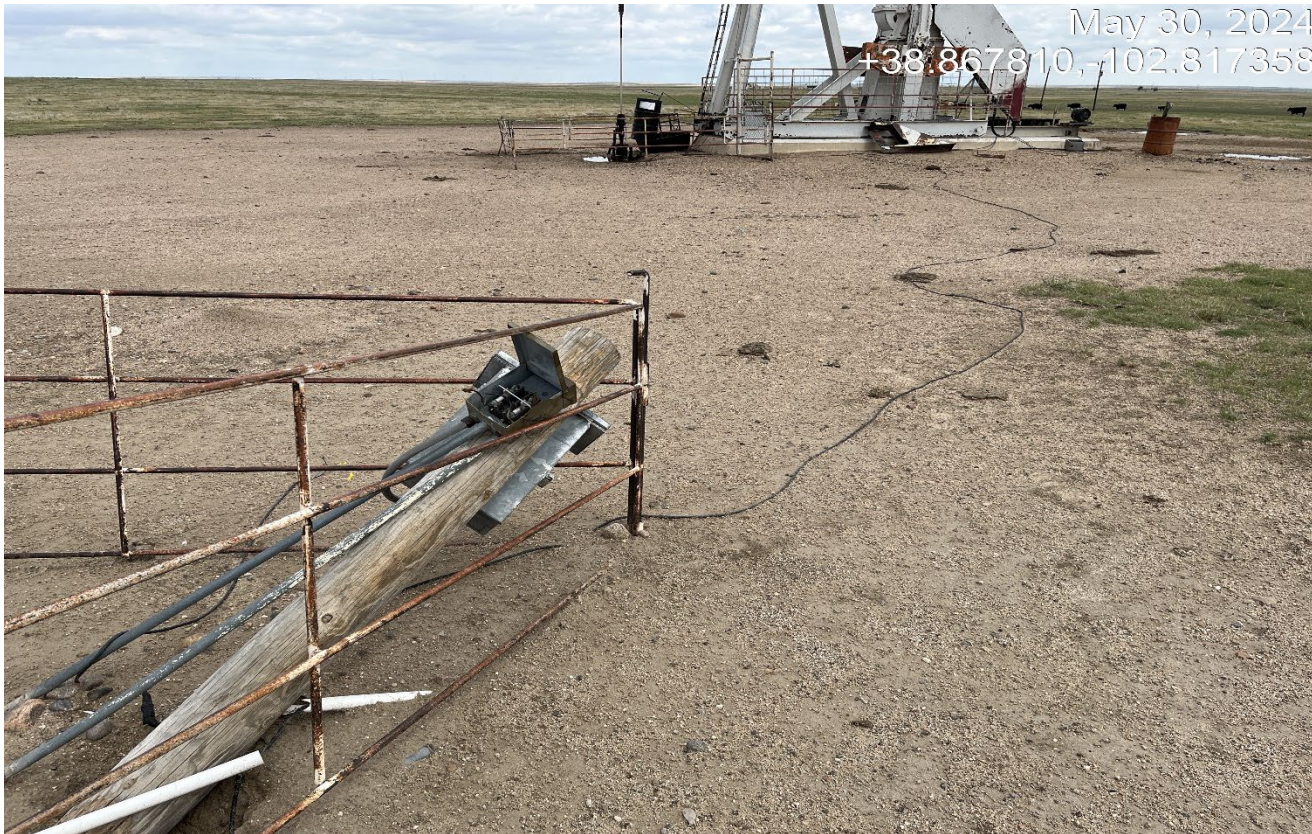
**Photo 7.** Facing toward the electric utility just south of the well. The electric wire is on the surface and not protected which is a safety concern. The electric breaker is disconnected from the electric line.
