Inspection Photos

Location Name: CAERUS PICEANCE LLC GRAHAM 32-12 (L32) Pad

Location #: 334830

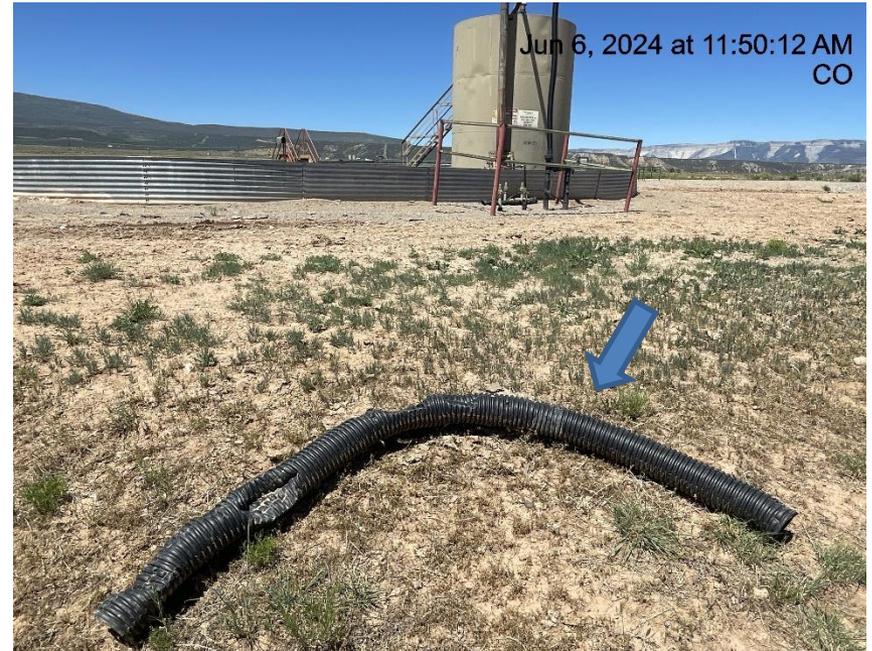
Photo # 9944 Debris

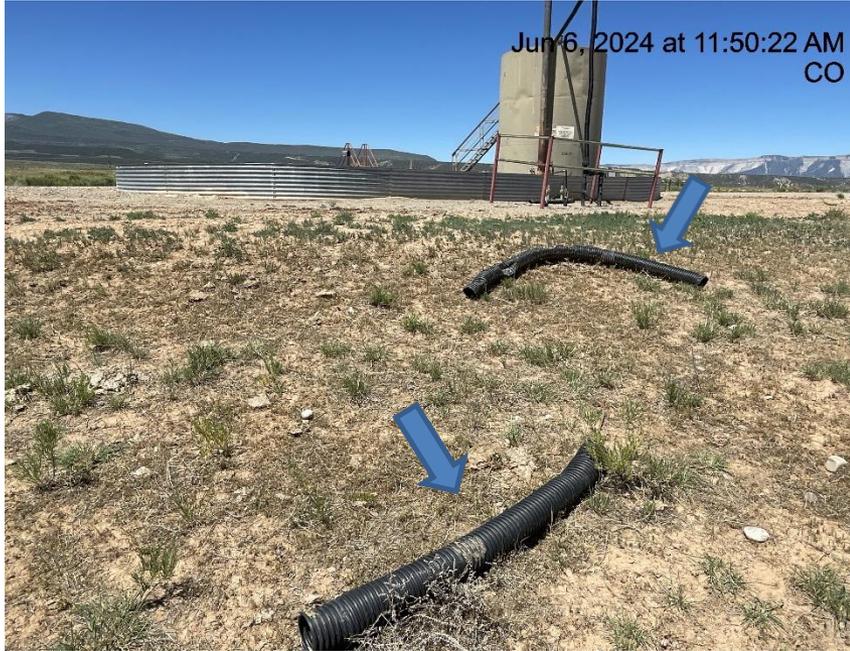
Photo # 9945 Debris

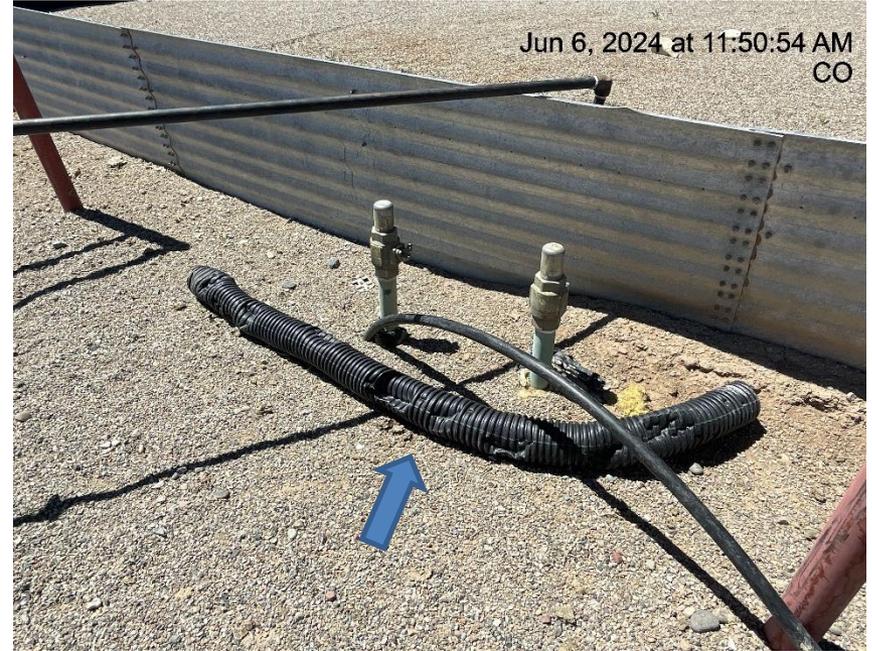
Photo # 9946 Debris

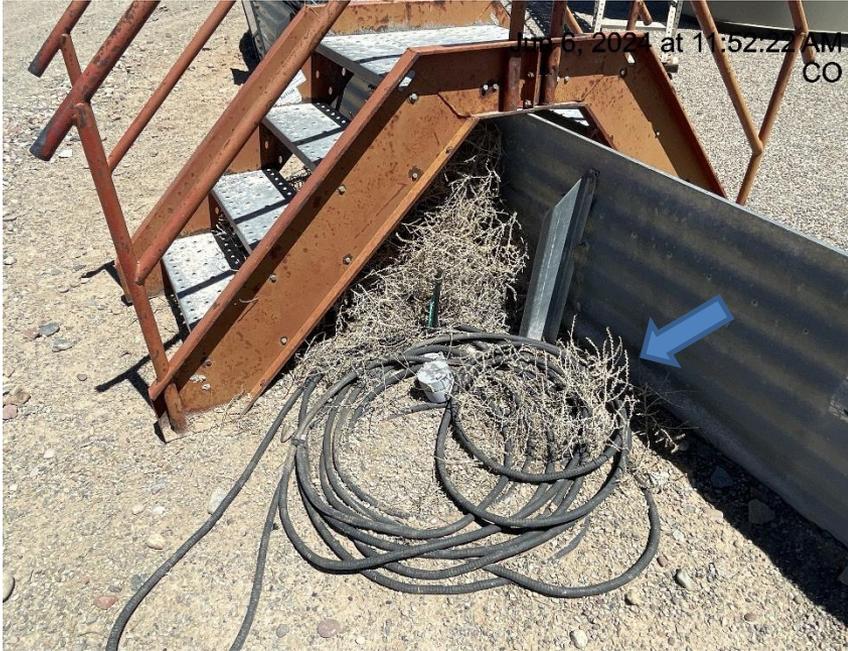
Photo # 9947 Debris

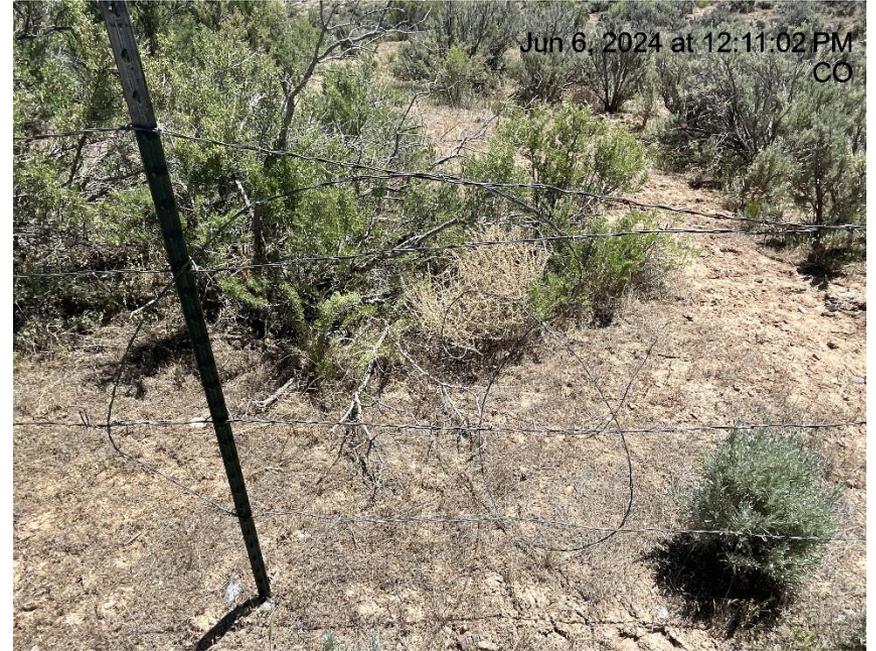
Photo # 9948 Barbed wire fence needs maintenance/wildlife hazard

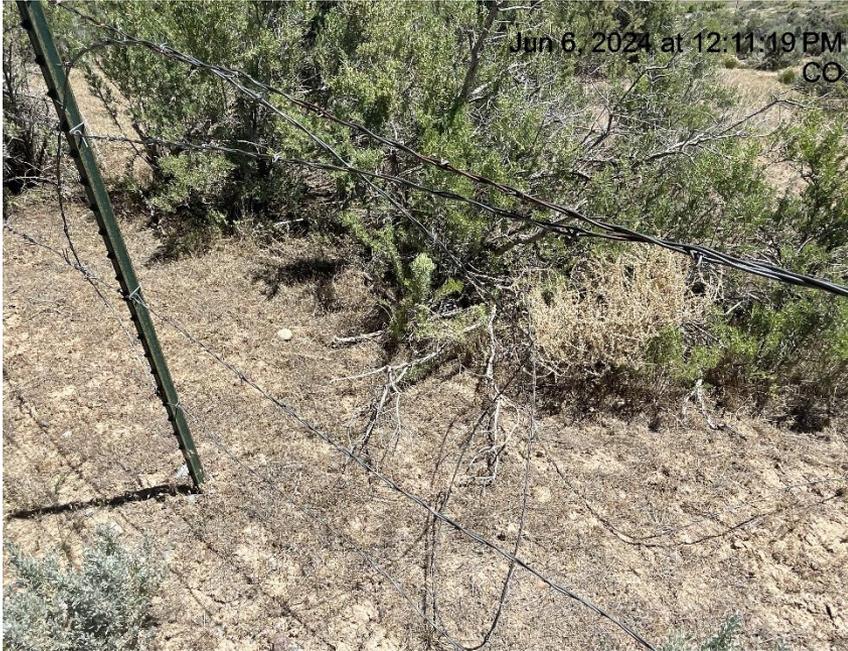
Photo # 9949 Barbed wire fence needs maintenance/wildlife hazard

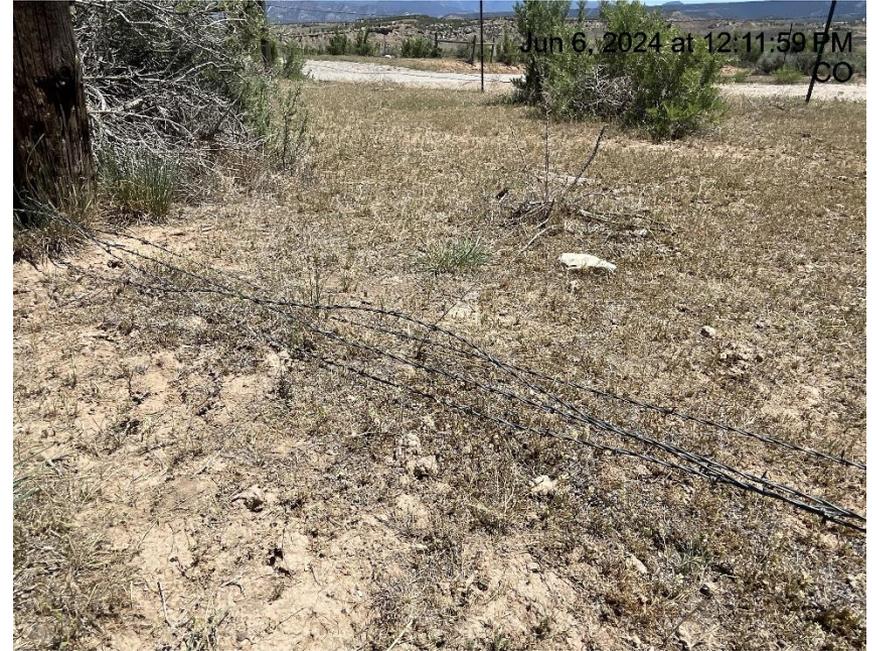
Photo # 9950 Barbed wire fence needs maintenance/wildlife hazard

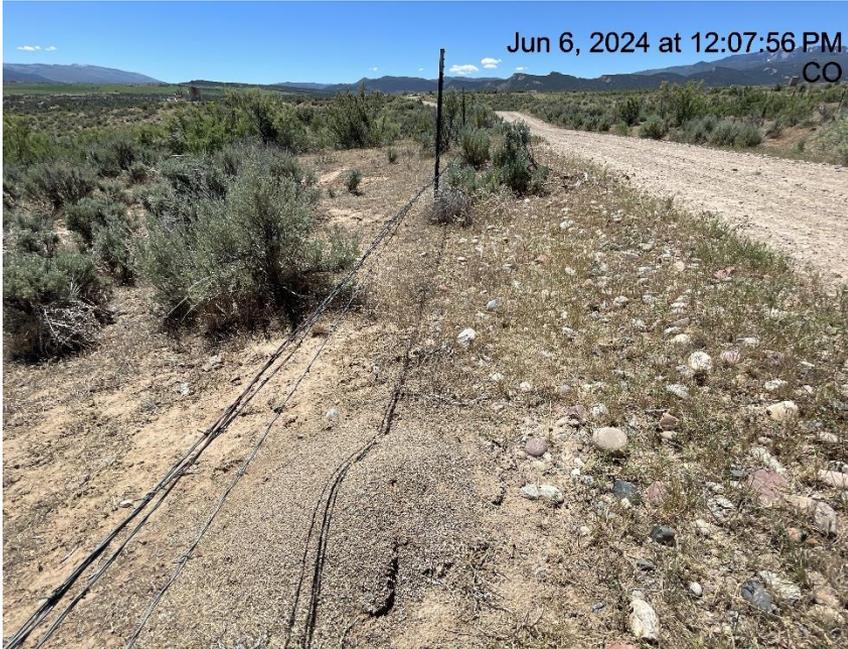
Photo # 9951 Barbed wire fence needs maintenance/wildlife hazard

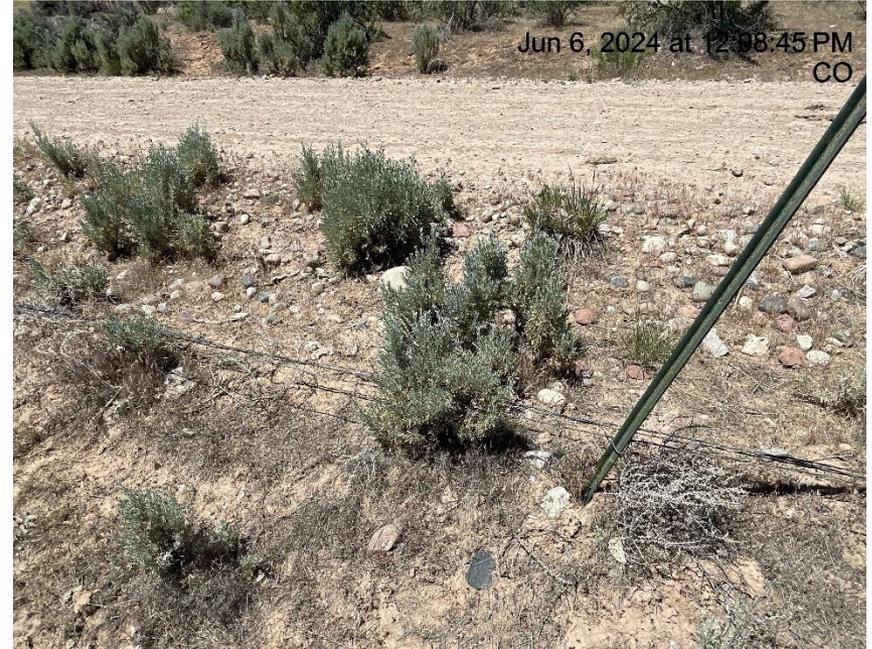
Photo # 9952 Barbed wire fence needs maintenance/wildlife hazard

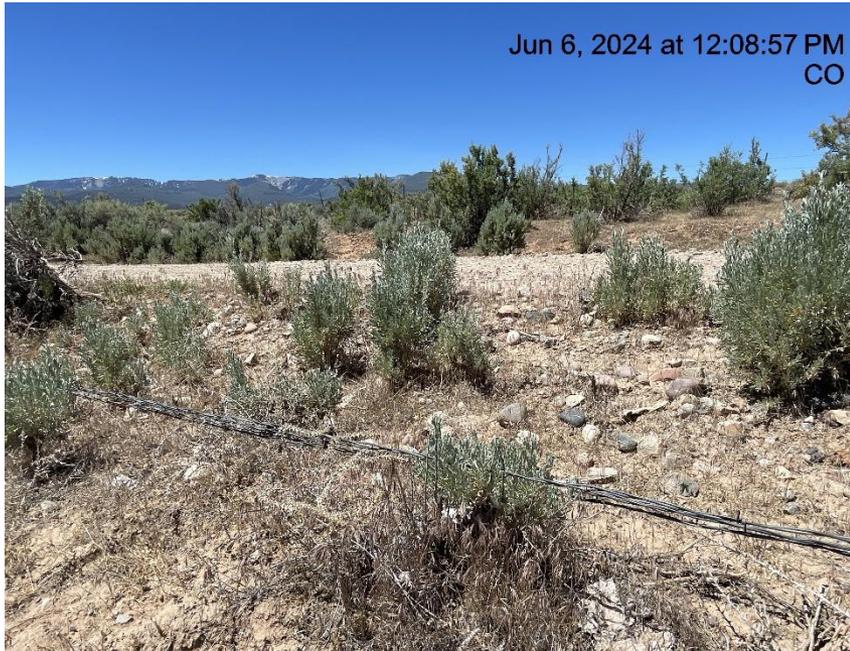
Photo # 9953 Barbed wire fence needs maintenance/wildlife hazard

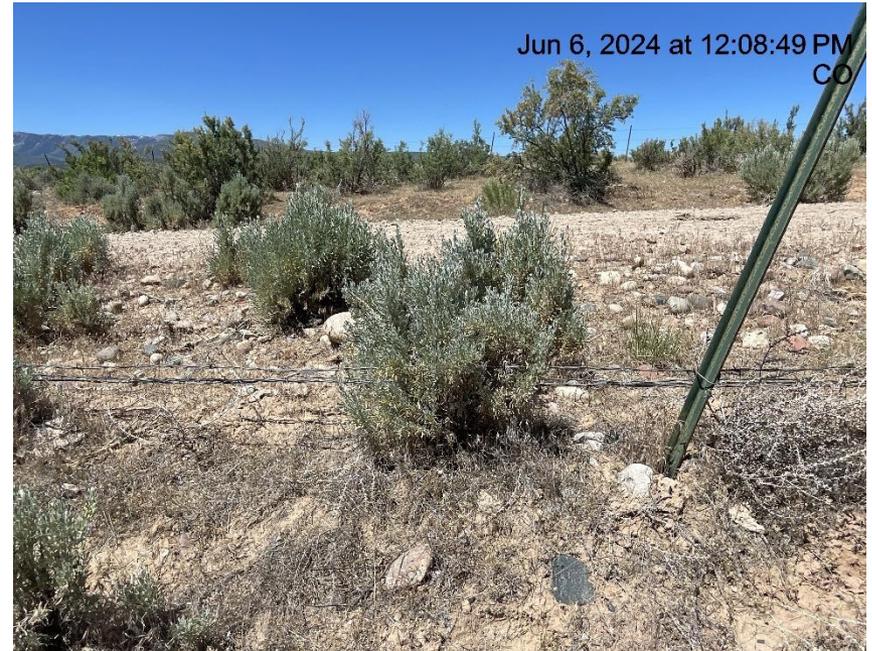
Photo # 9954 Barbed wire fence needs maintenance/wildlife hazard

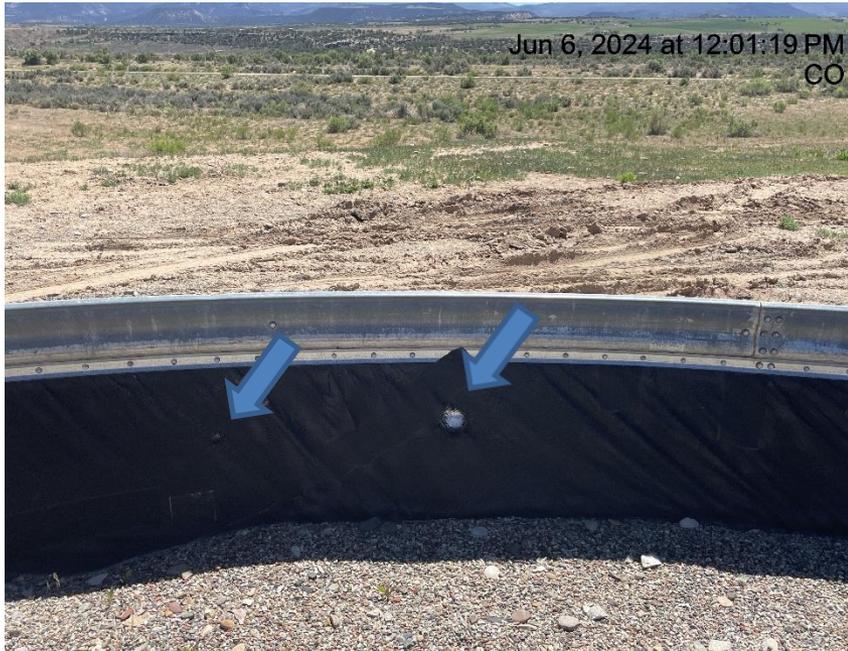
Photo # 9955 Holes in liner/liner needs maintenance

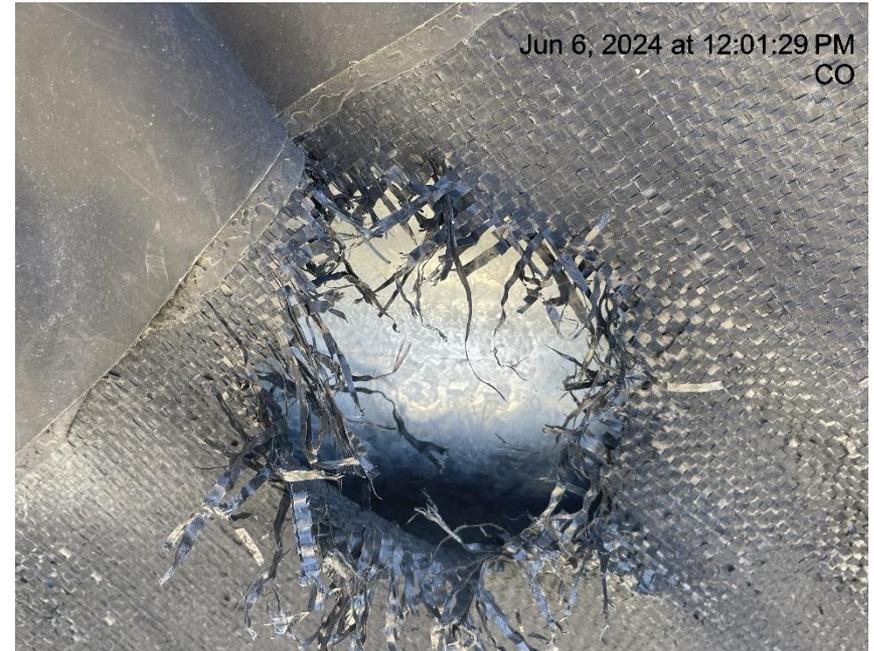
Photo # 9956 Hole in liner/liner needs maintenance

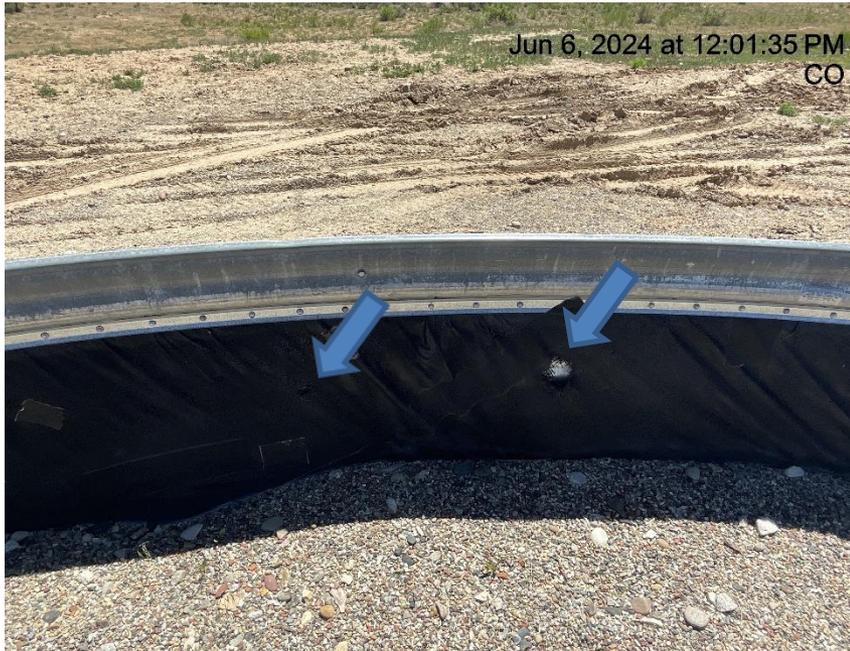
Photo # 9957 Holes in liner/liner needs maintenance

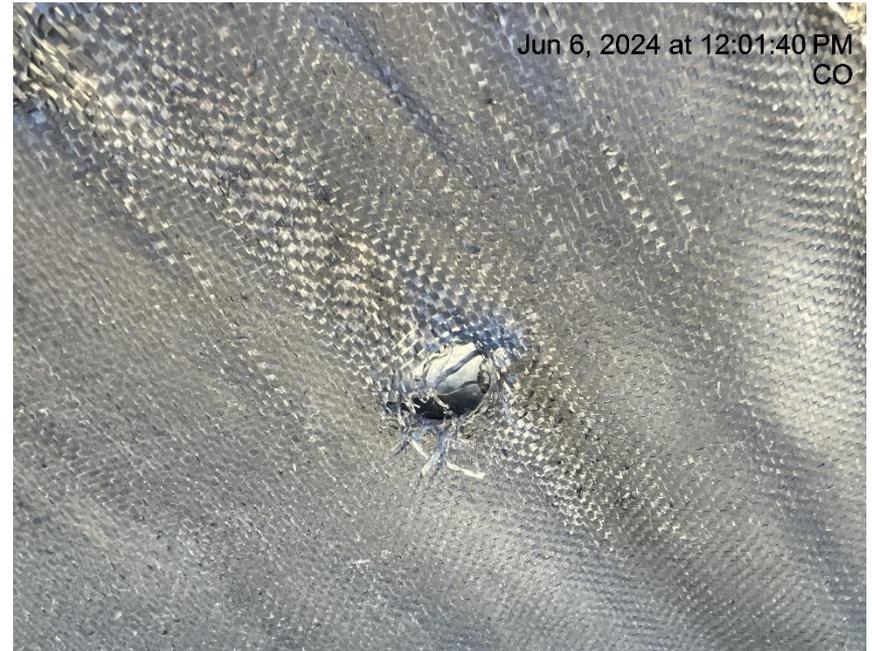
Photo # 9958 Hole in liner/liner needs maintenance

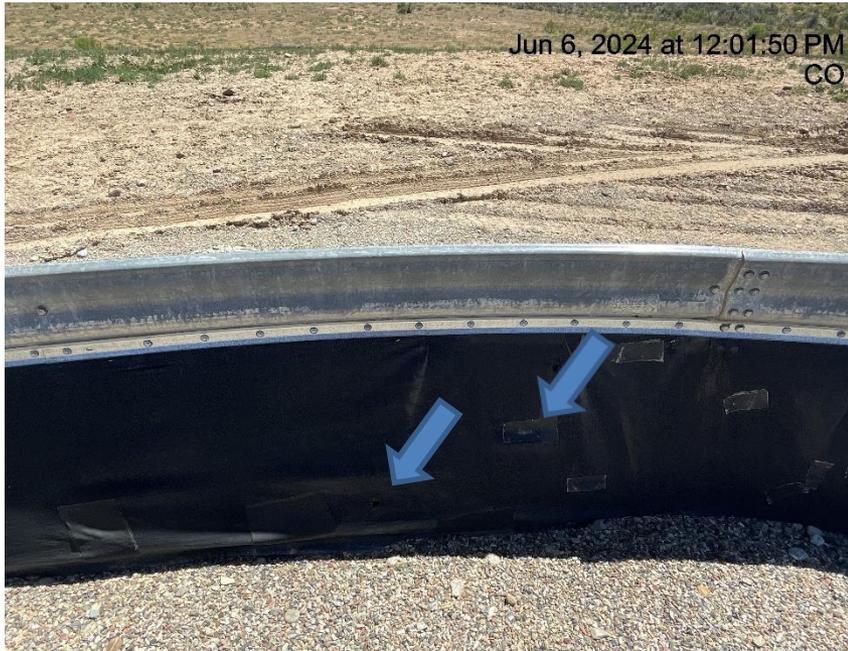
Photo # 9959 Holes in liner/liner needs maintenance

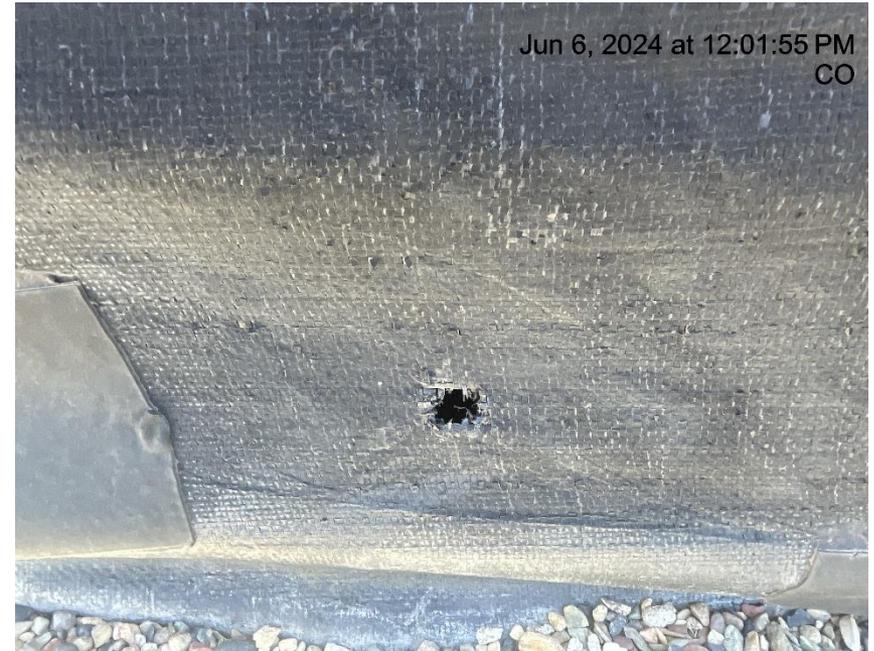
Photo # 9960 Hole in liner/liner needs maintenance

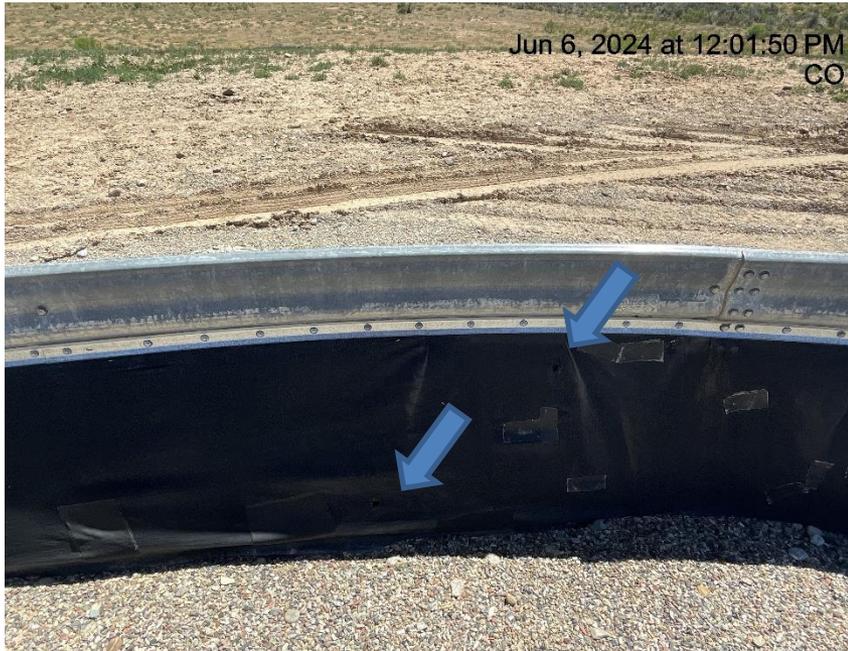
Photo # 9961 Holes in liner/liner needs maintenance

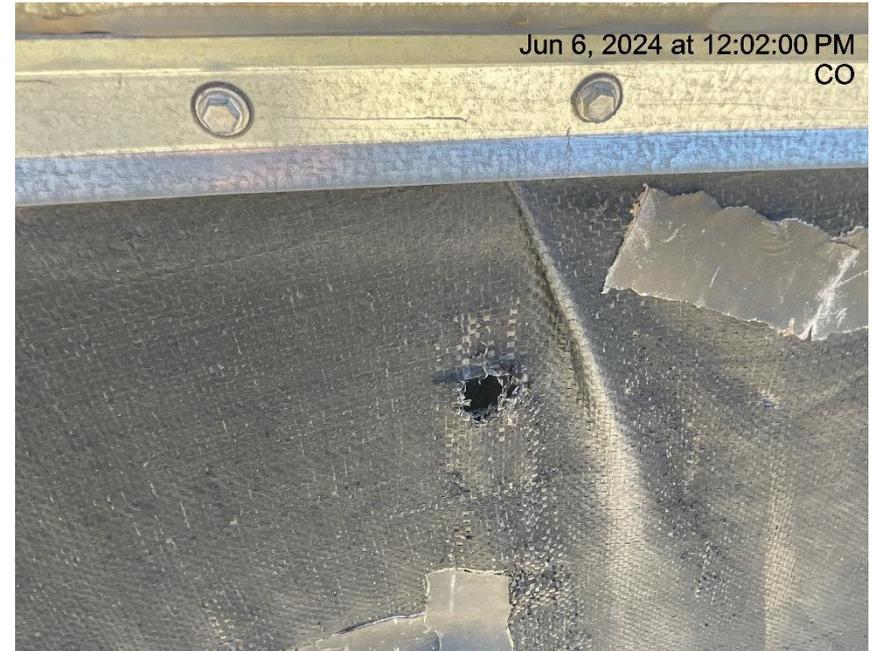
Photo # 9962 Hole in liner/liner needs maintenance

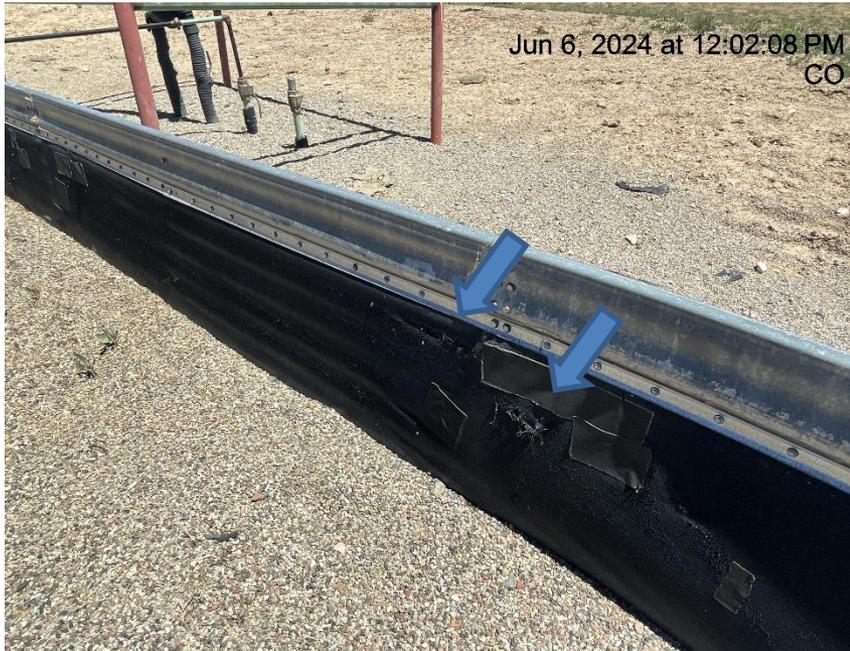
Photo # 9963 Holes in liner/liner needs maintenance

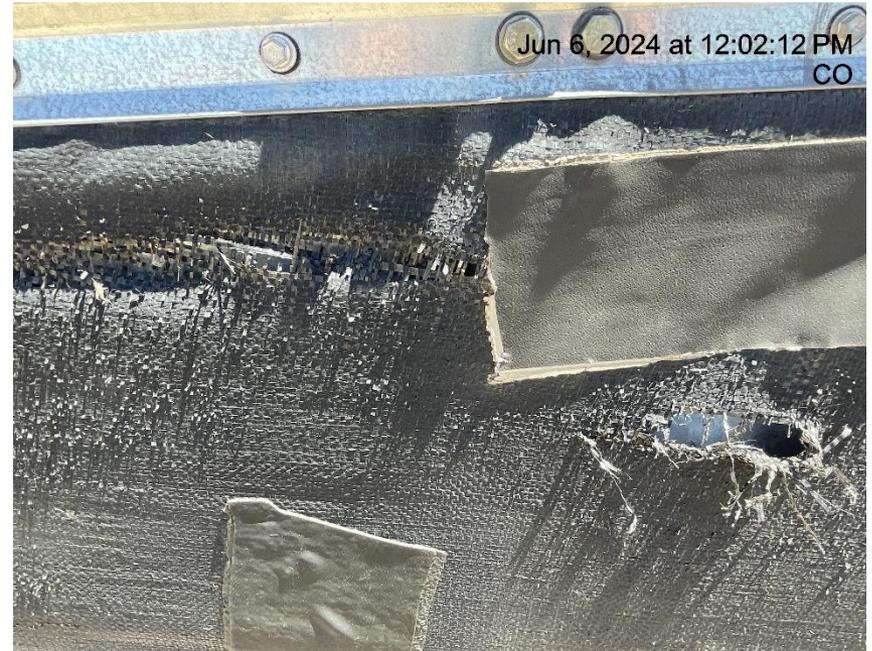
Photo # 9964 Holes in liner/liner needs maintenance

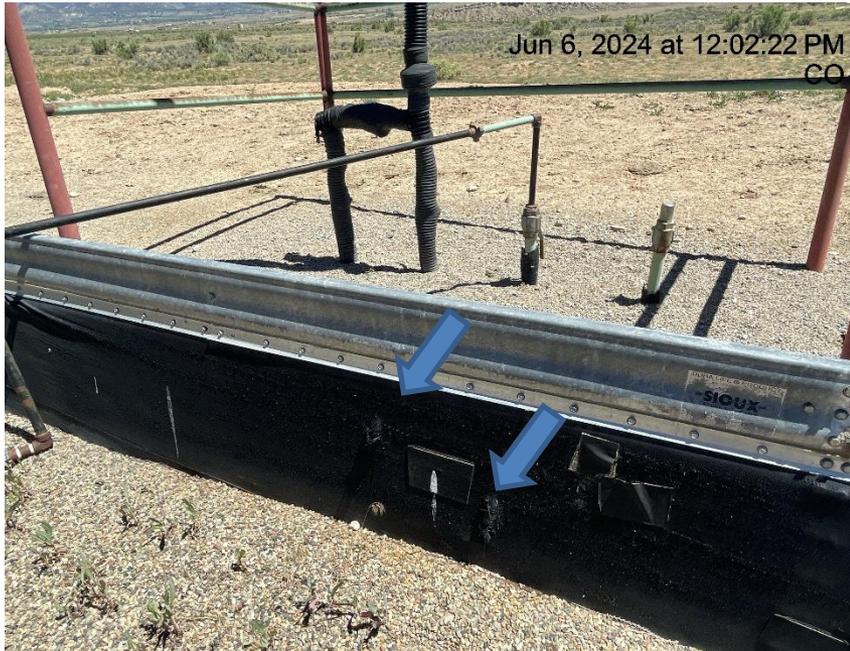
Photo # 9965 Holes in liner/liner needs maintenance

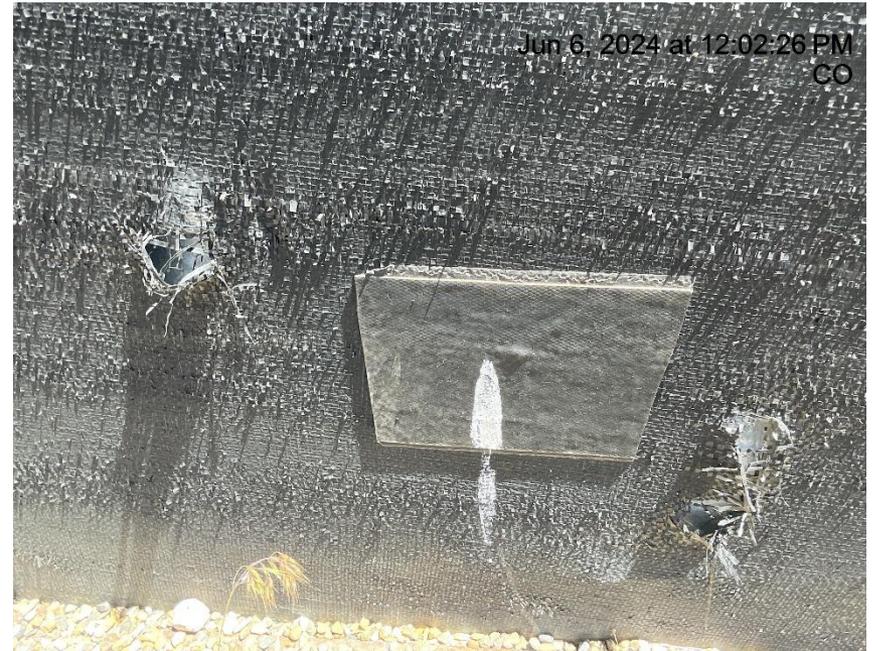
Photo # 9966 Holes in liner/liner needs maintenance

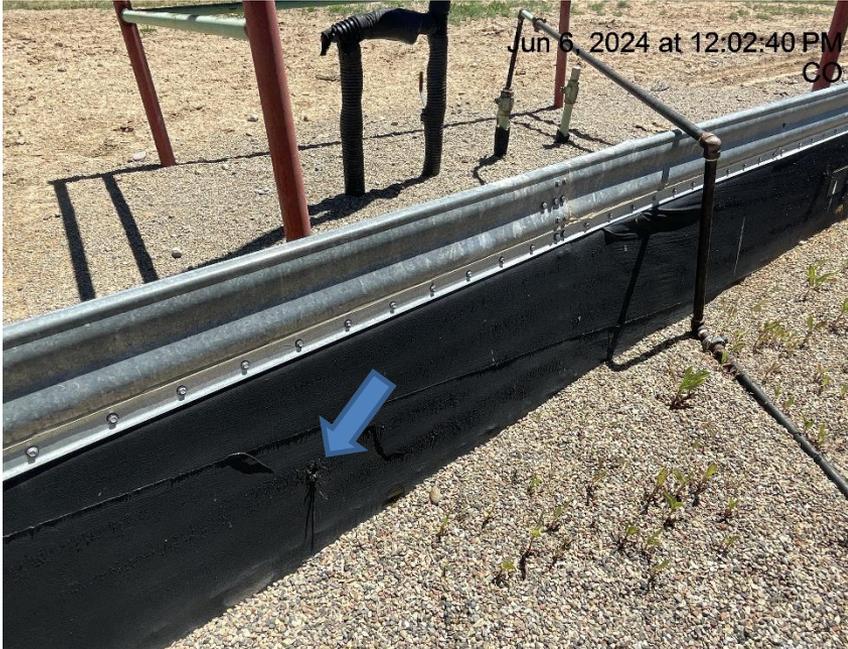
Photo # 9967 Hole in liner/liner needs maintenance

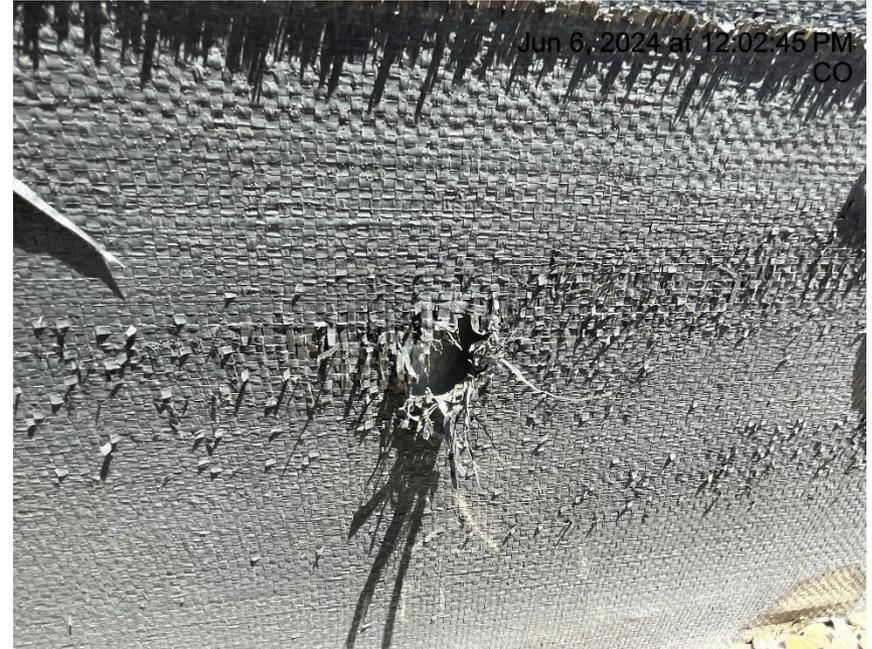
Photo # 9968 Hole in liner/liner needs maintenance

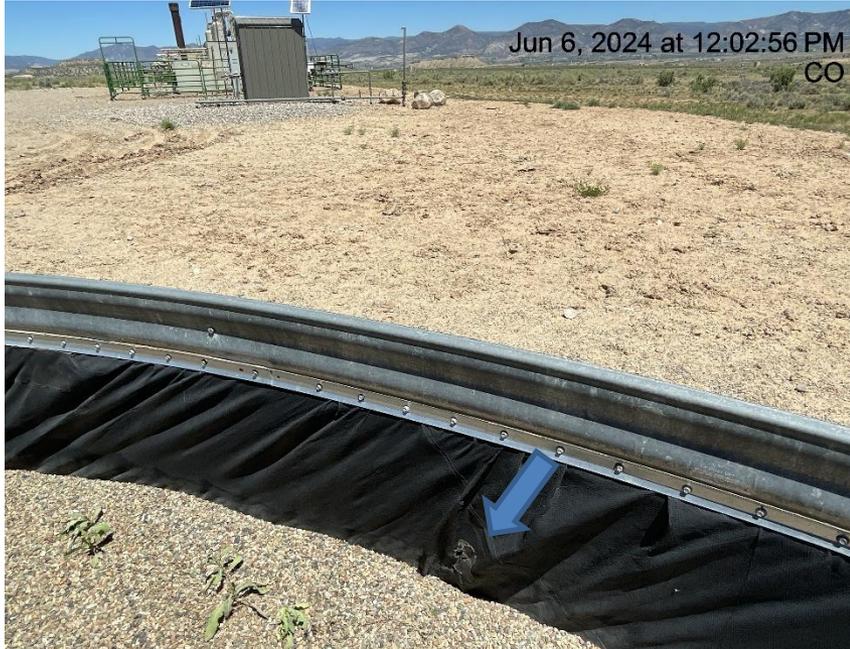
Photo # 9969 Hole in liner/liner needs maintenance

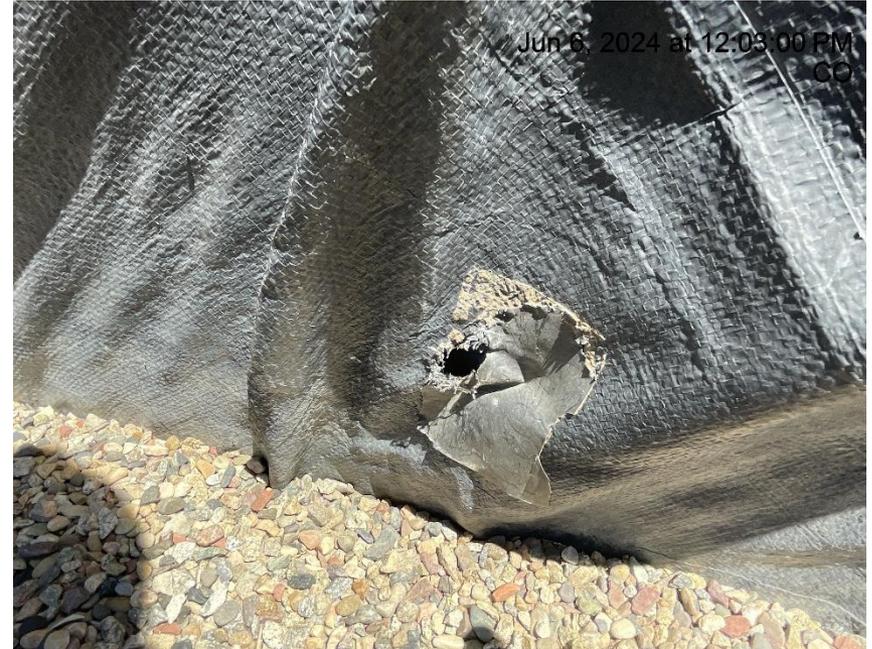
Photo # 9970 Hole in liner/liner needs maintenance

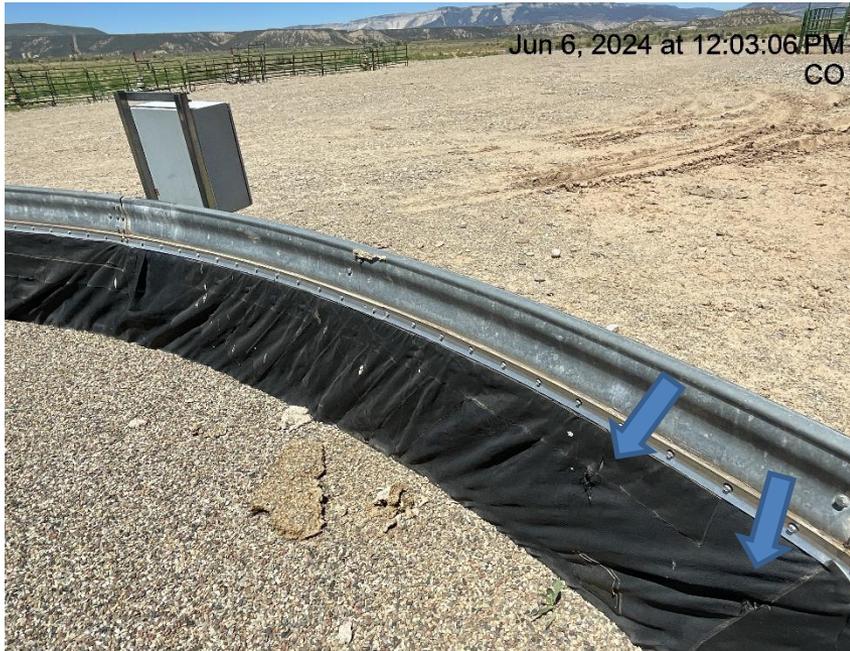
Photo # 9971 Holes in liner/liner needs maintenance

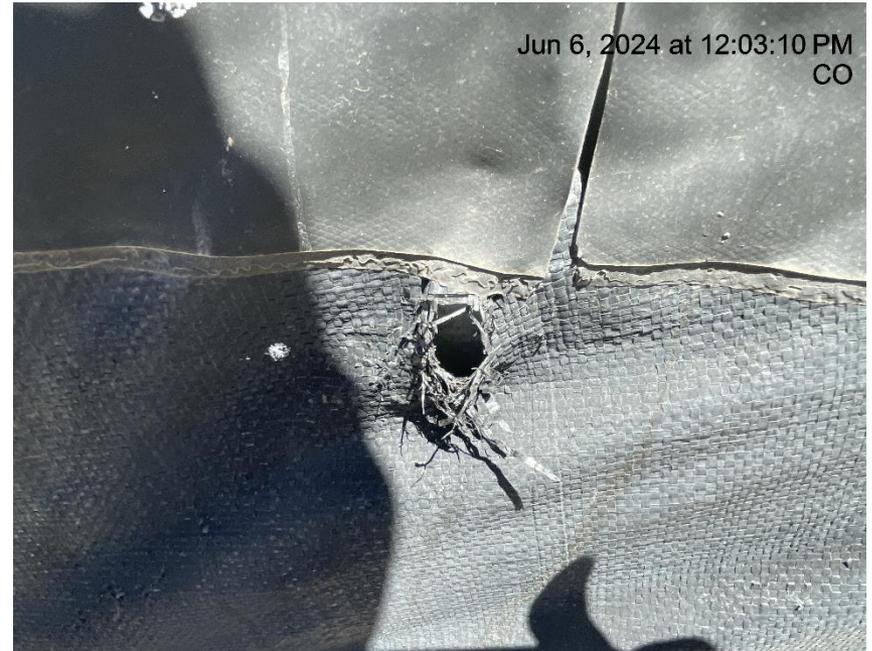
Photo # 9972 Hole in liner/liner needs maintenance

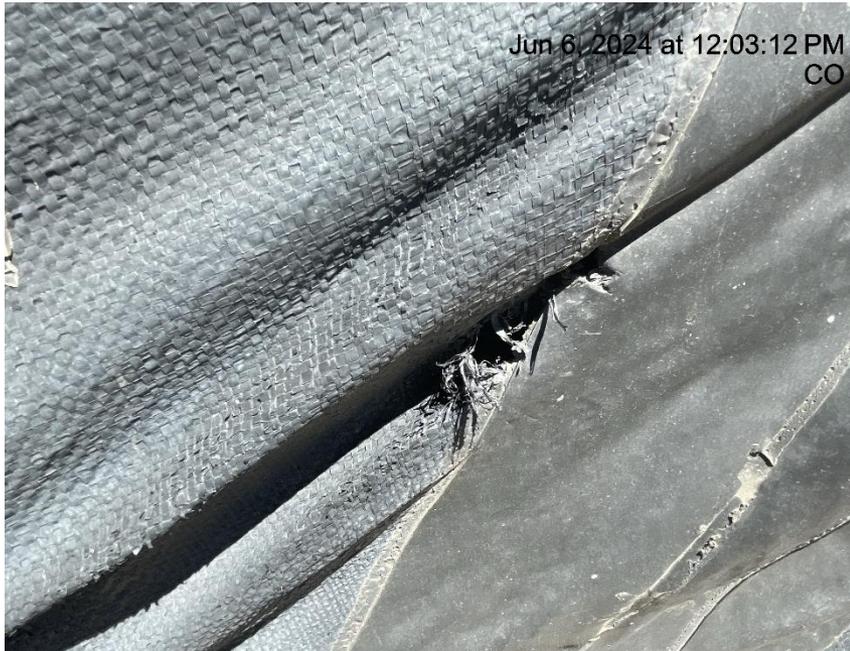
Photo # 9973 Hole in liner/liner needs maintenance
