Inspection Photos

Operator: Hilcorp Energy Company - 10133

Location ID: 325300

Inspection Photos
Location Name: Squires 1, 4
Location ID: 325300

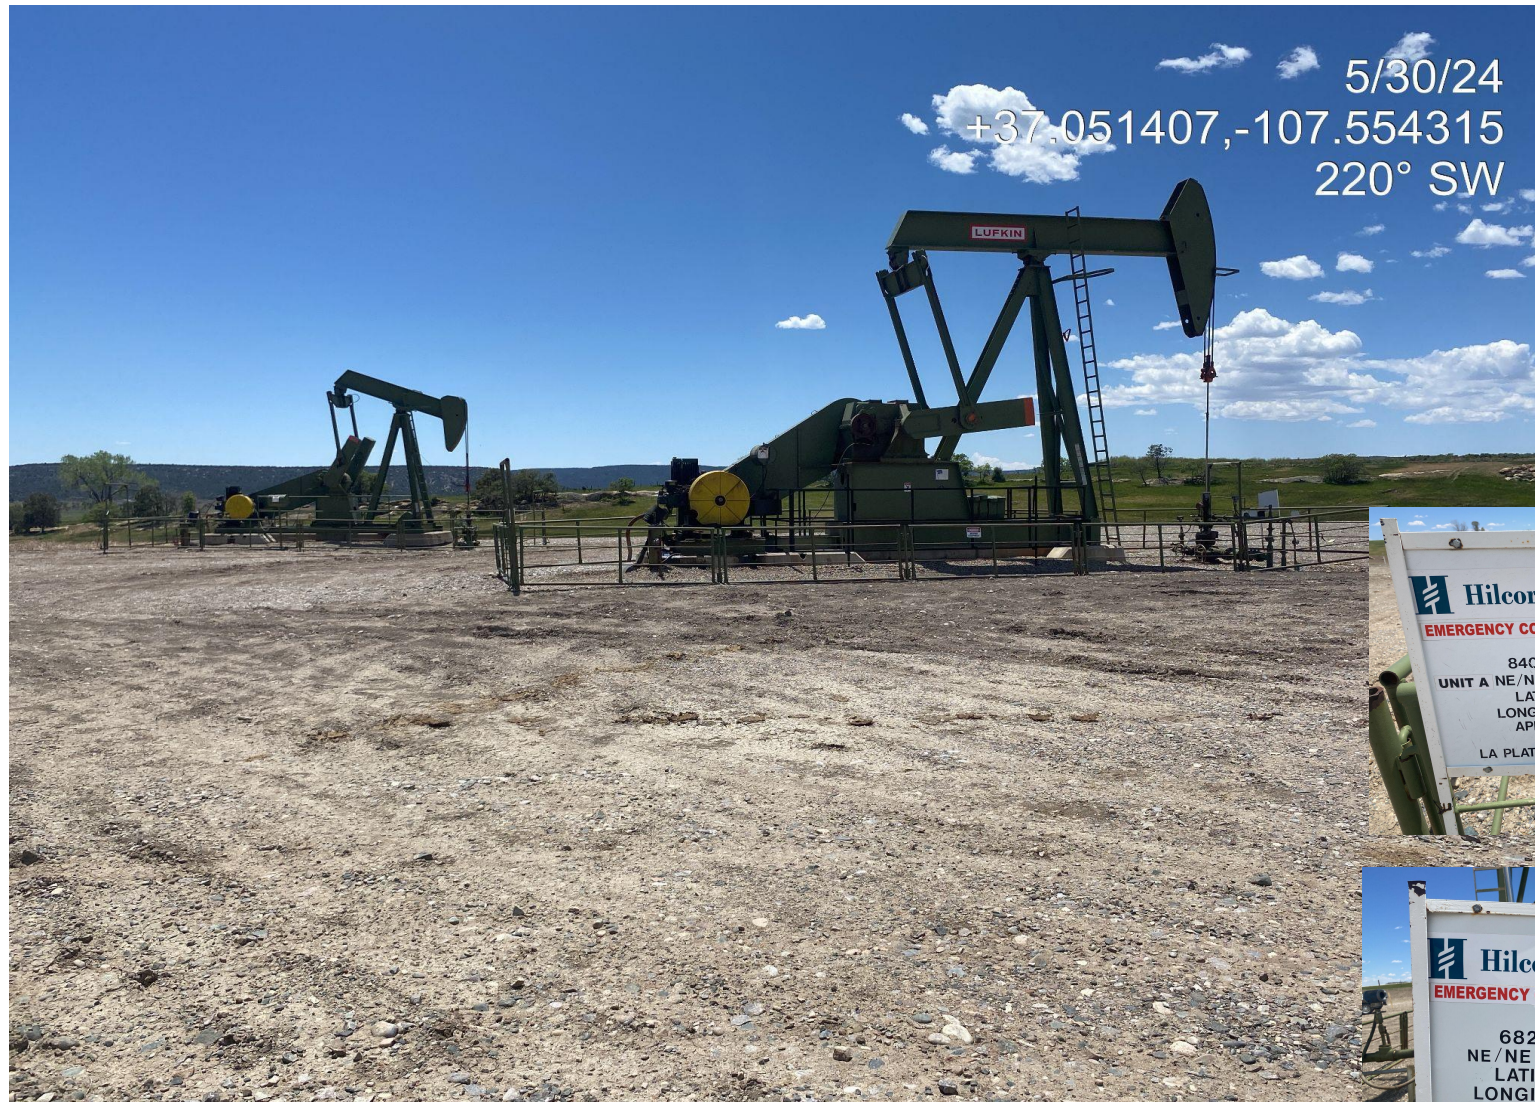
Photo 1. View of the well disturbance taken from the access road facing center.

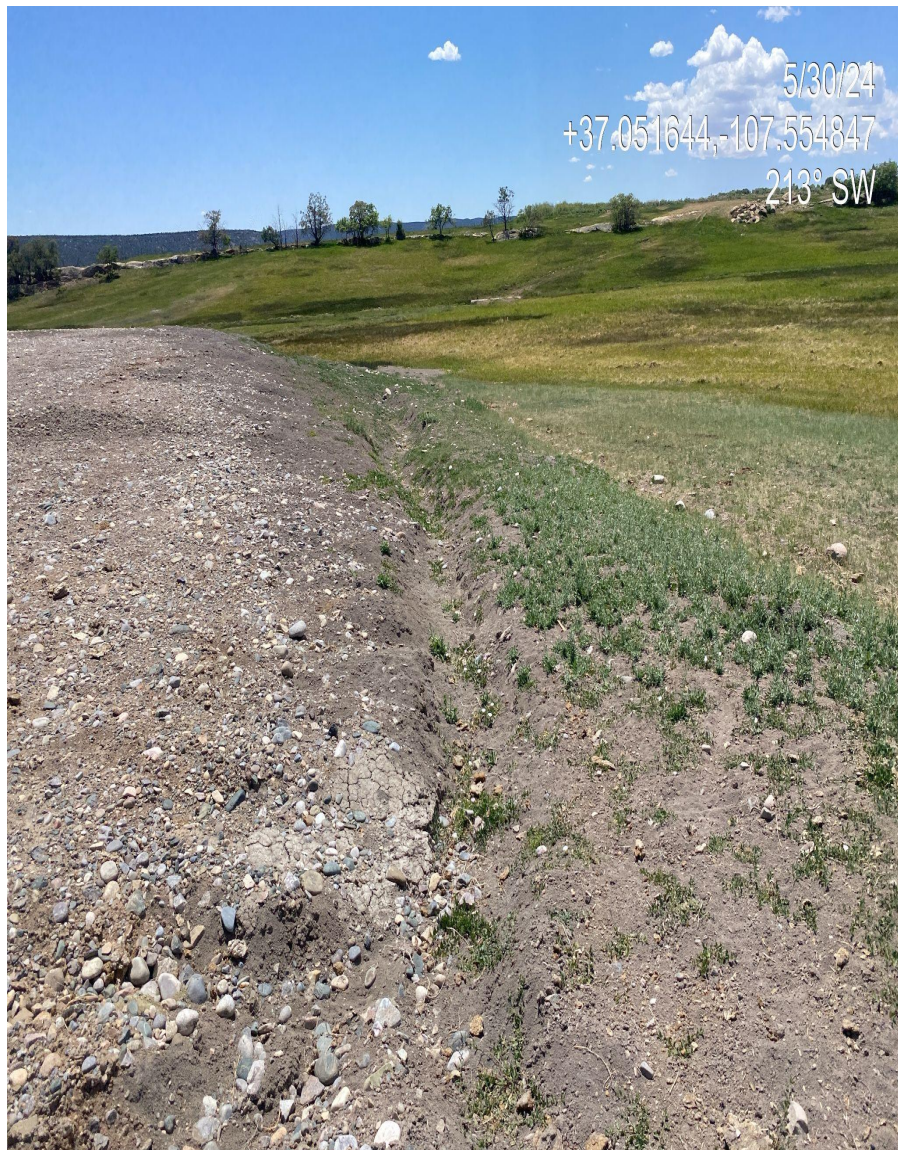
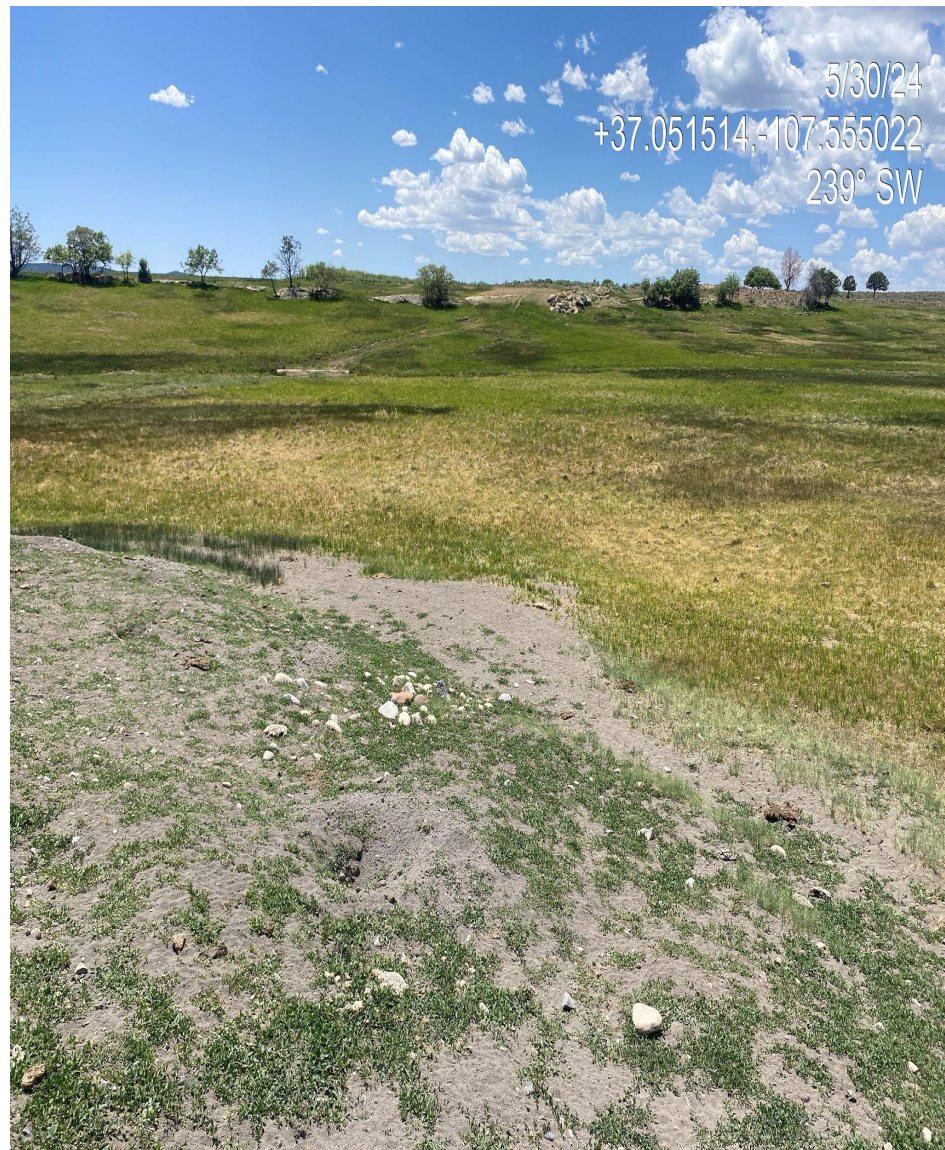
Photo 2. View of the diversion and evidence of sediment transport/deposition. Reseeding appears unsuccessful as interim reclamation areas to the south are dominated by weedy vegetation.

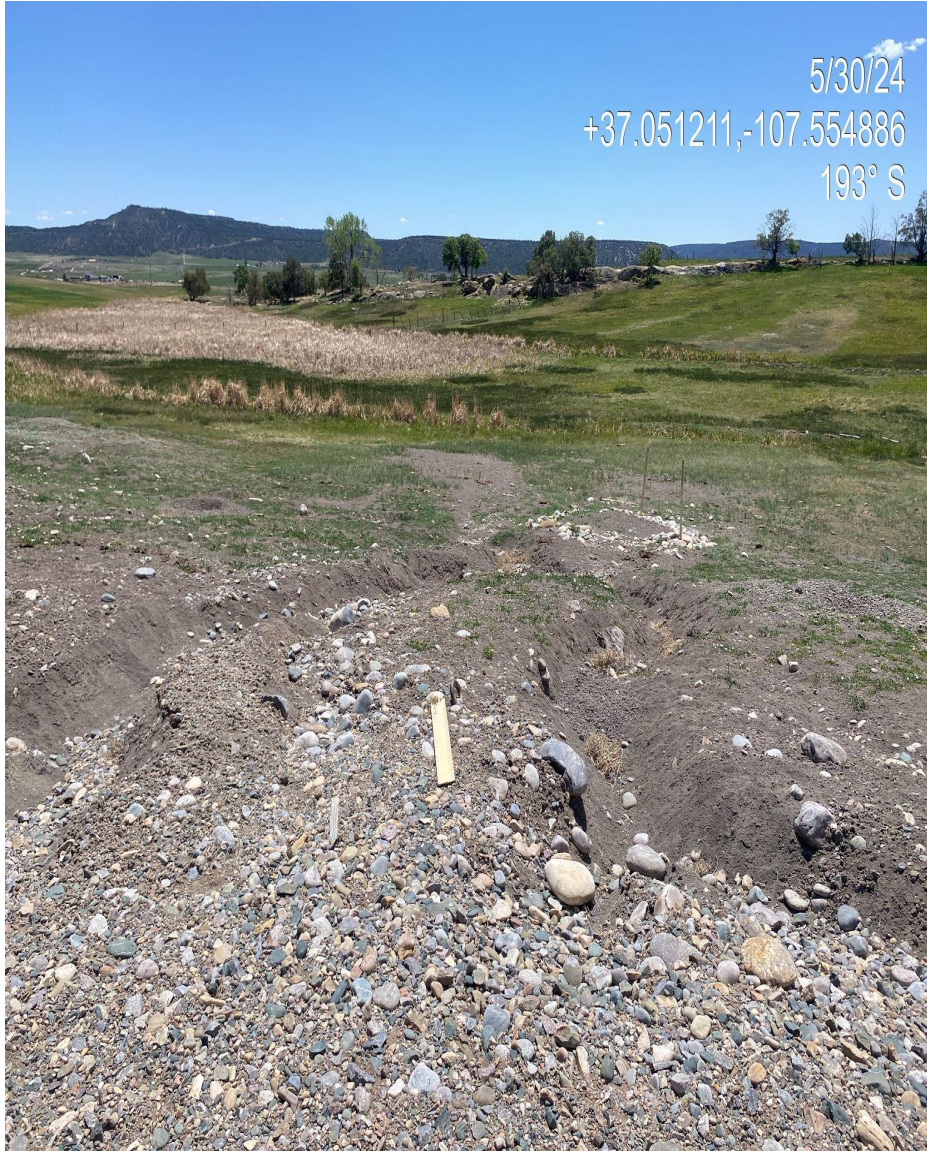
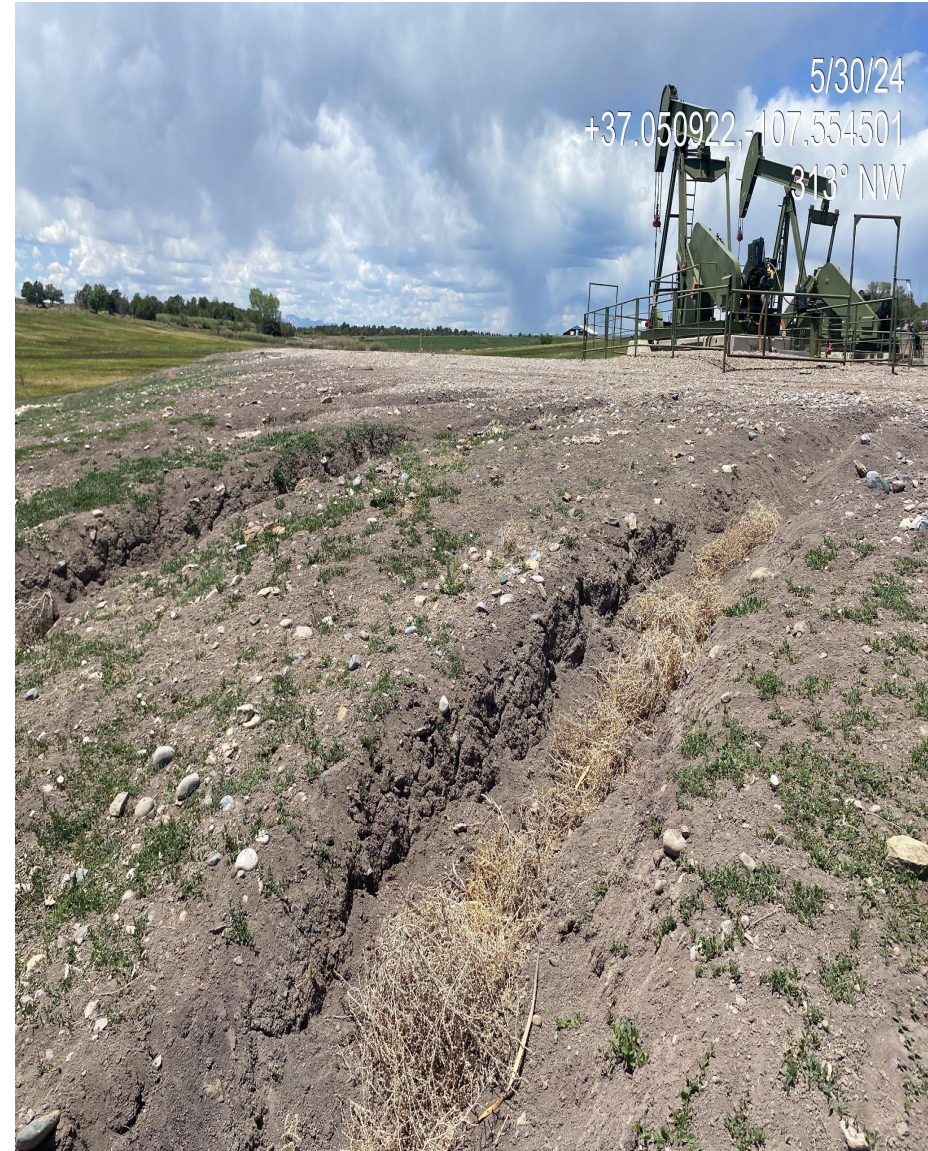
Photo 3. Sever gully erosion observed forming throughout the southern portions of the interim reclamation area, additional stabilization is needed.

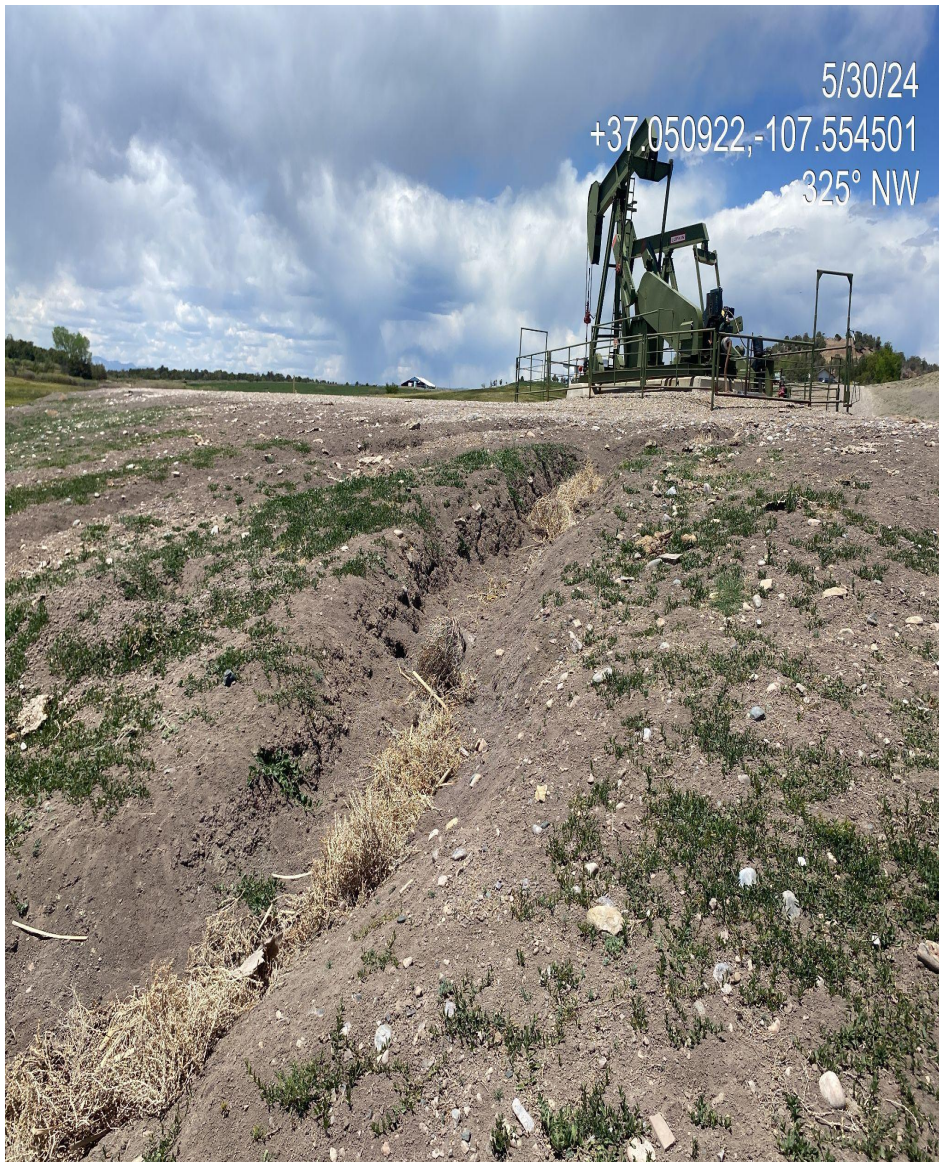
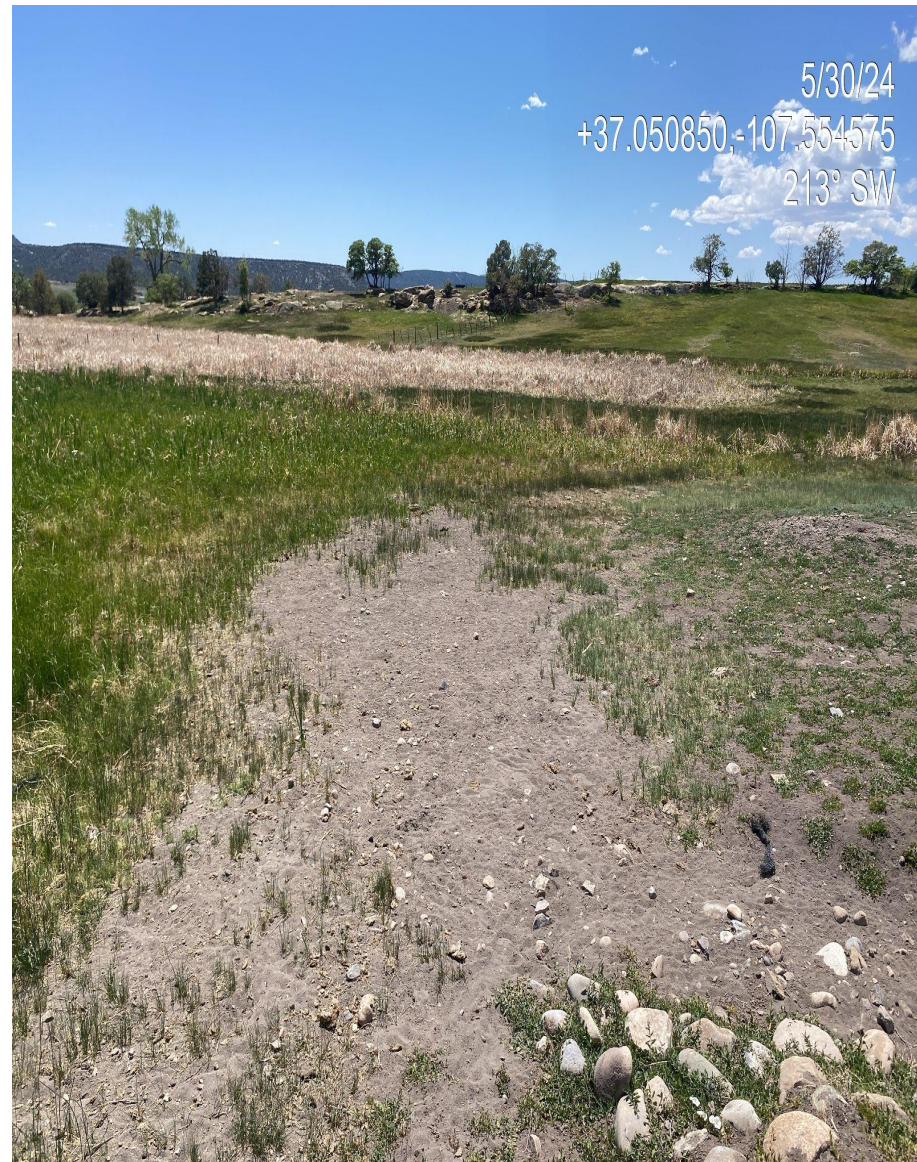
Photo 4. Additional photos of gully erosion and evidence of sediment transport off of location in the southern interim reclamation area.

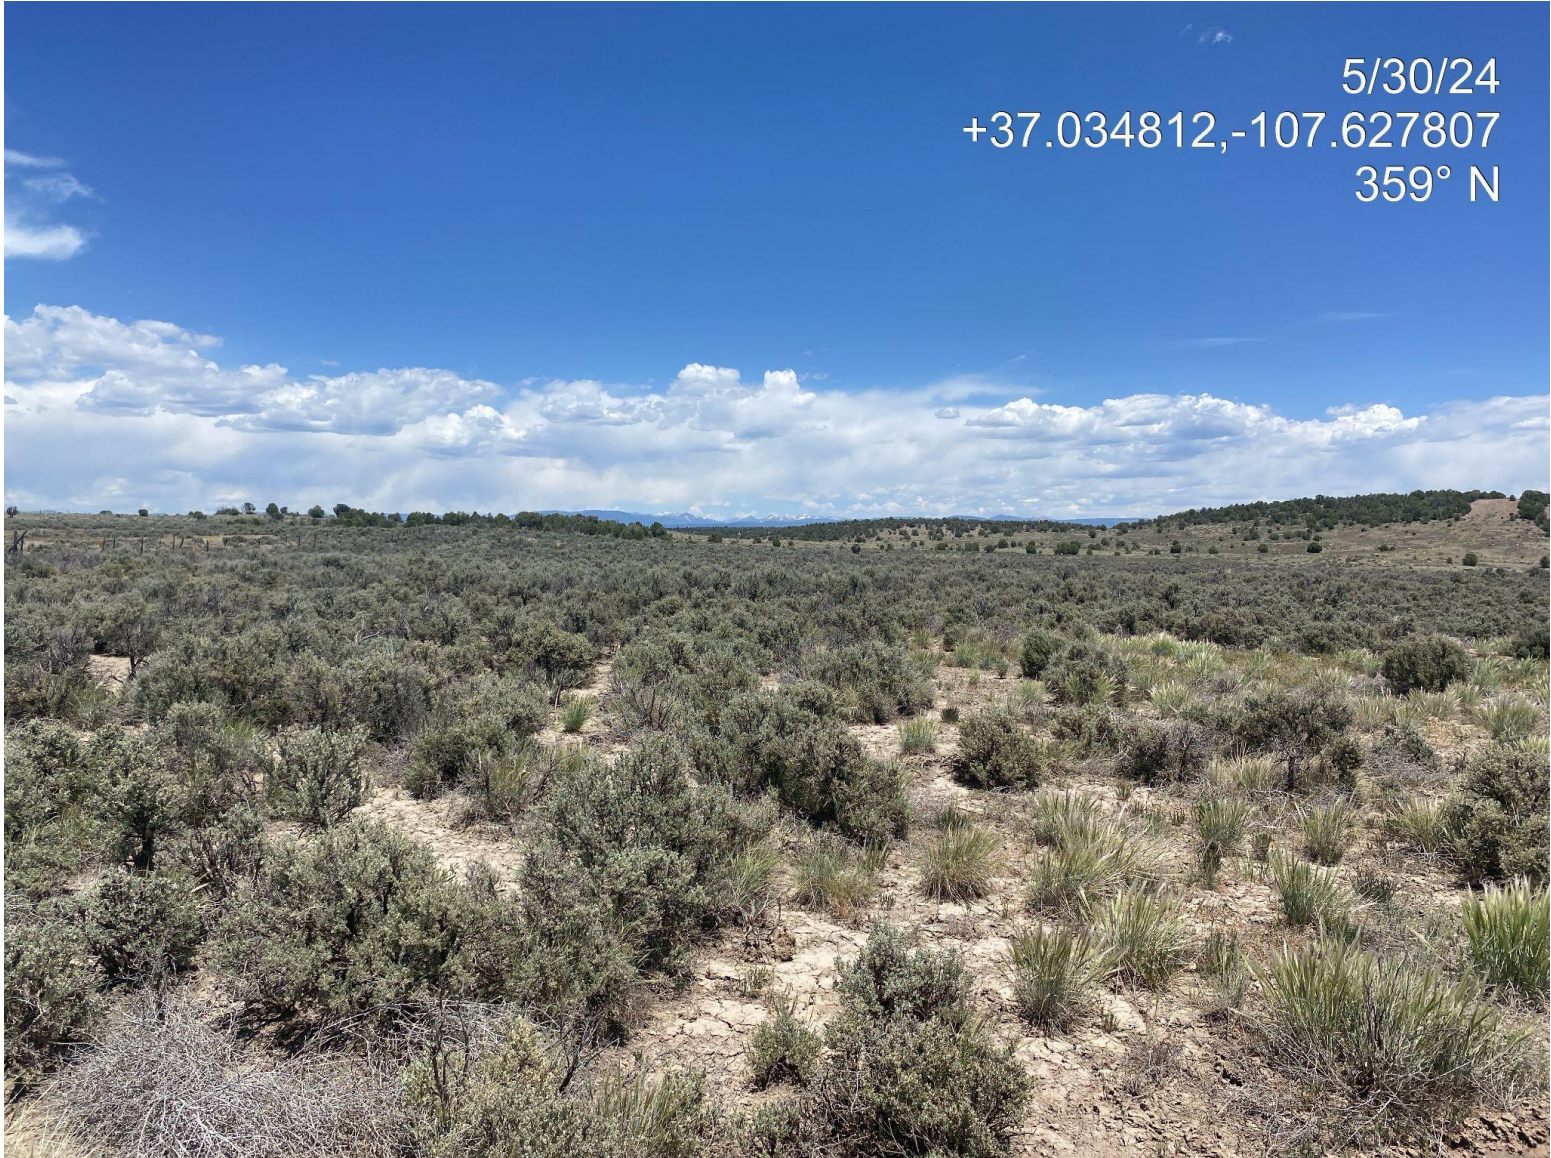
Photo 6. Reference are comprised of sage brush and squirrel tail.
