Inspection Photos

Operator: CAERUS PICEANCE LLC - 10456

Location ID: 335928

Inspection Doc: 696205850

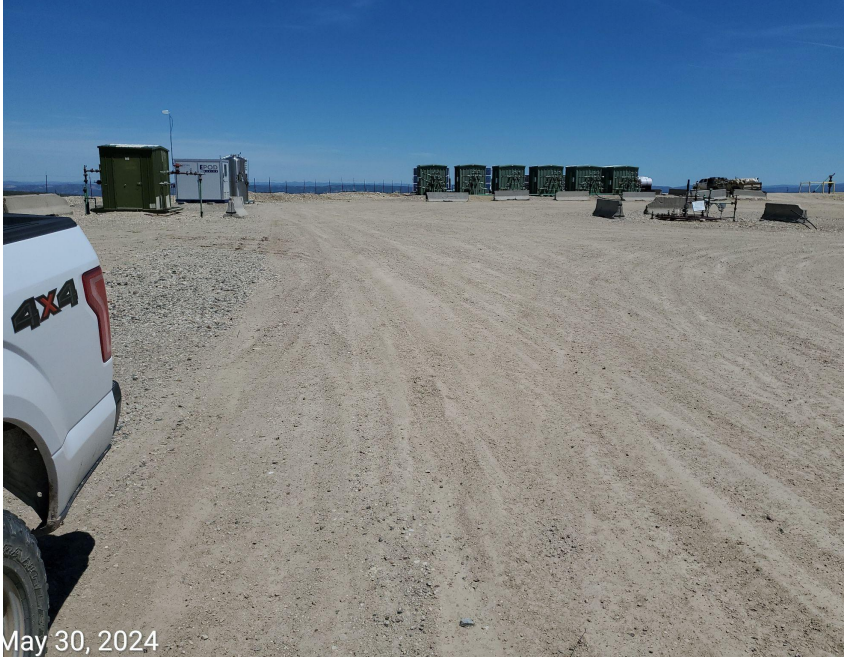
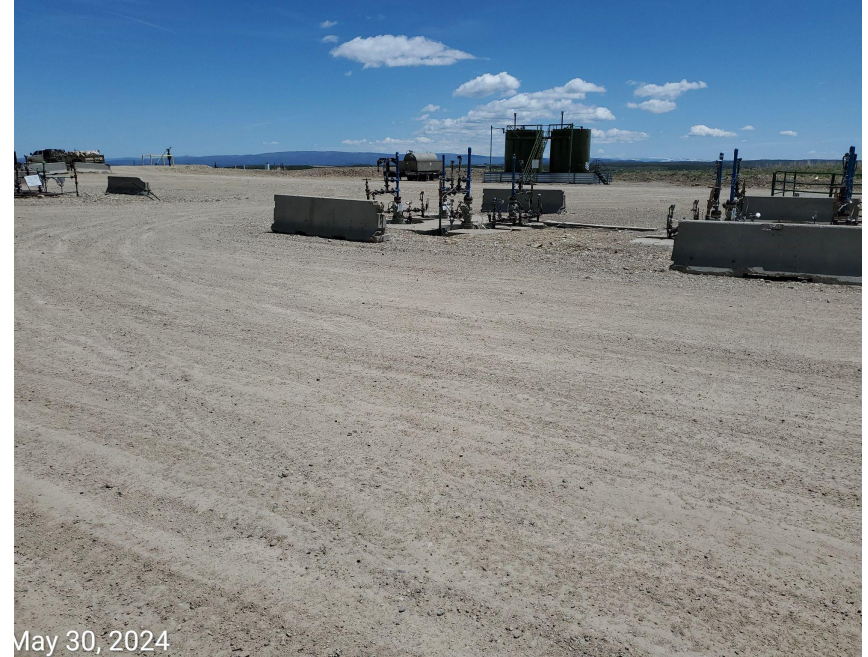
Photo 1: Photos 1-2 taken from the west end of the Location. Photo provides an overview of the Location from north, southeast, northeast to south.

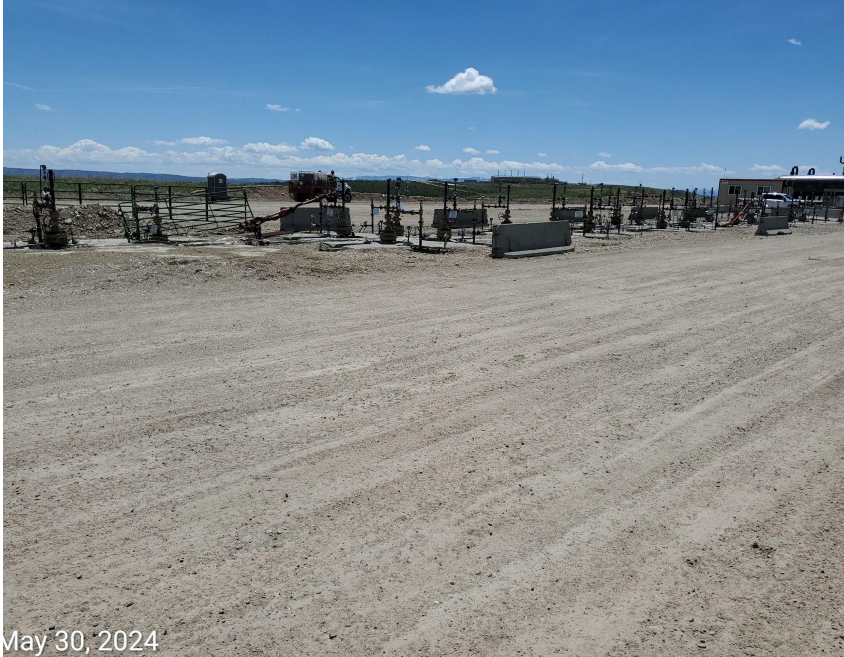
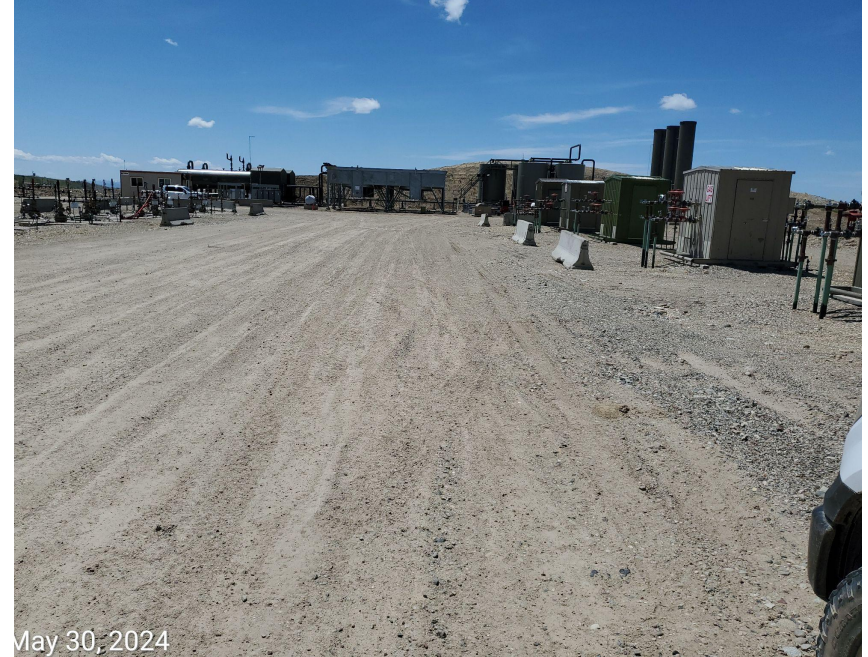
Photo 2: See comments under photo 1.

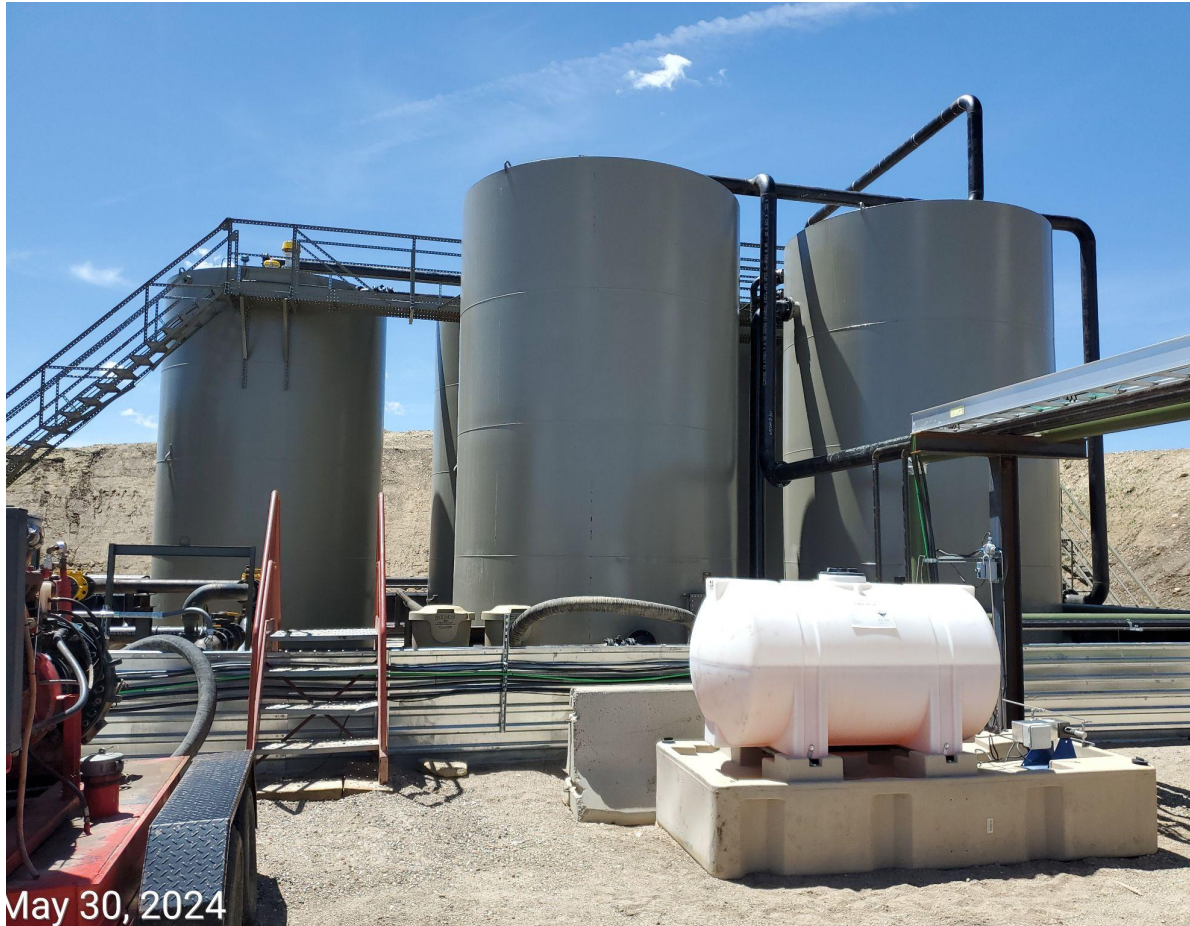
Photo 3: New tank facility on the south end of the Location. Signage at tanks/facility not observed.

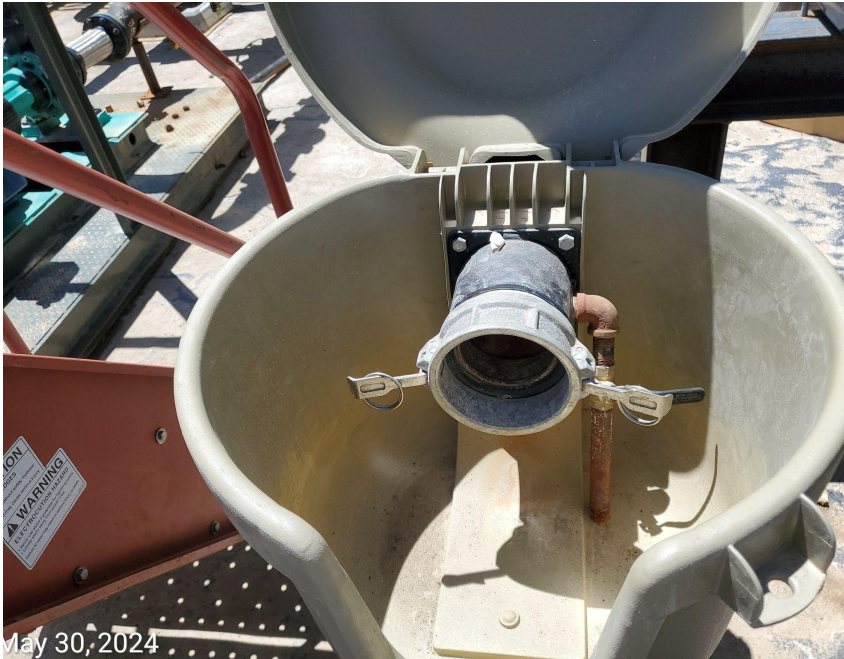
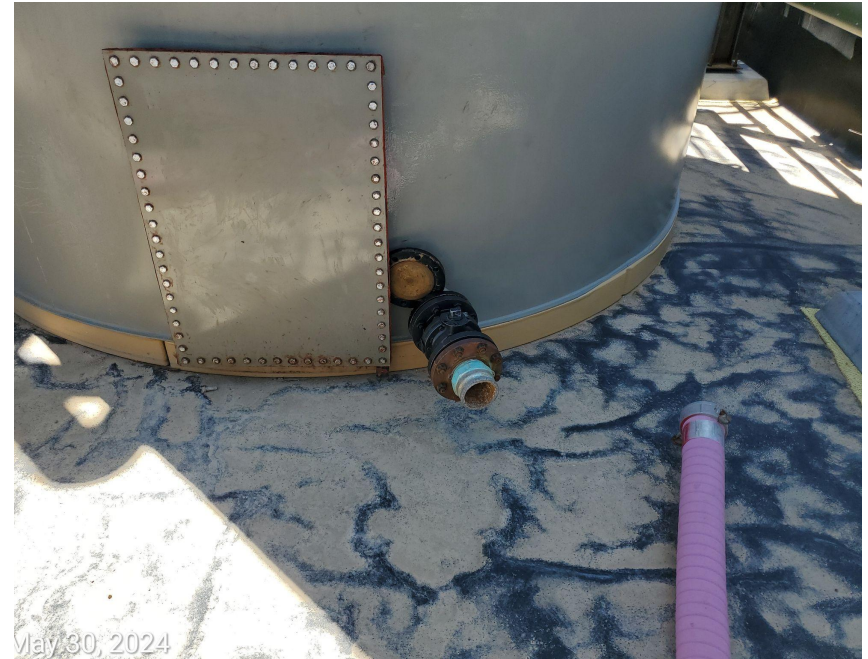
Photo 4: Photos examples showing lines at tanks both on the south and north end of the Location are missing required cap/plug.

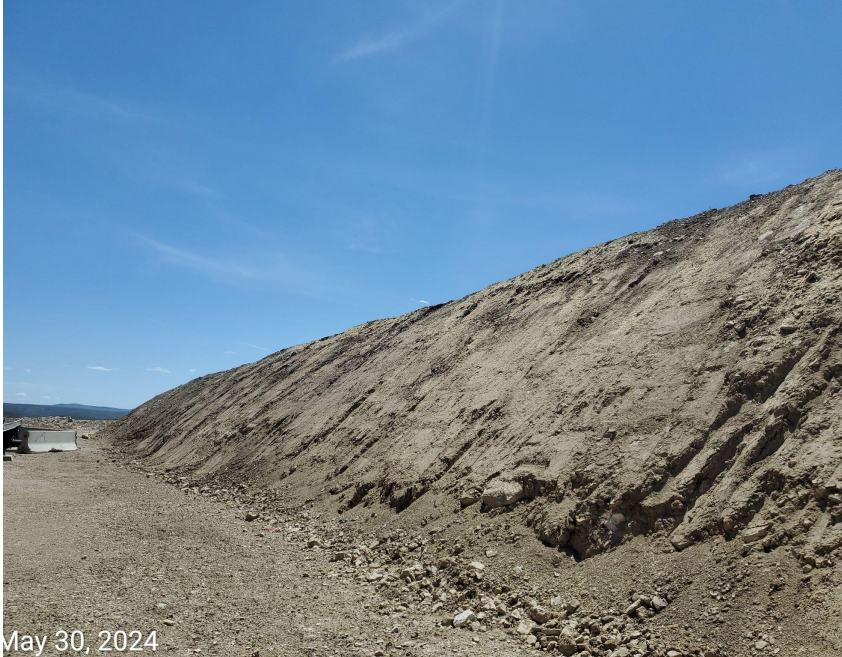
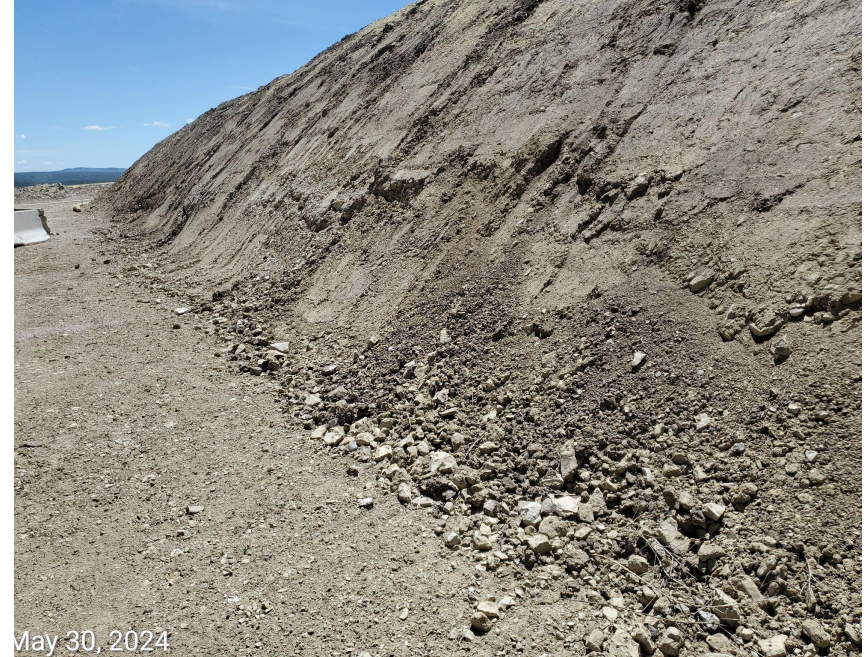
Photo 5: Photos taken from the cut slopes on the south end of the Location. Slope compaction is beginning to fail.

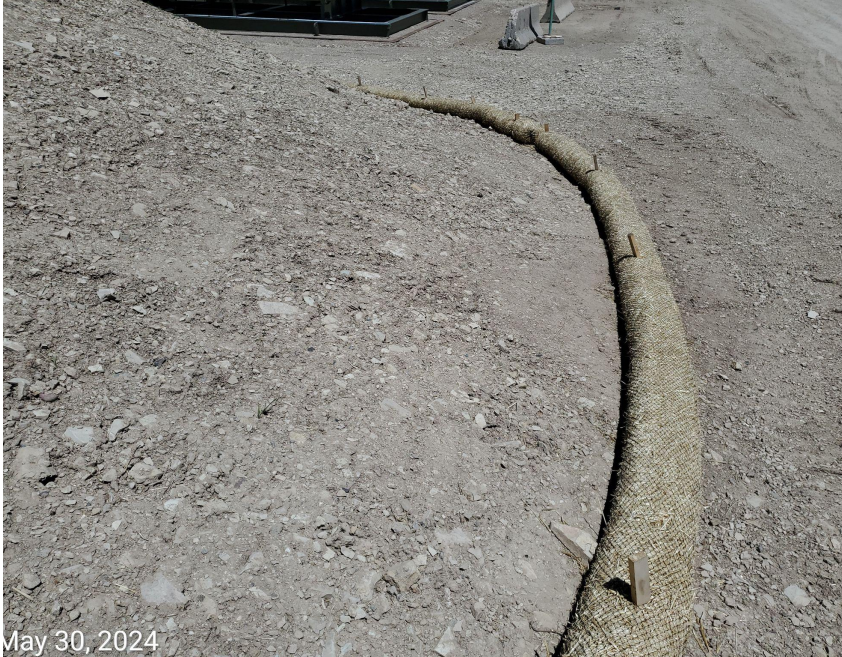
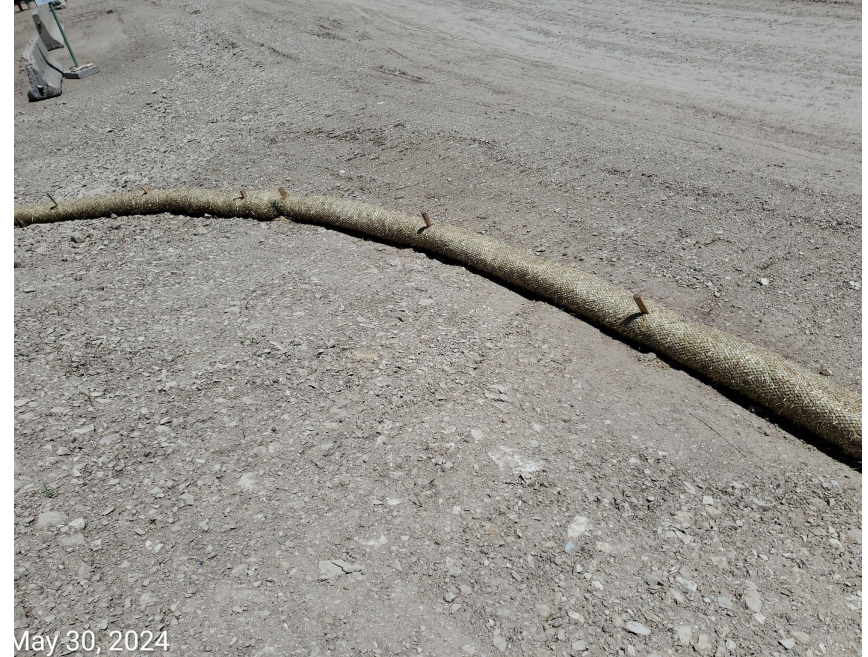
Photo 6: Photos examples showing erosion logs on the Location that have not been properly back-filled per good engineering practice.

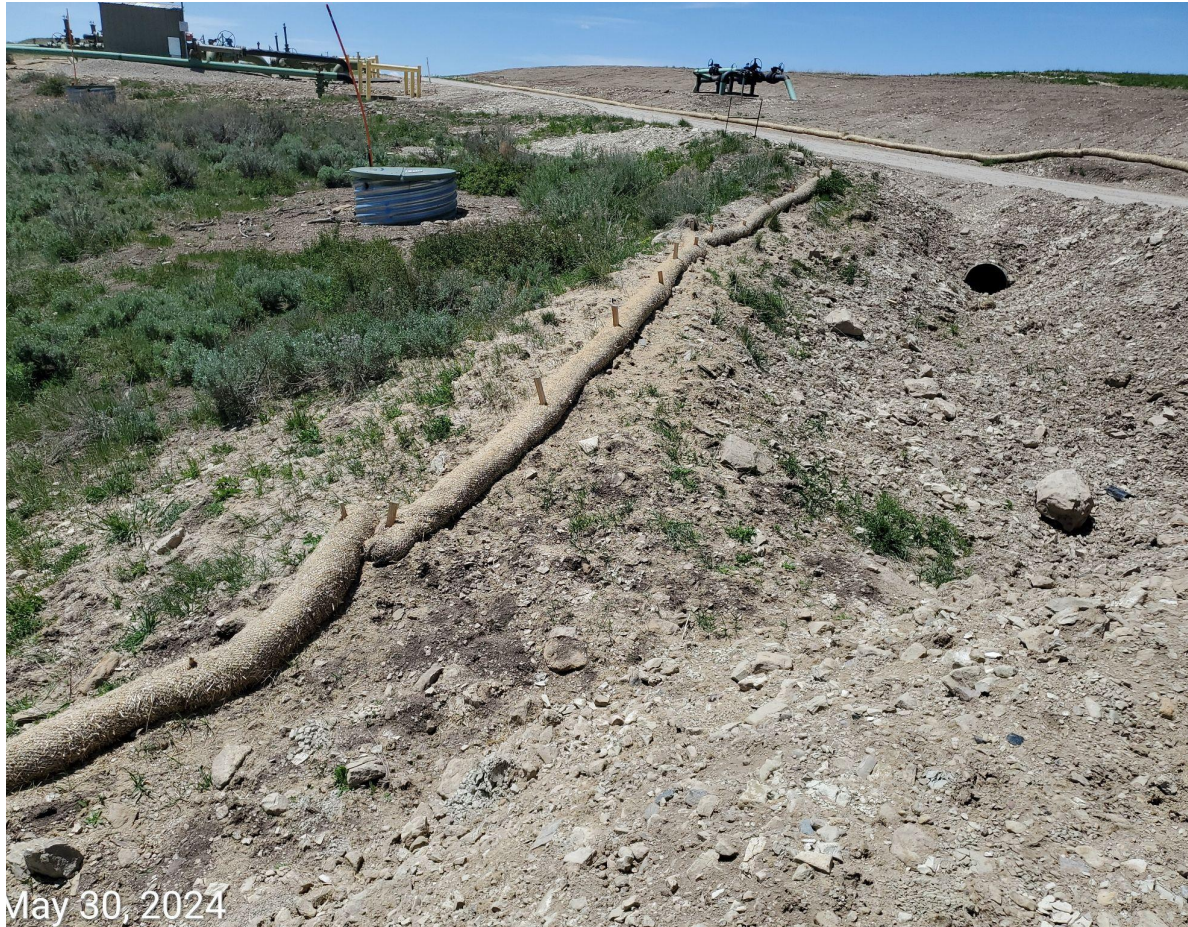
Photo 7: Photos examples showing erosion logs on the Location that have not been properly back-filled per good engineering practice.

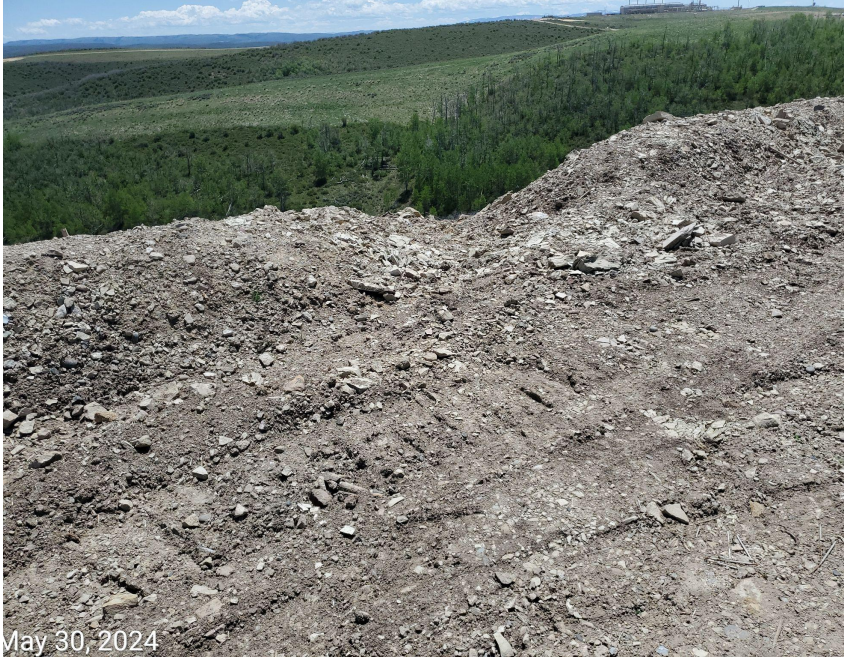
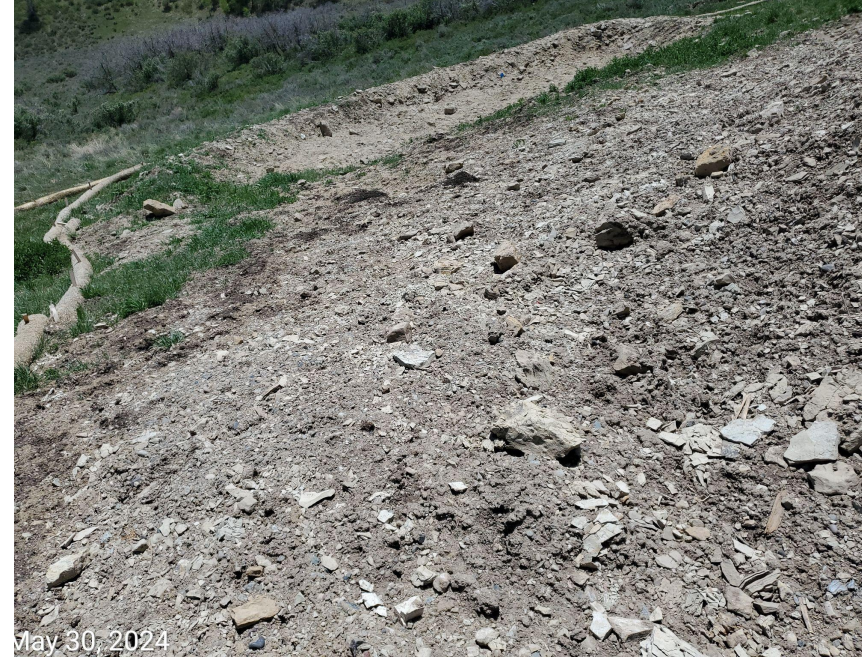
Photo 8: Photos taken from the southeast end of the working pad surface. Photo shows outlet leading from the working pad surface to the sediment trap has not been installed with armoring per good engineering practice. Stormwater would discharge directly onto the bare slopes to the trap, and will likely result in to erosion, degradation and sediment transport. Advise maintenance prior to erosion issues and to ensure BMP is adequate to minimize erosion, degradation and sediment transport.

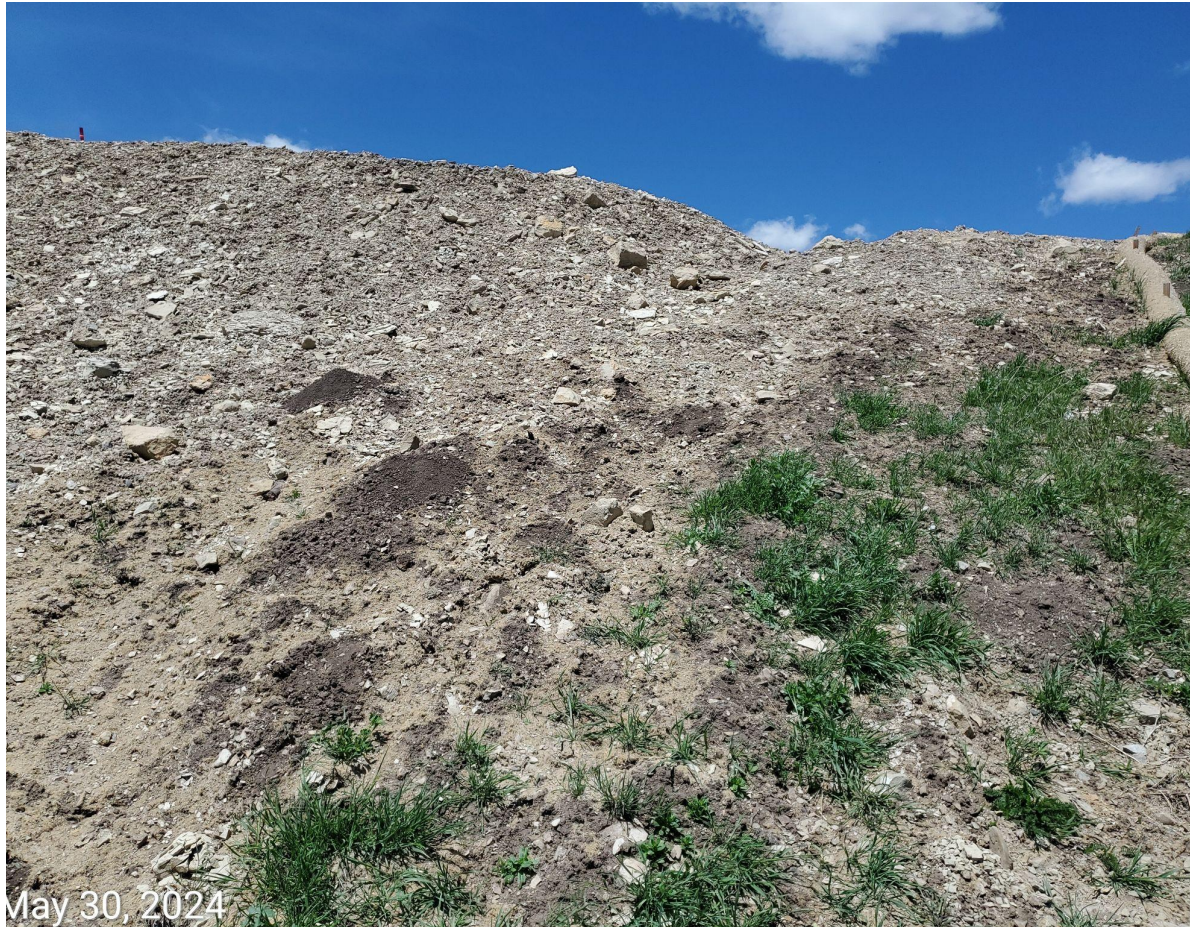
Photo 9: See comments under photo 8.

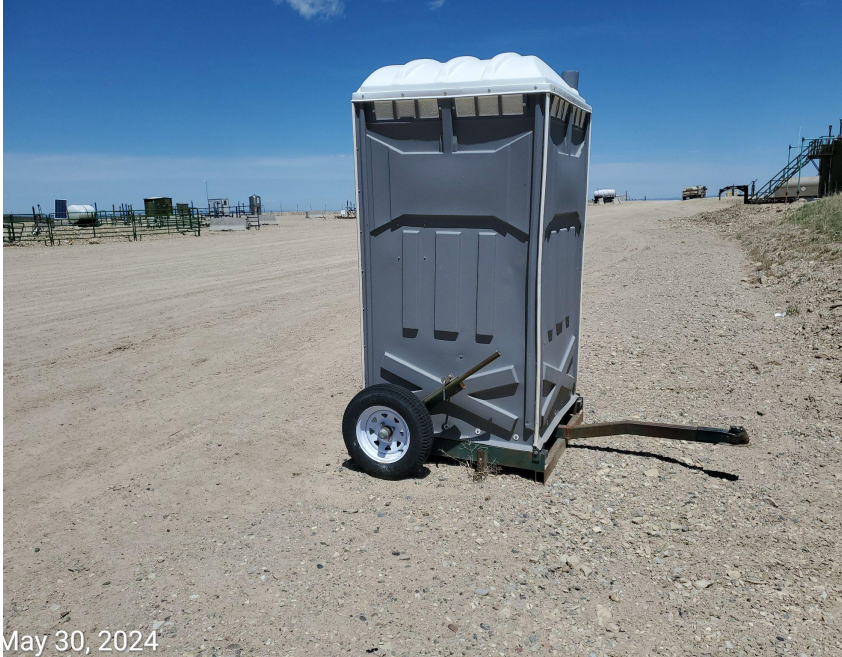
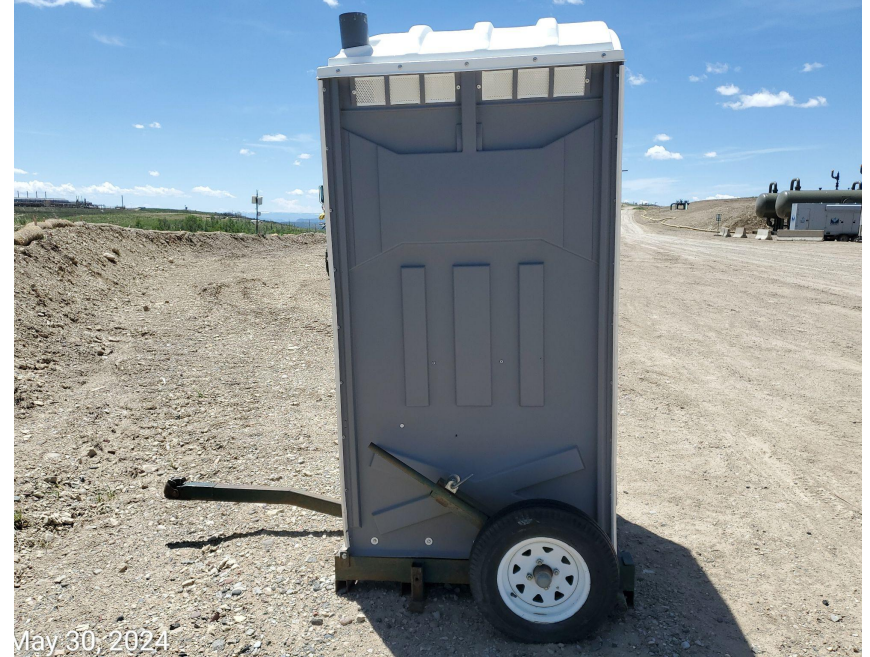
Photo 10: Sanitary facility (porta john) has not been physically secured. Storing facility on a small trailer is not adequate.

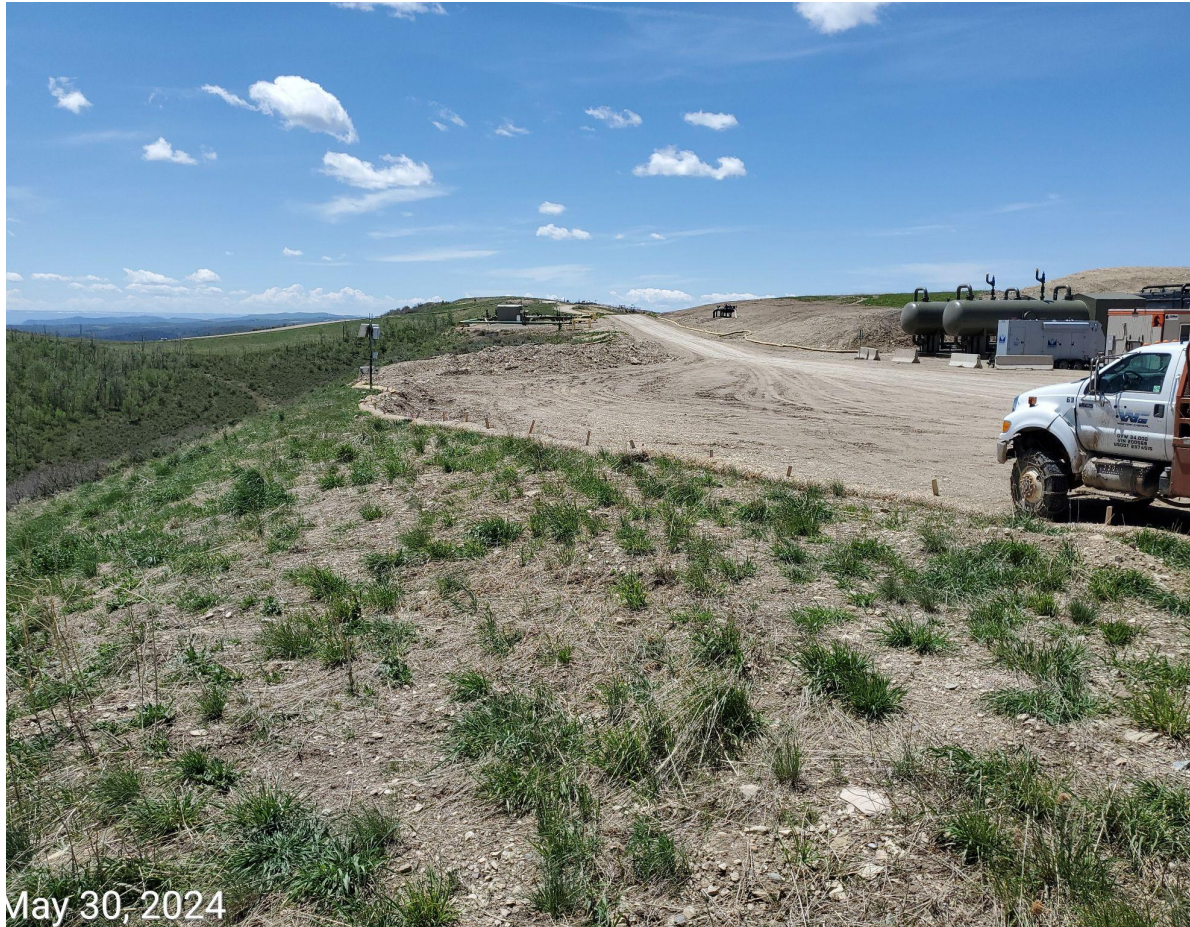
Photo 11: Photo taken from the east end of the Location, facing south. Photo shows areas of the working pad surface that will require 1003 reclamation.
