Caerus Piceance LLC
Canary Unit 6602
Location ID: 315334

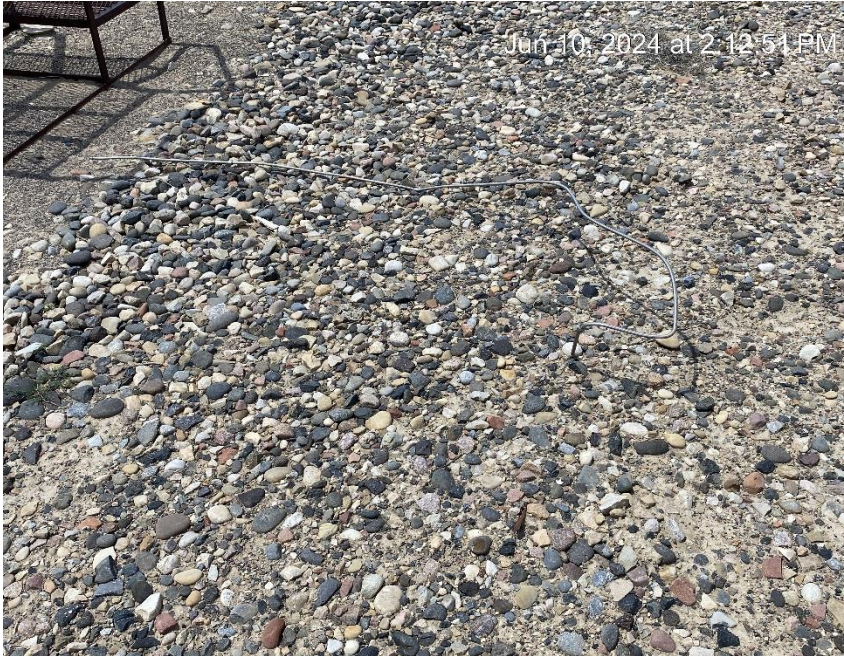
Debris

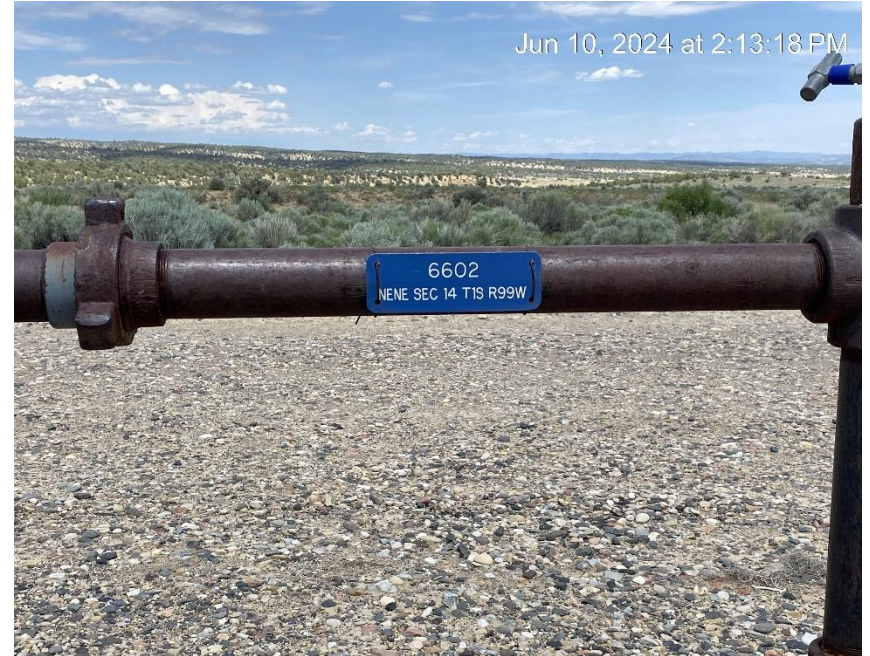
When replaced additional information will be required

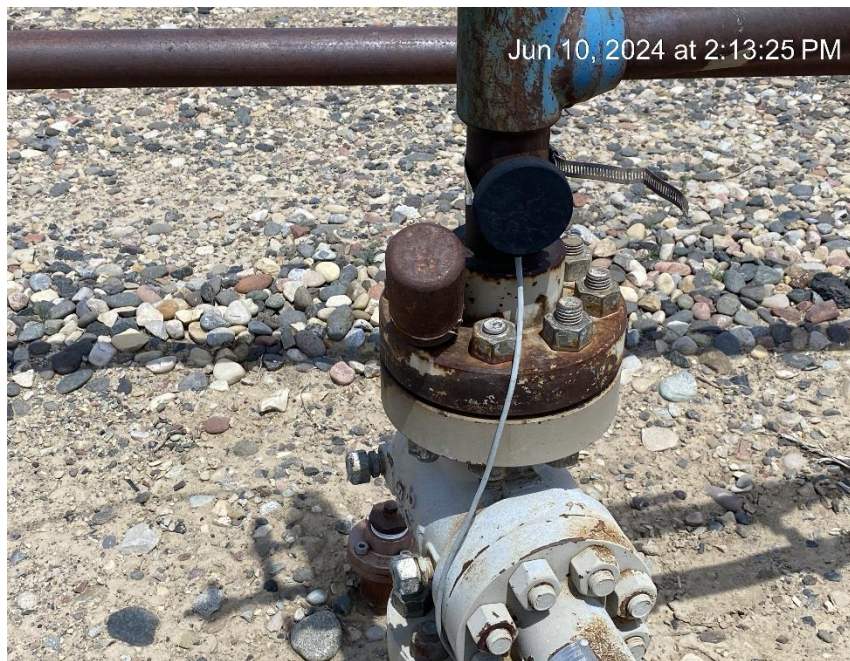
Debris

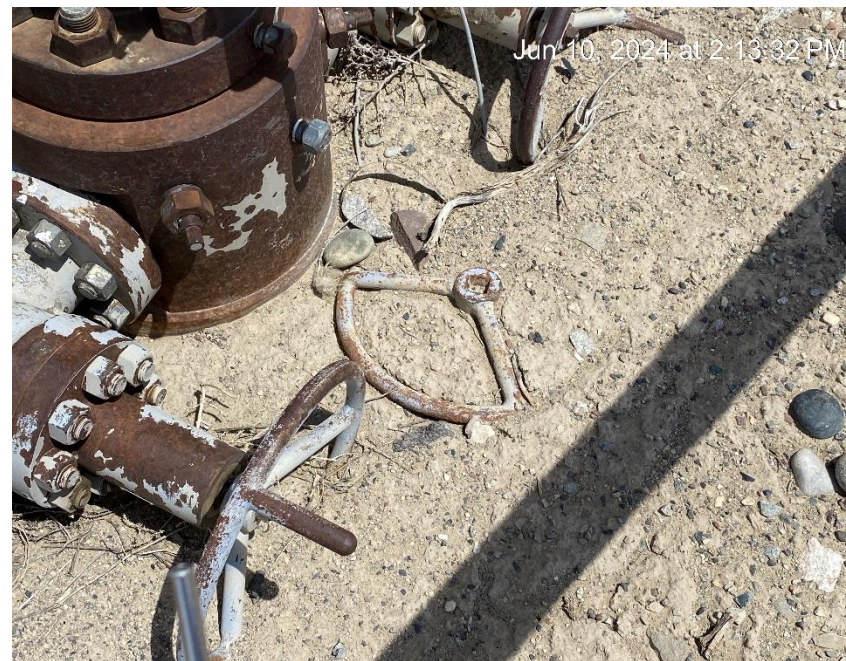
Debris

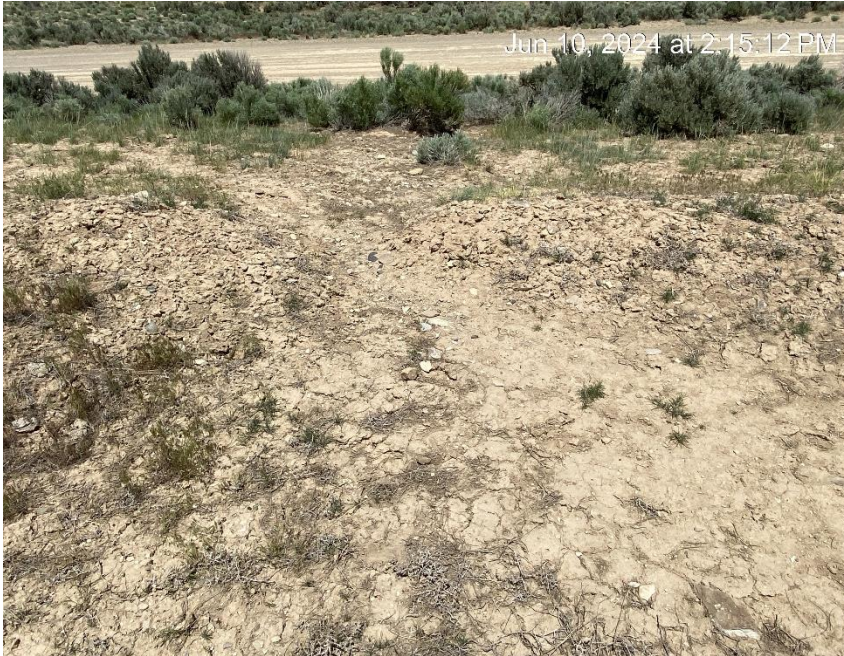
Stormwater BMP needing maintenance

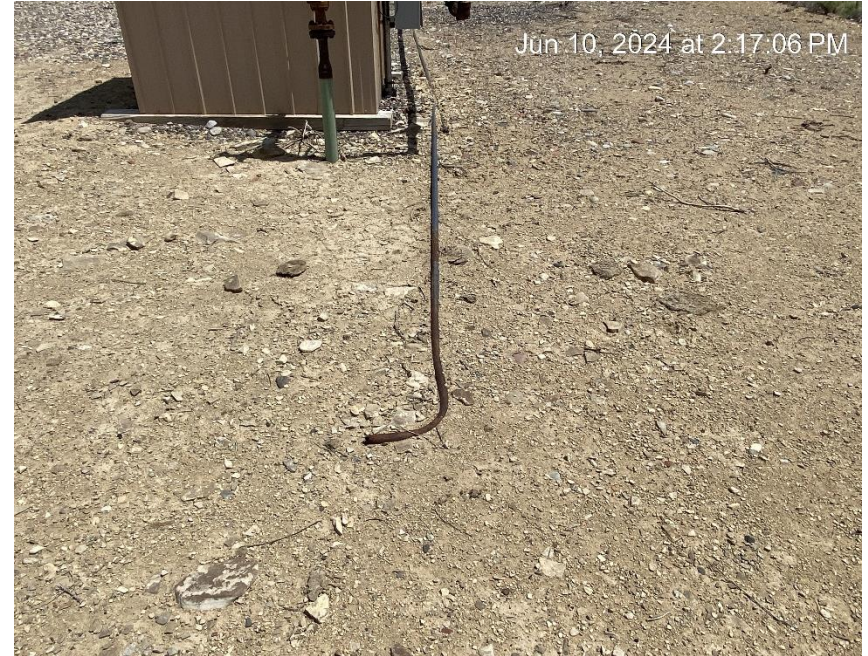
Debris

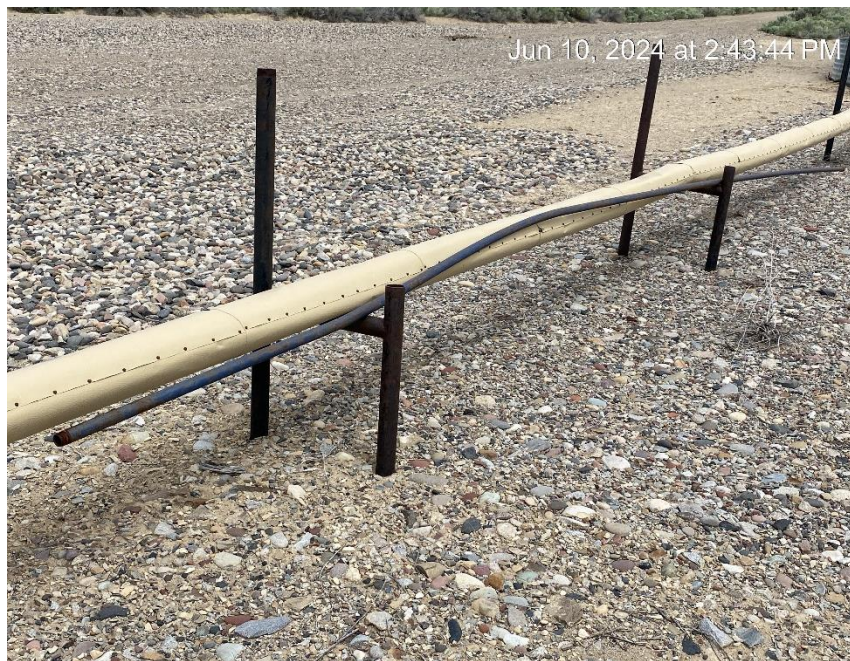
Debris

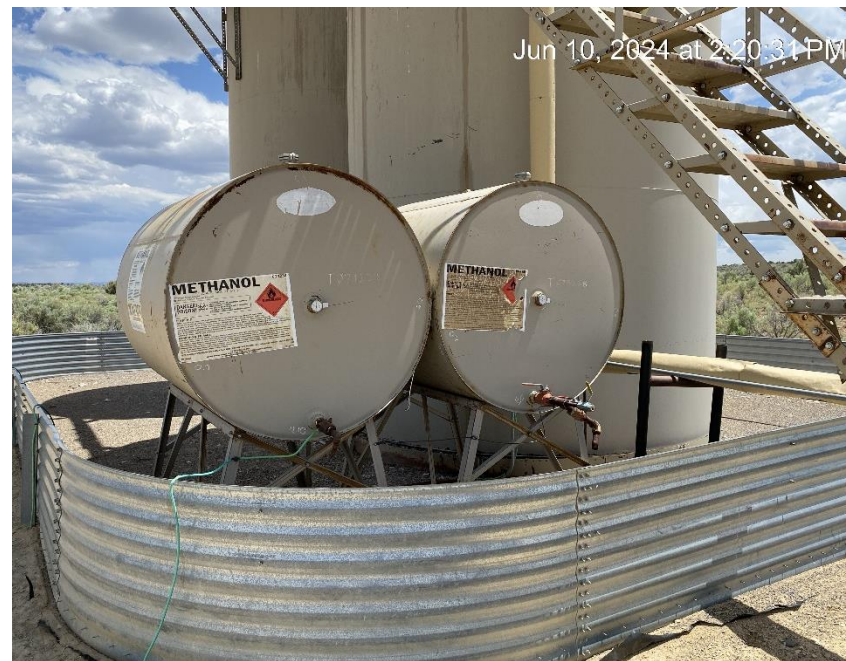
Unused equipment
