Inspection Photos

API: 071-06970

Operator: WAPITI OPERATING LLC

Inspection Date: 6/10/2024

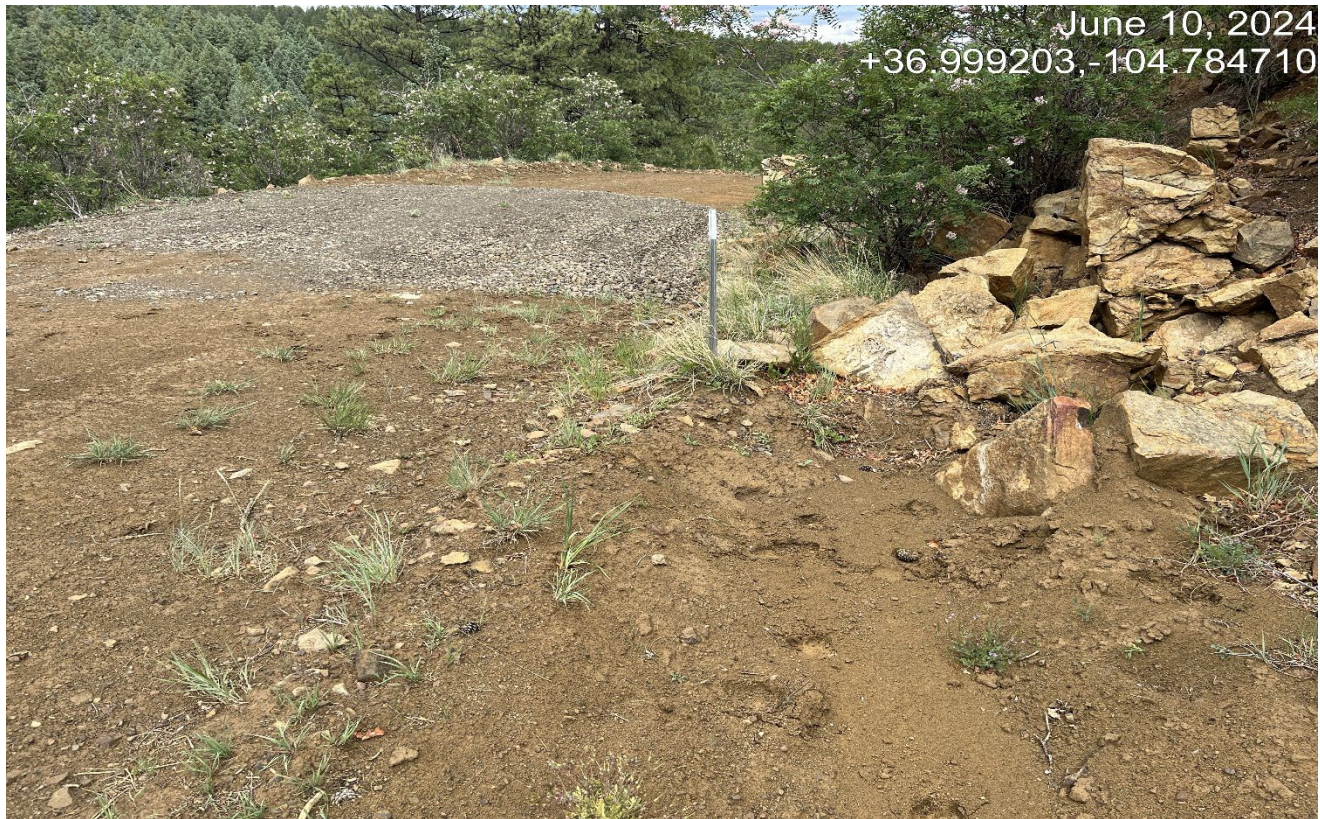
Photo 1. Facing northeast along the access road. The culvert has filled in with sediment and needs to be cleaned out.

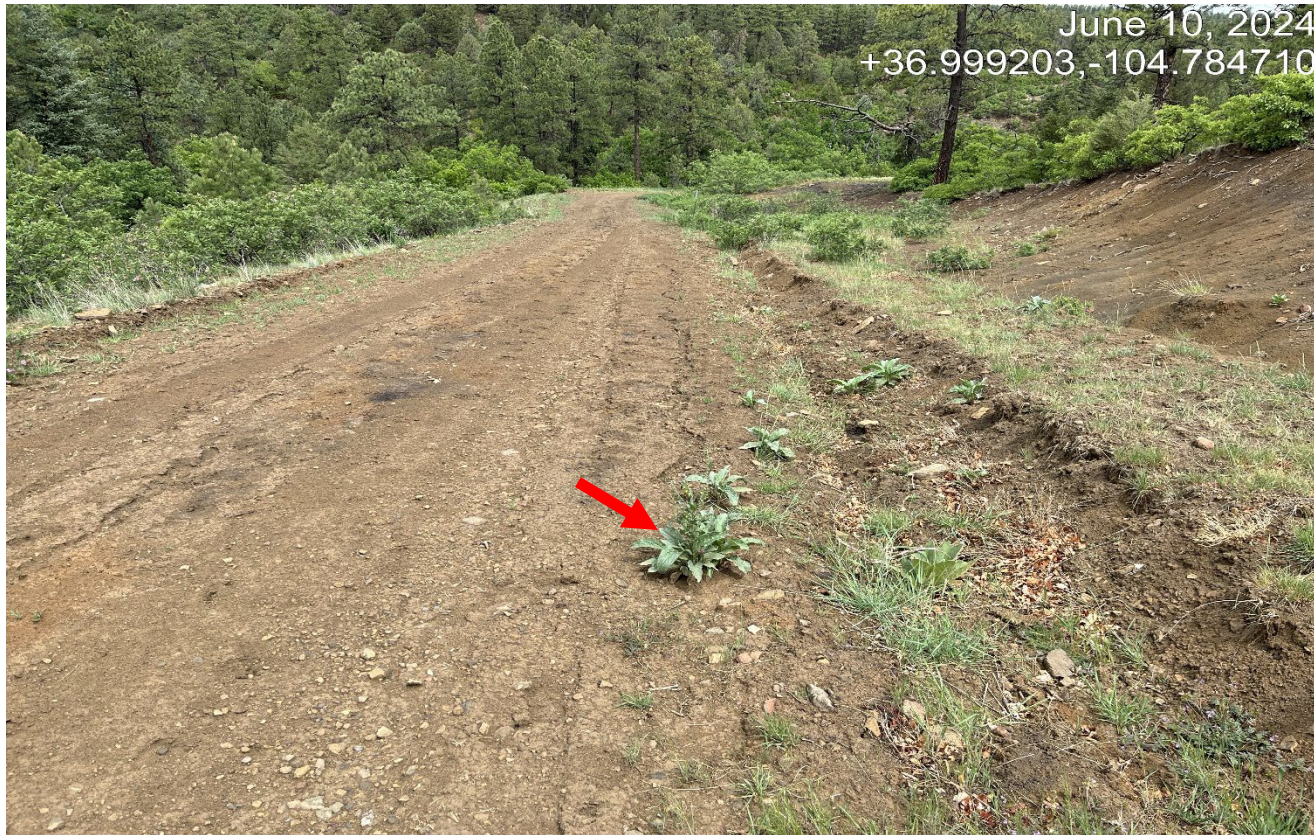
Photo 2. Facing northeast along the road. There are noxious weeds that need to be controlled. Houndstongue

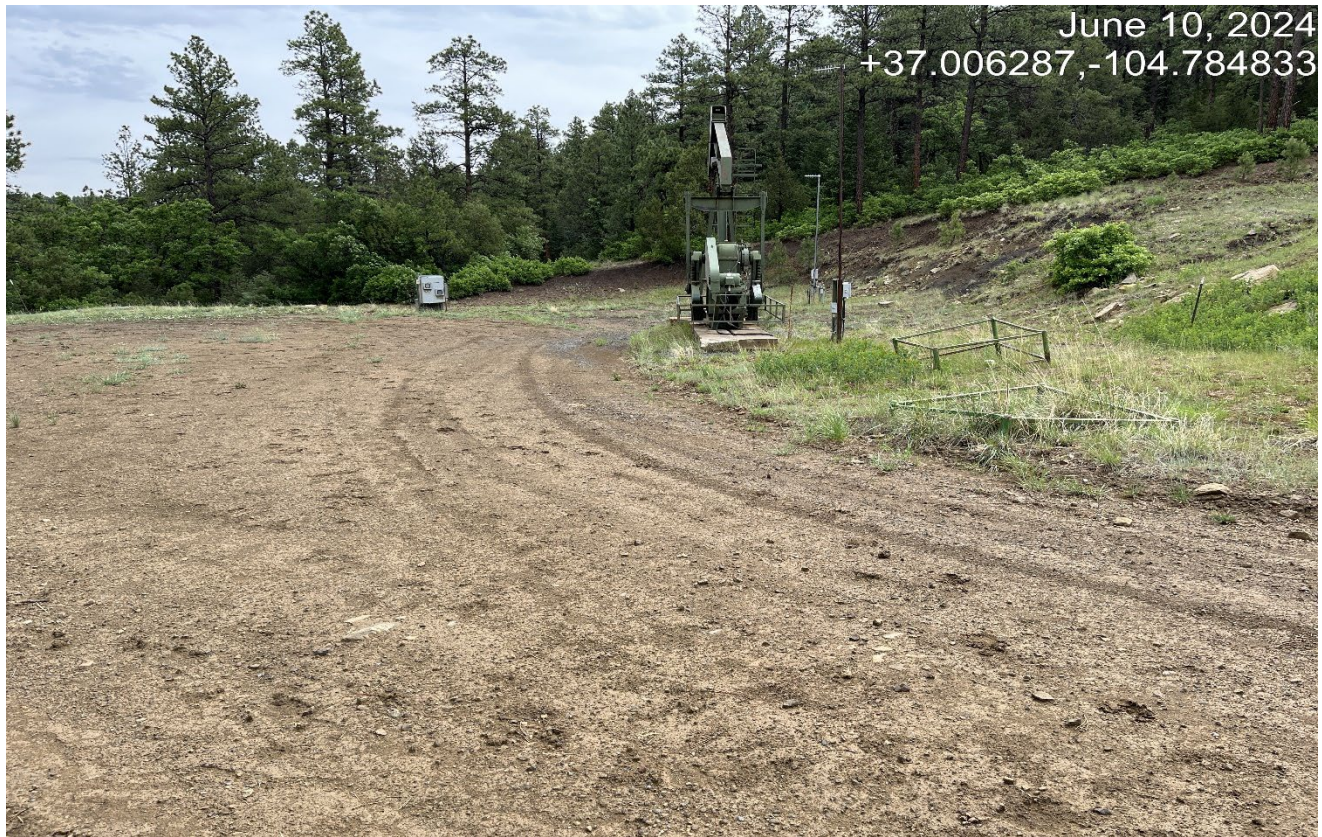
Photo 3. Facing east toward the wellsite.

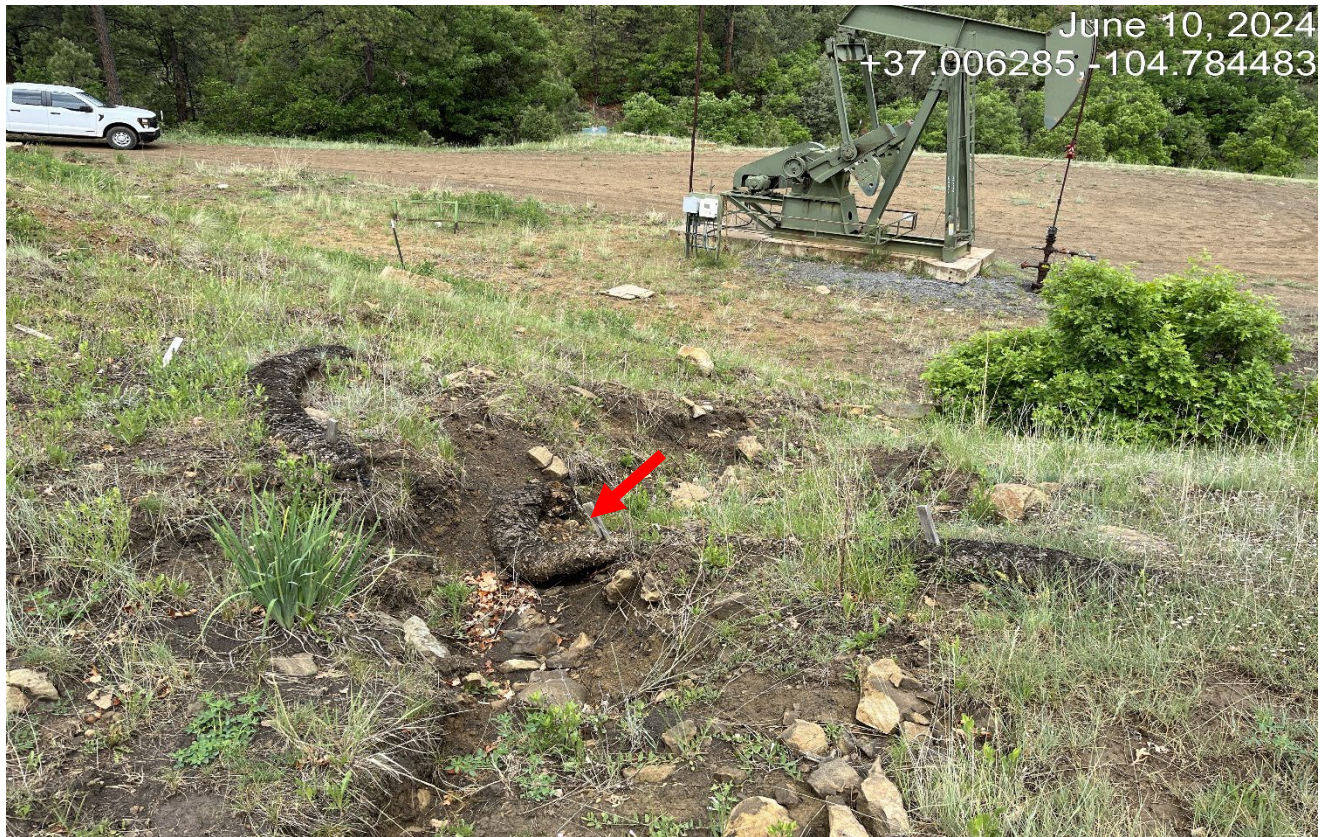
Photo 4. Facing northwest the cut slope. There are erosion channels that need to be repaired. The wattles at red arrow has failed.

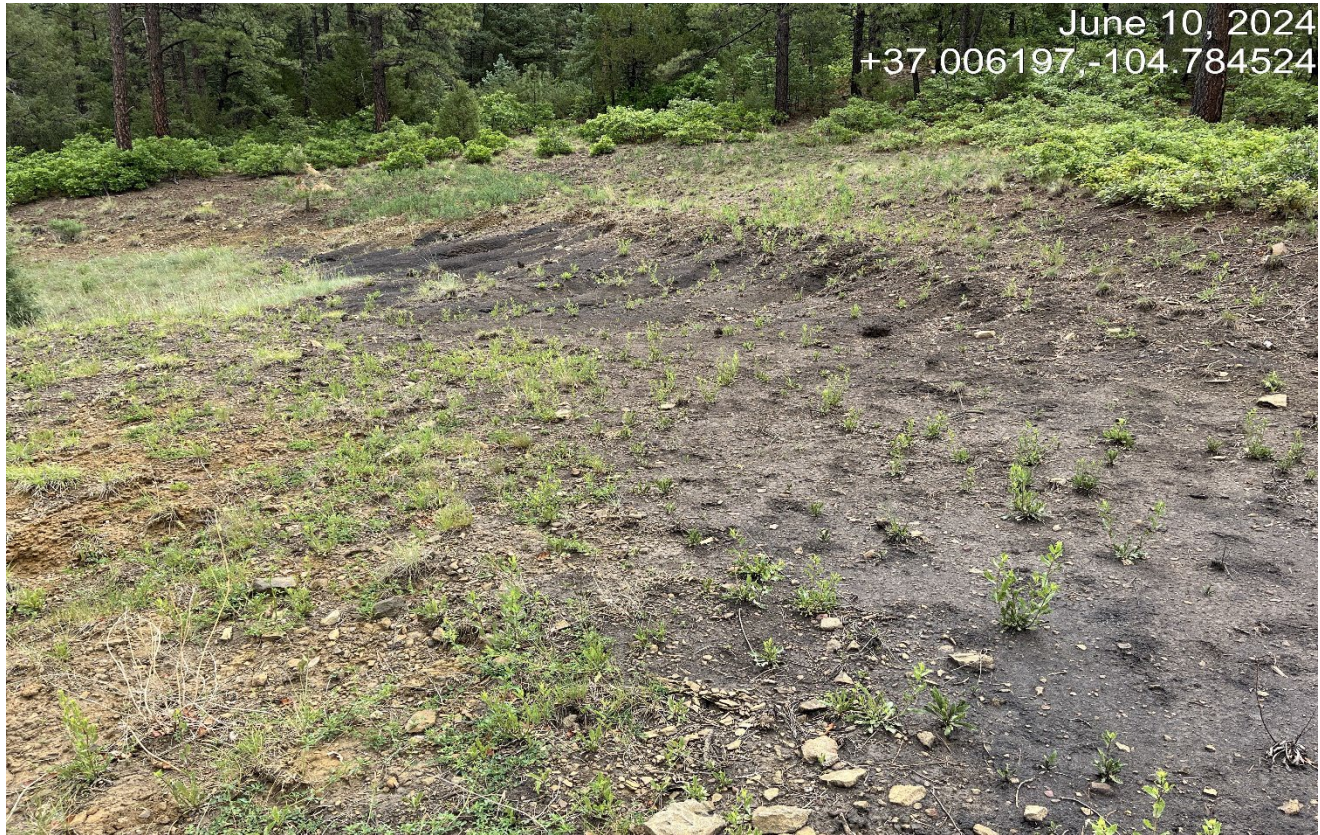
Photo 5. The top of the cut slope need to be stabilized and may require a run-on ditch or other BMP's.

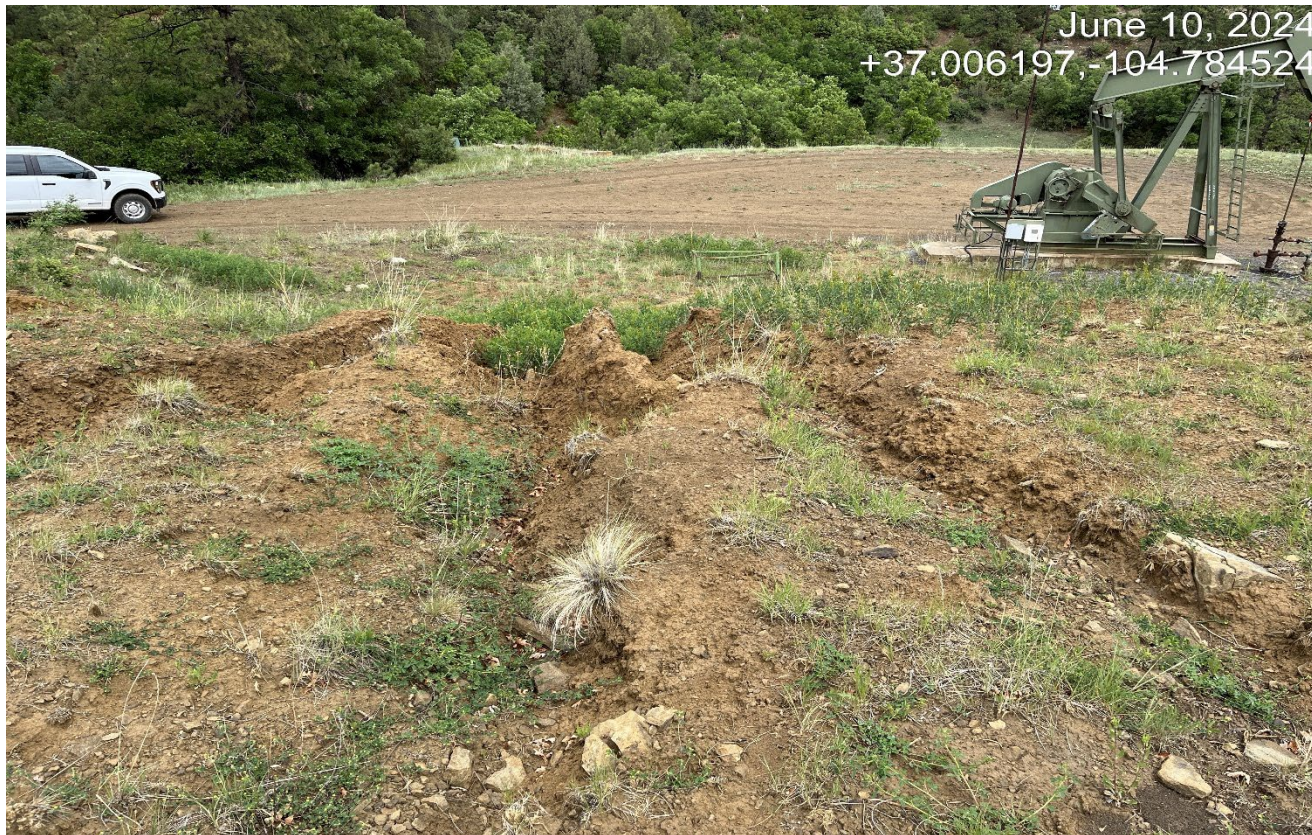
Photo 6. Facing northwest along the cut slope. There are erosion channels that must be repaired and stabilized.

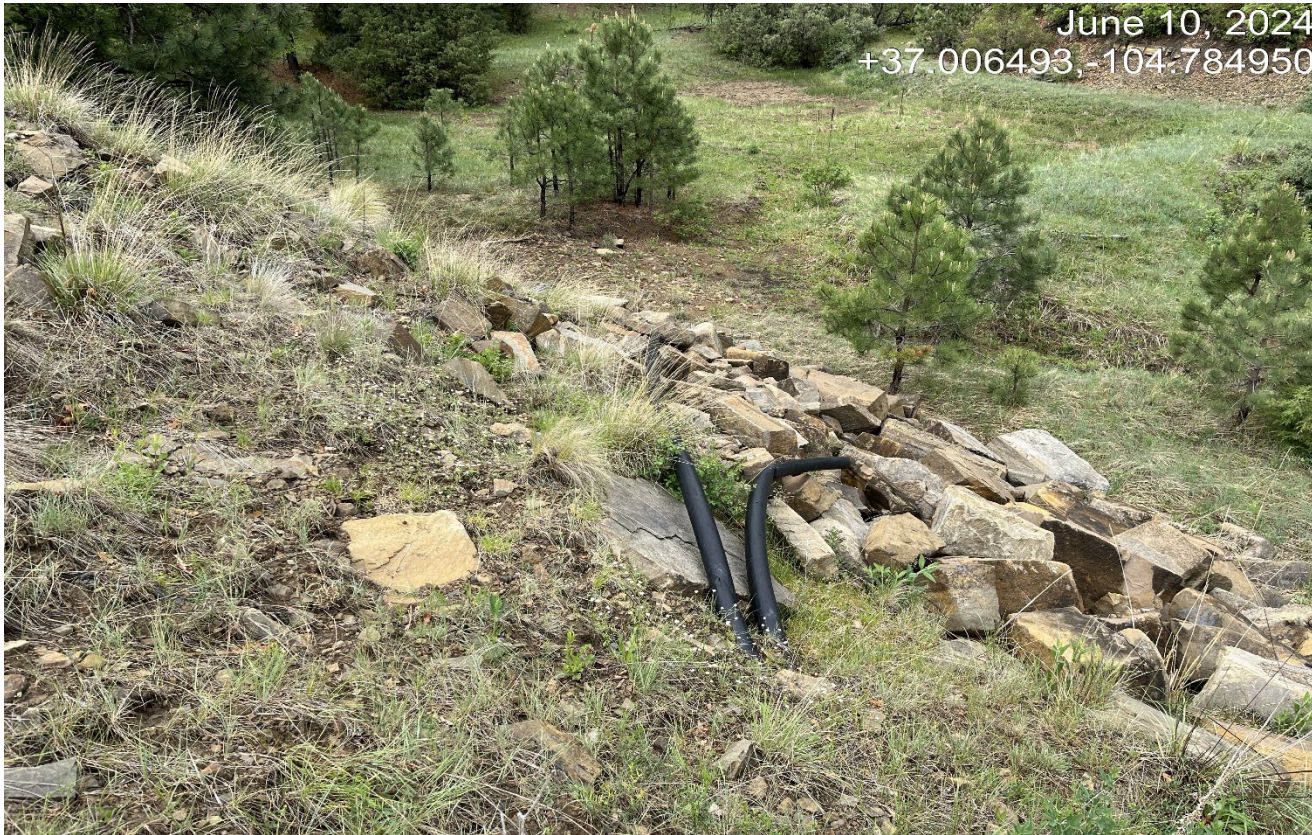
Photo 7. There are black polylines at the fill slope that must removed.

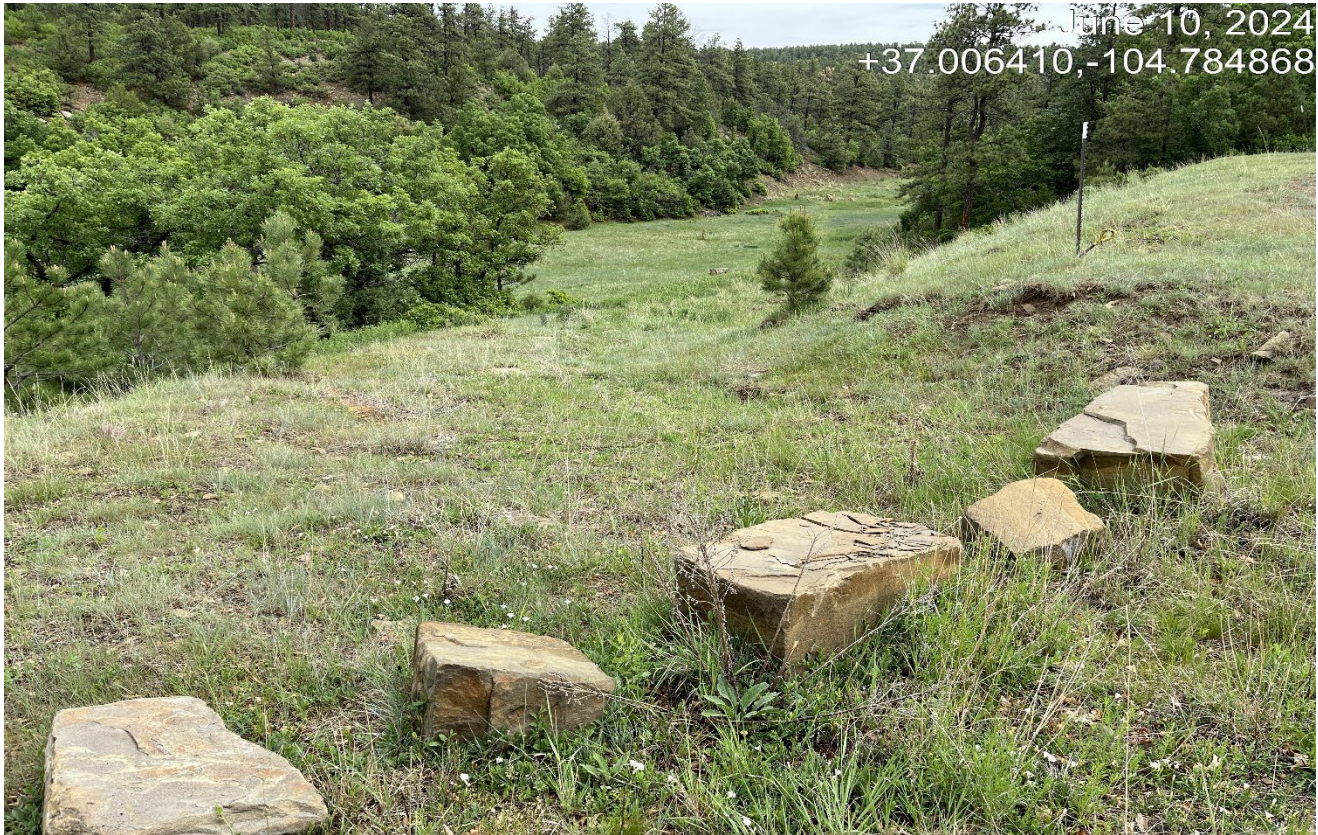
Photo 8. Facing northeast toward the flowline.

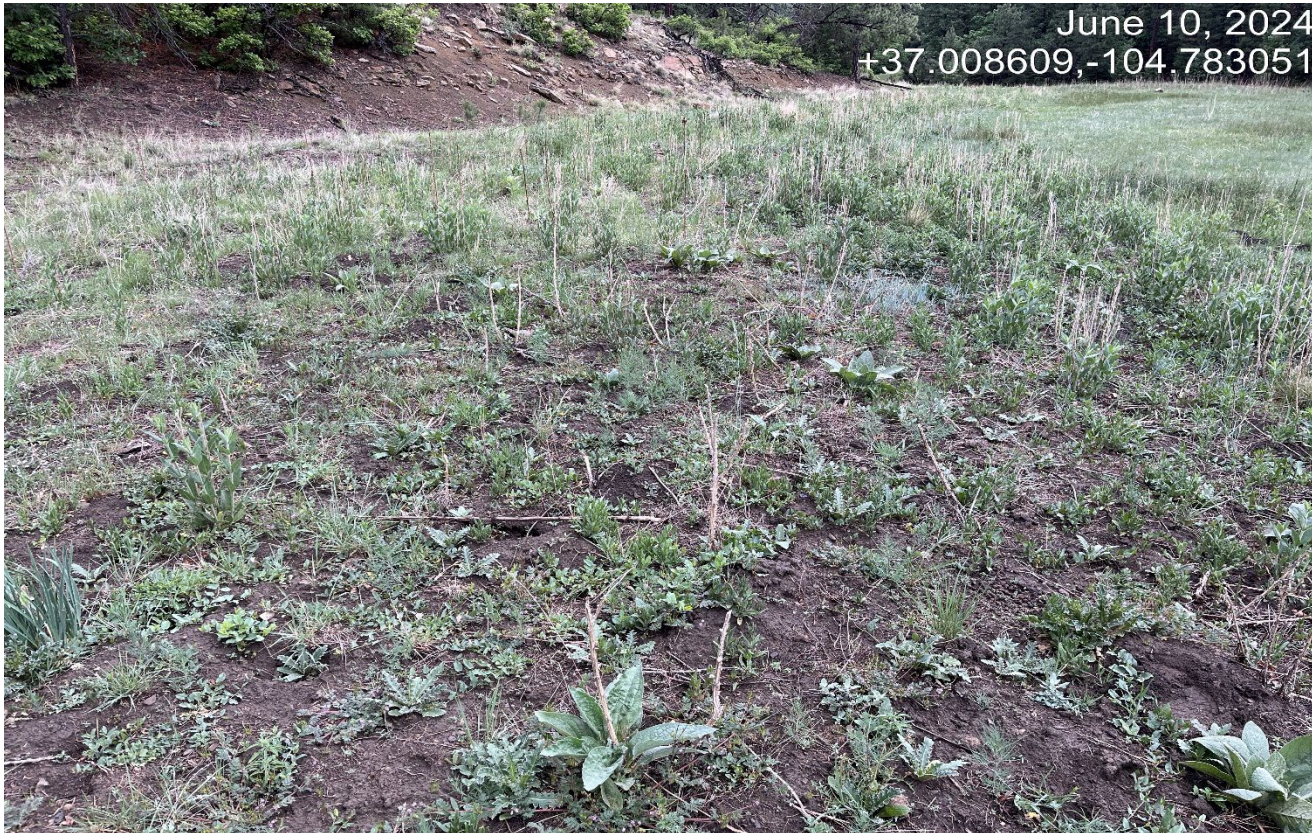
Photo 9. Facing northeast along the flowline. There are numerous noxious weeds that must be controlled. Observed Canada thistle, Houndstongue, Mullein.

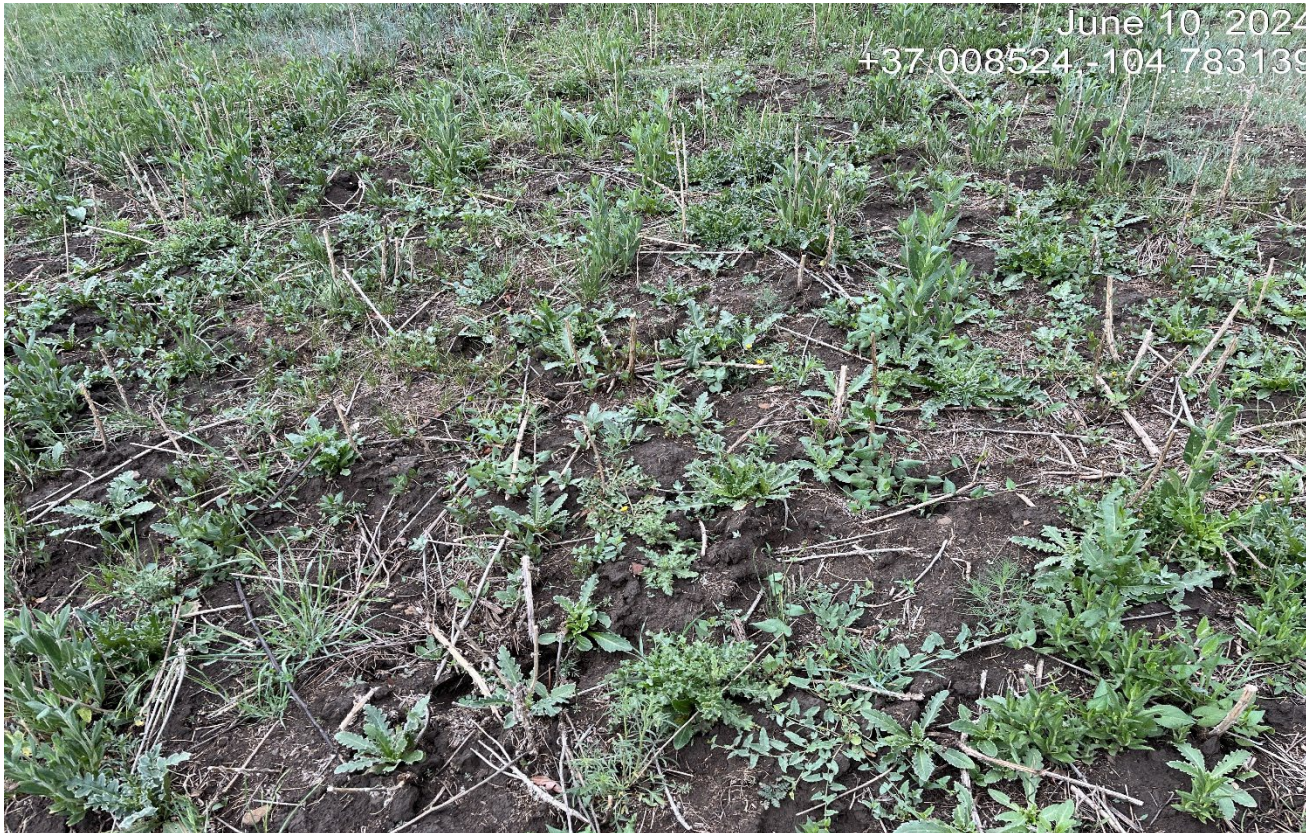
Photo 10. There are numerous noxious weeds that must be controlled. Observed Canada thistle, Houndstongue, Mullein.

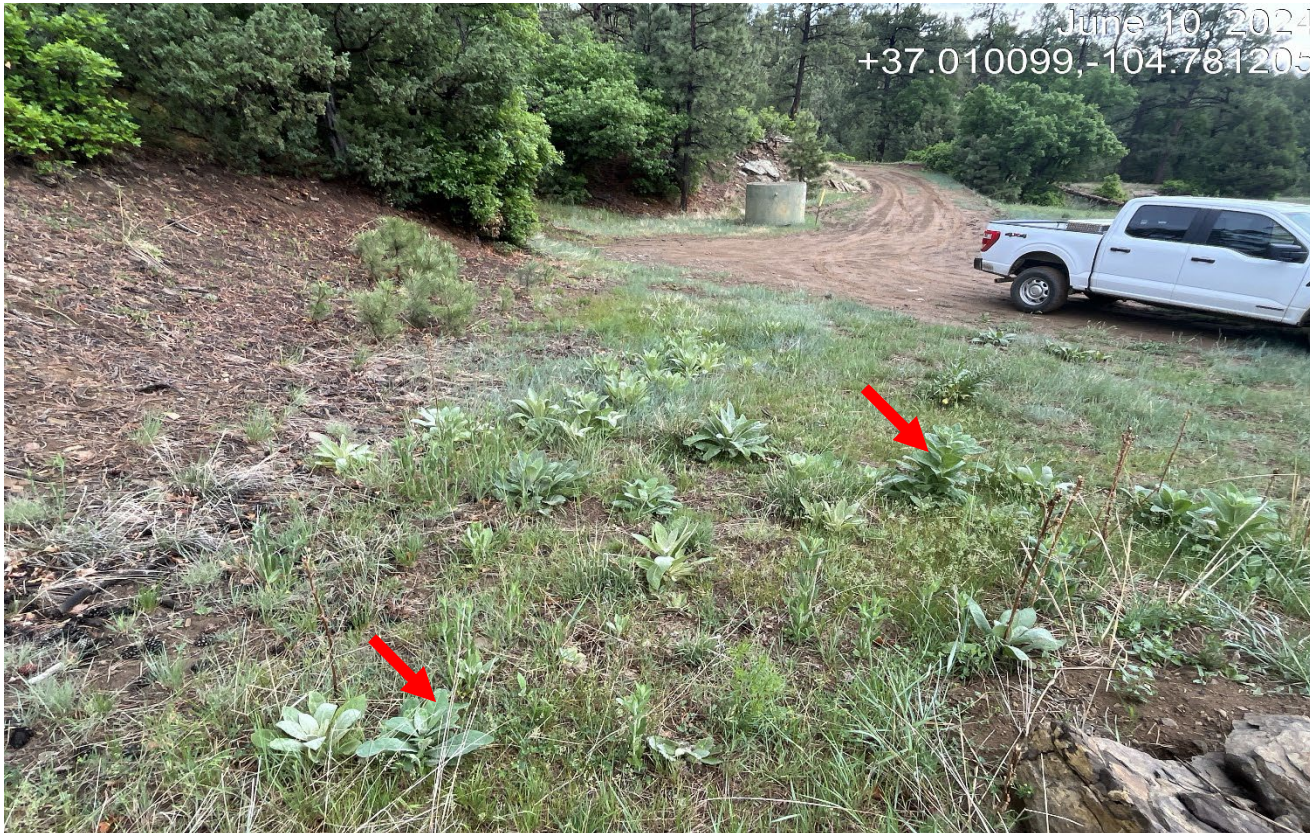
Photo 11. Facing northeast along the flowline near the offsite tank in the canyon. There are numerous noxious weeds that must be controlled.
