Inspection Photos
Location Name: Wardell H 18-16Jl
Location ID: 331228

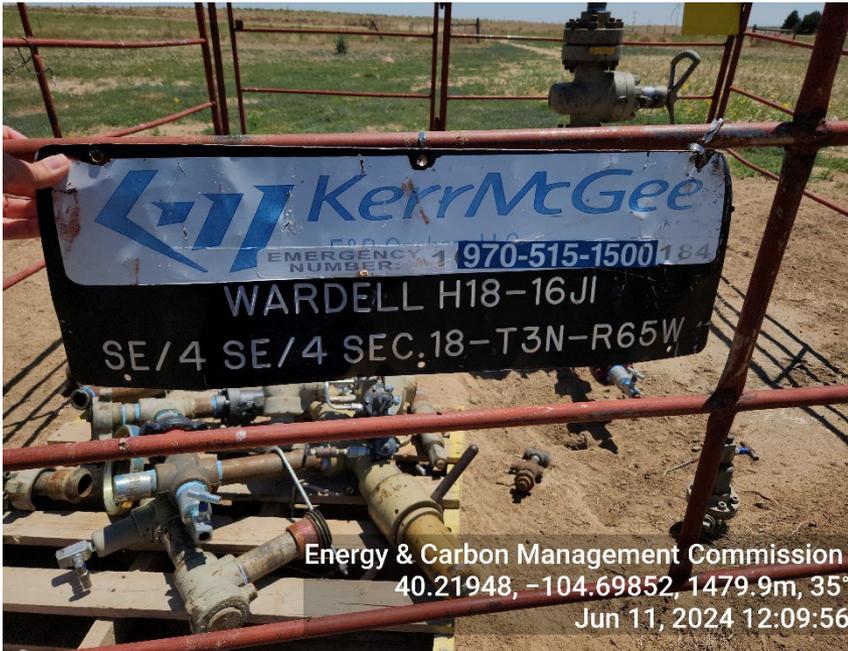
Photo 1: Wellhead Sign

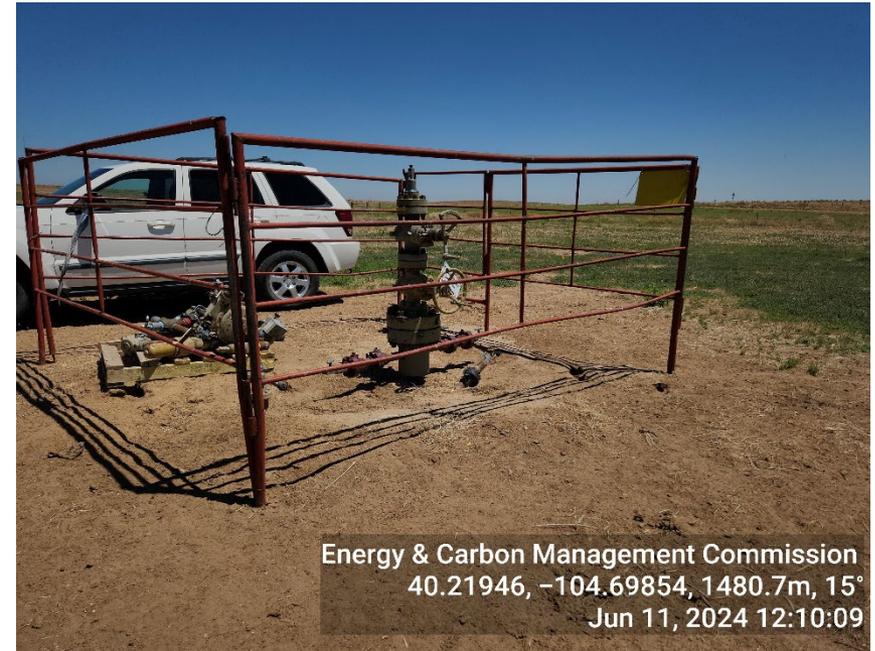
Photo 2: TA Wellhead

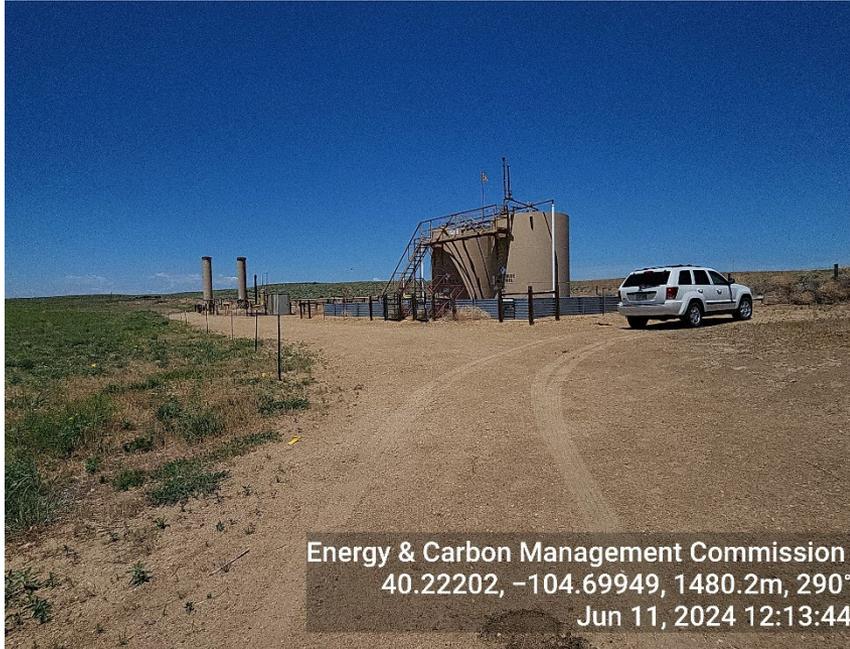
Photo 3: Location from entrance

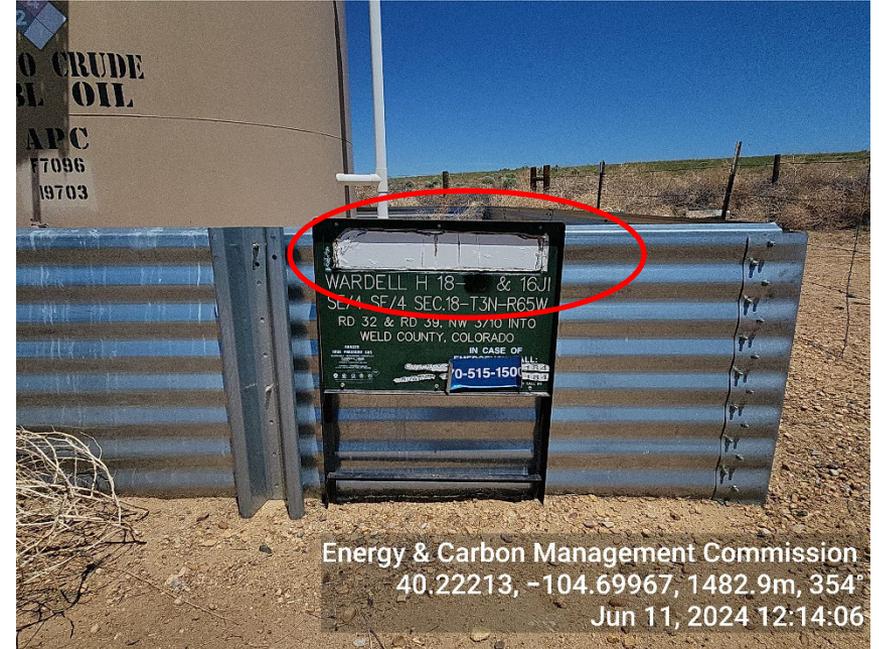
Photo 4: Tank Battery Sign, Operator not legible

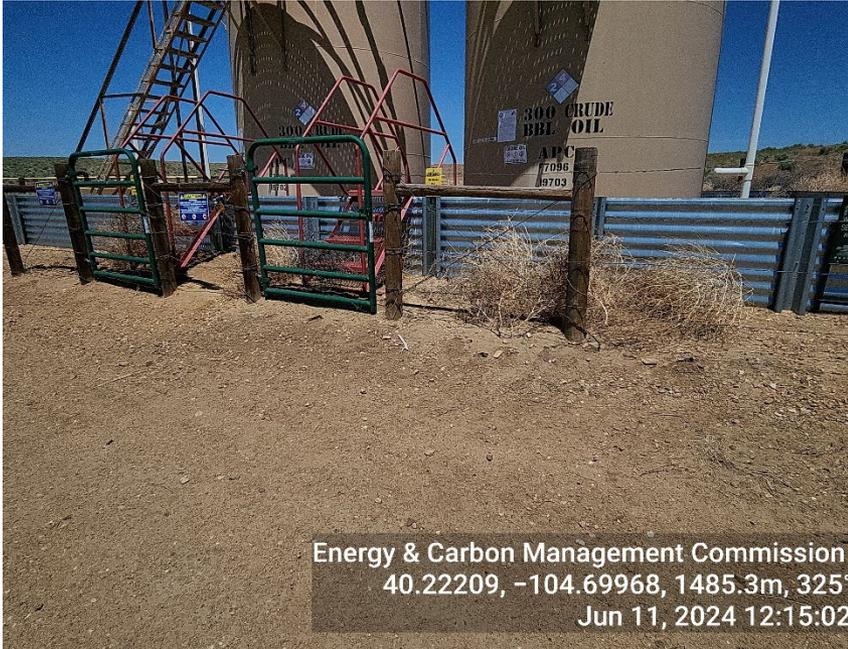
Photo 5: Debris

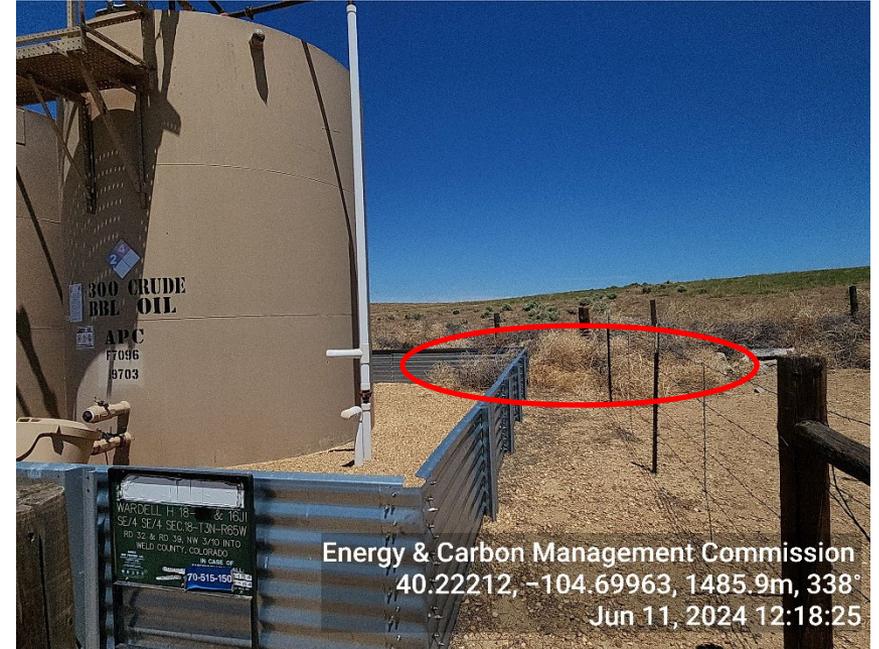
Photo 6: Debris

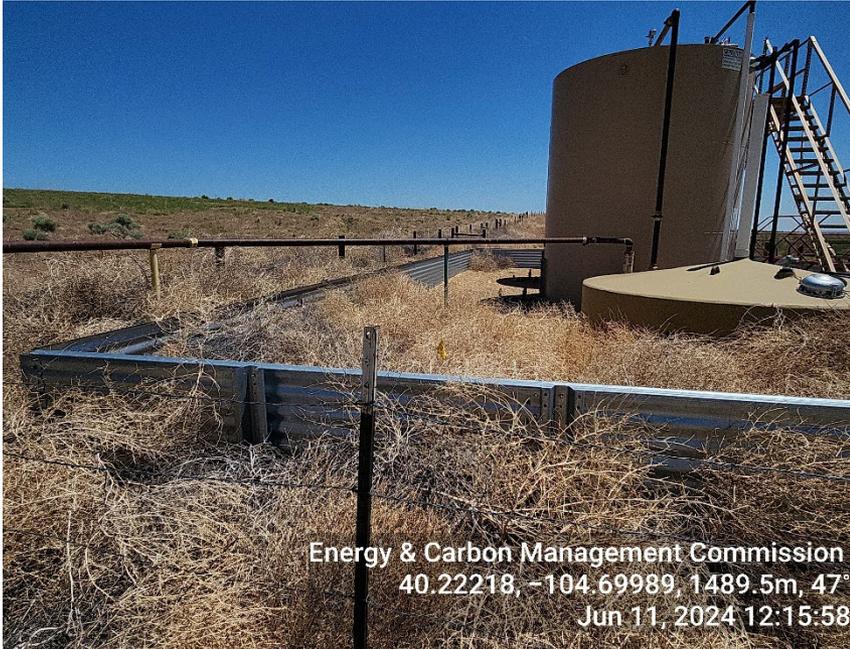
Photo 7: Debris

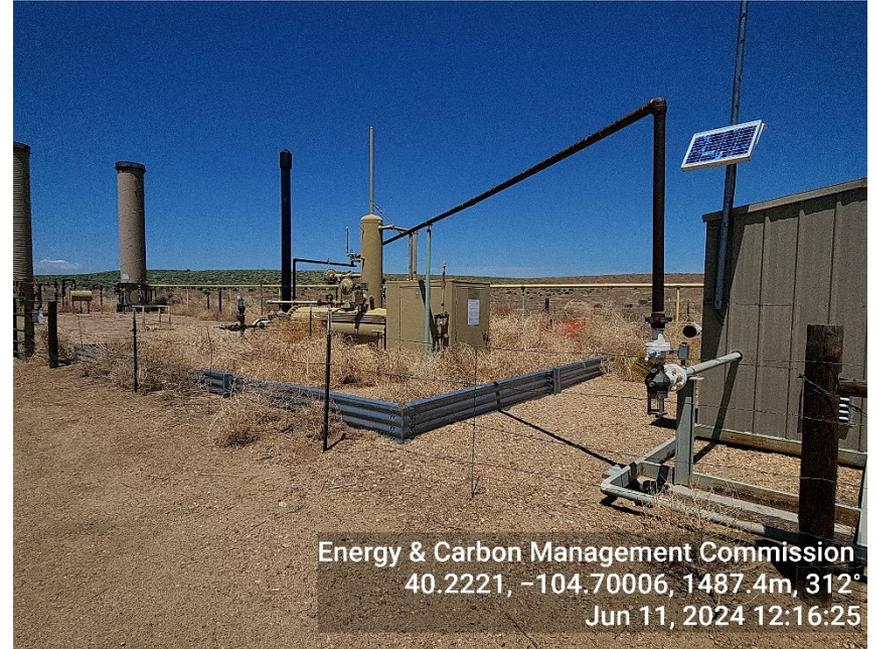
Photo 8: Debris

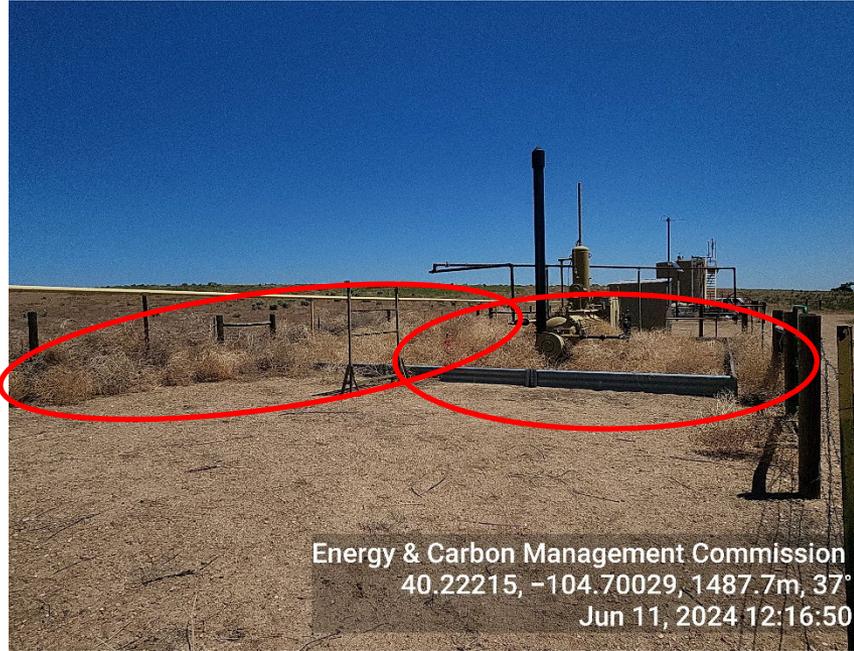
Photo 9: Debirs

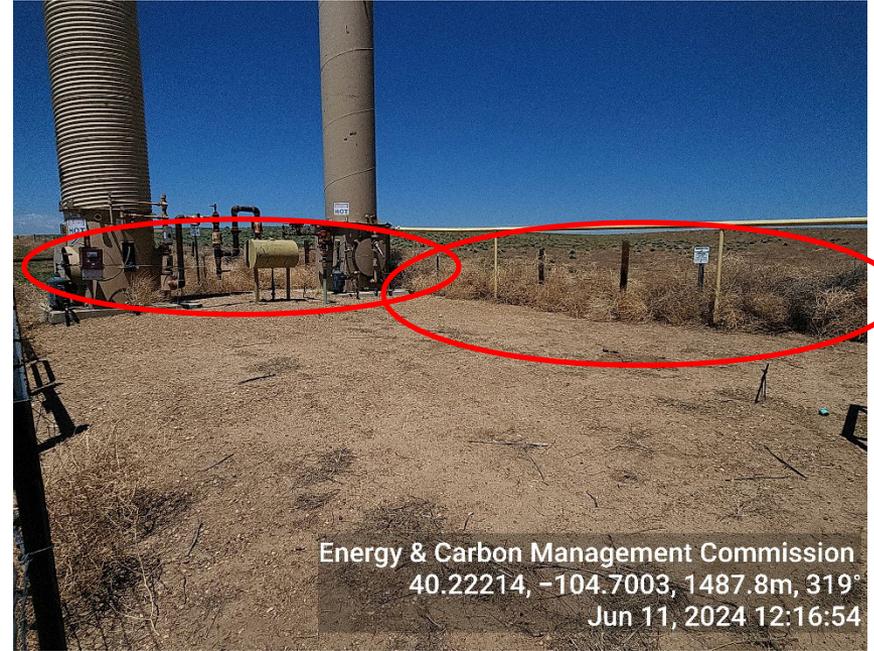
Photo 9: Deirbs

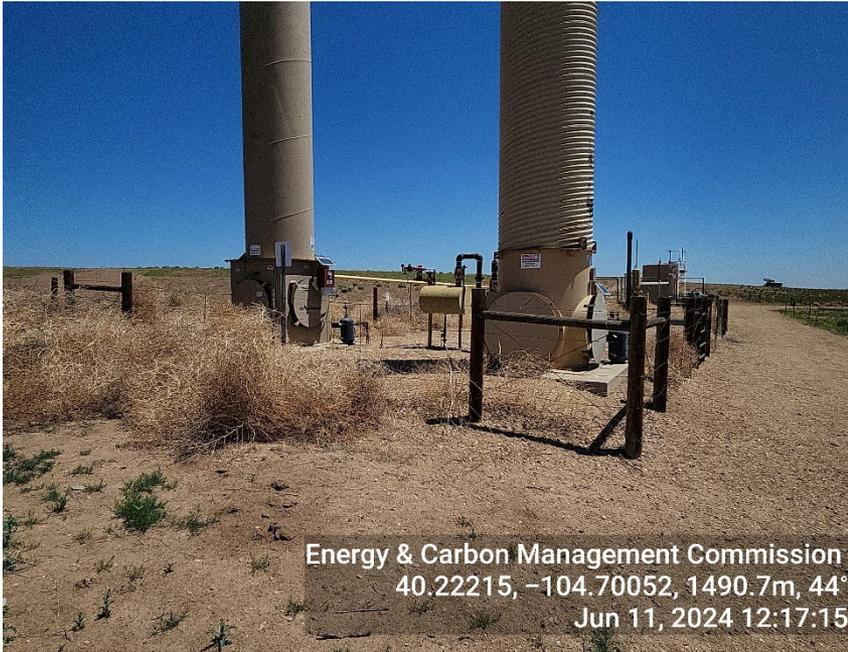
Photo 10: Debris
