Inspection Photos

Loc: 412161

Operator: WAPITI OPERATING LLC

Inspection Date: 6/10/2024

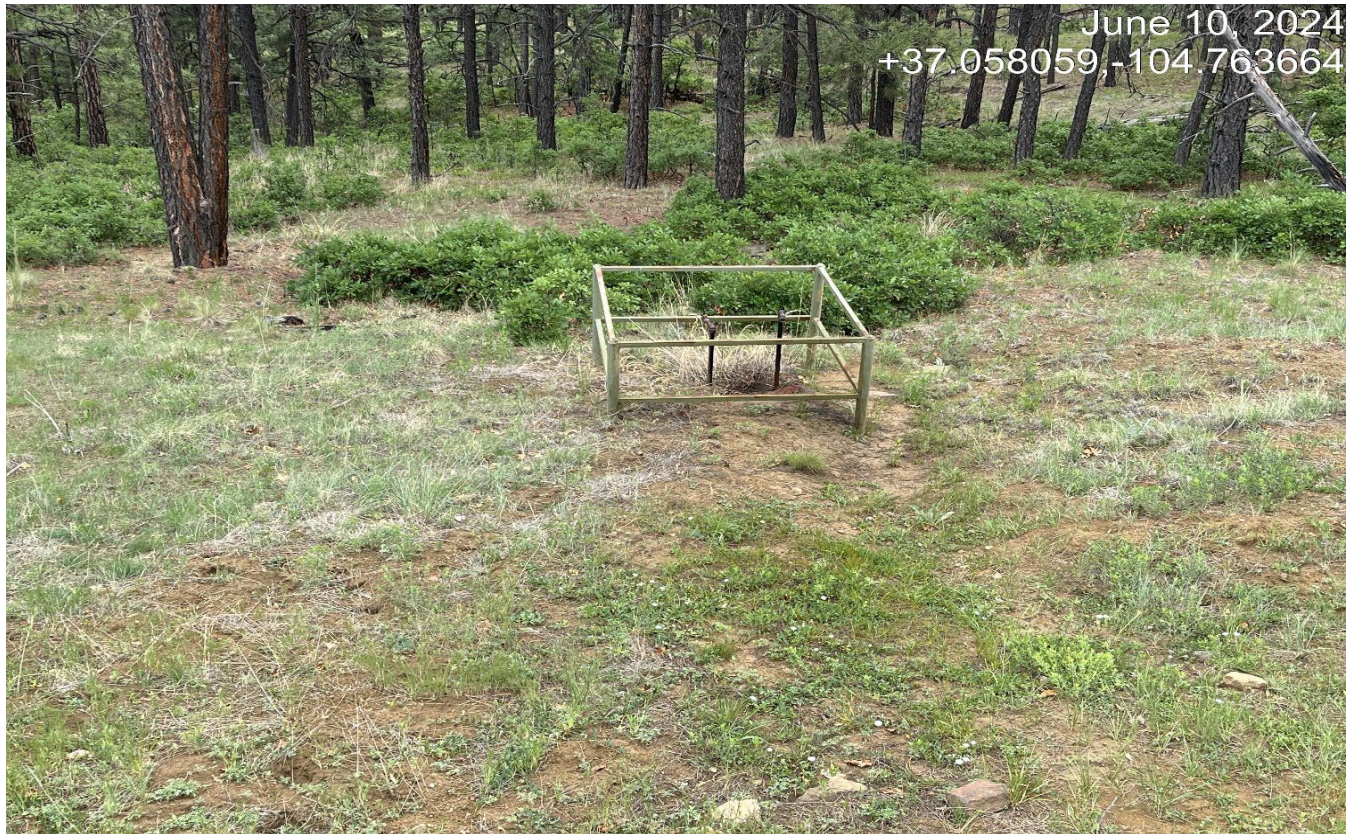
Photo 1. There was a riser observed along the flowline that was venting gas.

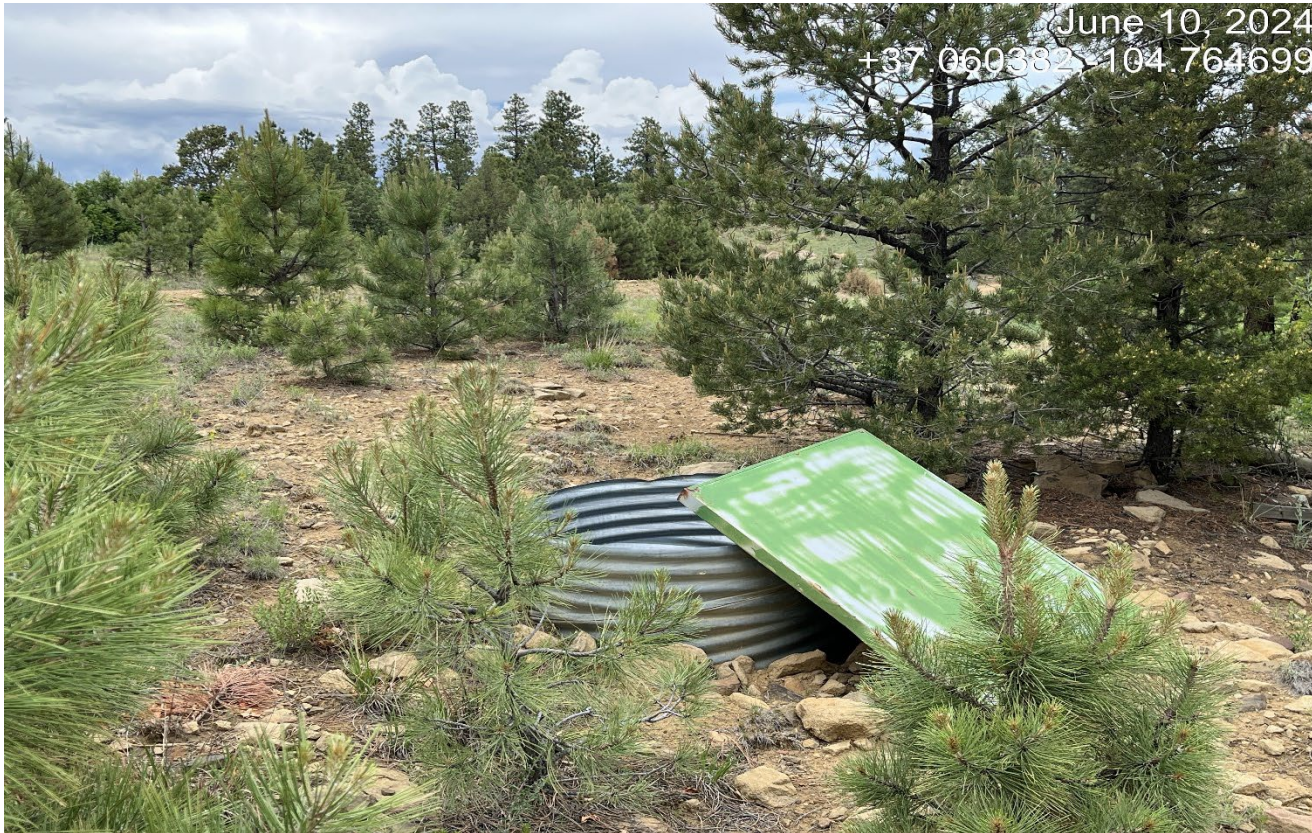
Photo 2. This culvert is not covered along the flowline. The lid needs to be kept on to prevent wildlife entry..

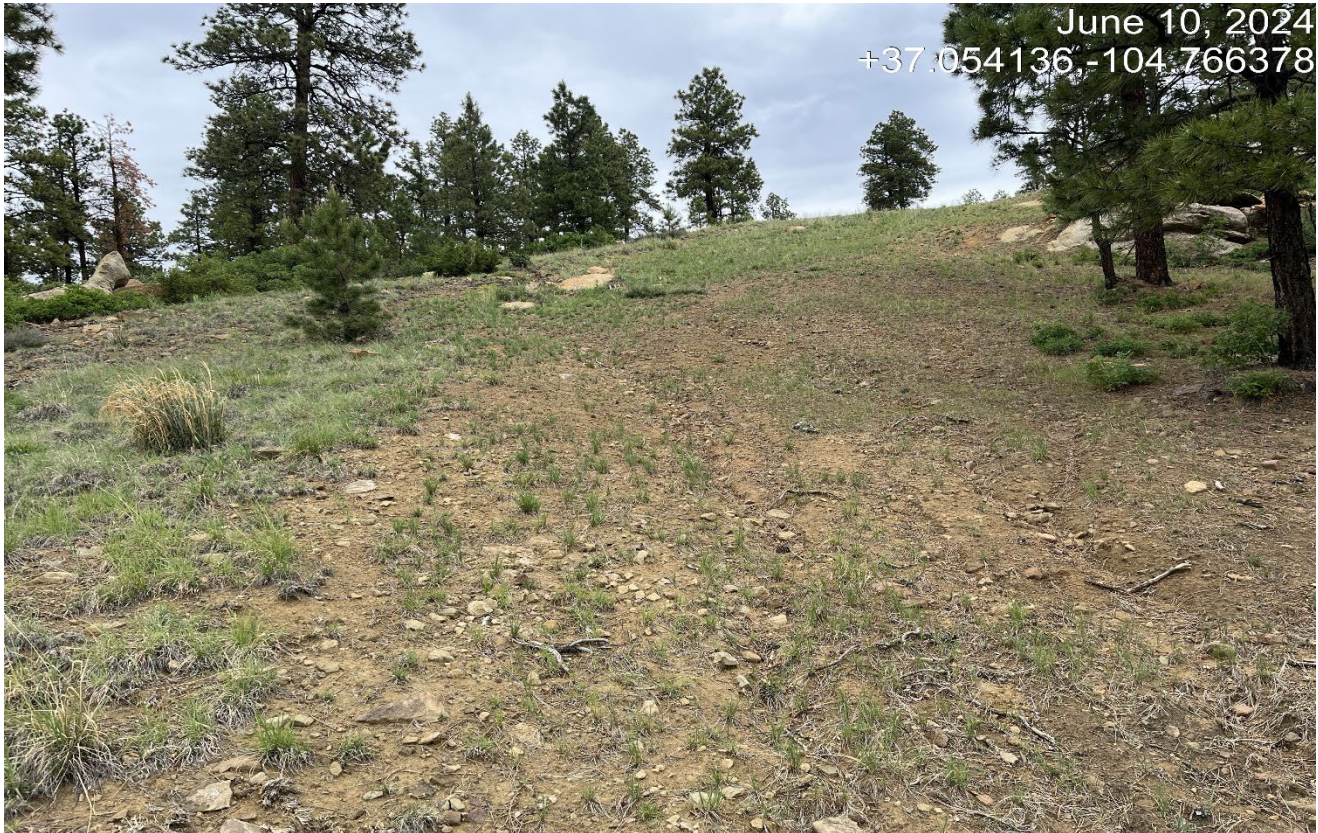
Photo 3. Facing northwest along the flowline where disturbance had occurred. The vegetation is establishing and stabilizing soils..

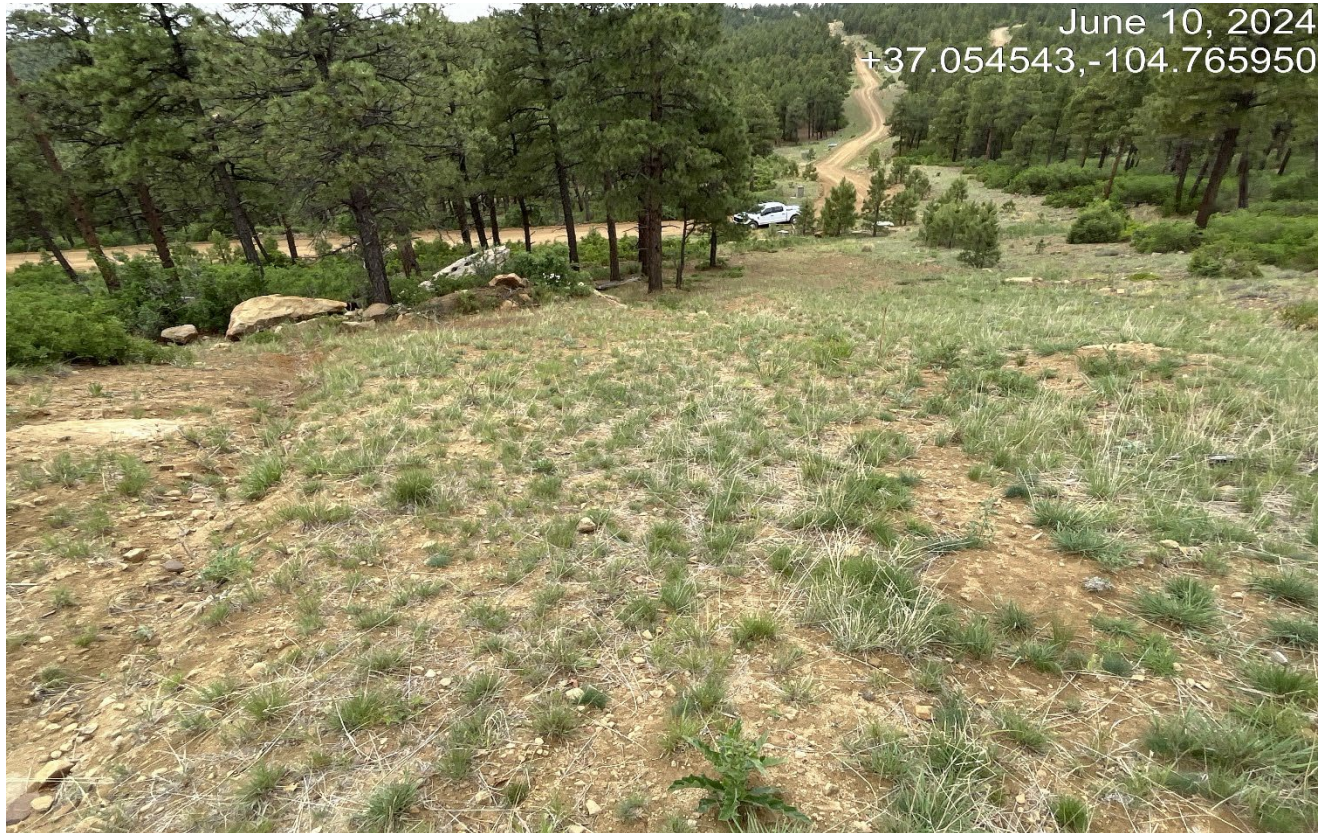
Photo 4. Facing south along the flowline where disturbance had occurred. The vegetation is establishing and stabilizing soils..

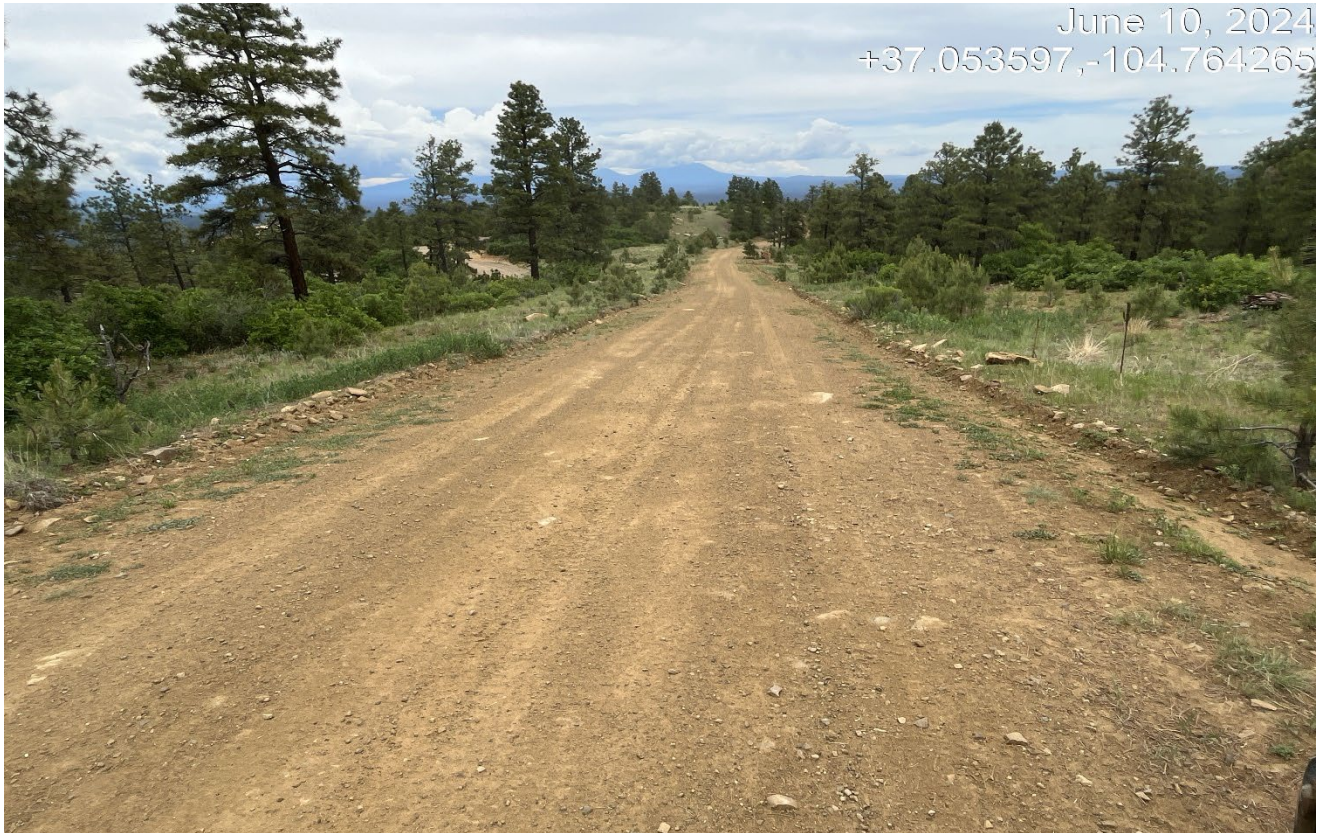
Photo 5. Facing north along the access road.

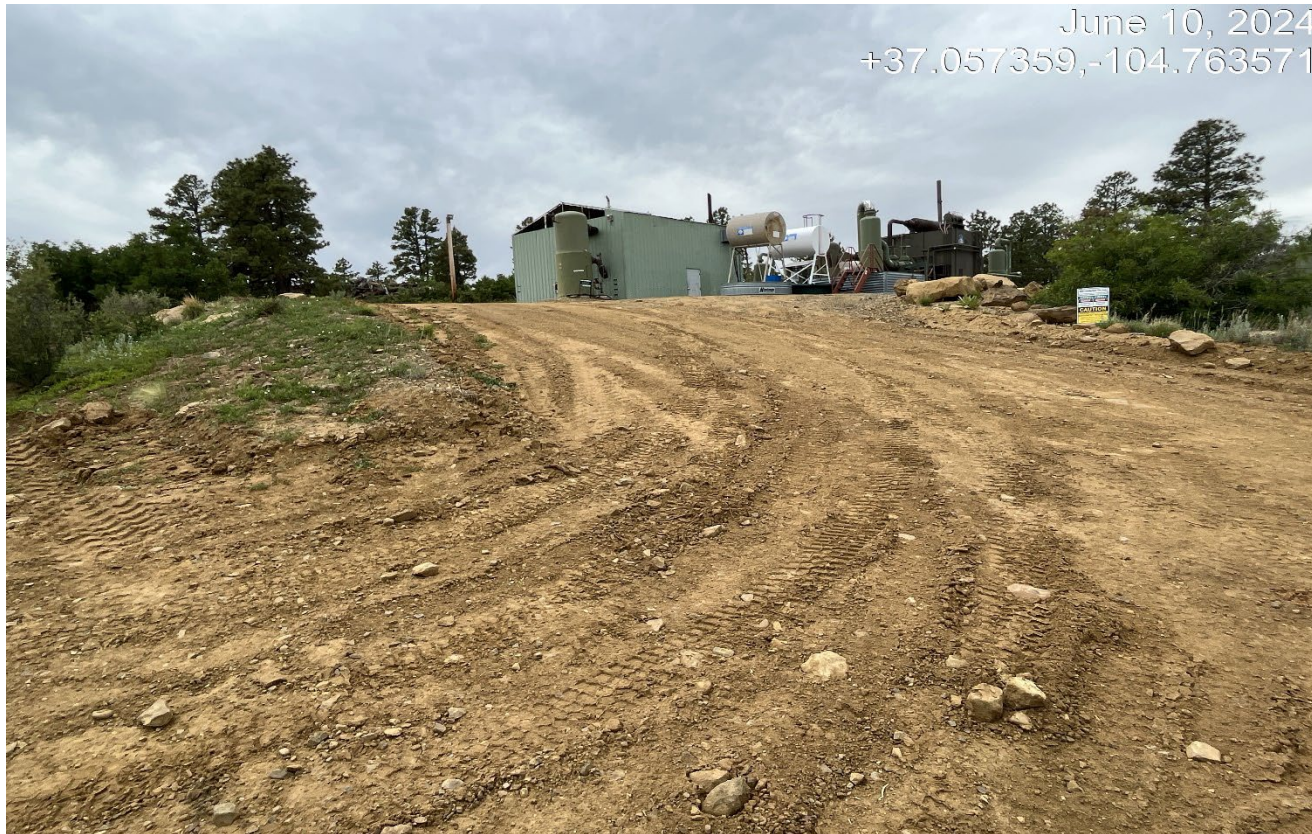
Photo 6. Facing southwest toward the compressor station.
