Inspection Photos

Location Name: TEP ROCKY MOUNTAIN LLC HOLL RWF 13-31 Pad

Location ID: 417582

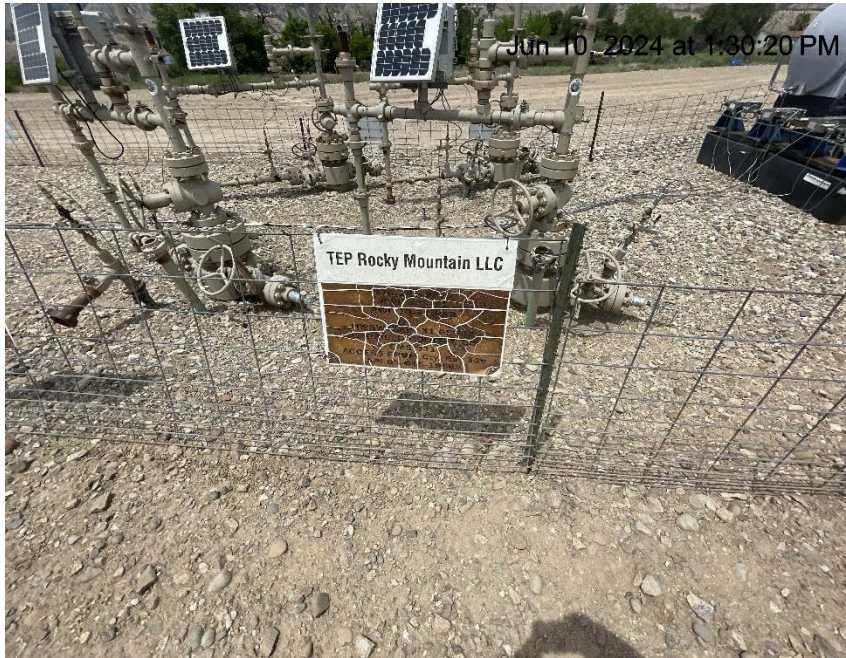
Photo # 219 Wellhead sign weathered & cracking/sign is becoming illegible & does not comply with CECMC rules

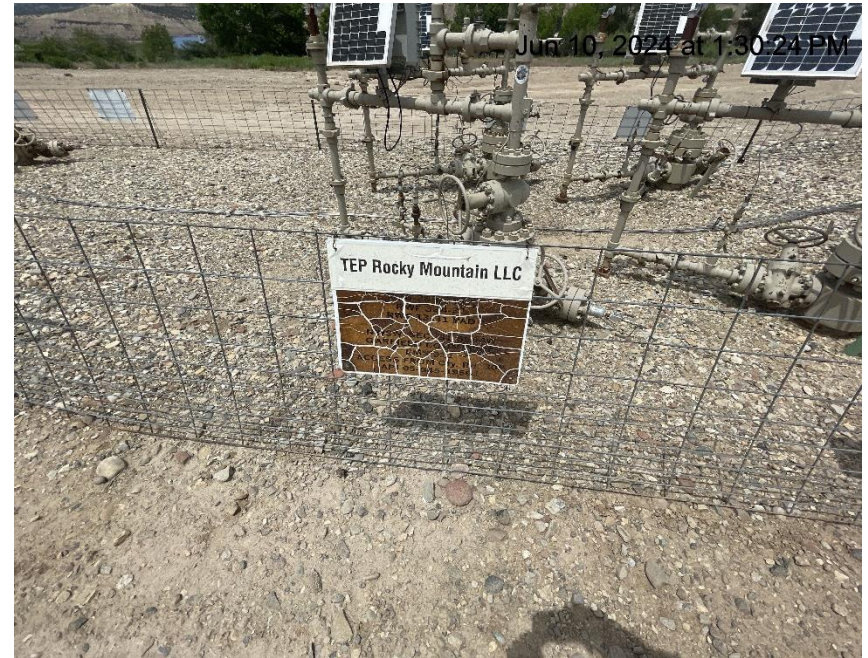
Photo # 220 Wellhead sign weathered & cracking/sign is becoming illegible & does not comply with CECMC rules

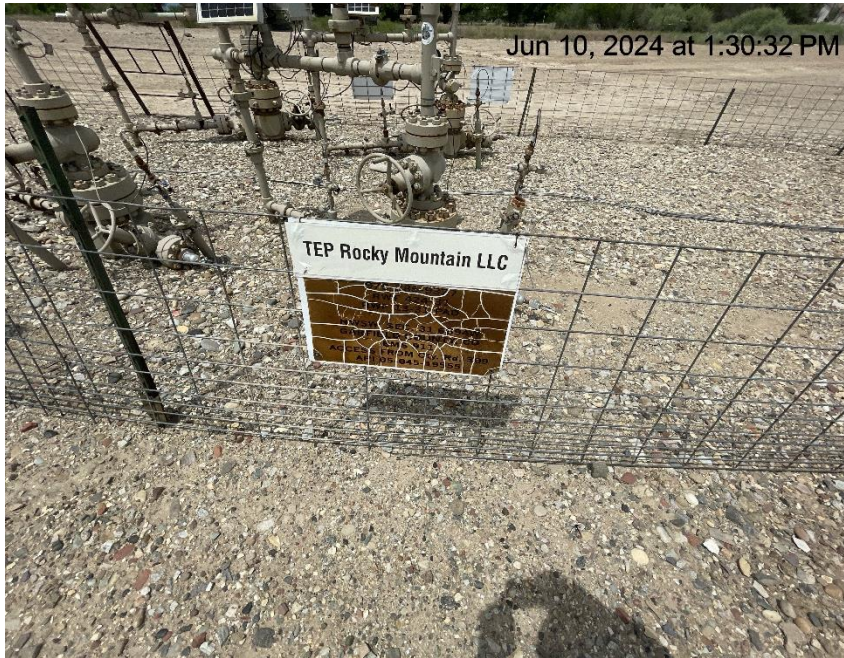
Photo # 221 Wellhead sign weathered & cracking/sign is becoming illegible & does not comply with CECMC rules

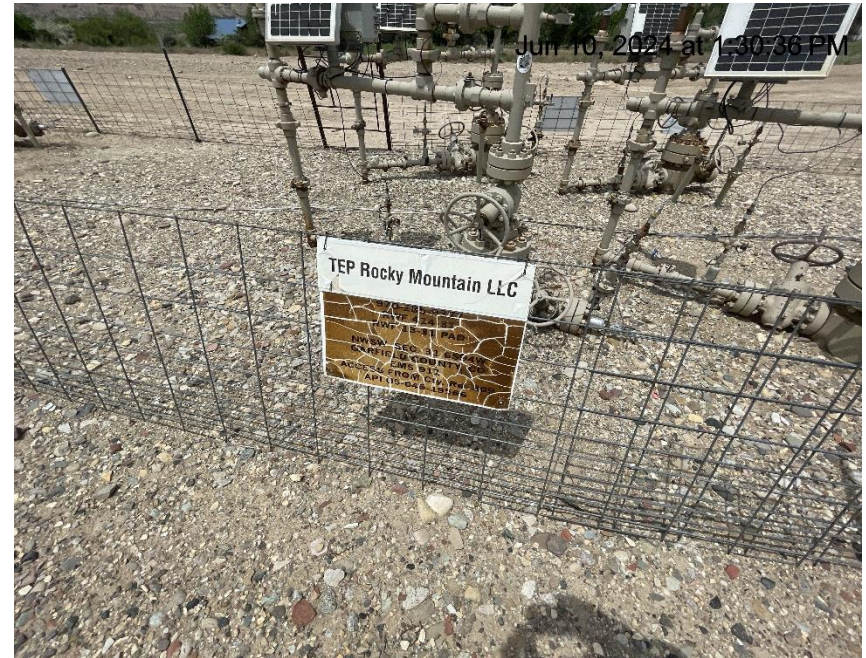
Photo # 222 Wellhead sign weathered & cracking/sign is becoming illegible & does not comply with CECMC rules

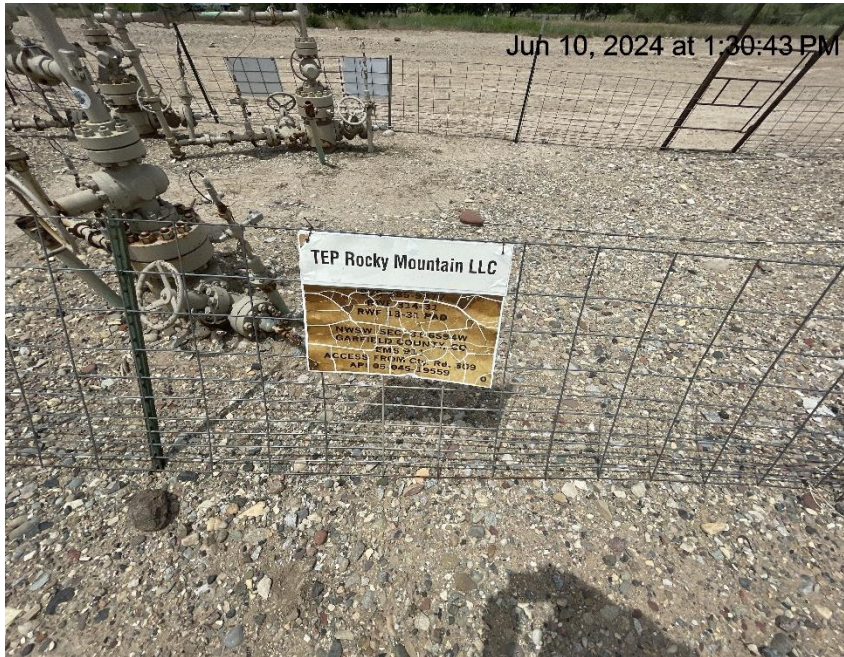
Photo # 223 Wellhead sign weathered & cracking/sign is becoming illegible & does not comply with CECMC rules

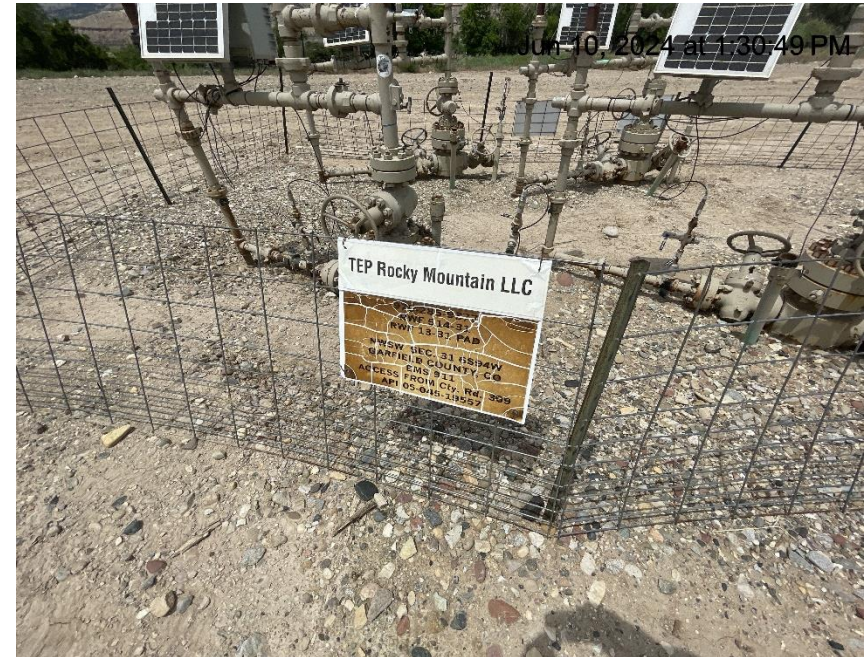
Photo # 224 Wellhead sign weathered & cracking/sign is becoming illegible & does not comply with CECMC rules

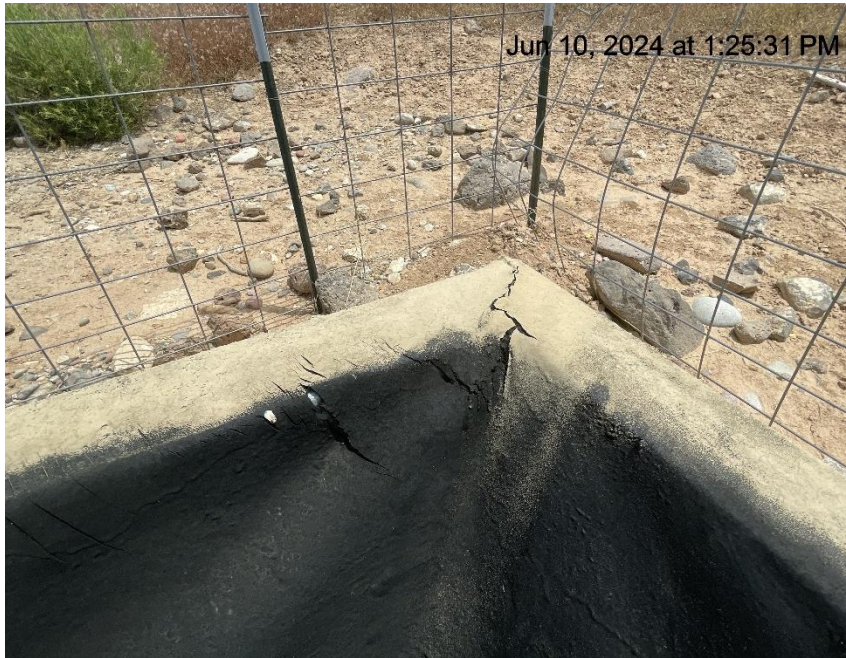
Photo # 225 Small amount of damage near top of secondary containment liner

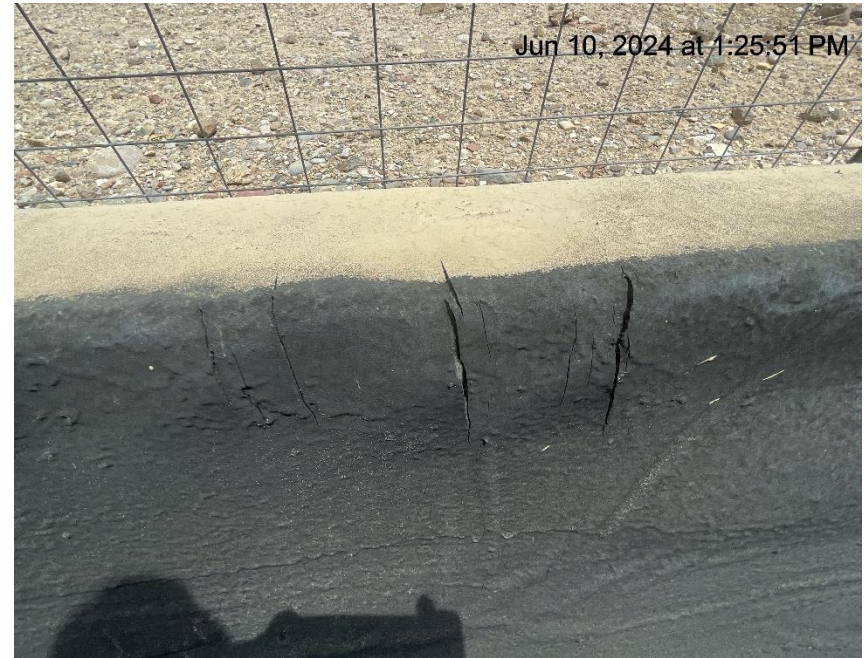
Photo # 226 Small amount of damage near top of secondary containment liner

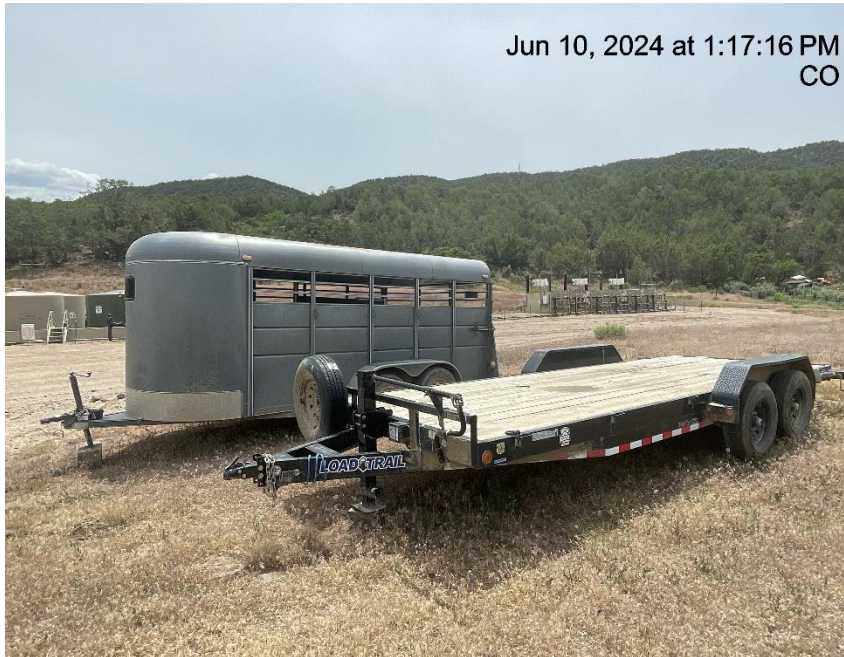
Photo # 227 Stored trailers on location in the interim area
