Inspection Photos

Location Name: TEP ROCKY MOUNTAIN LLC BUXTON RWF 23-30 pad

Location ID: 335503

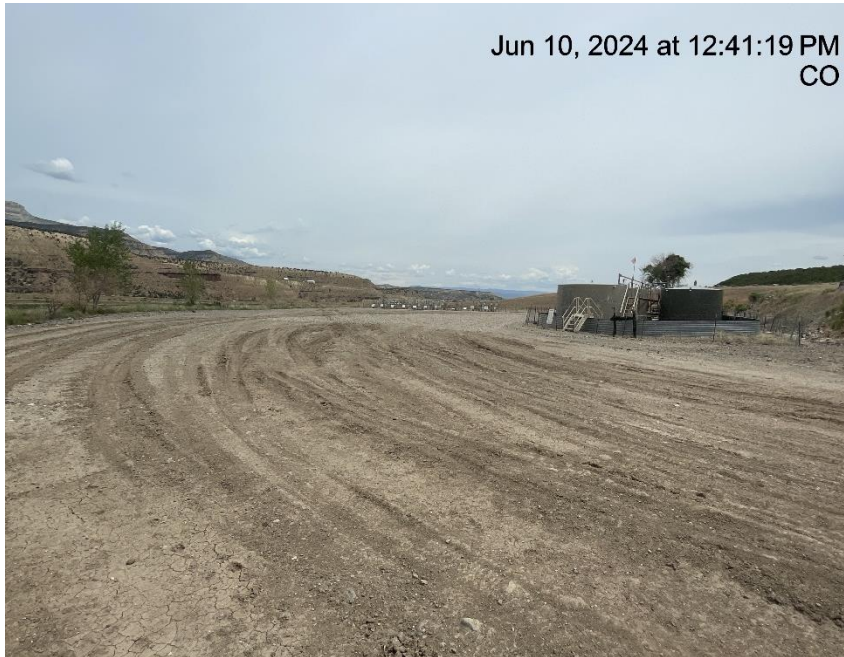
Photo # 150 From entrance to location

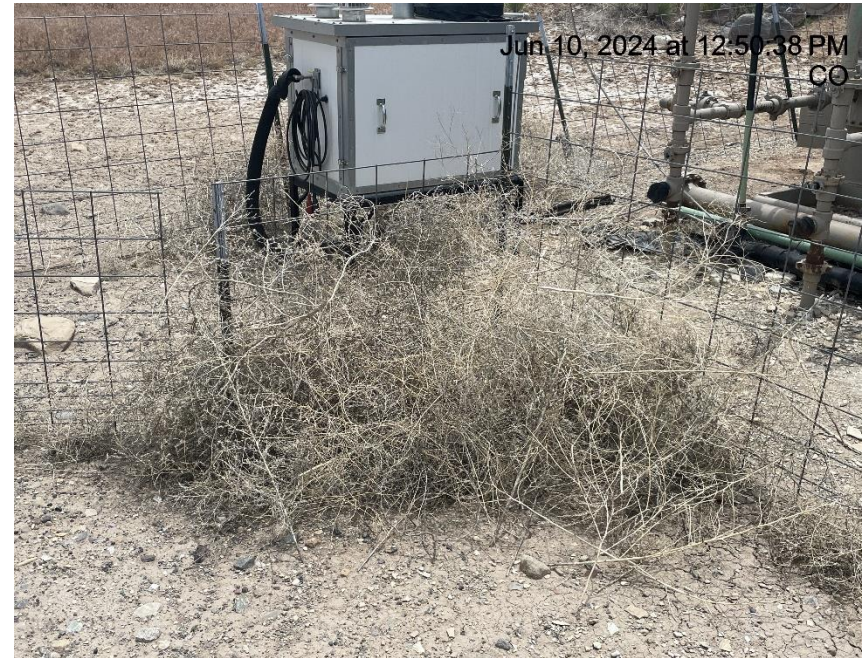
Photo # 157 Dead weeds/debris

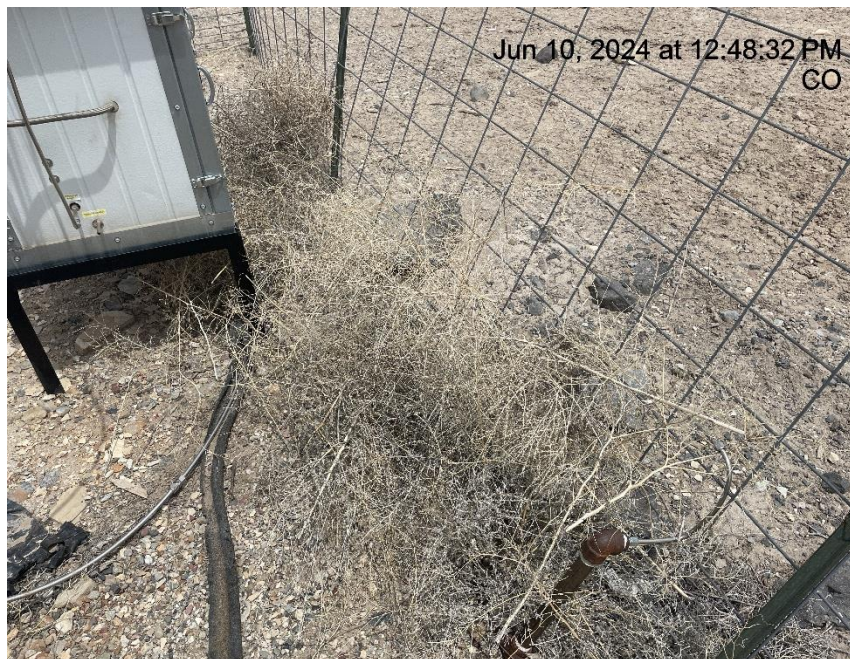
Photo # 158 Dead weeds/debris

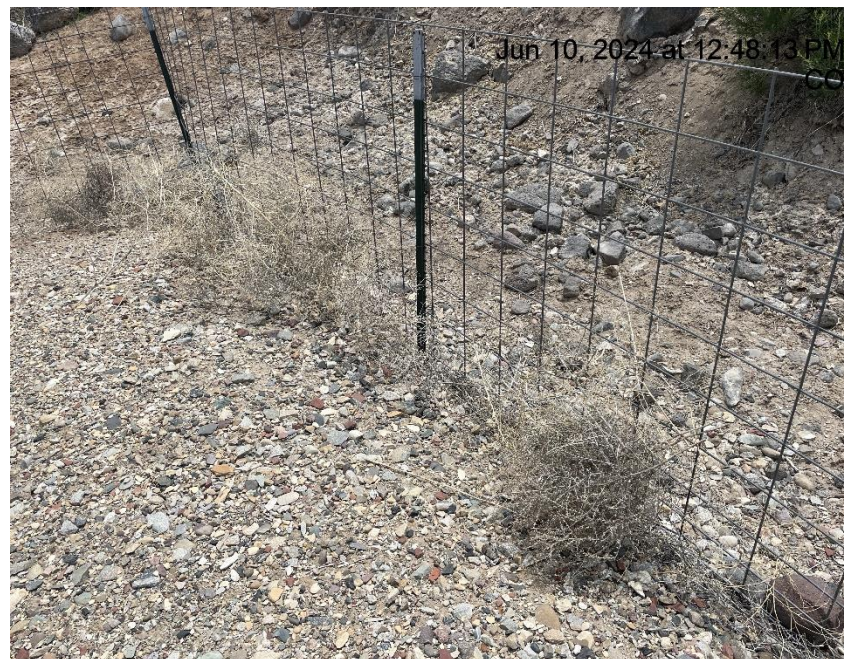
Photo # 159 Dead weeds/debris

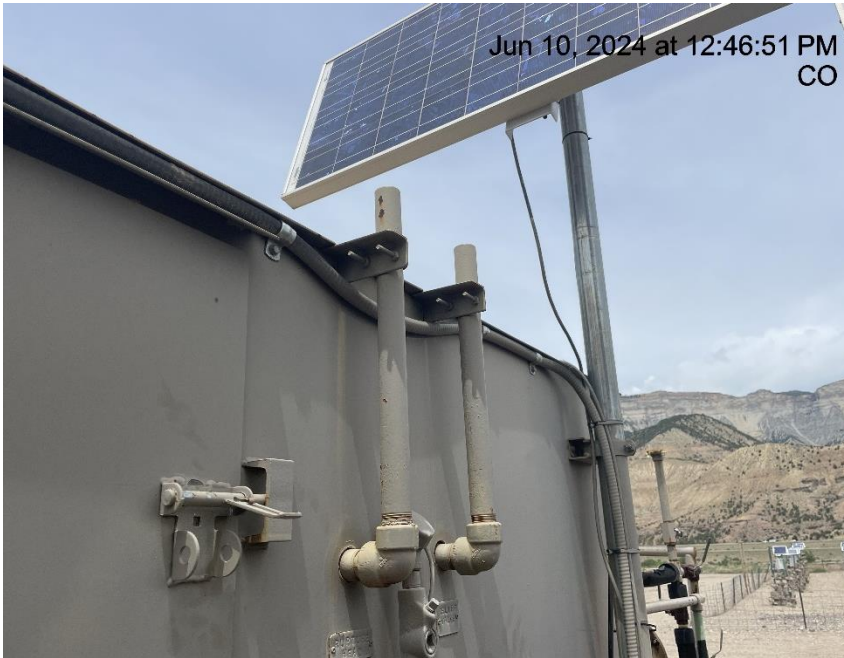
Photo # 160 PRV & rupture disc vent lines do not comply with CECMC pressure safety device rules

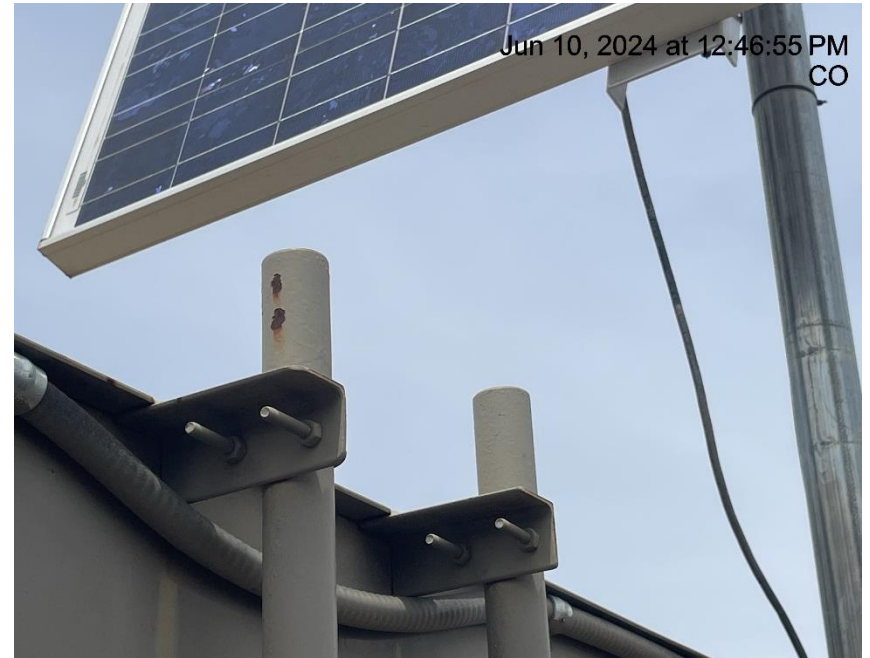
Photo # 161 PRV & rupture disc vent lines do not comply with CECMC pressure safety device rules
