Inspection Photos

Location Name: MUSTANG RESOURCES LLC JUHAN ASTRAL FED FEE 1-26-6S-94W Pad

Location ID: 311532

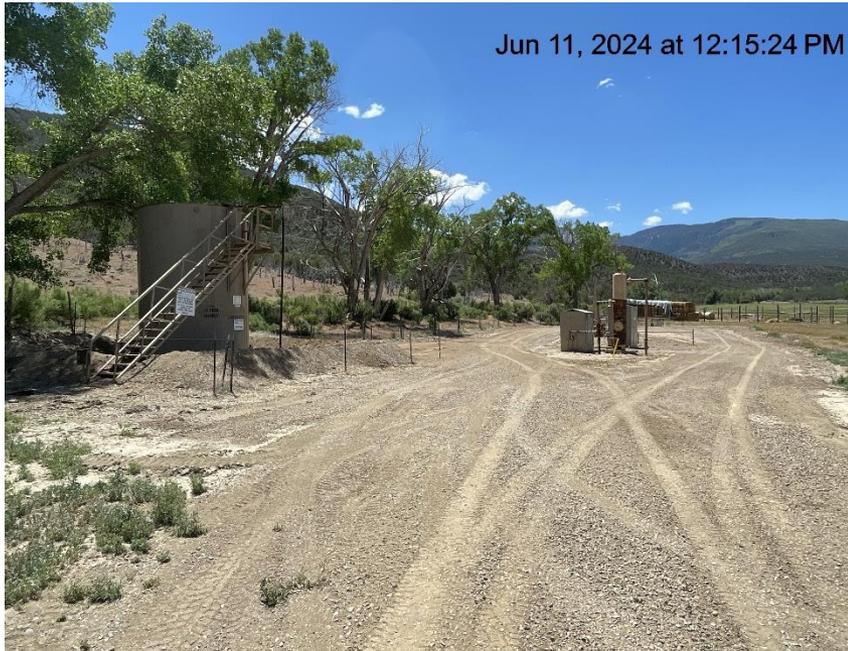
Photo # 476 From entrance to location

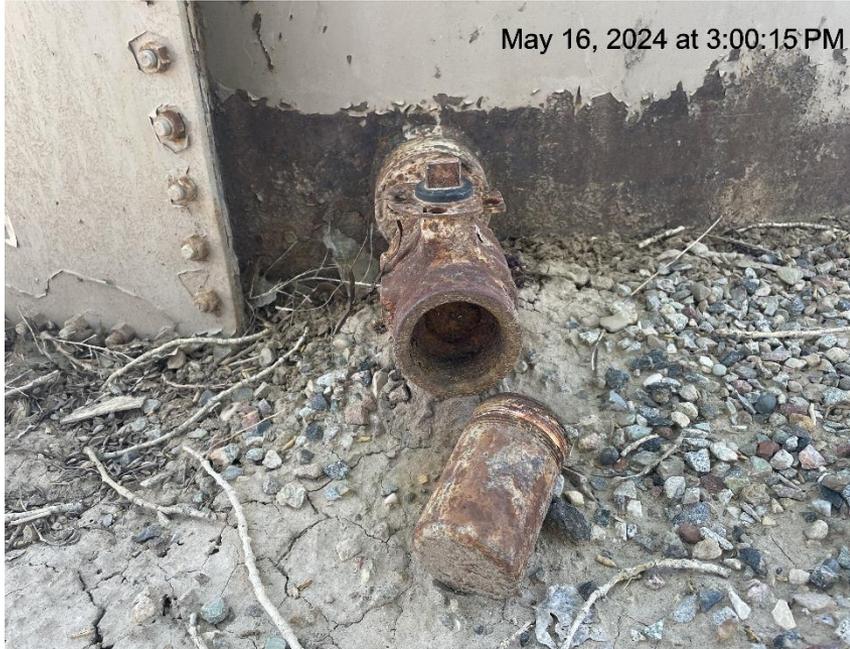
Photo # 7496 From inspection 708903824 conducted on 05/16/2024 Open ended load line

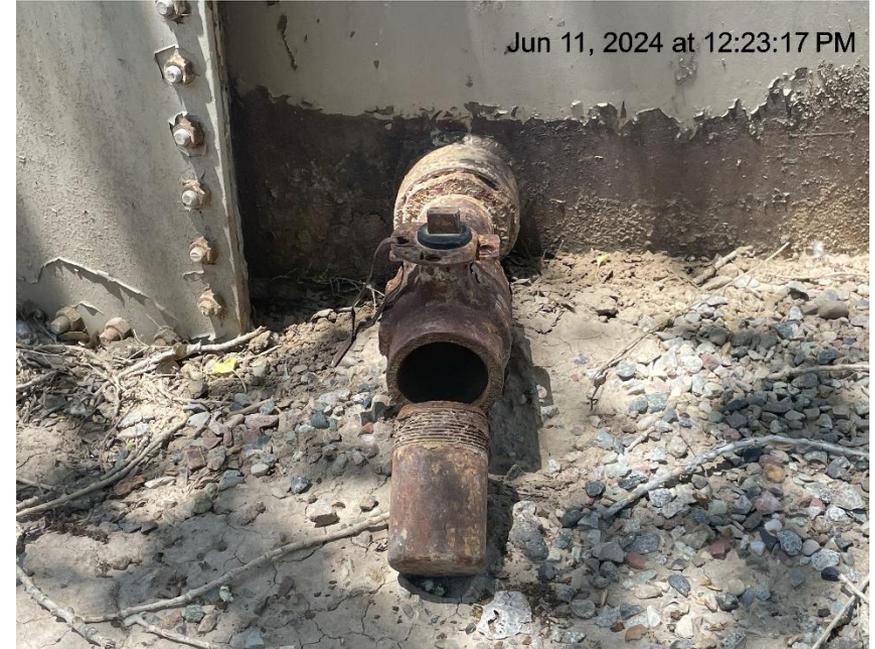
Photo # 482 Open ended load line

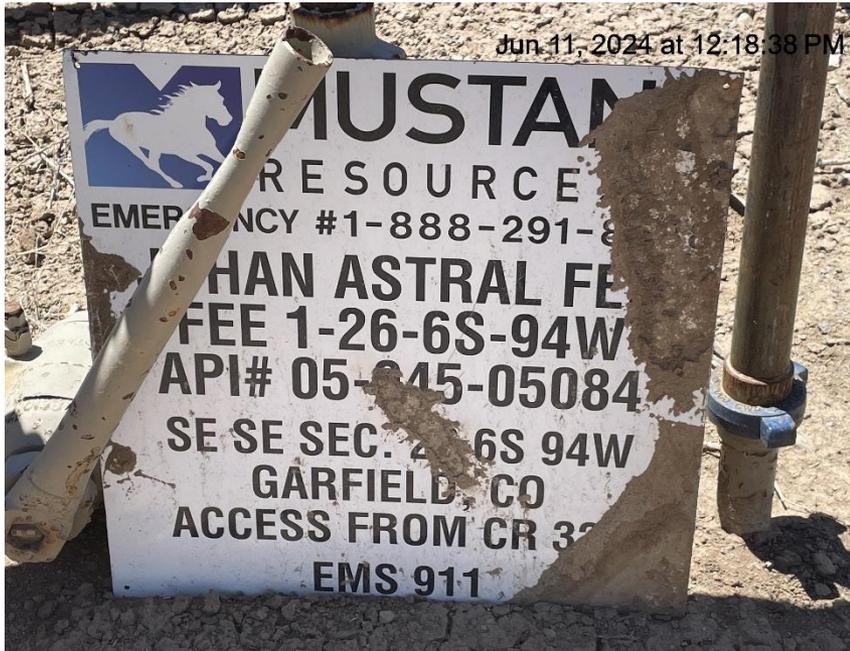
Photo # 483 Sign has mud on it & some required info is obscured
