Inspection Photos

Location Name: TEP ROCKY MOUNTAIN LLC POTTER RWF 532-31 Pad

Location ID: 335487

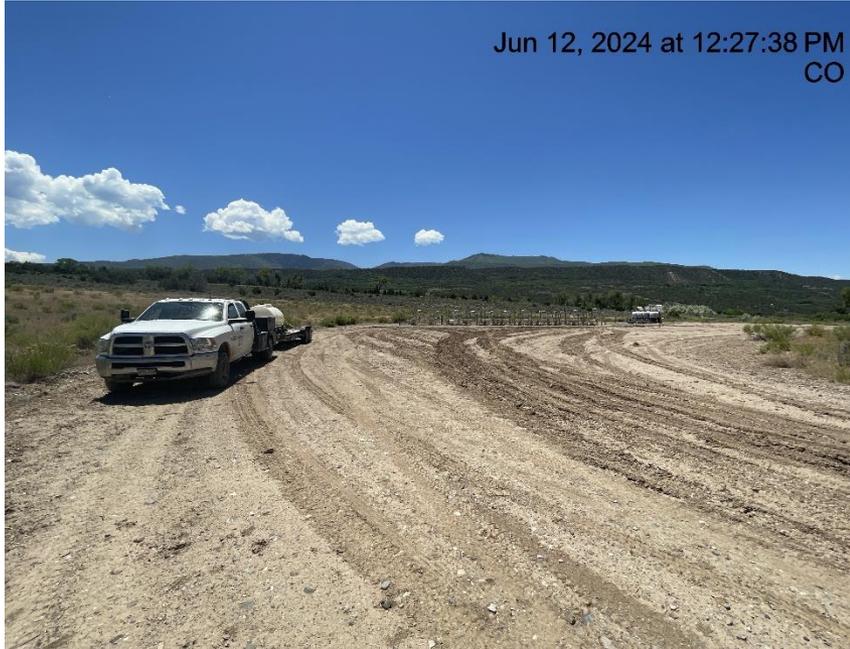
Photo # 636 From entrance to location

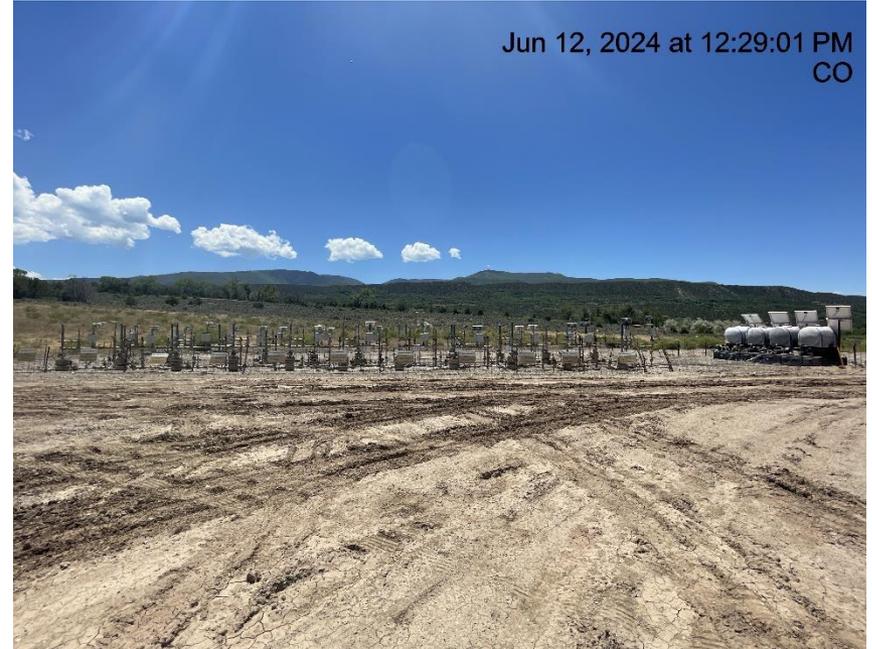
Photo # 637 Location

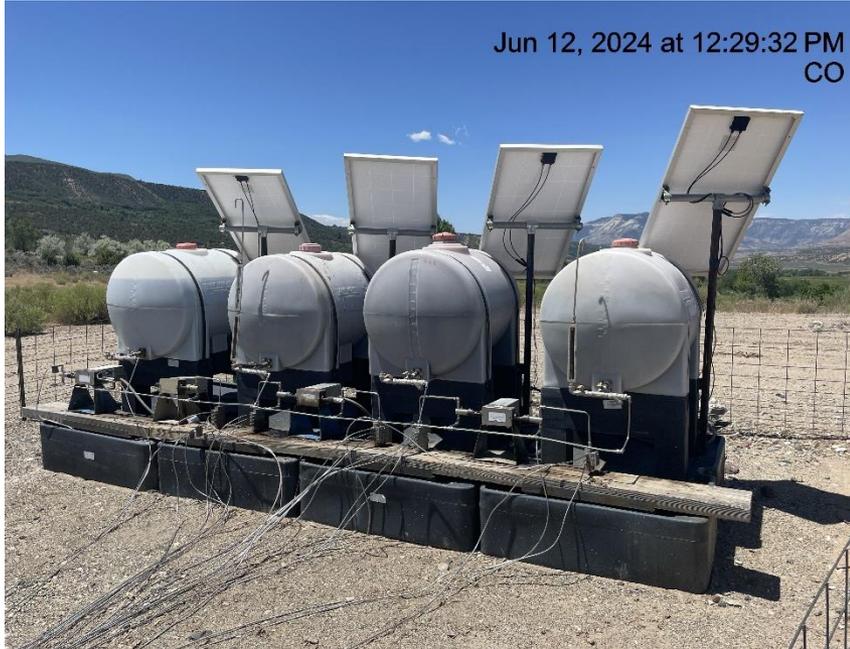
Photo # 638 Location

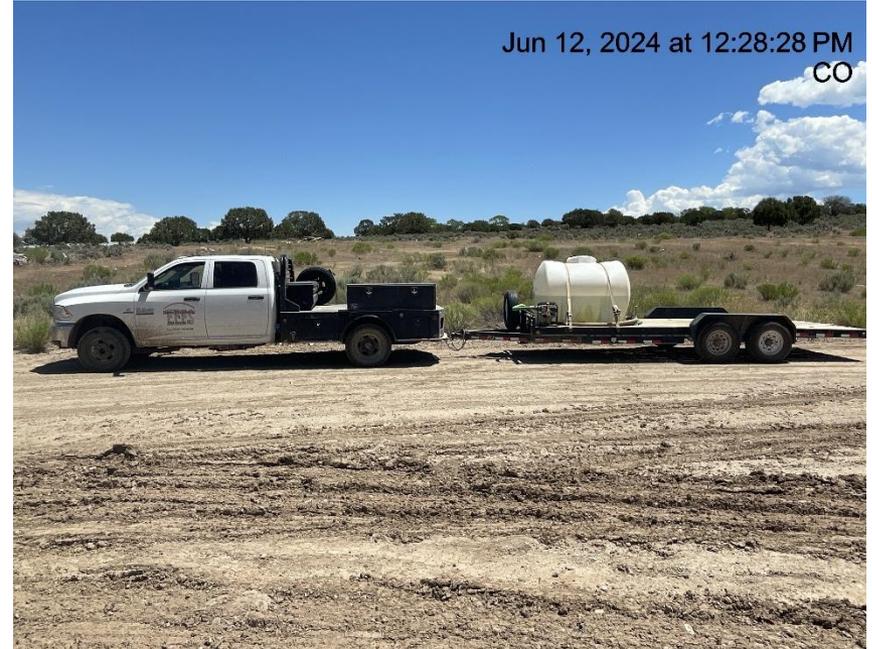
Photo # 639 Location

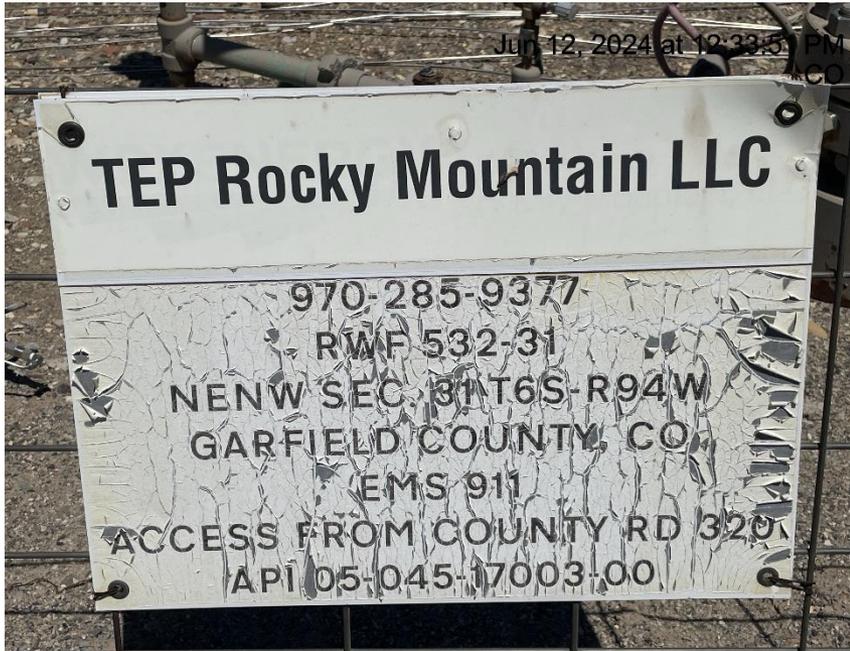
Photo # 640 Wellhead sign is weathered & peeling/some required info is starting to become illegible

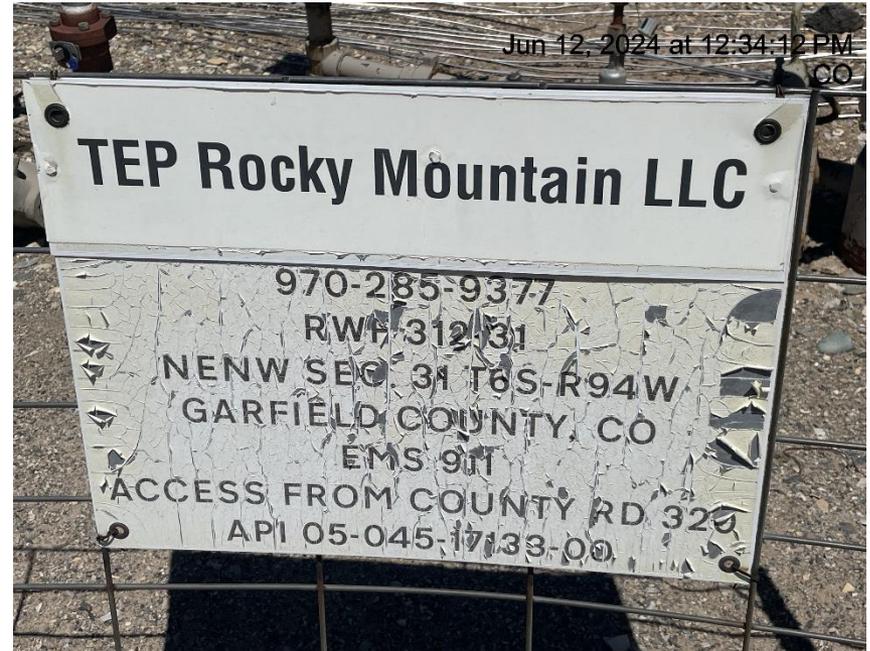
Photo # 641 Wellhead sign is weathered & peeling/some required info is starting to become illegible

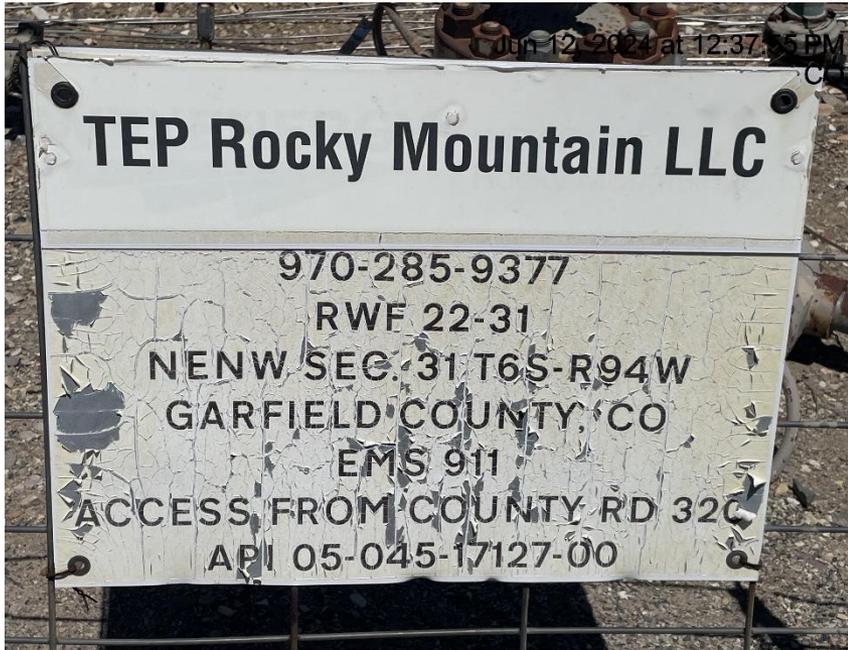
Photo # 642 Wellhead sign is weathered & peeling/some required info is starting to become illegible

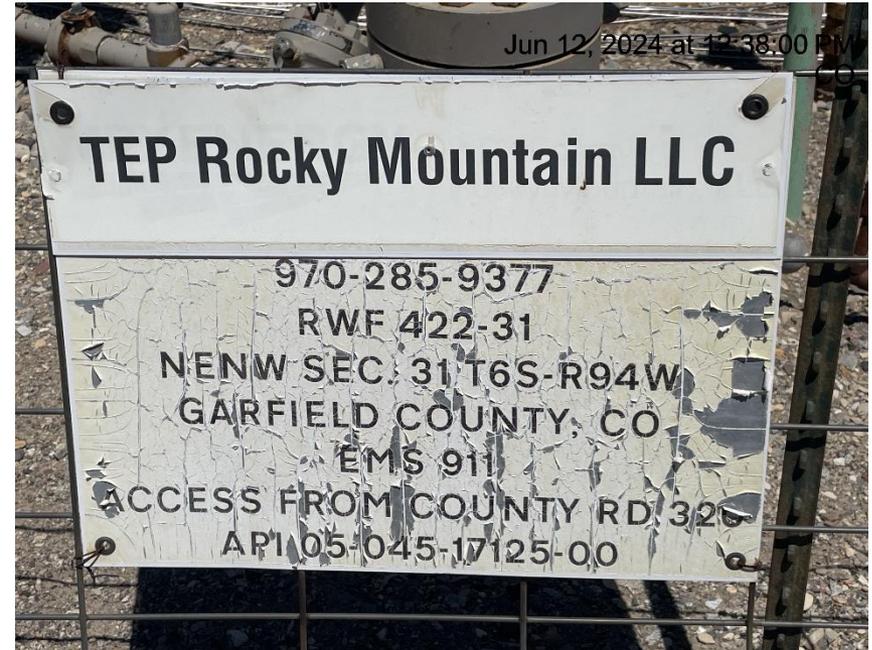
Photo # 643 Wellhead sign is weathered & peeling/some required info is starting to become illegible

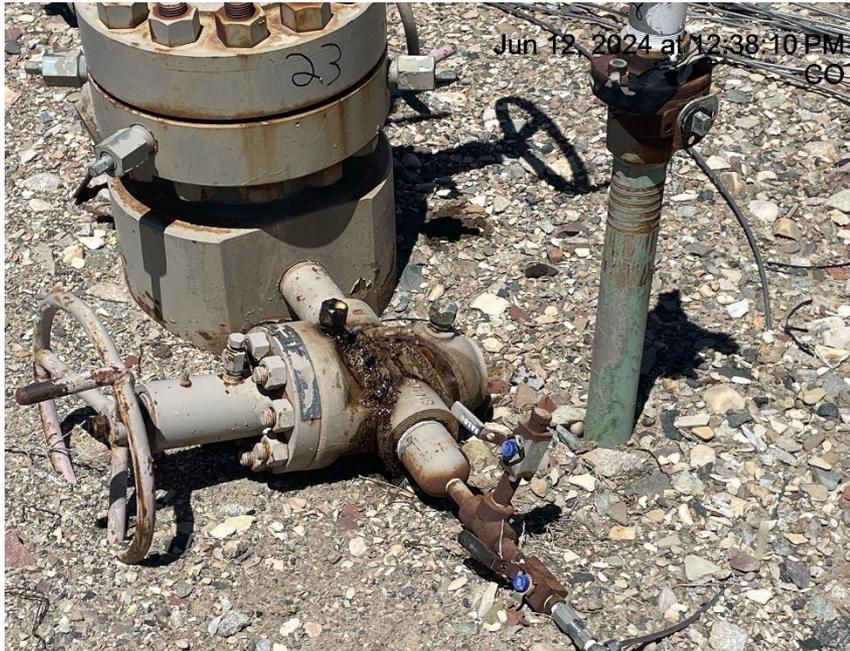
Photo # 644 Possible integrity issue with RWF 23-31 well casing valve

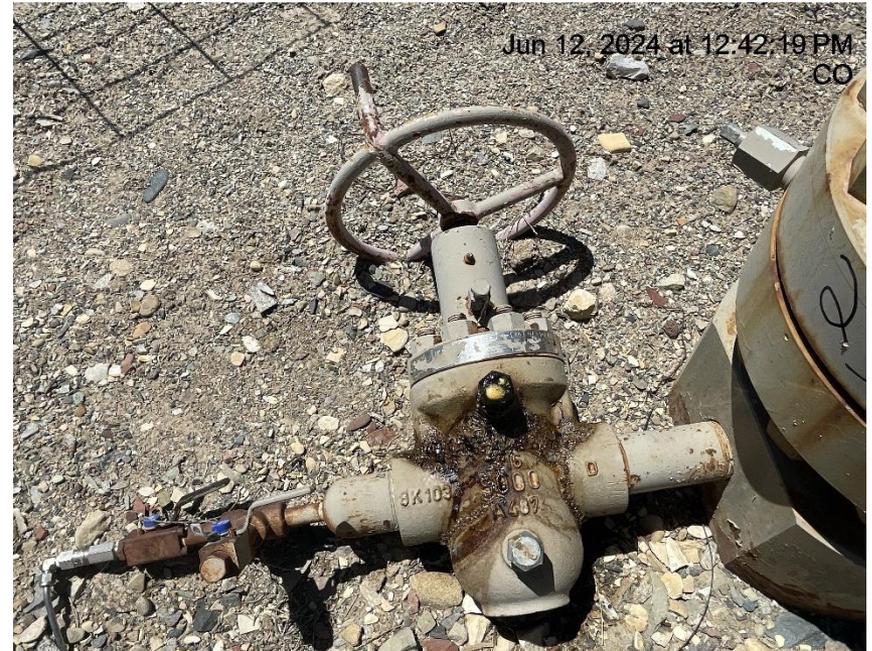
Photo # 645 Possible integrity issue with RWF 23-31 well casing valve

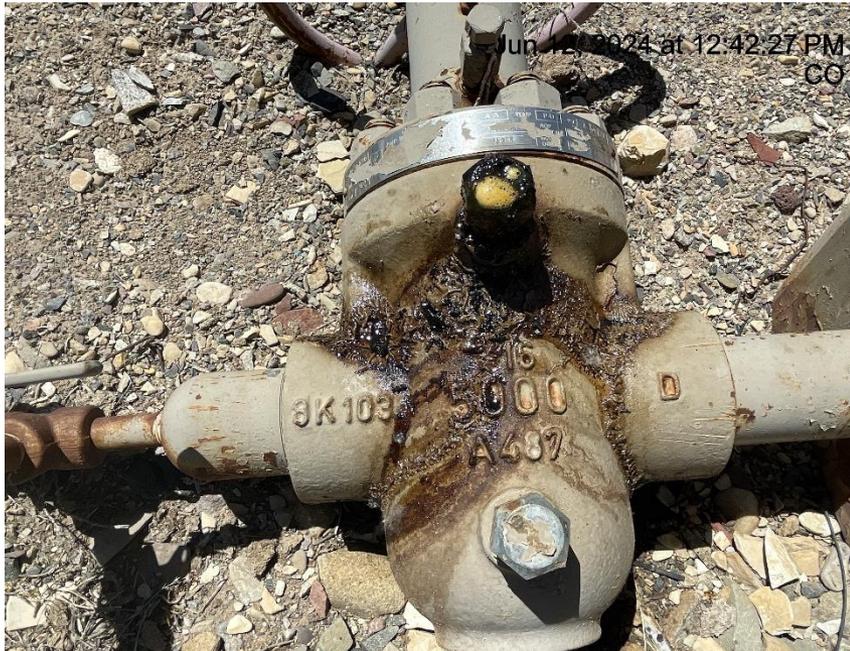
Photo # 646 Possible integrity issue with RWF 23-31 well casing valve

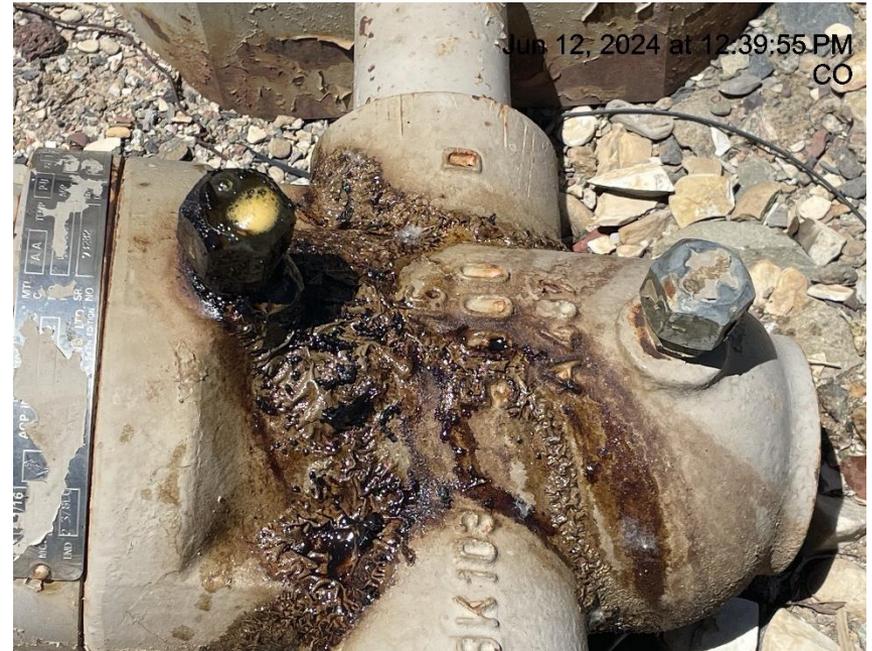
Photo # 647 Possible integrity issue with RWF 23-31 well casing valve
