Inspection Photos

API: 009-06539

Operator: SANDLIN OIL CORP

Inspection Date: 6/13/2024

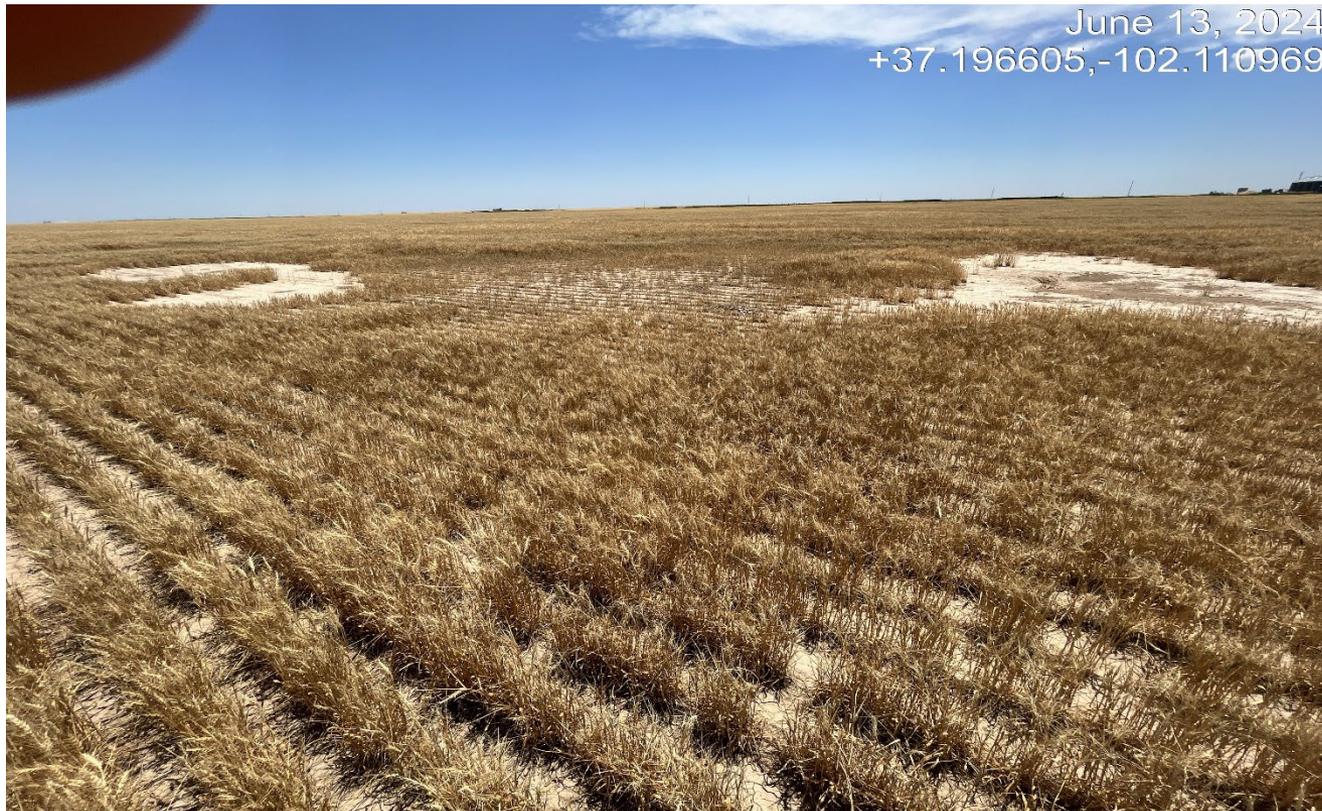
Photo 1. Facing southeast at the location. There are areas where the crop has not re-established.

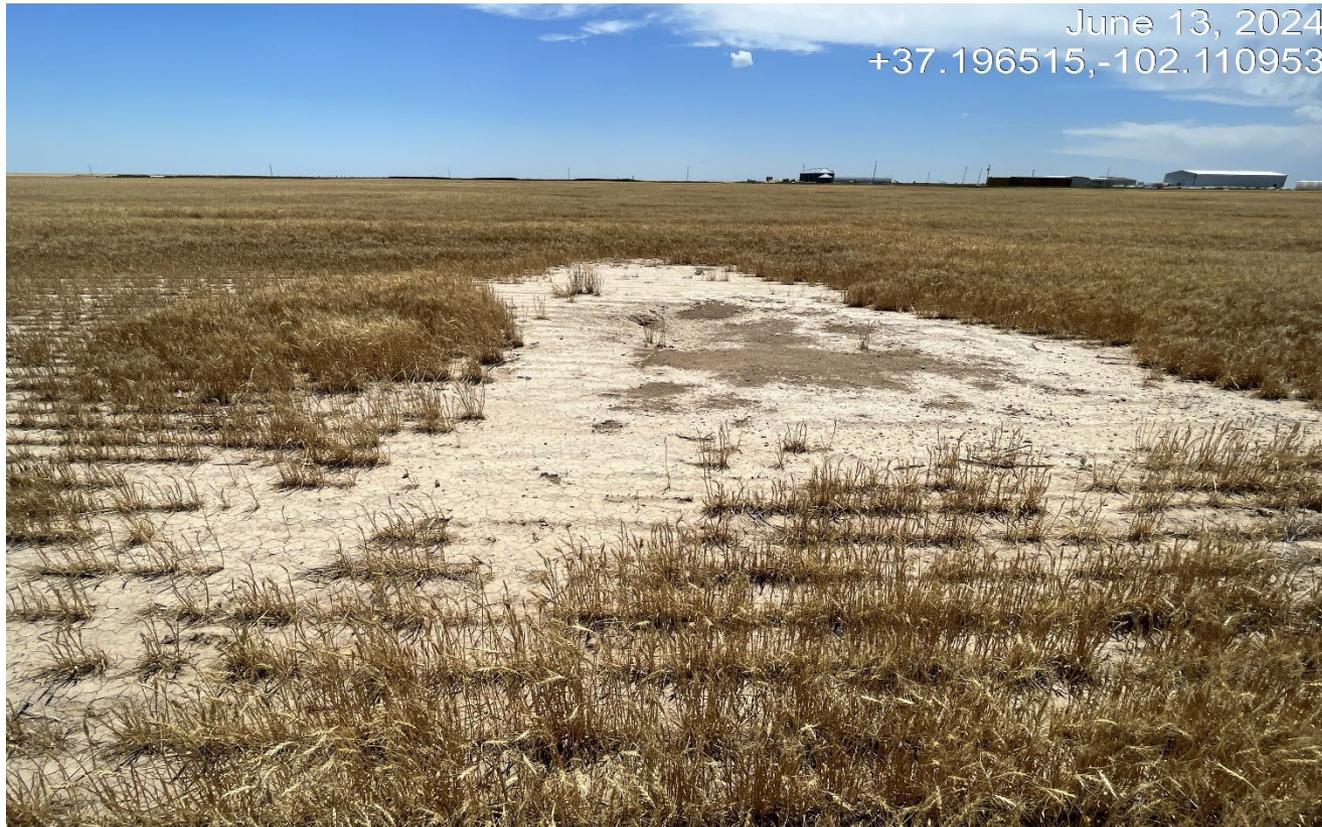
Photo 2. Facing south at the location. There are areas where the crop has not re-established.

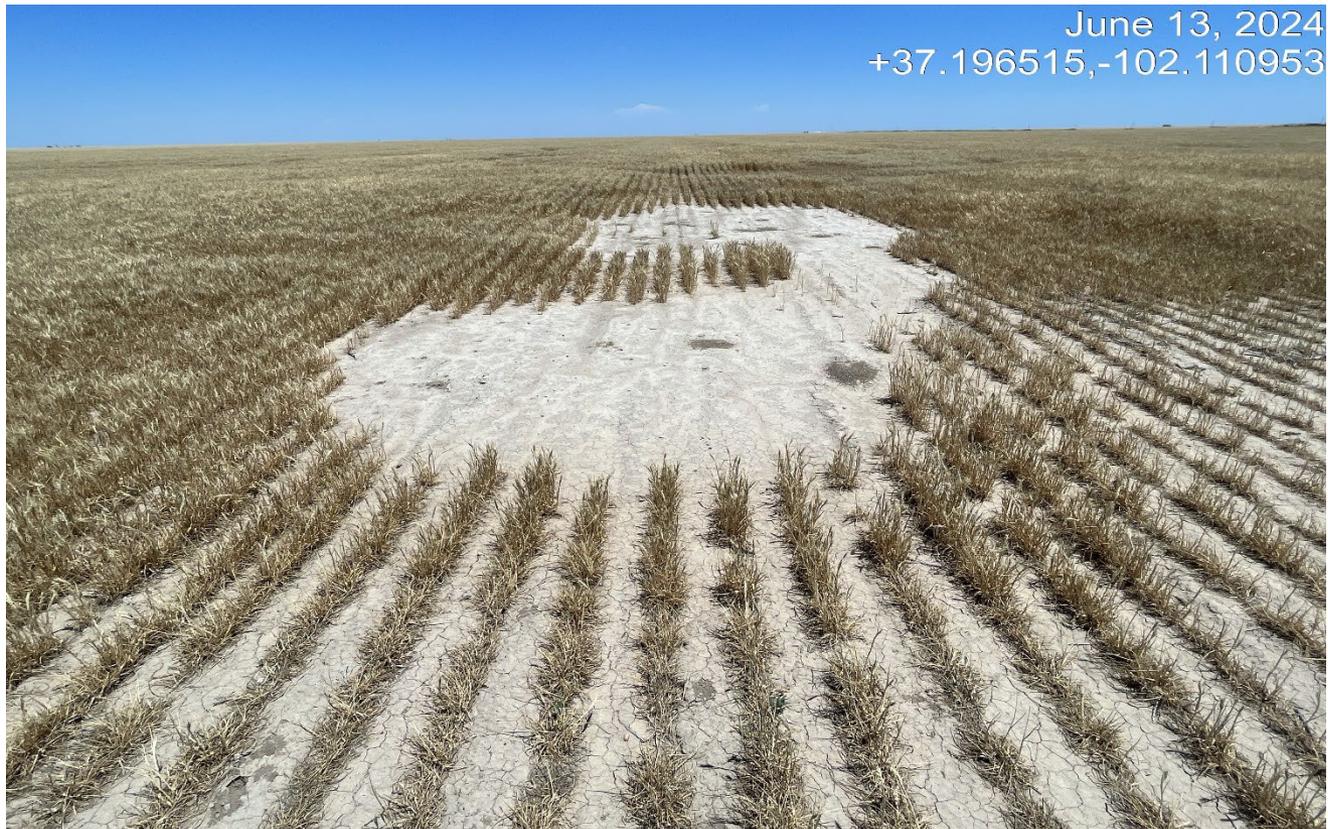
Photo 3. Facing east at the location. There are areas where the crop has not re-established.

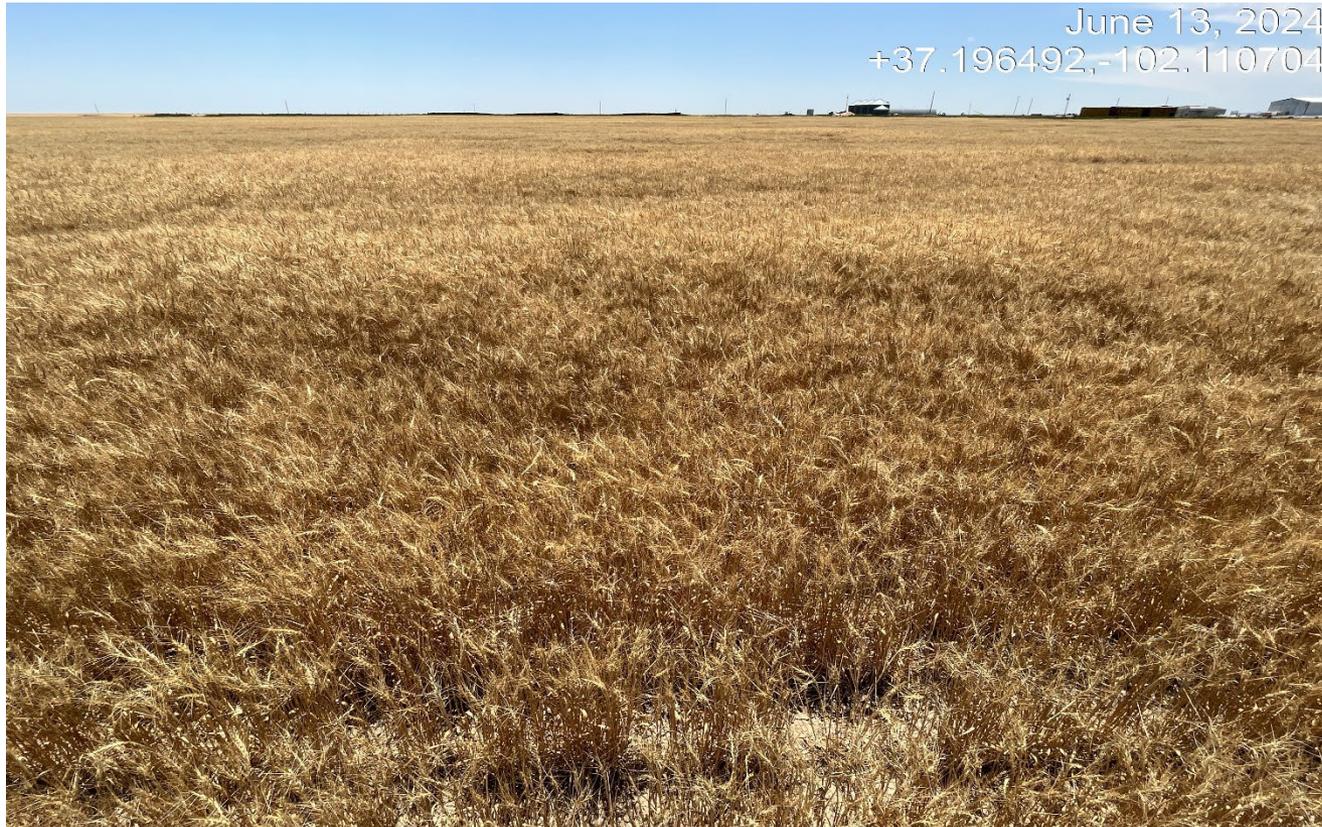
Photo 4. Facing south toward the surrounding crop which has a uniform crop cover..
