Inspection Photos

API: 009-06309

Operator: WEST TEXAS OPERATING
CO LLC DBA XTREME ENERGYCO

Inspection Date: 6/13/2024

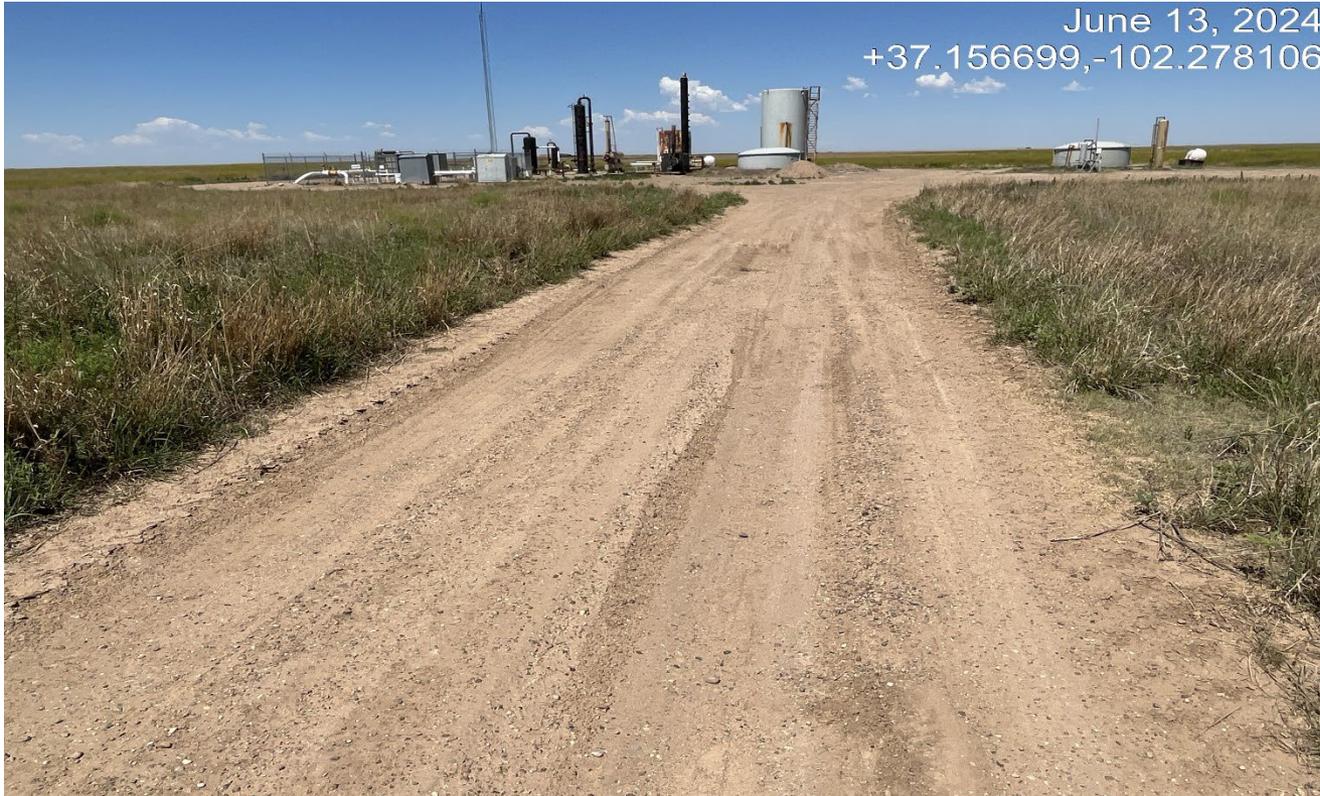
Photo 1. Facing east along the access road. There is rutted areas along the road that need maintenance.

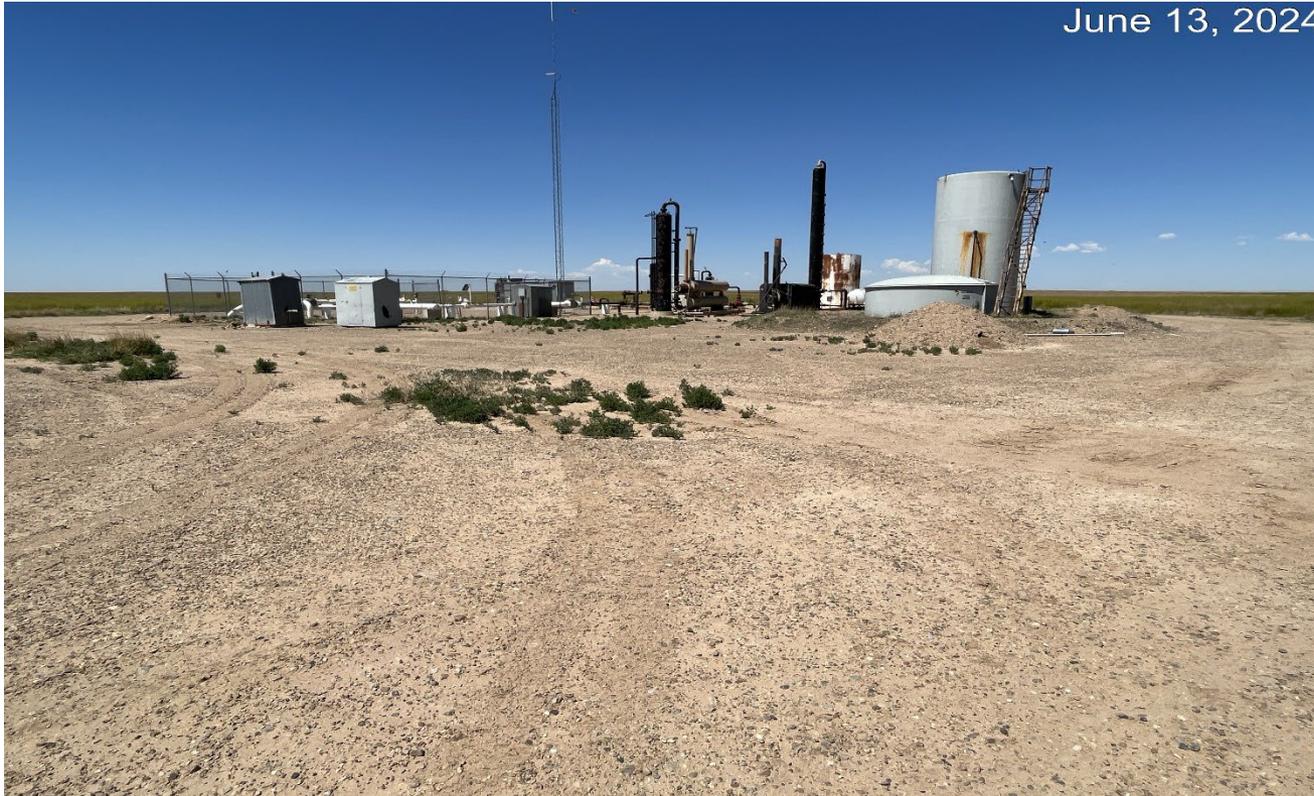
Photo 2. Facing southwest at the location.

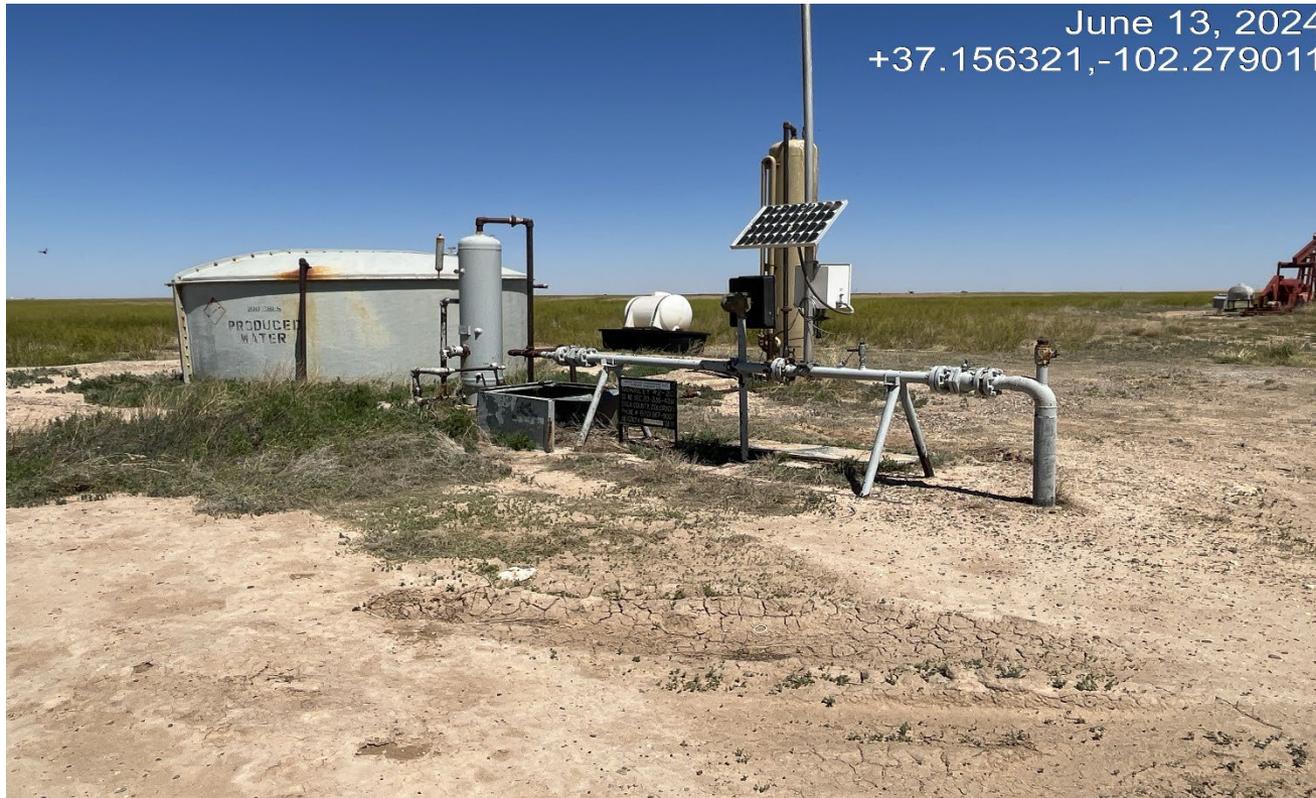
Photo 3. Facing northwest toward the wellsite.

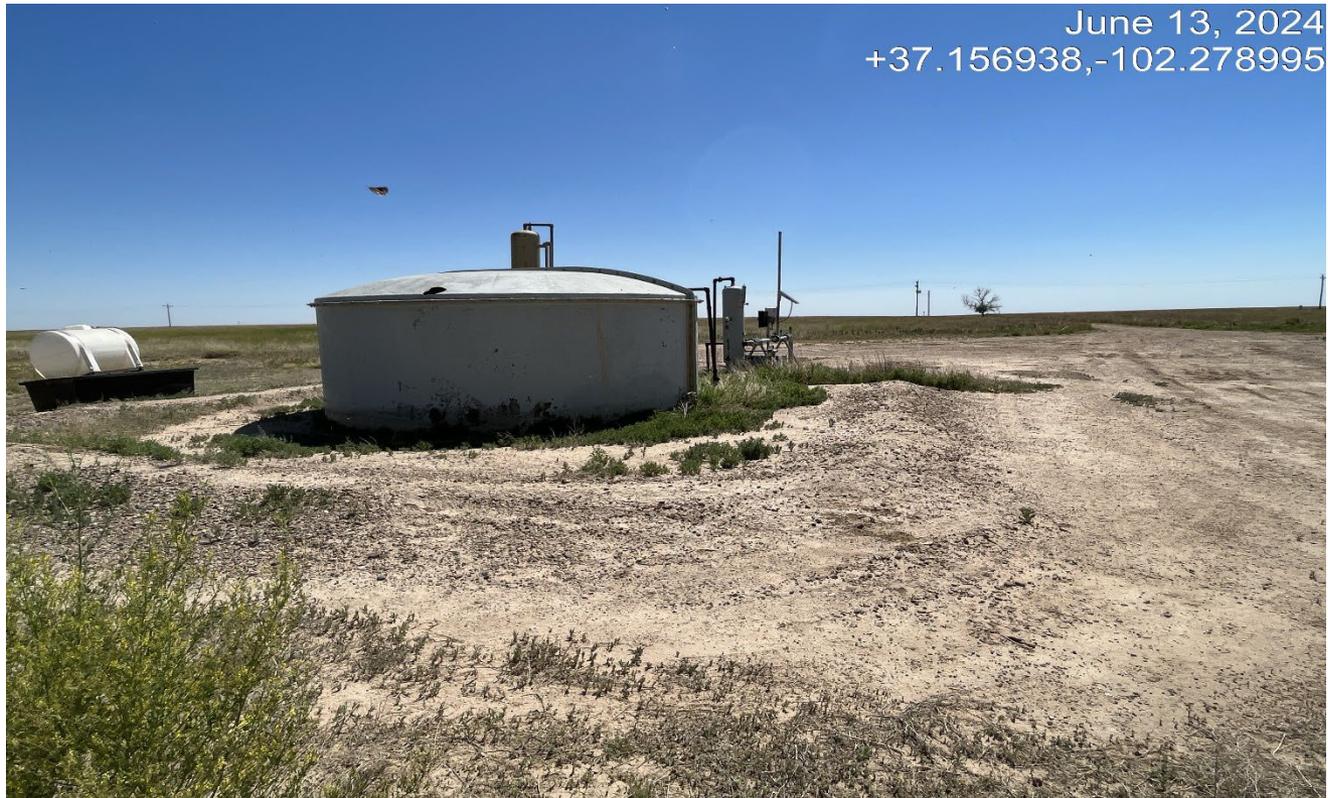
Photo 4. The berm around the tank is worn down and needs to be rebuilt.

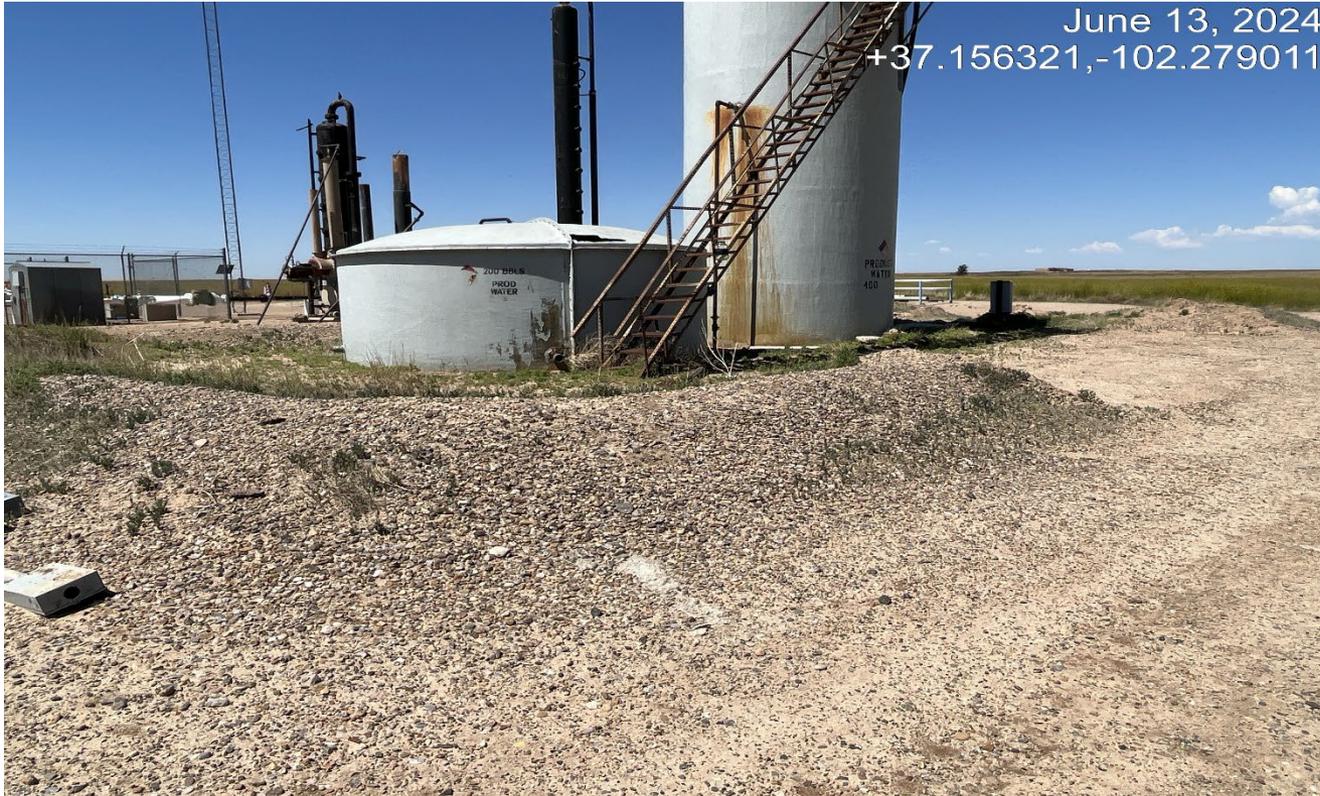
Photo 5. Facing southwest. There is no berm around the north and west side of the tank battery to prevent a spill. The labels on the tanks are faded and worn off.

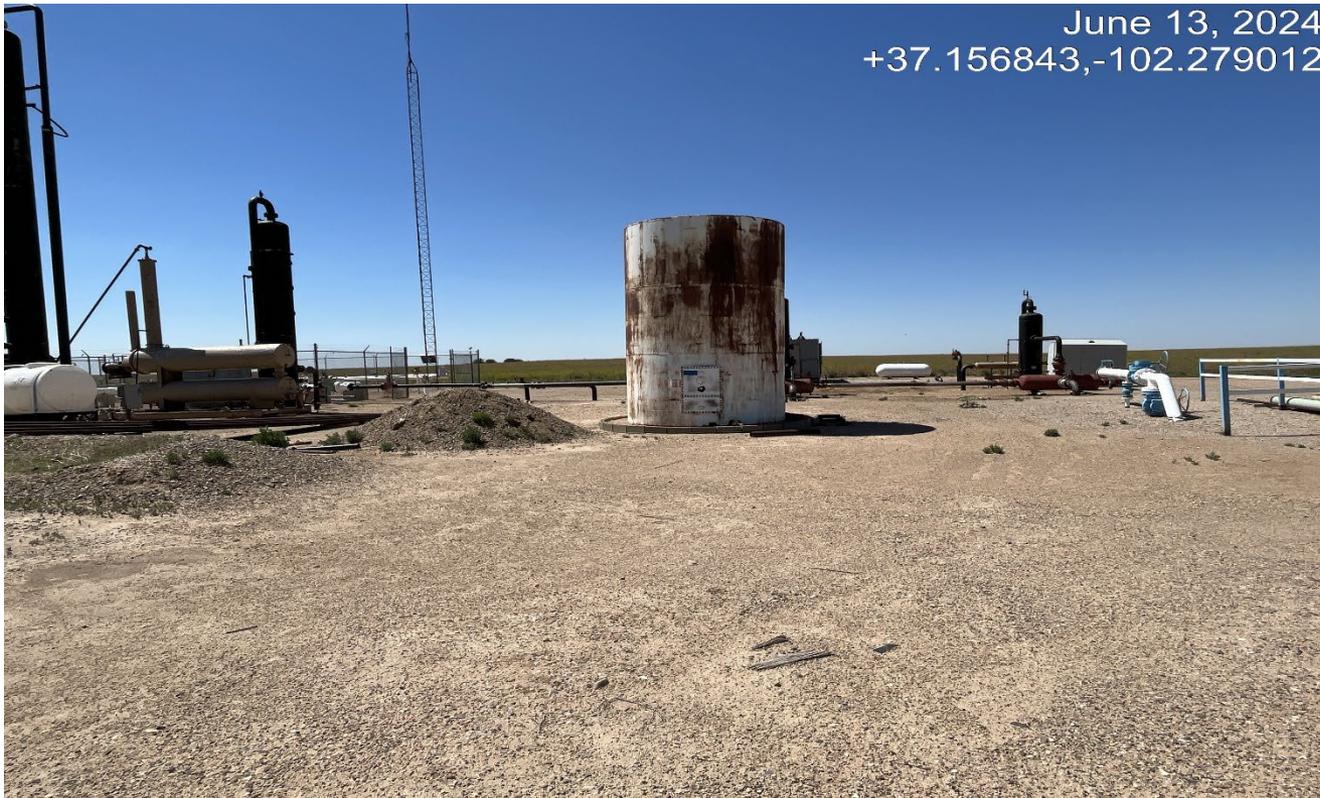
Photo 6. Facing south at the location. There is no secondary containment at the tank shown in the photo.

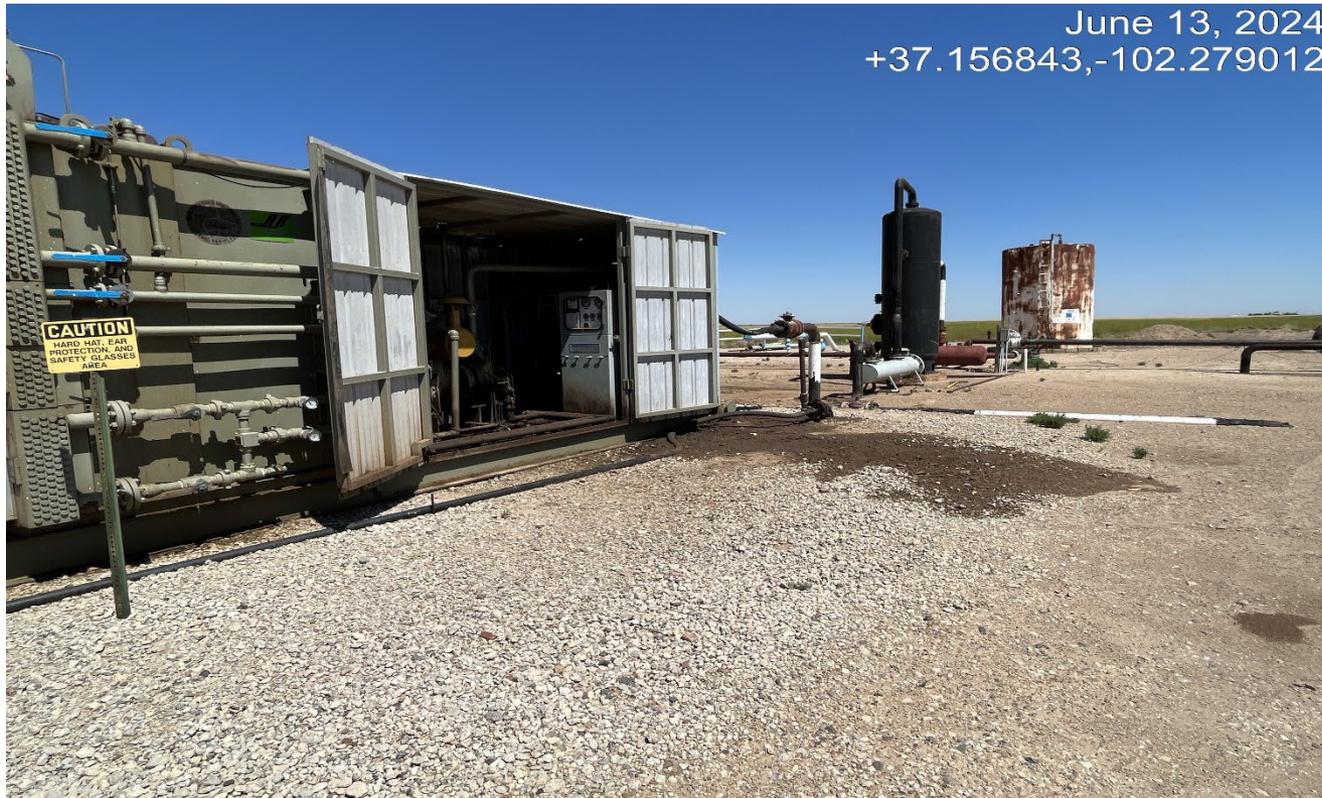
Photo 7. Facing toward the engine compressor. There is oil stained soils from the compresoor leaking lube oil.

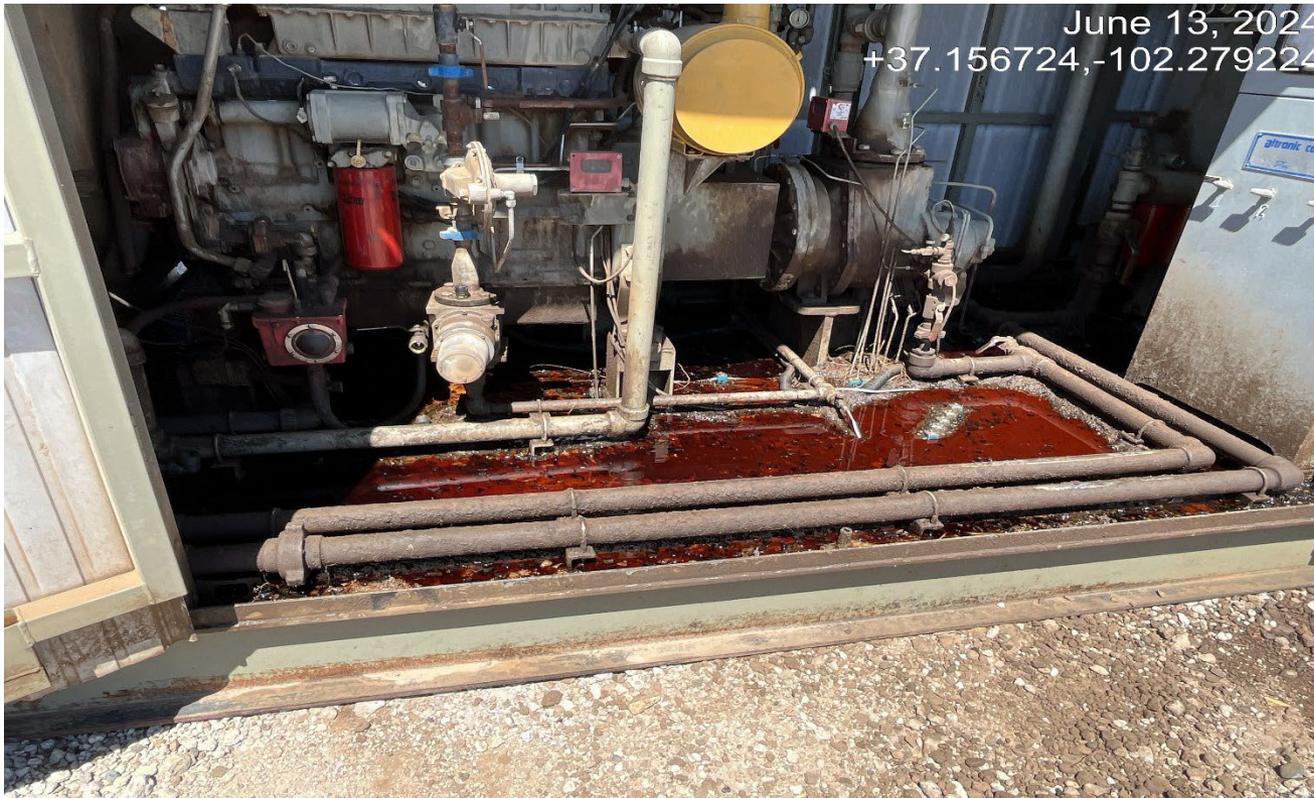
Photo 8. There is oily fluids in the engine skid that must be cleaned up.

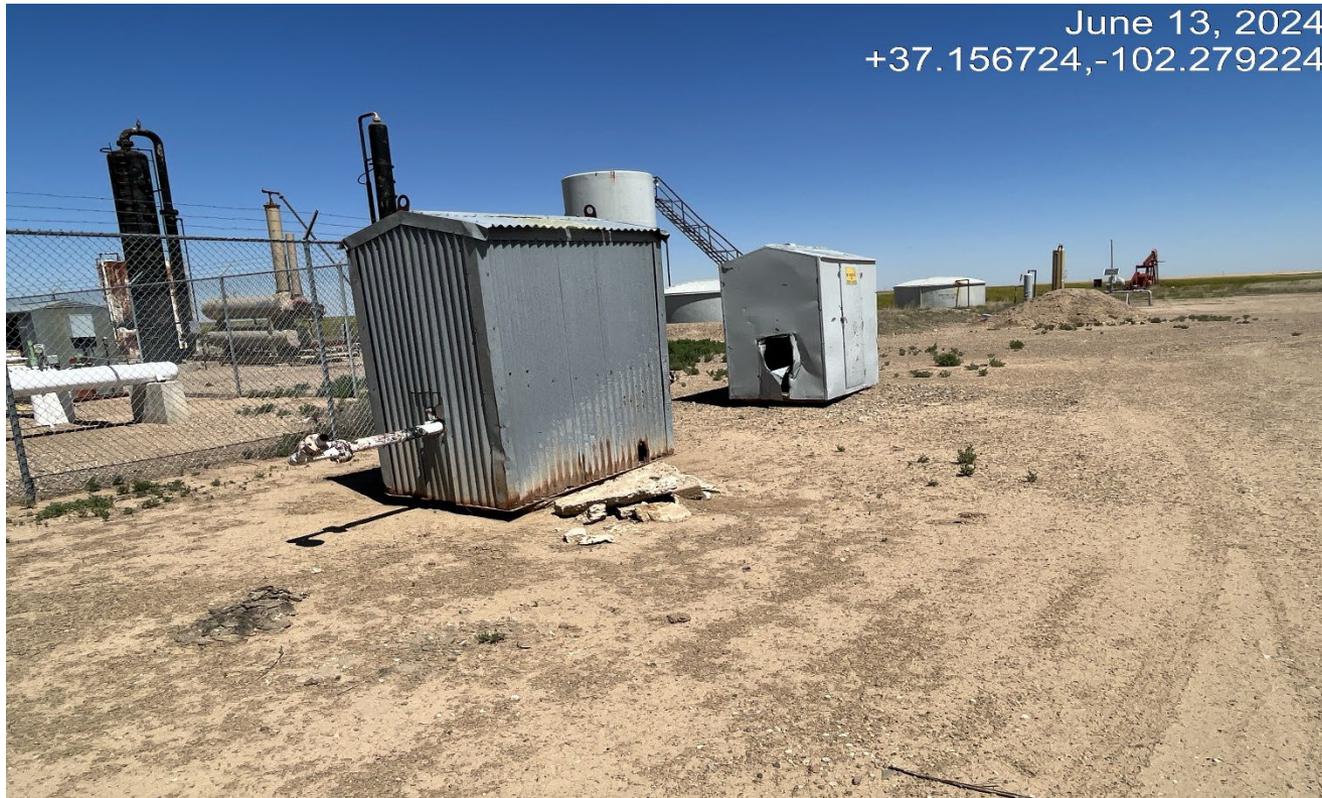
Photo 9. There are two unused meter sheds that need to be removed per Rule 606.

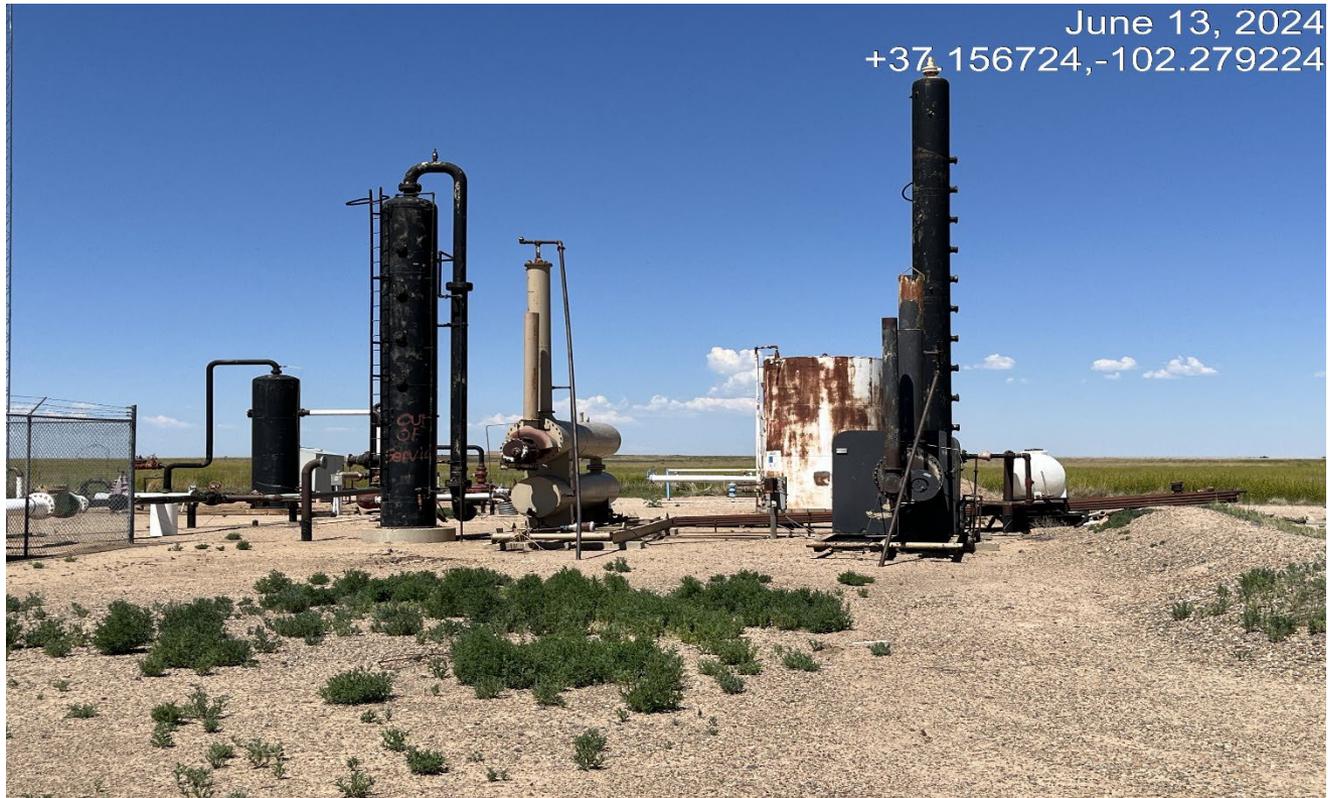
Photo 10. Facing east at the location. There are tow pieces of equipment not in use “out of service” that nedd to be removed.
