Inspection Photos
Location: UPRR 42 Pan Am F #4
Spill ID: 480343

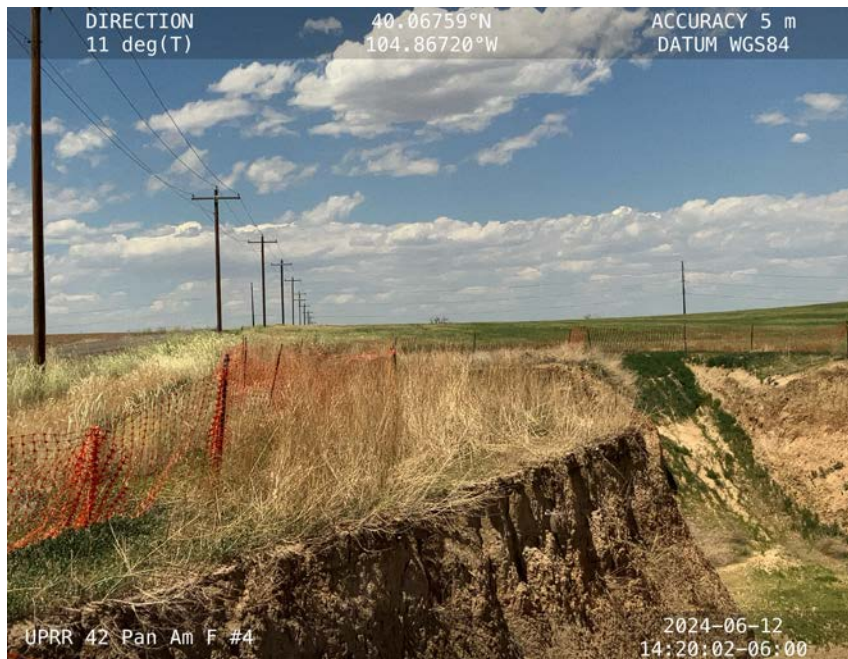
Photo 1 – Weeds

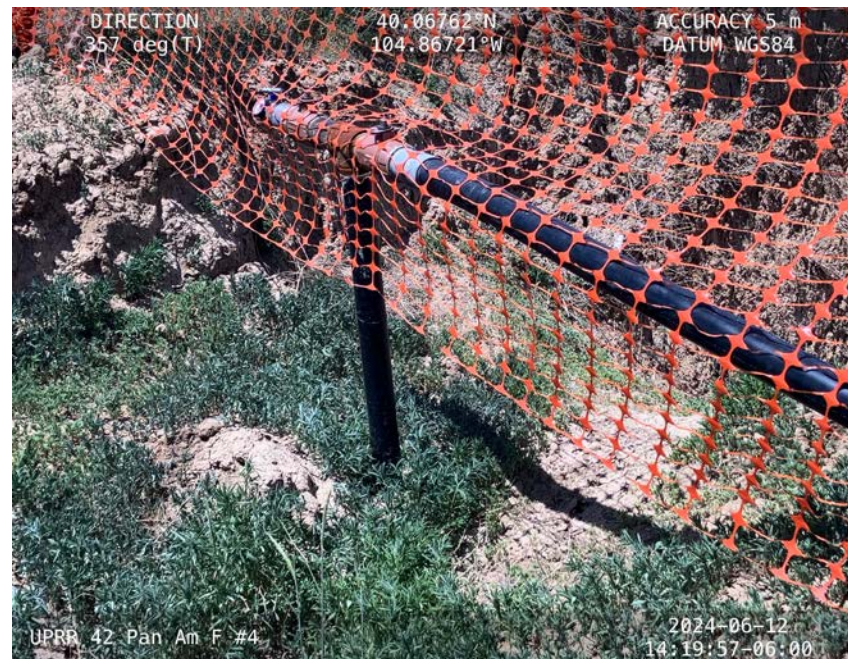
Photo 2 – Improper fencing

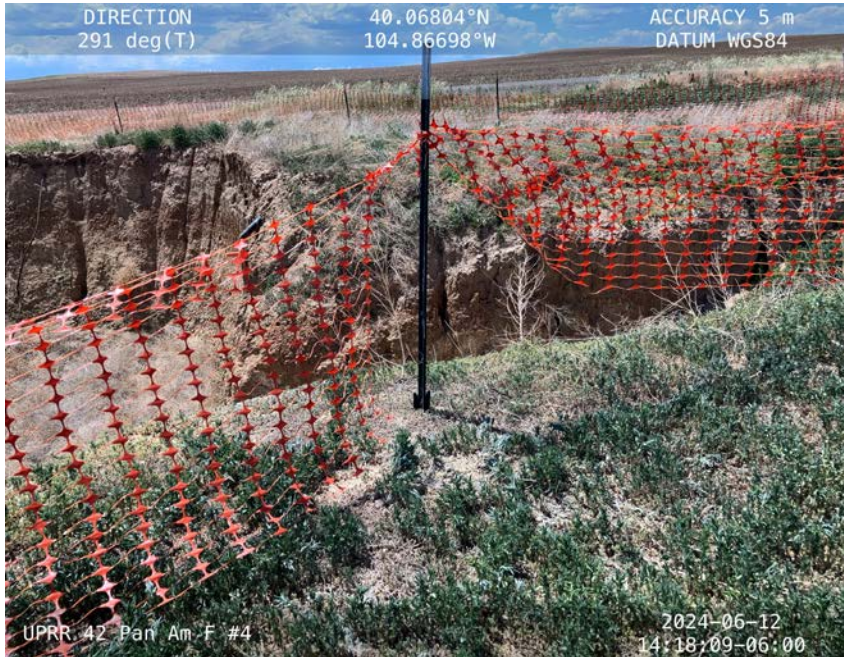
Photo 5 – Fencing torn

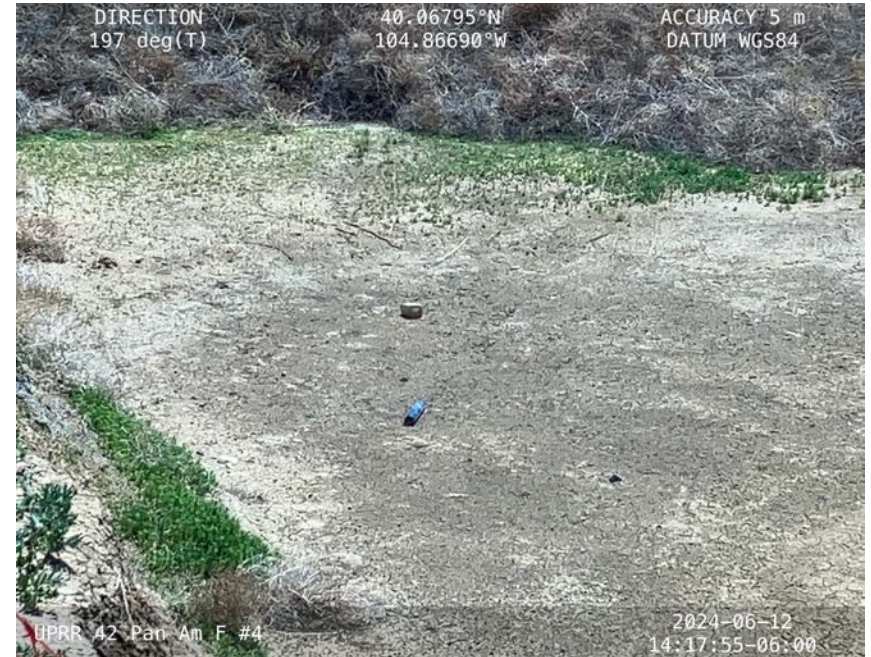
Photo 6 – Trash

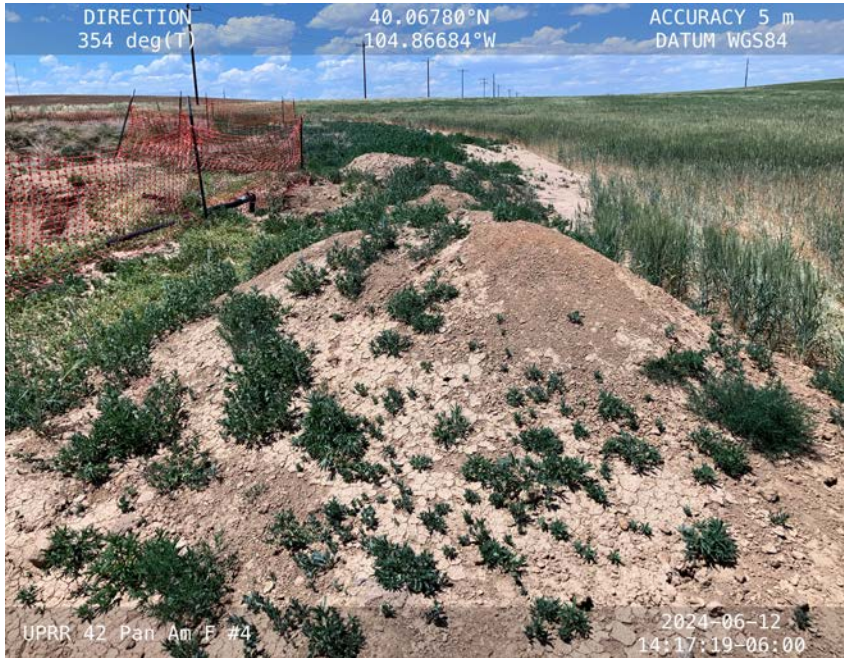
Photo 9 – Stockpile and weeds

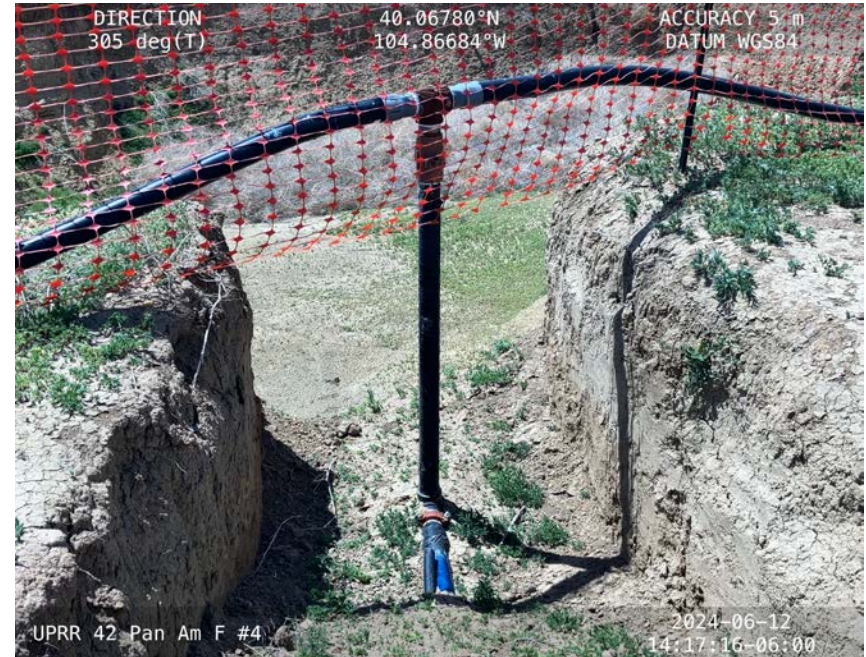
Photo 10 – Fencing does not properly surround excavation

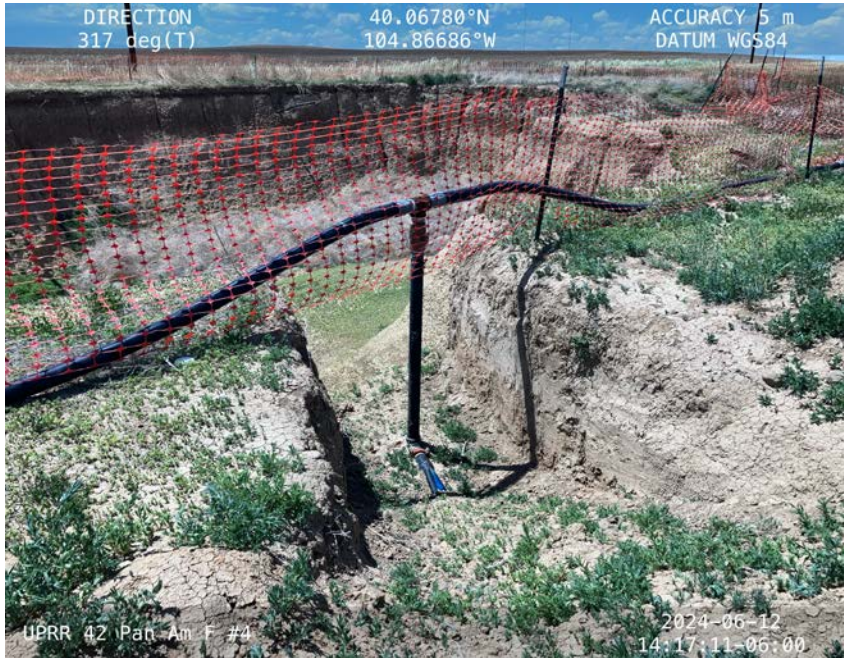
Photo 11 – Fencing does not properly surround excavation

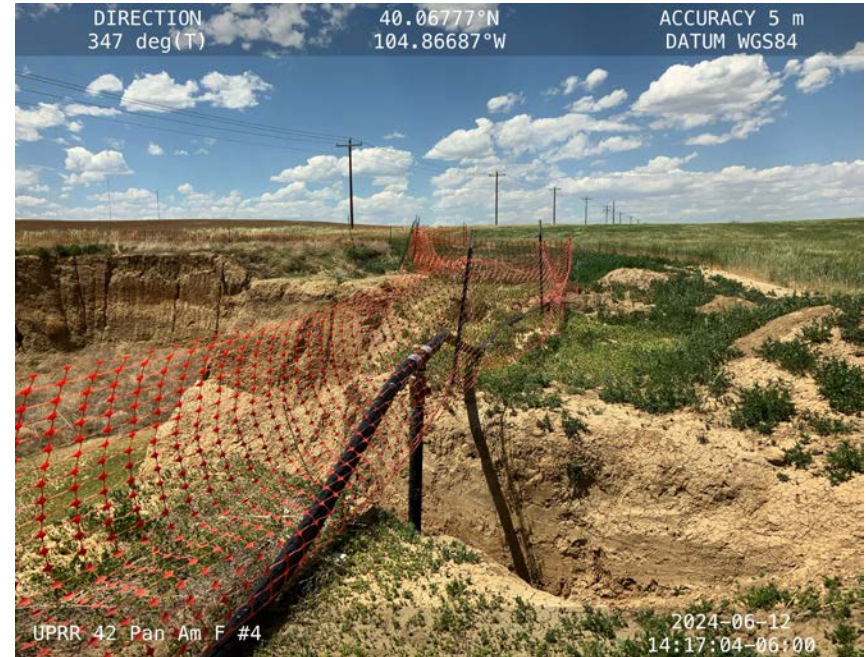
Photo 12 – Fencing does not properly surround excavation

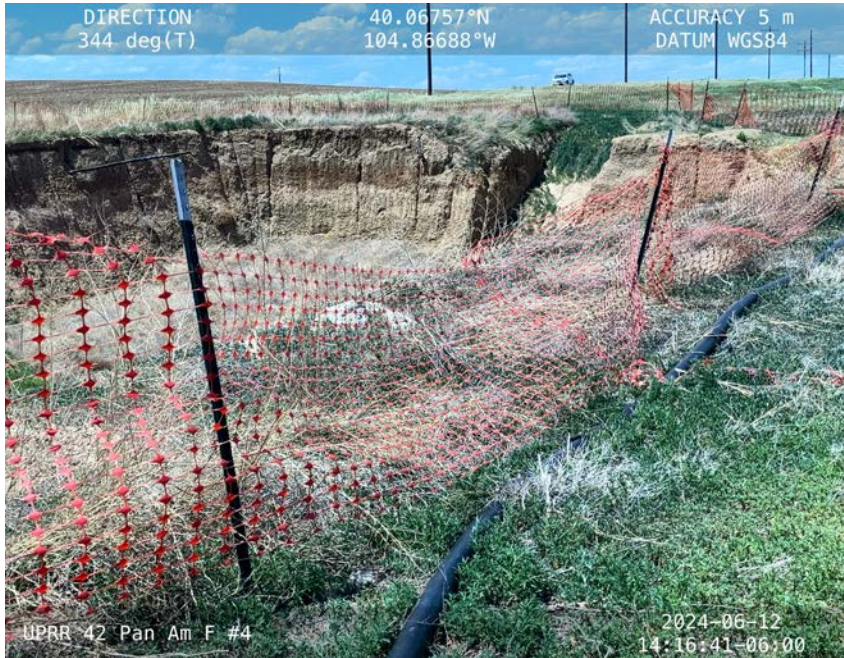
Photo 13 – Fencing down
