Inspection Photos

Loc: 483008

Operator: BNL (ENTERPRISE) INC

Inspection Date: 6/24/2024

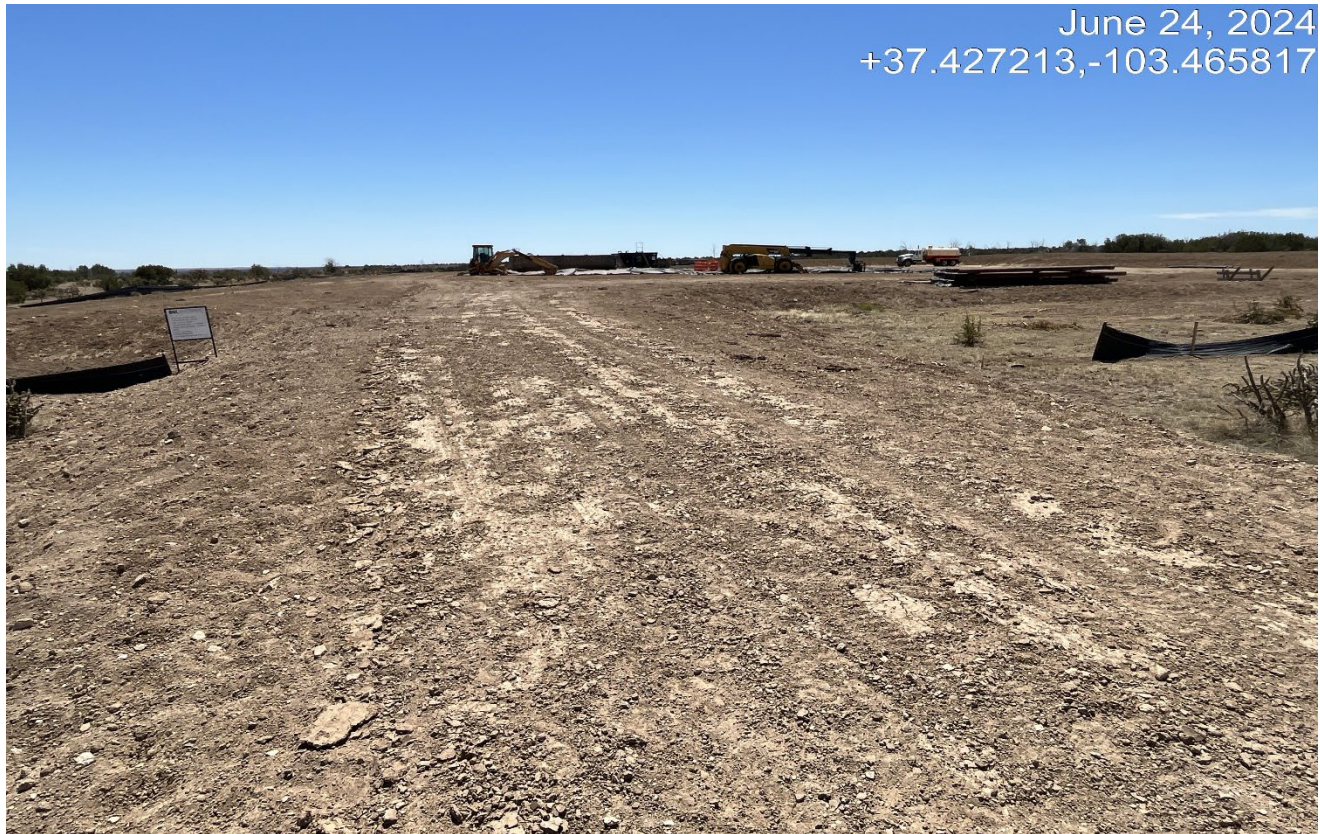
Photo 1. Facing east toward the access road and location.

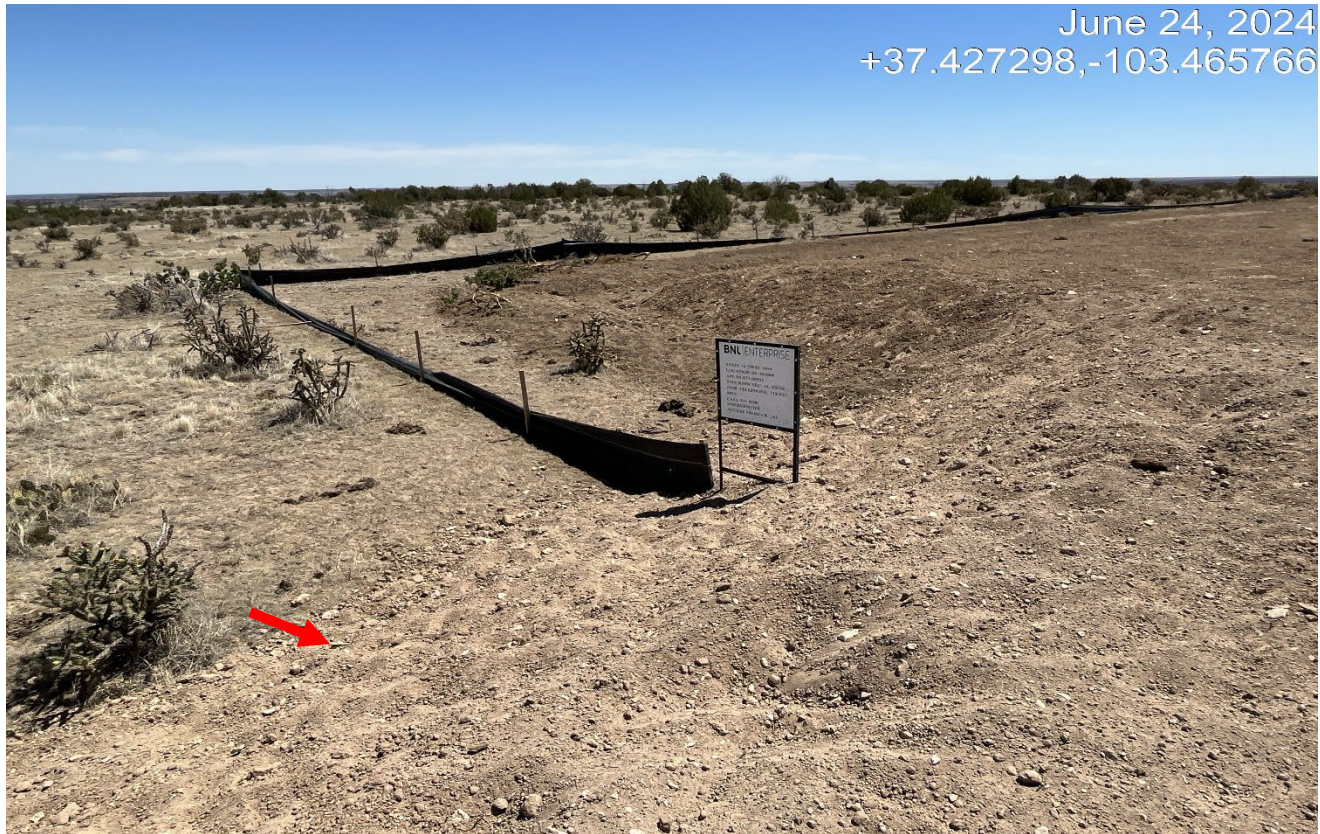
Photo 2. Facing toward the northwest side of the location. The silt fence is not maintained at the location. The loose soils along the access road at red arrow are not stabilized.

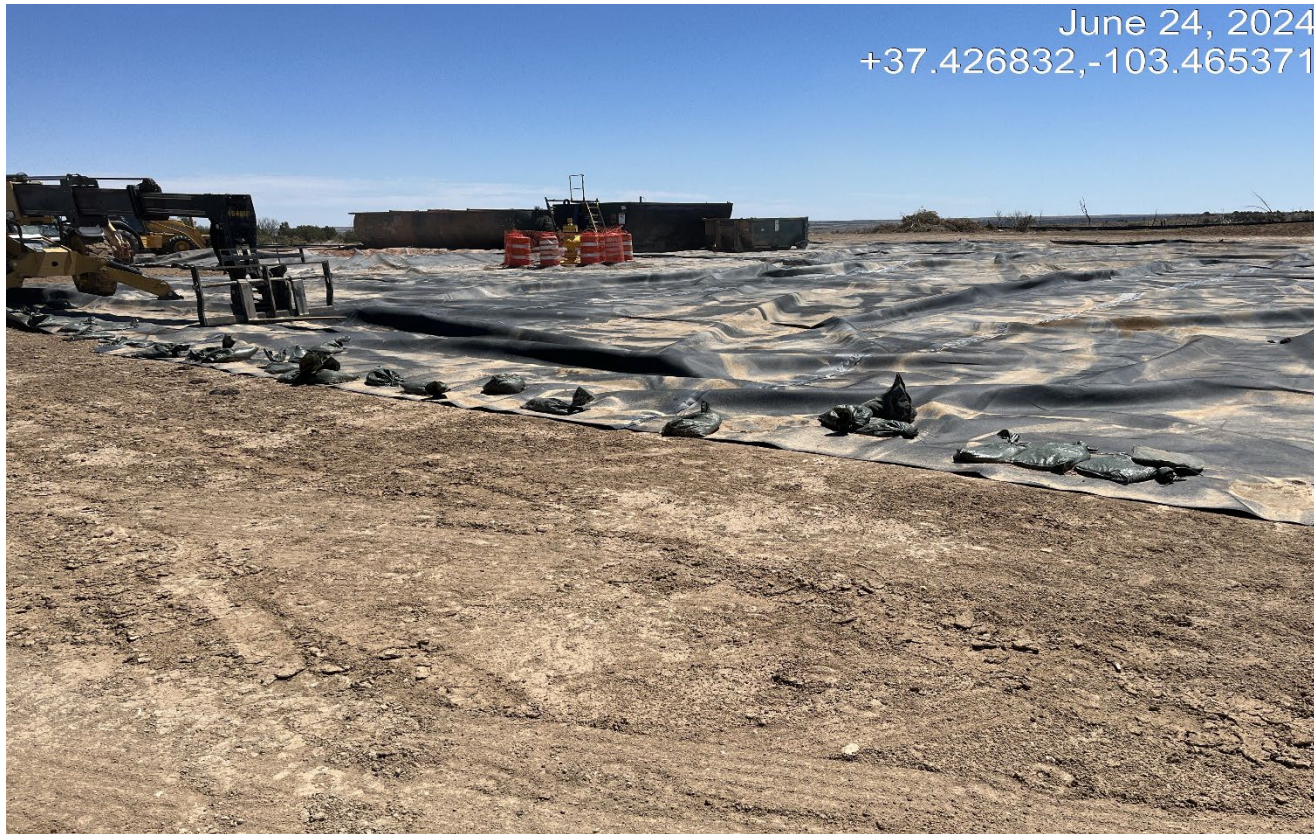
Photo 3. Facing northeast at the location. The well has been drilled and liner was used during the drilling process..

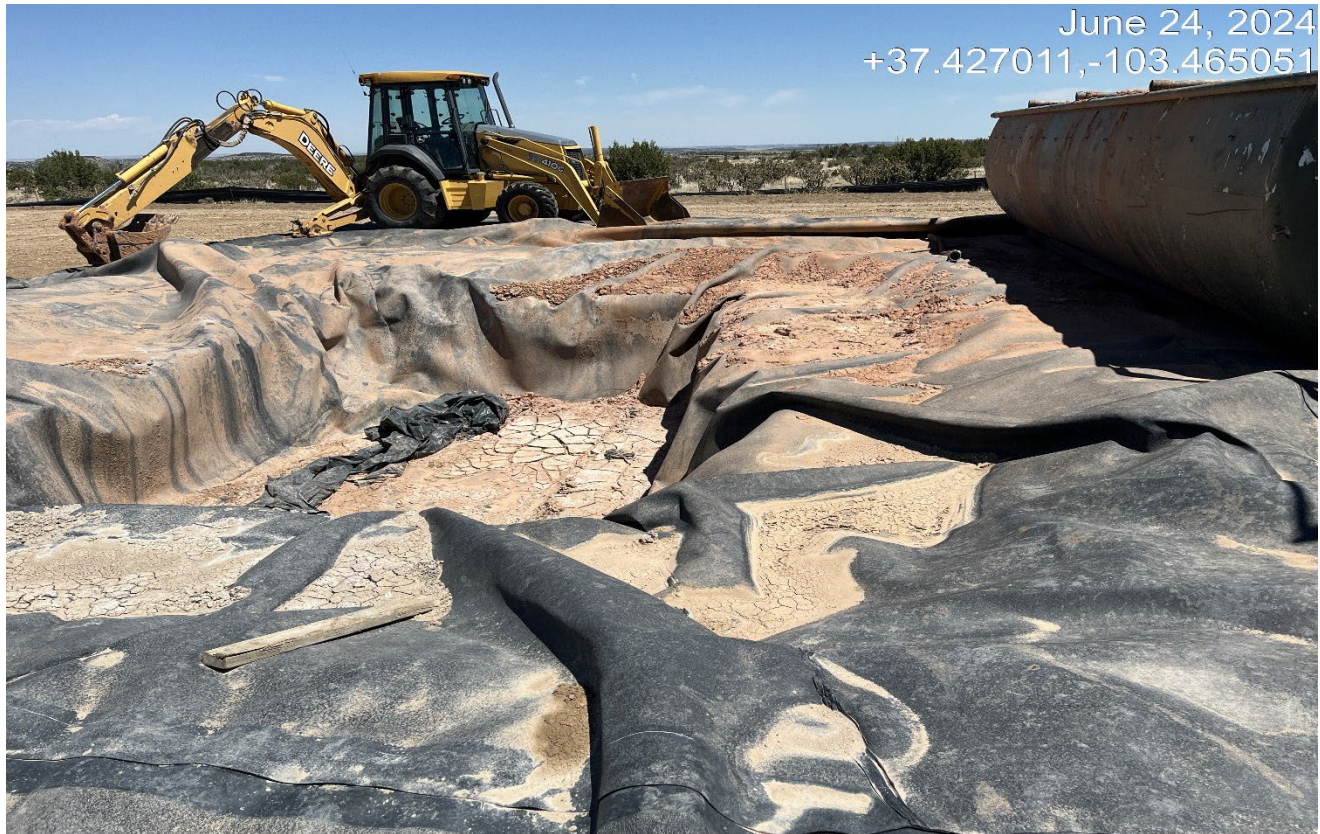
Photo 4. Facing south toward the cuttings trench..

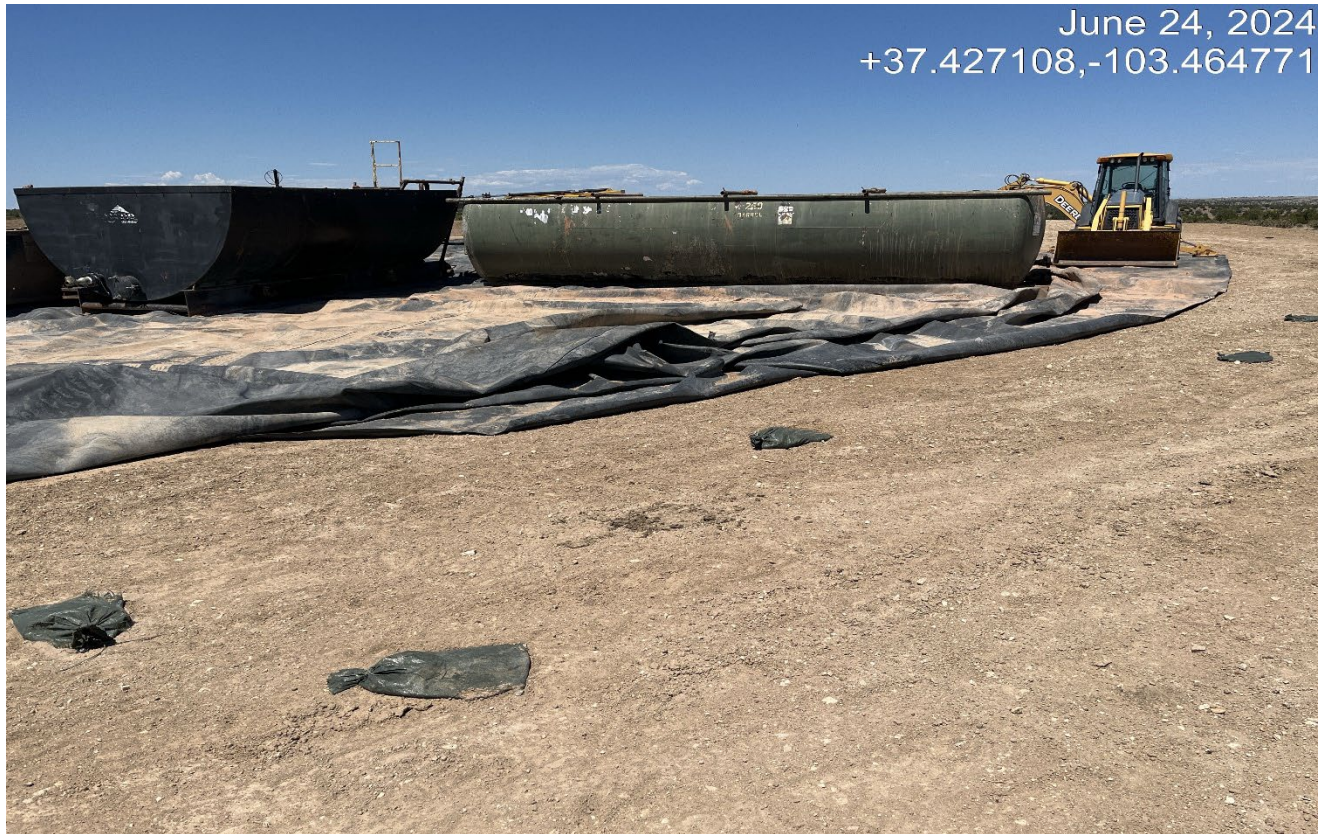
Photo 5. The tarp has become placed at the northeast side.

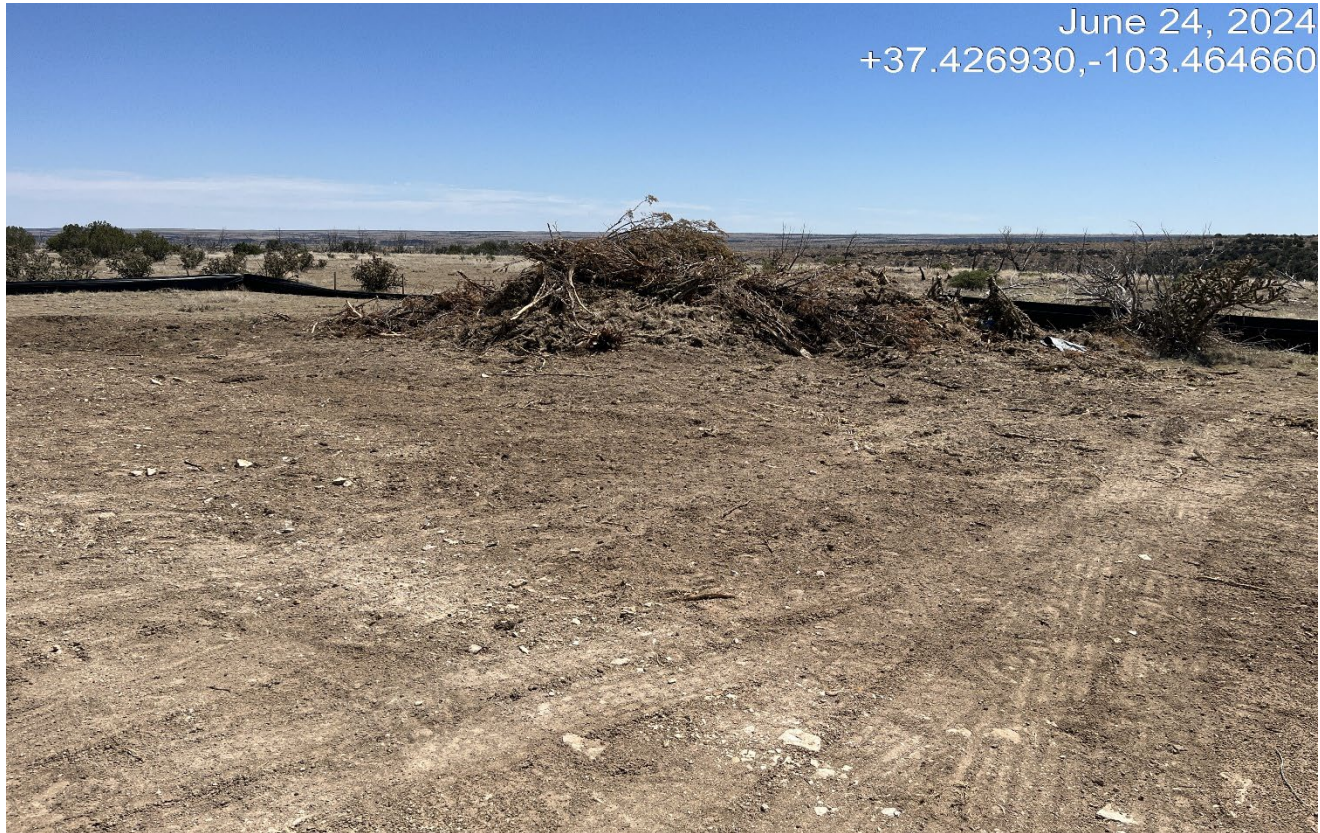
Photo 6. Facing toward the northeast side. This brush pile debris needs to be removed.

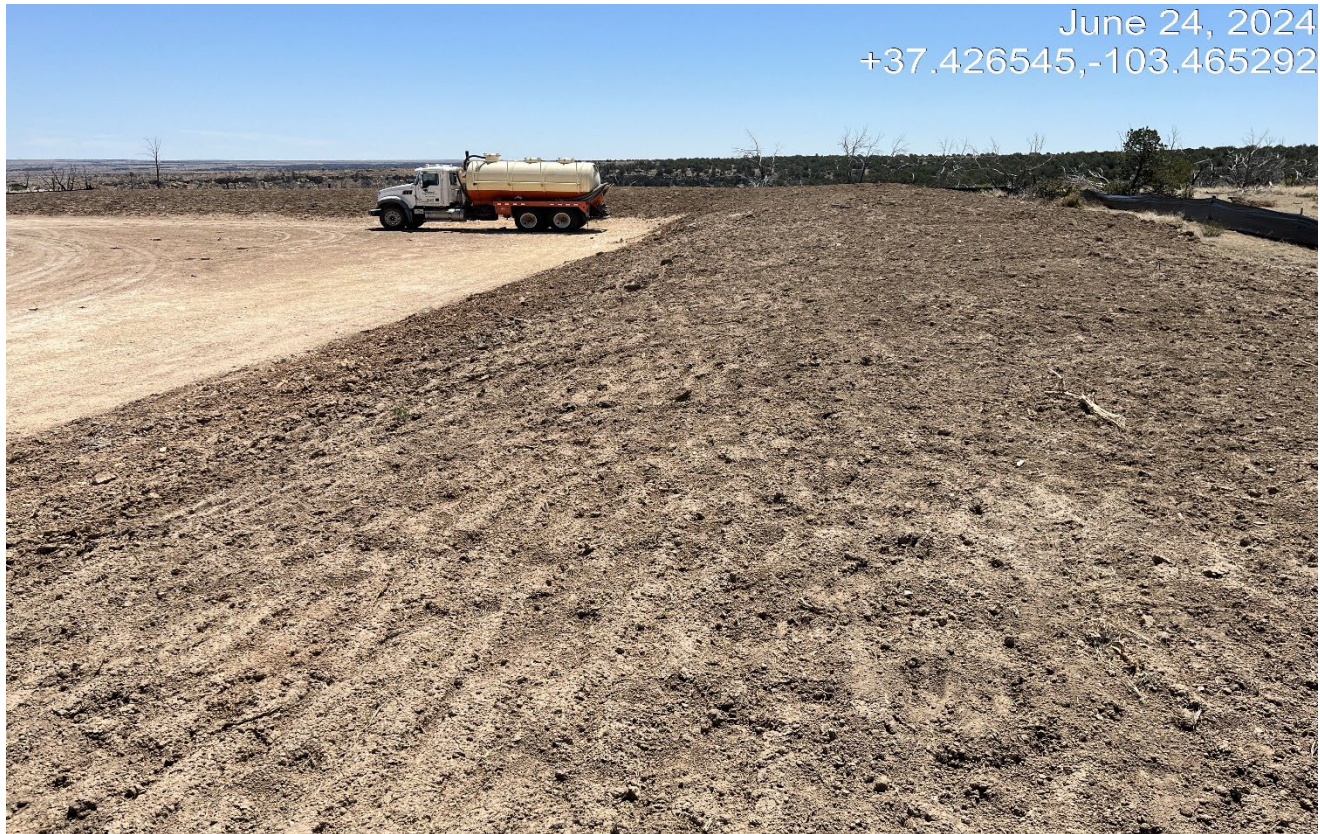
Photo 7. South side of the location facing east toward the topsoil pile. The topsoil has not been seeded and is not stabilized.

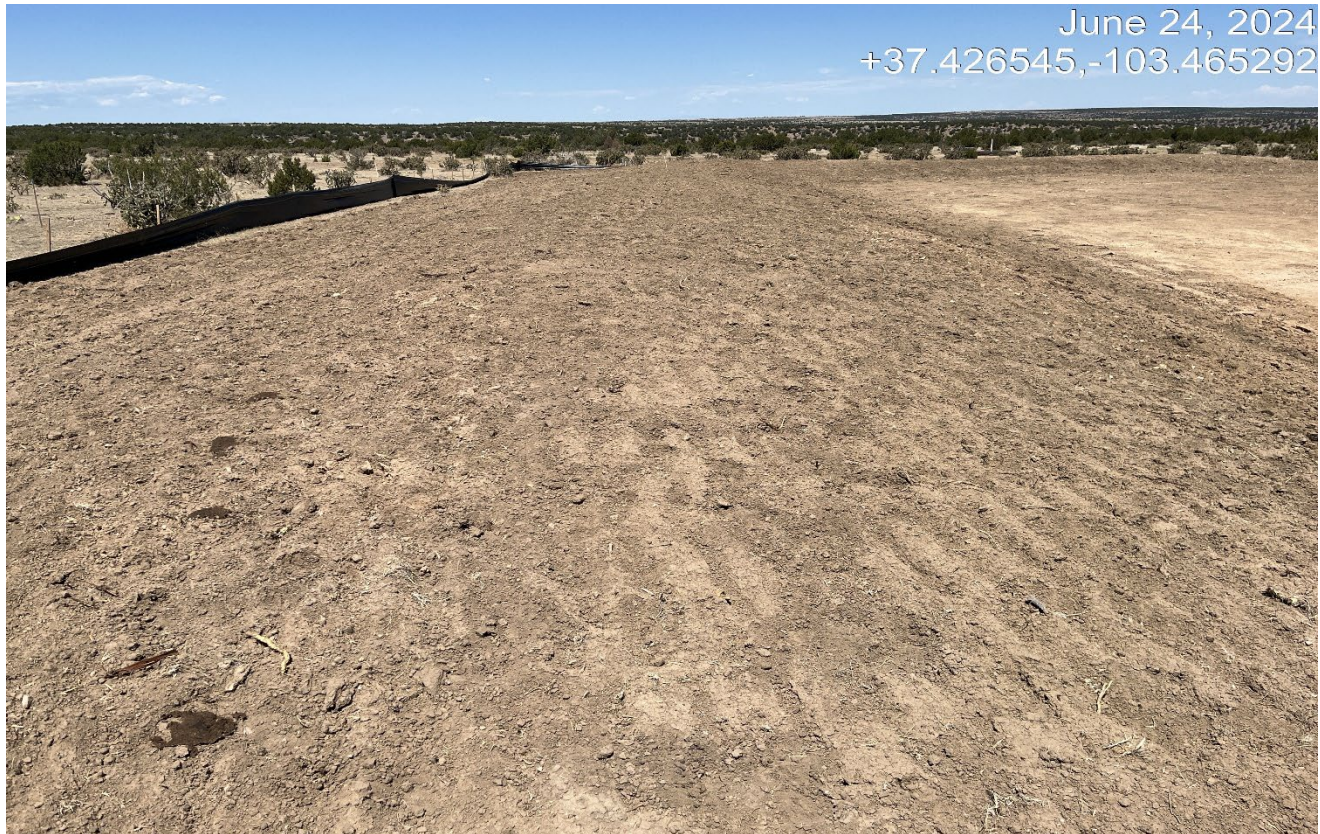
Photo 8. South side of the location facing west toward the topsoil pile. The topsoil has not been seeded and is not stabilized.
