# Inspection Photos

Loc: 484358

Operator: DESERT EAGLE OPERATING LLC

Inspection Date: 6/24/2024

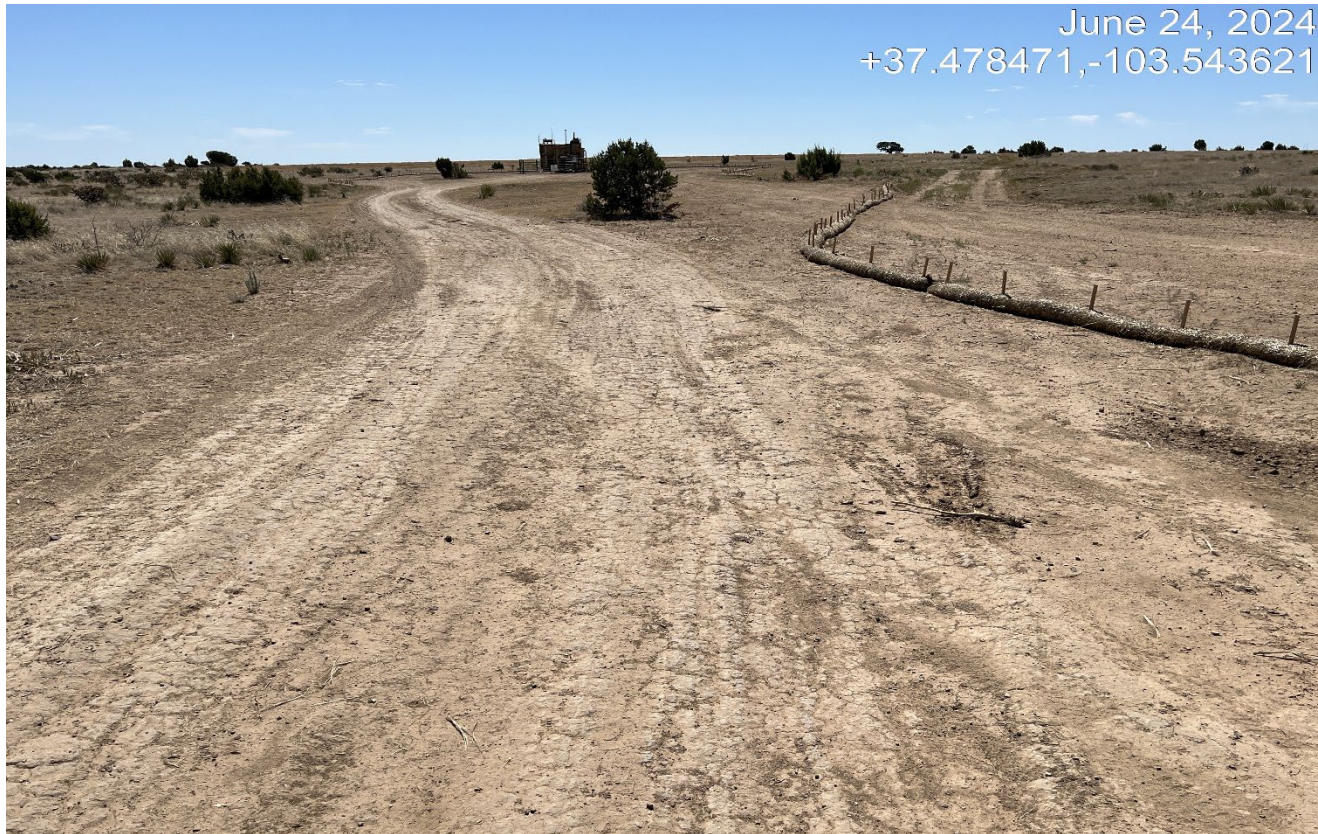
**Photo 1.** Facing east toward along the access road near the location. Topsoil was not salvaged along the road and soils are very compacted.

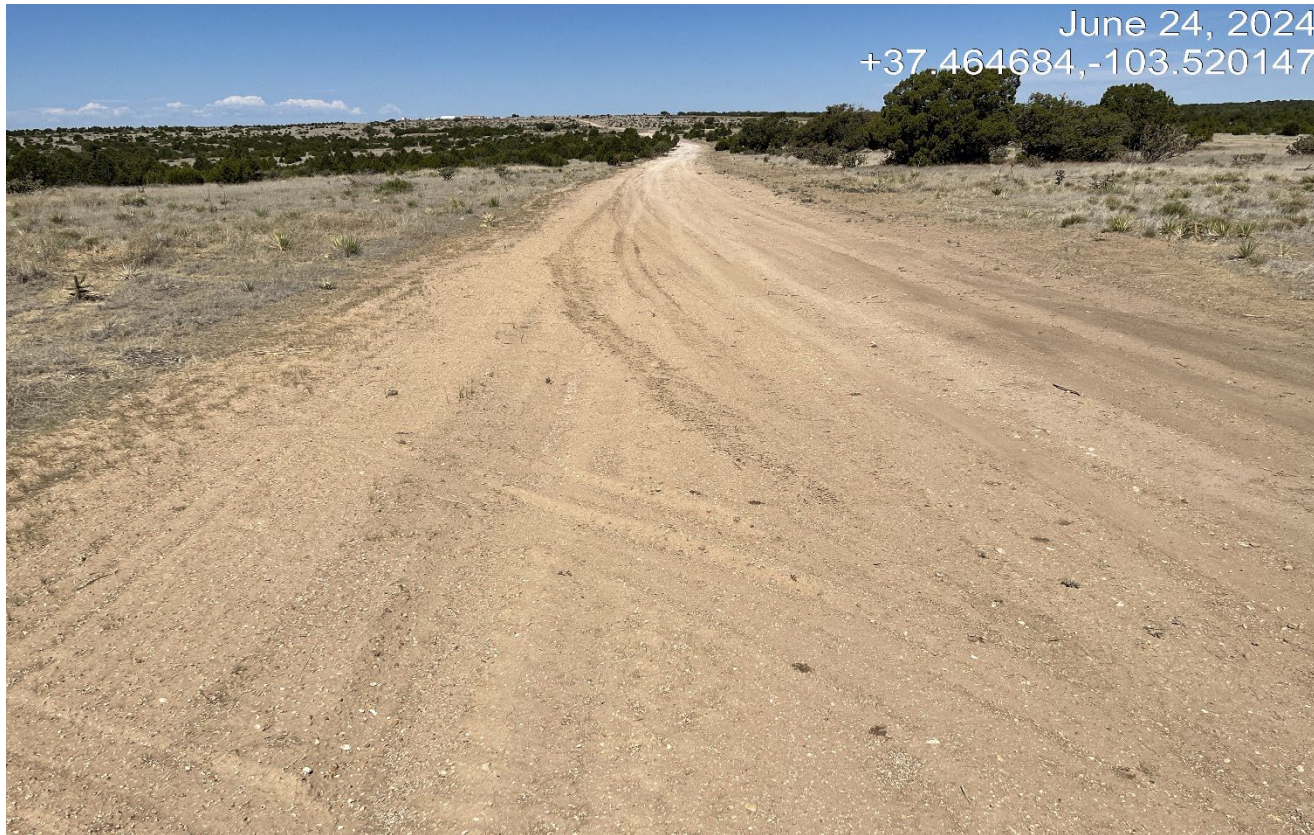
**Photo 2.** Facing back west toward the flowline disturbance. The vegetation is not establishing along the flowline and there are vehicle tracks which a causing unnecessary disturbance. The flowline must be reclaimed and stabilized.

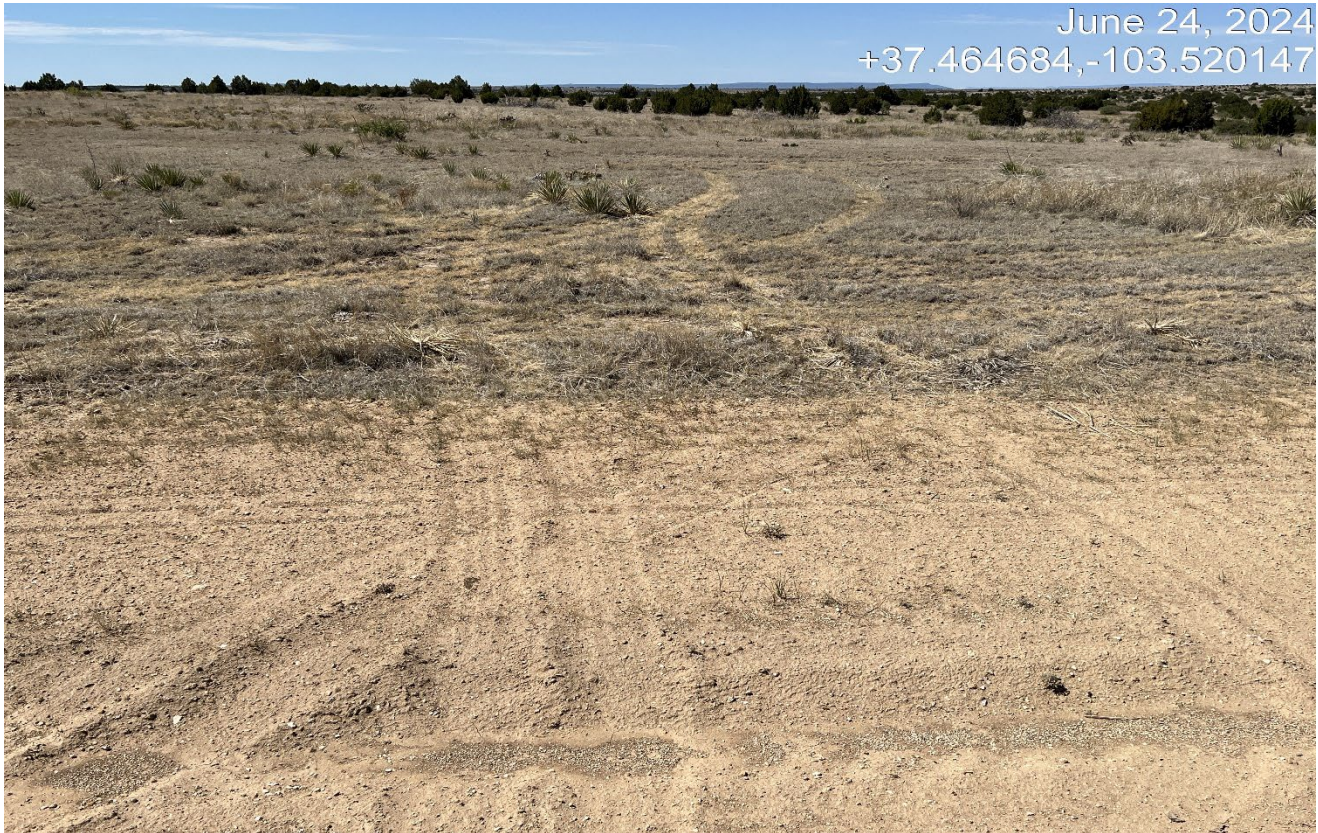
**Photo 3.** There are vehicle tracks going outside of the flowline disturbance. All vehicles must remain on the original access road boundary.

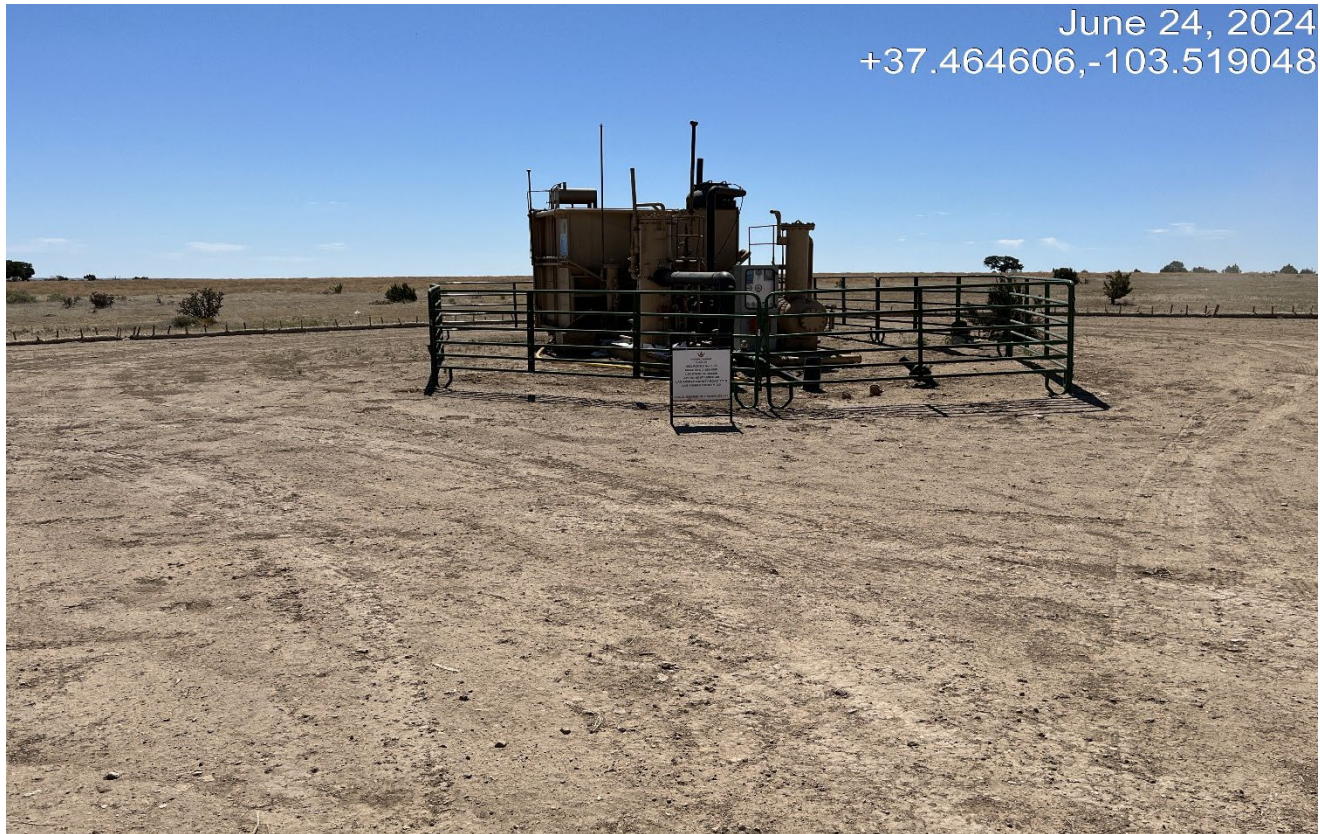
**Photo 4.** Facing east toward the wellsite.

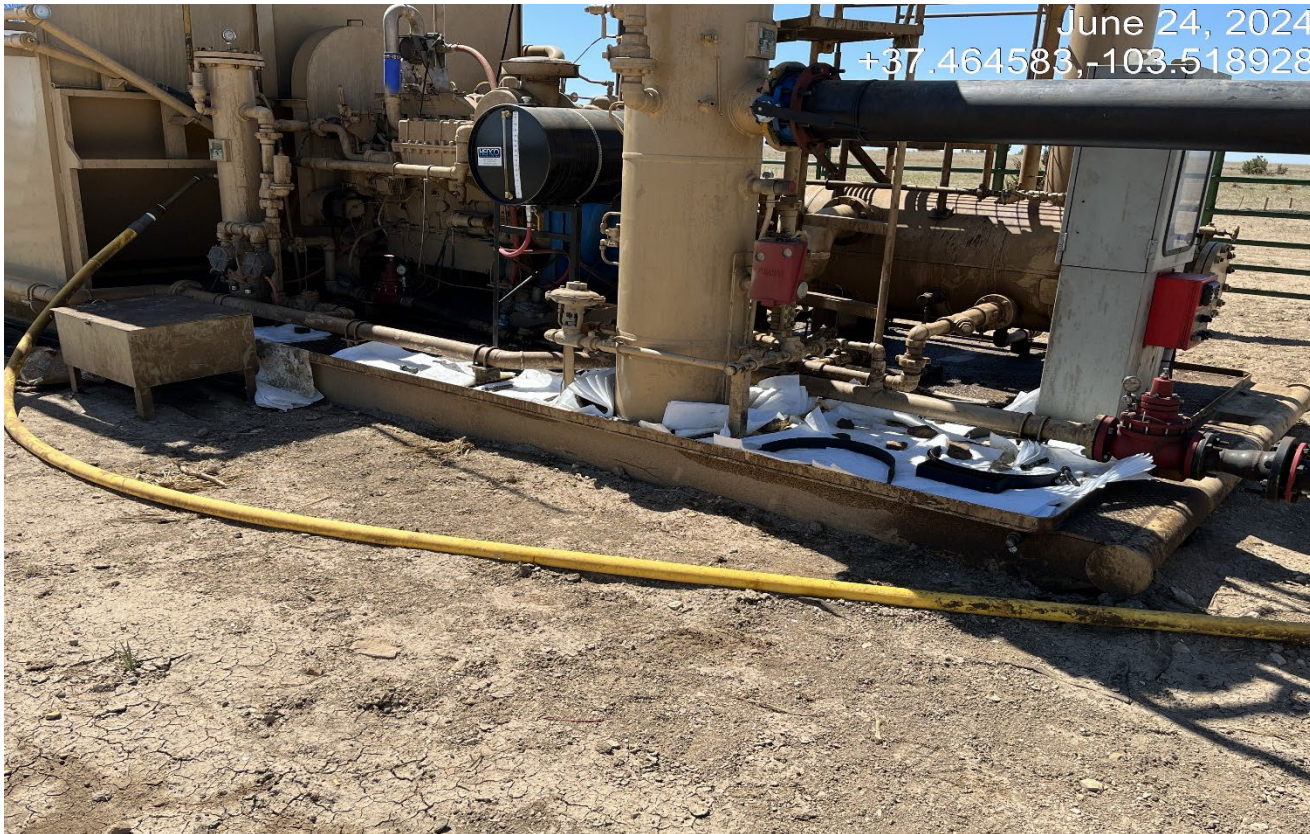
**Photo 5.** There absorbent cloths used for cleanup. Equipment should be repaired to prevent leaks.

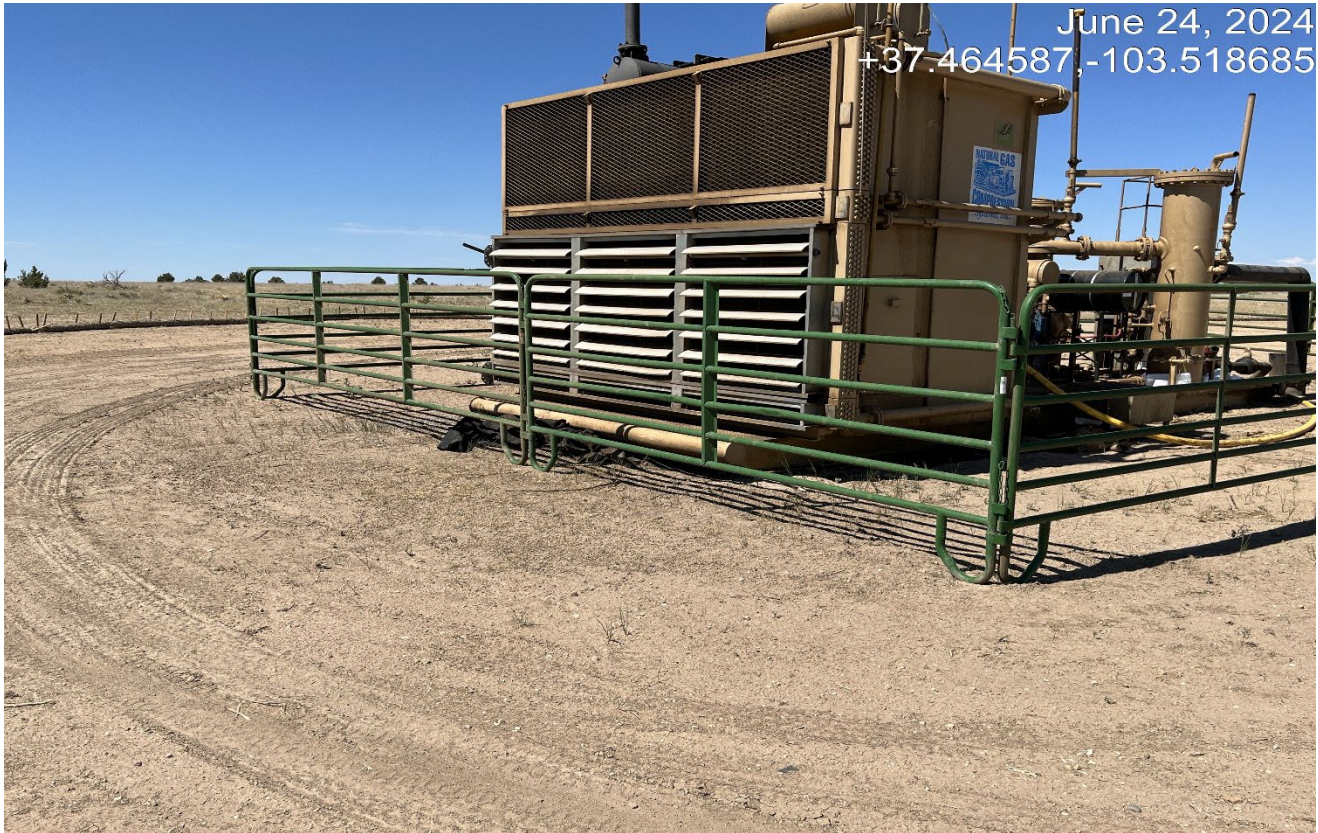
**Photo 6.** Facing toward the backside of the engine compressor.

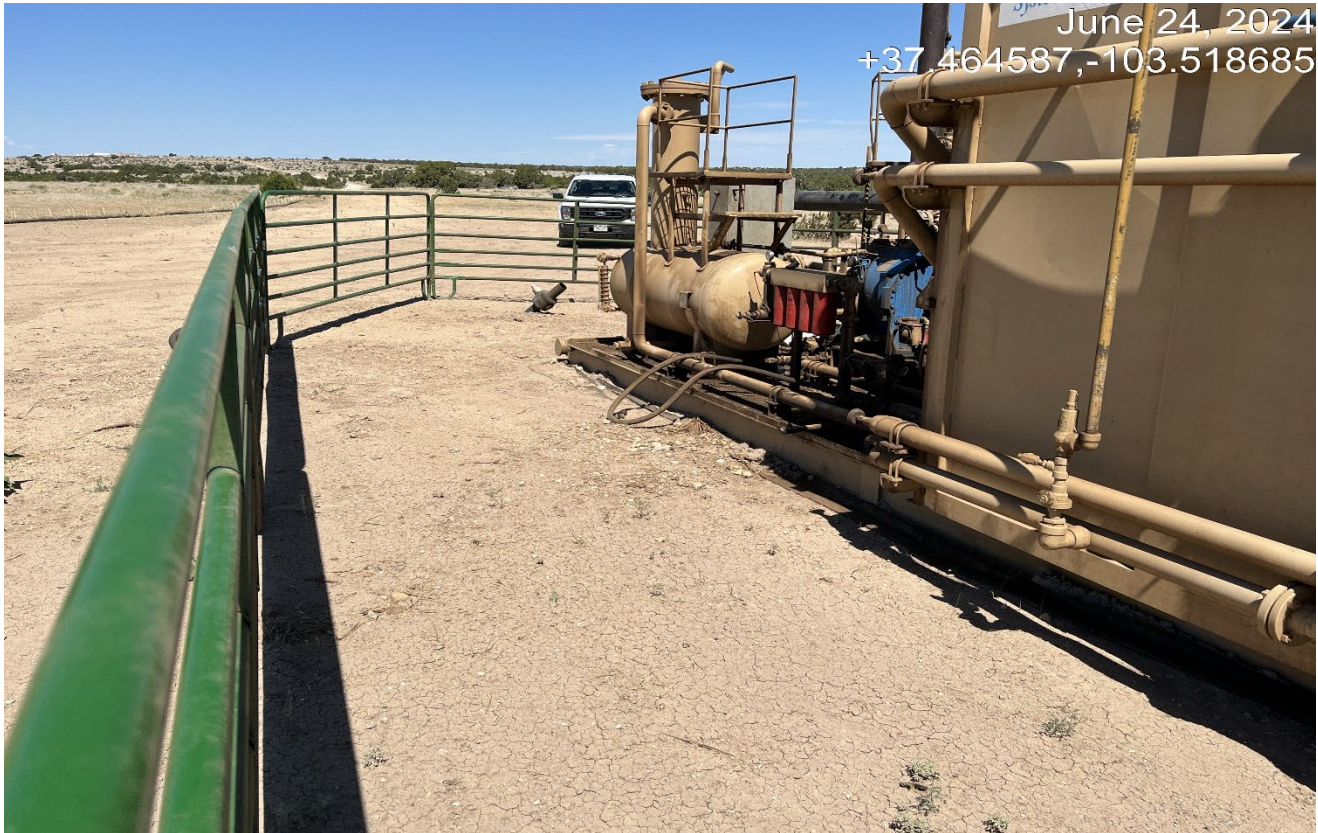
**Photo 7.** facing toward the south side of the compressor. Chemical barrels have been removed.

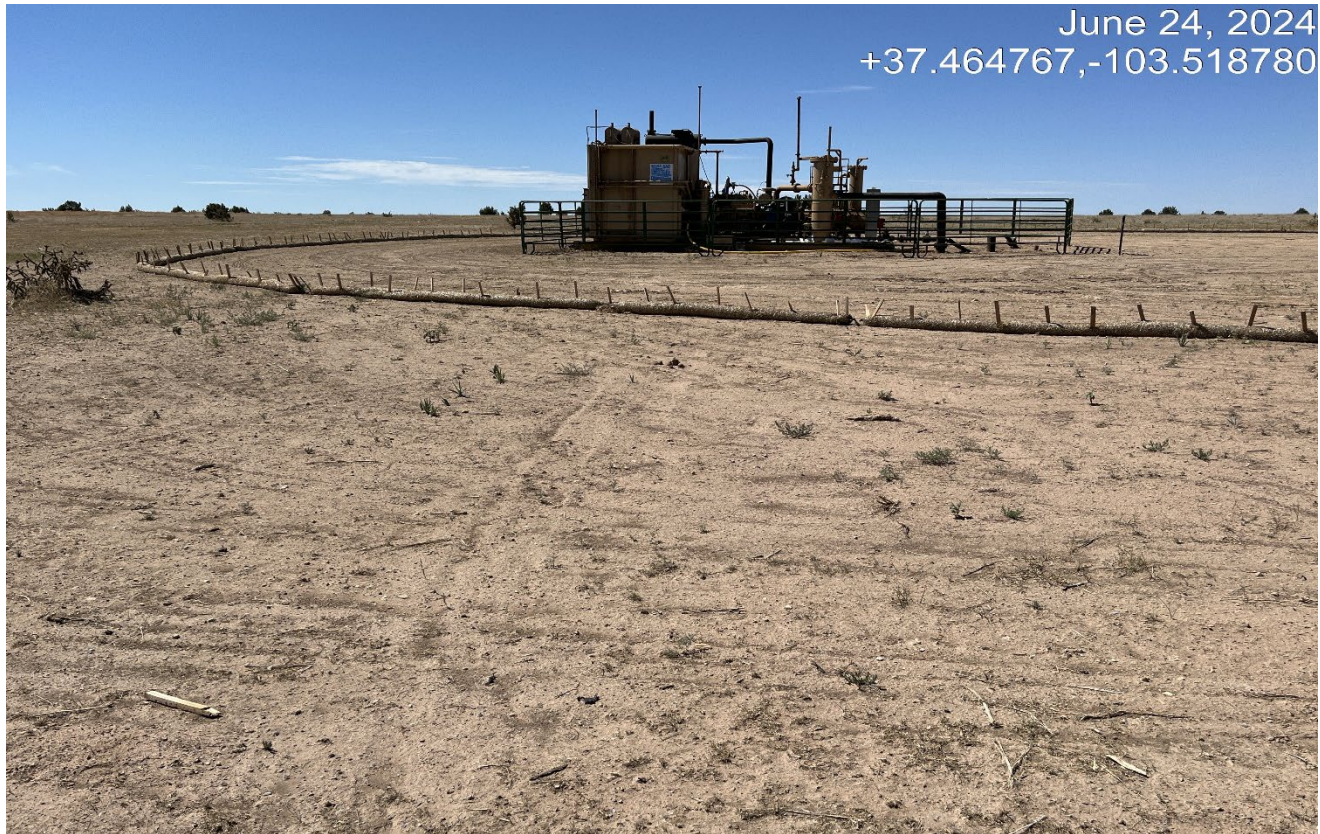
**Photo 8.** North side of the location facing south. The vegetation is not yet establishing at the disturbed interim areas.

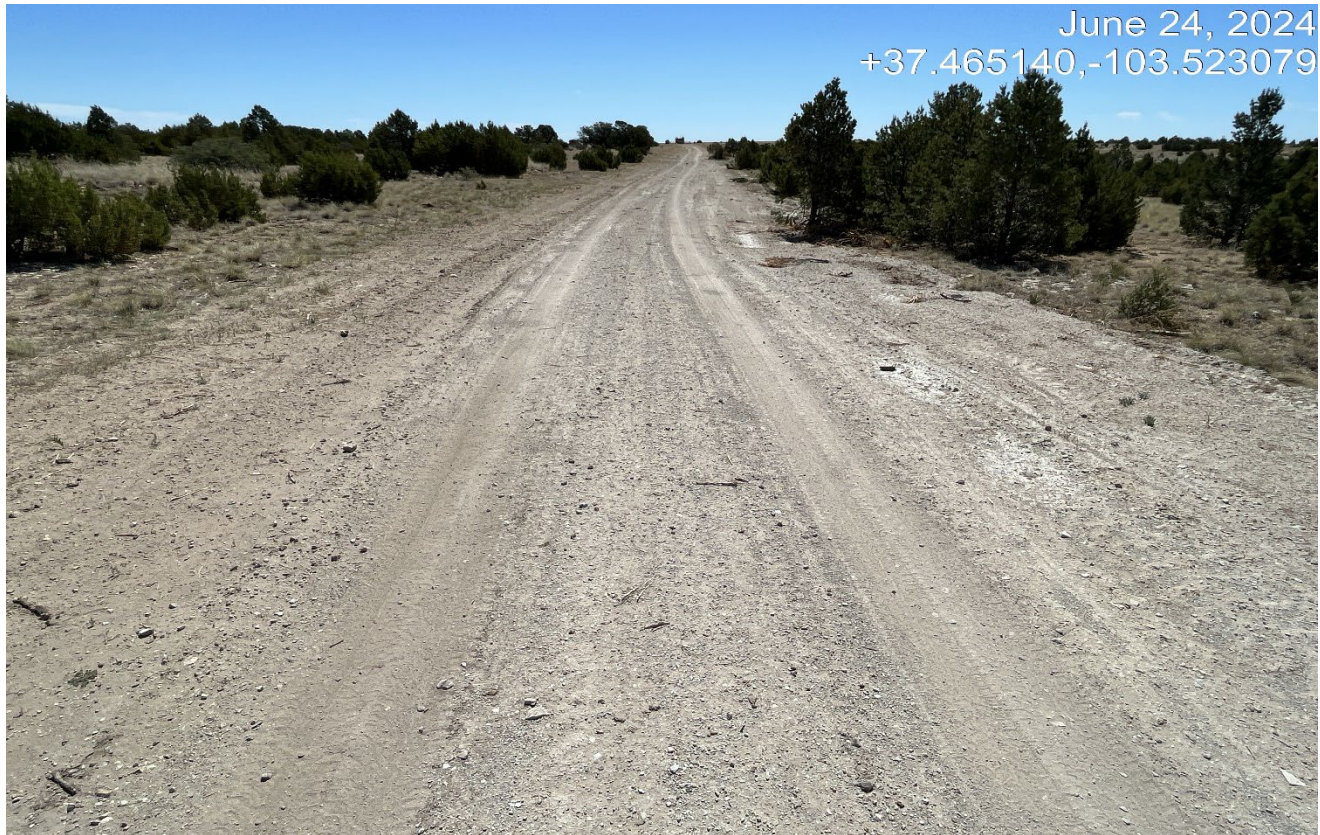
**Photo 9.** Facing east along the flowline. The vegetation is not establishing and soils are whitish and don't match the surrounding soils. Topsoil was not salvaged along the flowline which could be affecting vegetation. There are also vehicle tracks along the flowline causing unnecessary disturbance.

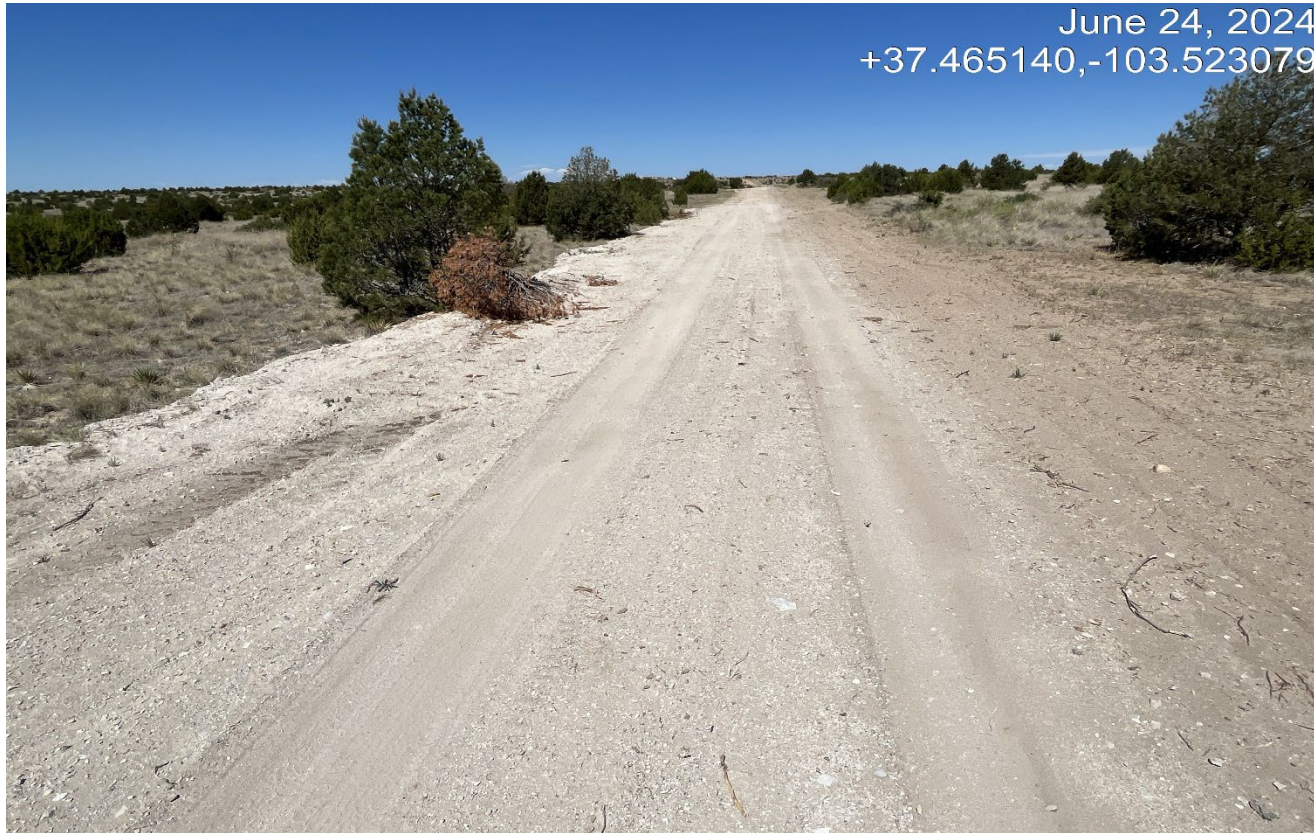
**Photo 10.** Facing west along the flowline. The vegetation is not establishing and soils are whitish and don't match the surrounding soils. Topsoil was not salvaged along the flowline which could be impacting revegetation. There are also vehicle tracks along the flowline causing unnecessary disturbance.
