Inspection Photos

Location Name: TEP ROCKY MOUNTAIN LLC BUXTON RWF 23-30 pad

Location ID: 335503

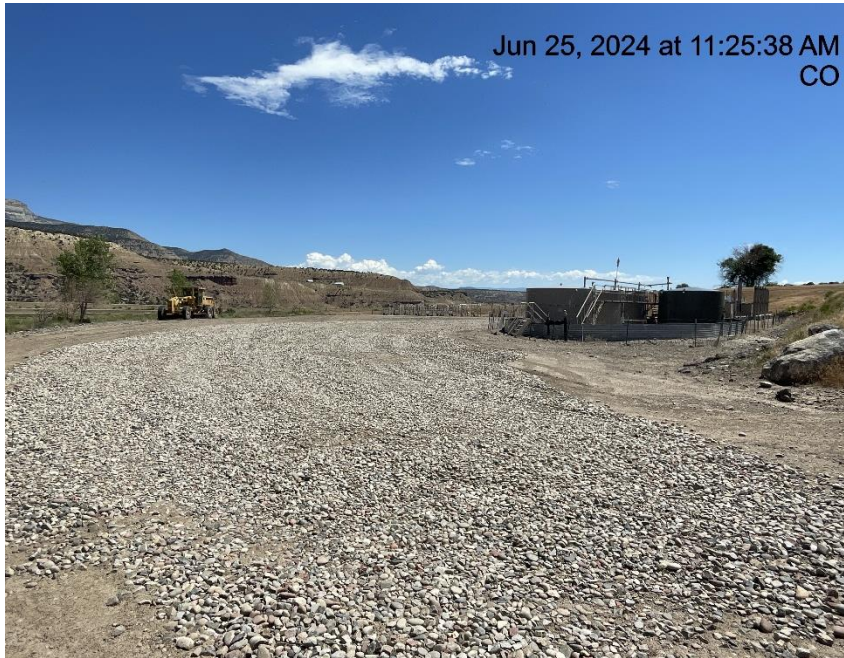
Photo # 1400 From entrance to location

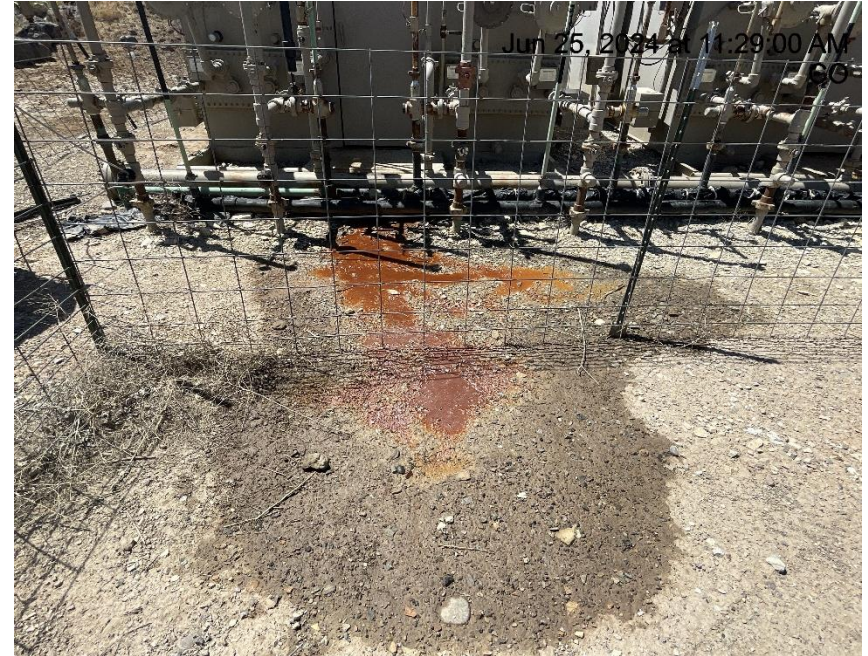
Photo # 1409 Mechanical Condition - Possible dump line leak & stained soils

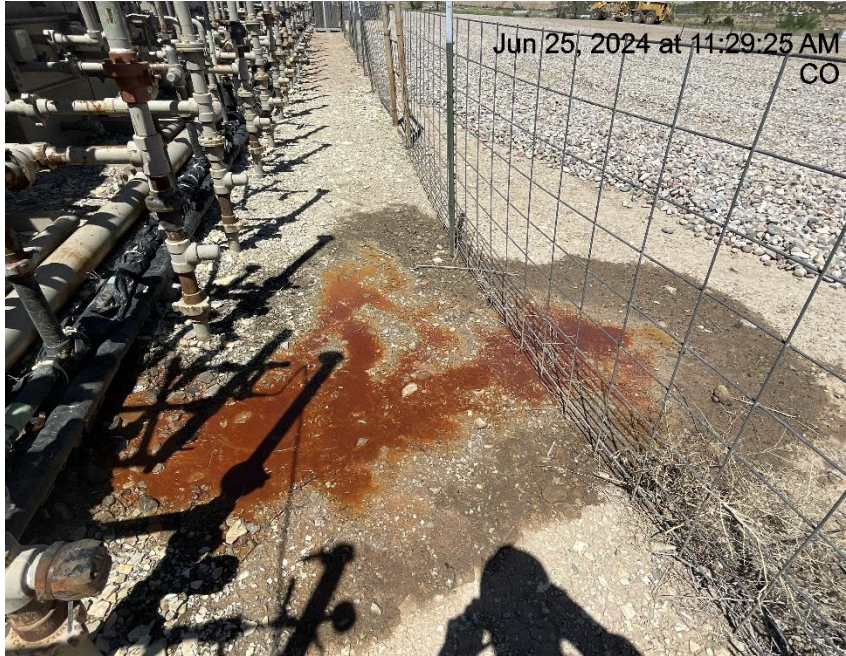
Photo # 1410 Mechanical Condition - Possible dump line leak & stained soils

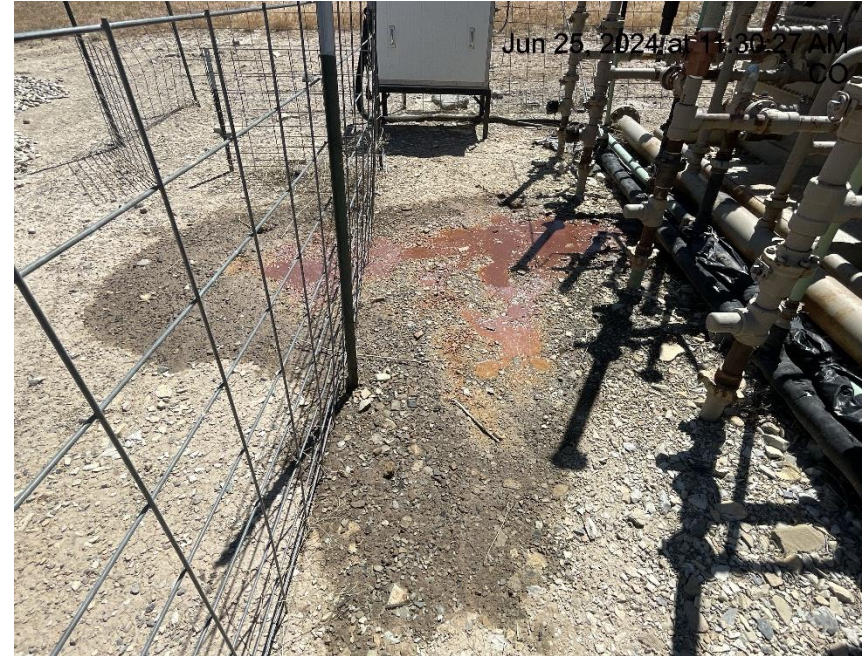
Photo # 1411 Mechanical Condition - Possible dump line leak & stained soils

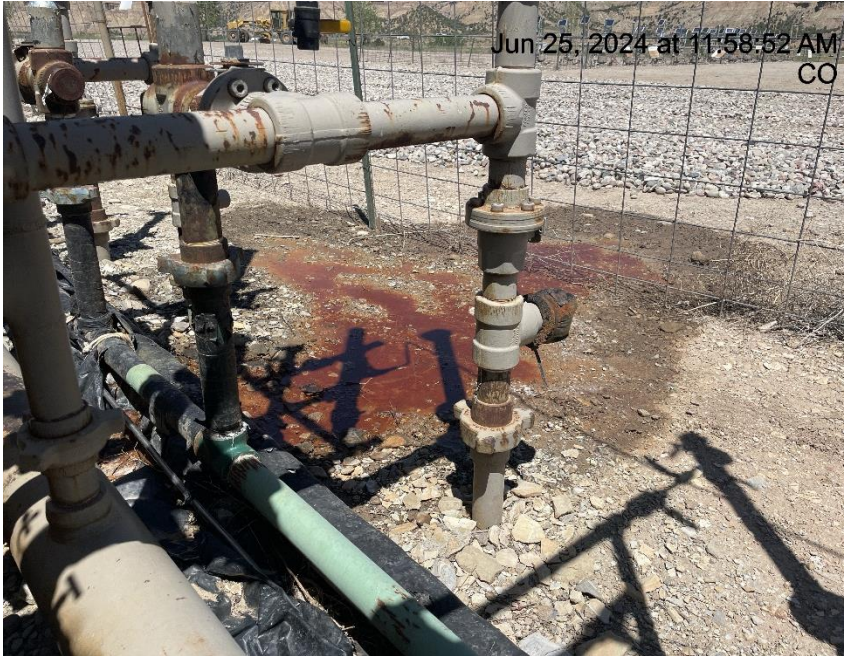
Photo # 1412 Mechanical Condition - Possible dump line leak & stained soils

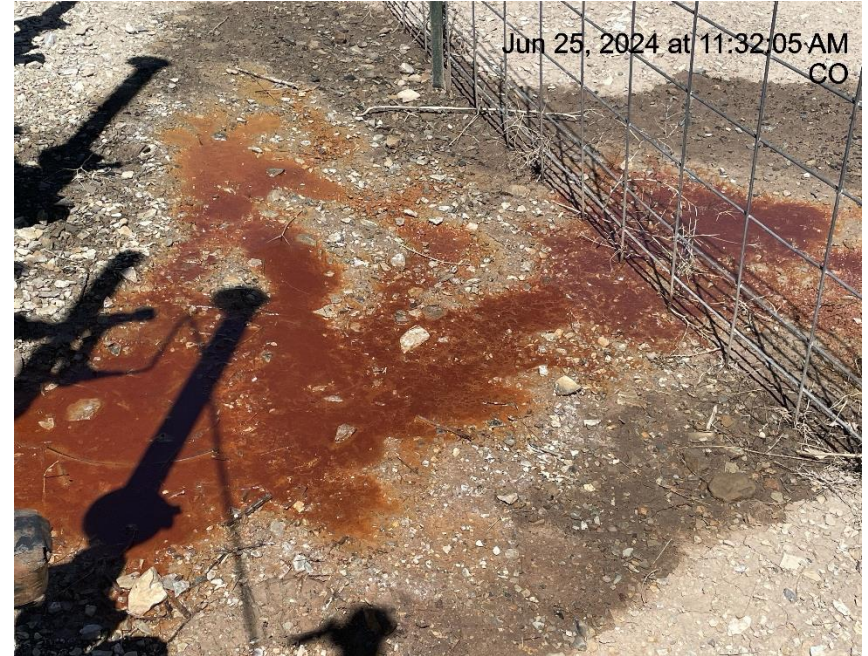
Photo # 1413 Mechanical Condition - Possible dump line leak & stained soils

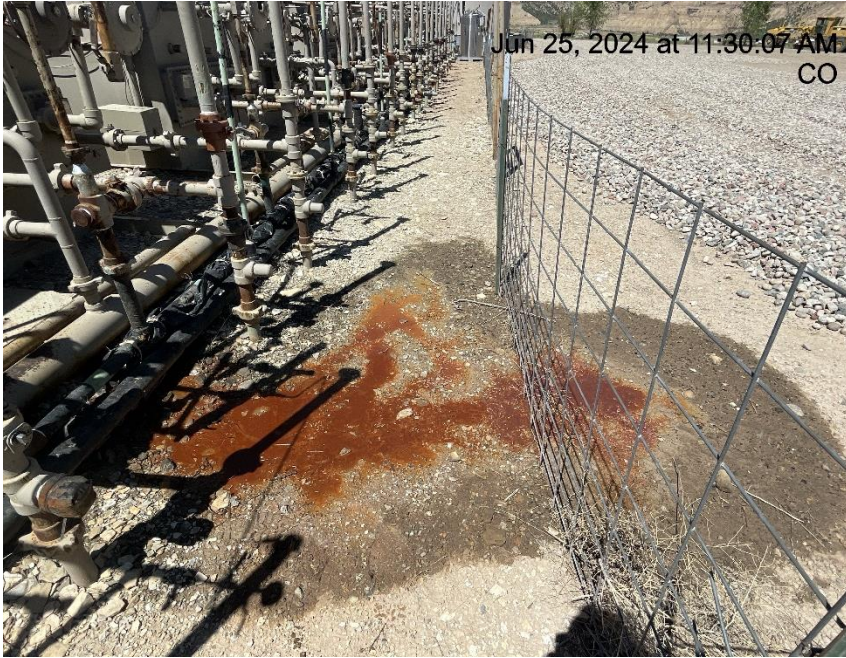
Photo # 1414 Mechanical Condition - Possible dump line leak & stained soils

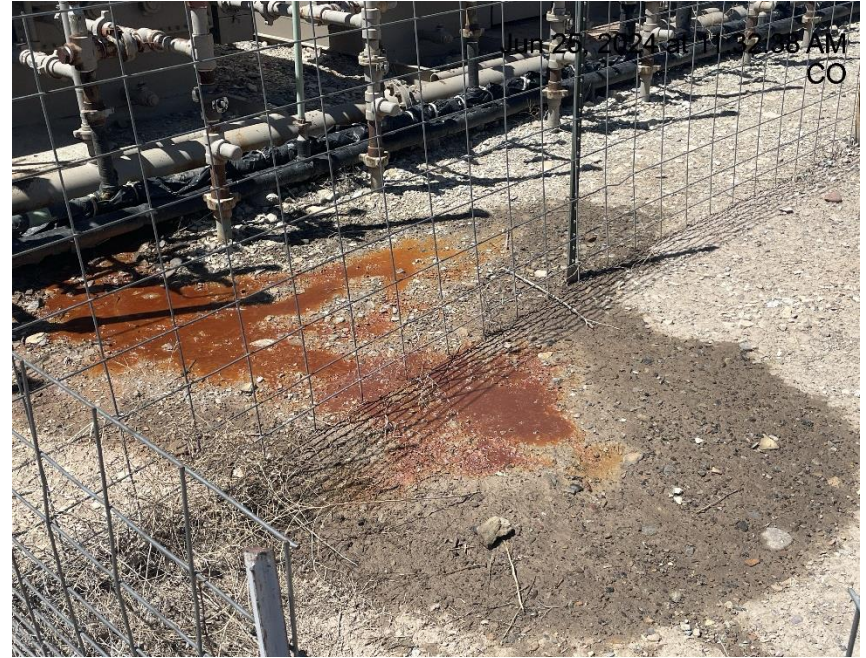
Photo # 1415 Mechanical Condition - Possible dump line leak & stained soils

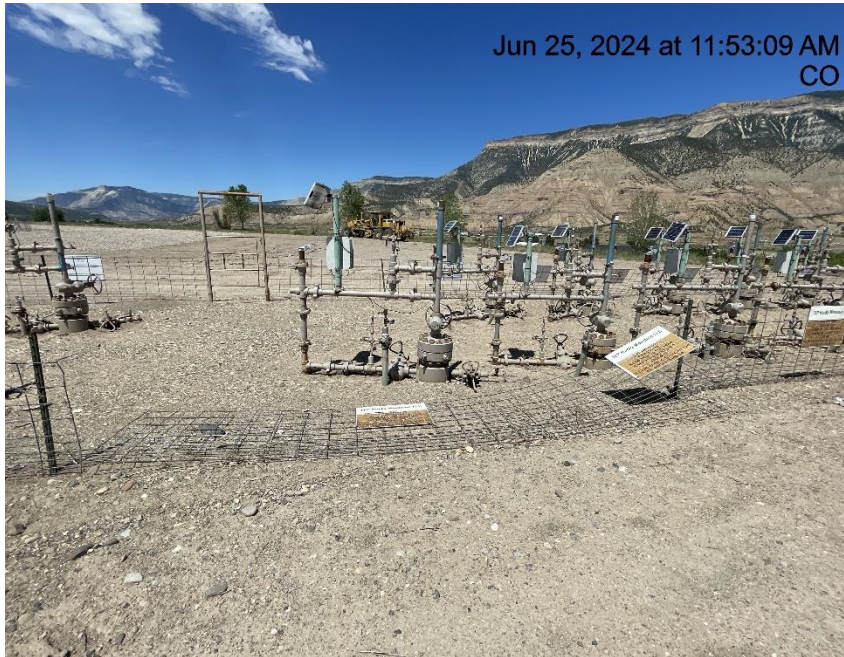
Photo # 1416 Hog panels laying on ground/wellhead sign not properly posted & multiple signs are also weathered & cracking

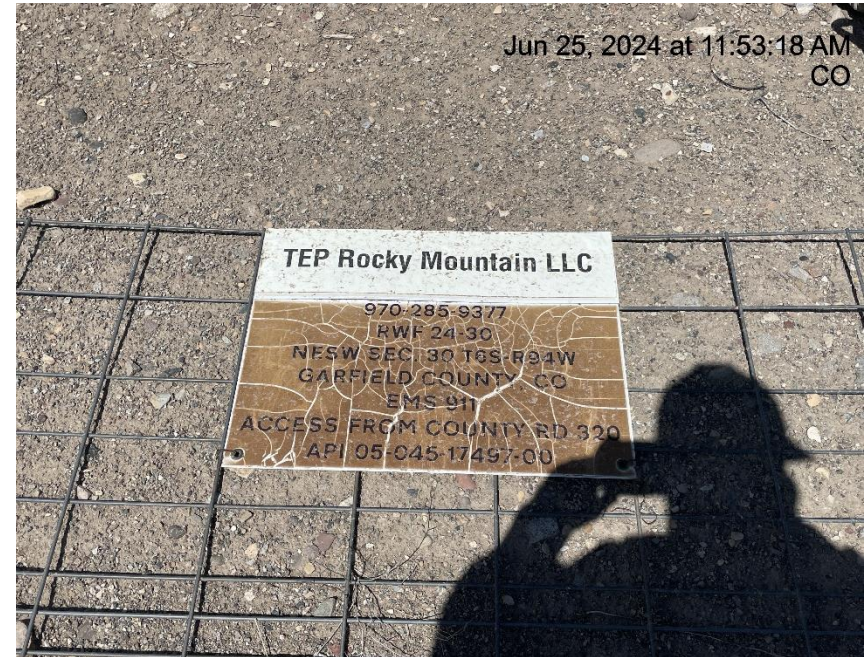
Photo # 1417 Hog panels laying on ground/wellhead sign not properly posted & sign is weathered & cracking

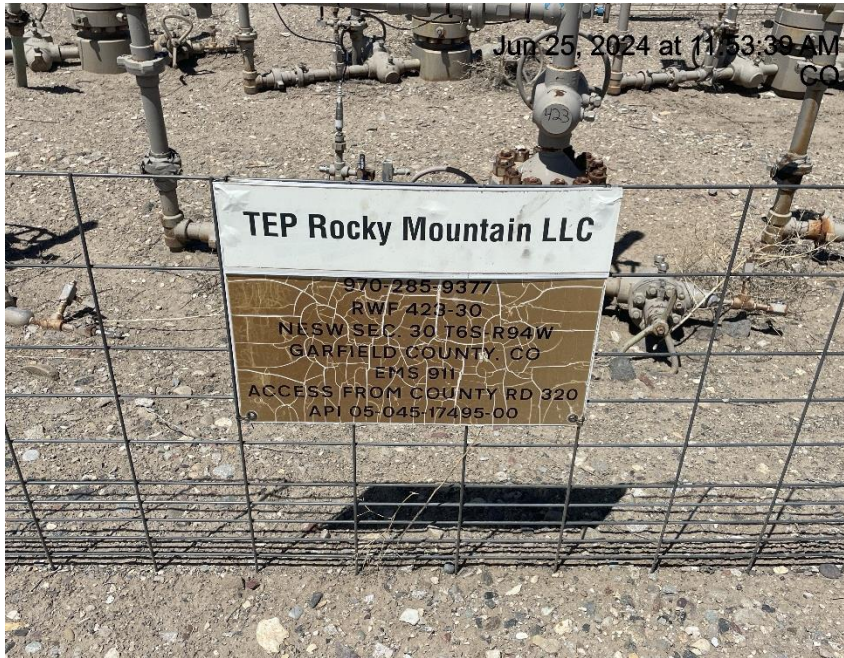
Photo # 1418 Wellhead sign weathered & cracking
