Inspection Photos

Loc: 484360

Operator: DESERT EAGLE OPERATING LLC

Inspection Date: 6/24/2024

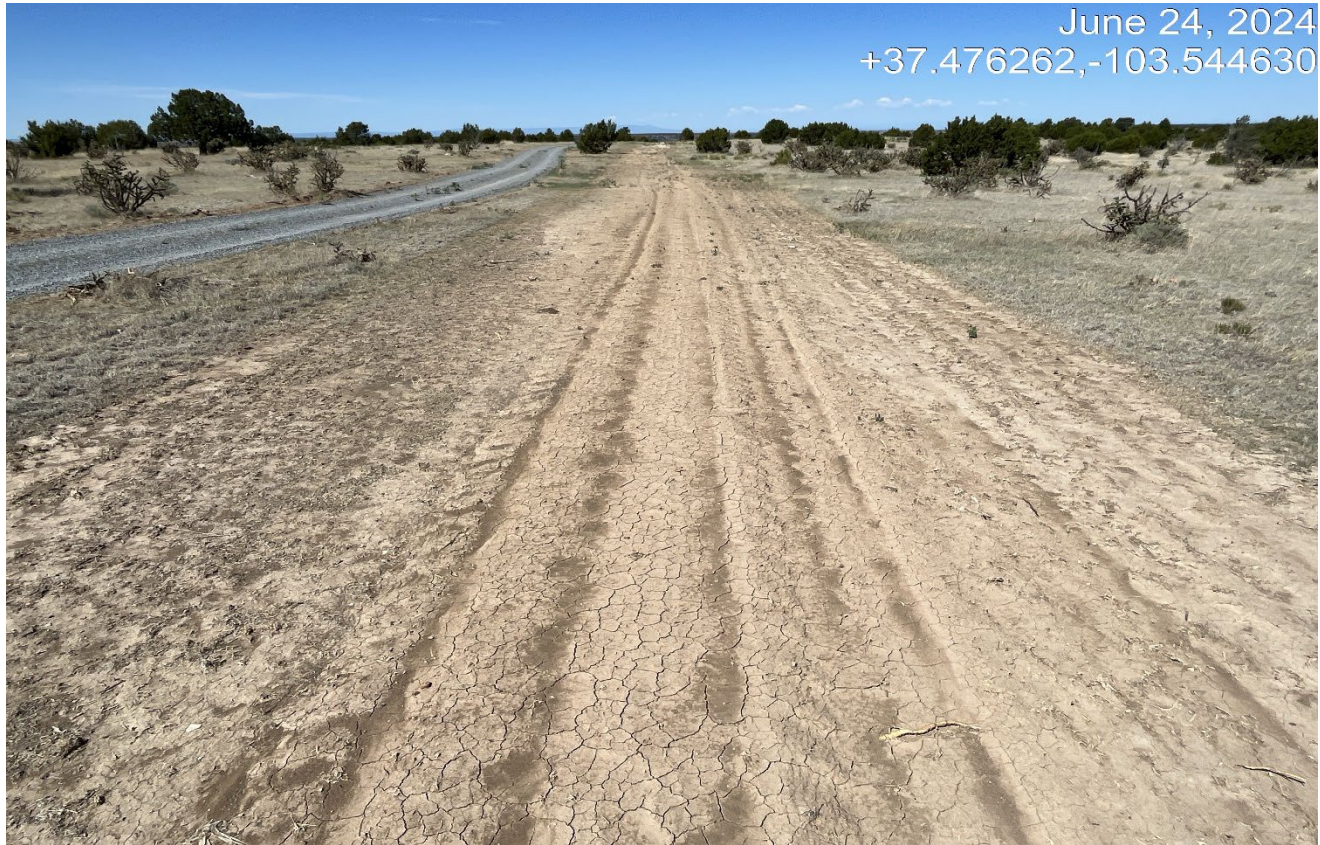
Photo 1. Facing west along the flowline. The vegetation is not yet establishing.

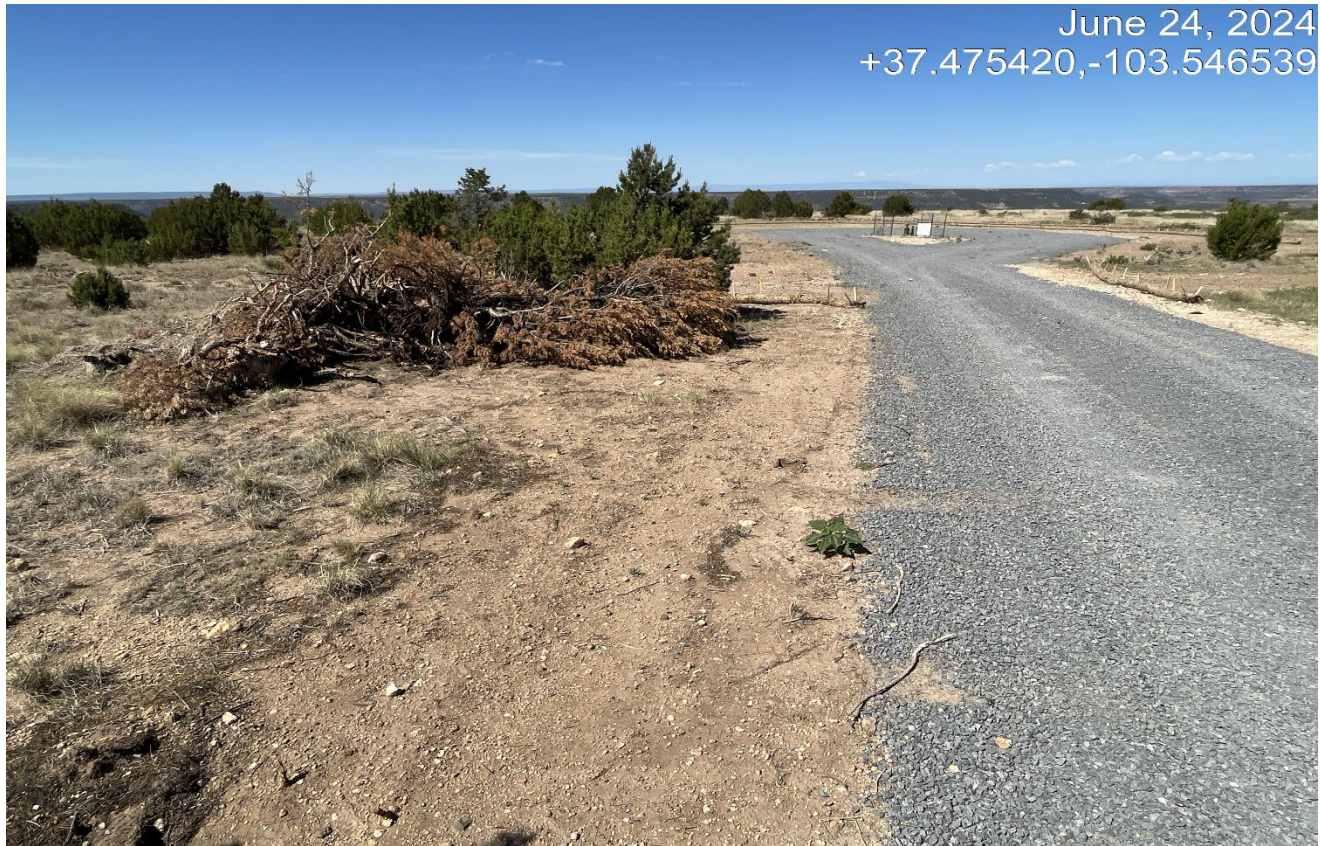
Photo 2. Facing west by the location. There is still tree debris that has not been removed. Previous corrective action was not completed.

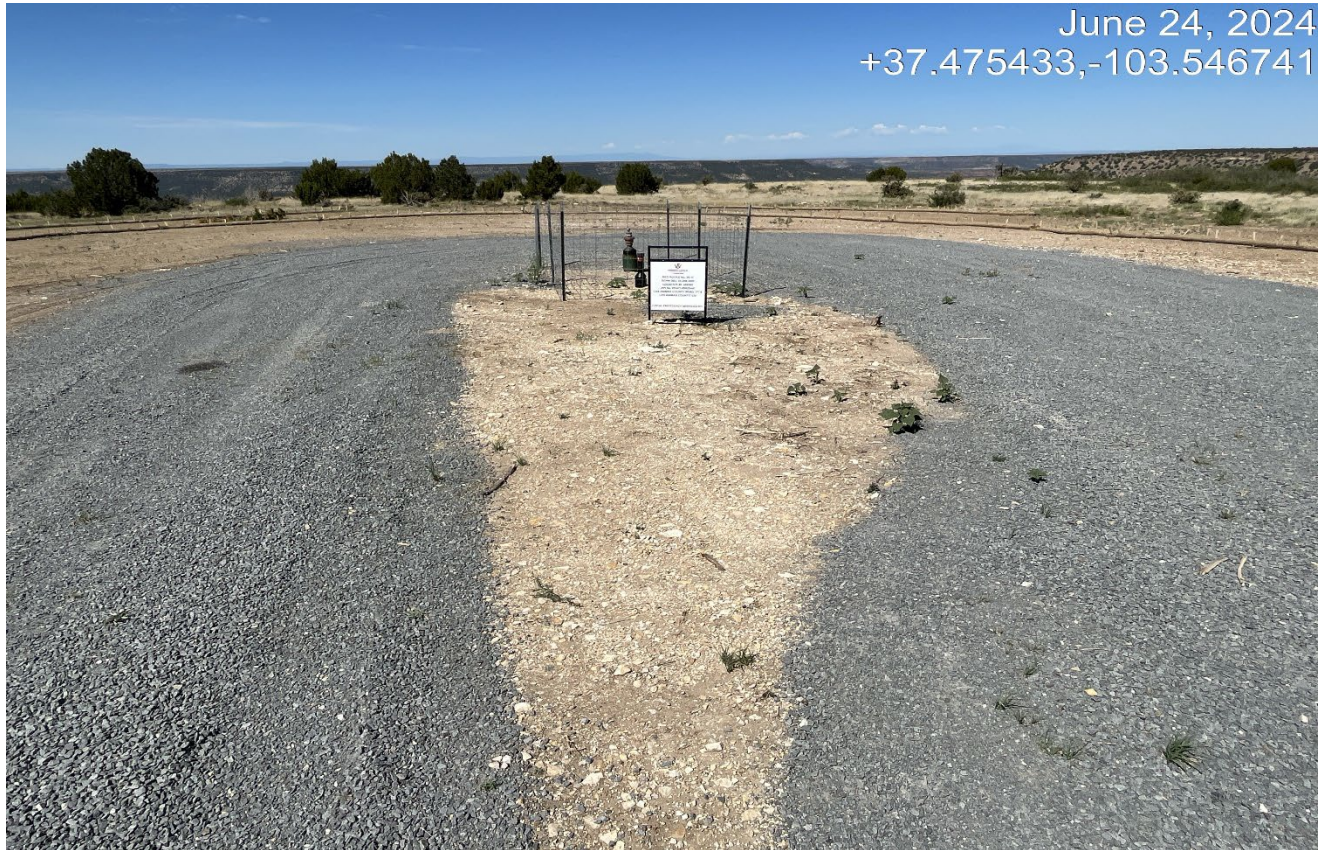
Photo 3. Facing west toward the wellsite.

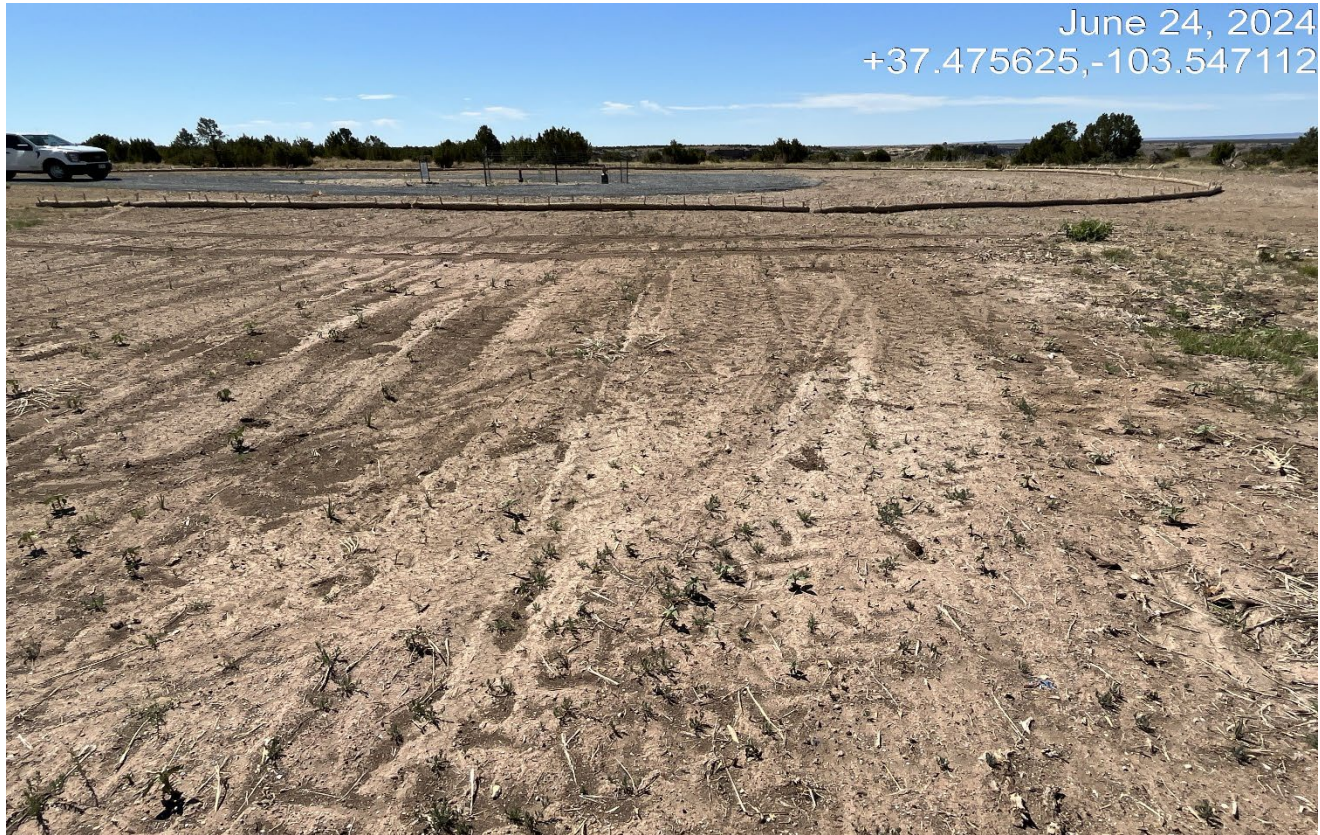
Photo 4. North side of the location facing south. Disturbed soils were reseeded but vegetation is not establishing very well yet.

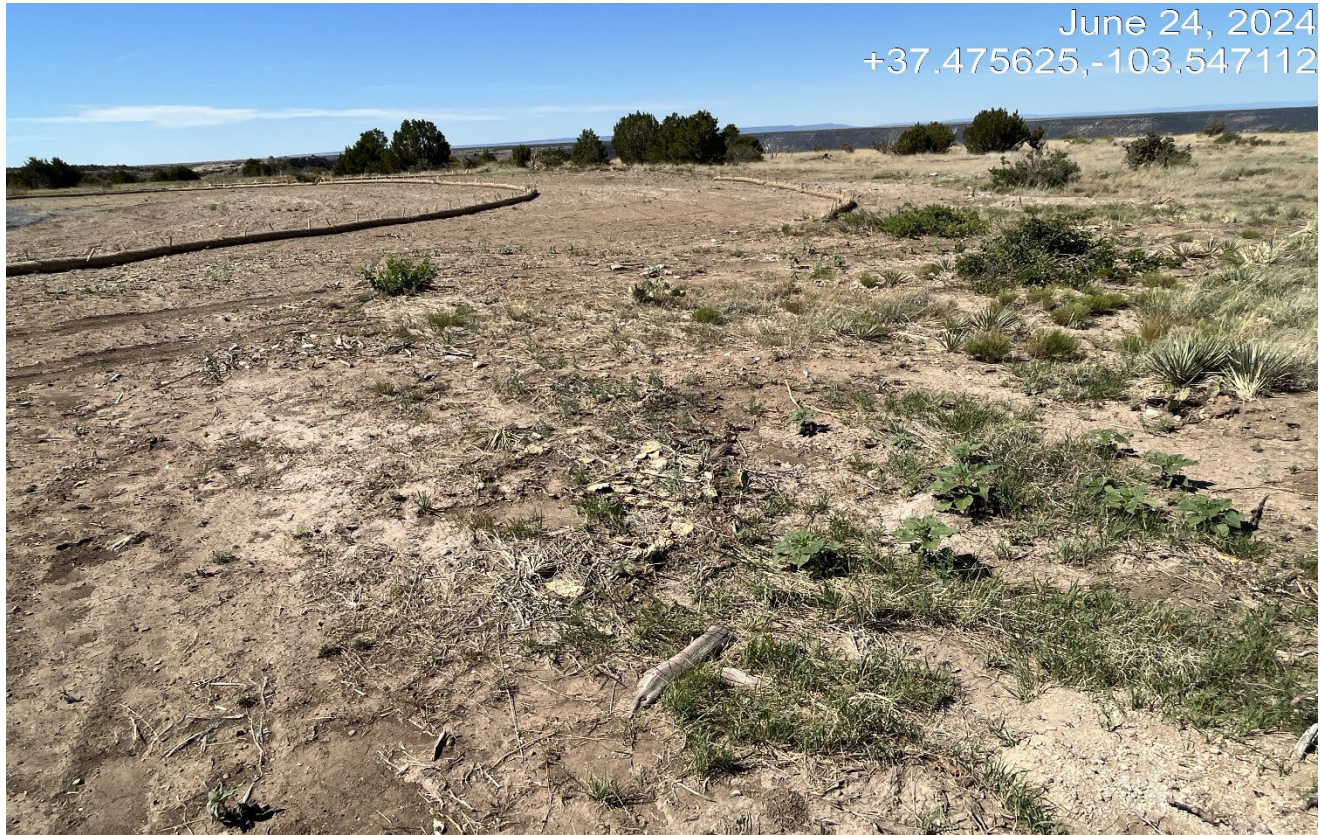
Photo 5. North side of the location facing southwest.

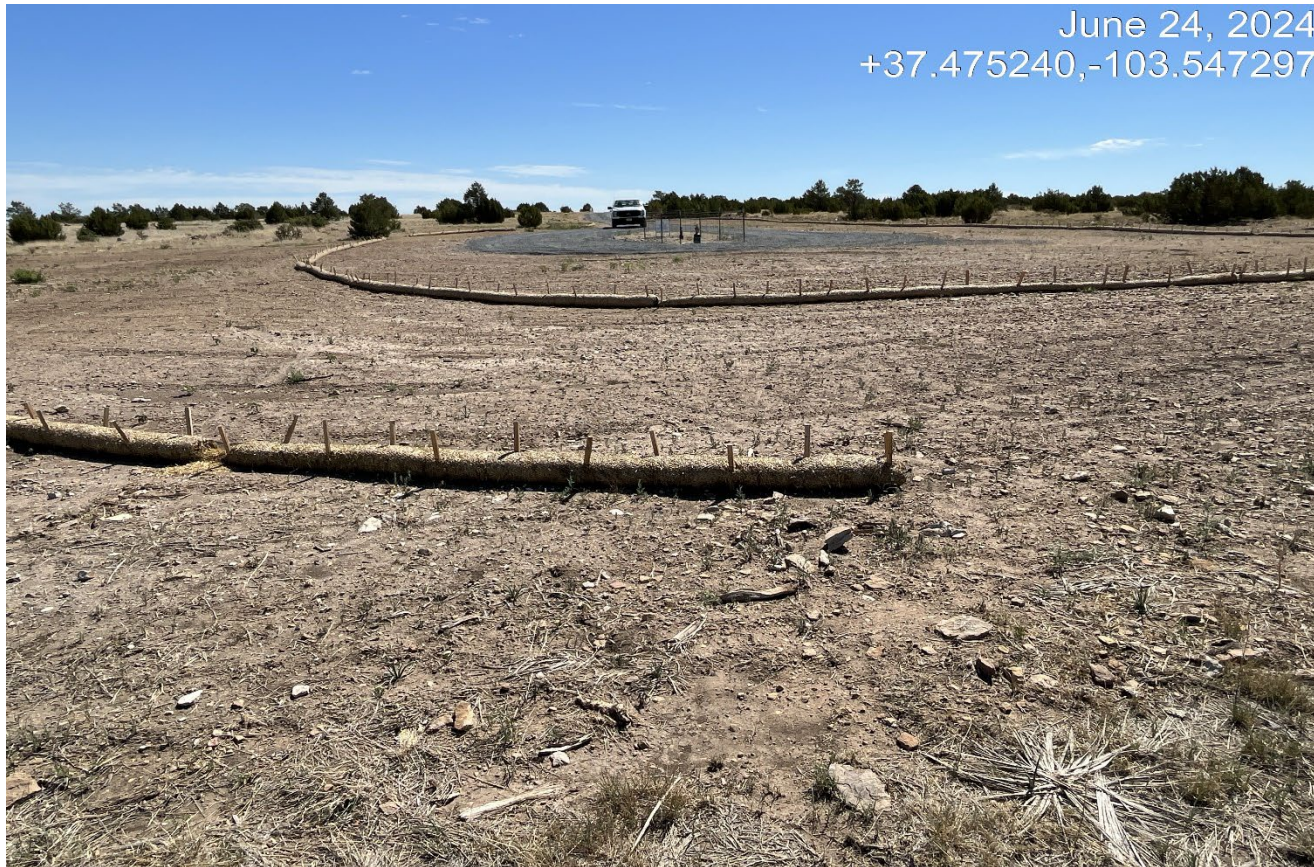
Photo 6. Facing east at the location. The straw wattles have been placed at the disturbance area and where the slope is at the northwest side of location.

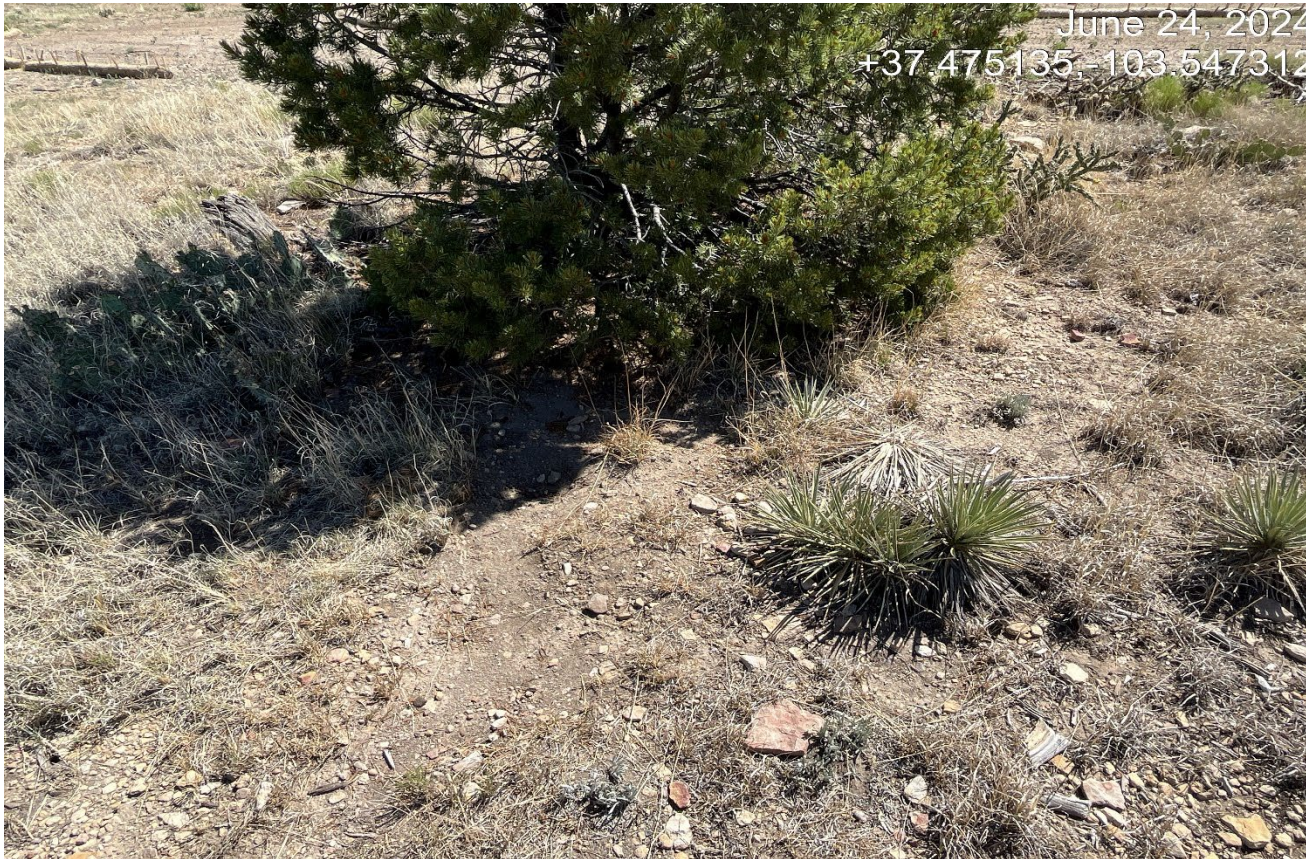
Photo 7. The stained soils have been cleaned up.

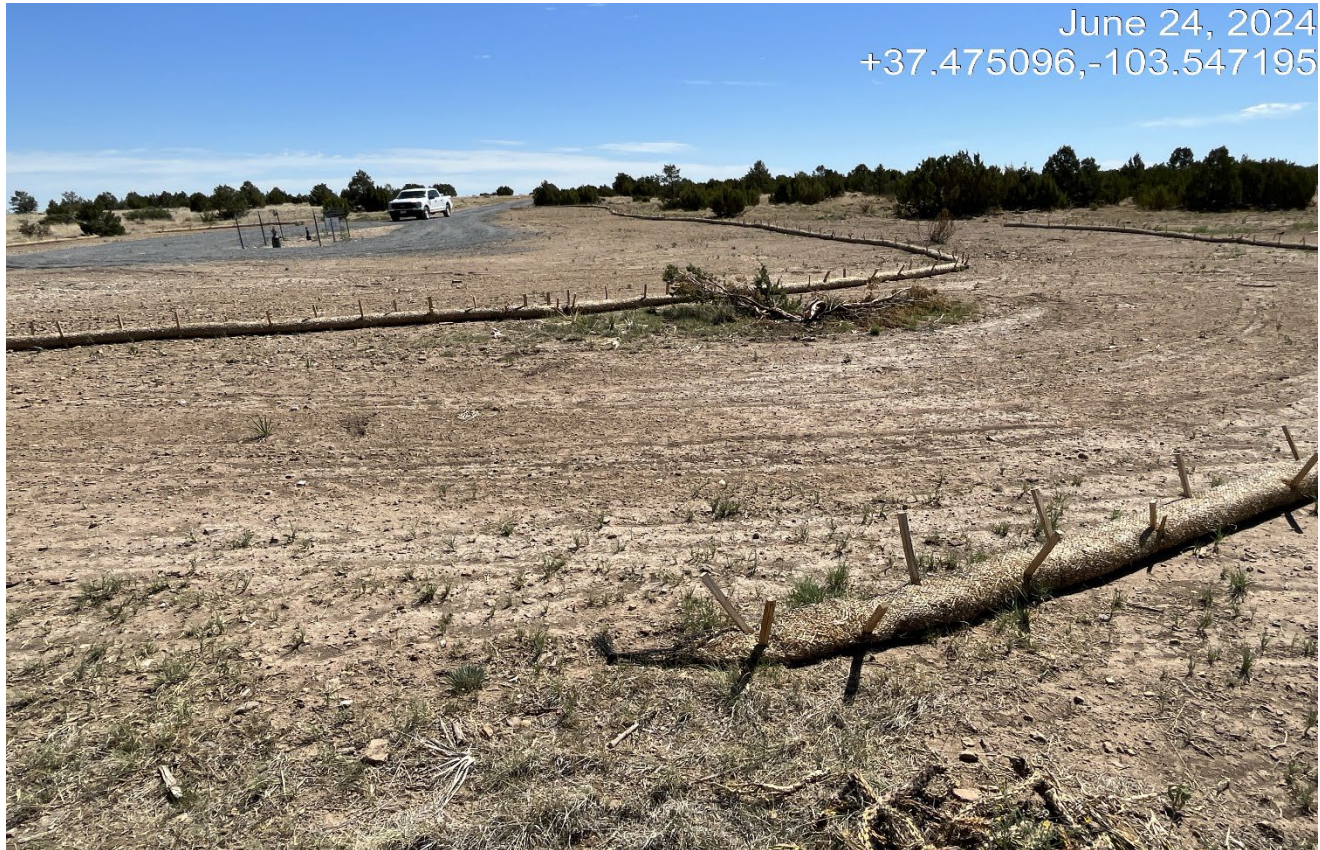
Photo 8. Facing east at the location. Disturbed soils have been seeded and will need to be monitored for vegetation establishment..
