# Inspection Photos

API: 011-06032

Operator: STRACHAN EXPLORATION INC

Inspection Date: 6/26/2024

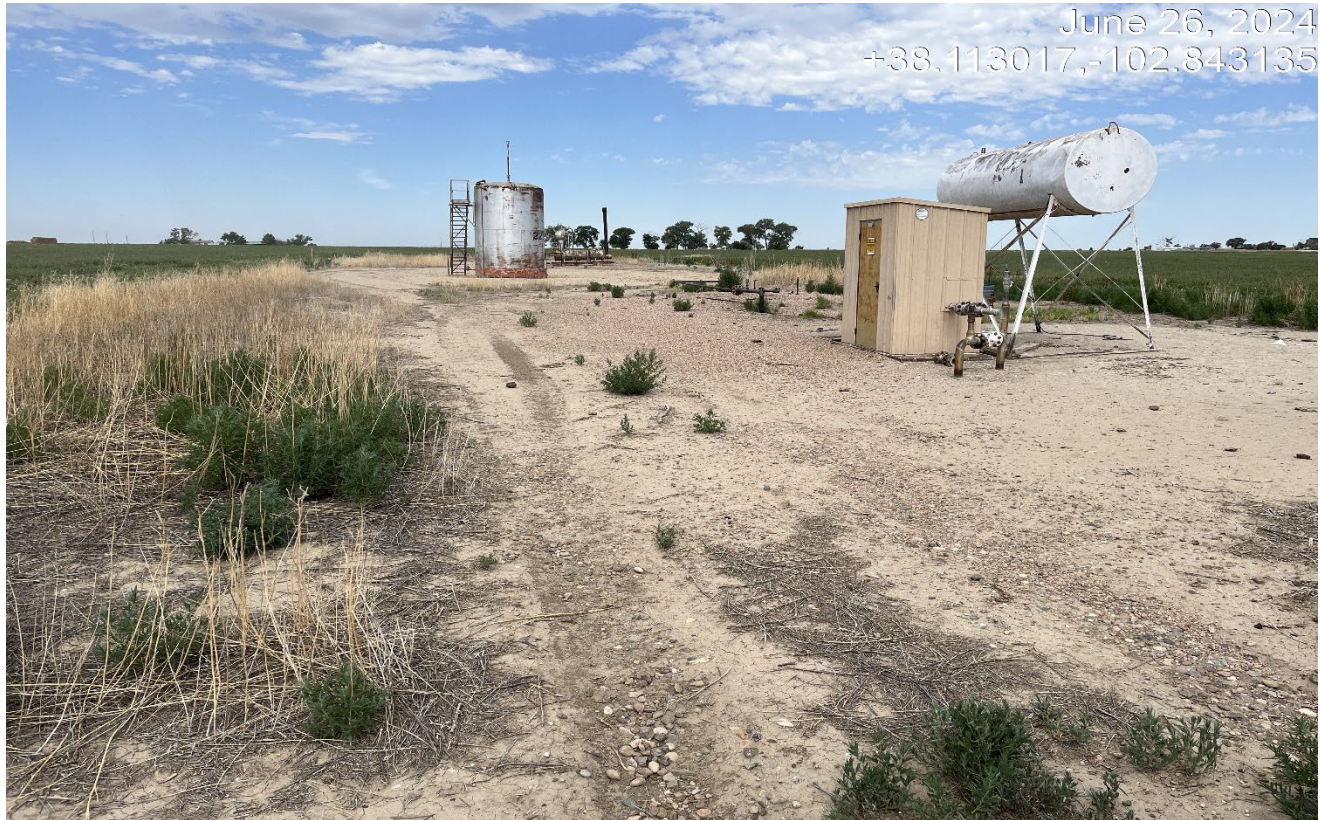
**Photo 1.** Facing west toward the location. There are tall undesirable weeds at the location that need to be controlled and removed. Previous CA was not completed.

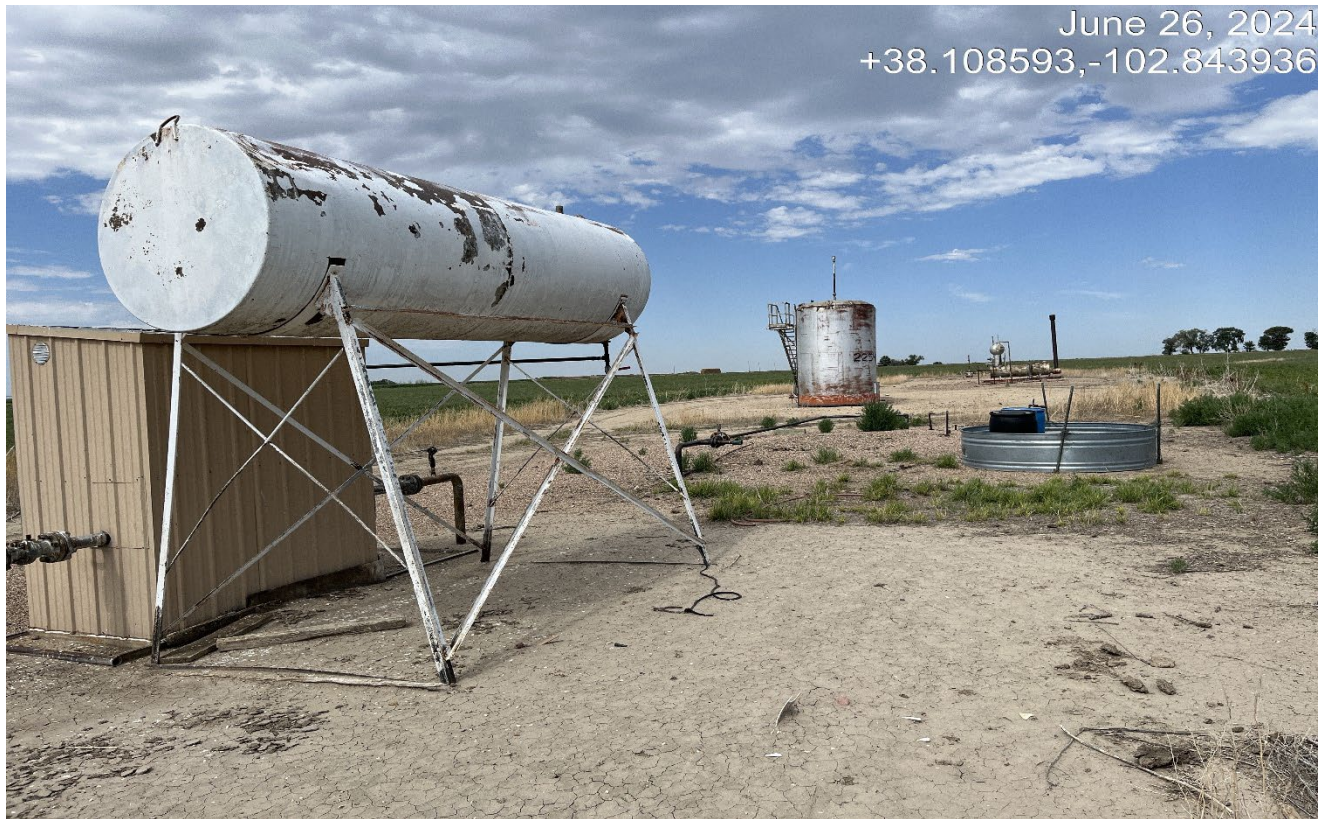
**Photo 2.** Facing toward the meter shed. There is no secondary containment of the fuel/chemical tank behind the shed.

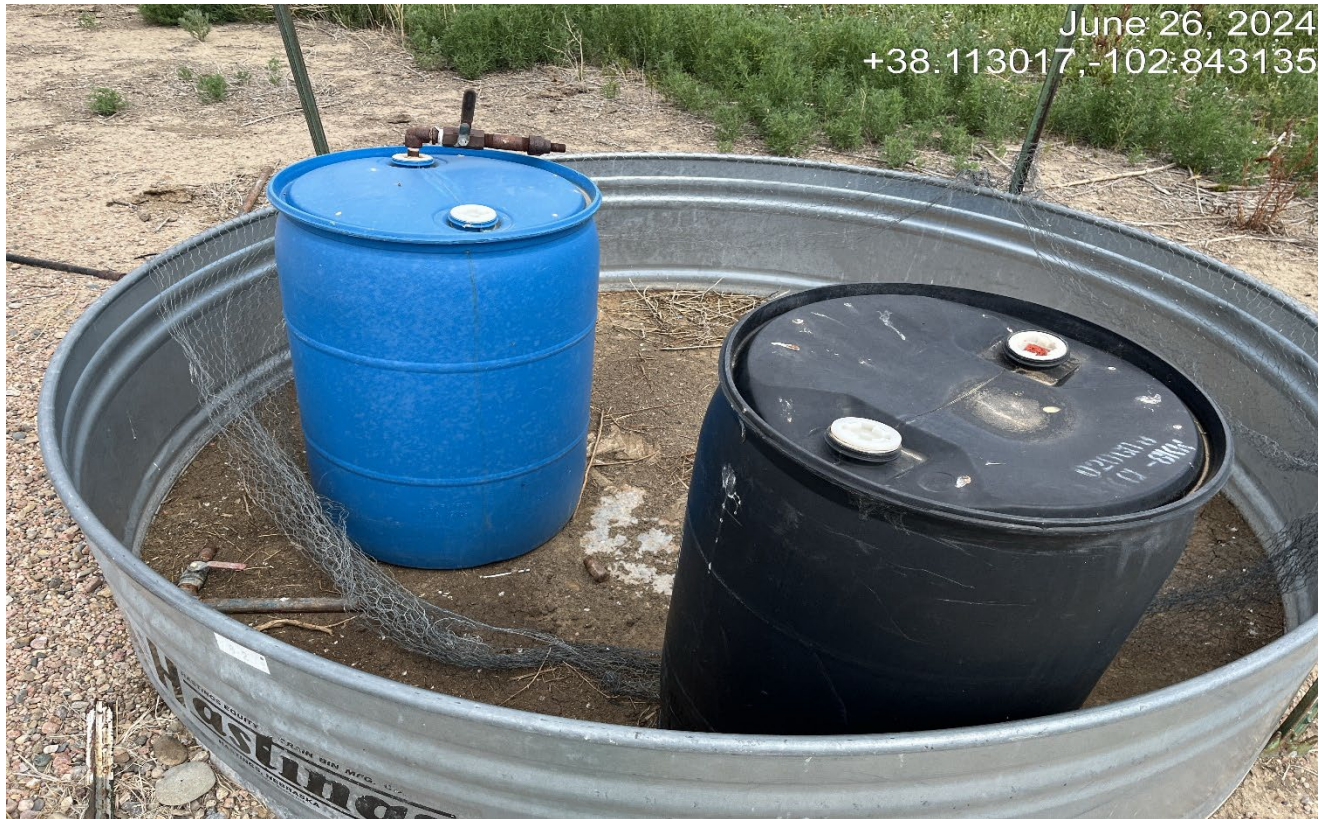
**Photo 3.** There are plastic drums with no labeling and one appears to be empty and not in use.

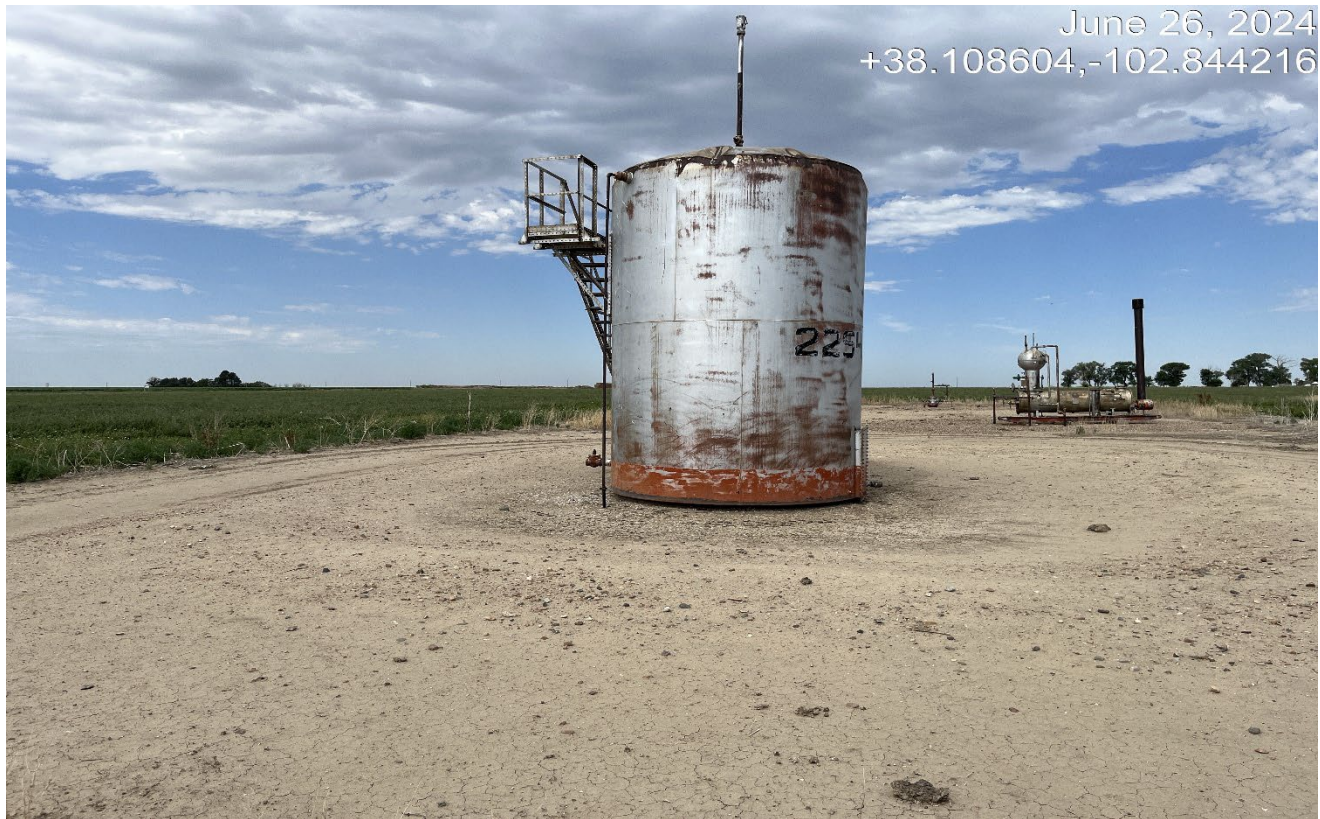
**Photo 4.** Facing toward the tank battery. There is insufficient secondary containment to contain a spill. Previous corrective action was not completed.

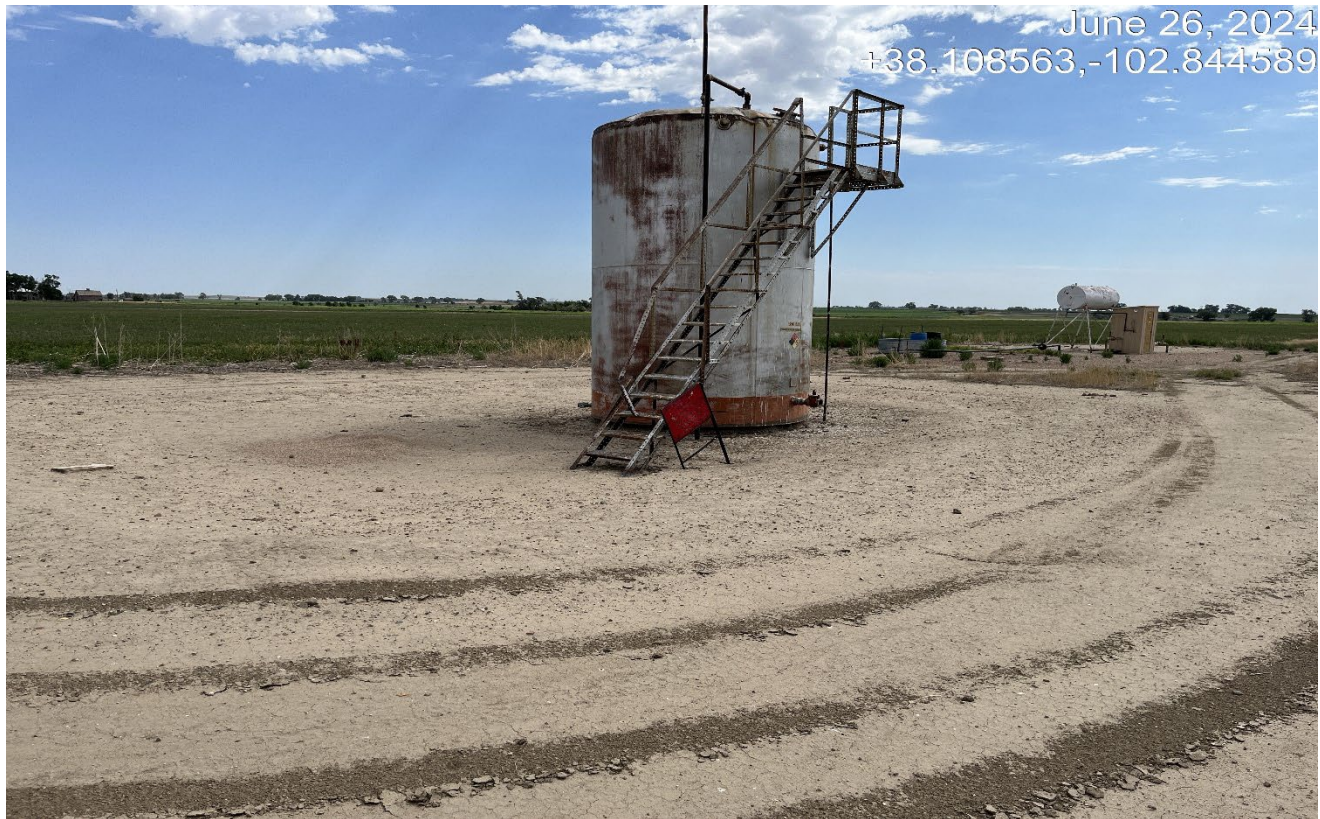
**Photo 5.** The sign at the tank does not reflect the current Operator sand is faded. Previous CA was not completed.

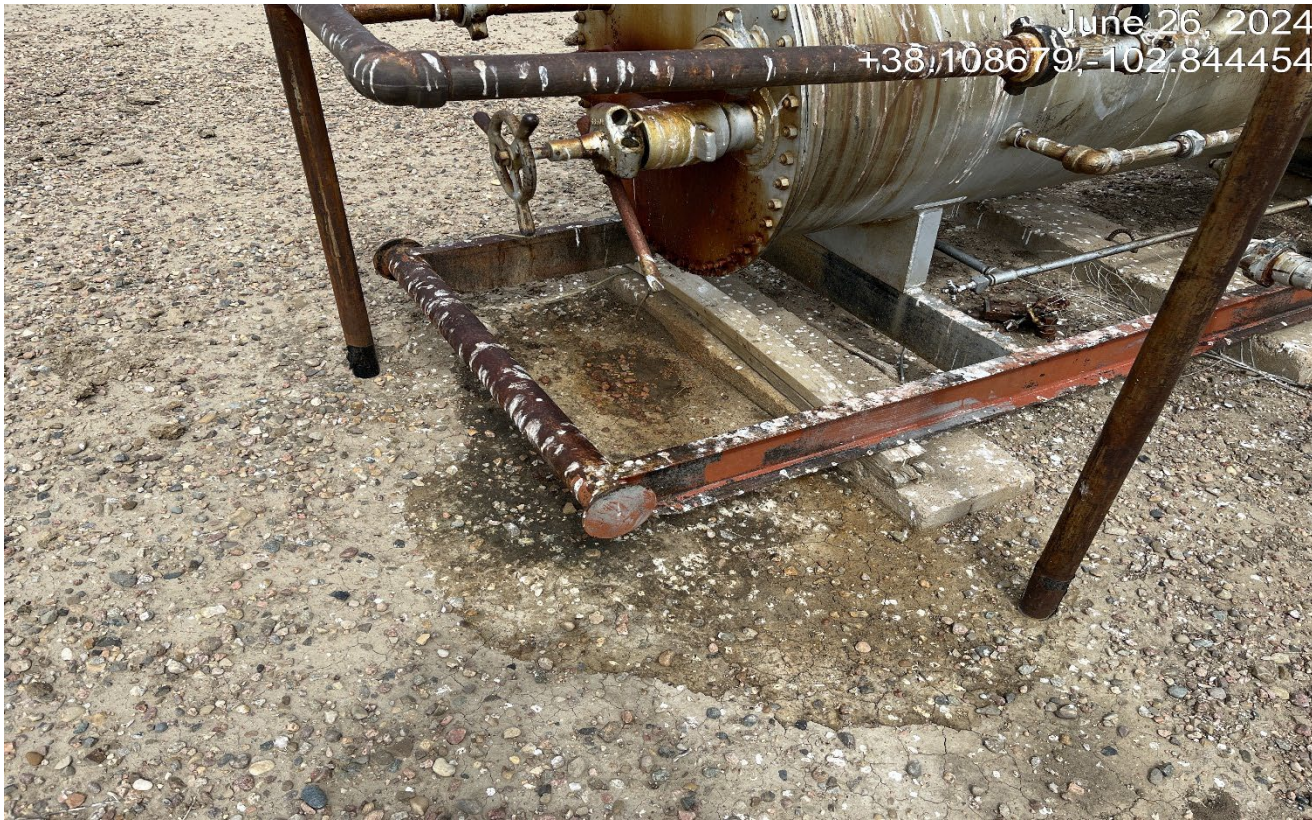
**Photo 7.** There is a dripping leak at the separator and stained soils. Previous corrective action was not completed.

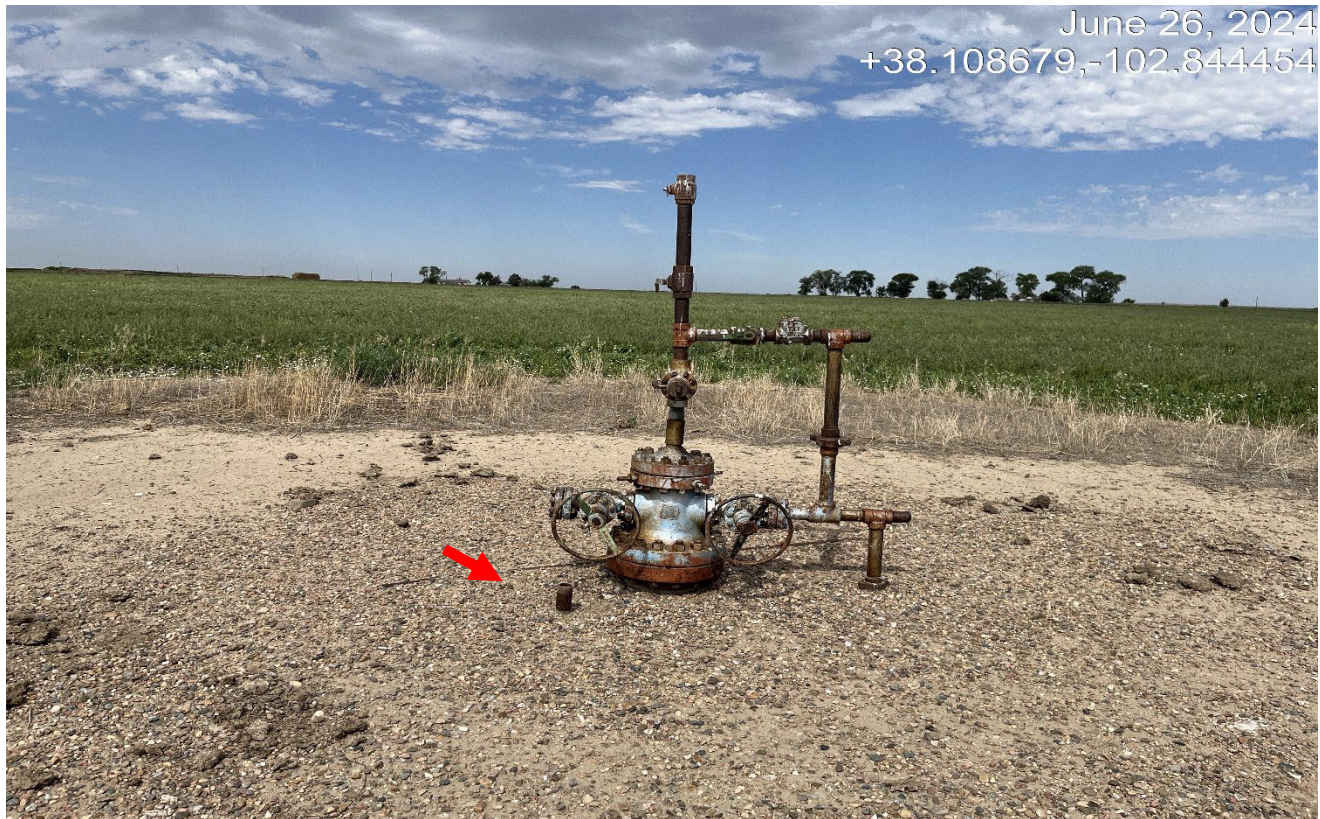
**Photo 8.** Facing toward the well. There is an uncapped pipe riser shown at red arrow.
