Inspection Photos  
Location Name: Antelope 42-19 PAD  
Location ID: 413543

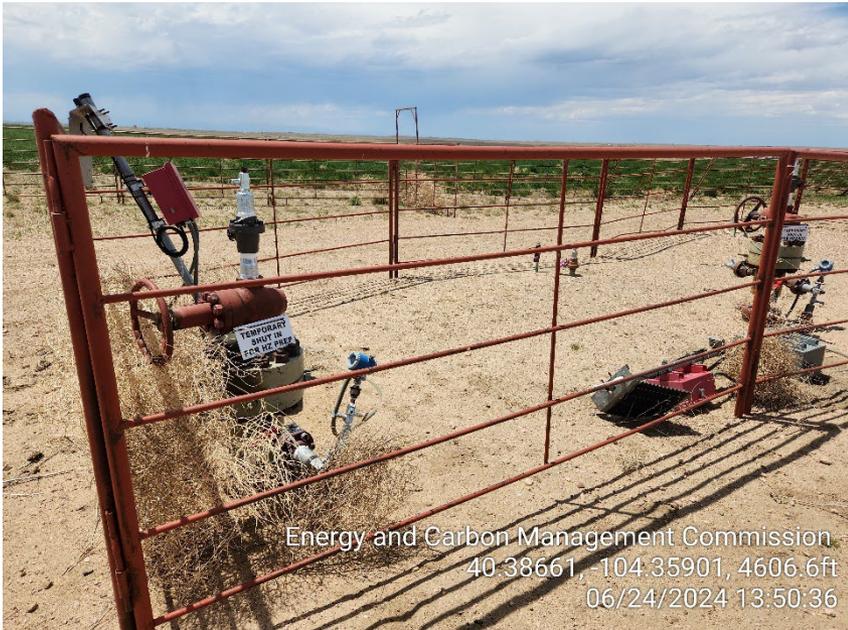
Photo 1 – Wellheads

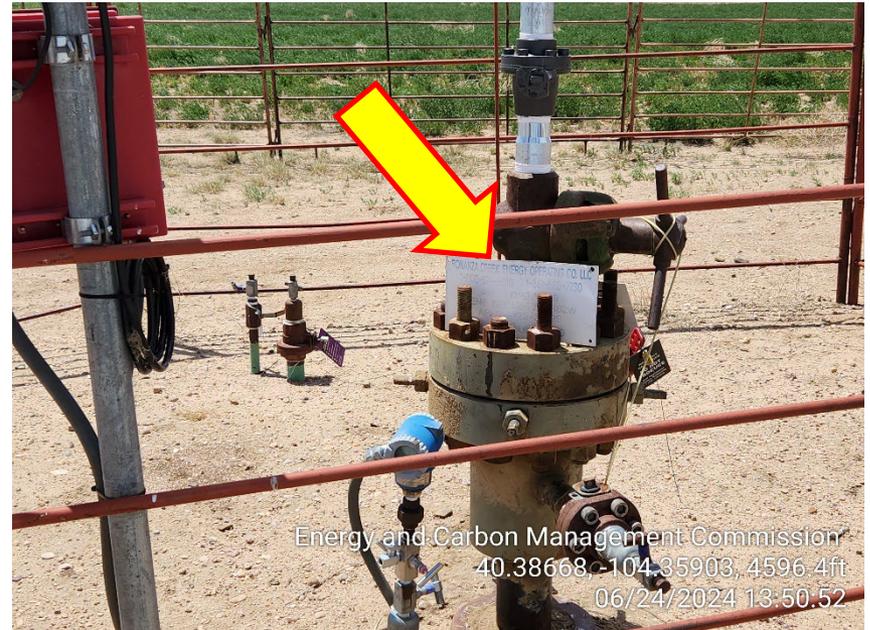
Photo 2 – Wellhead Sign faded no longer visible

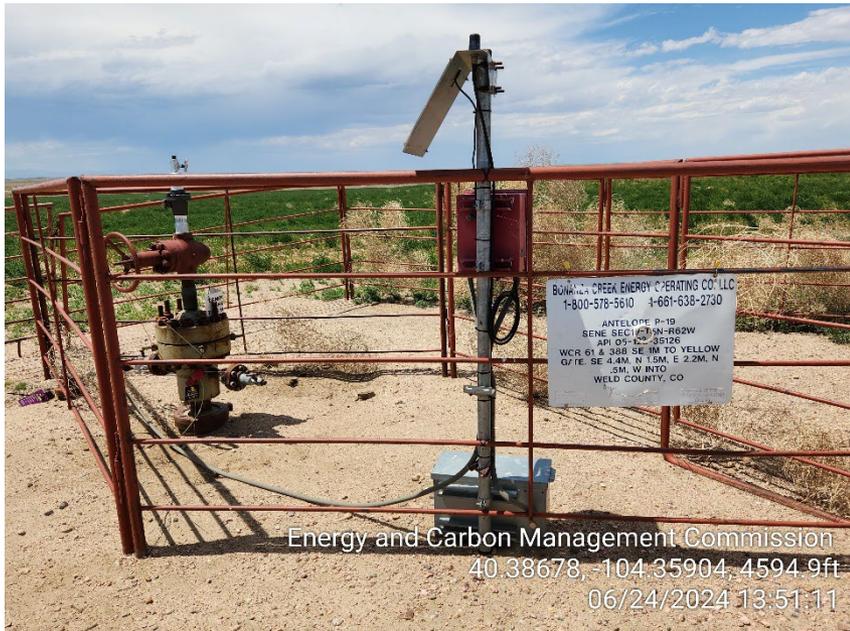
Photo 3 – P-19 Wellhead

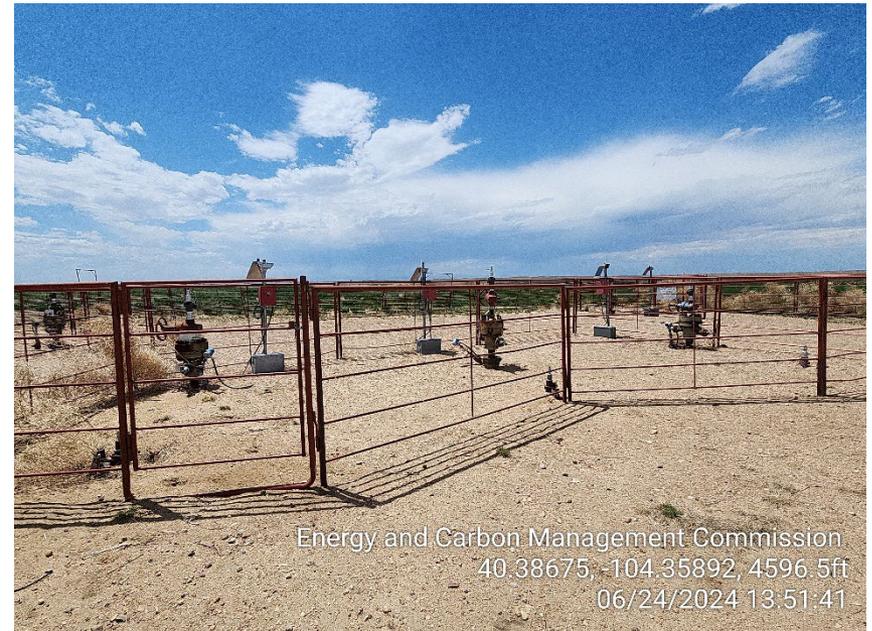
Photo 4 – Wellheads

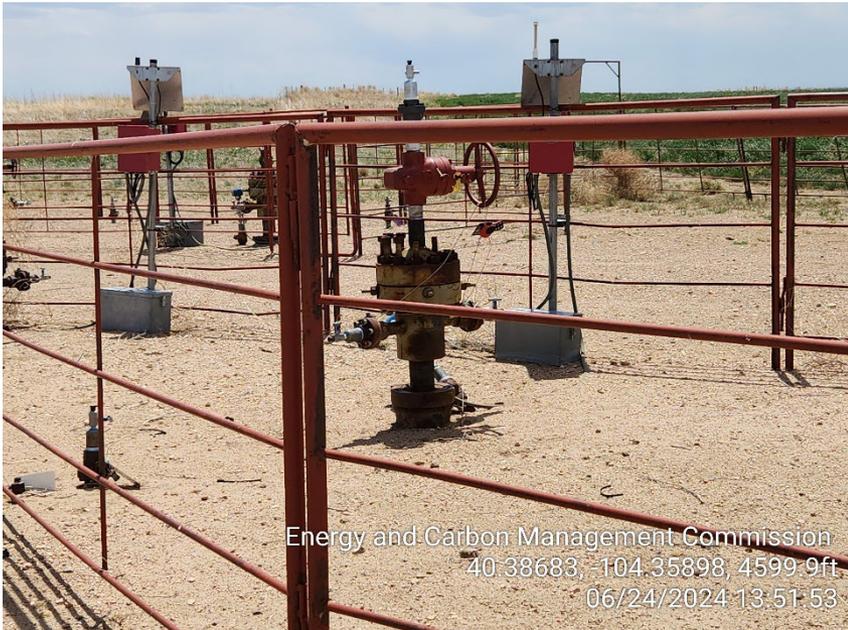
Photo 5 – Wellheads

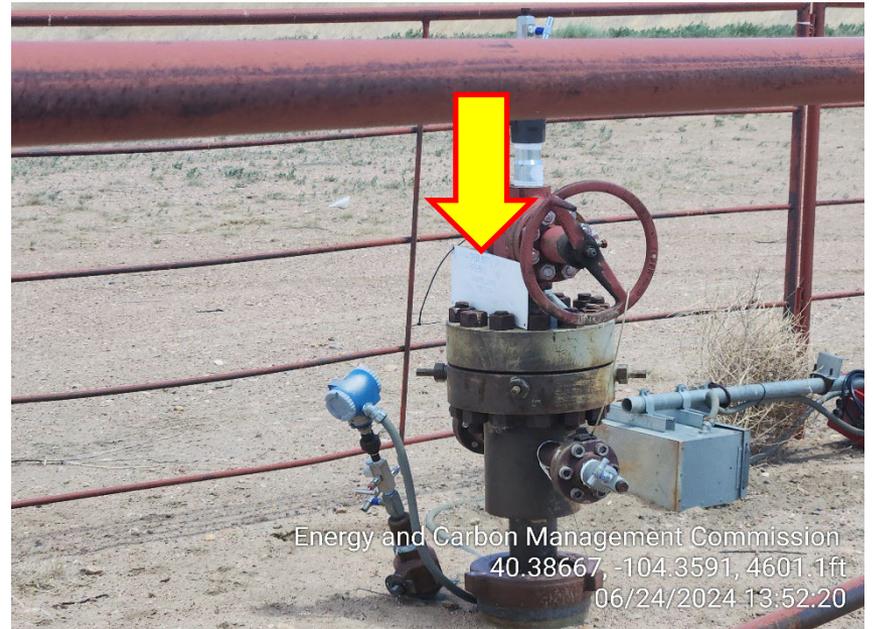
Photo 6 – Wellhead Sign has faded no longer visible

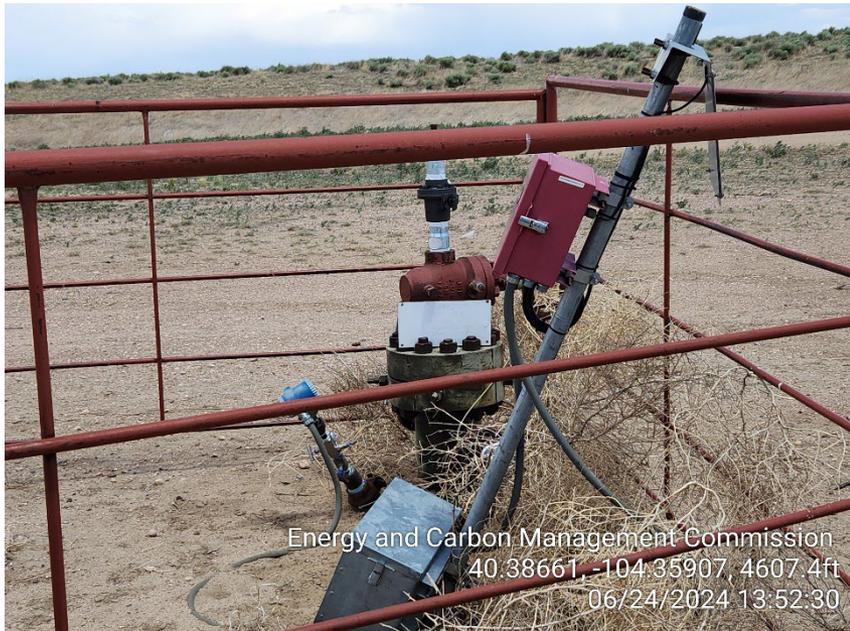
**Photo 7 – Wellhead Sign has faded no longer visible**

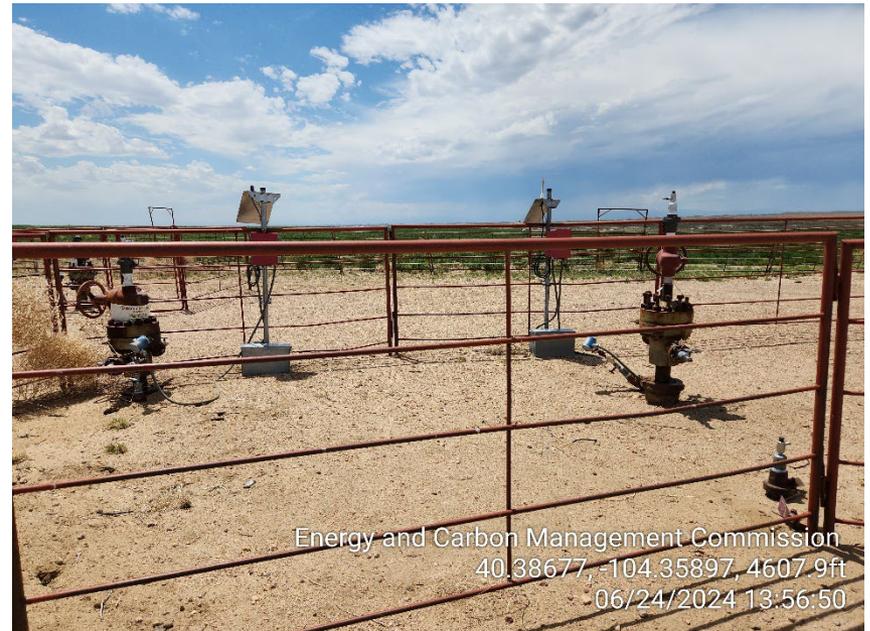
**Photo 8 – Wellheads – 42-19 Sign is on wrong well  
not 19G Sign is missing**

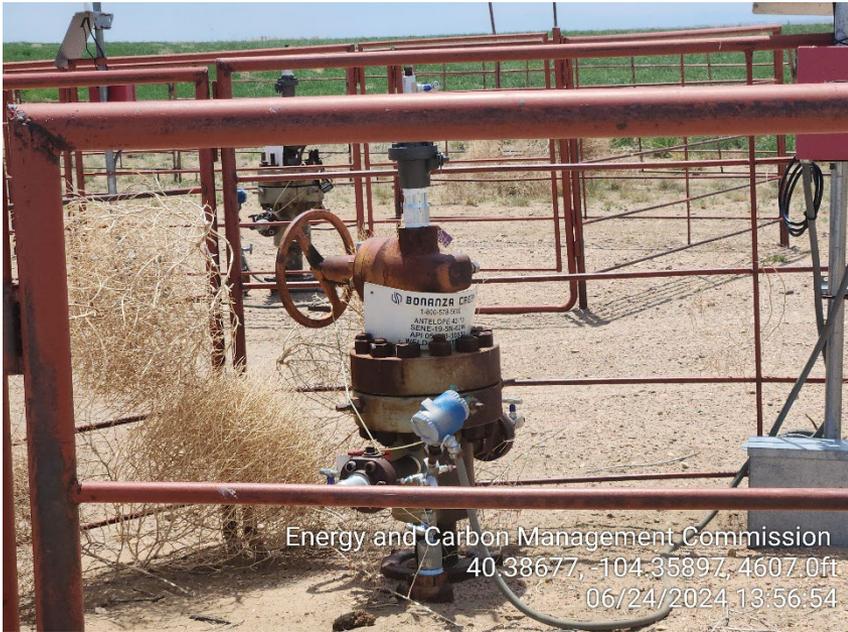
**Photo 9 – Sign is on Wrong Missing. This 19G NOT  
42-19**
