# Inspection Photos

ID: 444661

Operator: STRACHAN EXPLORATION INC

Inspection Date: 6/26/2024

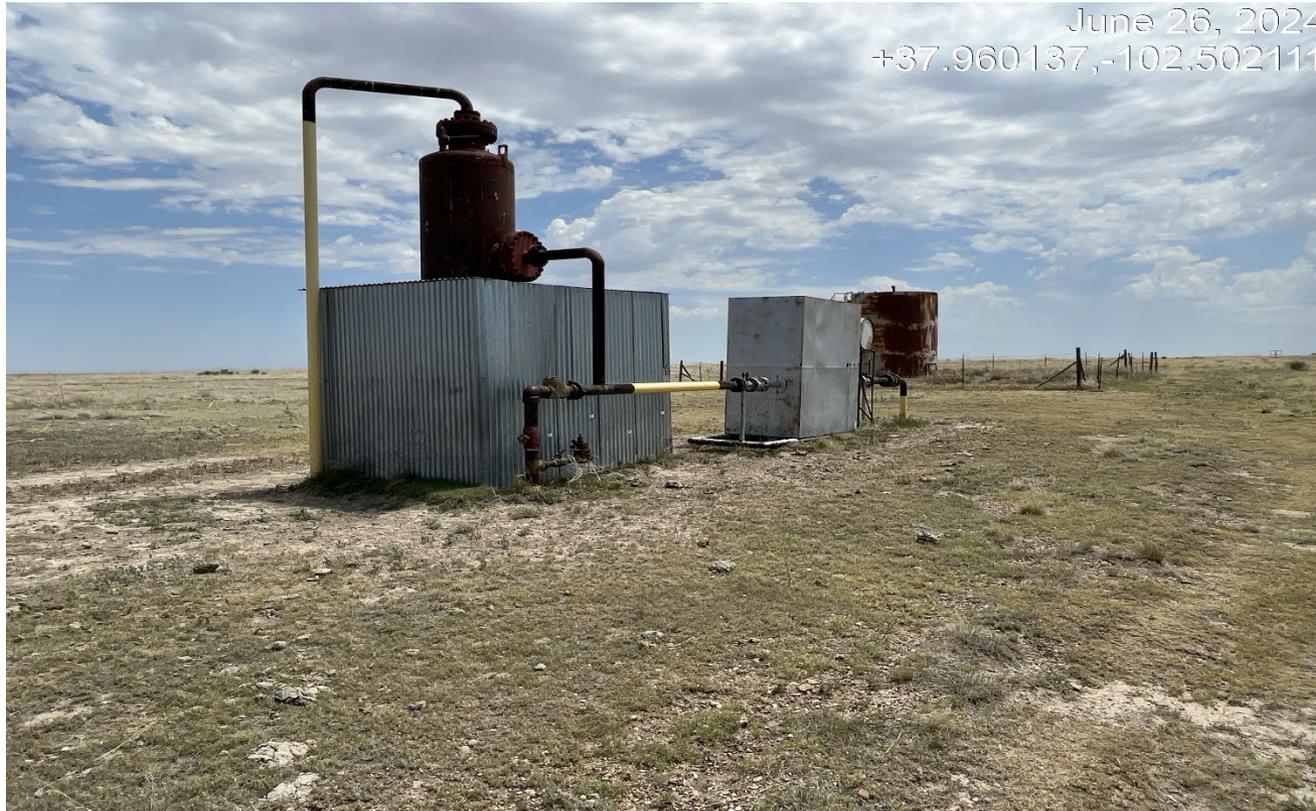
**Photo 1.** Facing northeast toward the compressor facility.

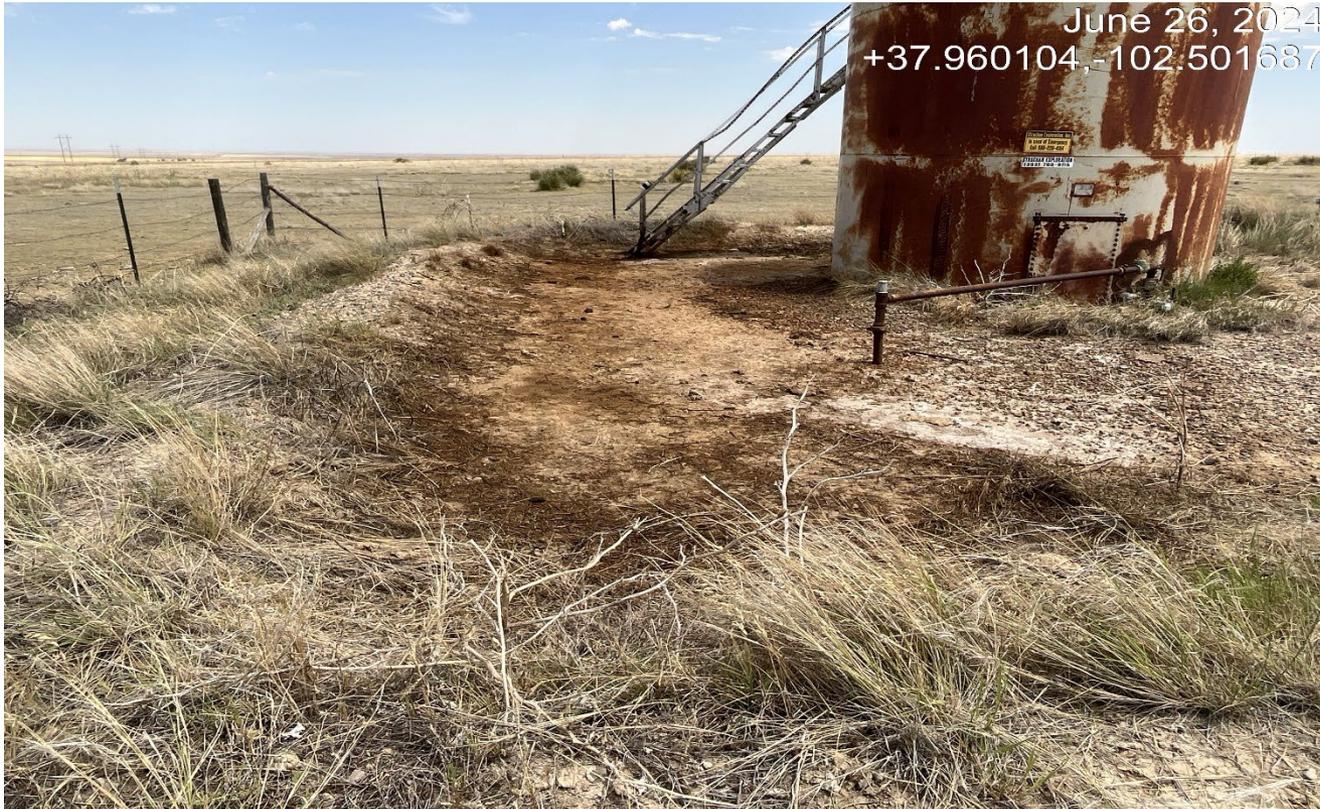
**Photo 2.** Facing northeast toward the tank. The leak that had occurred was not cleaned up. There is insufficient labeling and signage at the tank. Previous corrective action was not completed.

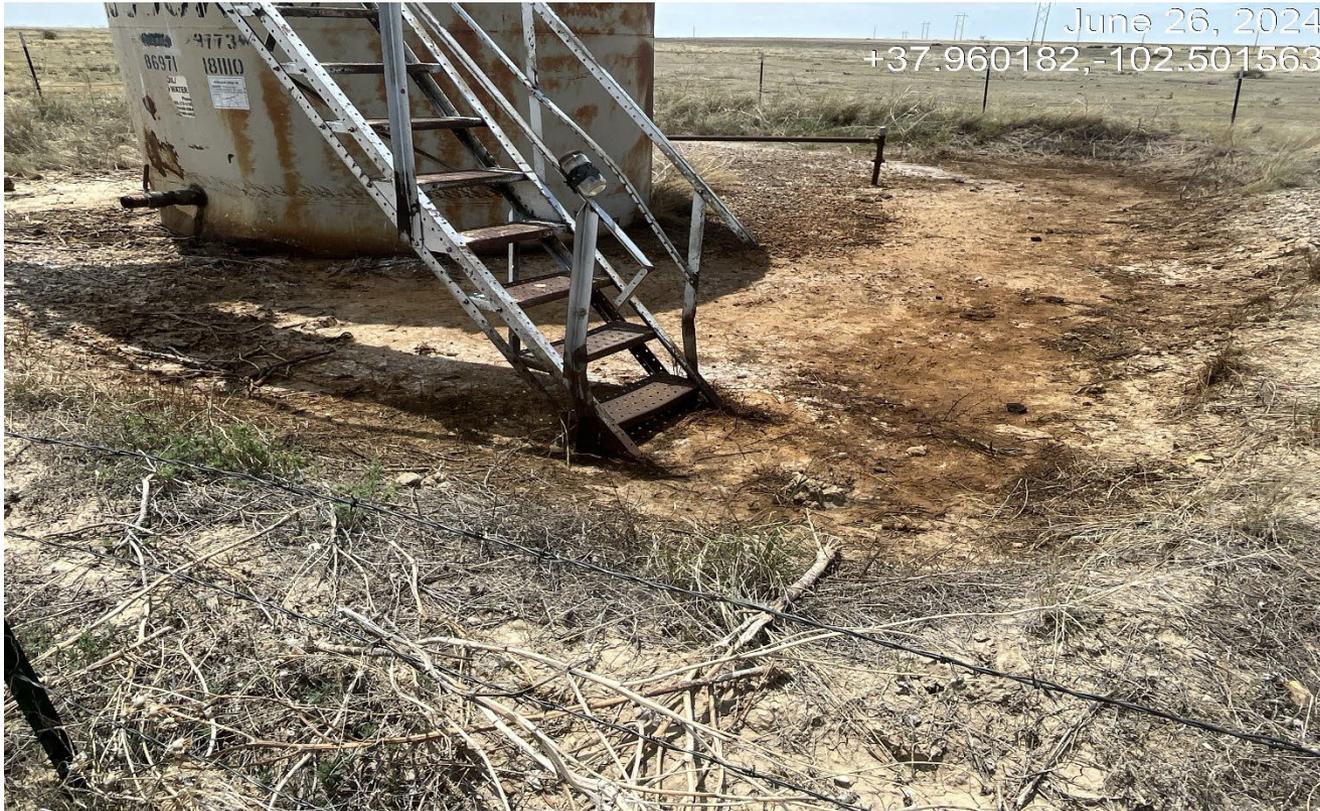
**Photo 3.** Facing east toward the tank. The leak that had occurred was not cleaned up. There is insufficient labeling and signage at the tank. Previous corrective action was not completed.

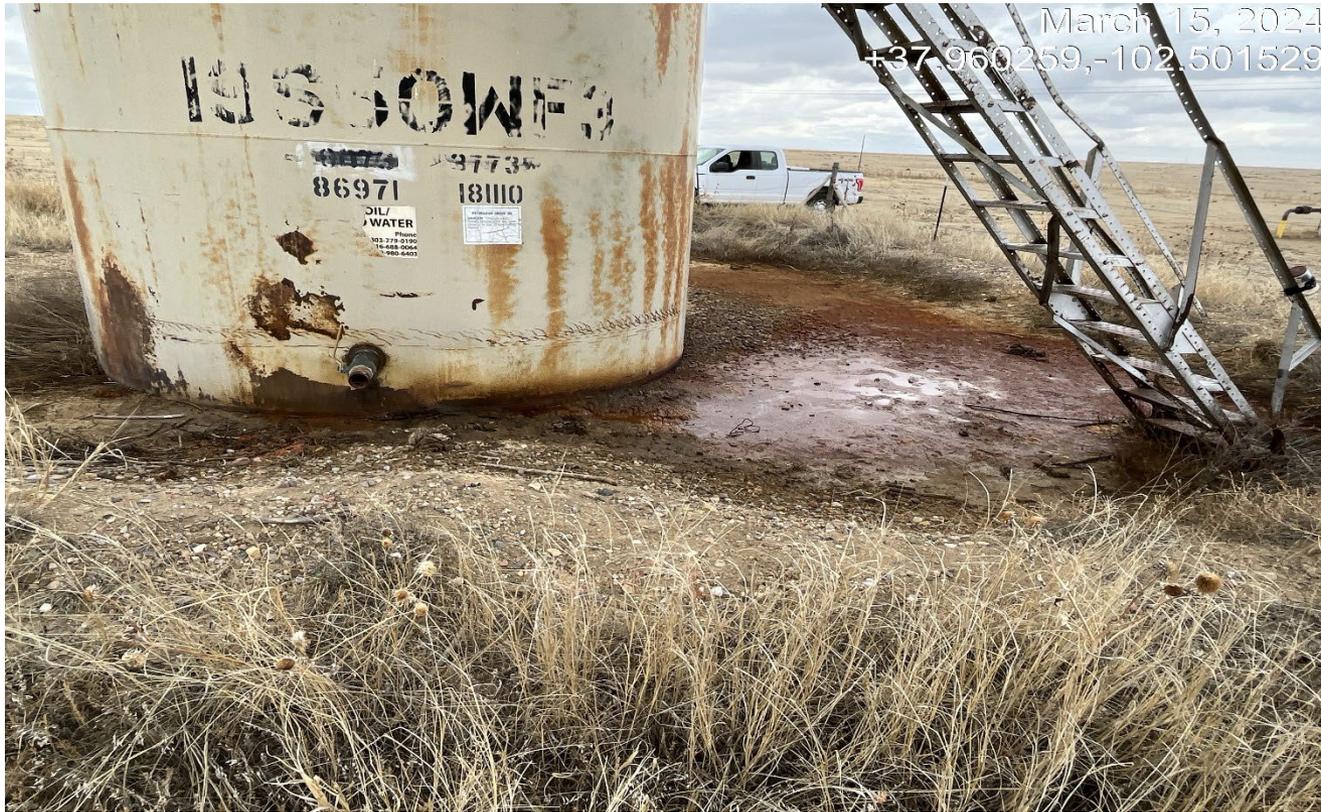
**Photo 4.** This photo was taken during the previous inspection on 3/15/2024.

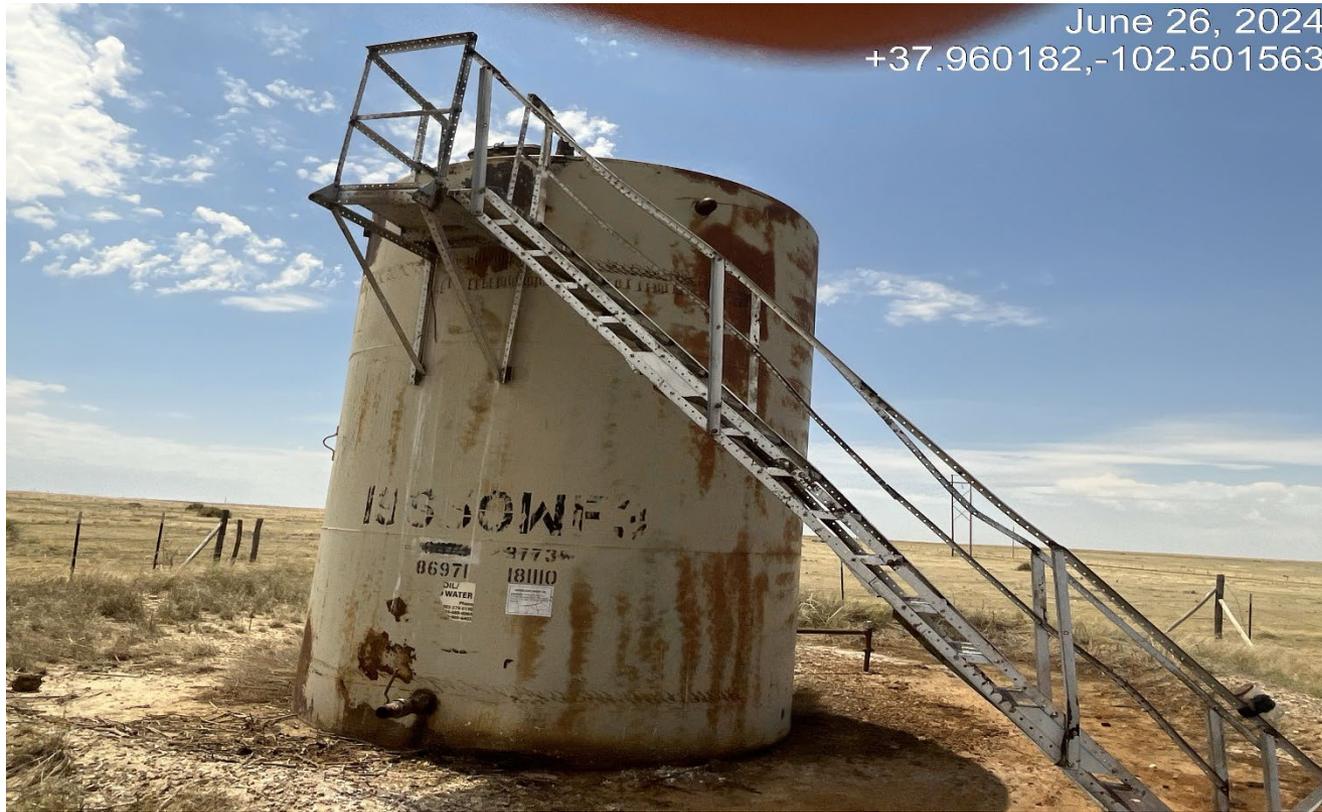
**Photo 5.** The migratory bird nest has been removed since the previous inspection.
