Inspection Photos

API: 099-06872

Operator: STRACHAN EXPLORATION INC

Inspection Date: 6/26/2024

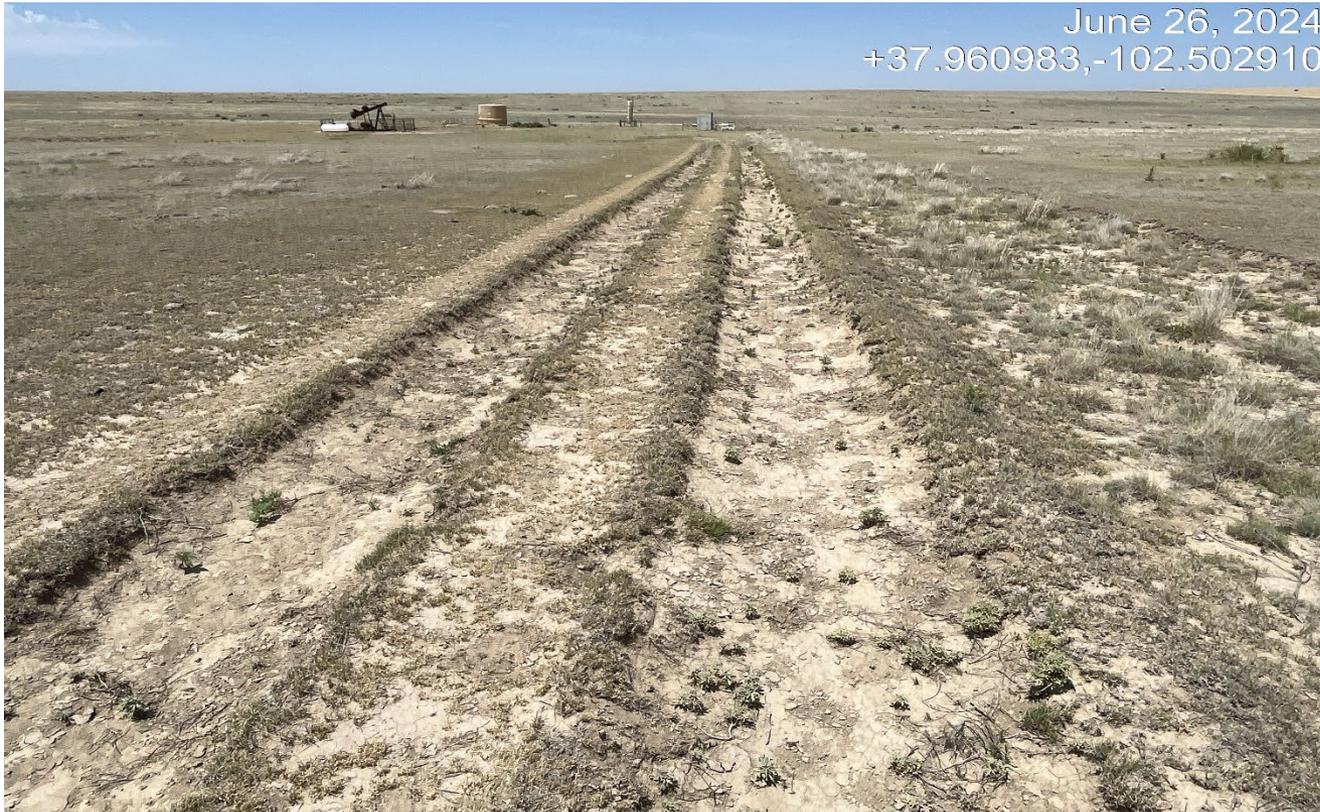
Photo 1. Facing east along the access road. There are deep ruts in the road and there are now vehicle tracks driving off the two track which is widening the road. The vehicle ruts need to be repaired and stabilized.

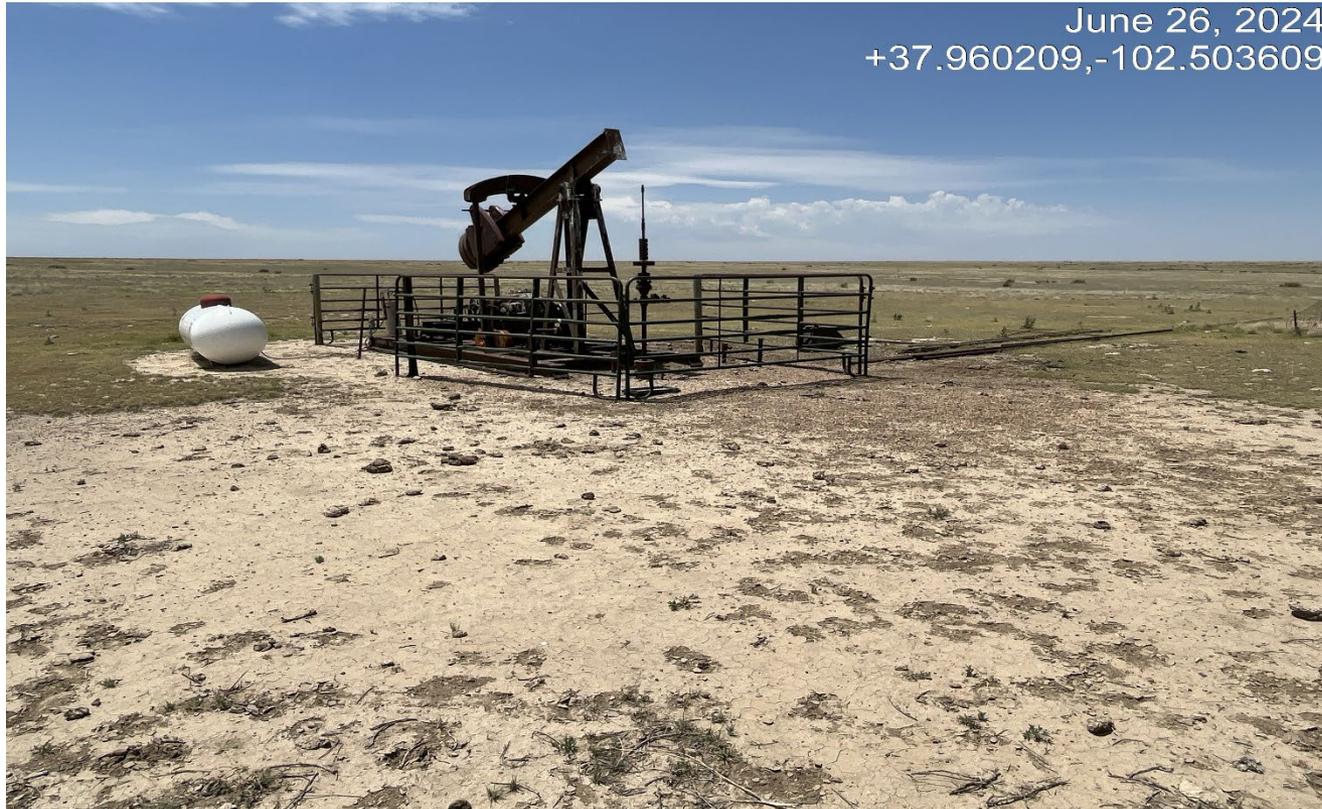
Photo 2. Facing southwest at the wellsite. There was no sign posted at the wellsite.

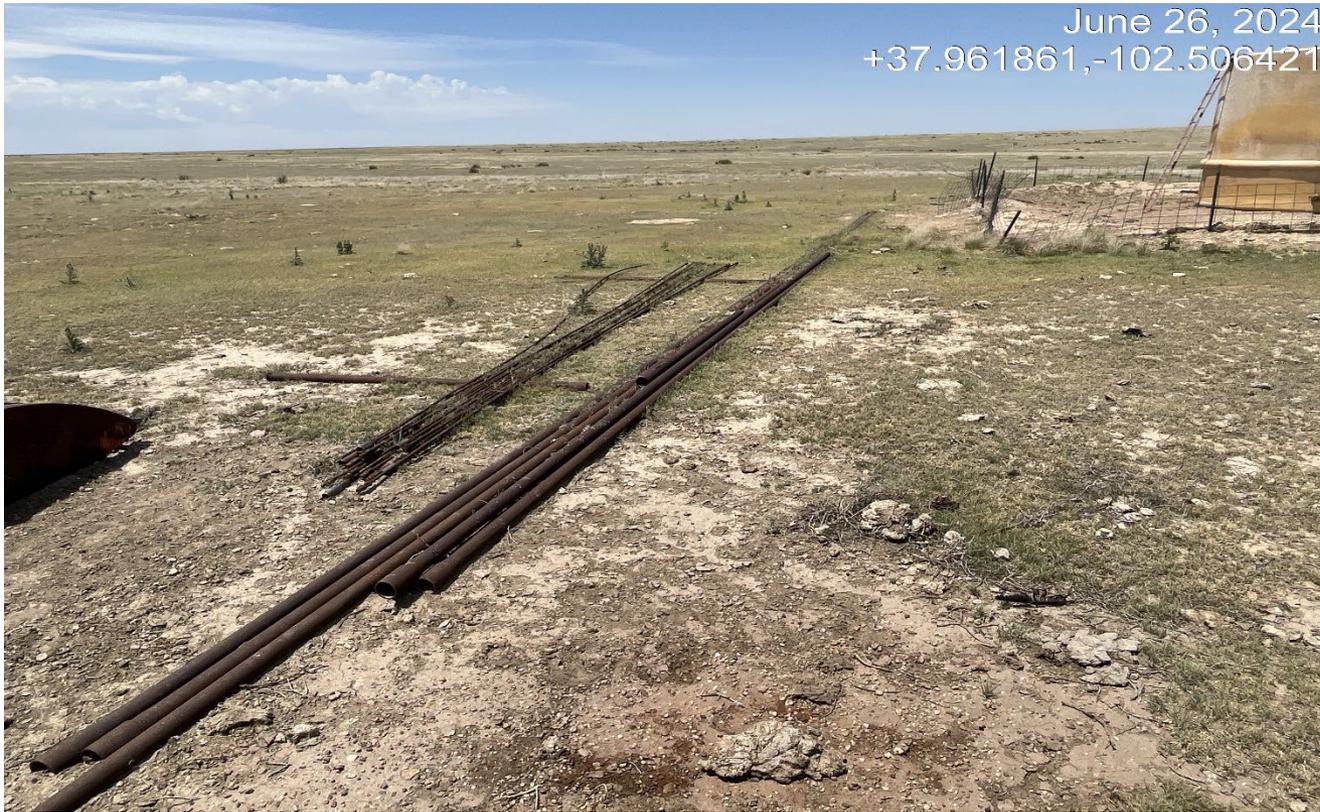
Photo 3. Facing southwest by the well. There is unused equipment and drilling pipe that needs to be removed. Previous corrective action was not completed.

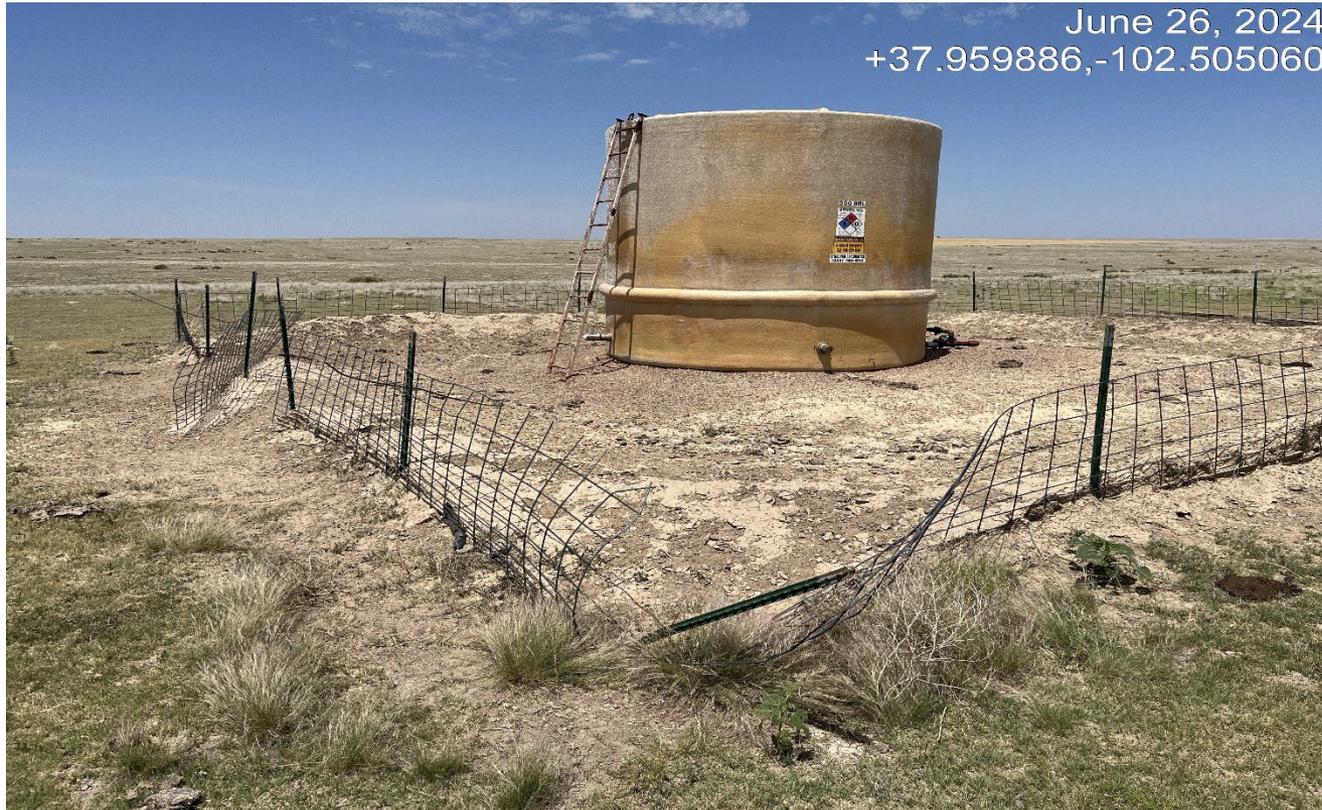
Photo 4. Facing toward the fiberglass tank. The fence around the tank is not maintained to prevent livestock entry.

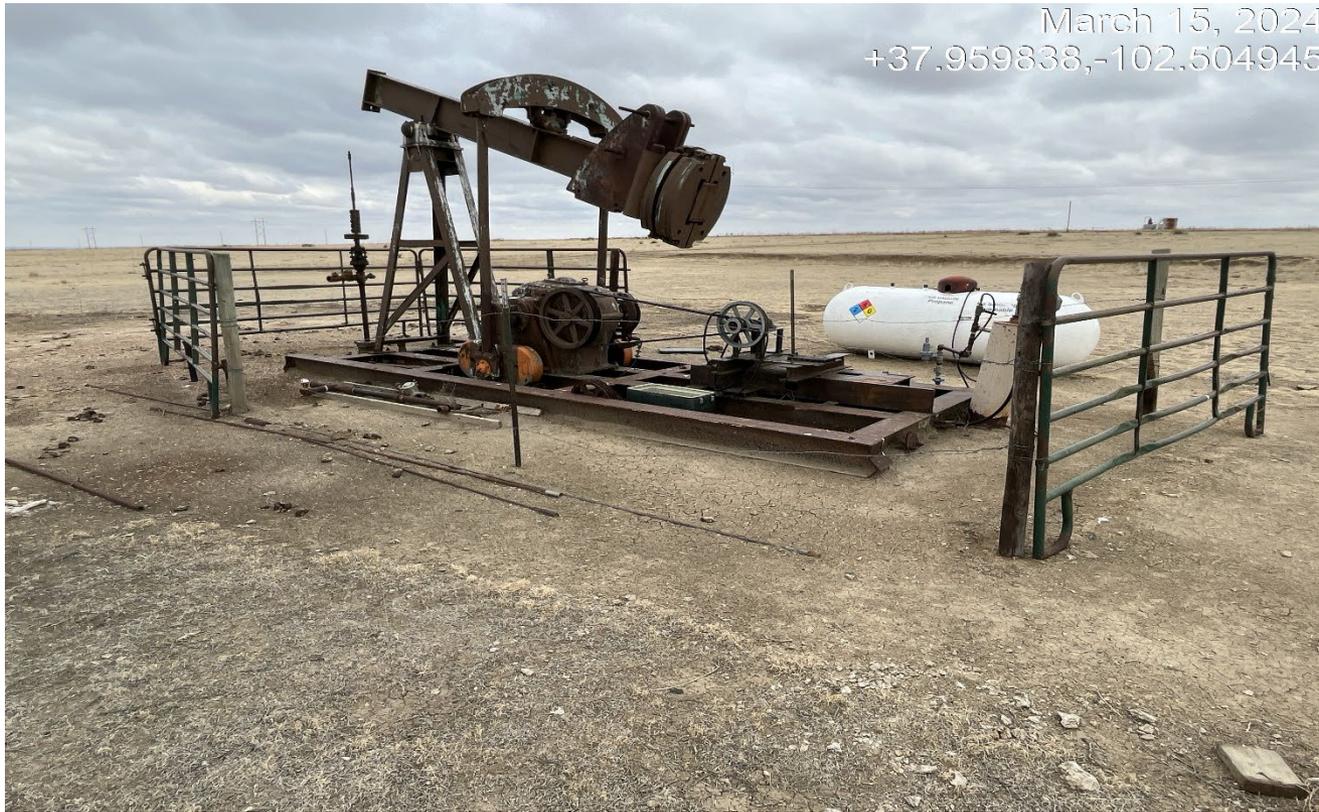
Photo 5. The fence around the pumpjack is insufficient to prevent livestock entry.
