Inspection Photos

Location Name: TEP Rocky Mountain LLC BRYNILDSON 13C-20-692 Pad

Location # 335379

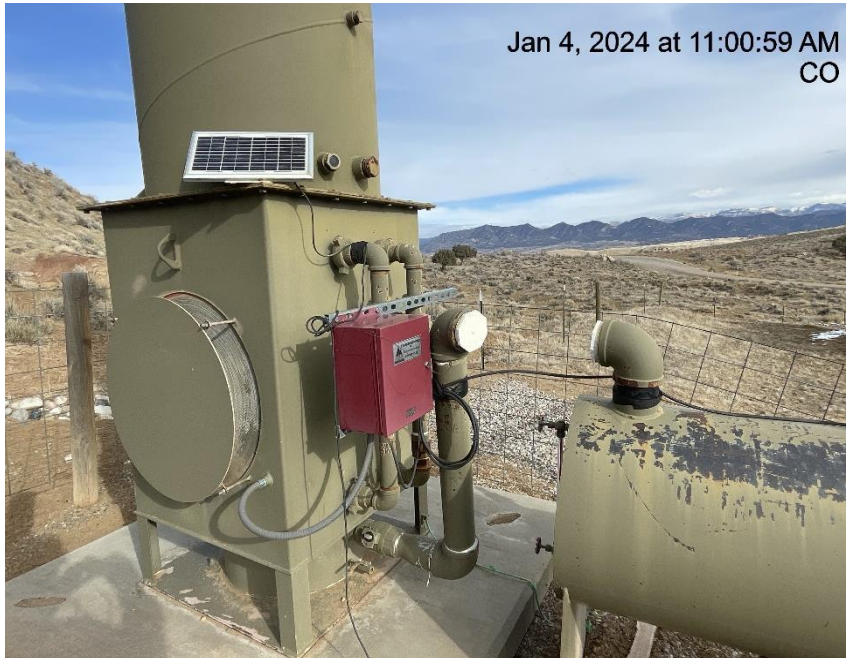
Photo # 1727 From inspection 708902717 conducted on 01/04/2024 Unused equipment – ECD disconnected

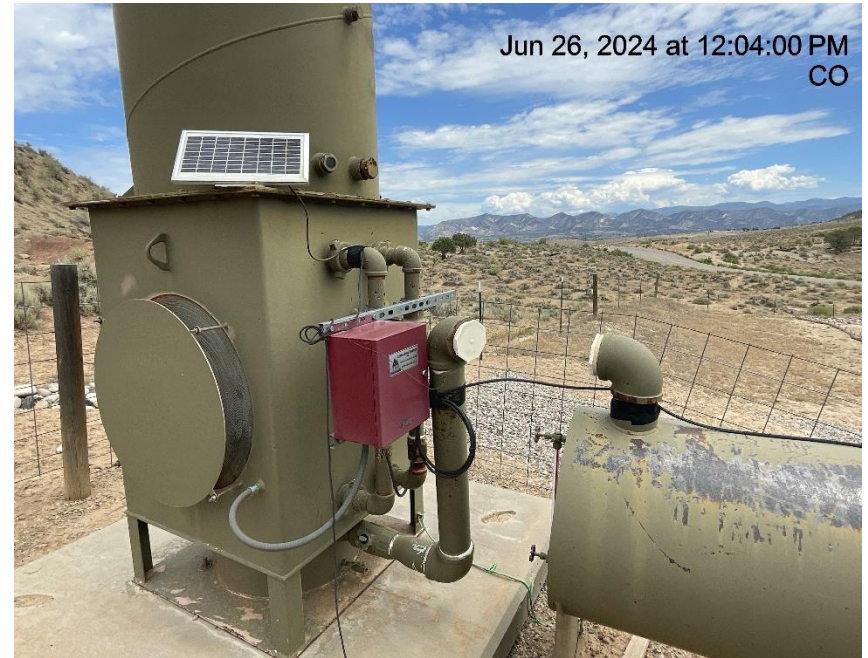
Photo # 1603 Unused equipment – ECD disconnected & not in use

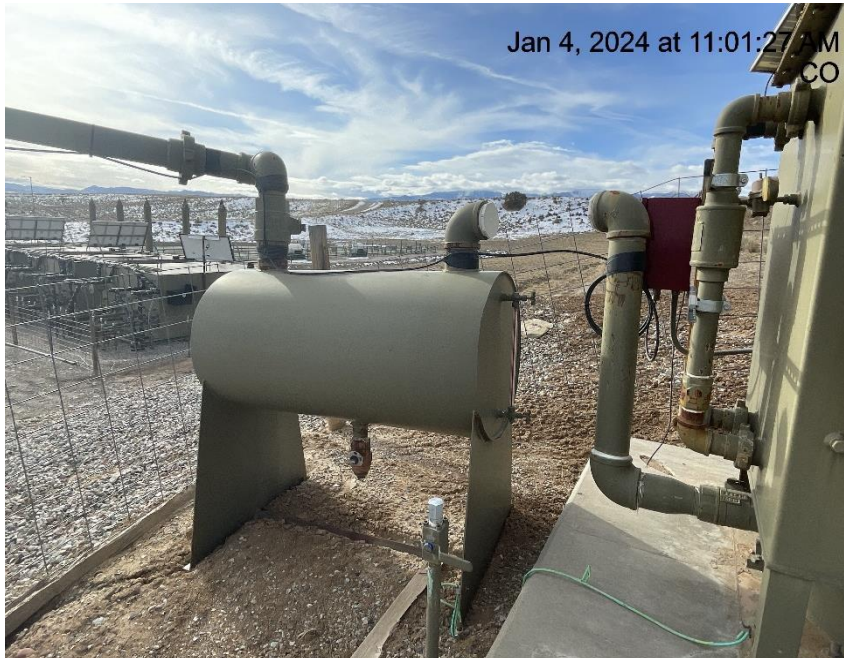
Photo # 1728 From inspection 708902717 conducted on 01/04/2024 Unused equipment – ECD disconnected

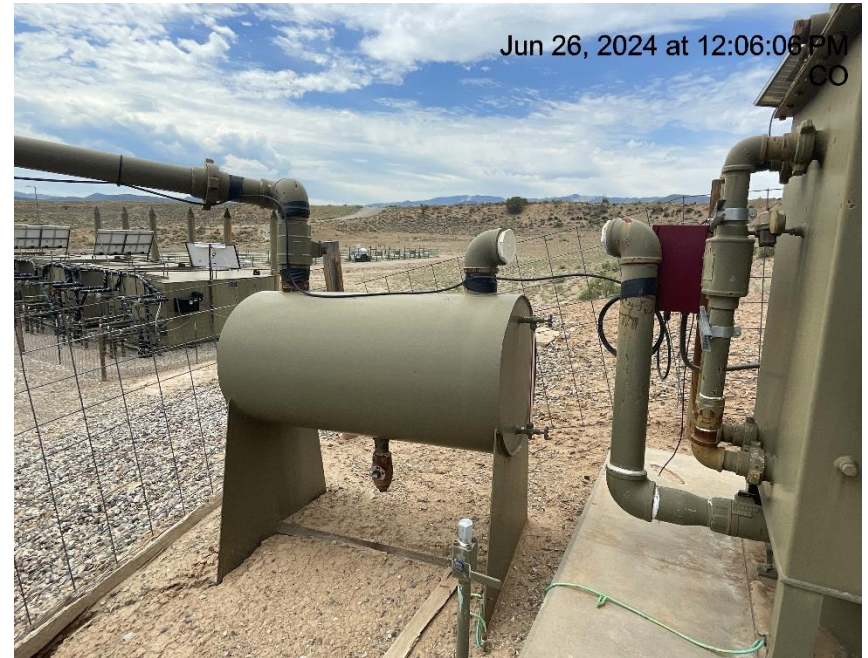
Photo # 1604 Unused equipment – ECD disconnected & not in use

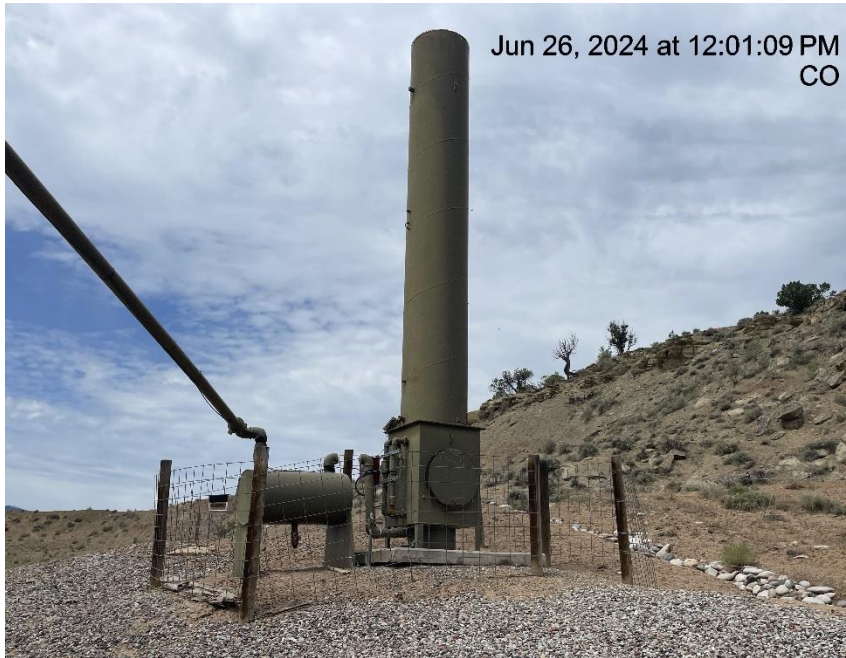
Photo # 1605 Unused equipment – ECD disconnected & not in use

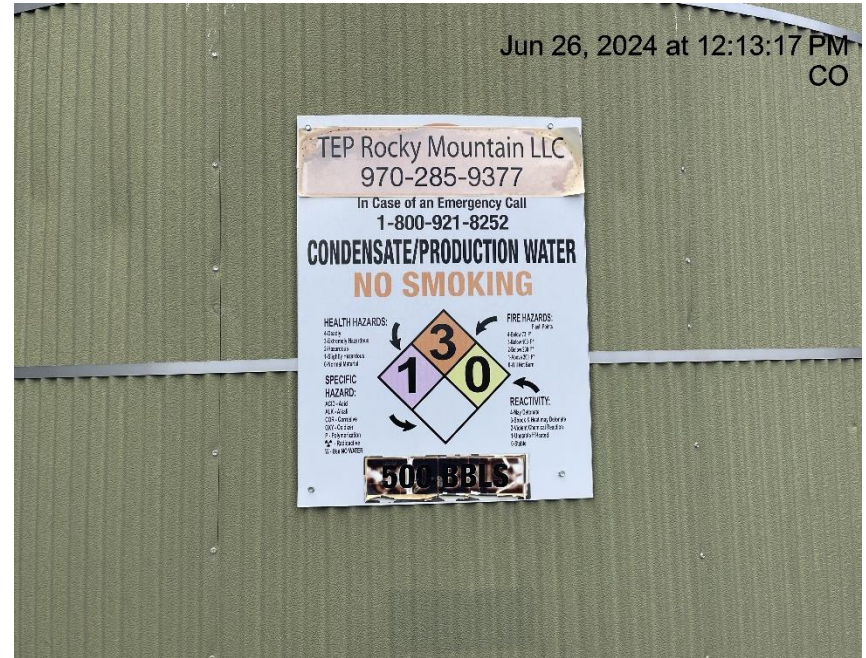
Photo # 1606 Tank capacity illegible

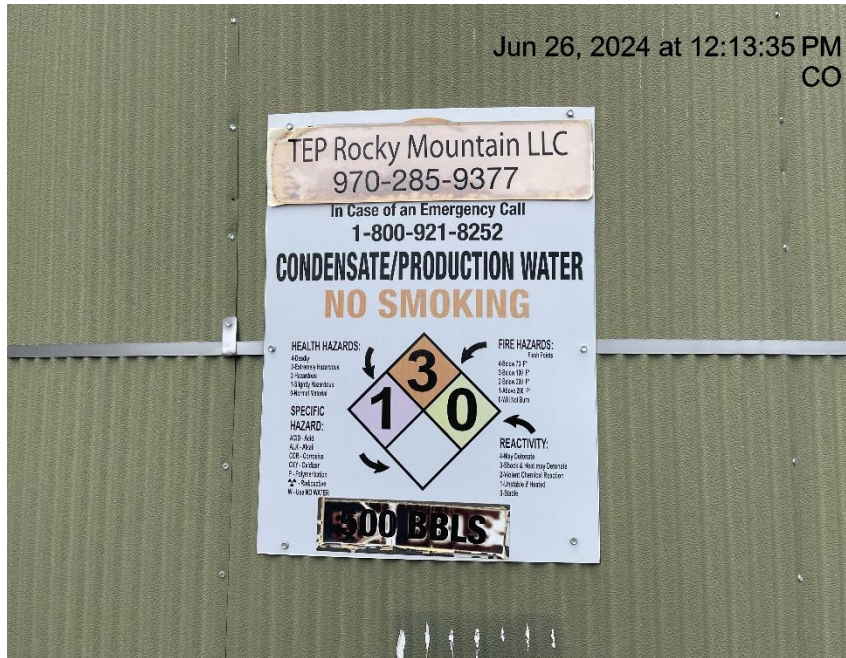
Photo # 1607 Tank capacity illegible
