Inspection Photos
Location Name: Bowman SWD 3B-28-5-44
API Number: 125-09914

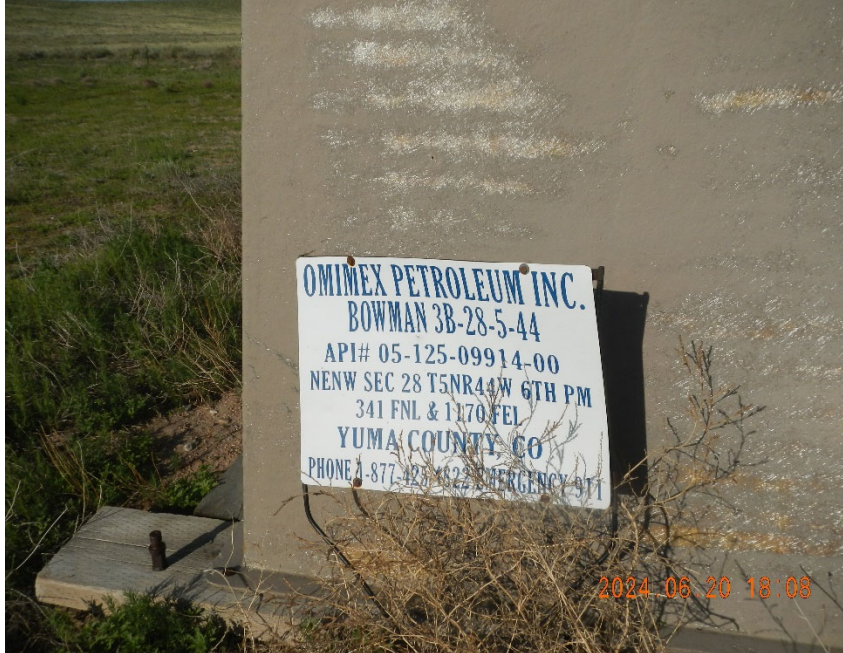
1. Lease sign at well site.

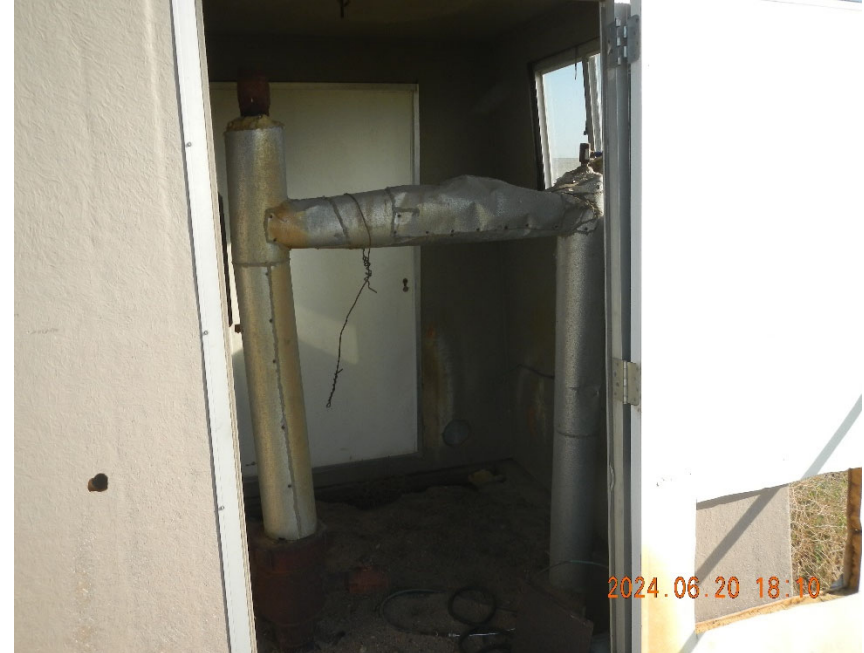
2. View of wellhead inside well house.

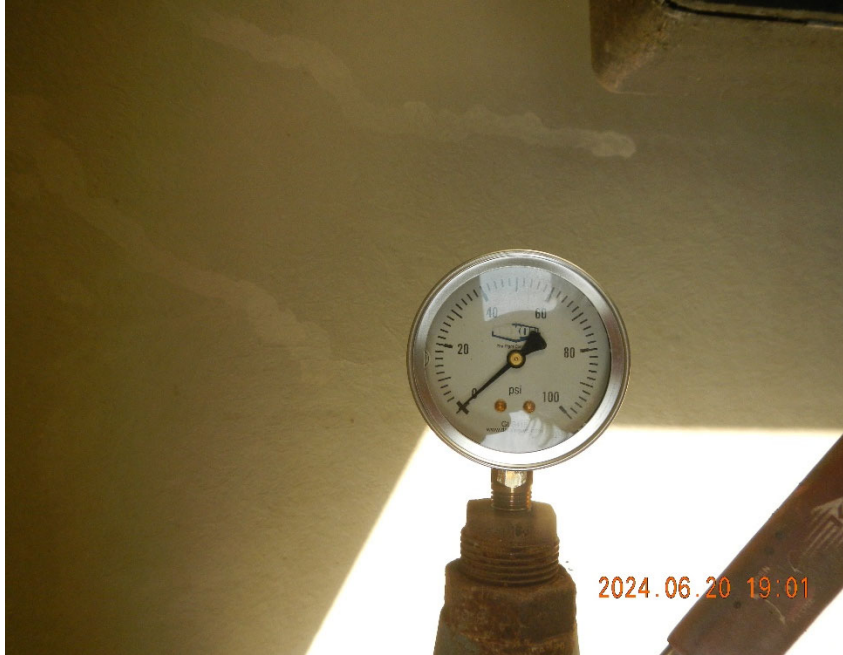
3. Tubing pressure at time of inspection.

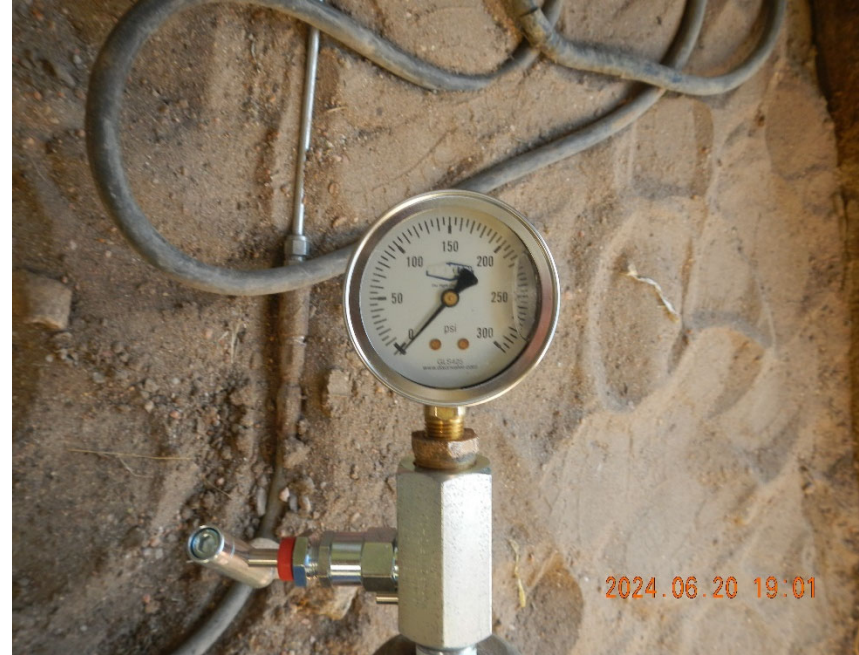
4. Casing pressure at time of inspection.

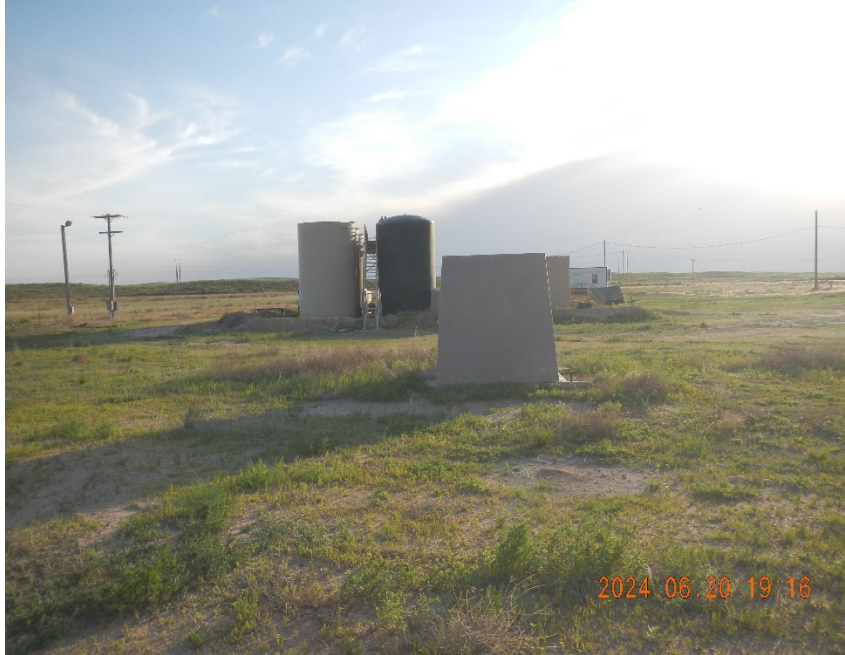
5. Well location overview looking towards Tank Battery.
Note vegetation.

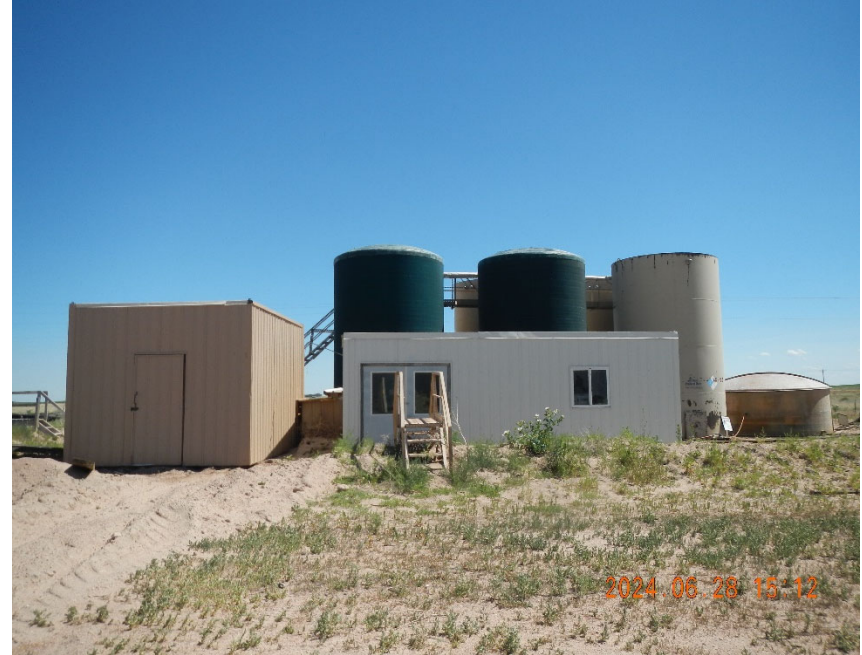
6. View of Tank Battery.

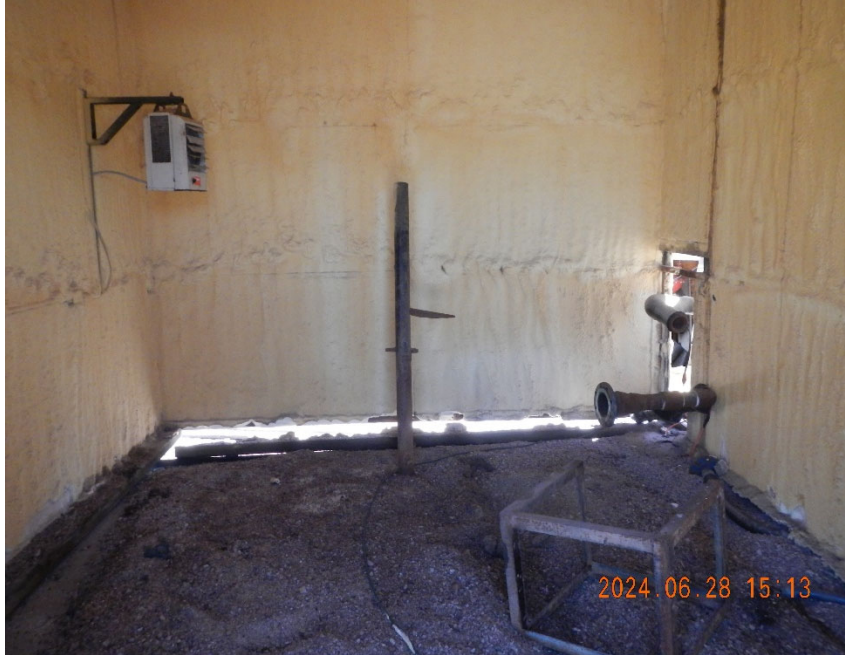
7. View inside Steel Injection Pump Shed. Pump has been removed.

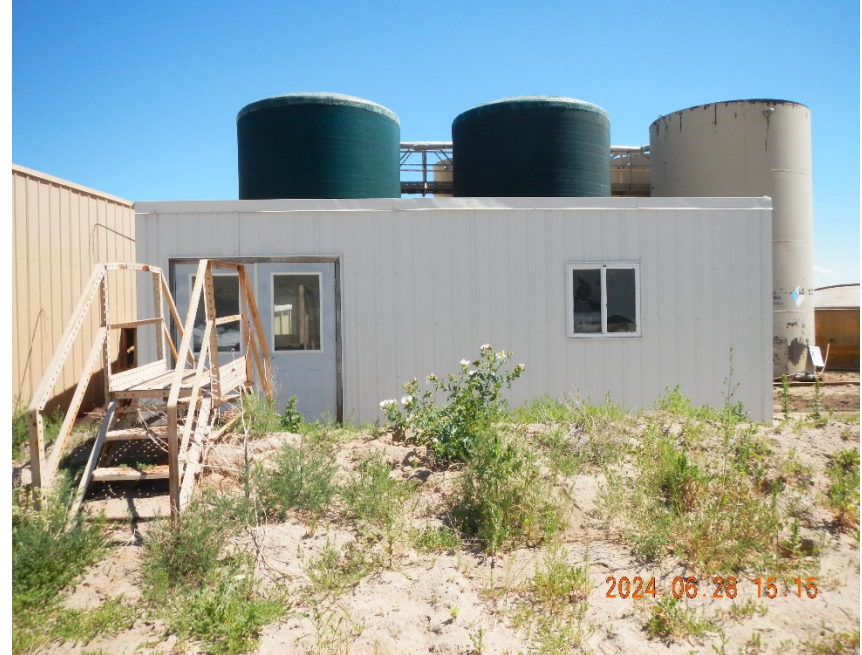
8. View of Injection Control and Equipment Building. Note vegetation.

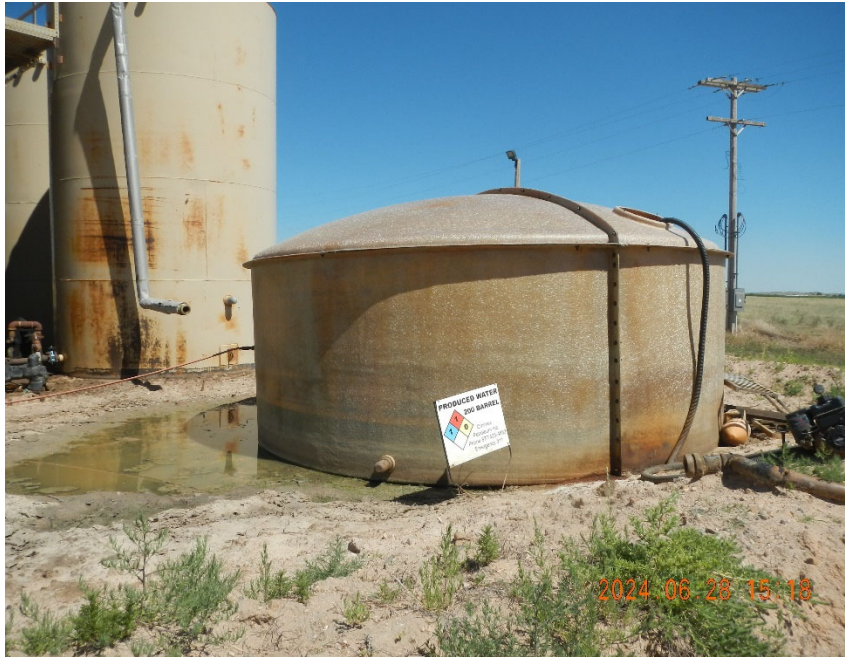
9. View of 200 BBL Fiberglass AST. Note vegetation, fluids, and equipment.

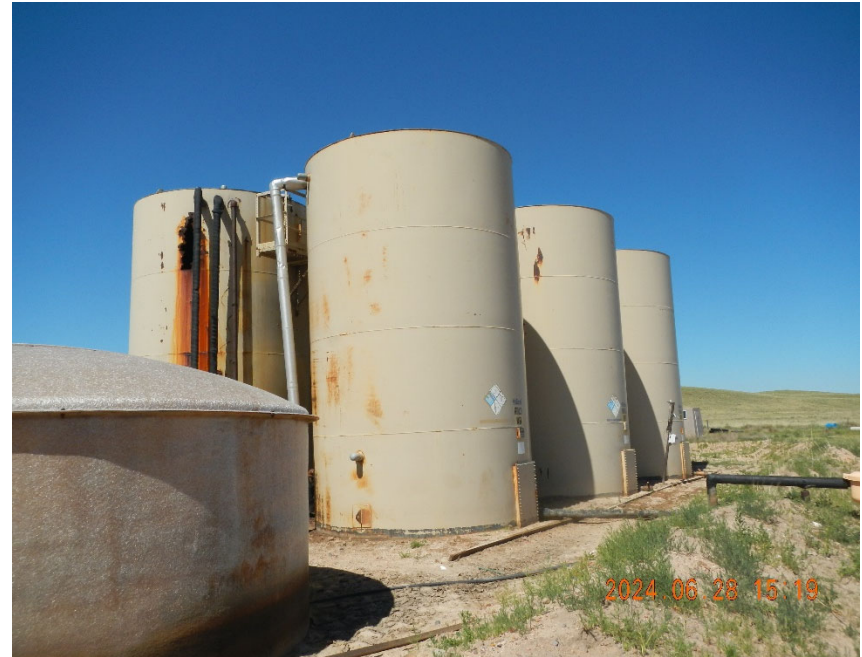
10. View of 400 BBL Steel AST's. Note vegetation and visible rust on tanks.

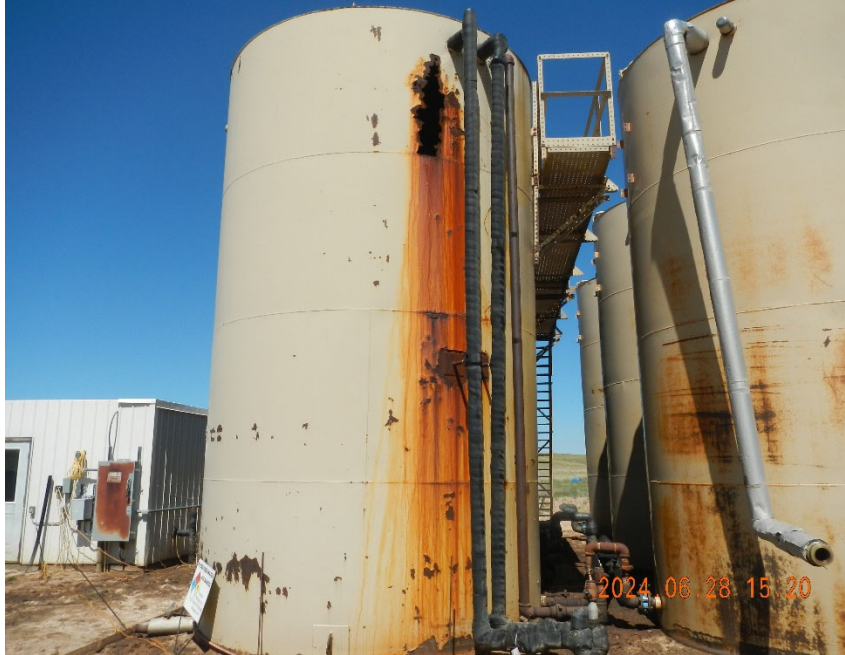
11. Steel AST has hole rusted through wall of tank.

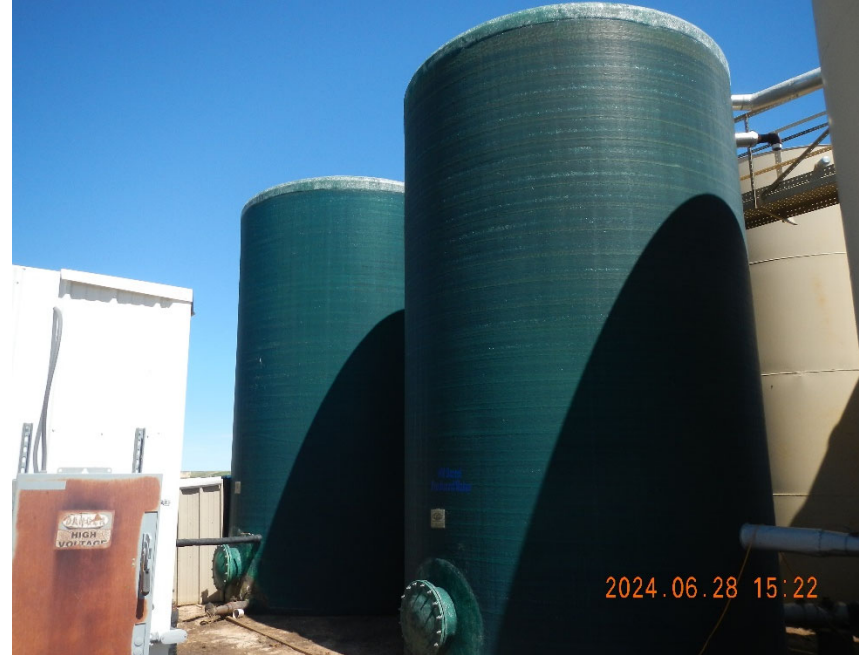
12. View of 400 BBL Fiberglass AST's.

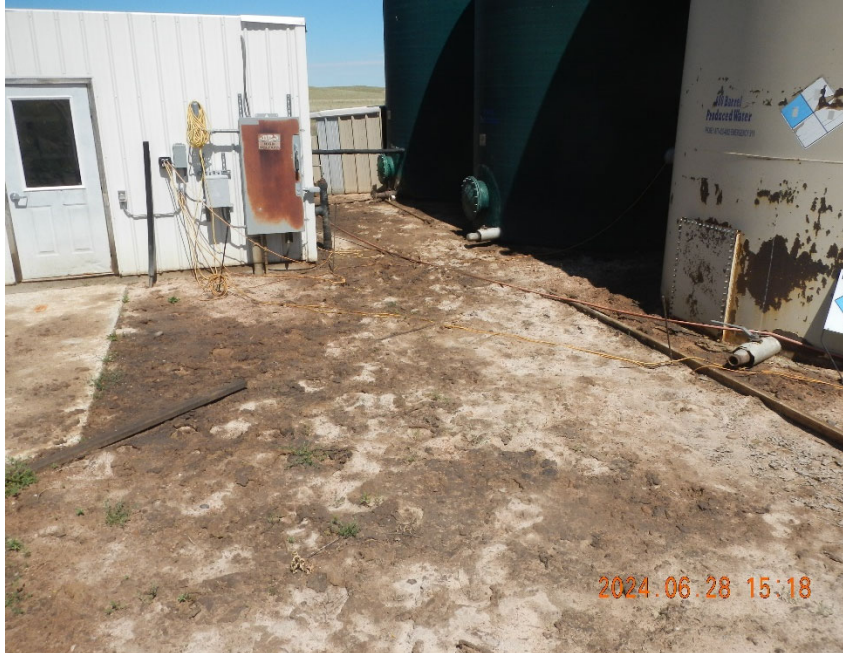
13. Visible staining of soil and concrete inside berms at tank battery.

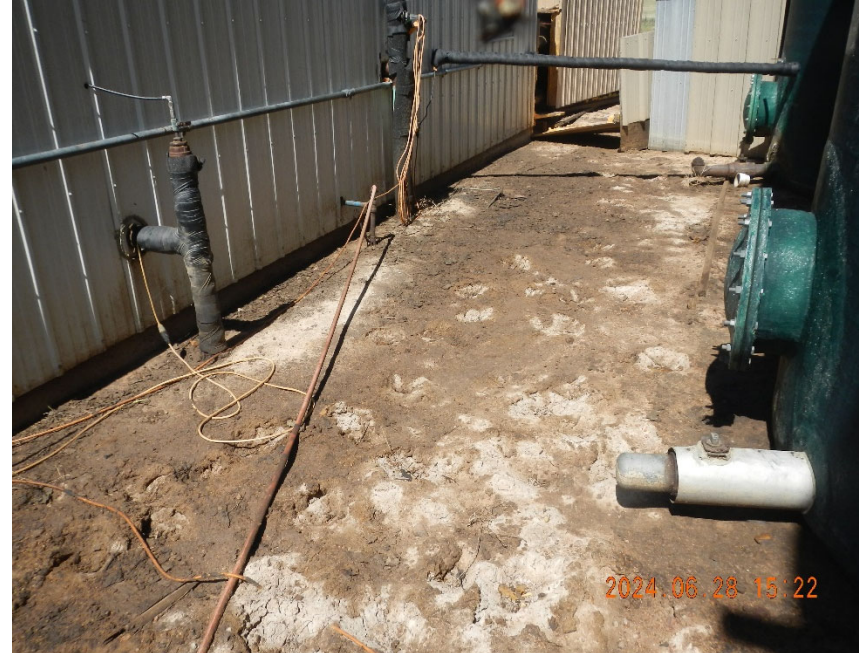
14. Additional view of soil staining inside berms. Staining is present throughout the inside of the bermed containment area.

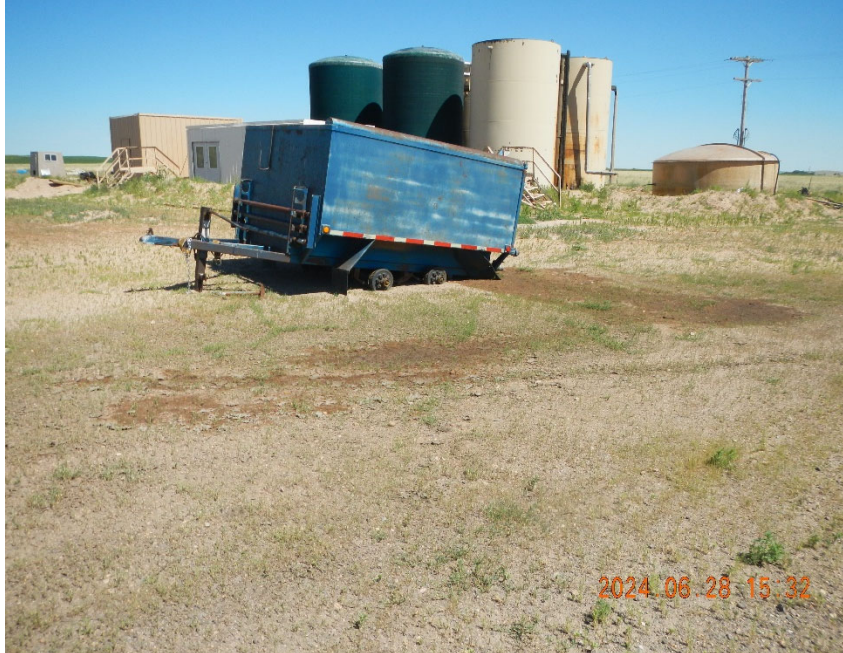
15. Leaking Open Top Tank Trailer. Wet discolored soil area is approximately 30' X 17'.

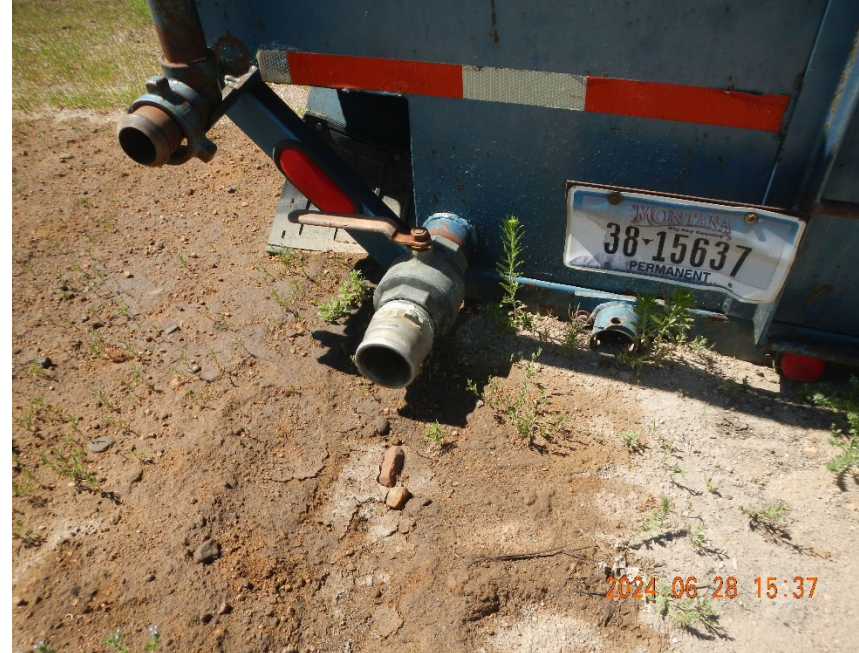
16. Leak is emanating from bottom of trailer.

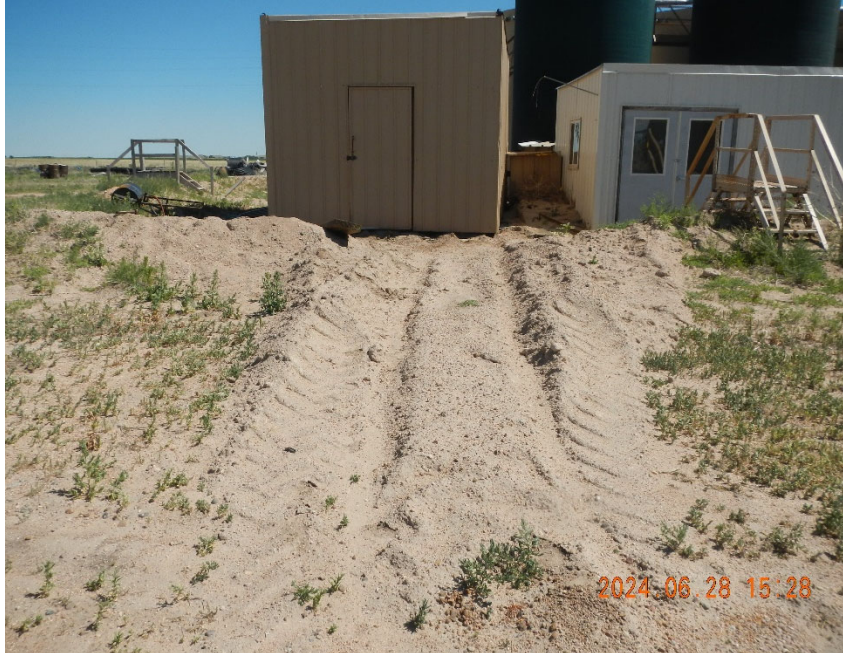
17. Containment berm opened up in front of Injection Pump making the berm inoperable as a BMP.

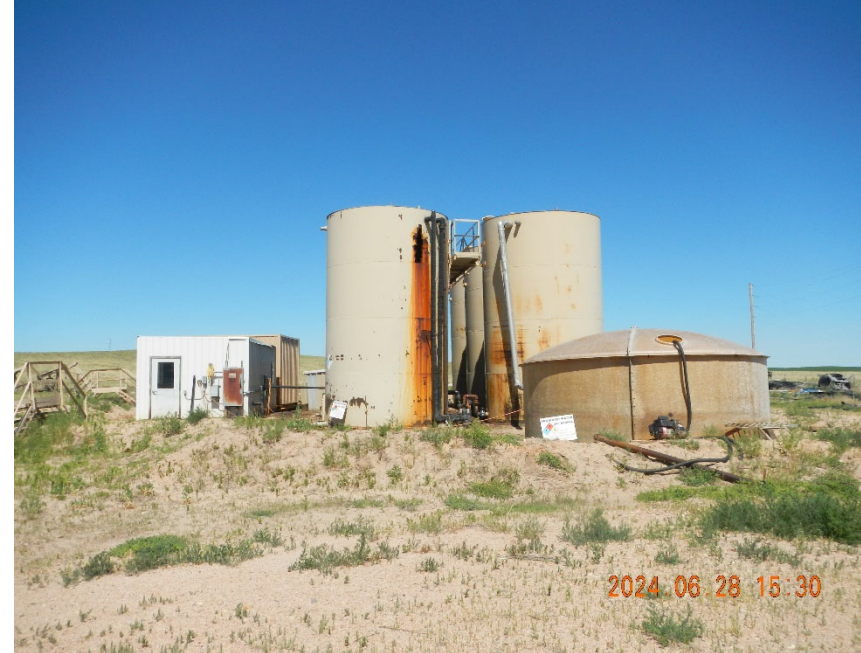
18. View looking East towards Tank Battery. This is the view that is visible of Facility from State Highway.
