Construction and Stormwater Inspection

Operator: PROVIDENCE OPERATING LLC DBA POCO
OPERATING - 10694

Location ID: 451646

Inspection Photos
Location Name: Brighton Lakes 20-17
Location ID: 451646

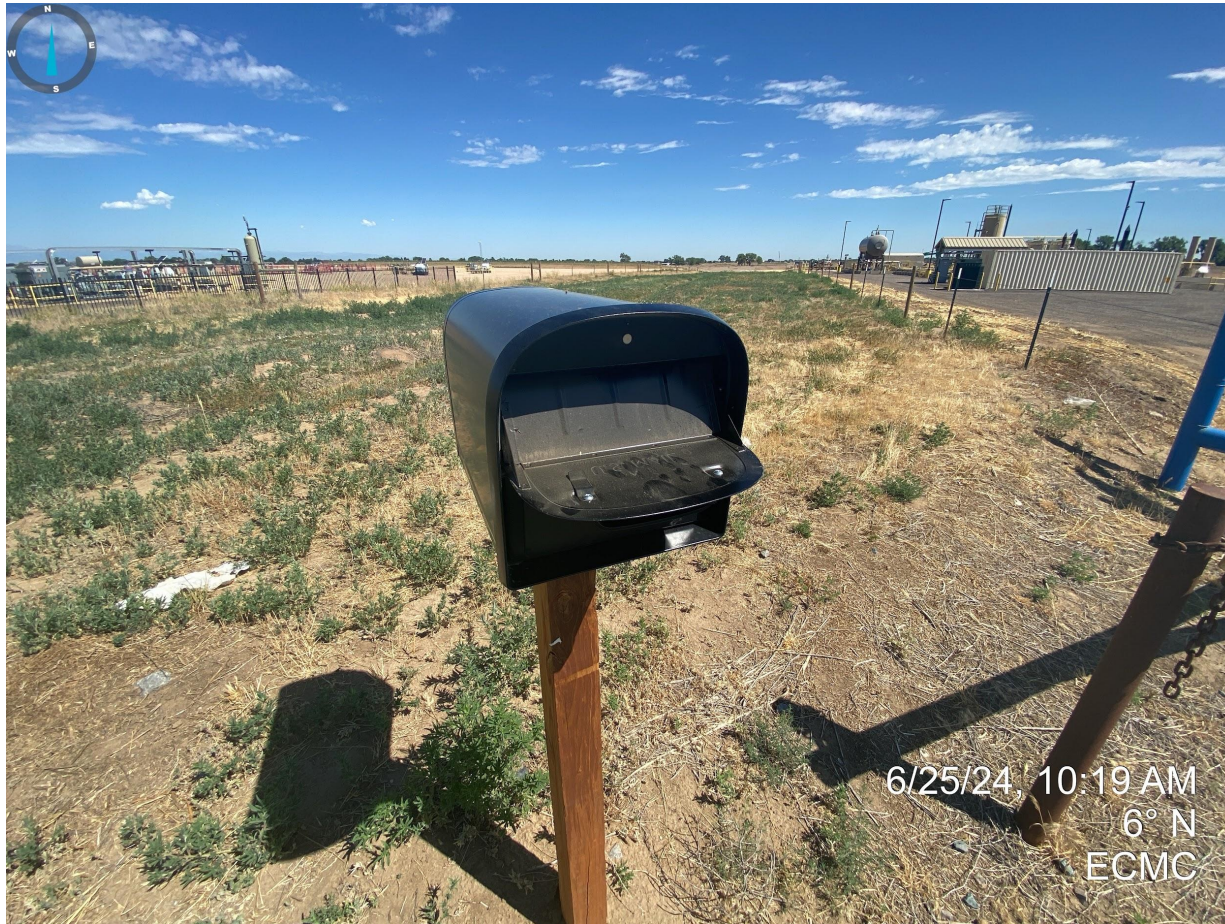
Photo 1. Form 2A posted on location in compliance with Rule 406.c

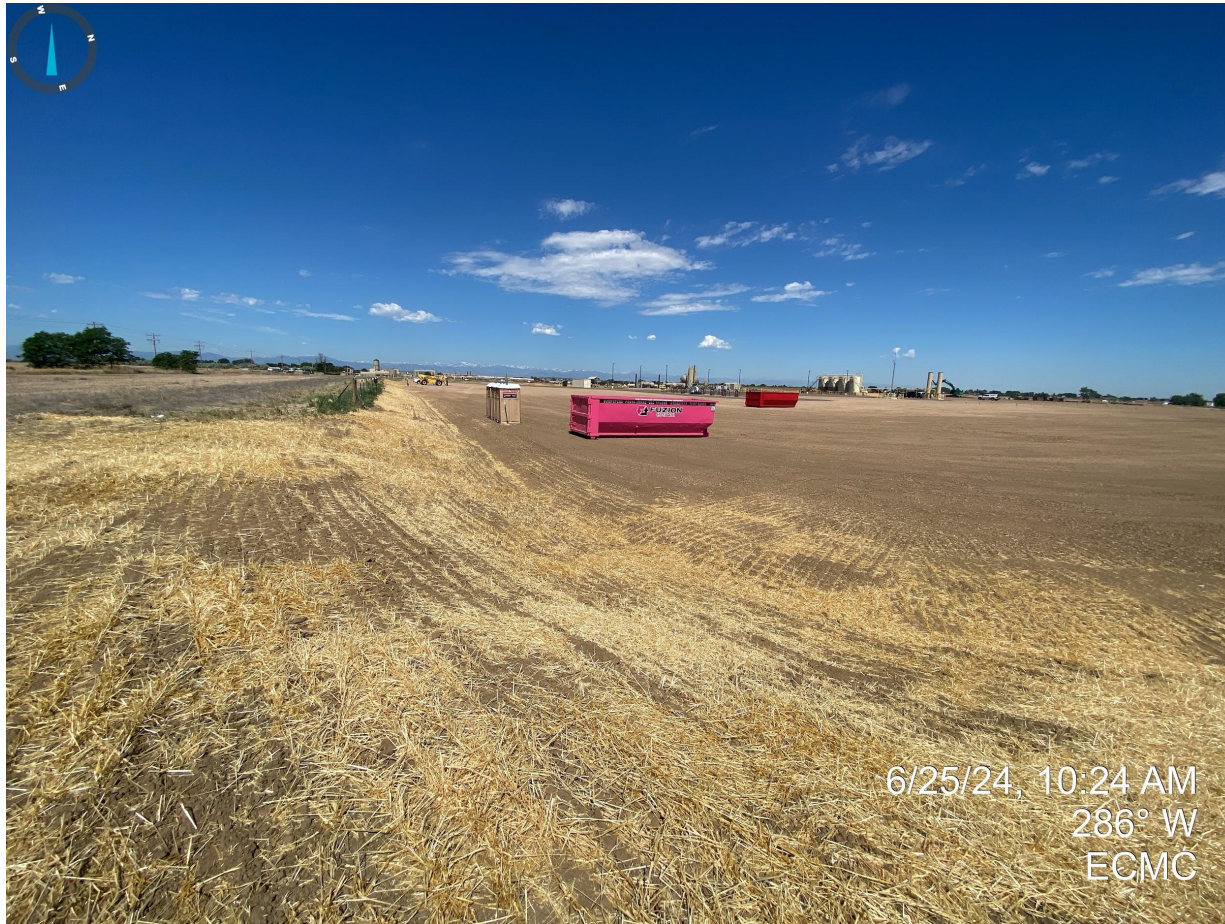
Photo 2. Southeast corner of the drilling pad. Stormwater BMPs appear to have been repaired and slopes have been stabilized with crimped mulch observed.

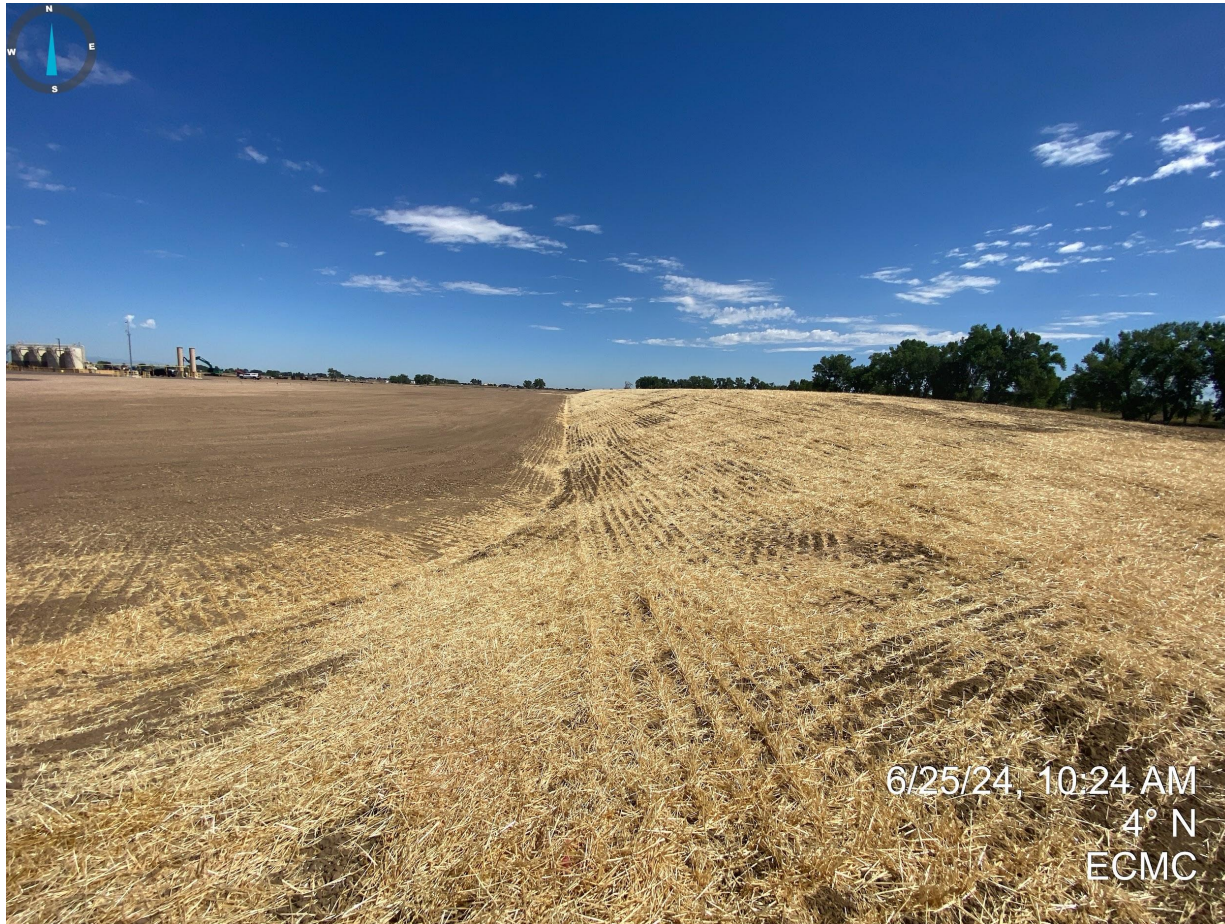
Photo 3. Southeast corner of the drilling pad, facing north. See comments in Photo 2.

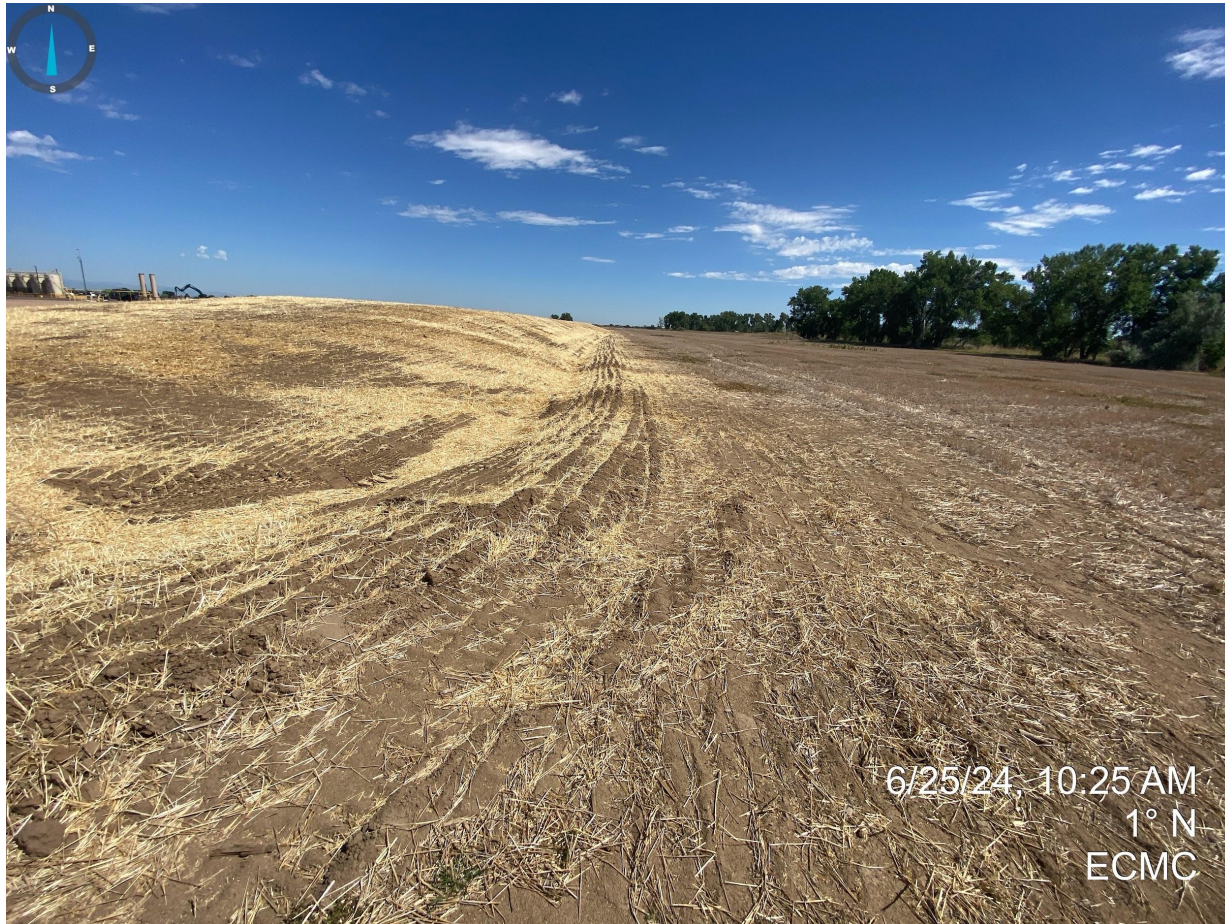
Photo 4. Southeast corner of the location. Perimeter stormwater ditch and berm, and topsoil stockpile pictured.

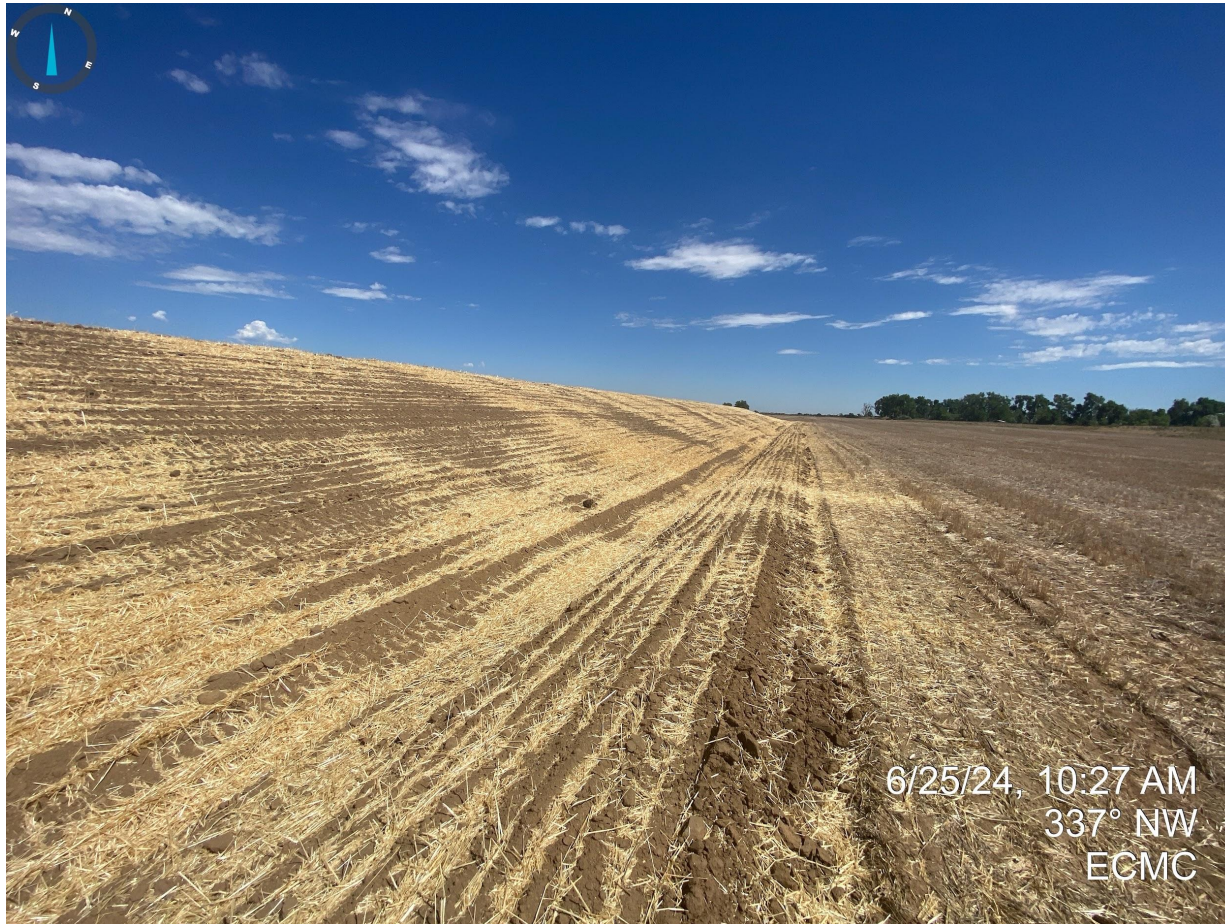
Photo 5. Eastern portion of the topsoil stockpile. Topsoil appears to have been salvaged in compliance with Rule 1002.b and stabilized with the evidence of crimped mulch and drill rows, in compliance with Rule 1002.c.

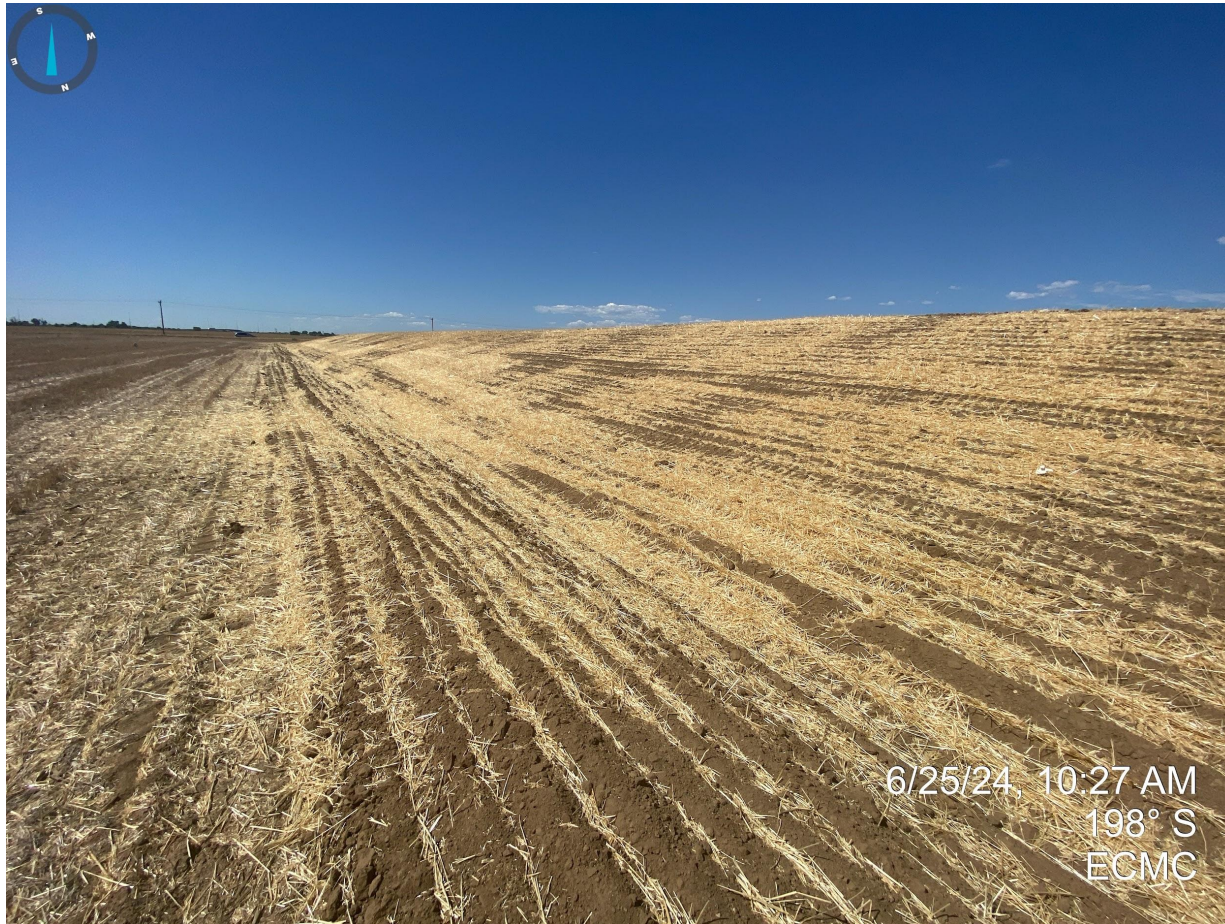
Photo 6. Eastern portion of the topsoil stockpile, facing south. See comments in Photo 5.

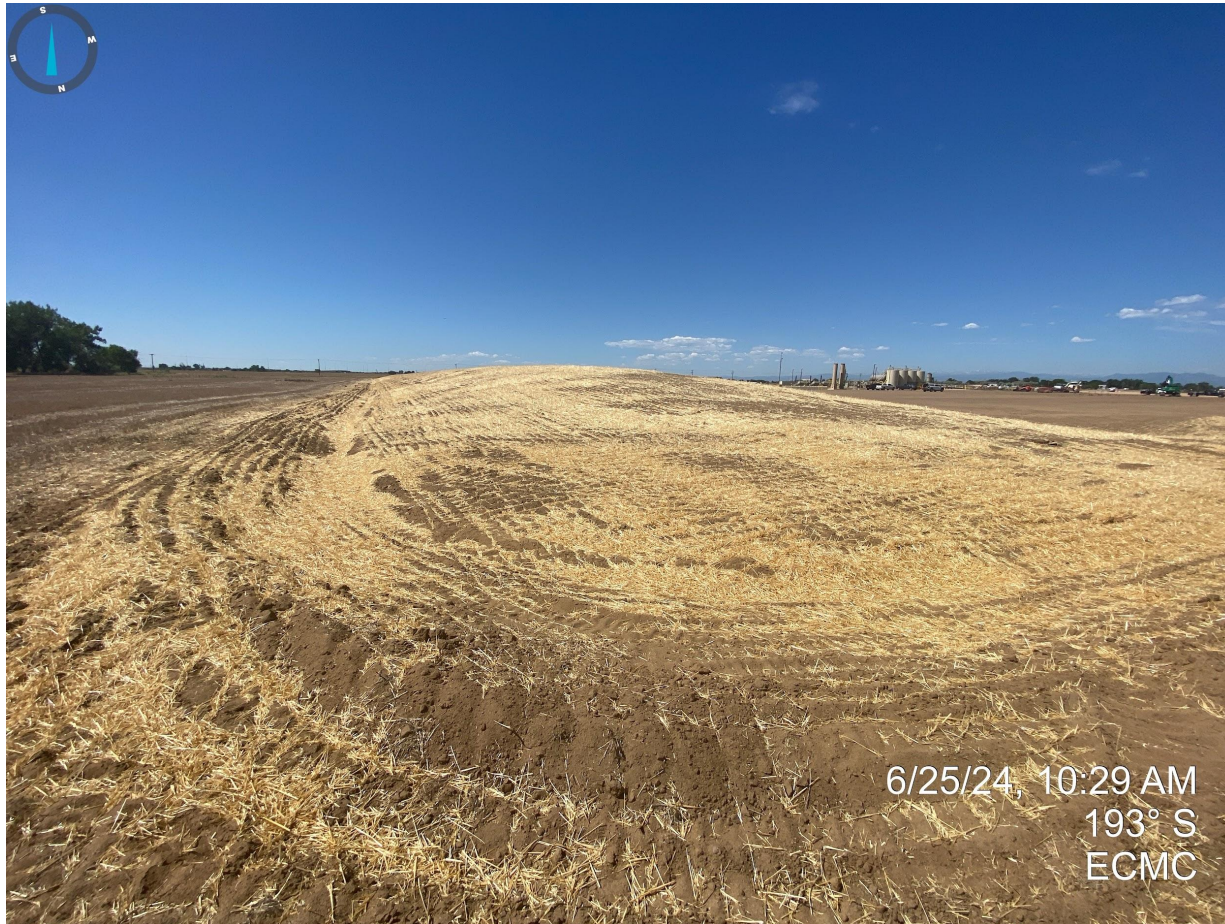
Photo 7. Northern portion of the topsoil stockpile, facing south. See comments in Photo 5.

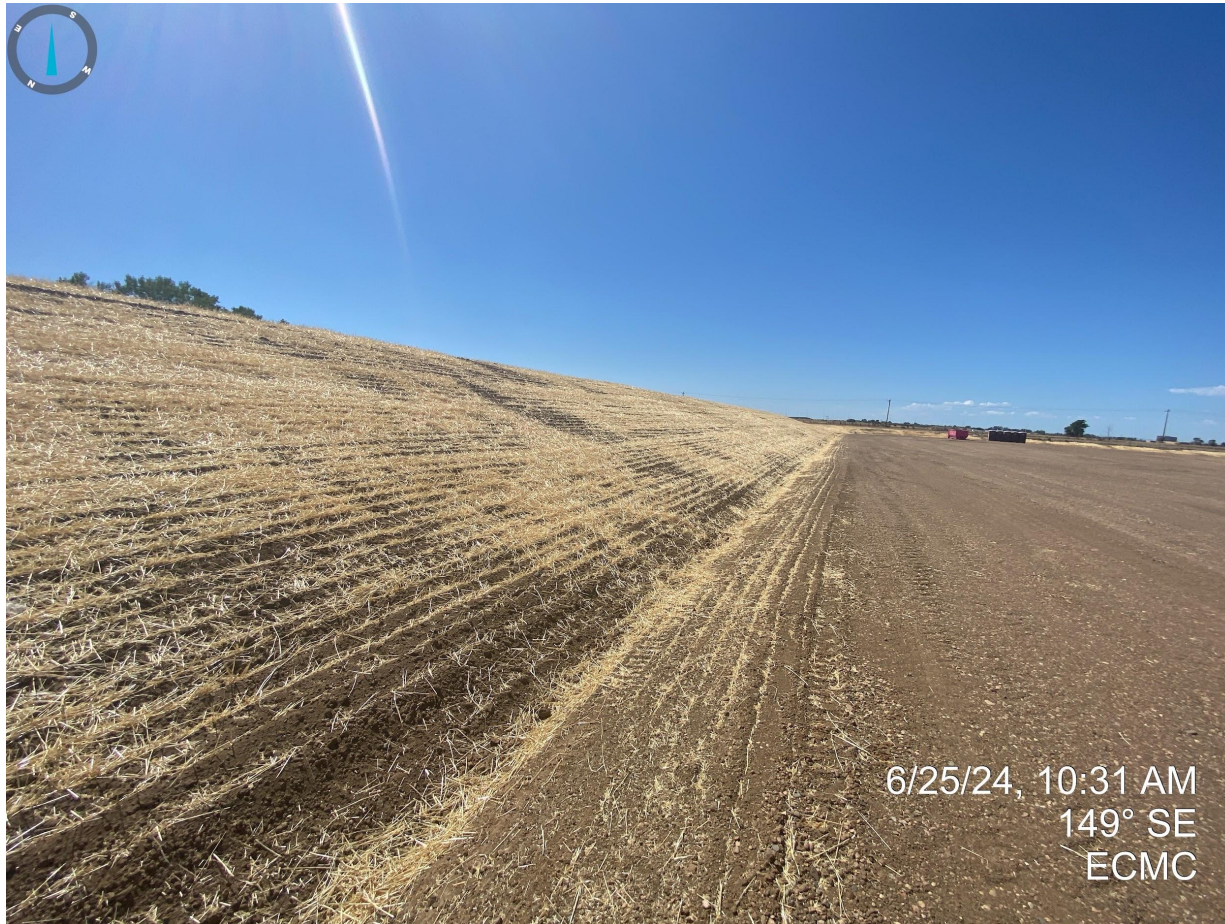
Photo 8. Western portion of the topsoil stockpile, facing southeast. See comments in Photo 5.

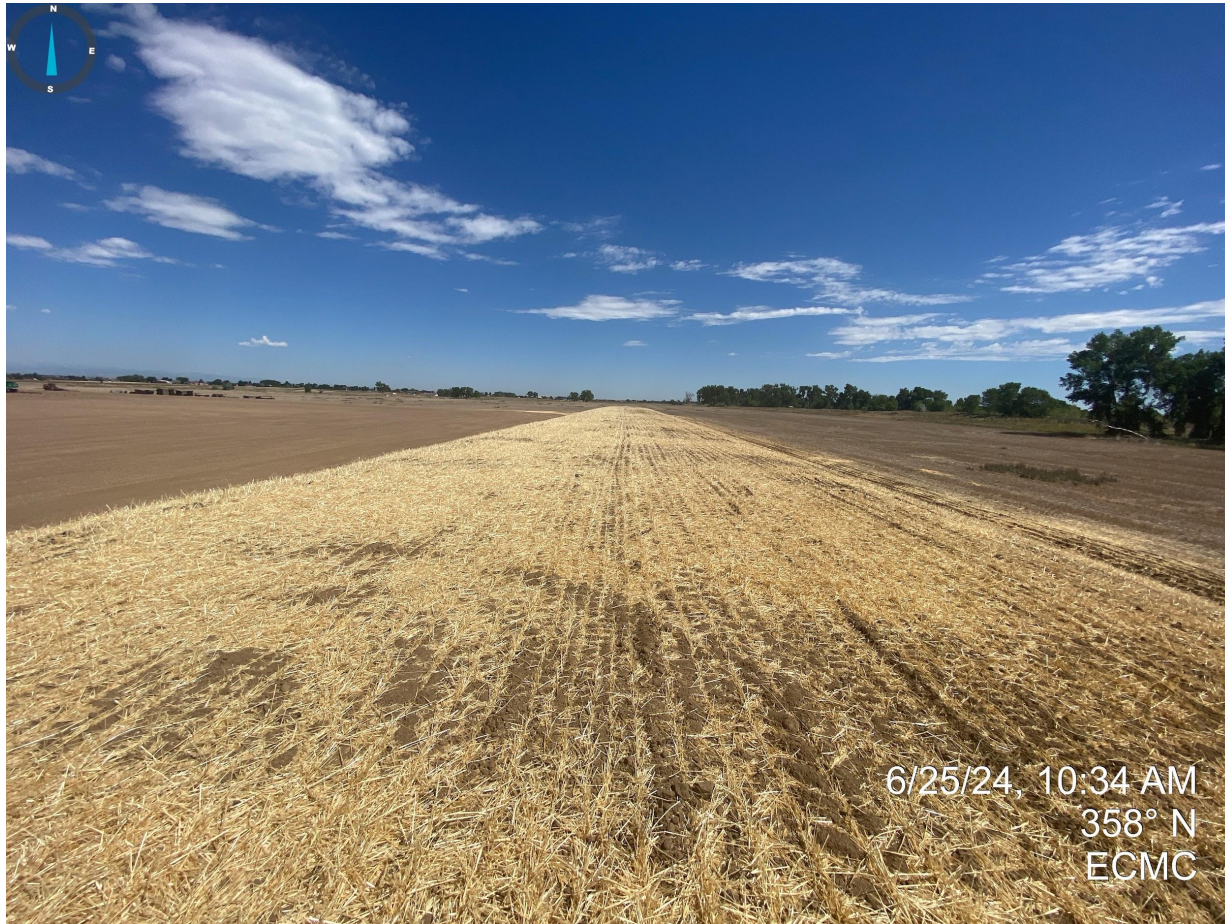
Photo 9. Top portion of the topsoil stockpile, facing north. See comments in Photo 5.

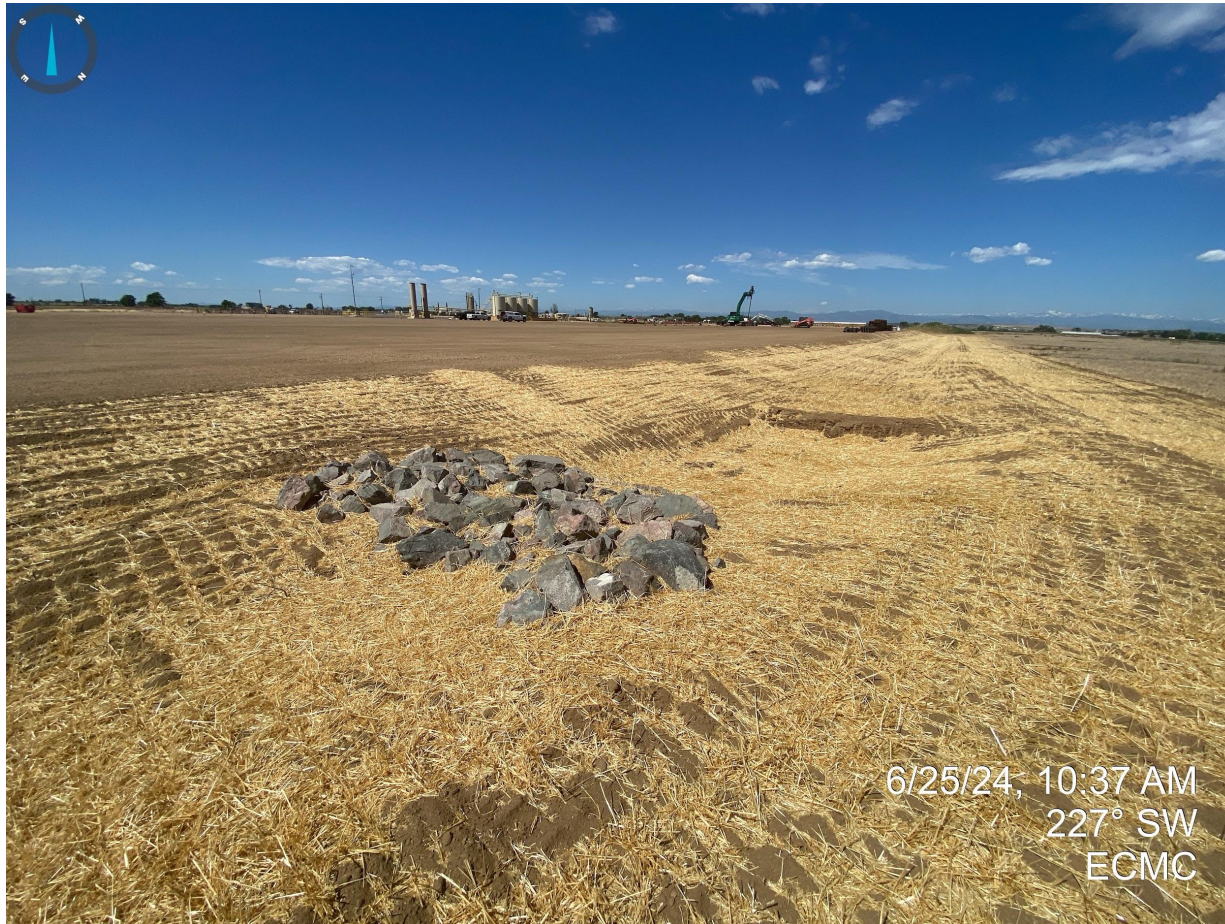
Photo 10. Sediment trap and ditch and berm installed on the northeastern/northern portion of the construction area.

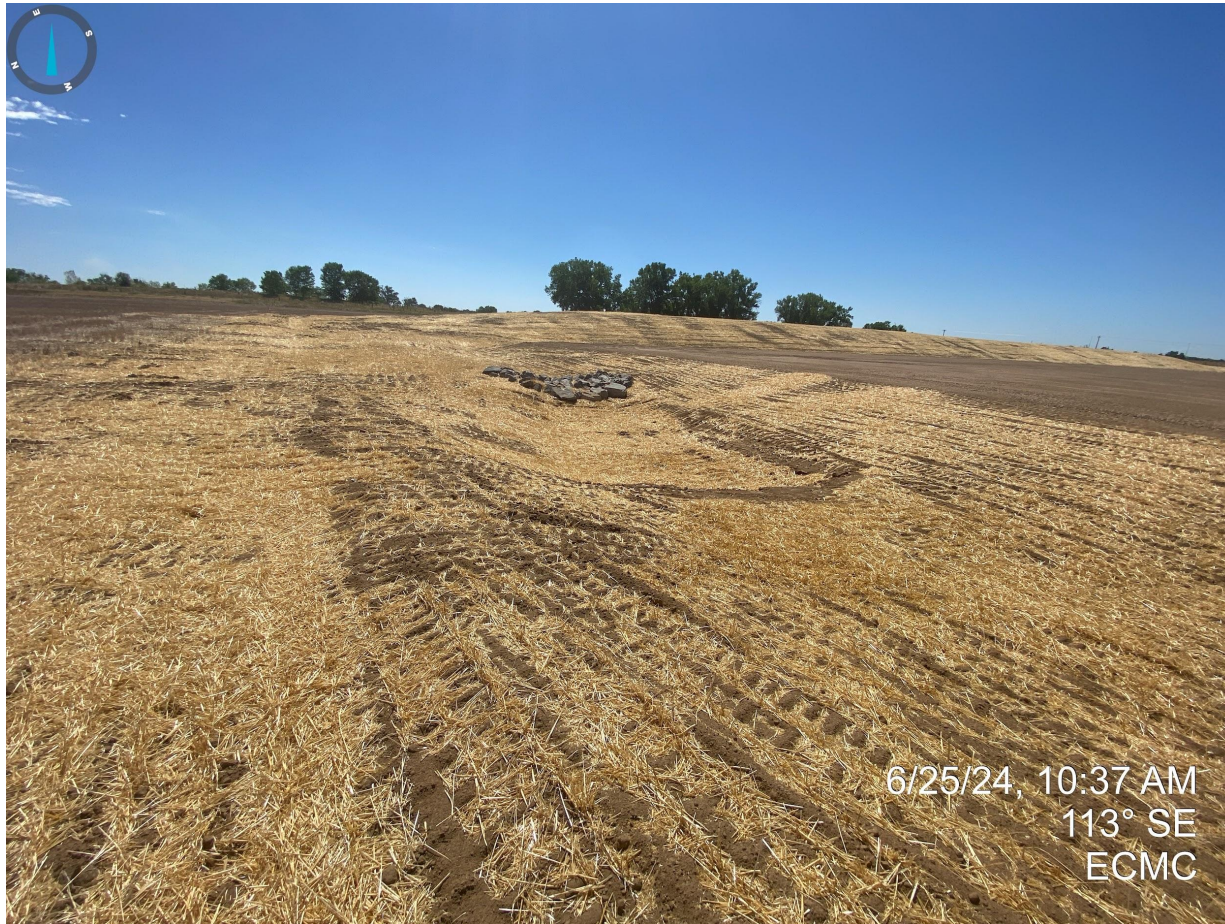
Photo 11. Facing southeast; see comments in Photo 10.

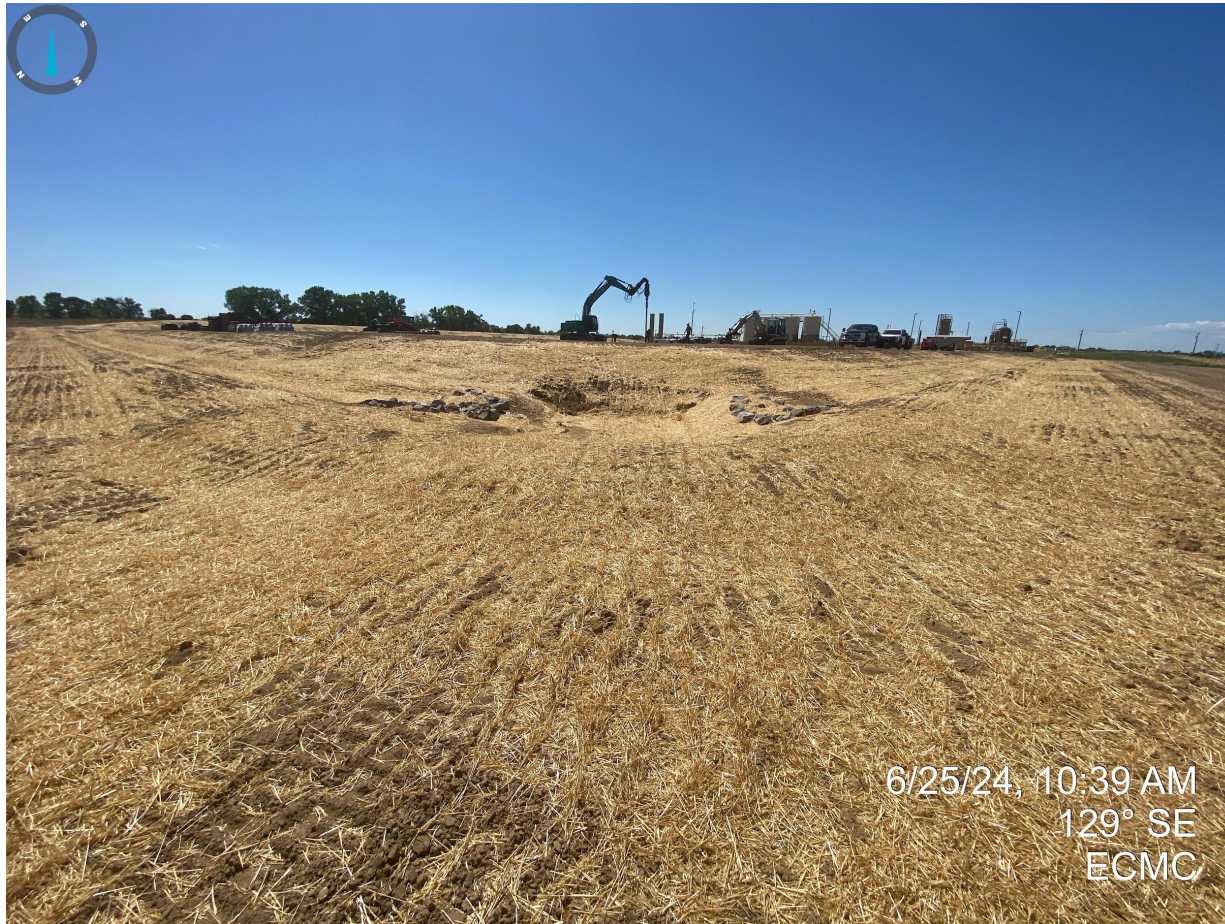
Photo 12. Sediment trap and ditch and berm installed on the northwestern portion of the construction area.

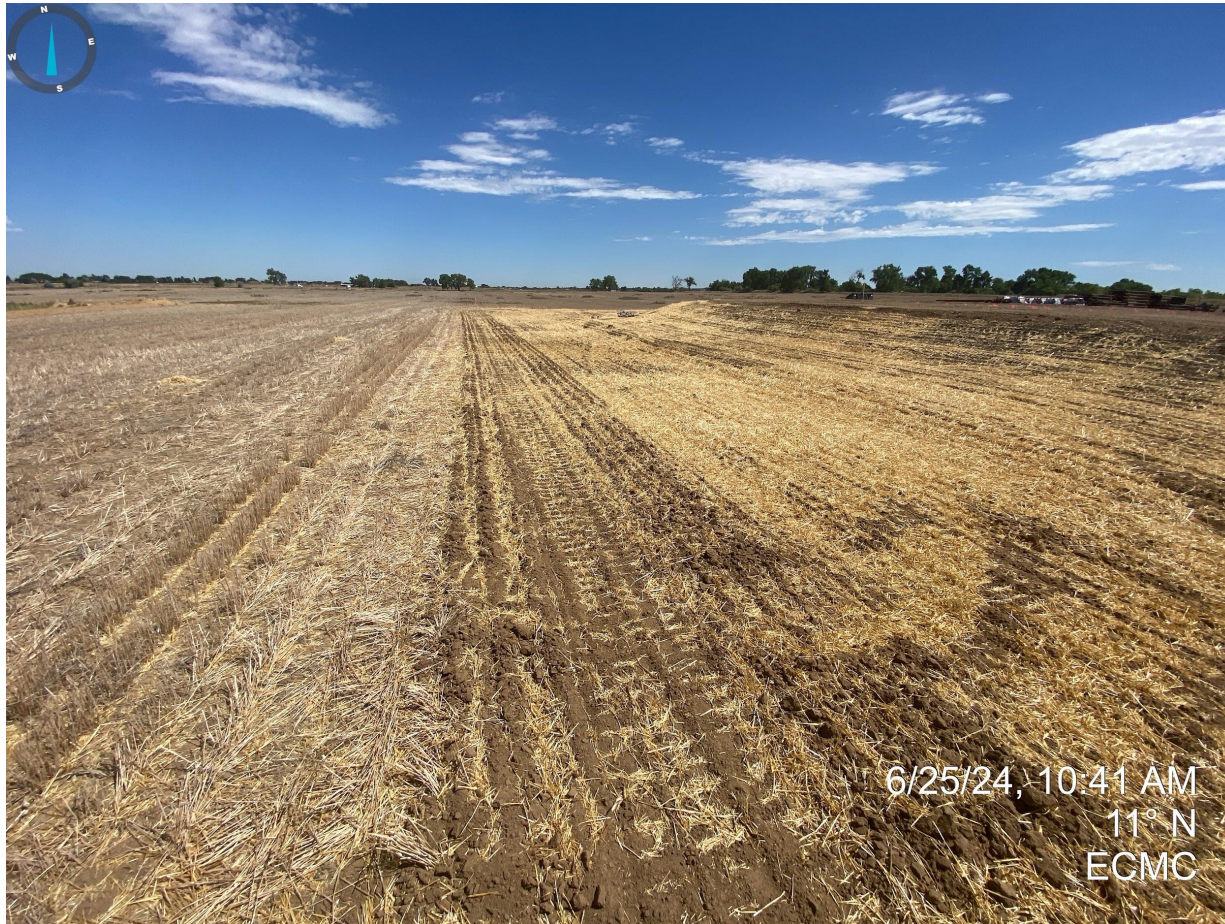
Photo 13. Perimeter ditch and berm installed along the western portion of the construction area.

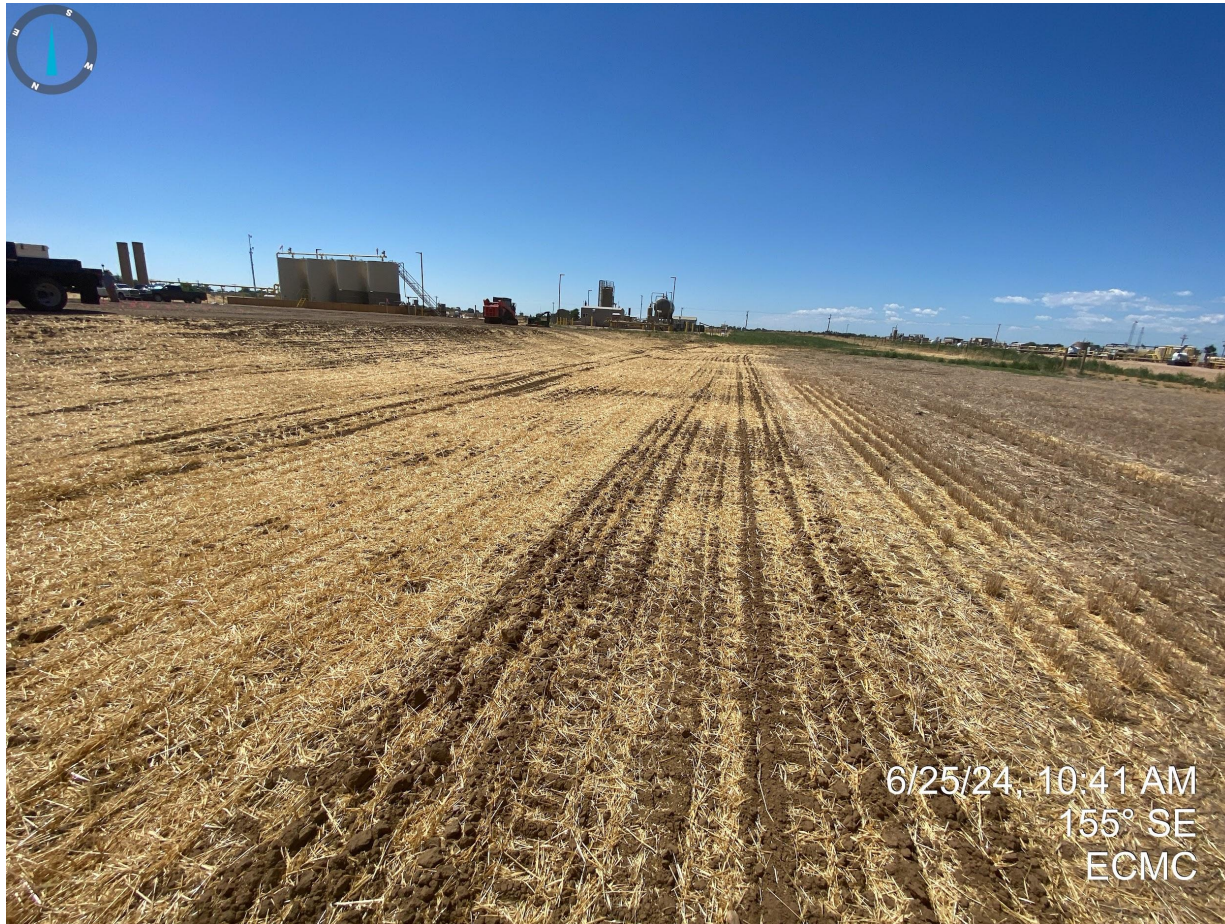
Photo 14. Facing southeast; see comments in Photo 13.

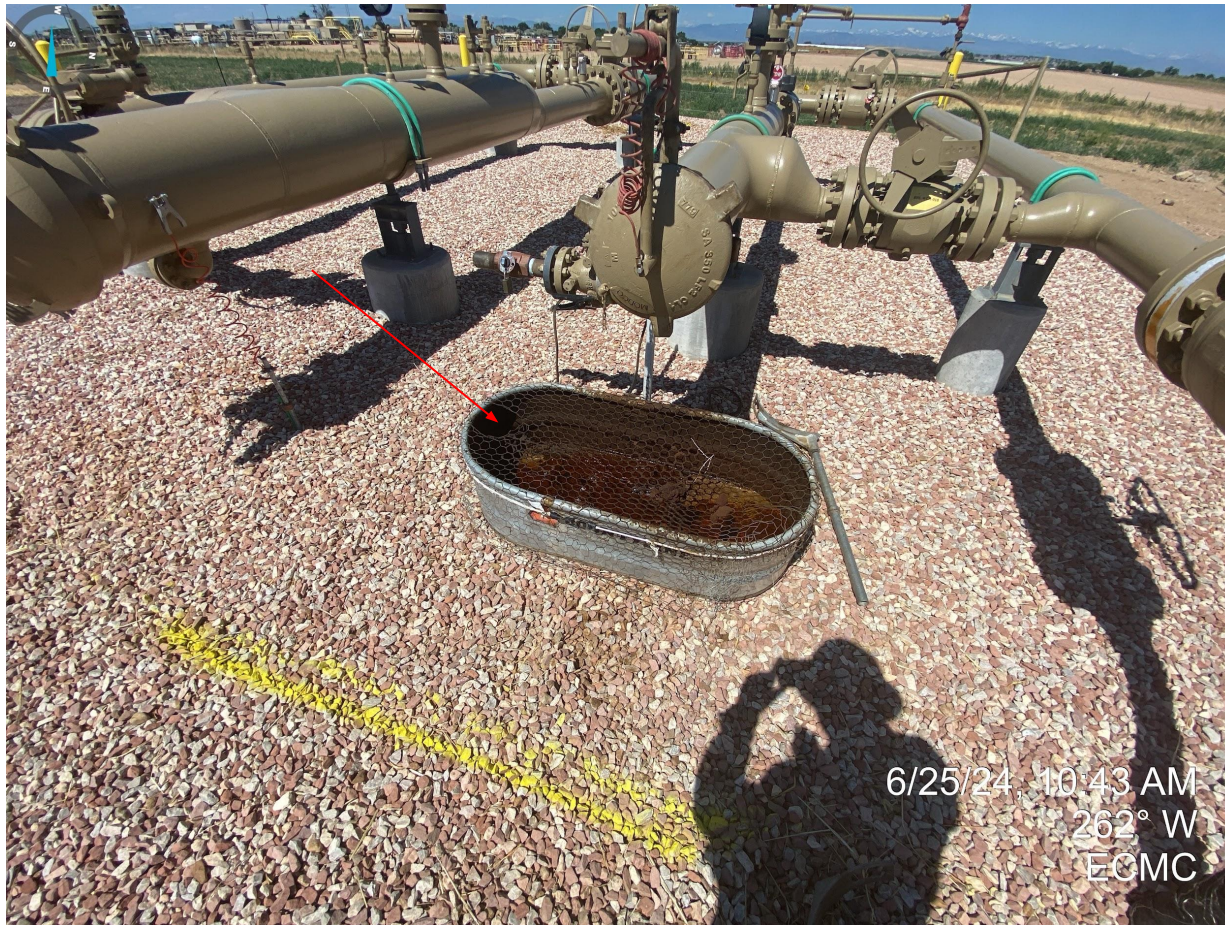
Photo 15. Netting does not appear to have been repaired since the previous inspection. Additionally, free fluids observed within secondary containment need to be properly disposed of.

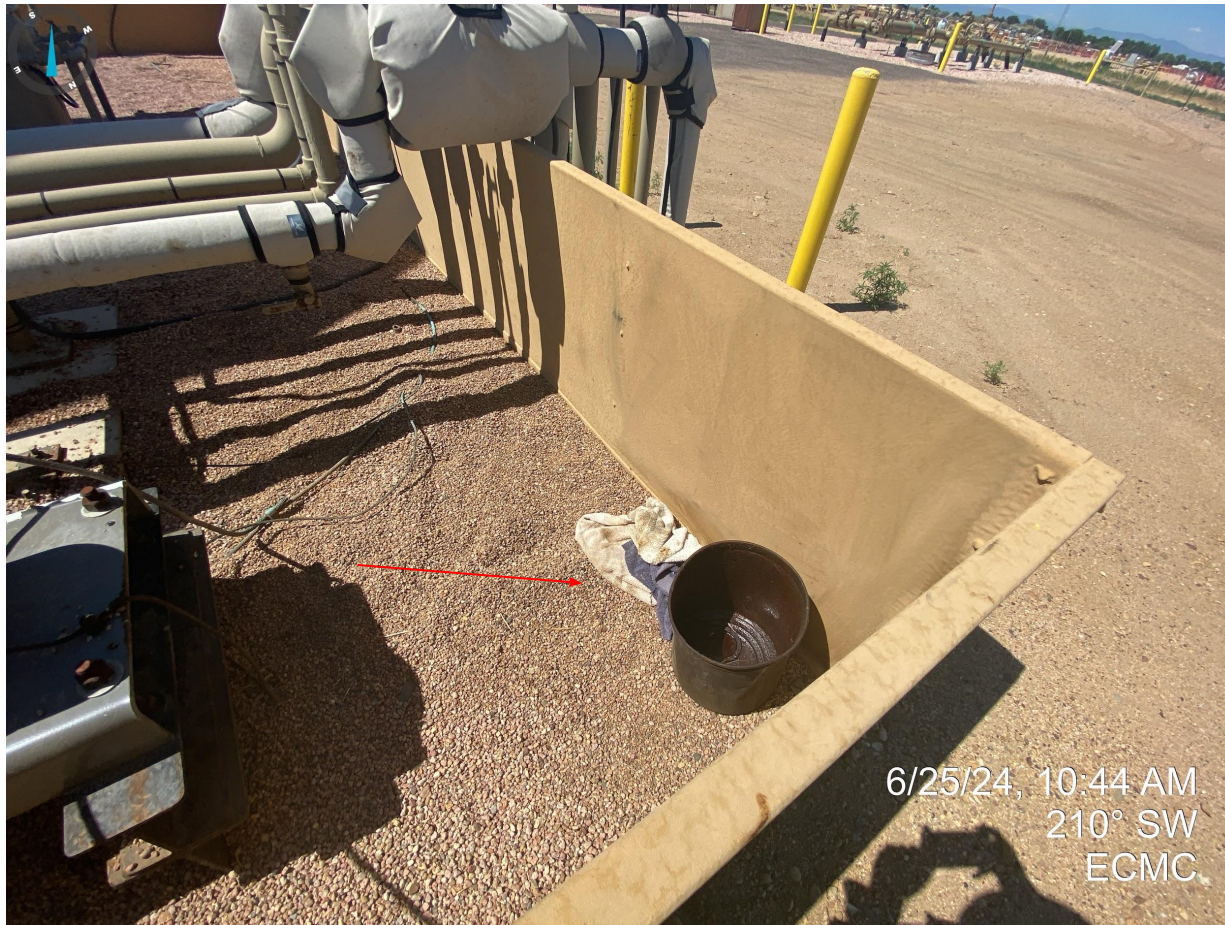
Photo 17. Debris within tank battery secondary containment.

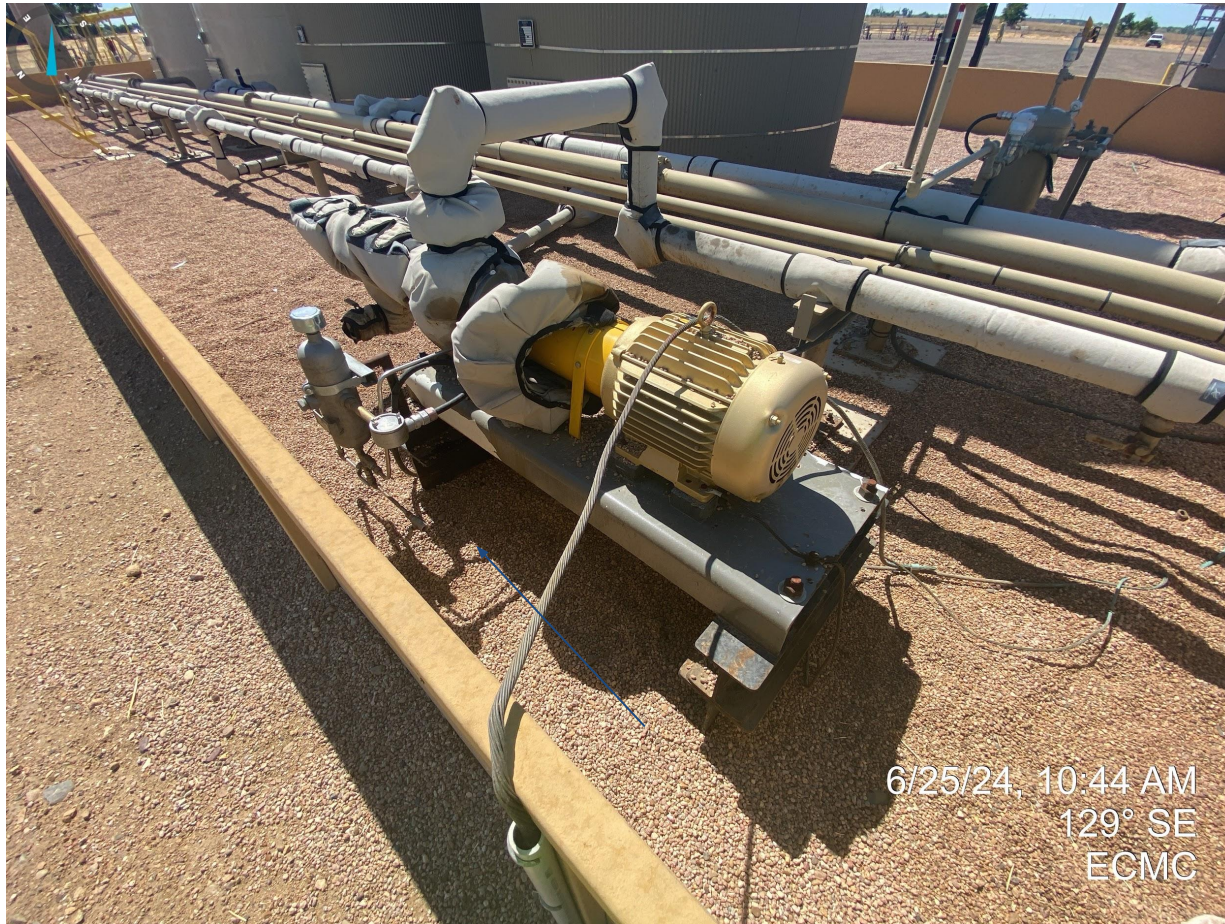
Photo 18. Previously documented stained soils appear to have been removed and disposed of.

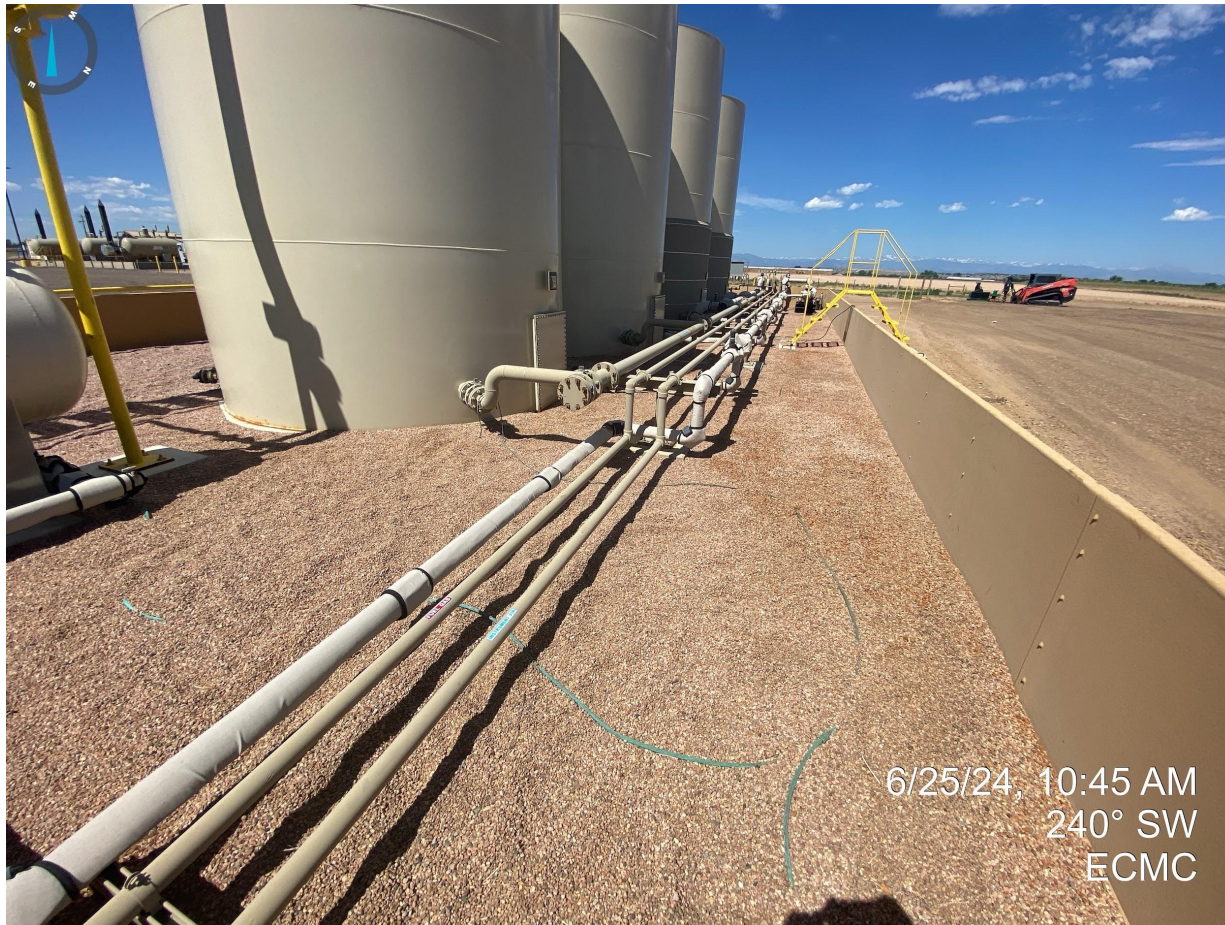
Photo 19. Previously documented unused equipment appears to have been removed.

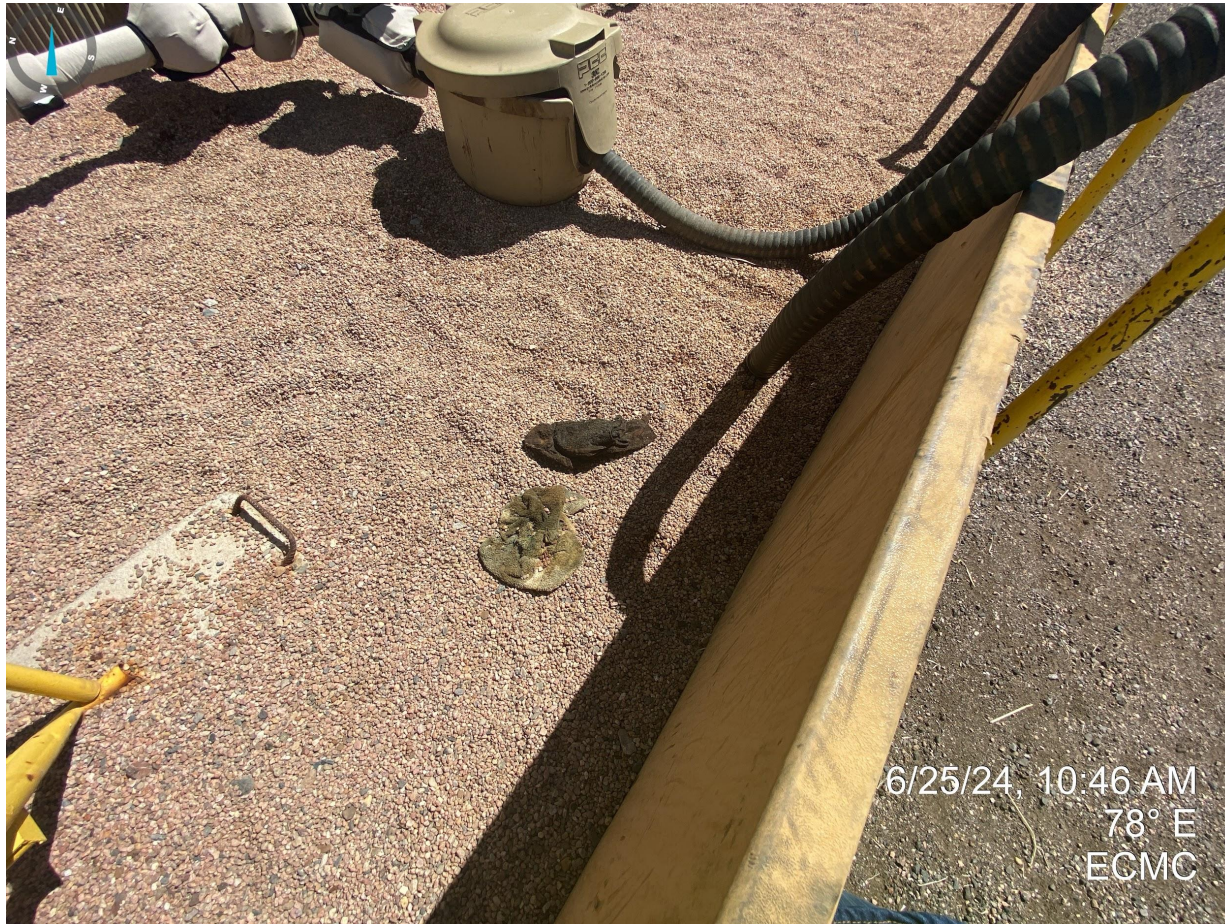
Photo 20. Oily rags (debris) observed within tank battery secondary containment.

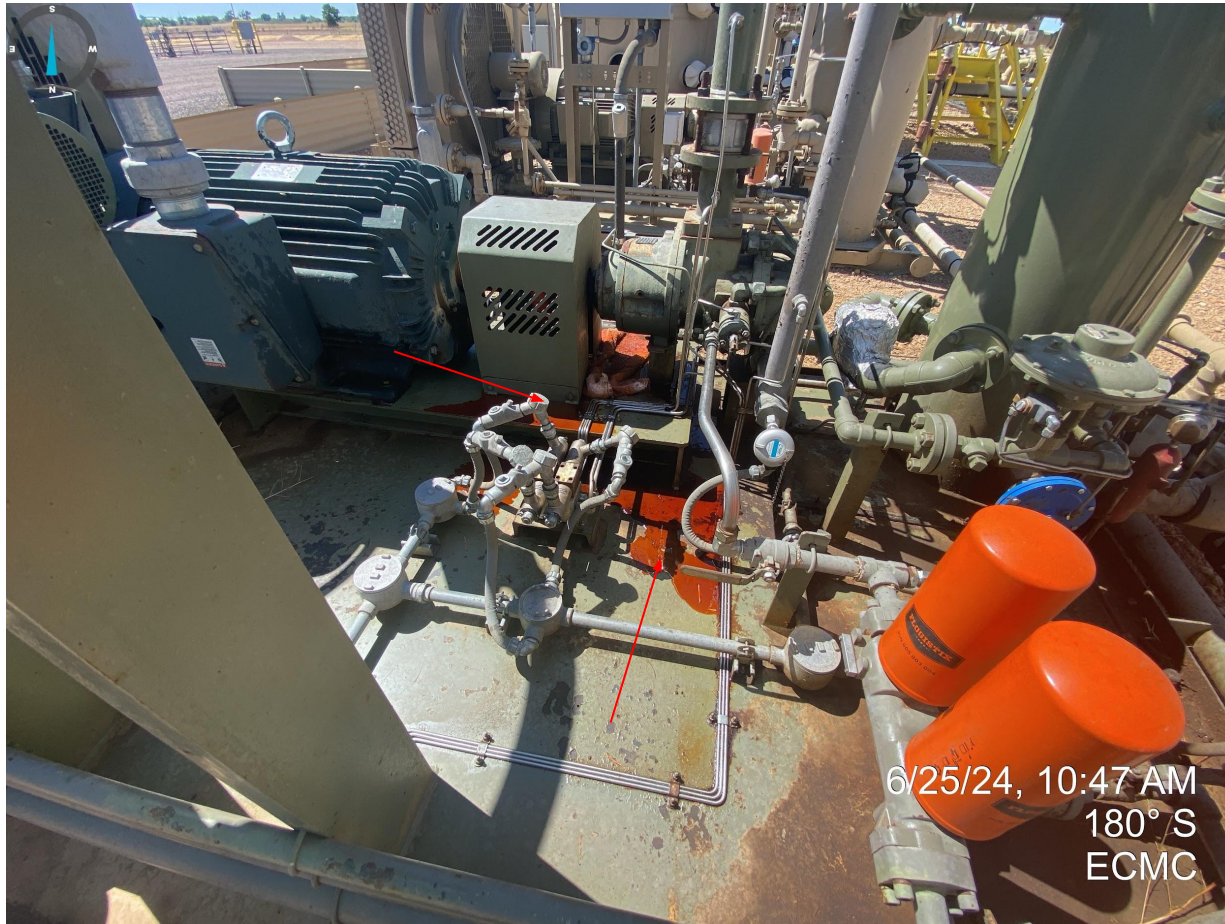
Photo 21. Free fluids observed within compressor skid on west side of location.
