Construction and Stormwater Inspection

Operator: PROVIDENCE OPERATING LLC DBA POCO
OPERATING - 10694

Location ID: 451646

Inspection Photos
Location Name: Brighton Lakes 20-17
Location ID: 451646

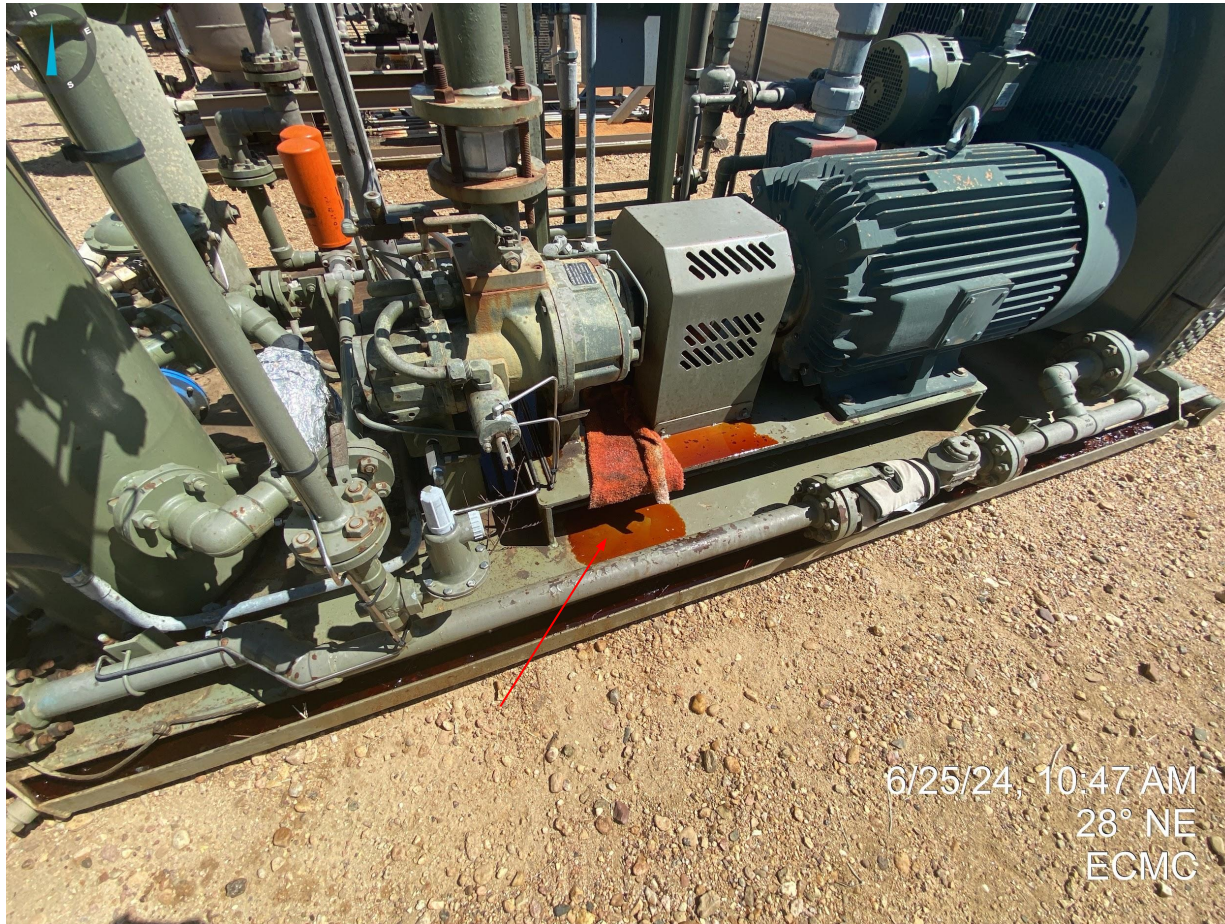
Photo 22. Free fluids observed within compressor skid on west side of location.

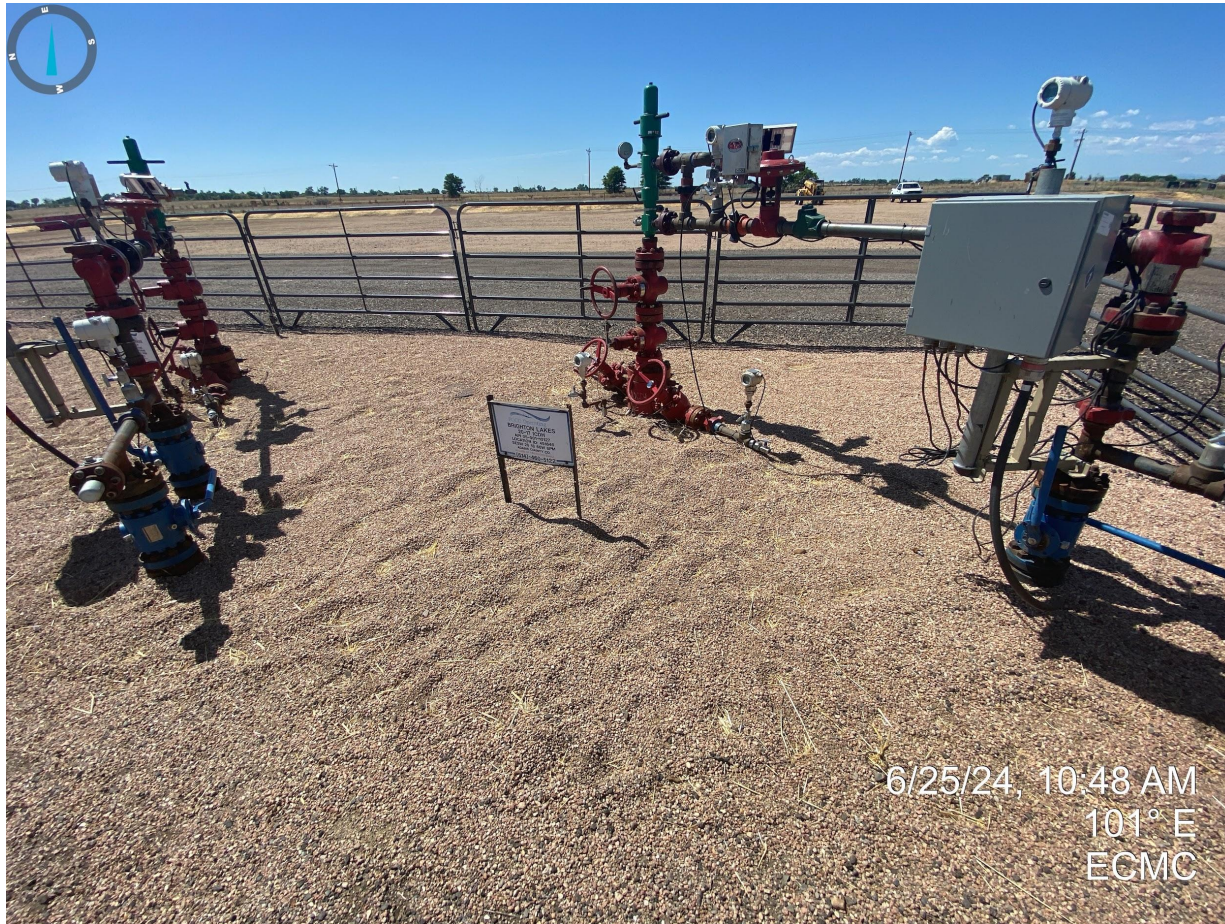
Photo 23. Stained soil around wellheads appears to have been removed and disposed of.

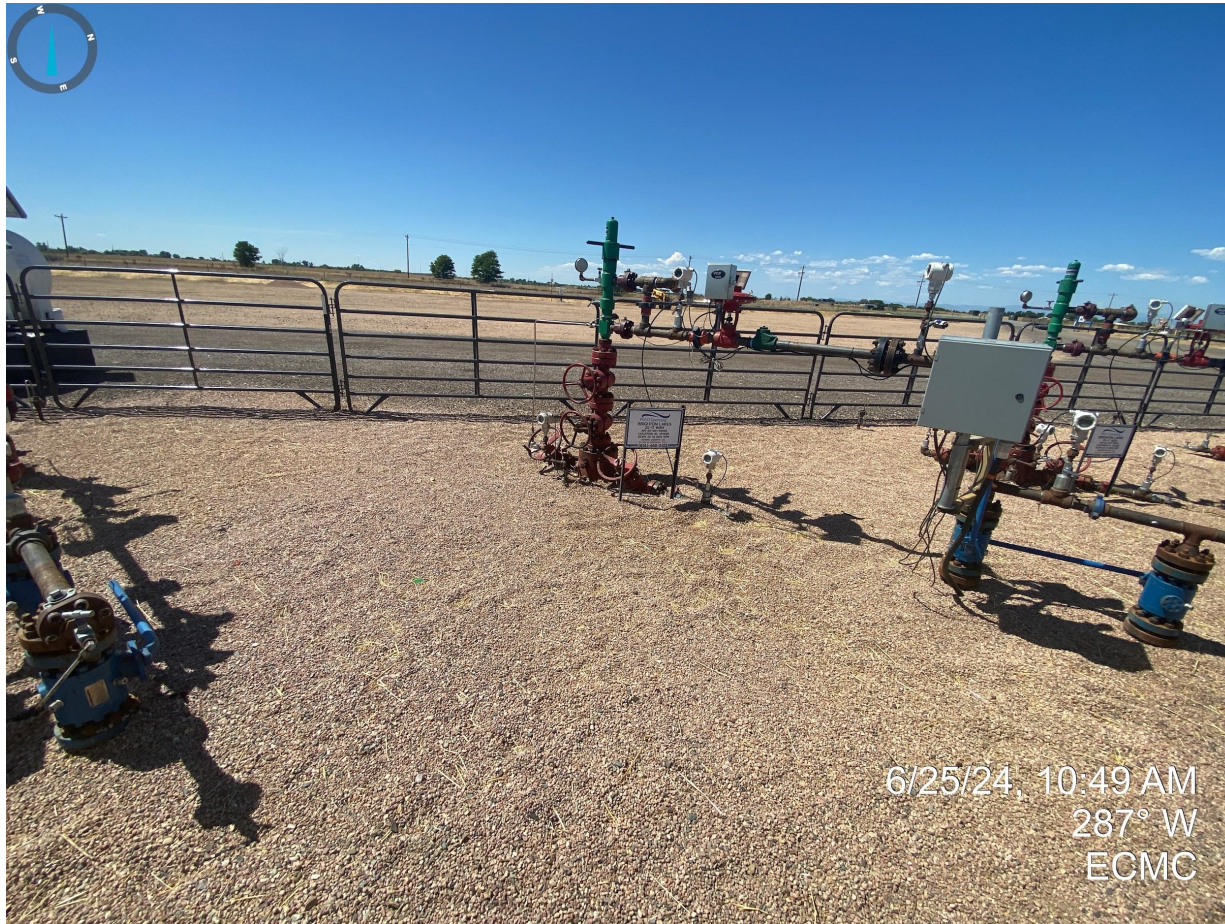
Photo 24. Stained soil around wellheads appears to have been removed and disposed of.

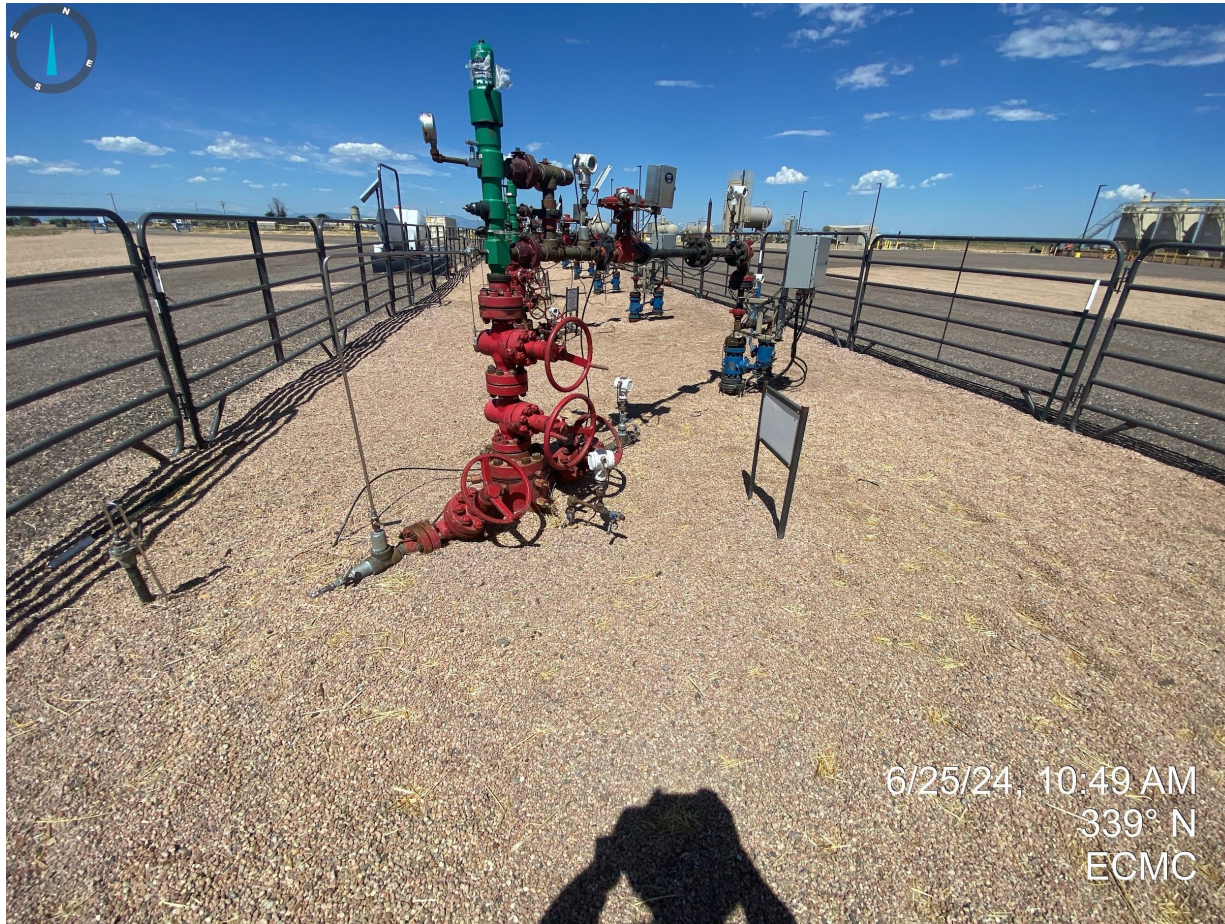
Photo 25. Stained soil around wellheads appears to have been removed and disposed of.

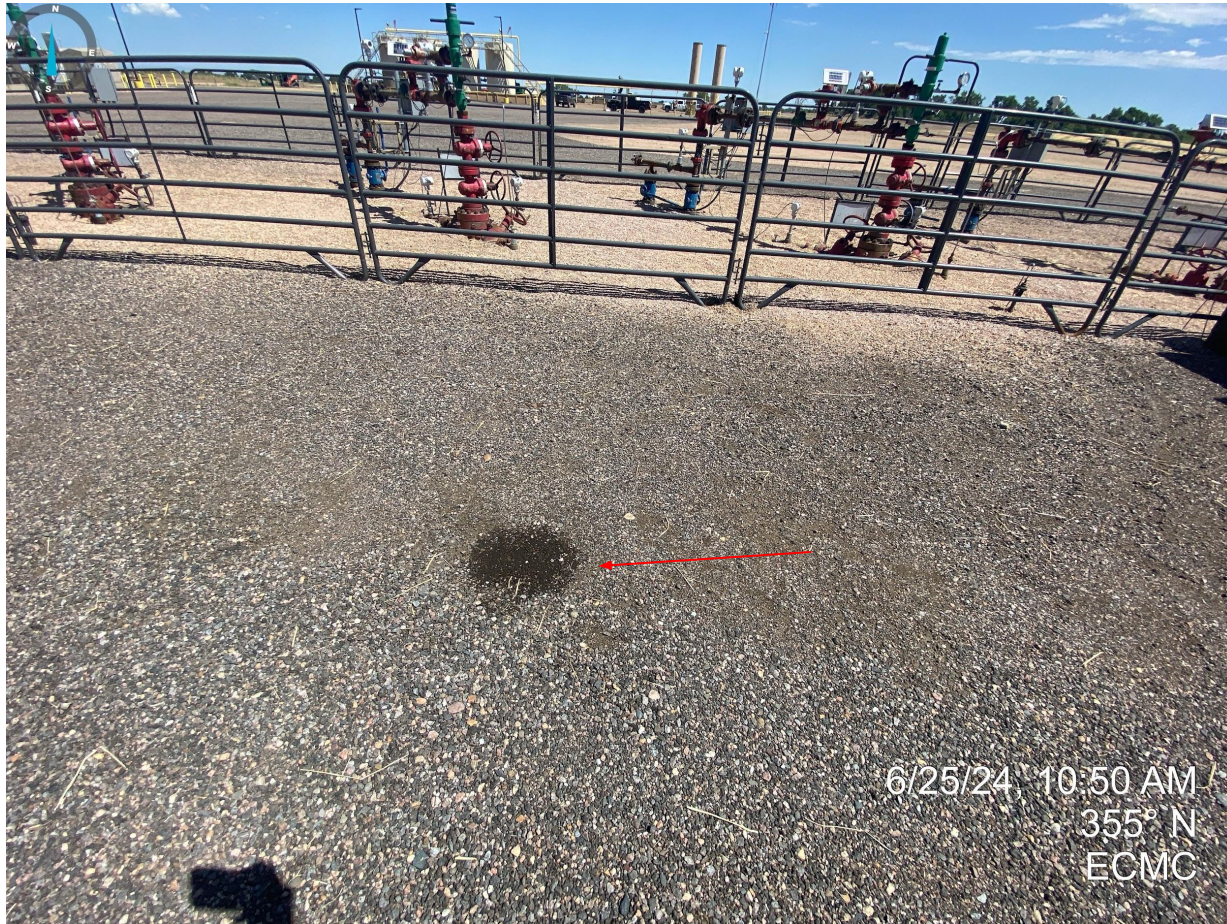
Photo 26. Stained soil south of wellheads.

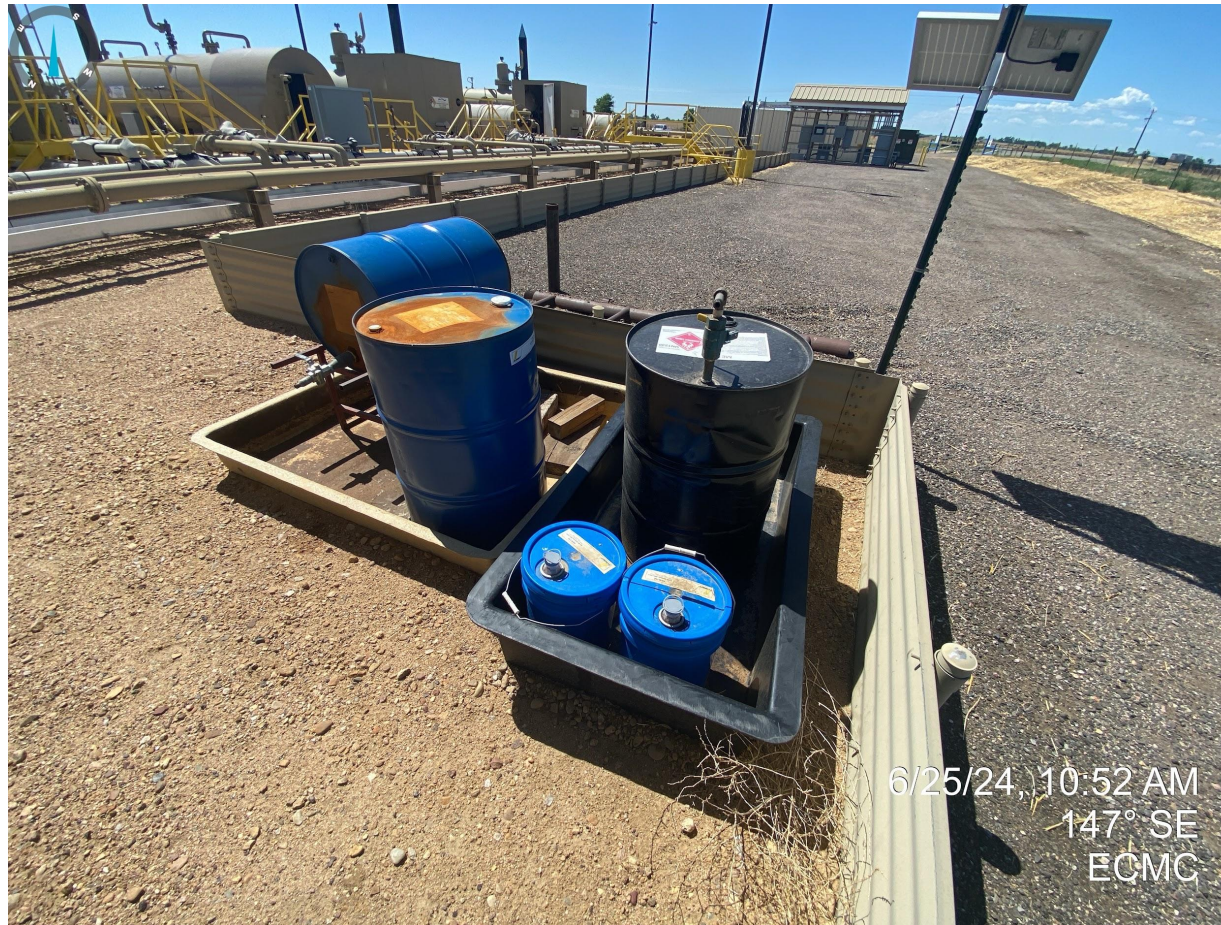
Photo 27. No wildlife netting observed around secondary containment on west end of location.

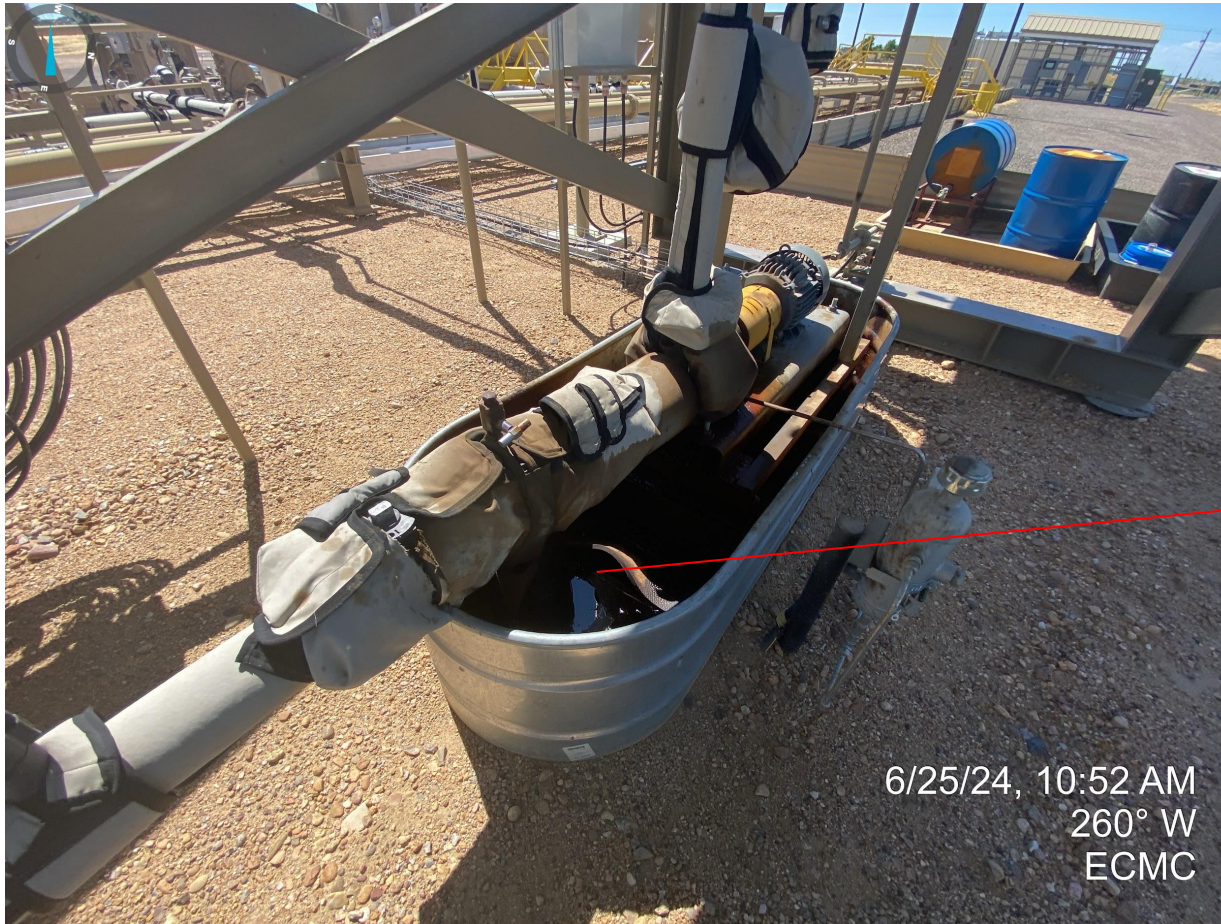
Photo 28. No wildlife netting observed around secondary containment on west end of location. Additionally, free fluids need to be properly removed and disposed of.

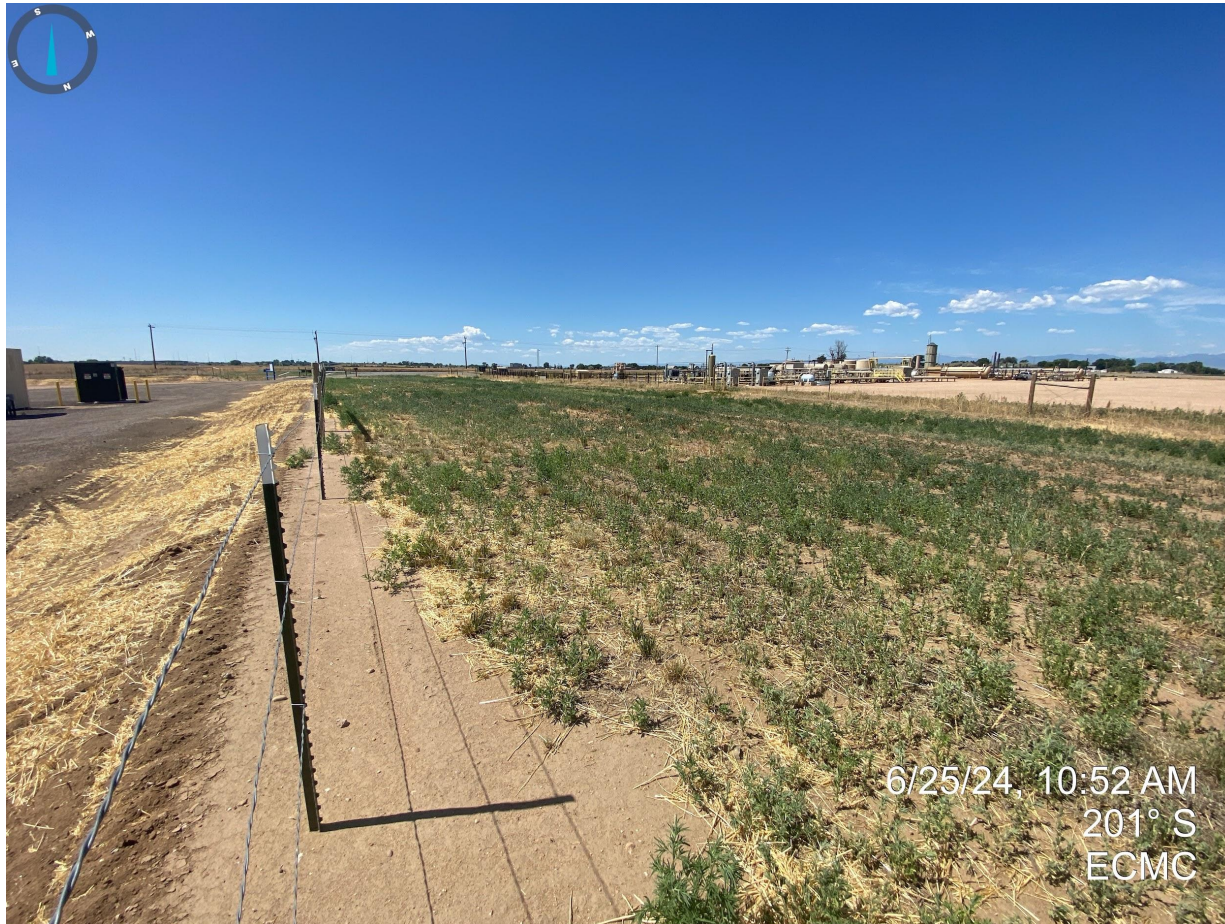
Photo 29. Weedy vegetation on the west end of the location appears to have been mowed. The Operator will need to continue to monitor and manage the location for undesirable vegetation.
