Interim Reclamation and Stormwater Inspection

Date: 06/25/2024

Operator: PDC ENERGY INC - 69175

Location ID: 436062

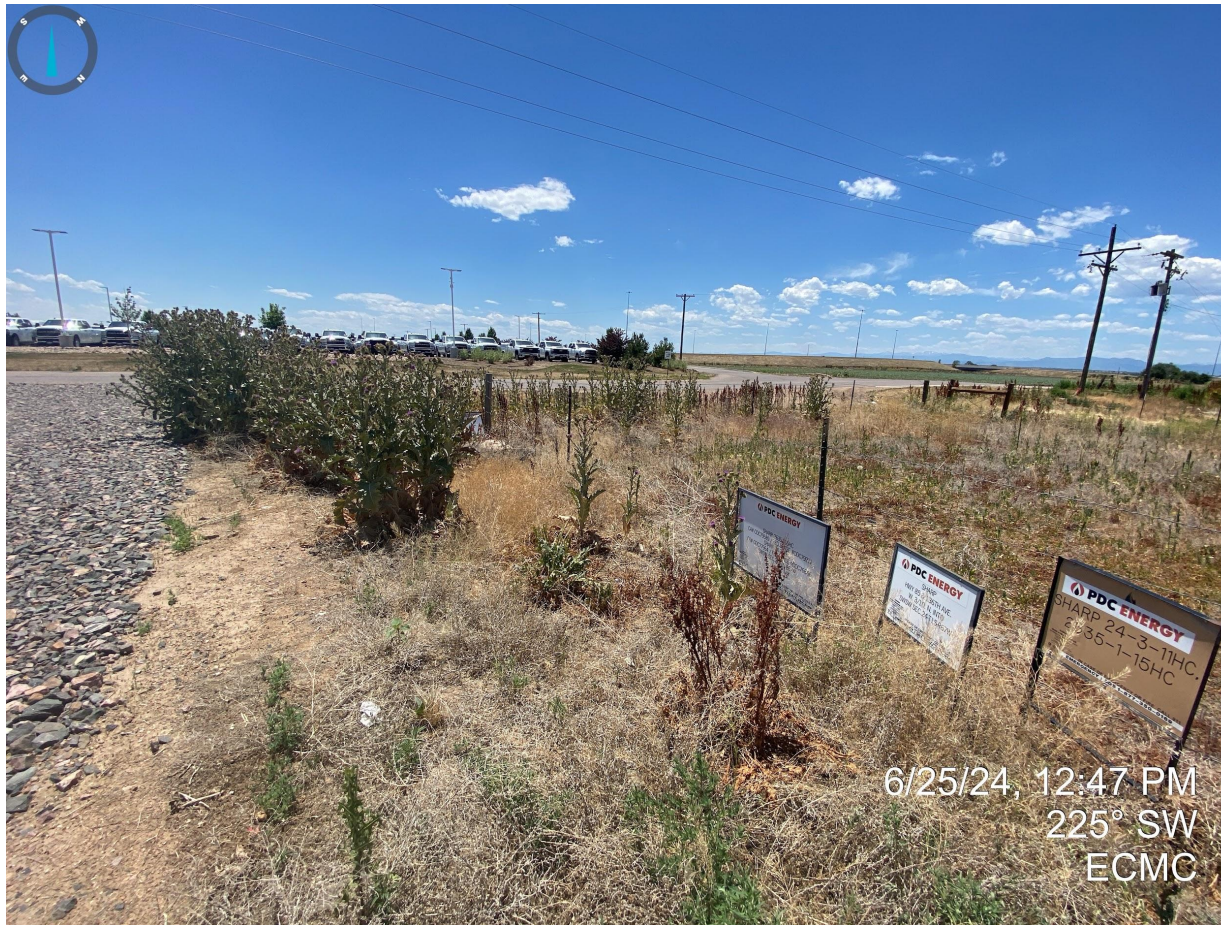
Photo 1. Undesirable vegetation (kochia, curly dock) and CO Noxious Weeds (List B - canada thistle, scotch thistle; List C - cheatgrass) observed at the location entrance. This portion of the location does not appear to have been managed for weeds.

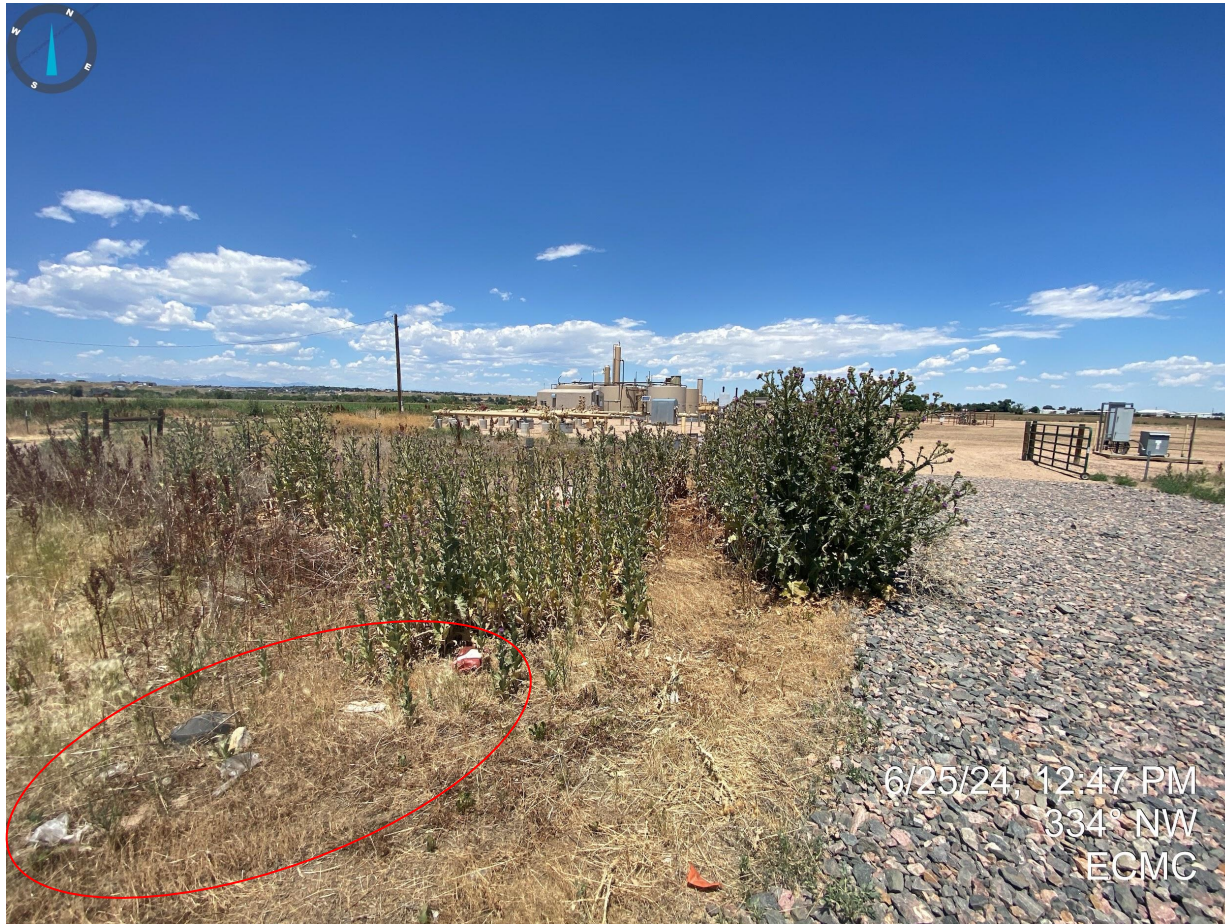
Photo 2. Continued from Photo 1. Also pictured, trash and debris.

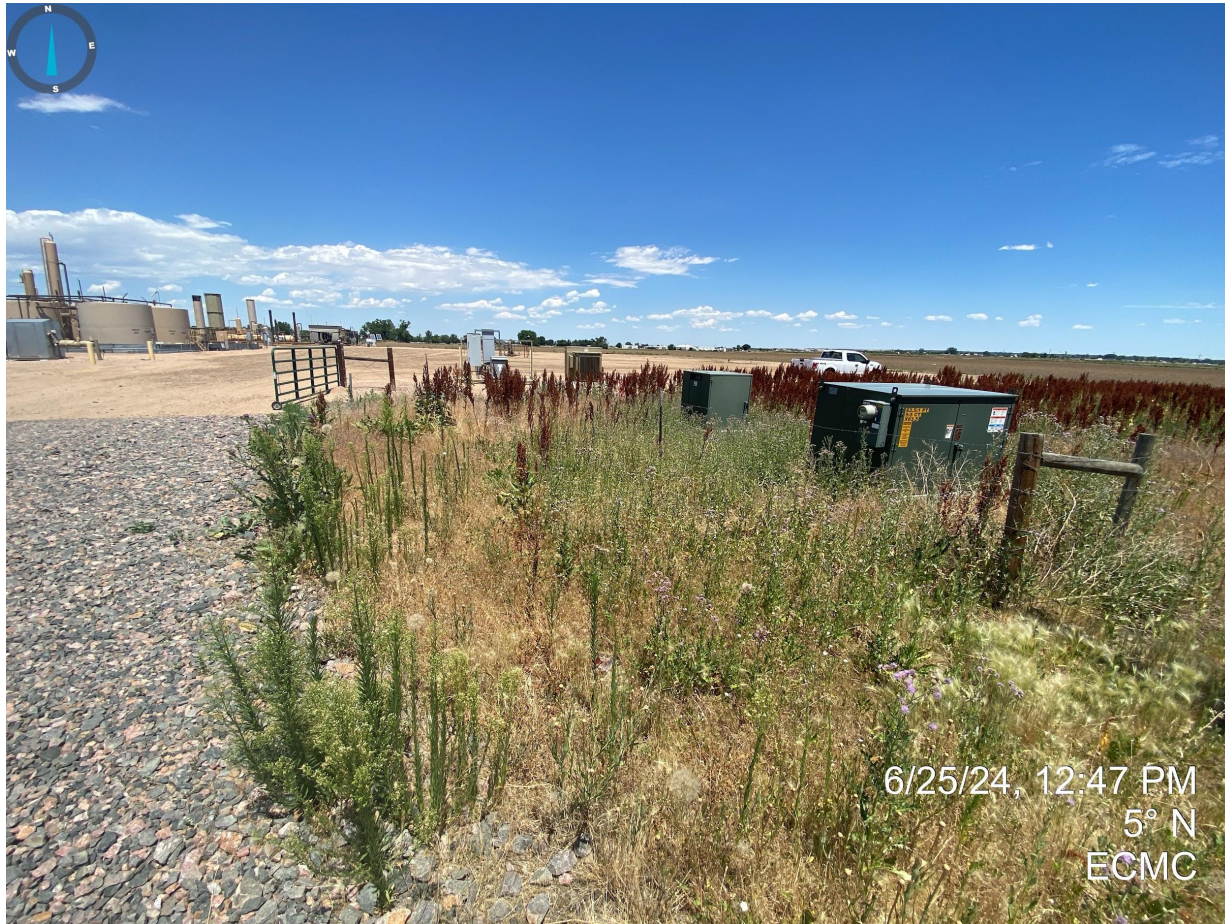
Photo 3. See comments in Photo 1.

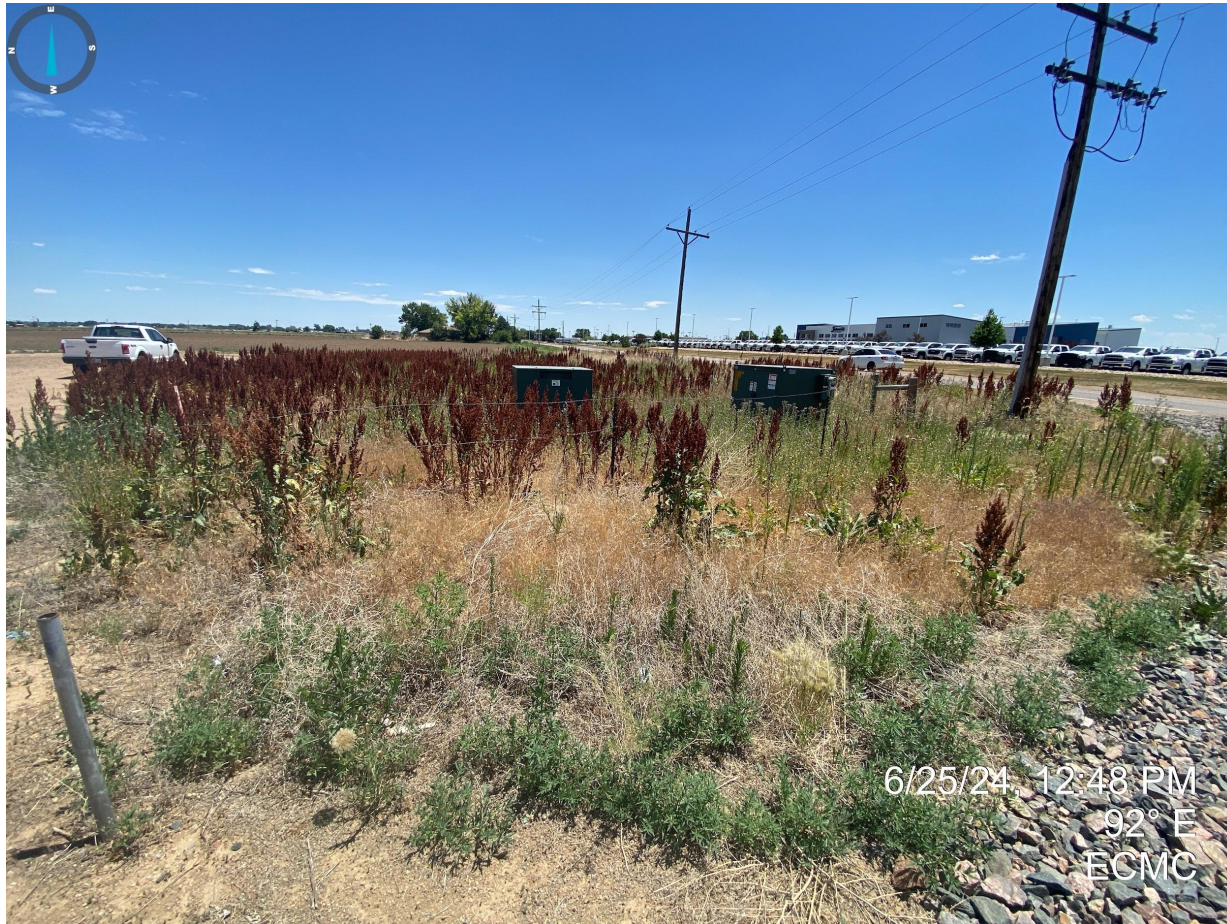
Photo 4. See comments in Photo 1.

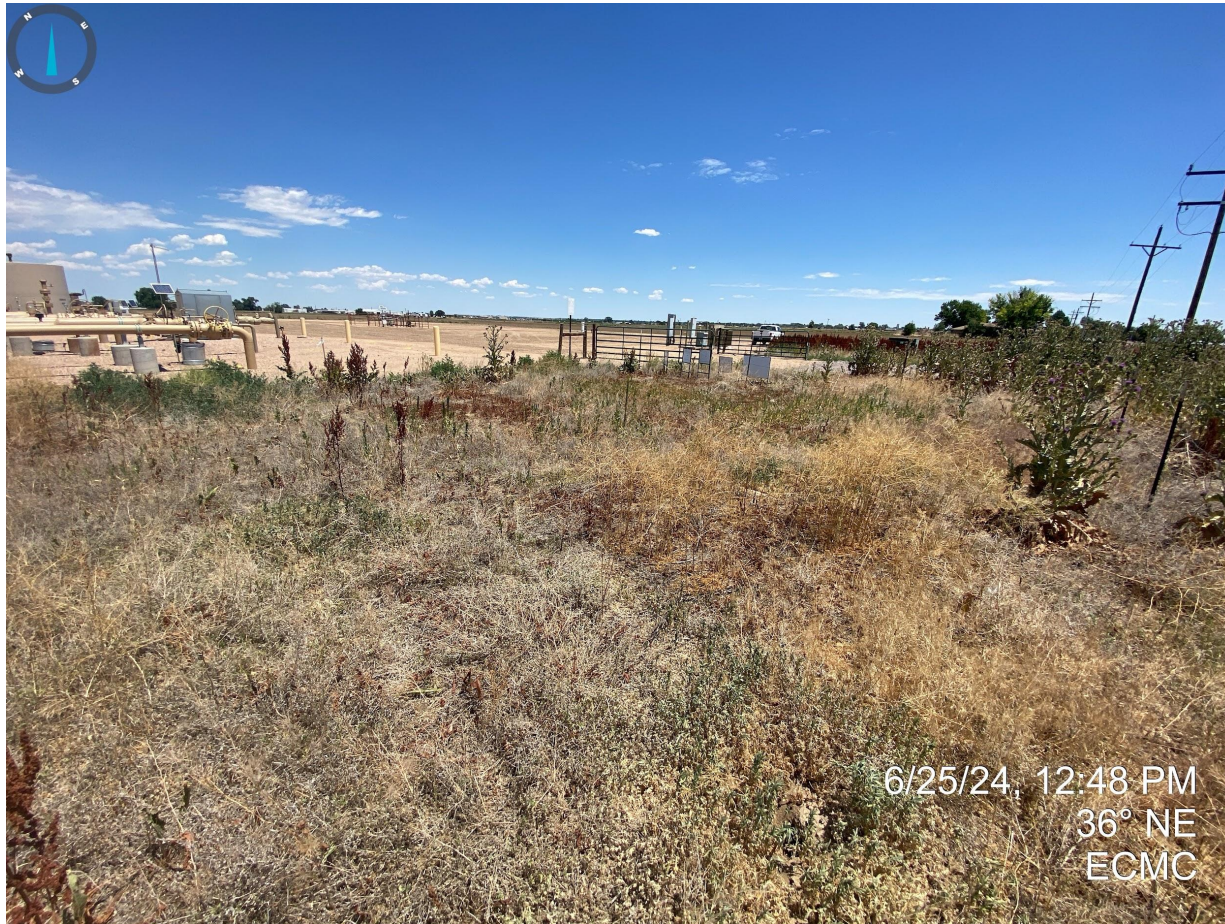
Photo 5. Southwest portion of the location; See comments in Photo 1.

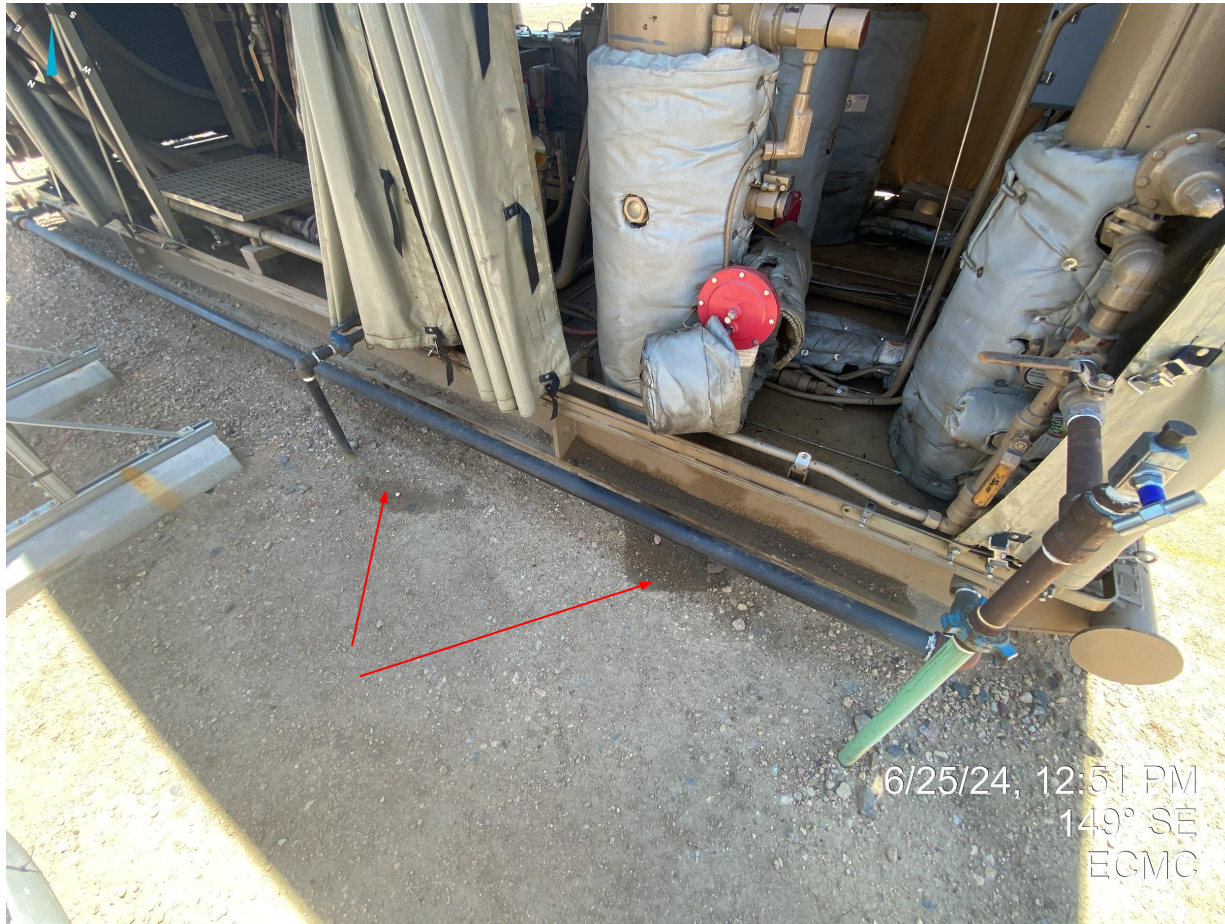
Photo 6. Stained soil at compressor skid.

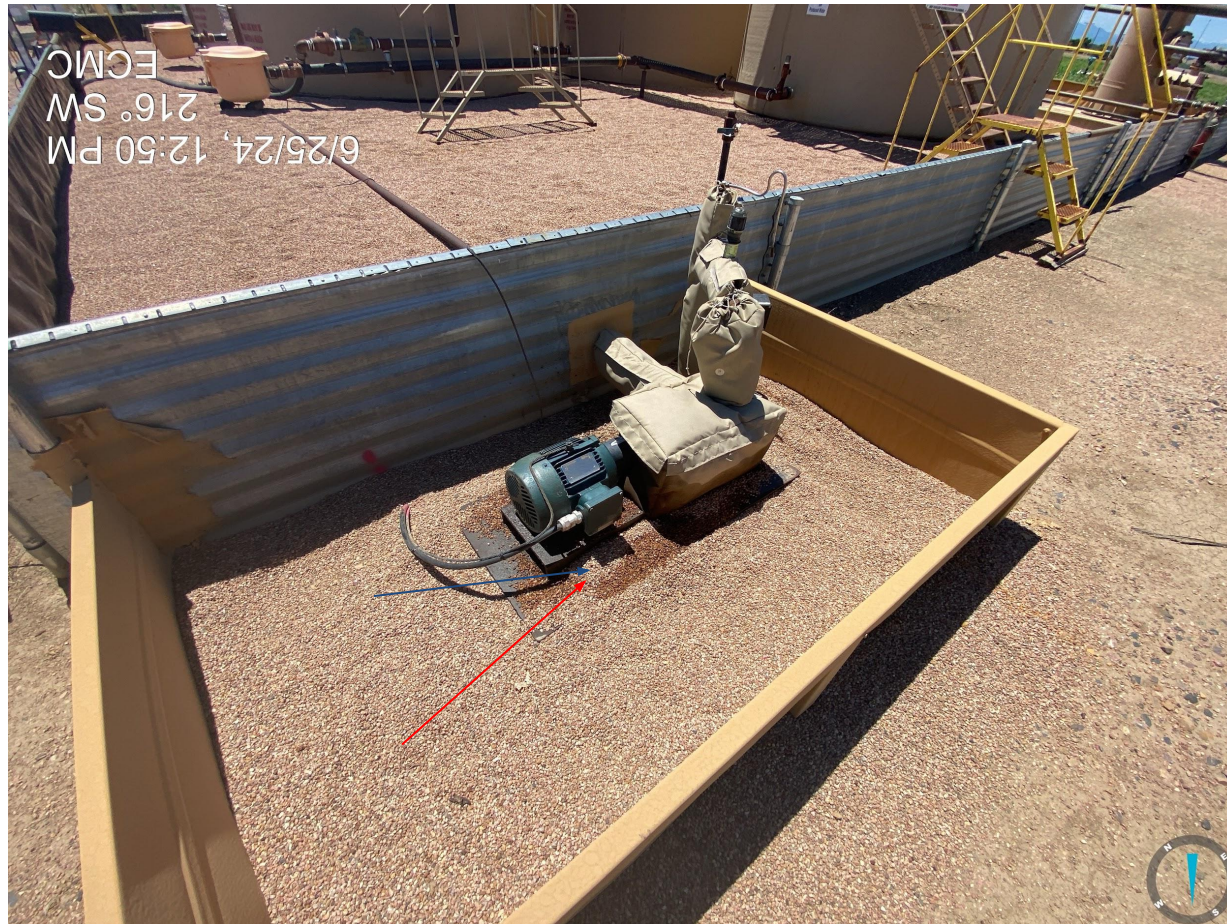
Photo 7. Stained soil within secondary containment.

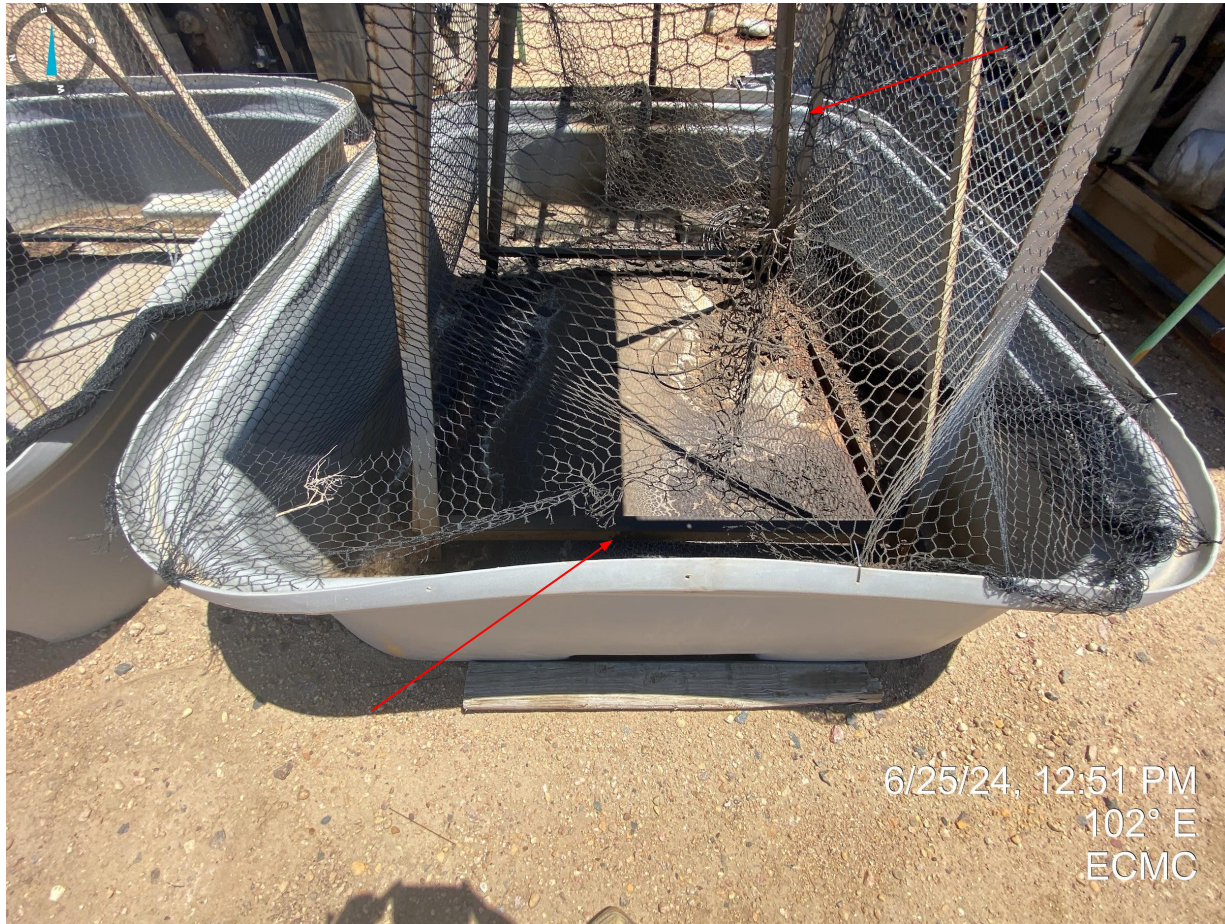
Photo 8. Wildlife netting requires repair/replacement.

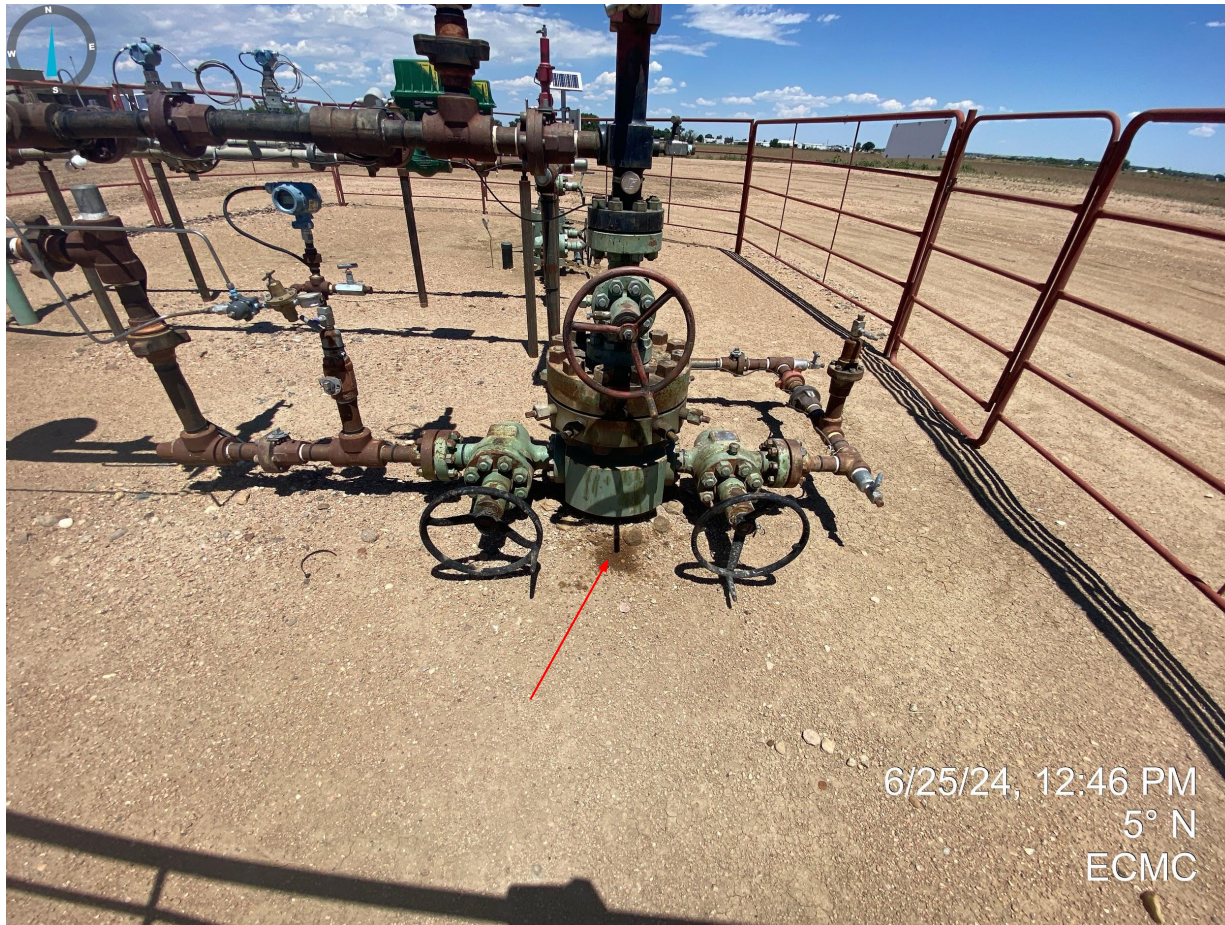
Photo 9. Stained soil at wellhead.

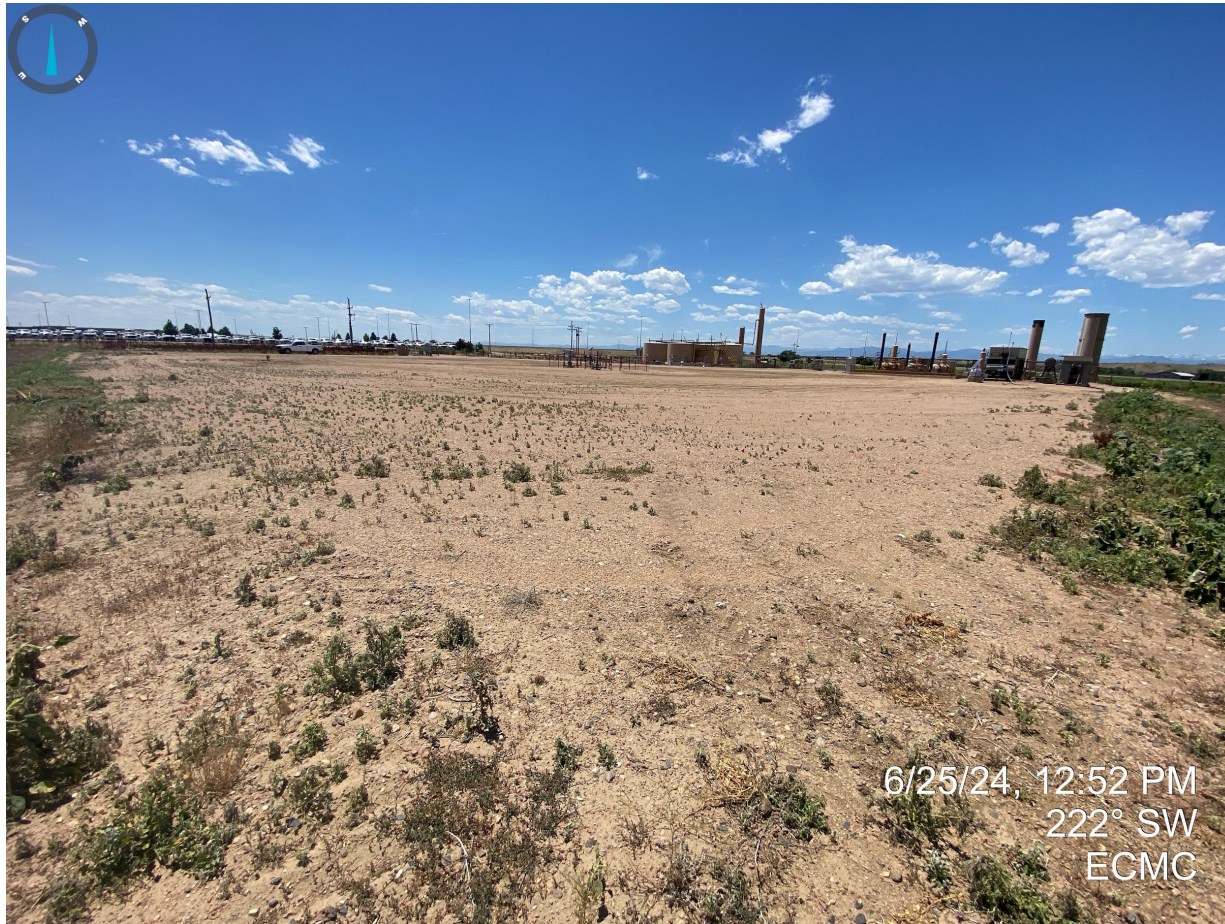
Photo 10. Northeast corner of the location. Weeds along the northern and eastern portions appear to have been sprayed with herbicide. The southern portion of the location near the entrance does not appear to have been sprayed; refer to Photos 1-5 for additional.
