Construction and Stormwater Inspection

Date: 06/26/2024

Operator: NOBLE ENERGY INC - 100322

Location ID: 483513

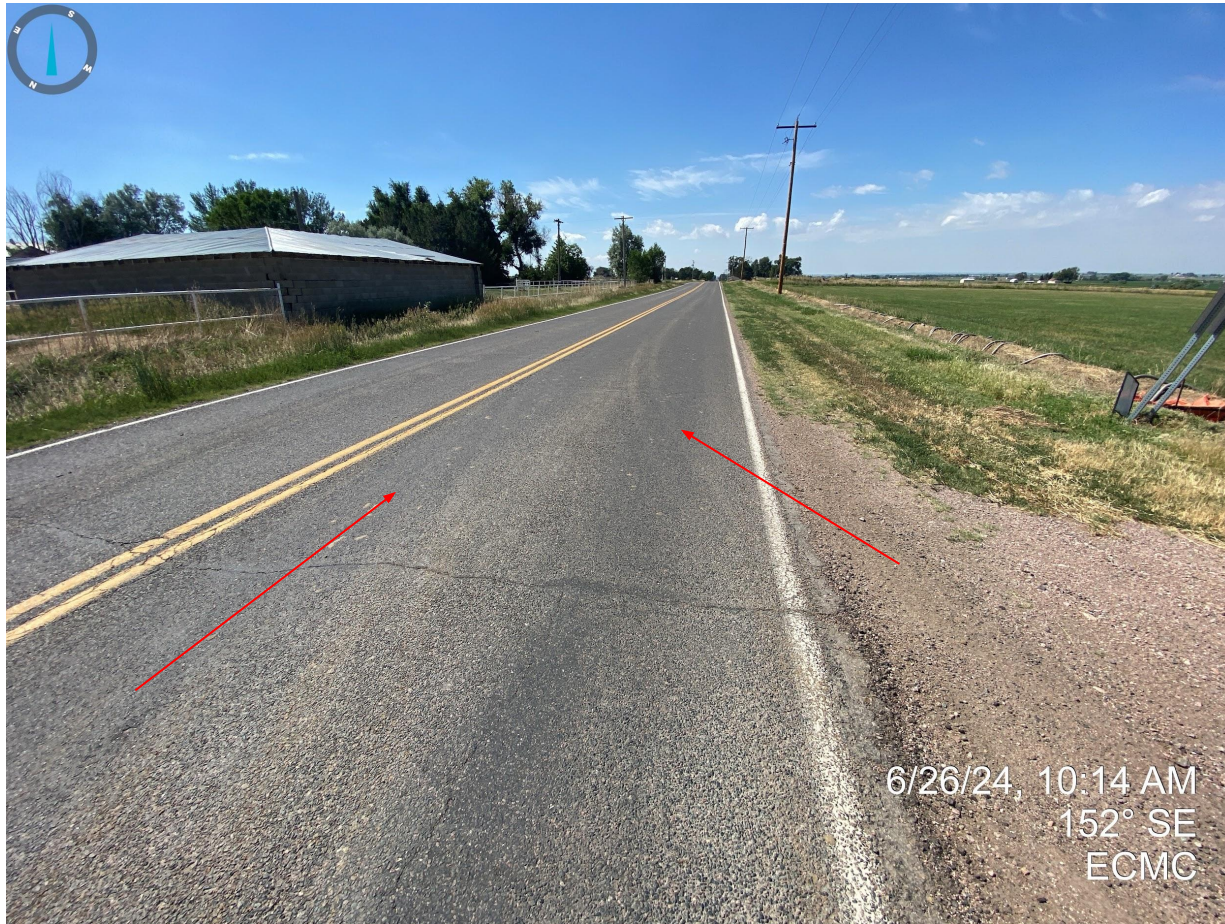
Photo 1. Facing south on WCR 51, near the location entrance. Vehicle track out observed originating from the location entrance.

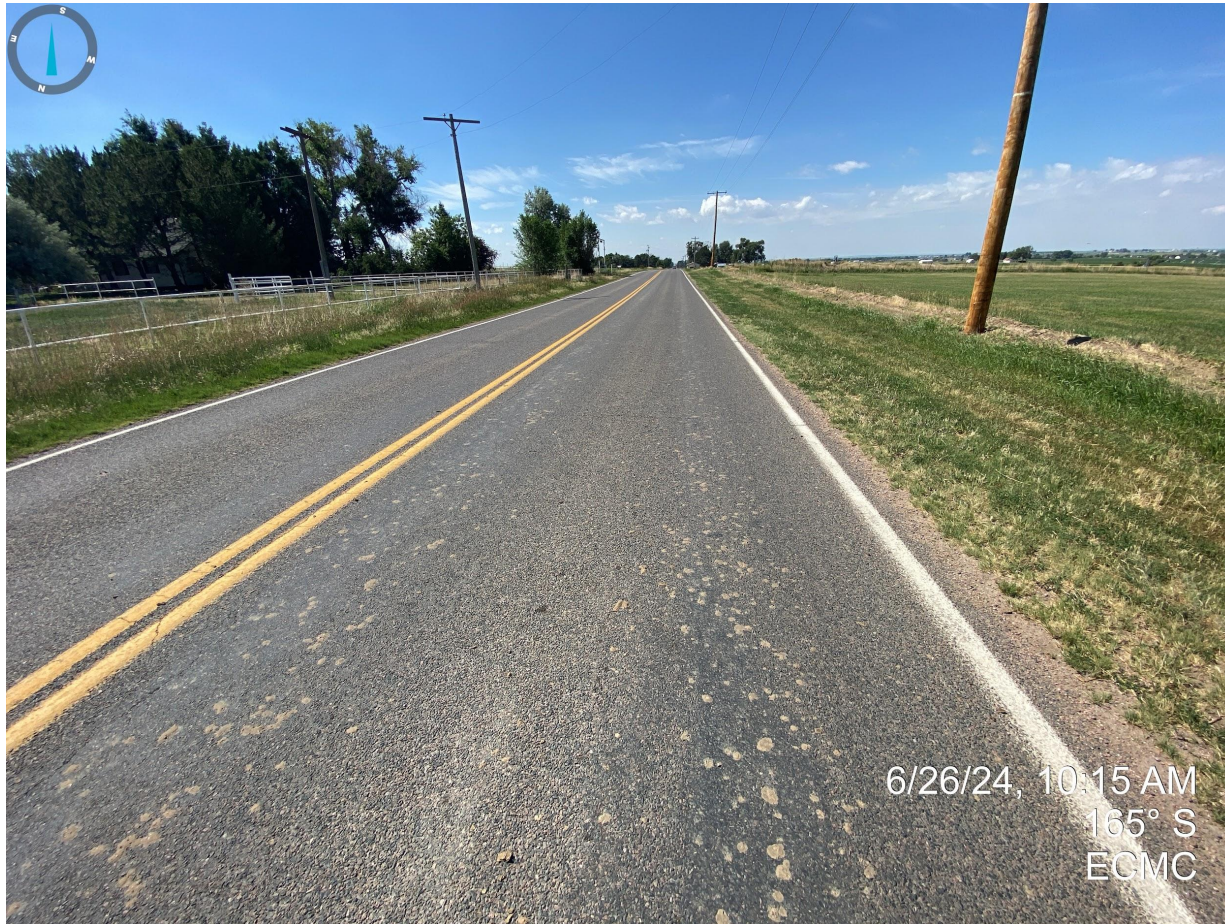
Photo 2. Continued from Photo 1, facing south.

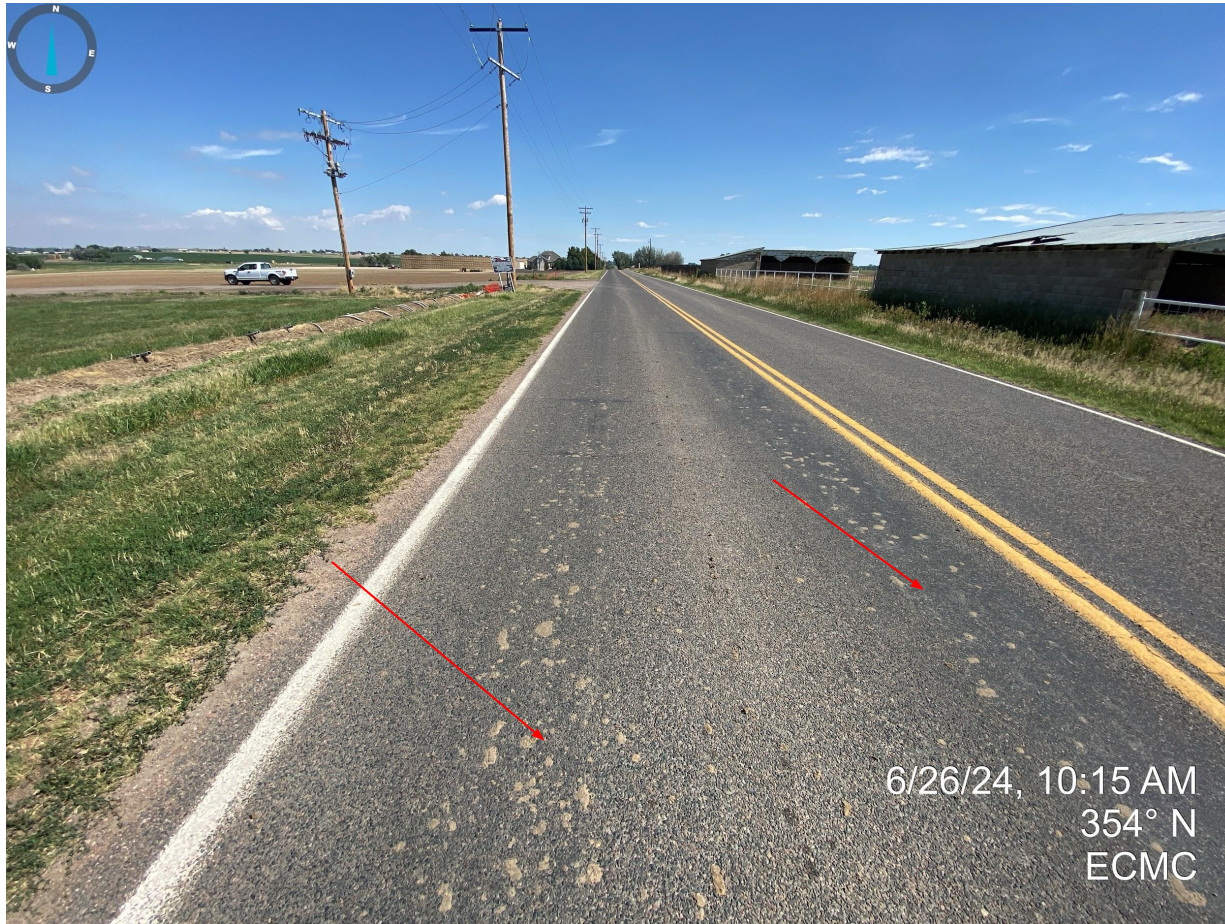
Photo 3. Facing north on WCR 51, south of the location entrance. Vehicle track out observed originating from the location entrance.

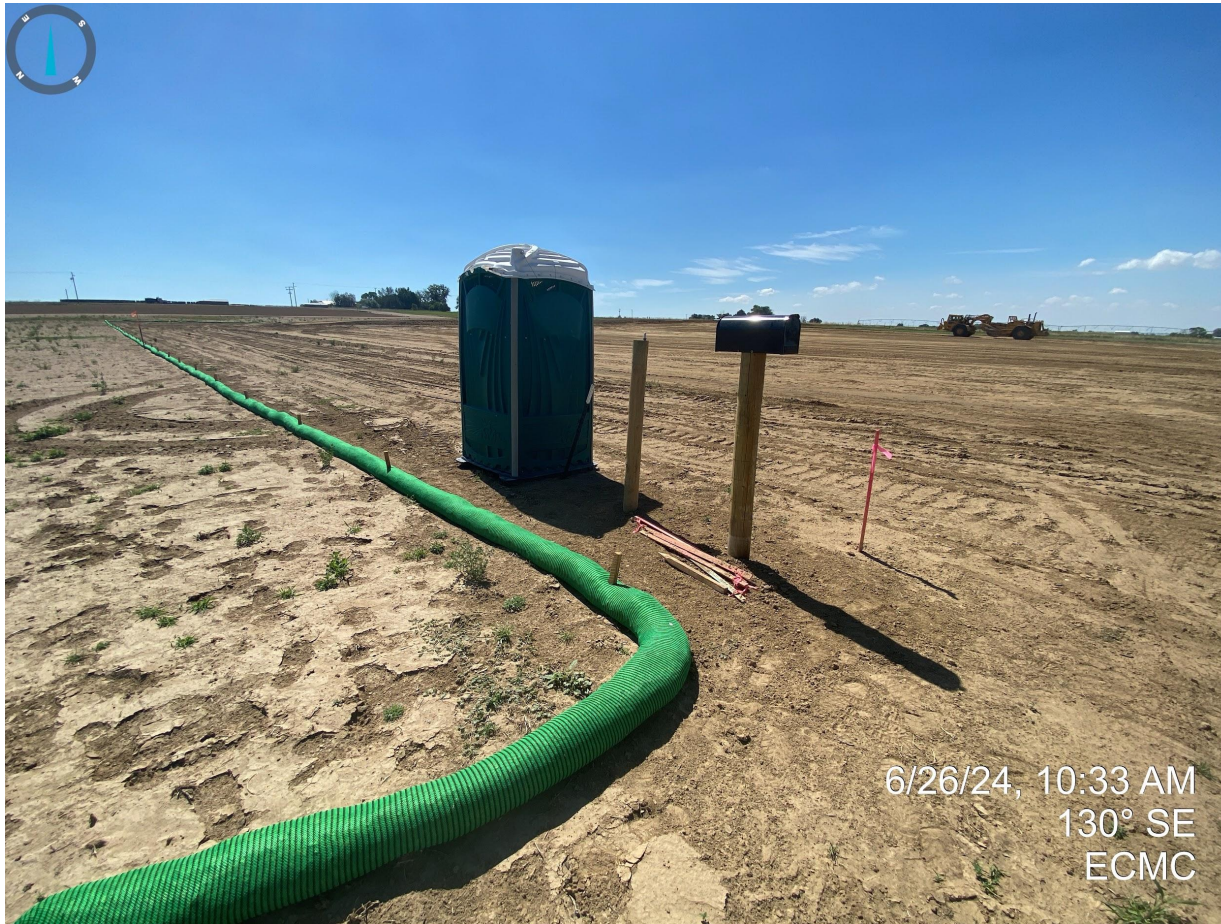
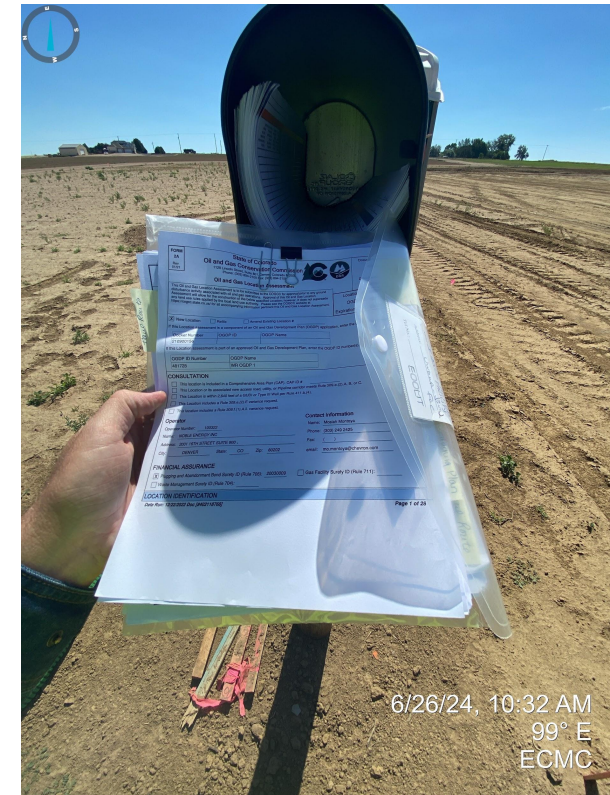
Photo 4. Form 2A posted on location.

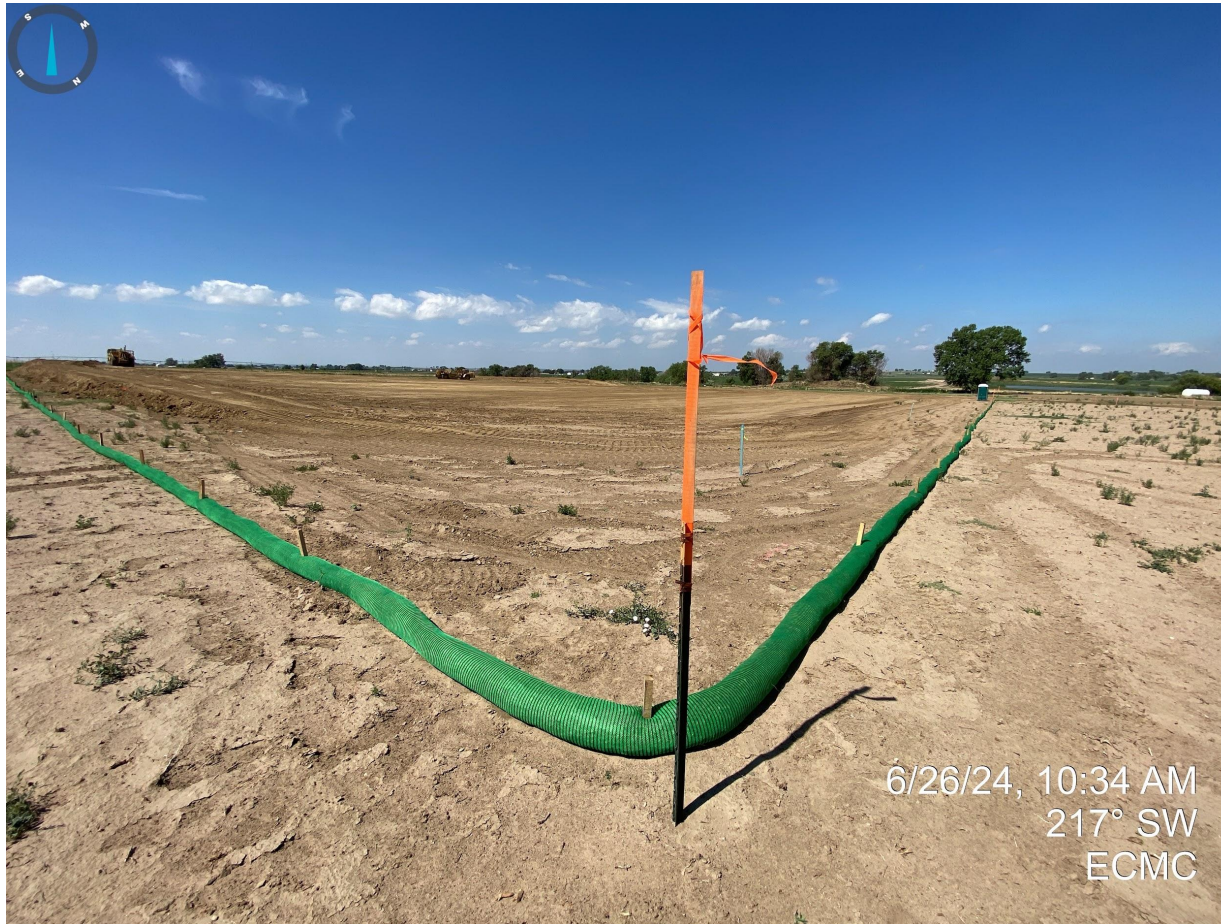
Photo 5. Northeast corner of the construction area. Temporary BMPs (filtrexx wattles) have been installed along the entire perimeter during the construction phase. More permanent BMPs should be selected and installed upon completion of the pad.

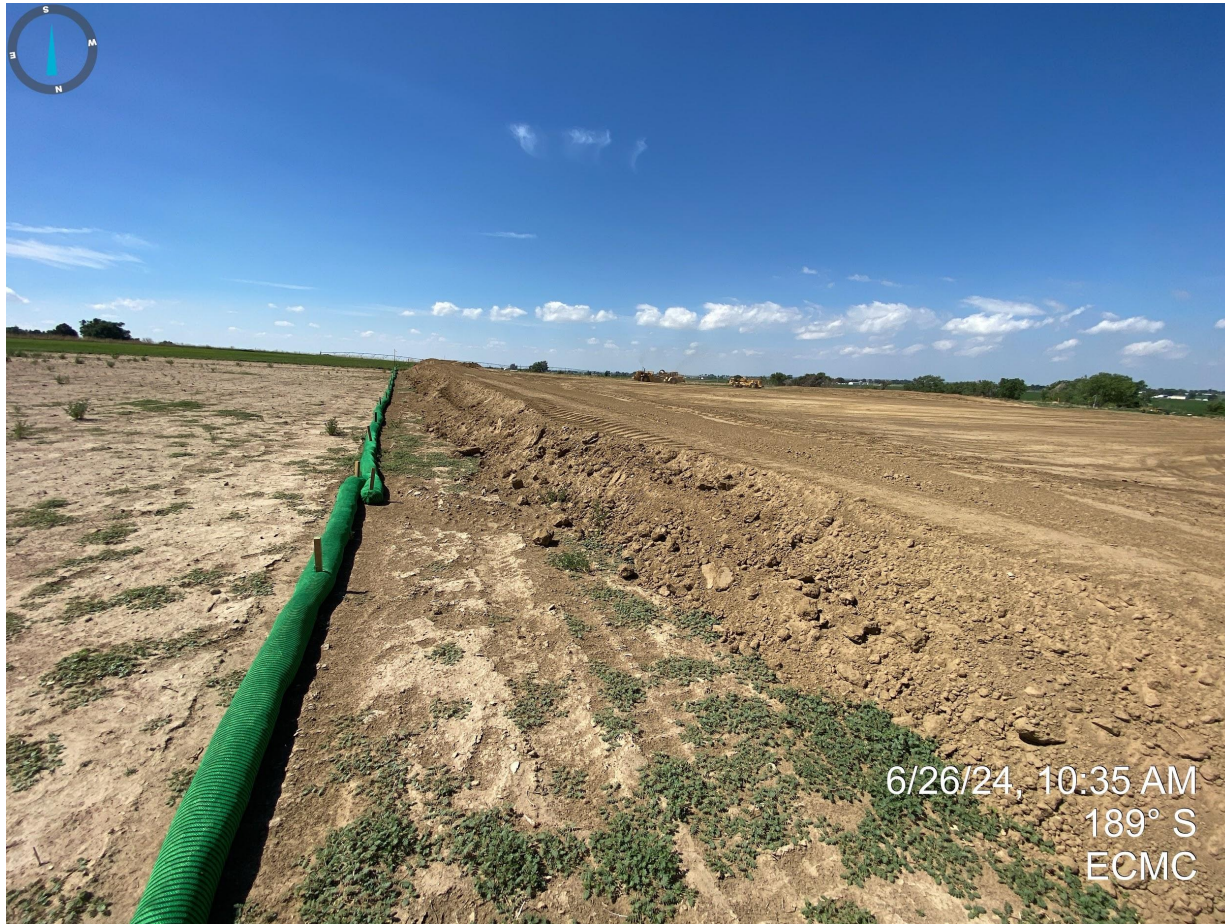
Photo 6. Topsoil stockpile on the eastern portion of the pad; topsoil salvage activities were ongoing at the time of this inspection.

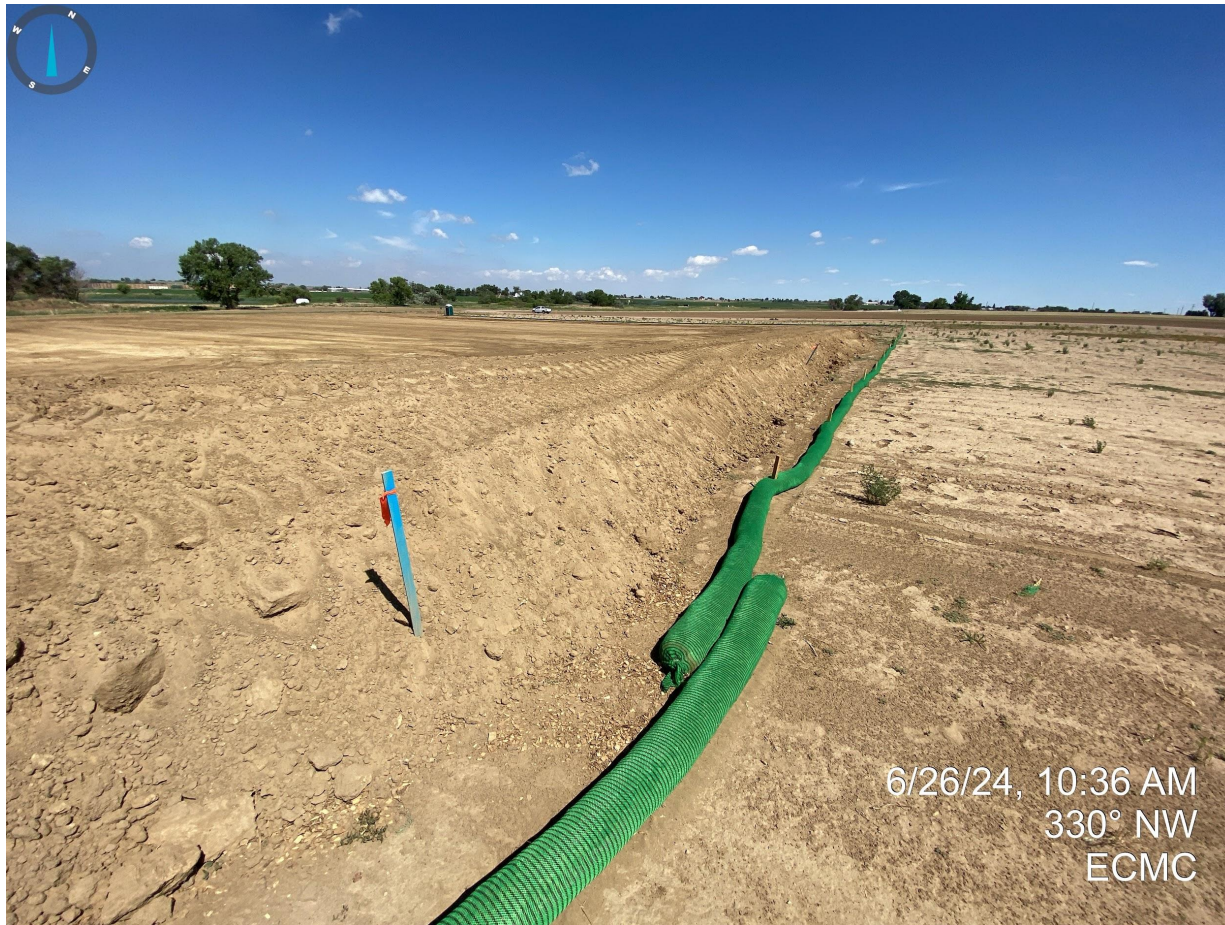
Photo 7. Facing northwest along the eastern portion of the location; see comments in Photo 6.

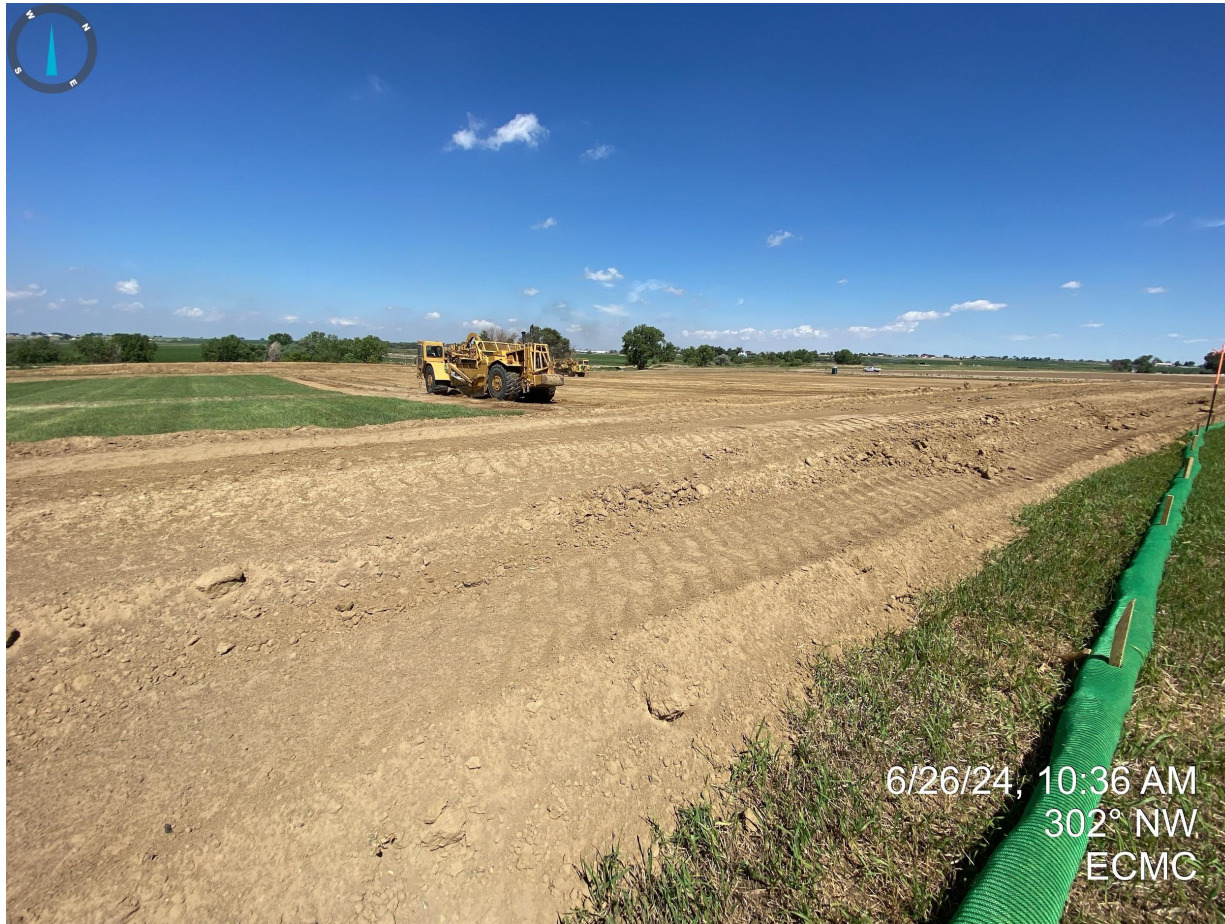
Photo 8. Topsoil salvage activities were ongoing at the time of this inspection. The Operator shall ensure that all topsoil is salvaged from the location, in compliance with Rule 1002.b.

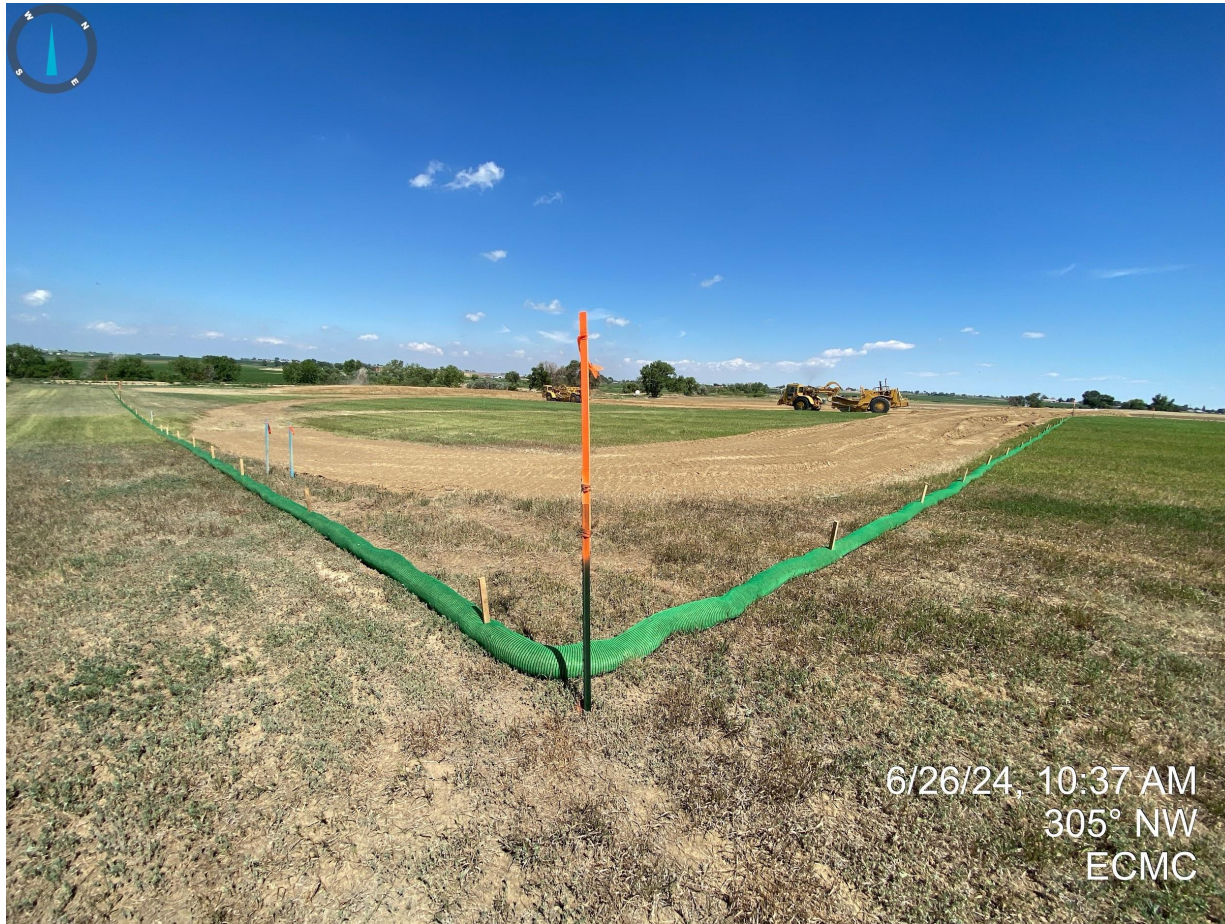
Photo 9. Southeast corner of the construction area. Temporary BMPs (filtrexx wattles) have been installed along the entire perimeter during the construction phase. More permanent BMPs should be selected and installed upon completion of the pad.

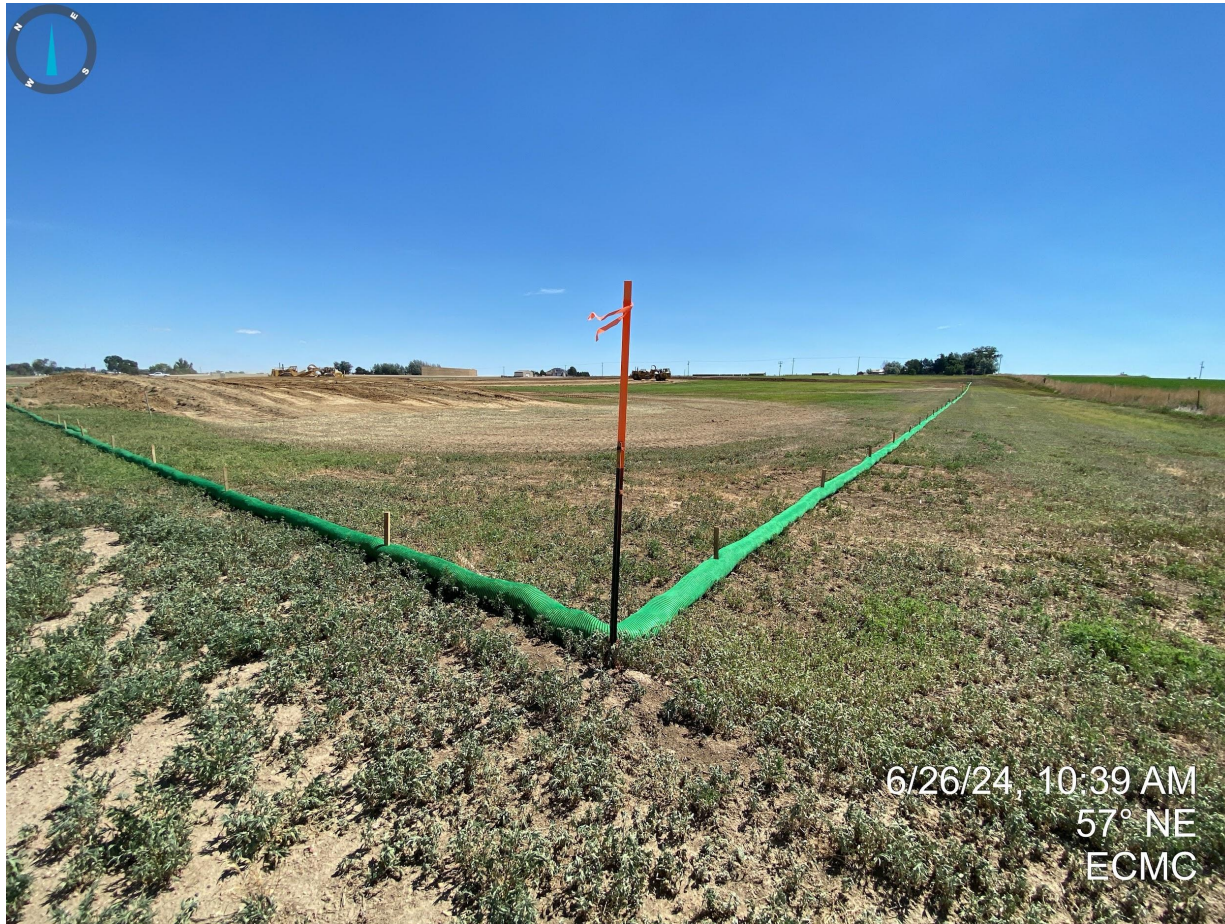
Photo 10. Southwest corner of the construction area. Temporary BMPs (filtrexx wattles) have been installed along the entire perimeter during the construction phase. More permanent BMPs should be selected and installed upon completion of the pad.

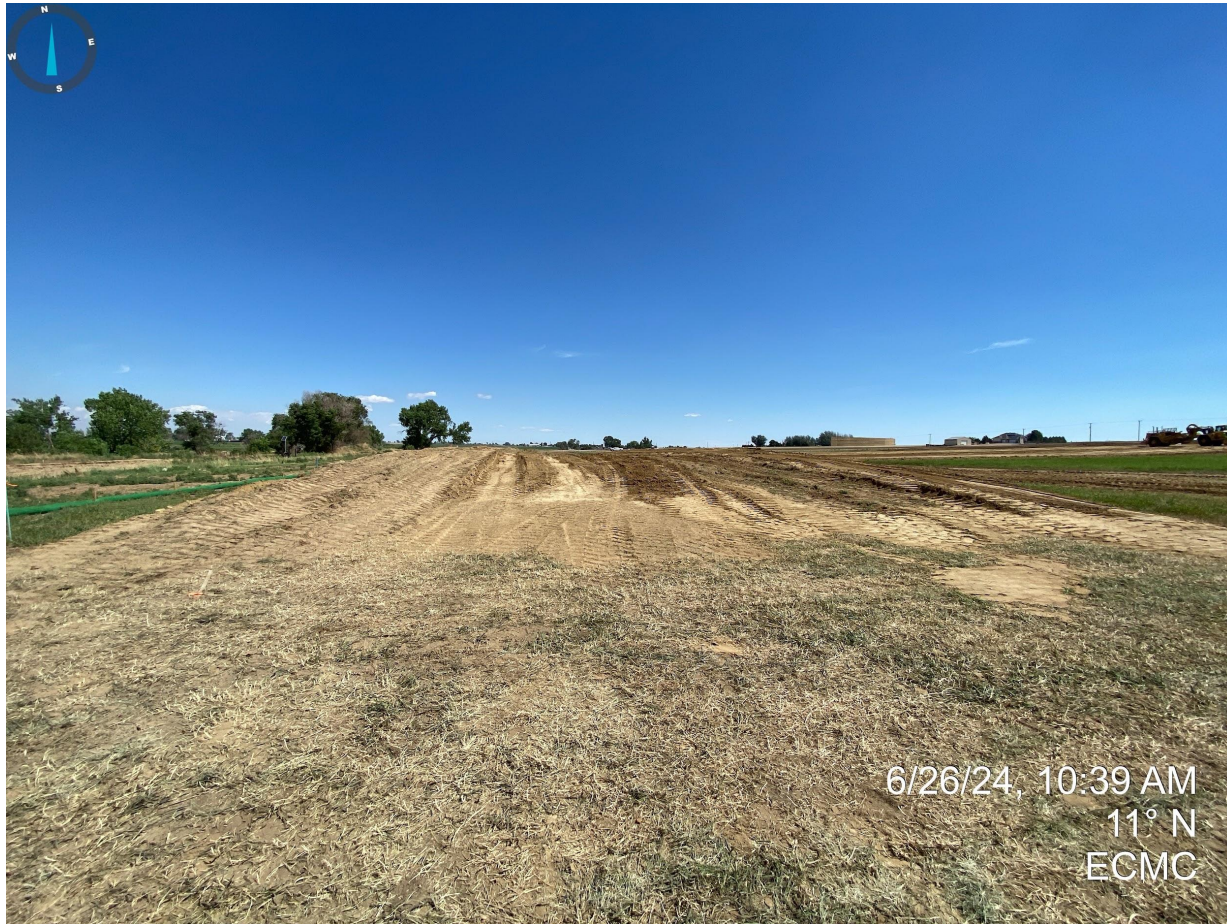
Photo 11. Topsoil stockpile on the western portion of the location. Topsoil salvage activities were ongoing at the time of this inspection.

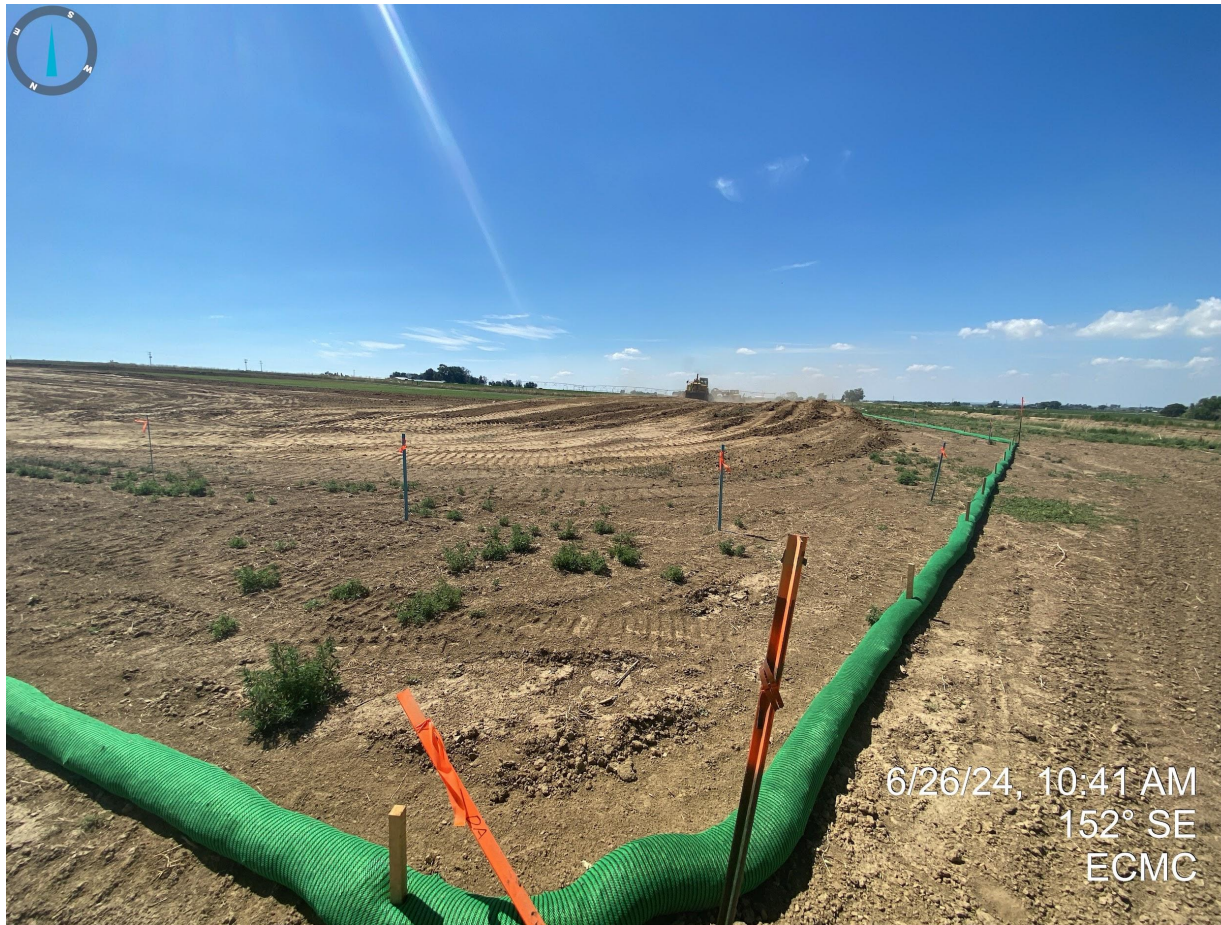
Photo 12. West/center portion of the construction area. Temporary BMPs (filtrex wattles) have been installed along the entire perimeter during the construction phase. More permanent BMPs should be selected and installed upon completion of the pad.

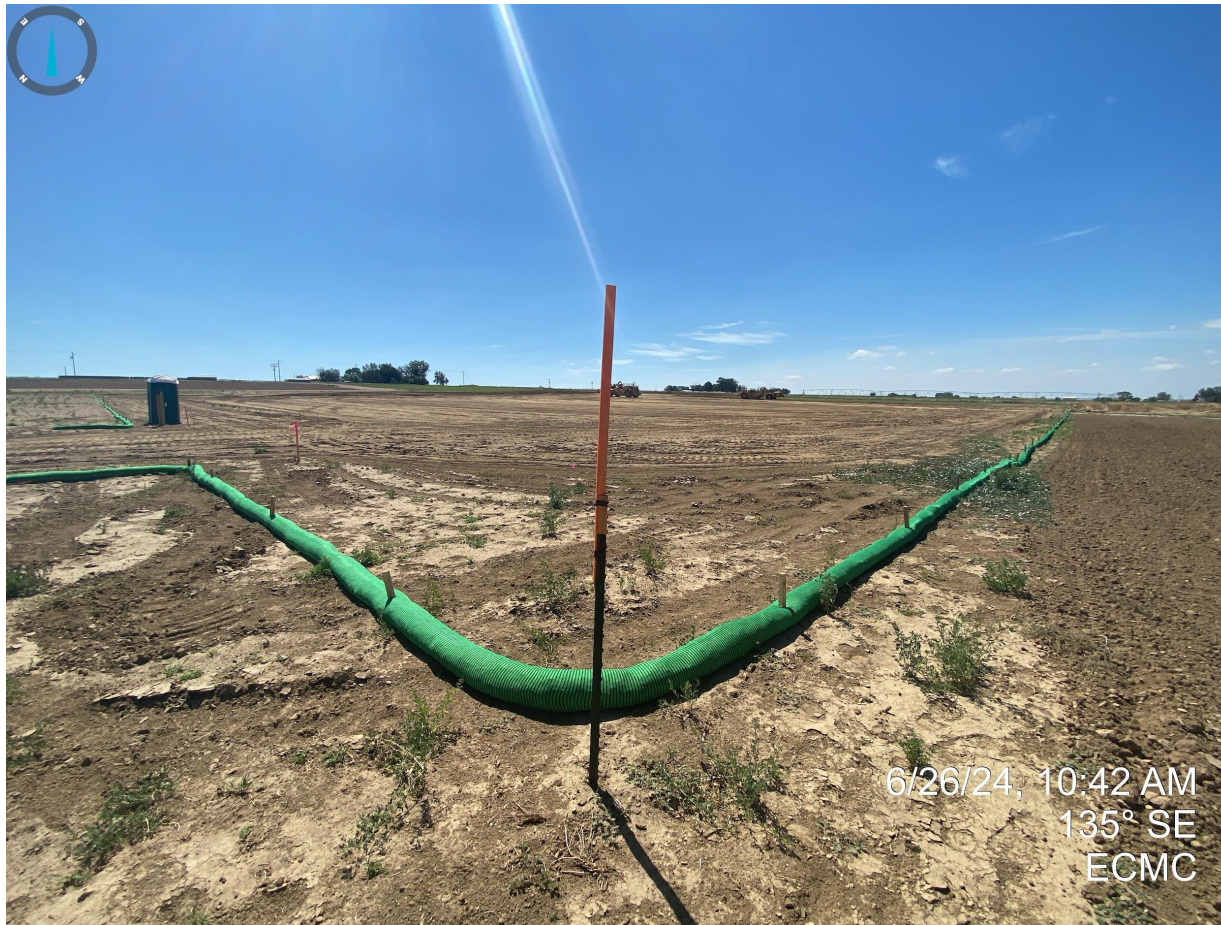
Photo 13. Northwest corner of the construction area. Temporary BMPs (filtrexx wattles) have been installed along the entire perimeter during the construction phase. More permanent BMPs should be selected and installed upon completion of the pad.

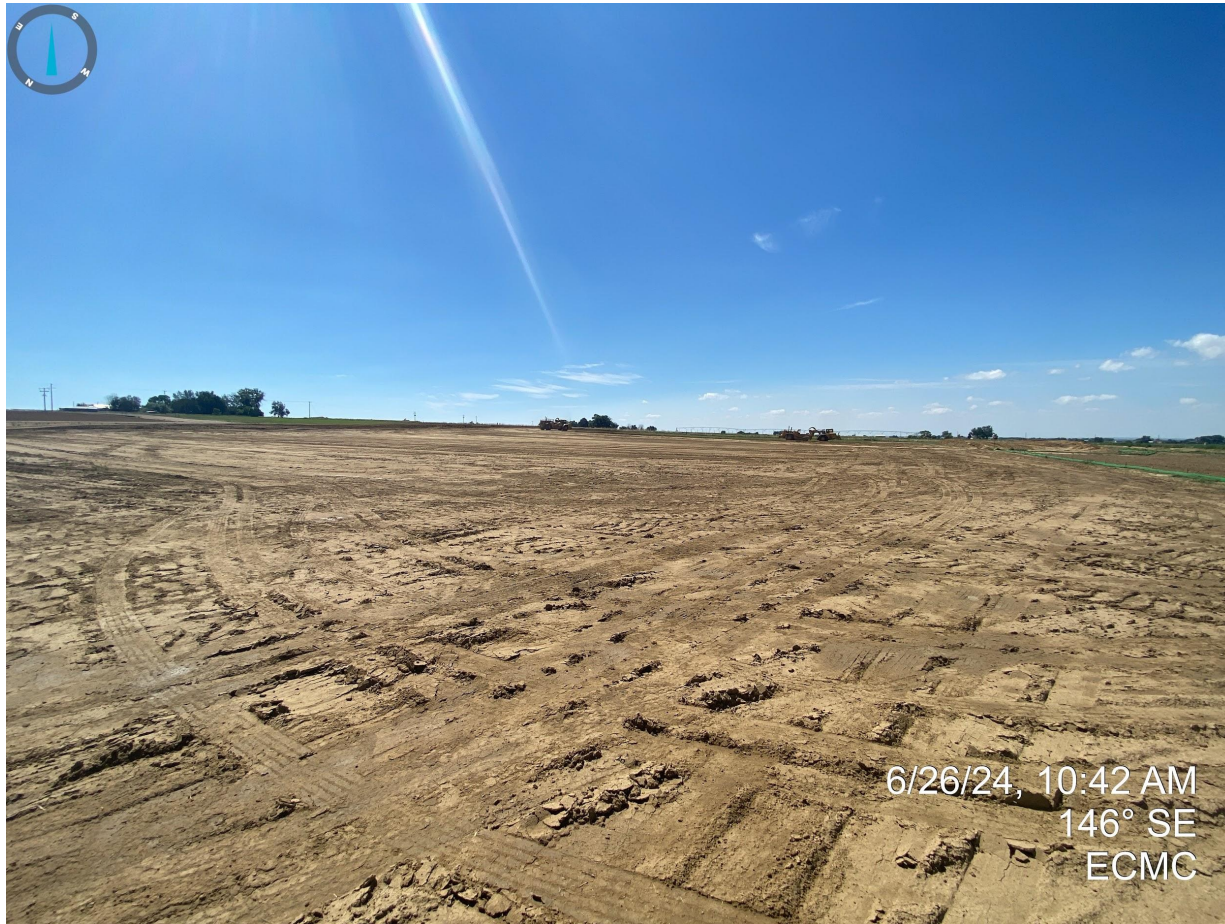
Photo 14. Overview of the location construction area; a follow-up inspection will be performed at a later date to ensure compliance with ECMC Rules.
