# Construction and Stormwater Inspection

Operator: NOBLE ENERGY INC - 100322

Location ID: 483562

Inspection Document #: 708201370

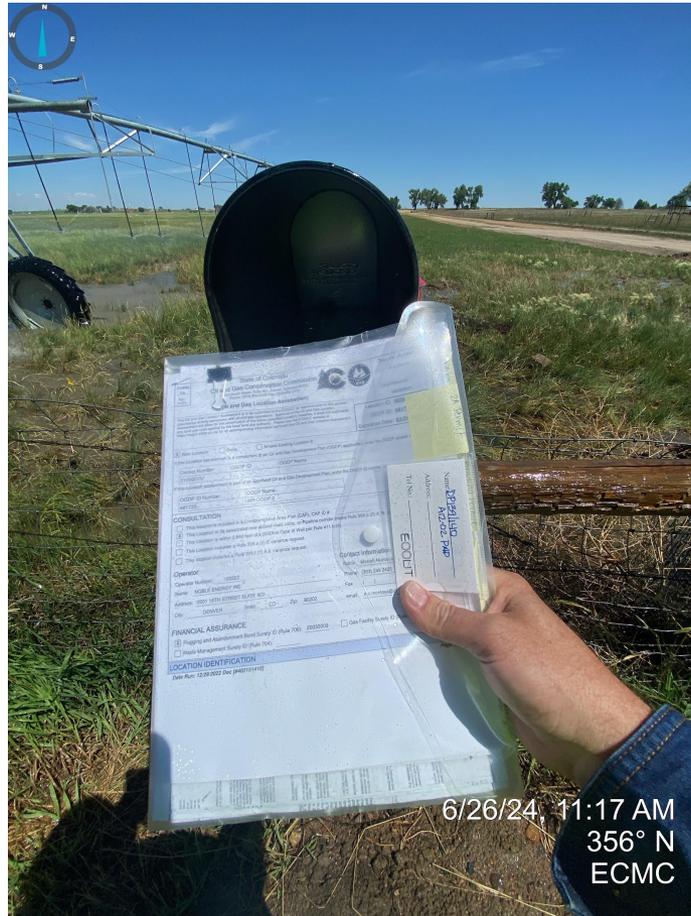
Photo 1. Form 2A posted on location.

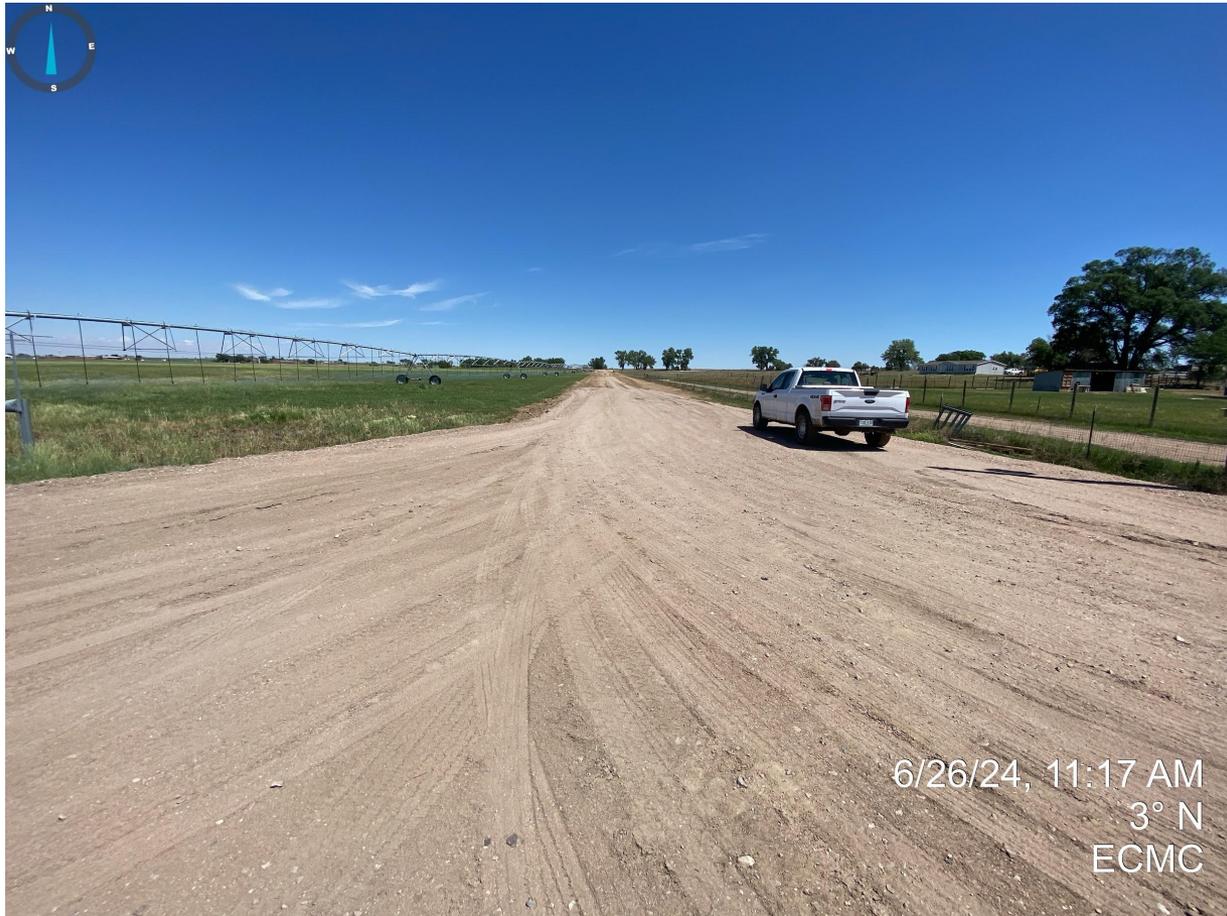
**Photo 2.** Taken near the start of the access road, facing north. At the time of this inspection, it did not appear that all topsoil had been salvaged from the access road but rather it appeared to have been grubbed of vegetation and graded. Operator shall ensure that all topsoil is salvaged in accordance with Rule 1002.b.

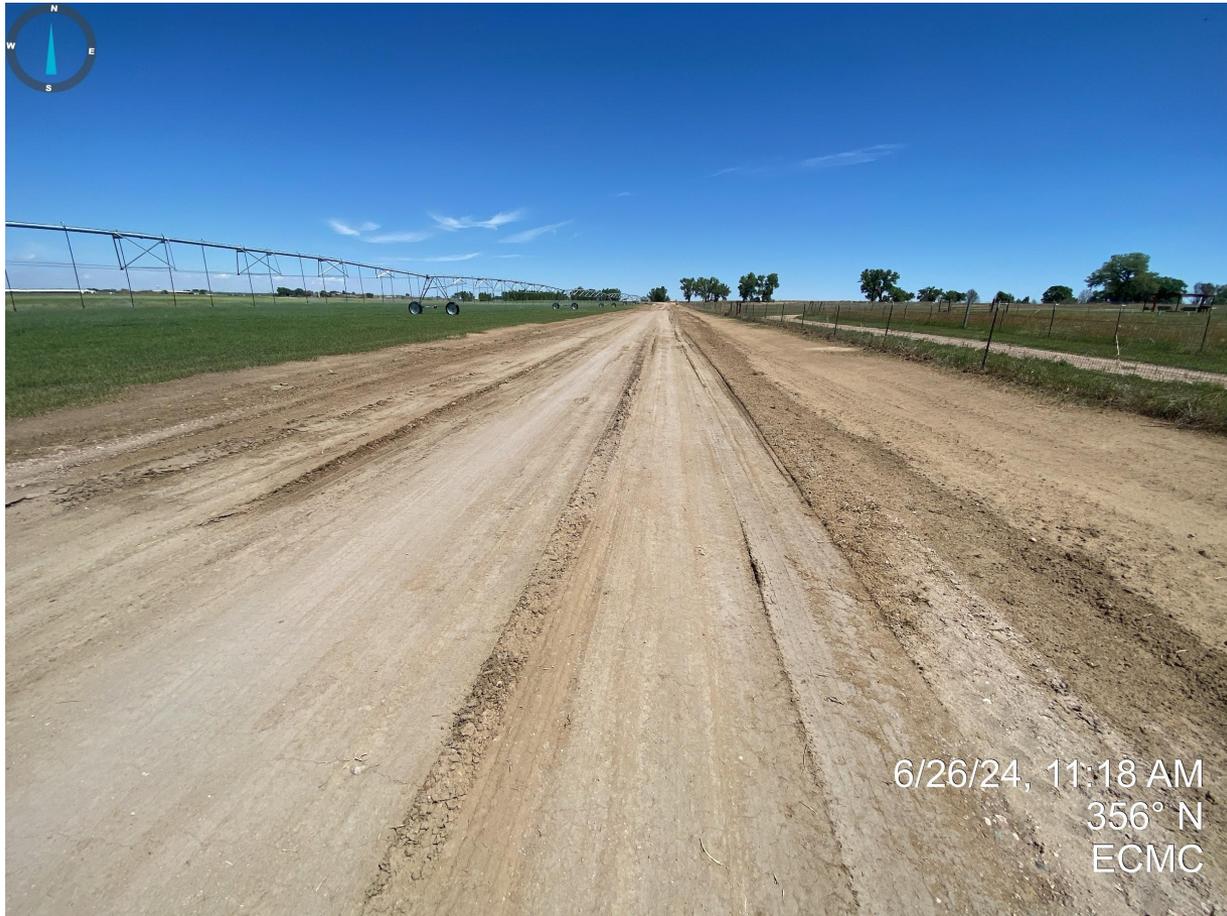
**Photo 3.** Taken from the access road, facing north. See comments in Photo 2.

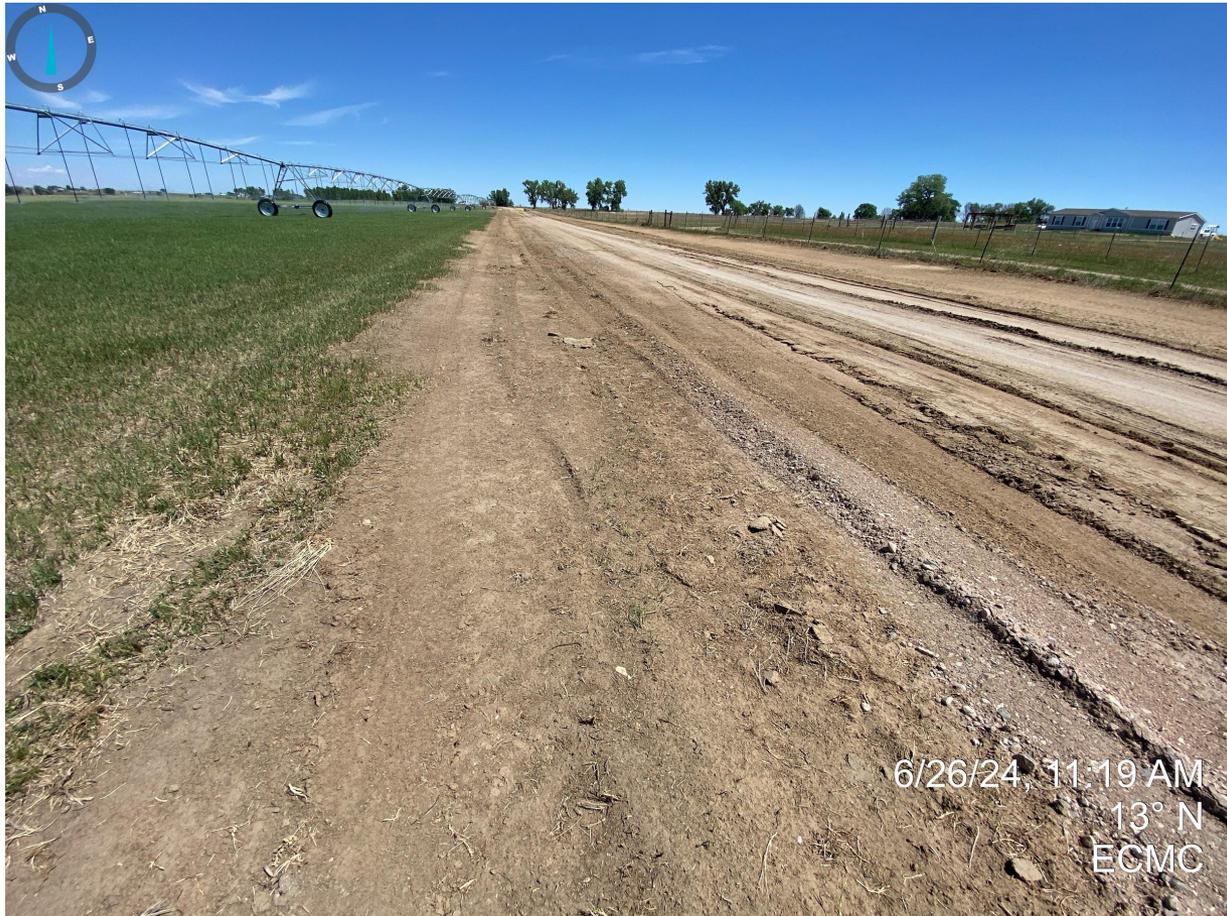
**Photo 4.** Taken from the access road, facing north. See comments in Photo 2.

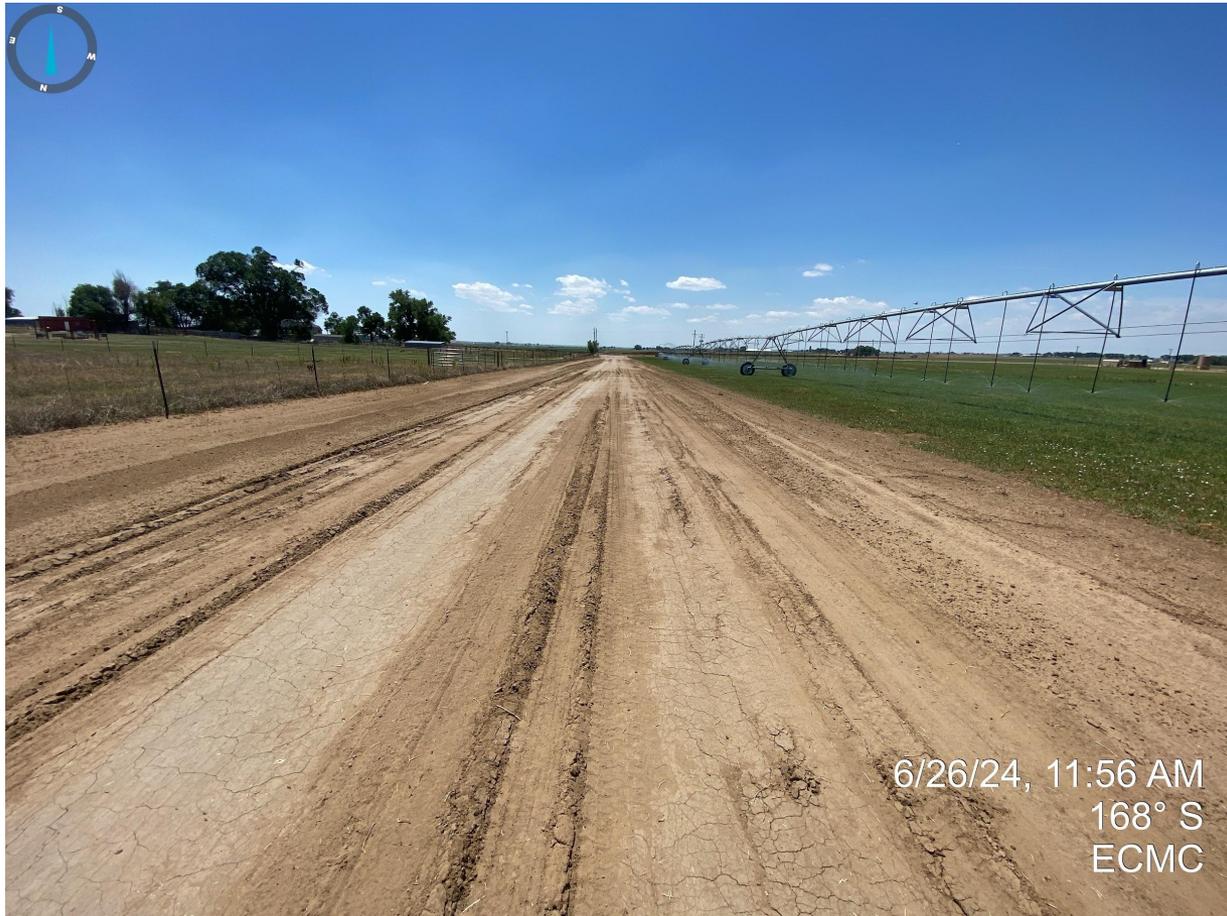
**Photo 5.** Taken from the access road, facing south. See comments in Photo 2.

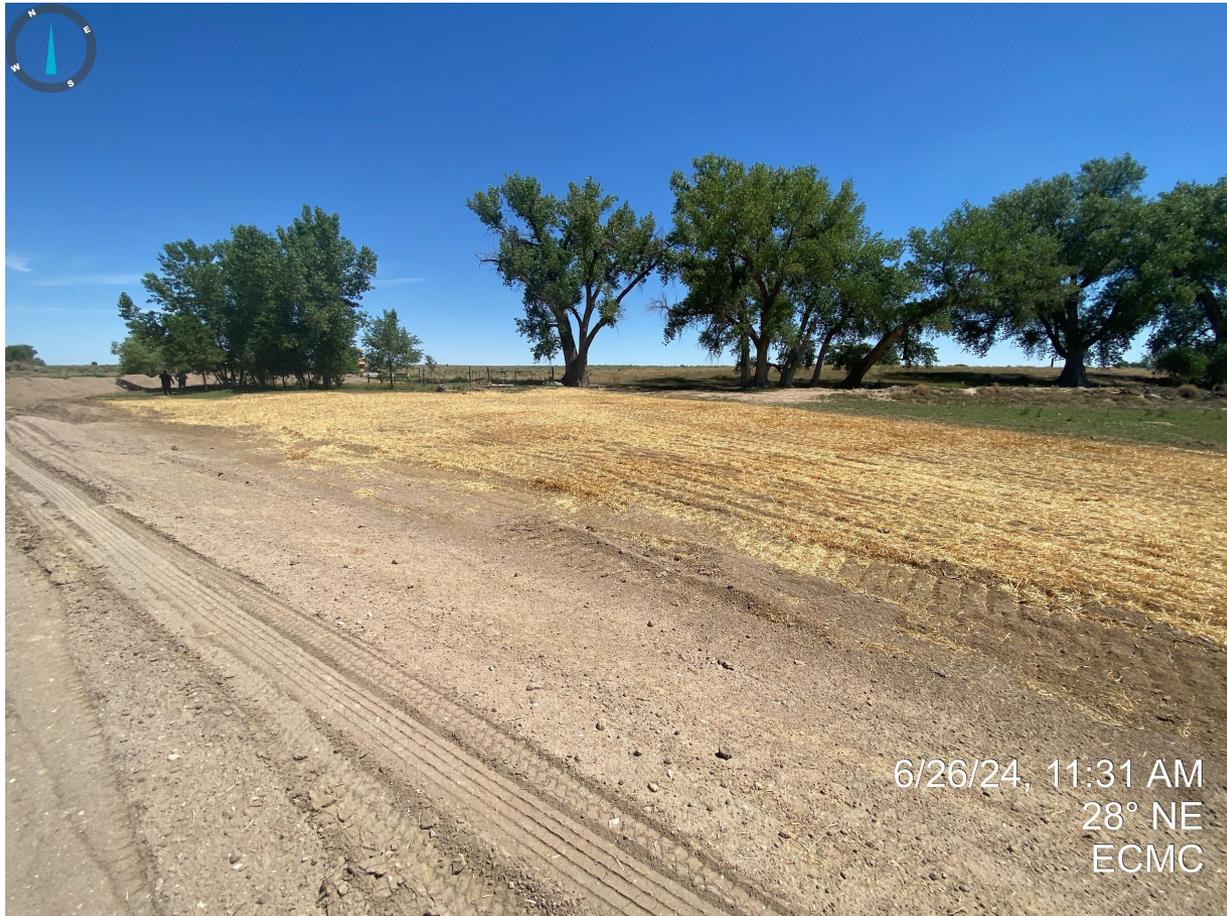
**Photo 6.** Taken from the access road, facing northeast. See comments in Photo 2.

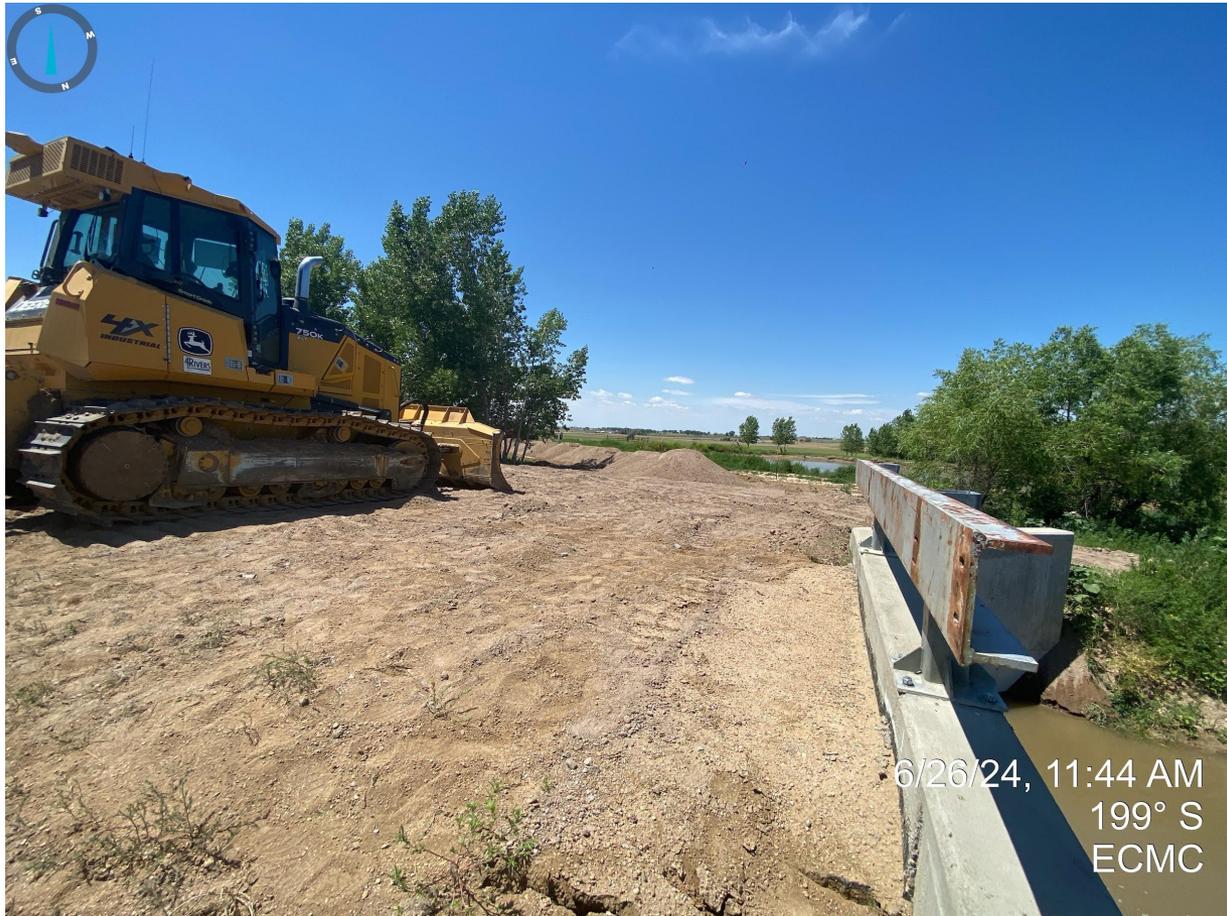
**Photo 7.** Taken from the northernmost point of the access road, facing south. Access road construction did not advance north of the canal crossing at the time of this inspection.

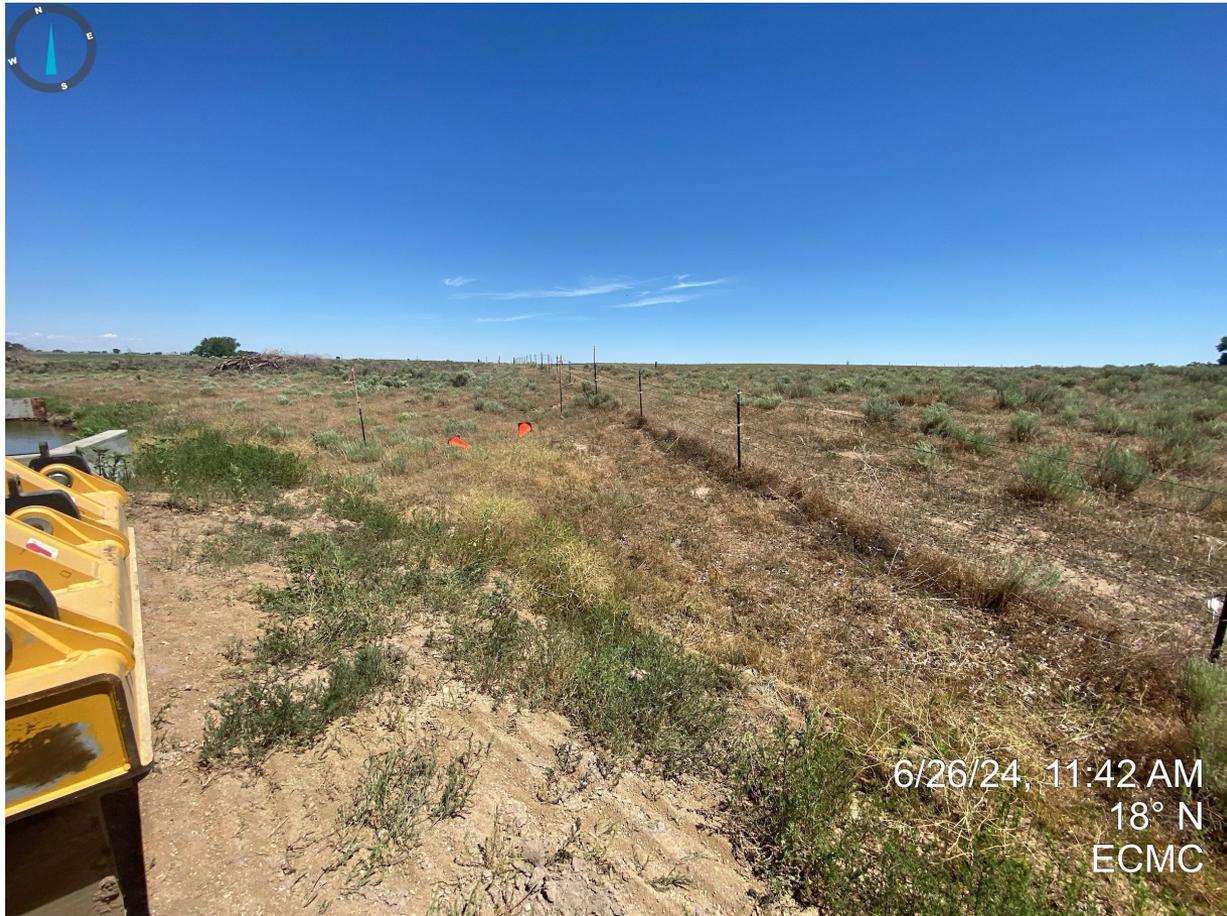
**Photo 8.** See comments in Photo 7.
