Inspection Photos
Location Name: Bledsoe SWD 1-18-3-43
API Number: 125-09352

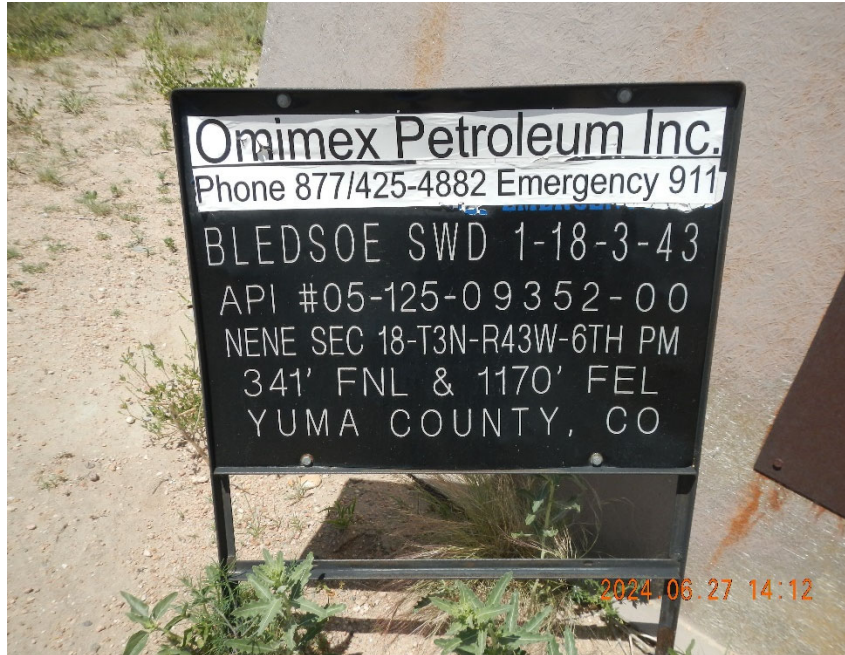
1. Lease sign at wellhead.

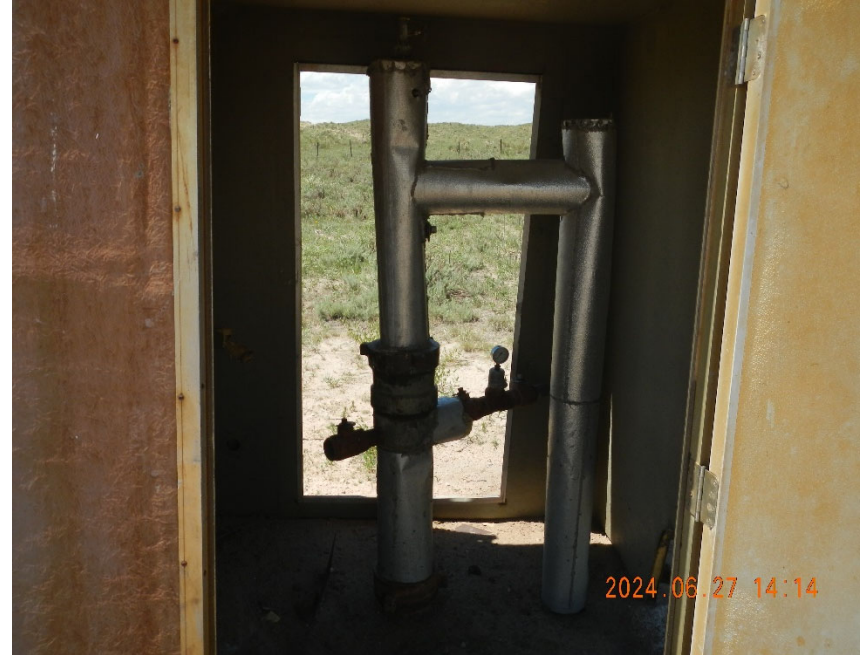
2. View of wellhead.

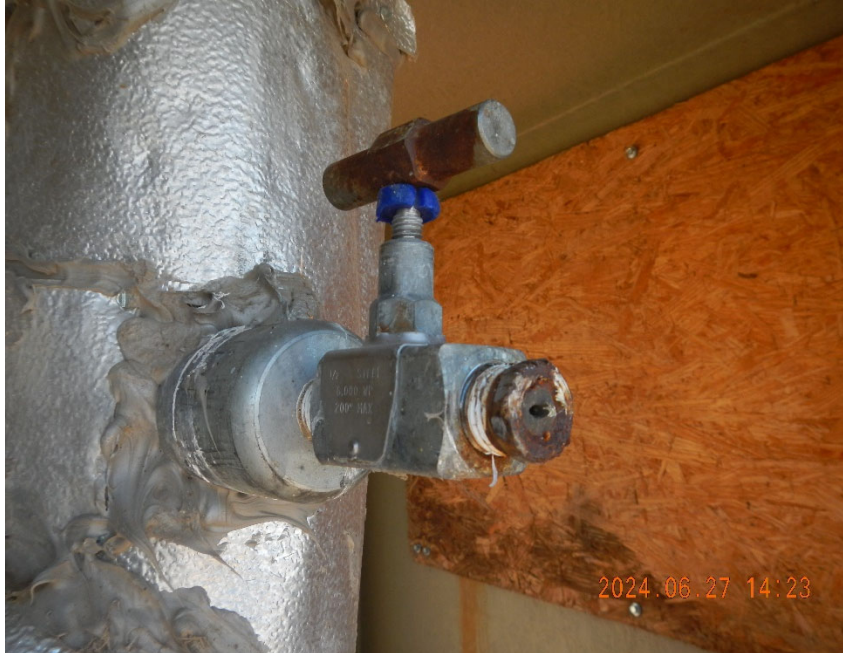
3. Open valve with broken off pressure gauge stem still in valve.

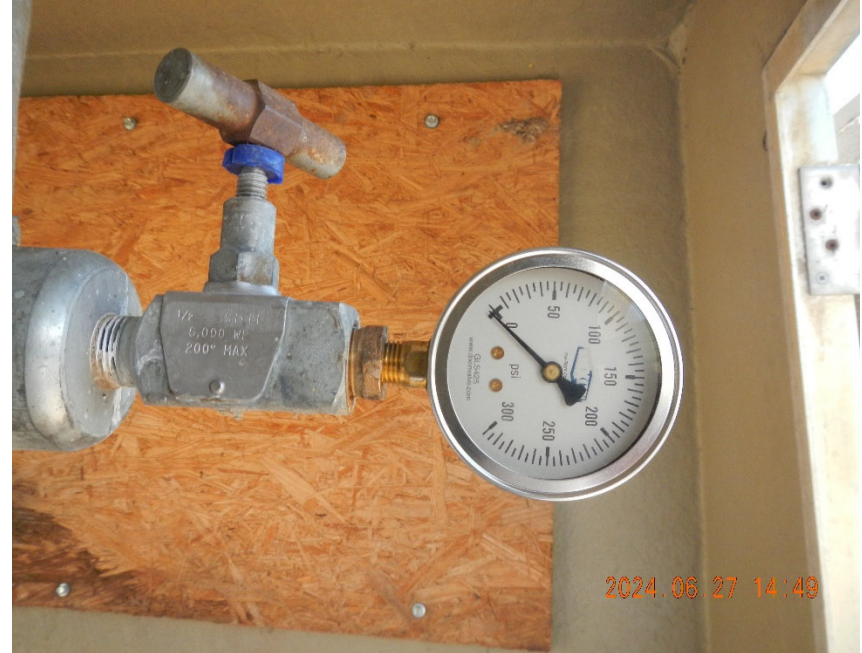
4. Tubing pressure at time of inspection.

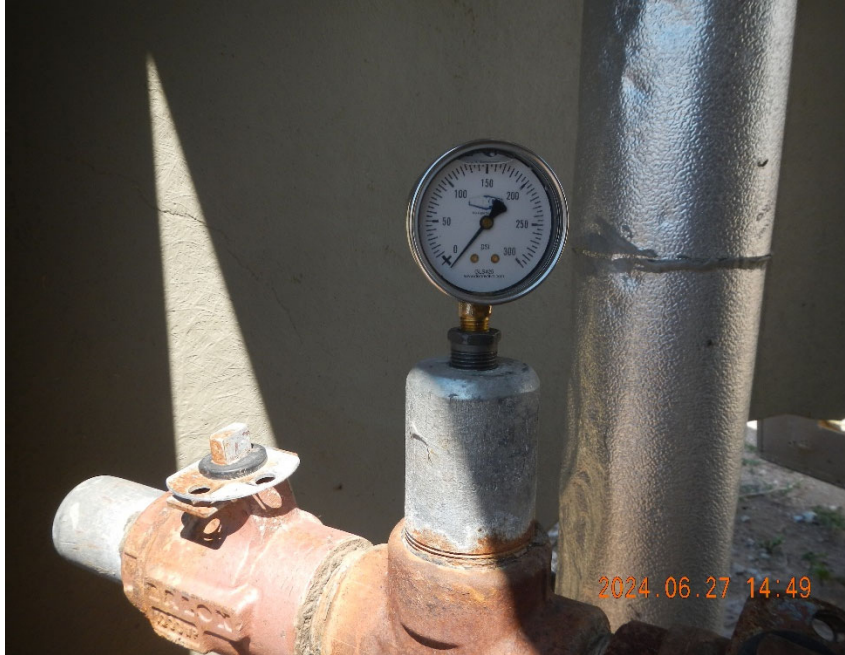
5. Casing pressure at time of inspection.

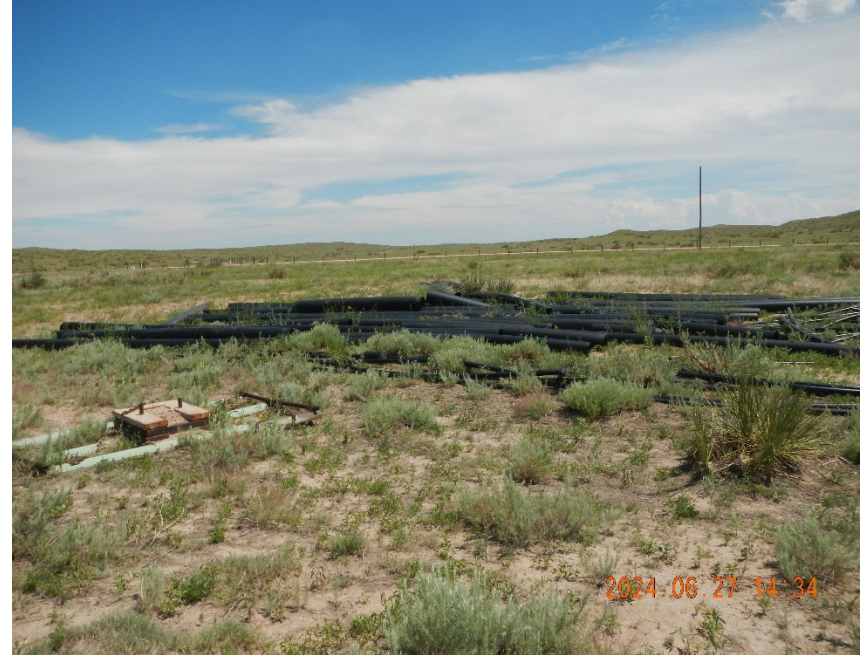
6. Debris and unused equipment on location. Note vegetation.

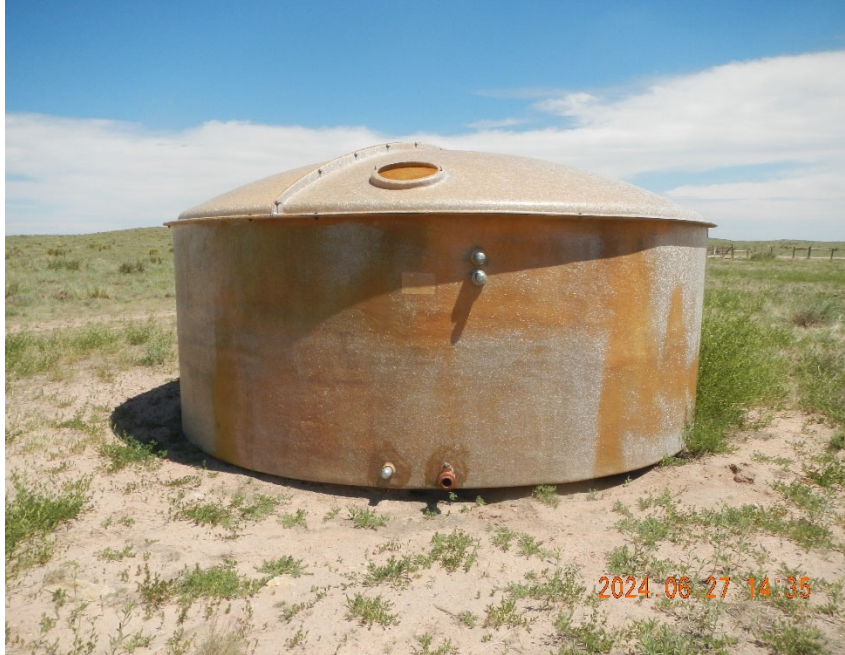
7. Unused tank on location. Note missing hatch cover.

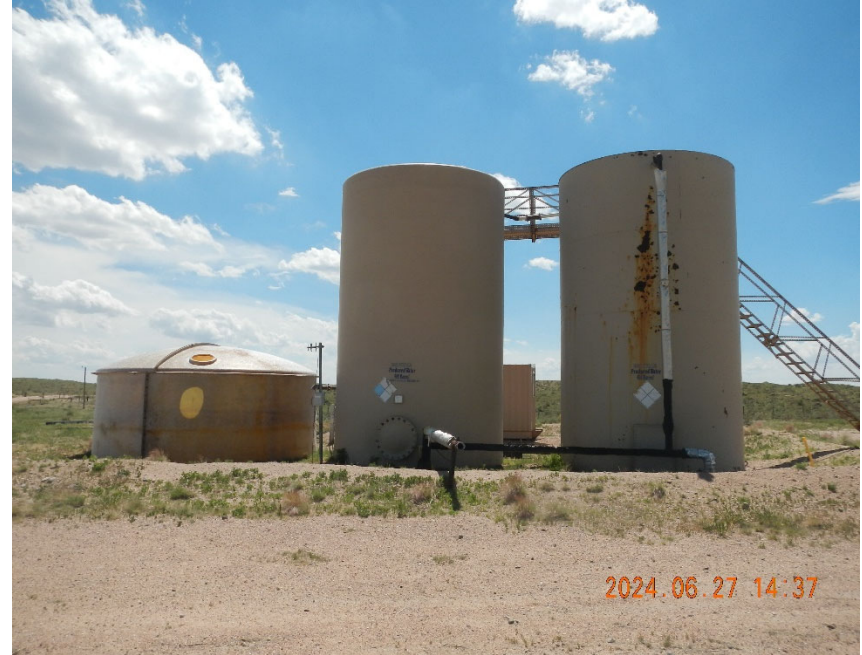
8. View of Tank Battery. Note vegetation.

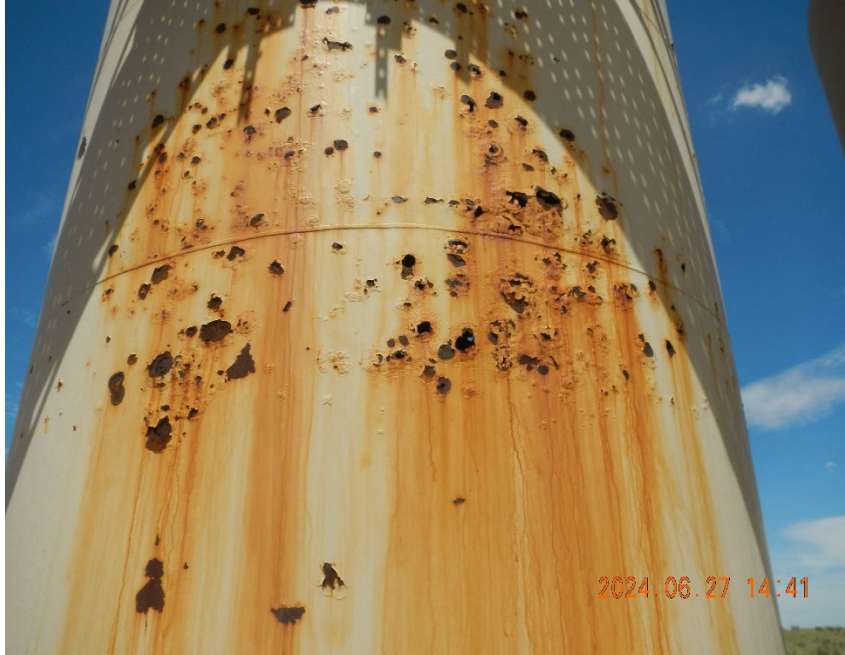
9. View of steel 400 BBL tank. Note rust streak and holes in tank walls.

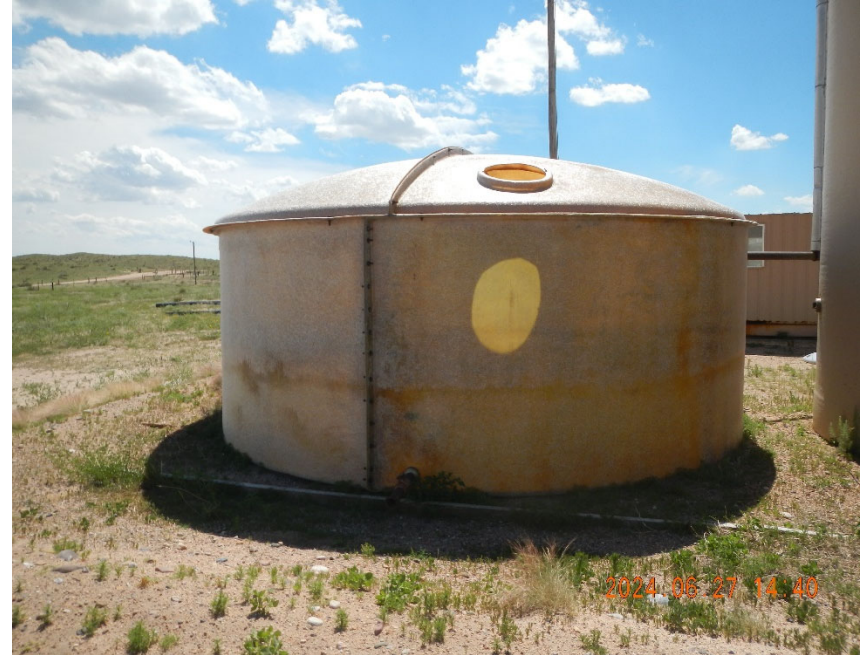
10. View of 200 BBL Fiberglass tank. Note missing labels, missing hatch cover, and vegetation.

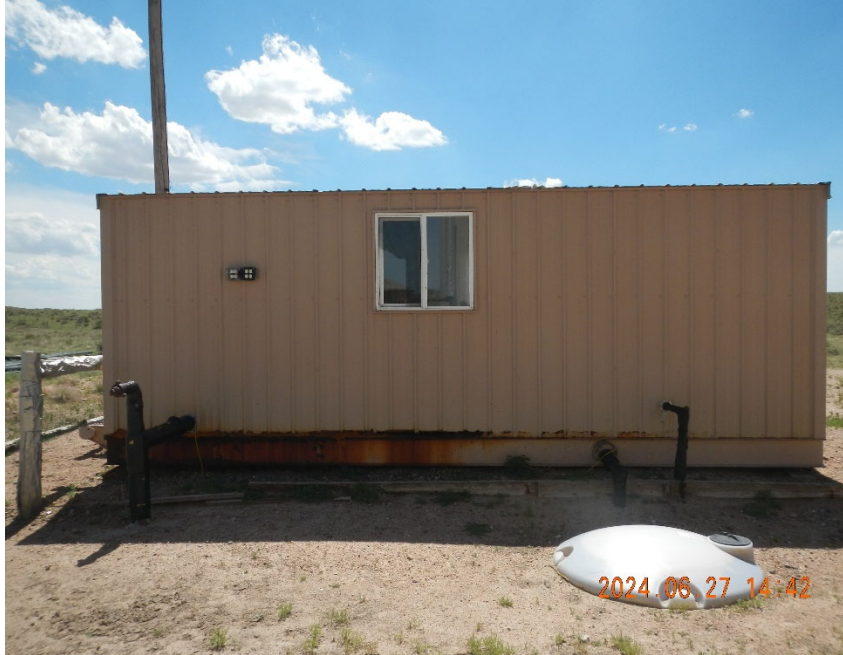
11. View of the backside of Injection Building and buried plastic tank.

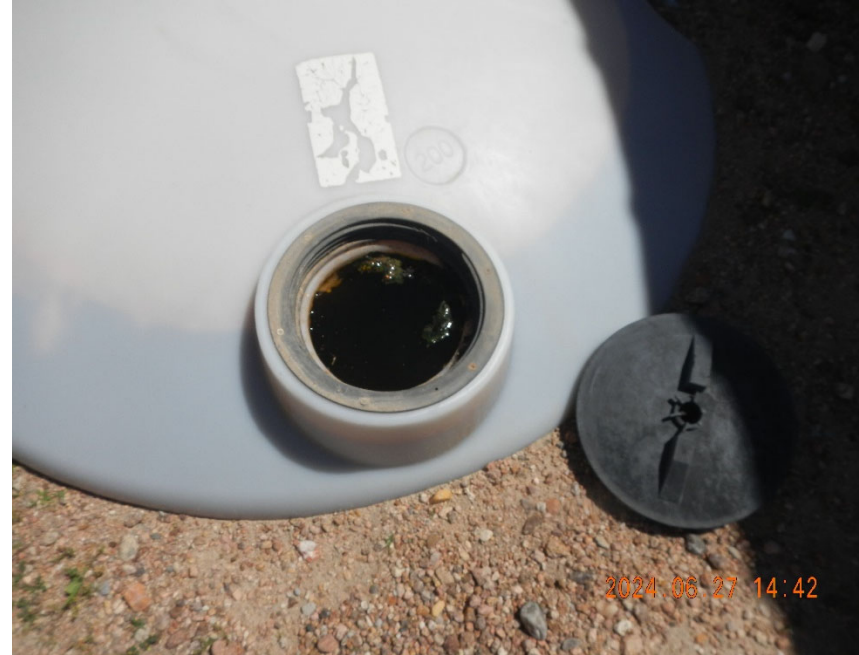
12. Tank has no labels or sign and is completely full at time of inspection.

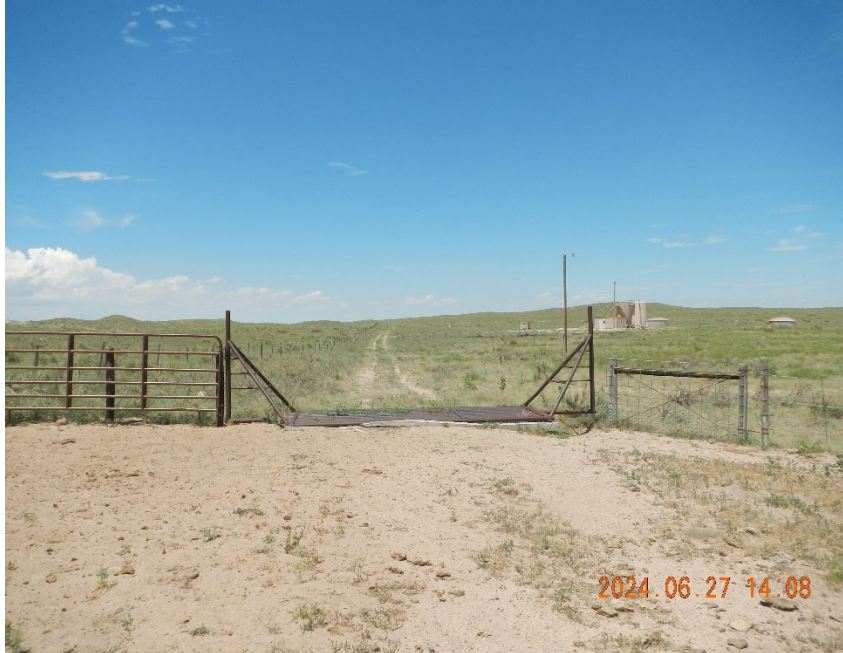
13. Two track access turn off from maintained CR.

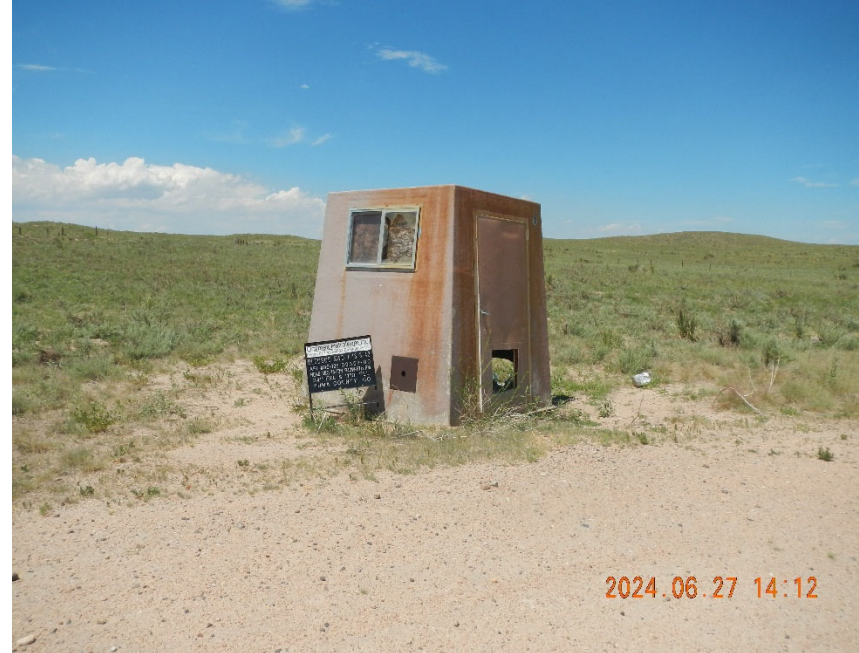
14. Well site overview.

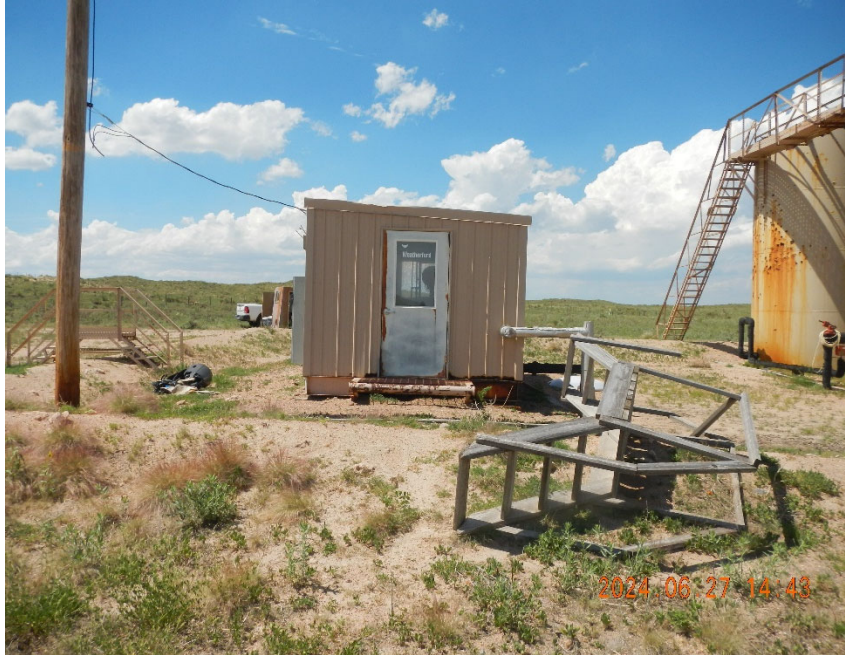
15. Overview of area around Injection Building. Note trash, vegetation, and unused equipment.

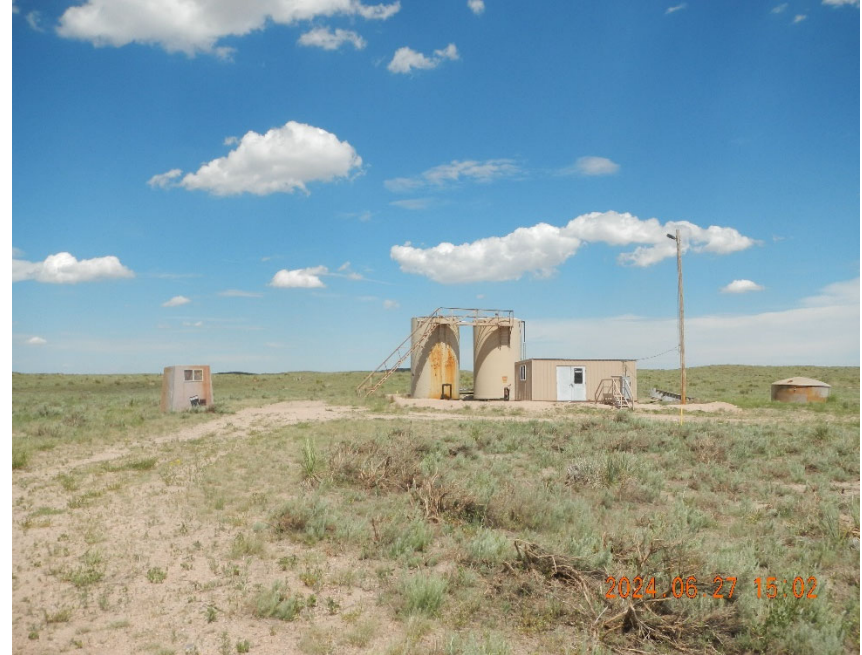
16 Location overview. Note vegetation.
