# Inspection Photos

**Operator:** PETROLEUM RESOURCE  
MANAGEMENT CORP - 10421

**Location ID:** 436485

**Inspection Doc:** 696205944

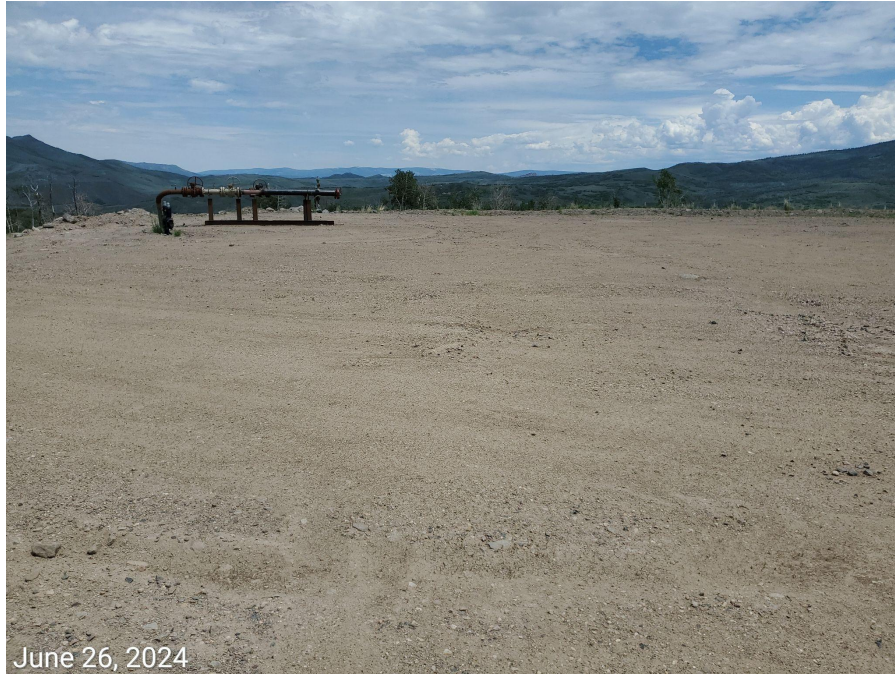
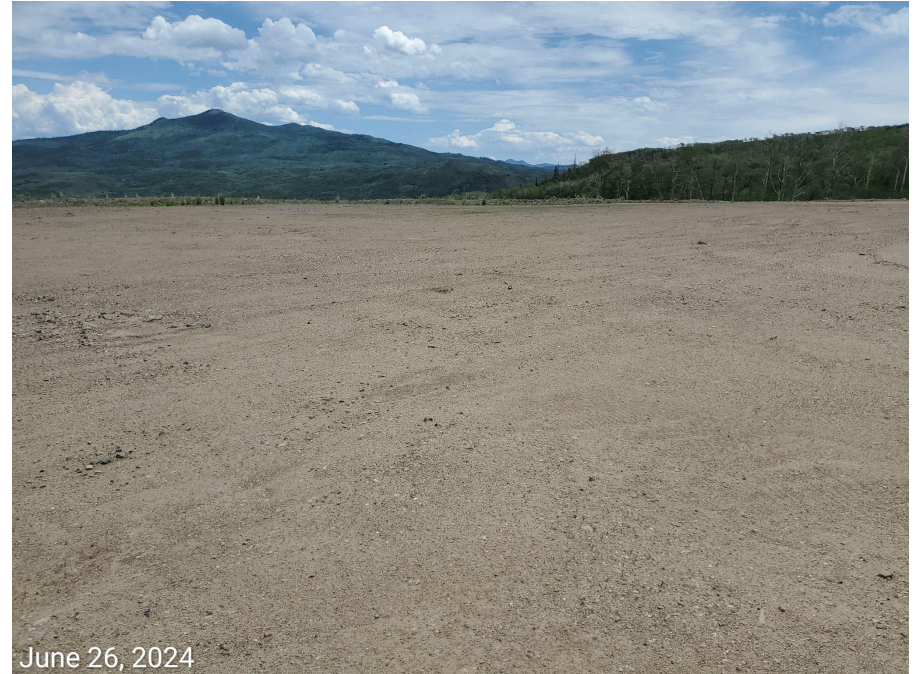
**Photo 1:** Photos 1-2 taken from the west end of the Location. Photos provide an overview of the Location from north, northeast, southeast to south. Photos show interim reclamation of areas not necessary for production has not been performed.

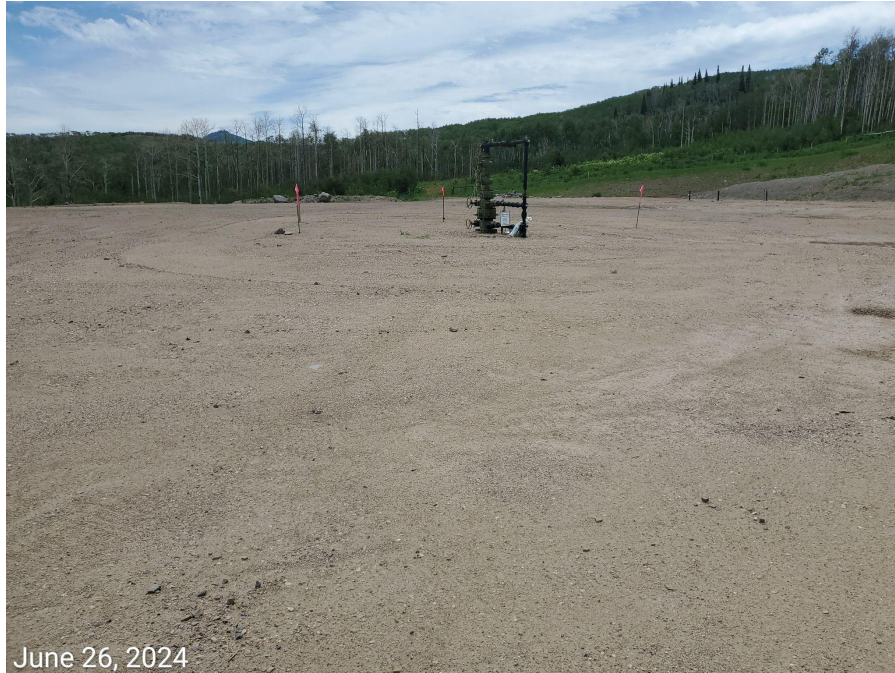
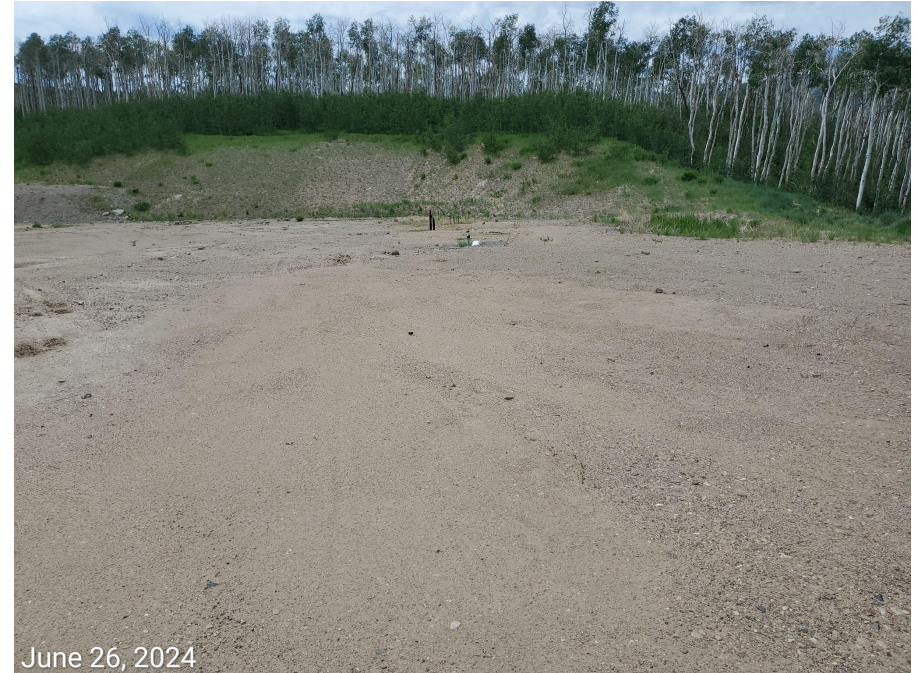
**Photo 2:** See Comments under photo 1.

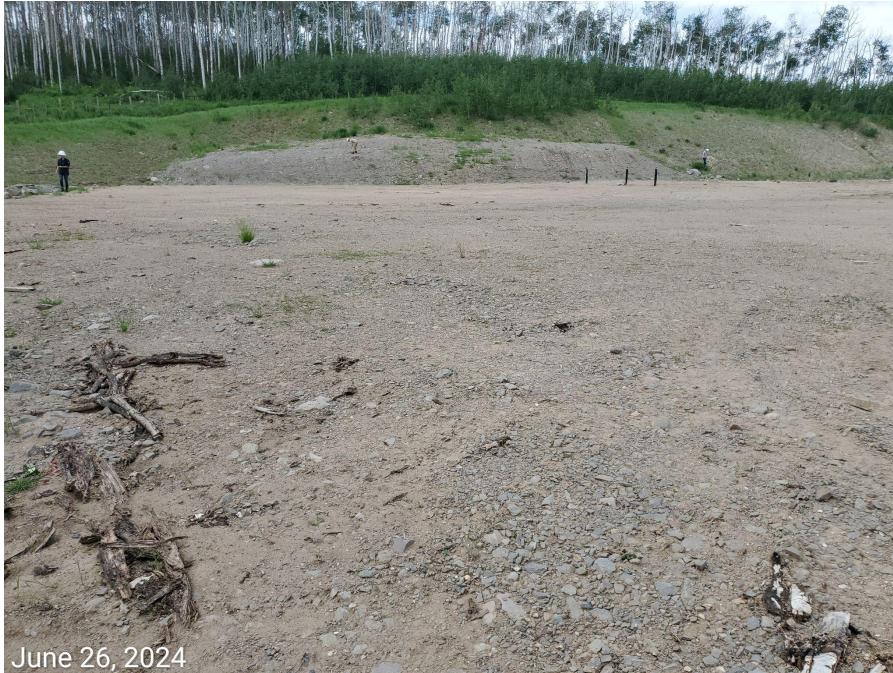
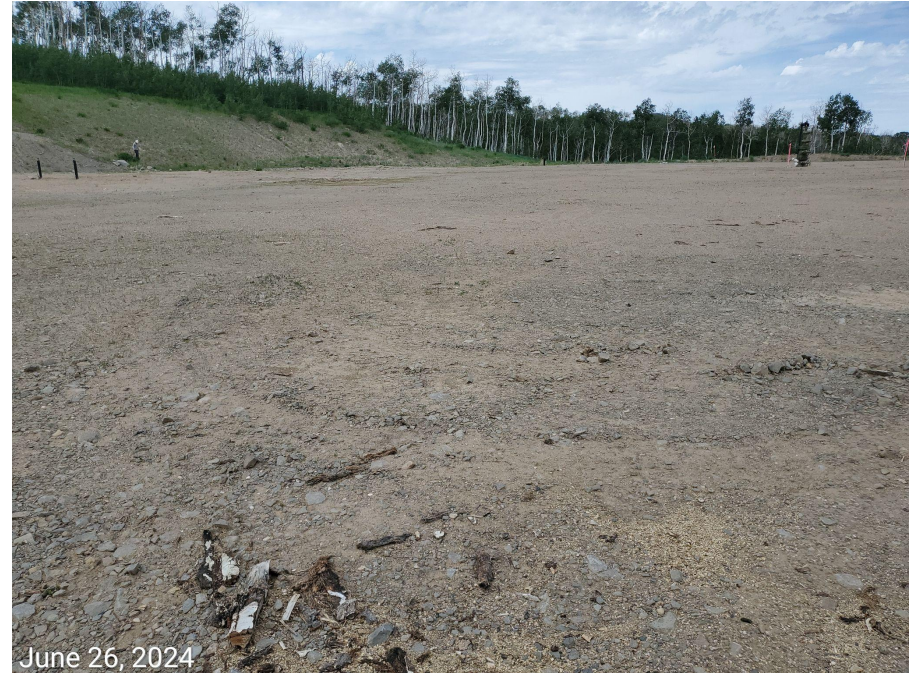
**Photo 3:** Photos 3-4 taken from the east end of the Location. Photos provide an overview of the Location from south, southwest, northwest to north. Photos show interim reclamation of areas not necessary for production has not been performed.

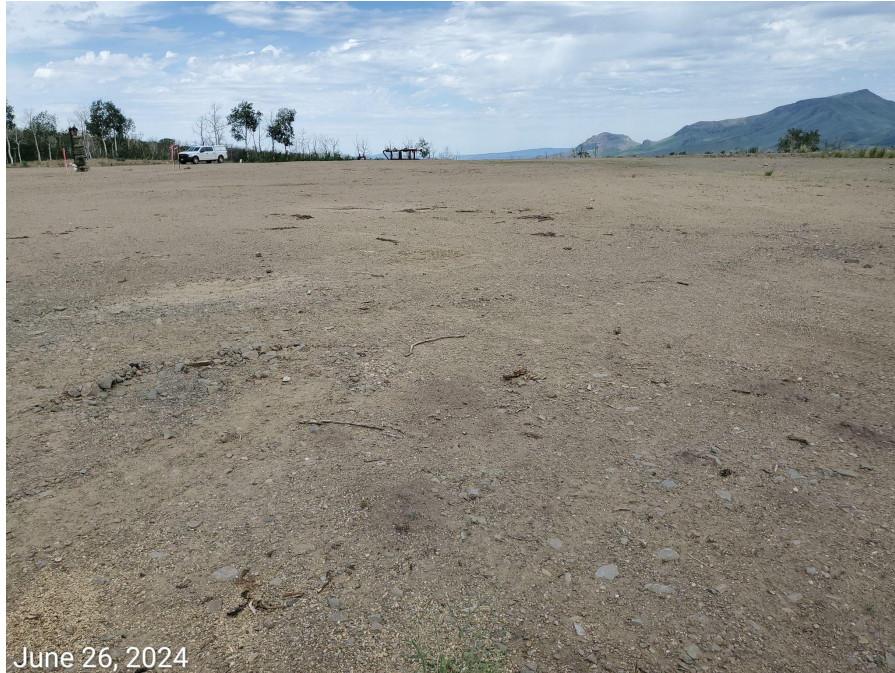
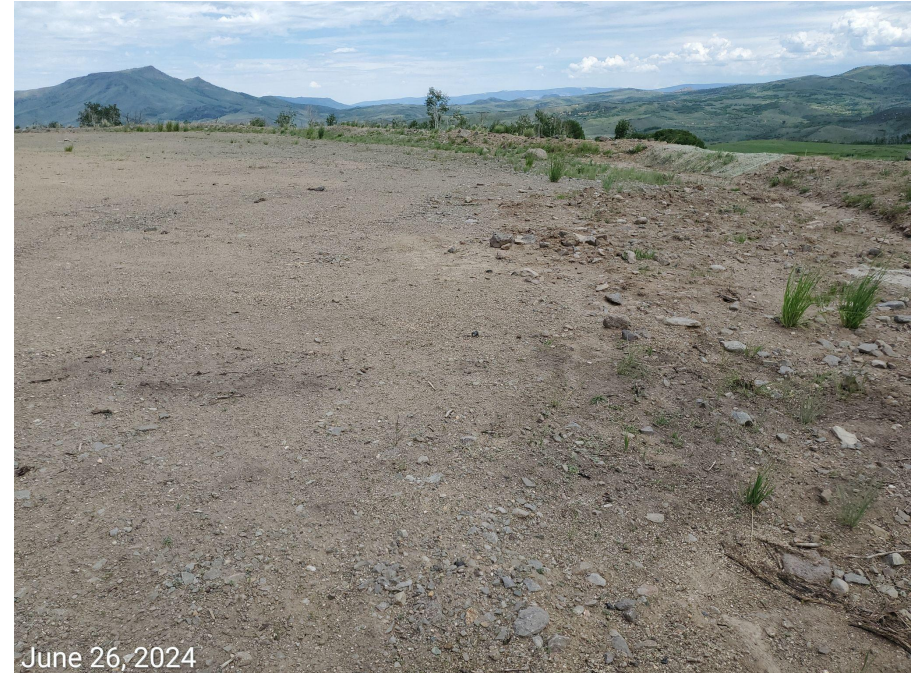
**Photo 4:** See comments under photo 3.

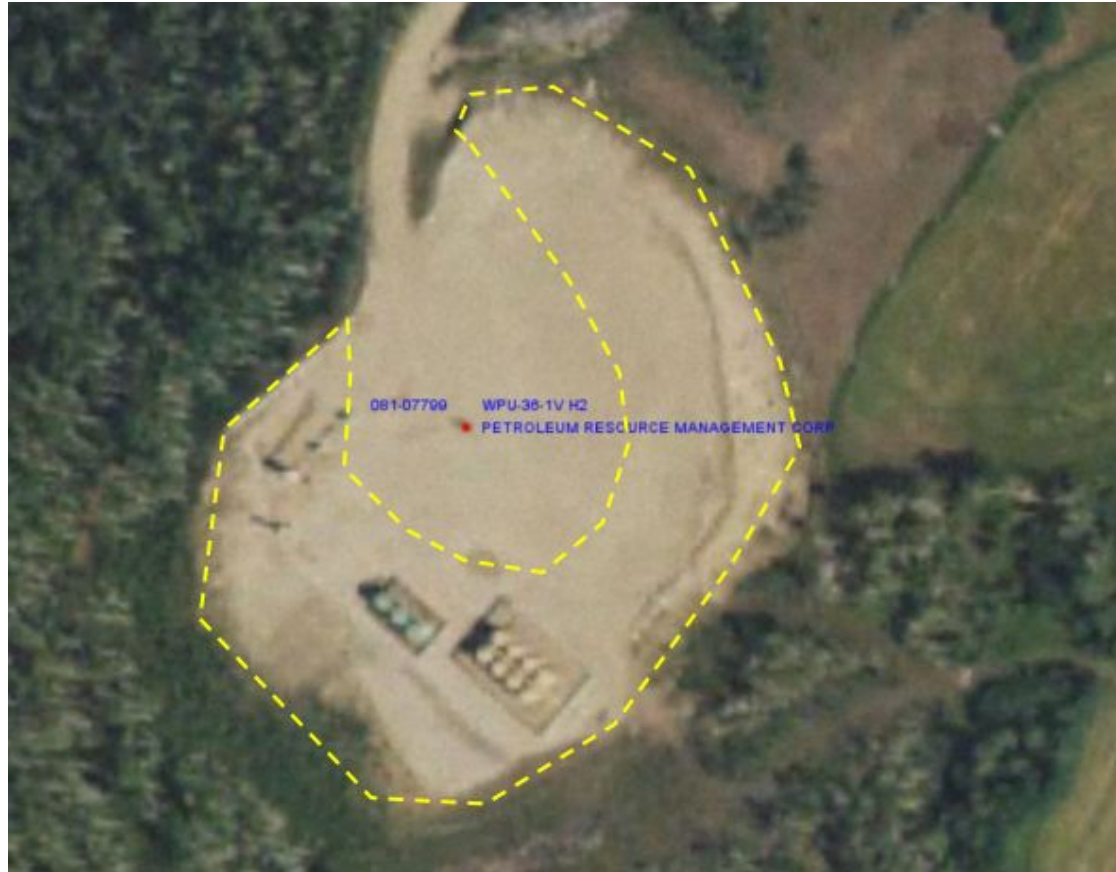
**Photo 5:** 2021 COGIC Aerial imagery of the Location. With exception to the well, all production equipment has been removed from the Location. Yellow polygon represents approximate areas of the Location (~75 foot buffer around the well) that are no longer necessary for production, and are subject to 1003 reclamation requirements.

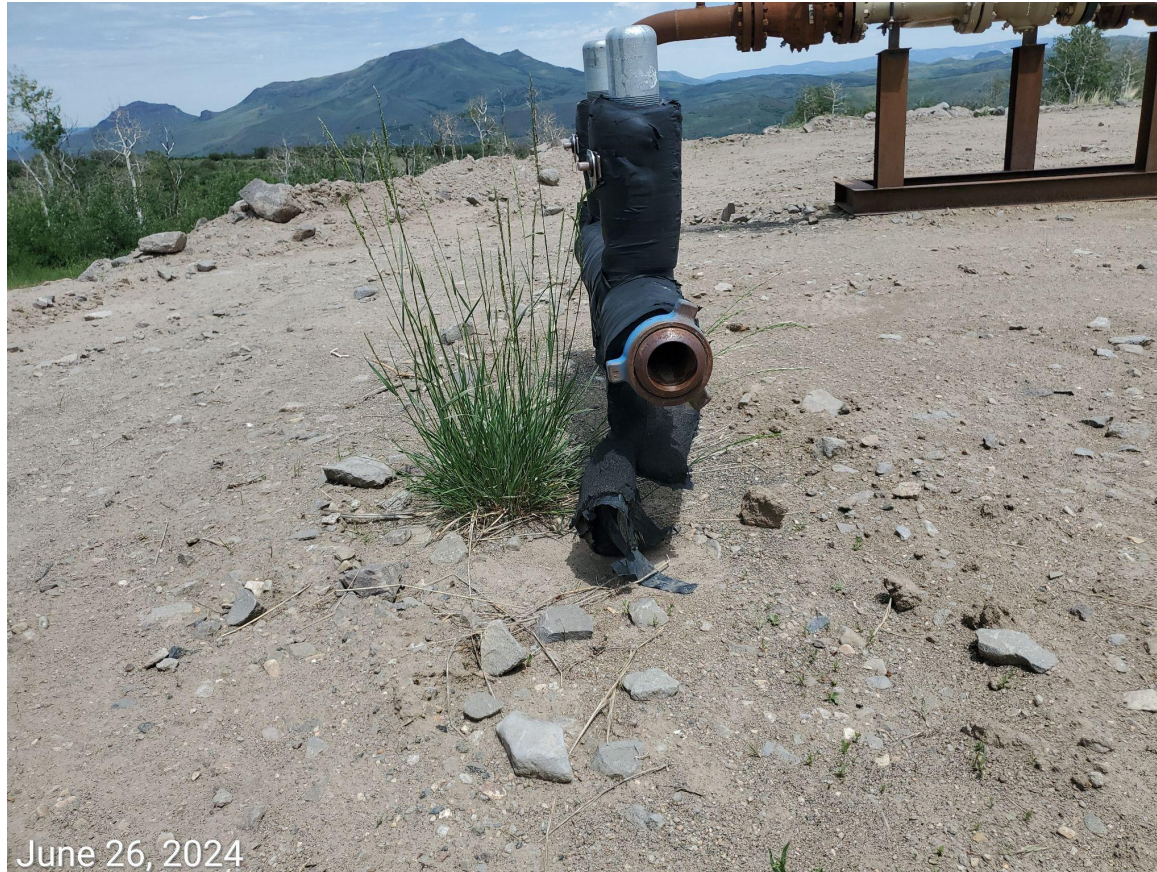
**Photo 6:** Pipe riser at Location entrance missing cap or cover to prevent wildlife access, including birds and bats.

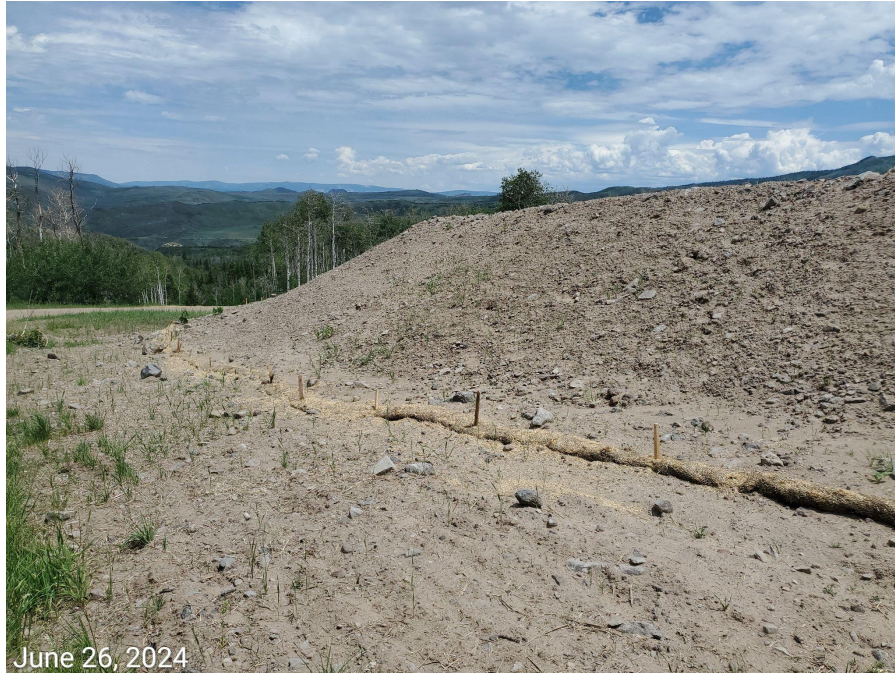
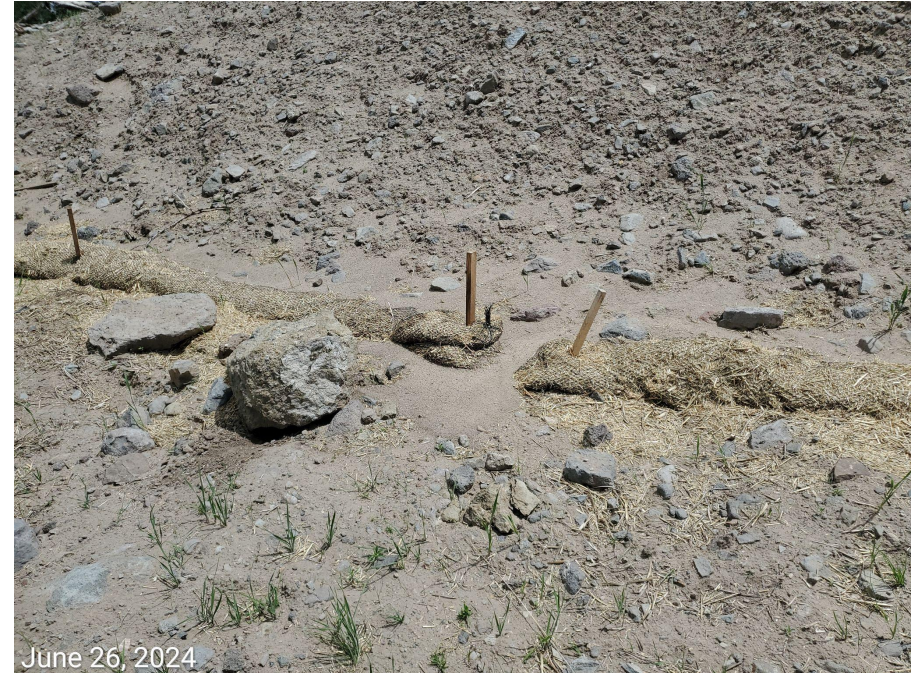
**Photo 7:** Photos taken from the fill slopes on the north end of the Location. Photo shows Operator has placed erosion logs at toe of the slopes; BMP has not been installed or maintained per good engineering practices. BMPs to minimize erosion and degradation at the slopes remains missing or insufficient

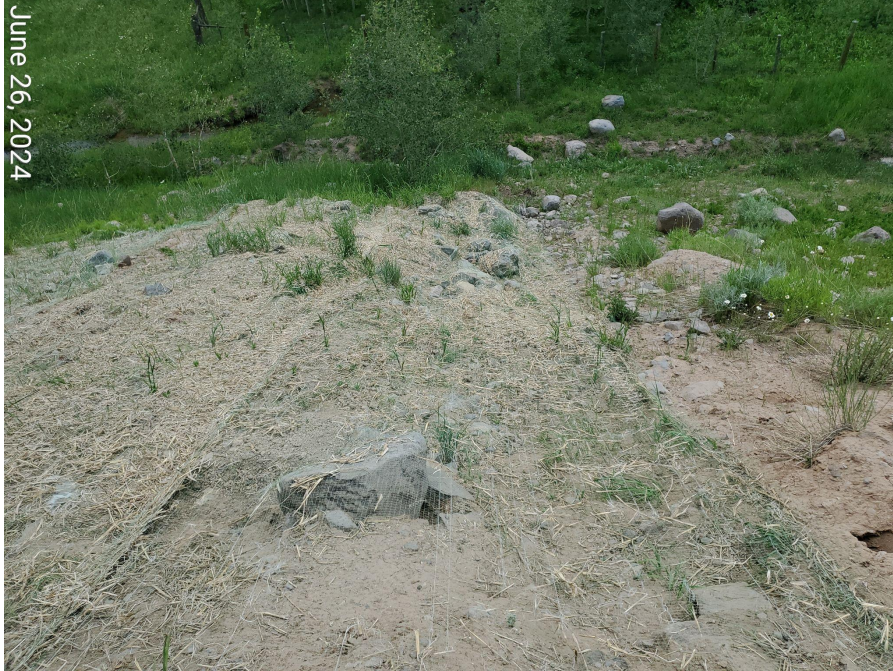
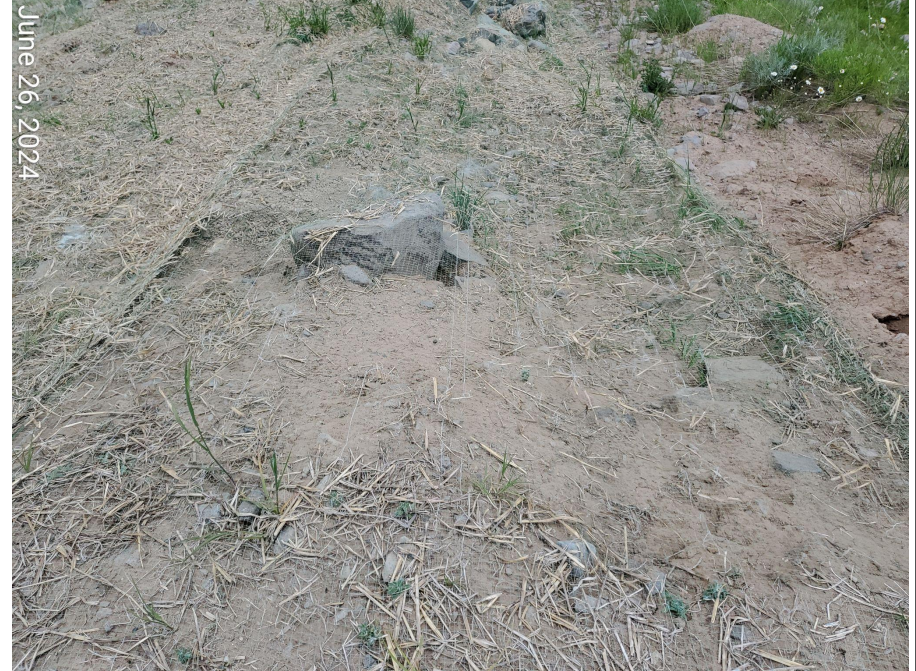
**Photo 8:** Photo taken from the fill slopes on the east end of the Location. Photo shows erosion blanket on sections of the slopes; BMP has not been installed per good engineering practice or maintained in a proper functioning condition and is not in full contact with the soil. Plastic netting is all that remains.

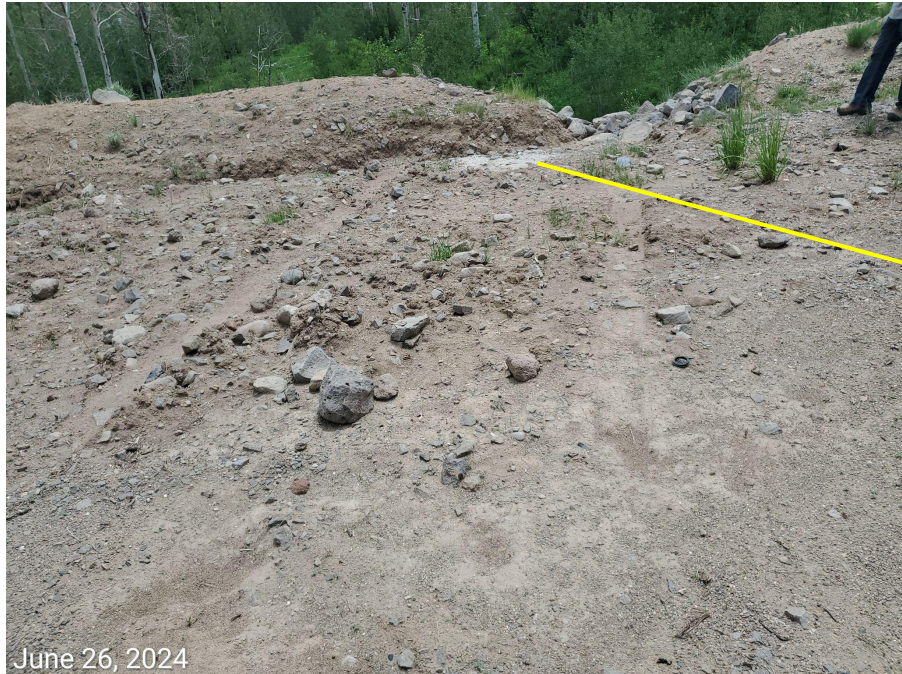
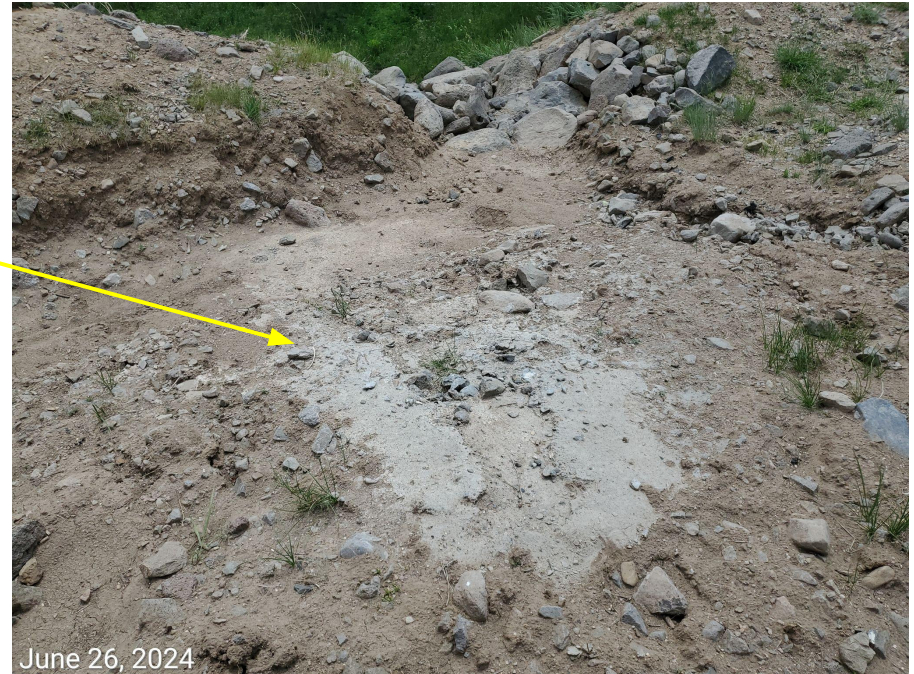
**Photo 9:** Photo taken from the stormwater outlet on the east end of the Location. Photo shows Operator appears to have utilized the stormwater outlet on the east end of the pad as a “wash out”; vehicle tracks observed at the BMP and cement waste has been poured into the control. This is improper management of non-E&P waste and does not comport with Rules 902.b, 906.a-b, and 1002.f.

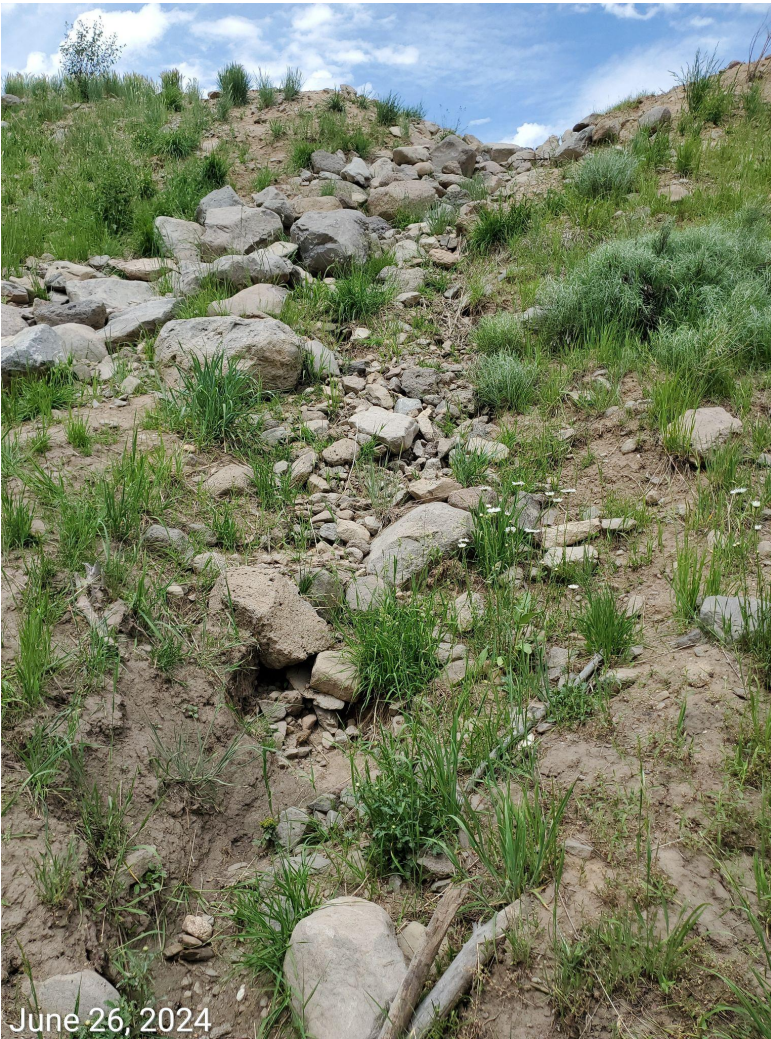
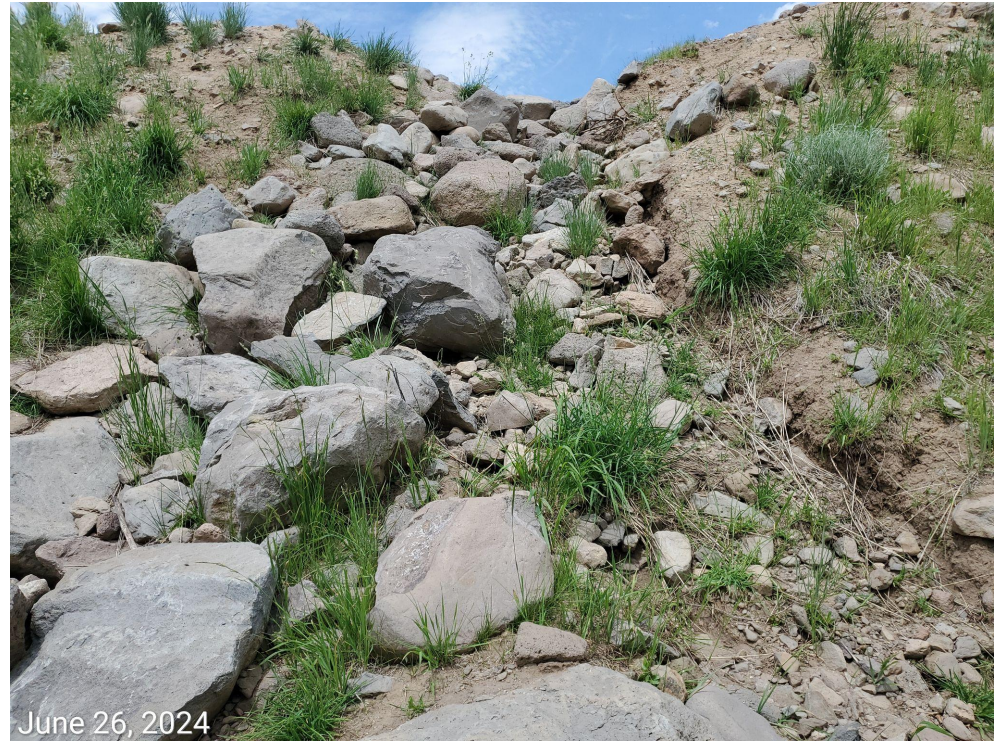
**Photo 10:** Continued from photo #9. Photo shows outlet has not been installed or maintained per good engineering practice; stormwater degradation to the walls has persisted. Outlets on the east and north end of the Location have not been installed or maintained per good engineering practice.

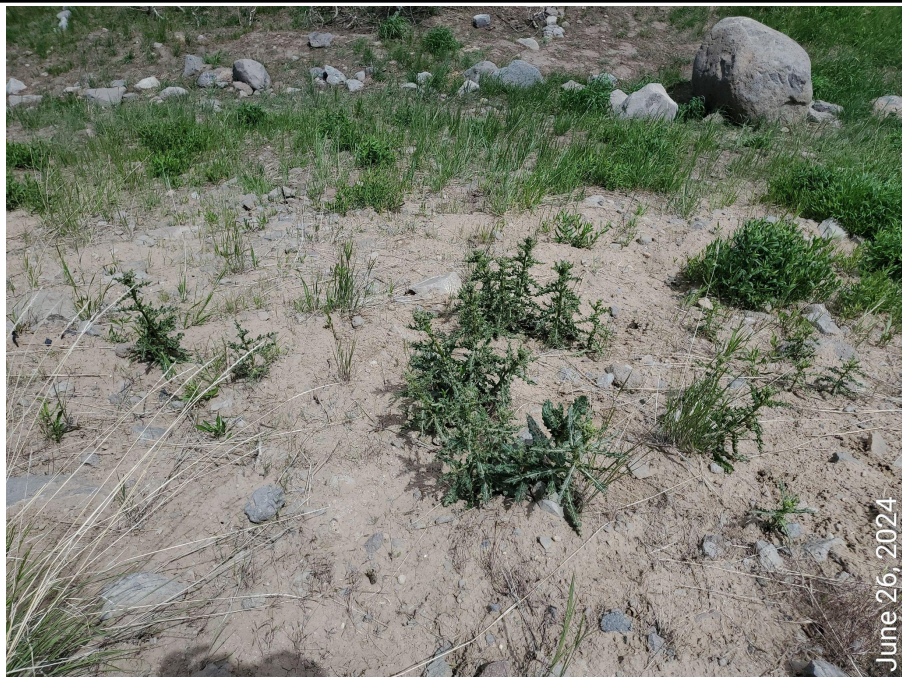
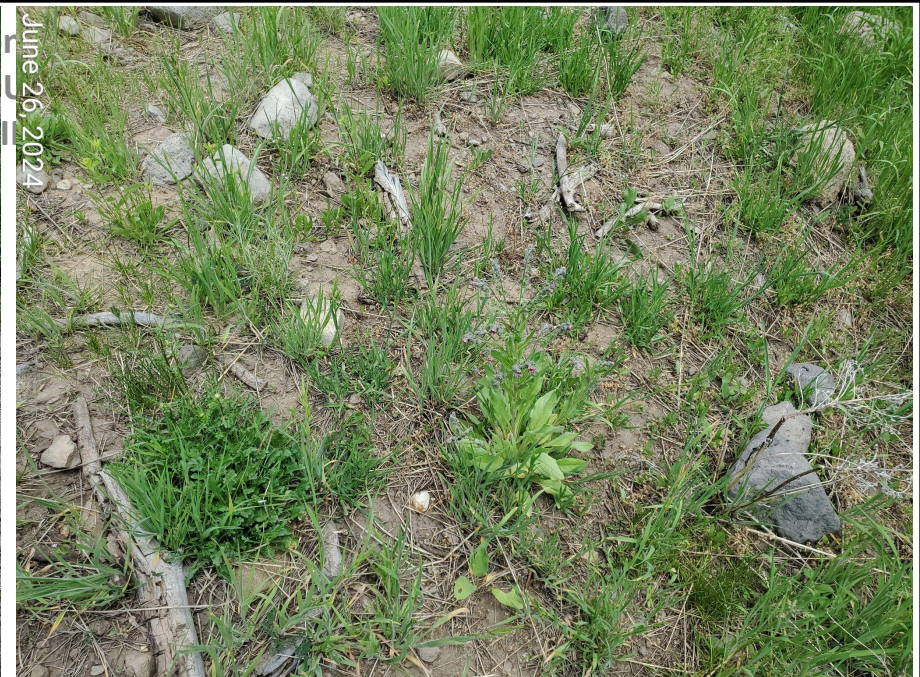
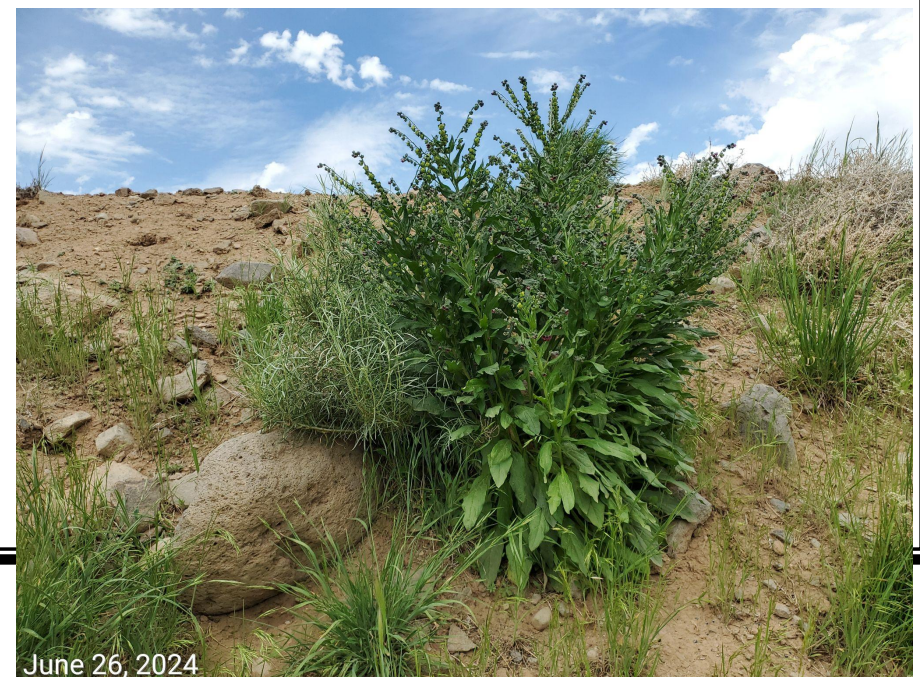
**Photo 11:** Photos throughout the Location and provide examples showing Noxious Weeds (Canada Thistle, Houndstongue) have continued to spread and establish on the Location.

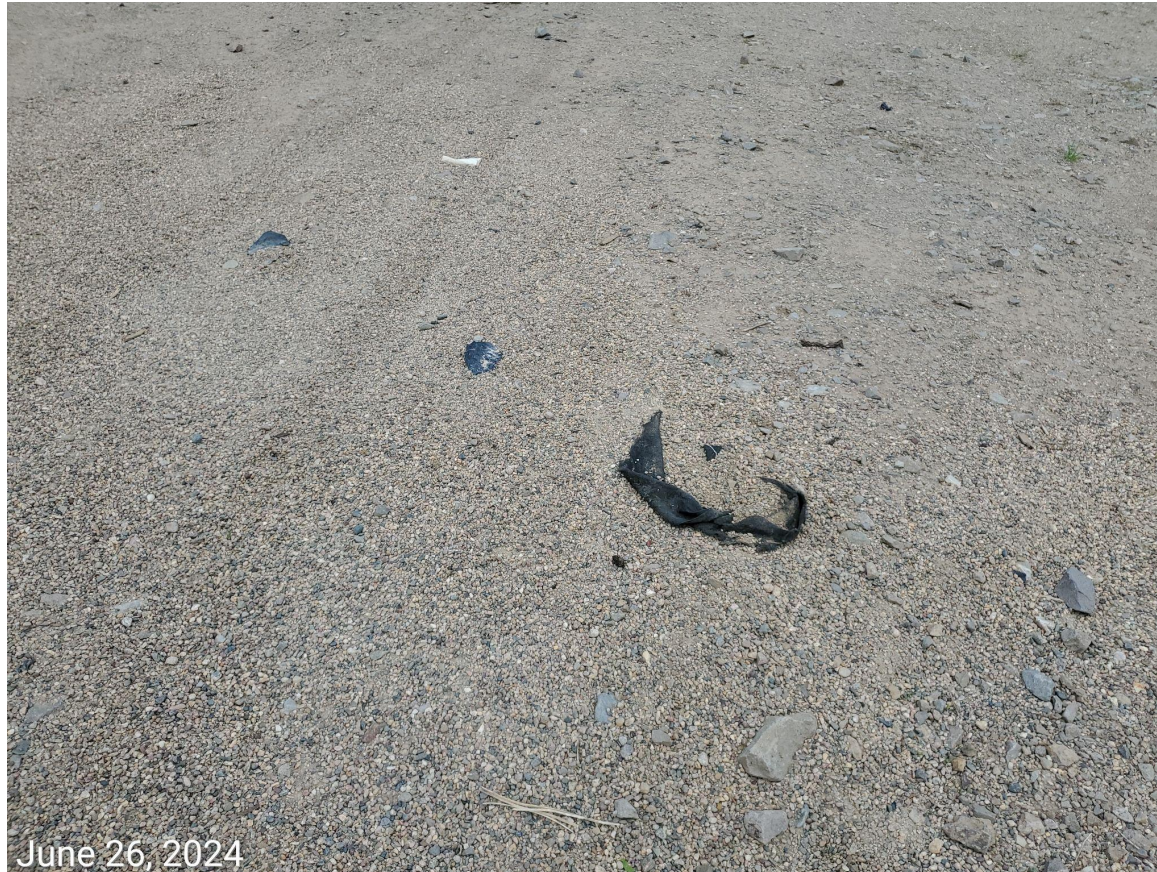
**Photo 12:** Liner material remaining and partially buried on the Location

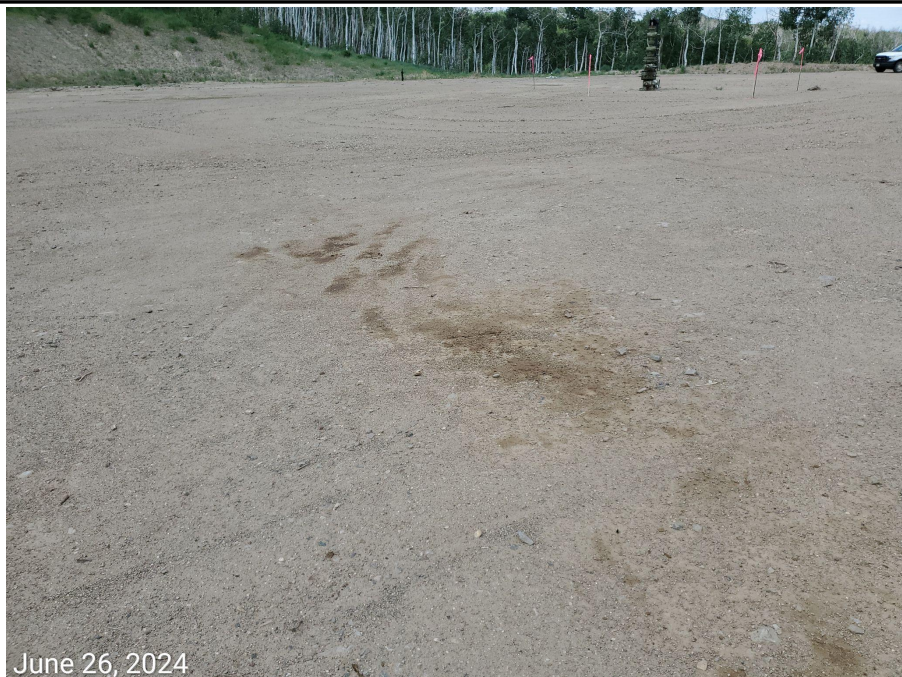
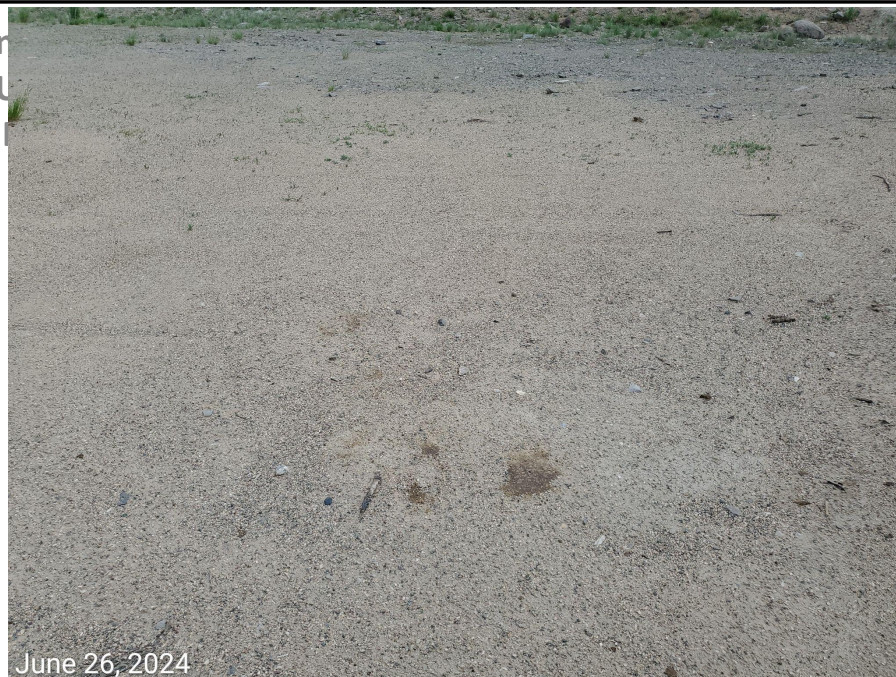
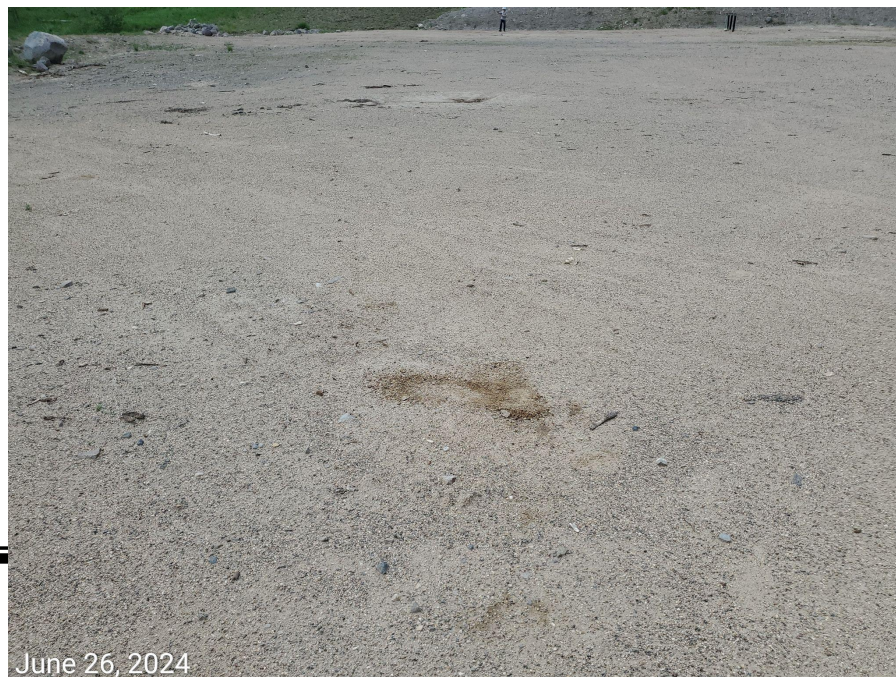
**Photo 13:** Photos 13-14 show stained soils remaining throughout the Location, including areas on the east end of the Location where the leaking tanks were observed stored.

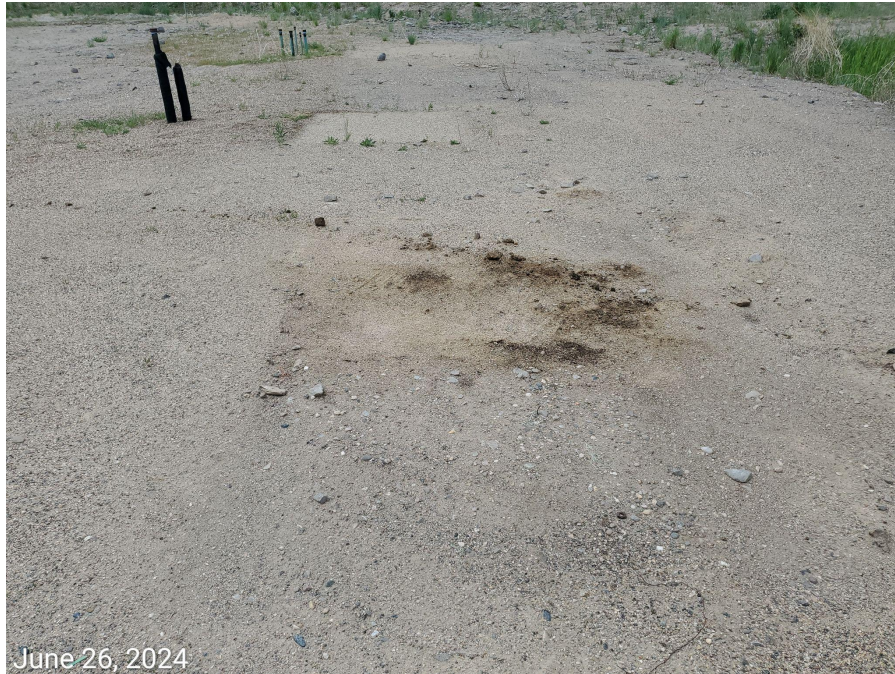
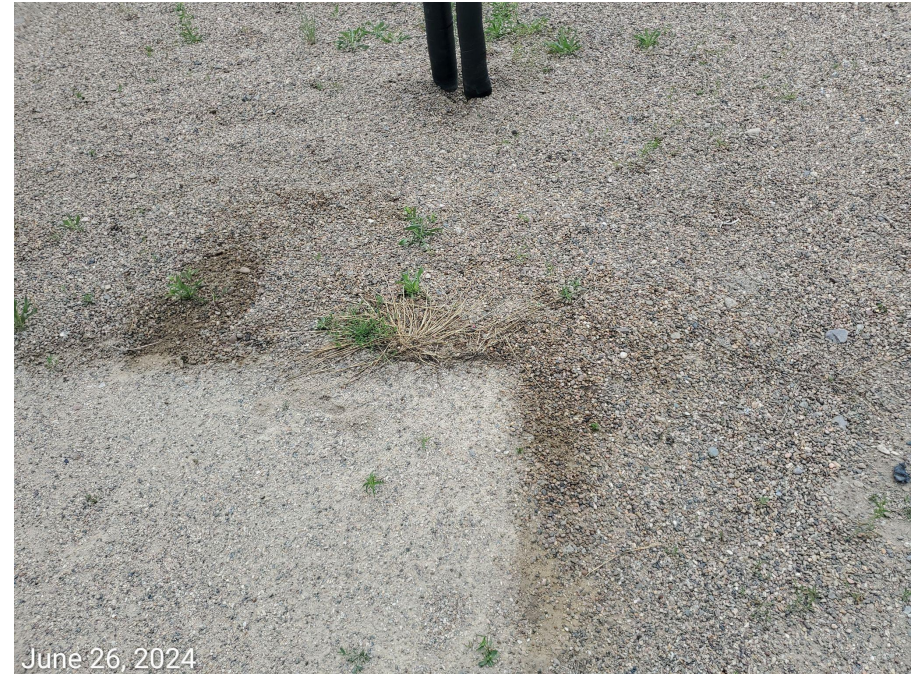
**Photo 14:** See comments under photo 13.

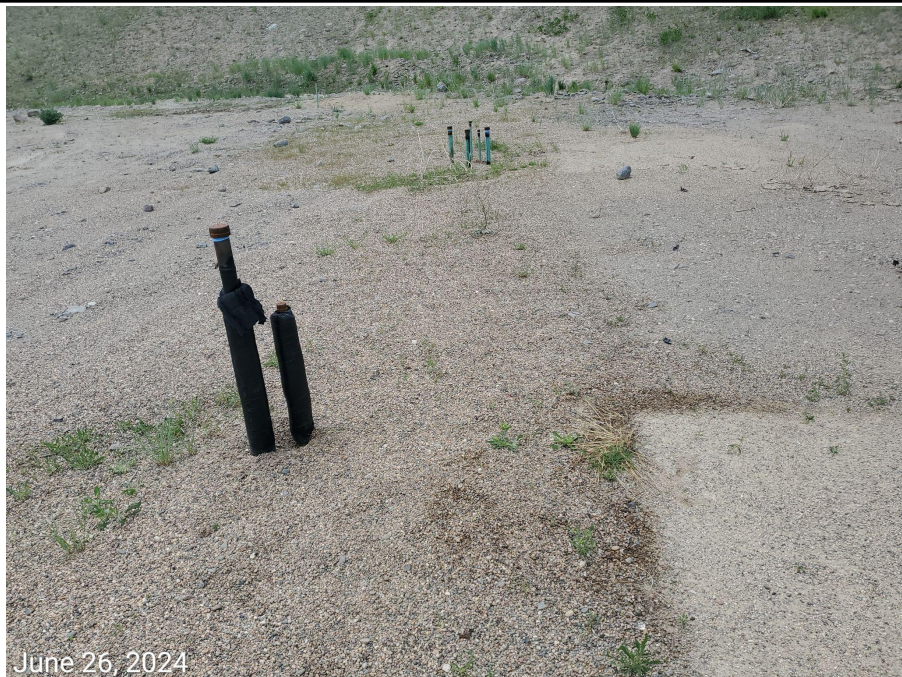
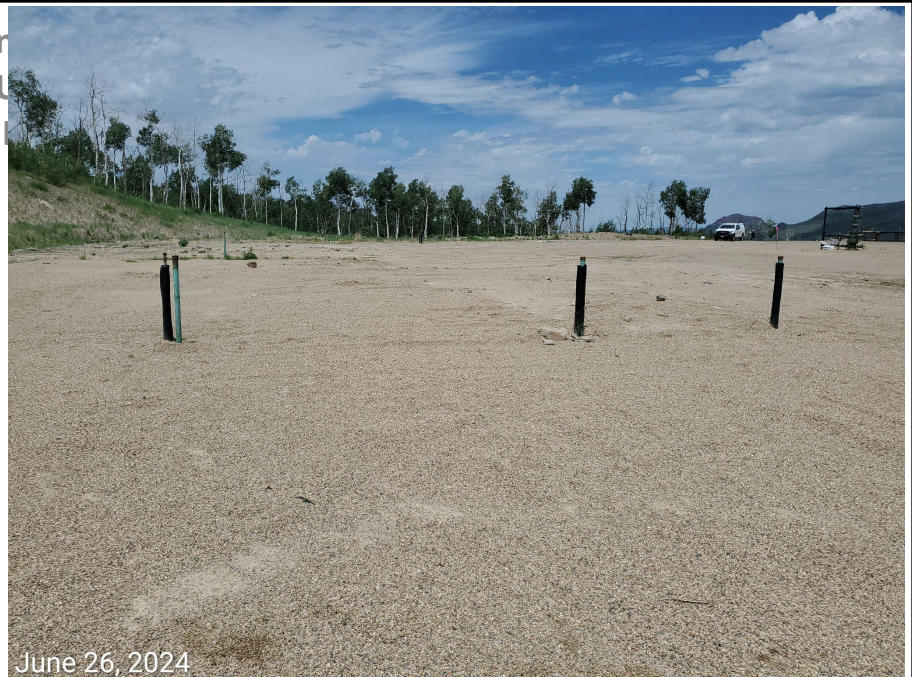
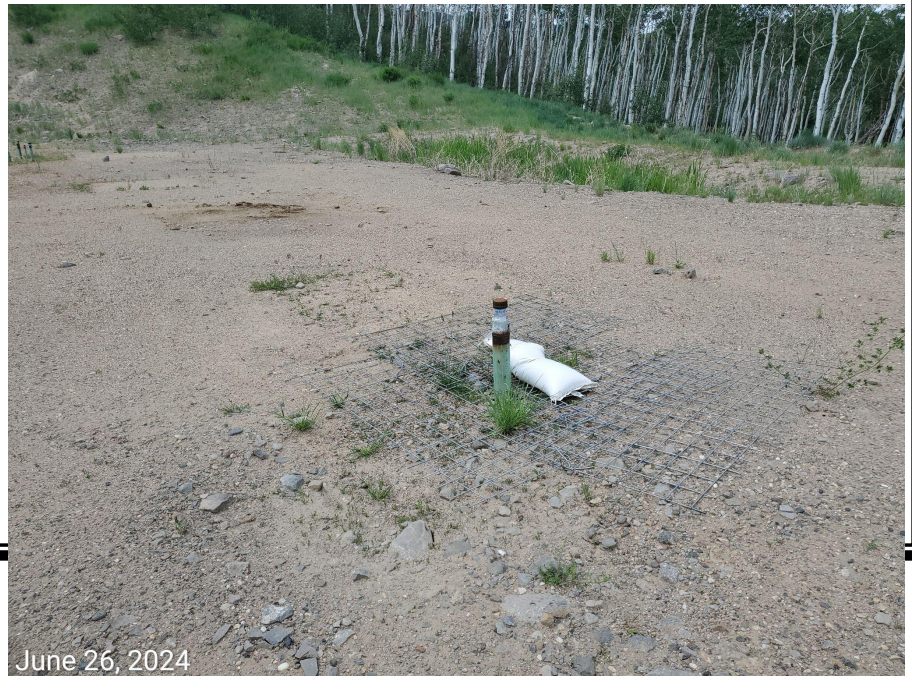
**Photo 15:** Photos examples showing unused riser equipment has not been removed from the Location.

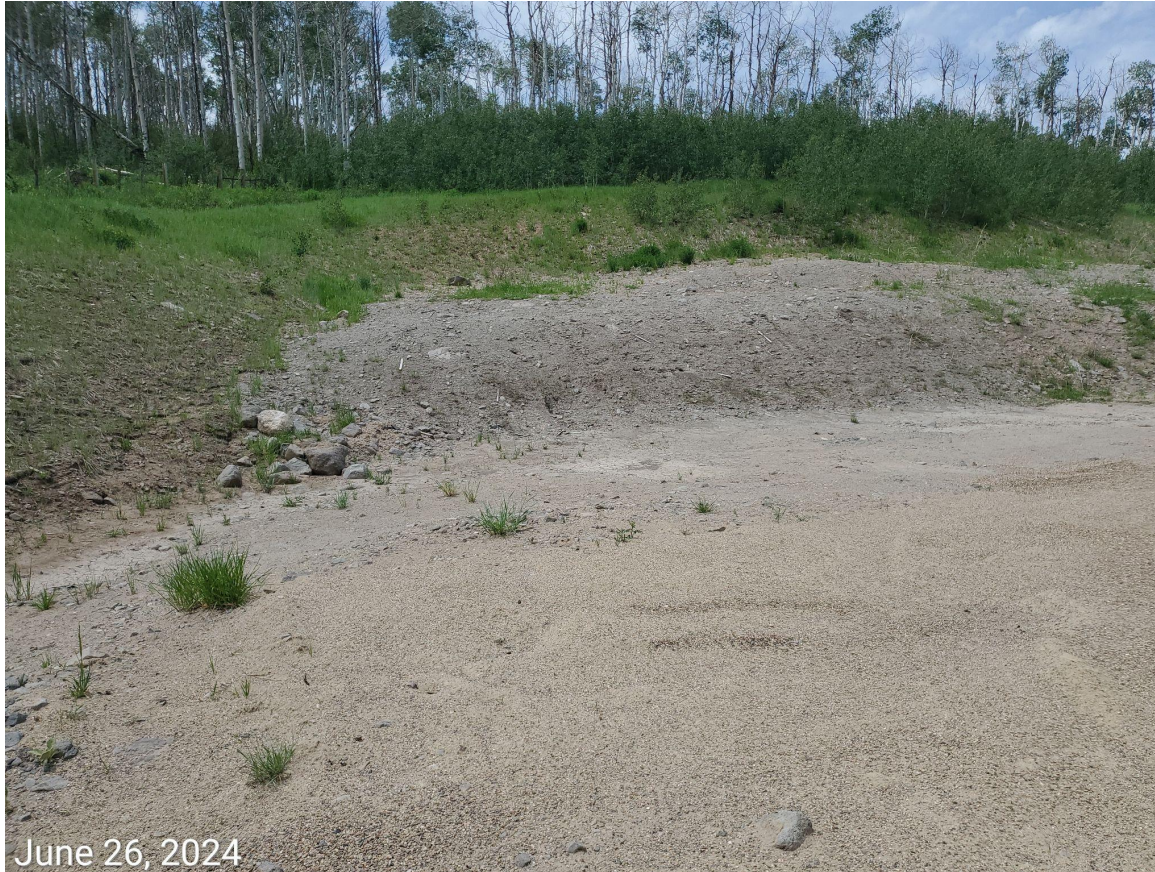
**Photo 16:** Photo shows drill cutting material improperly stored on the Location. Stormwater runoff has resulted in impacted material migrating off-site. BMPs to contain the E&P waste have not been implemented.

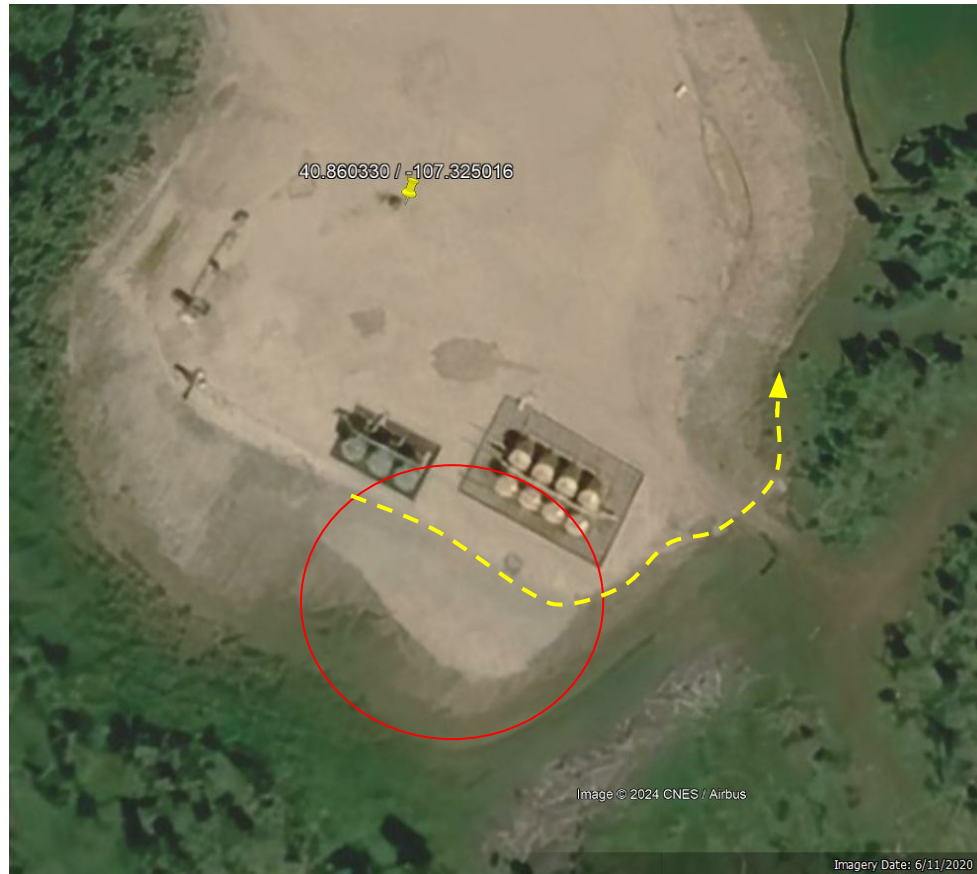
**Photo 17:** Continued from photo 16. Red circle represents the drill cuttings location on the pad. Yellow line shows the stormwater diversion ditch. Migration of impacted material observed.
