Inspection Photos

June 28th, 2024

Operator: Kinder Morgan CO2 CO - 46685

Inspection Photos
Location Name: DC 22, 24
Location ID: 454942

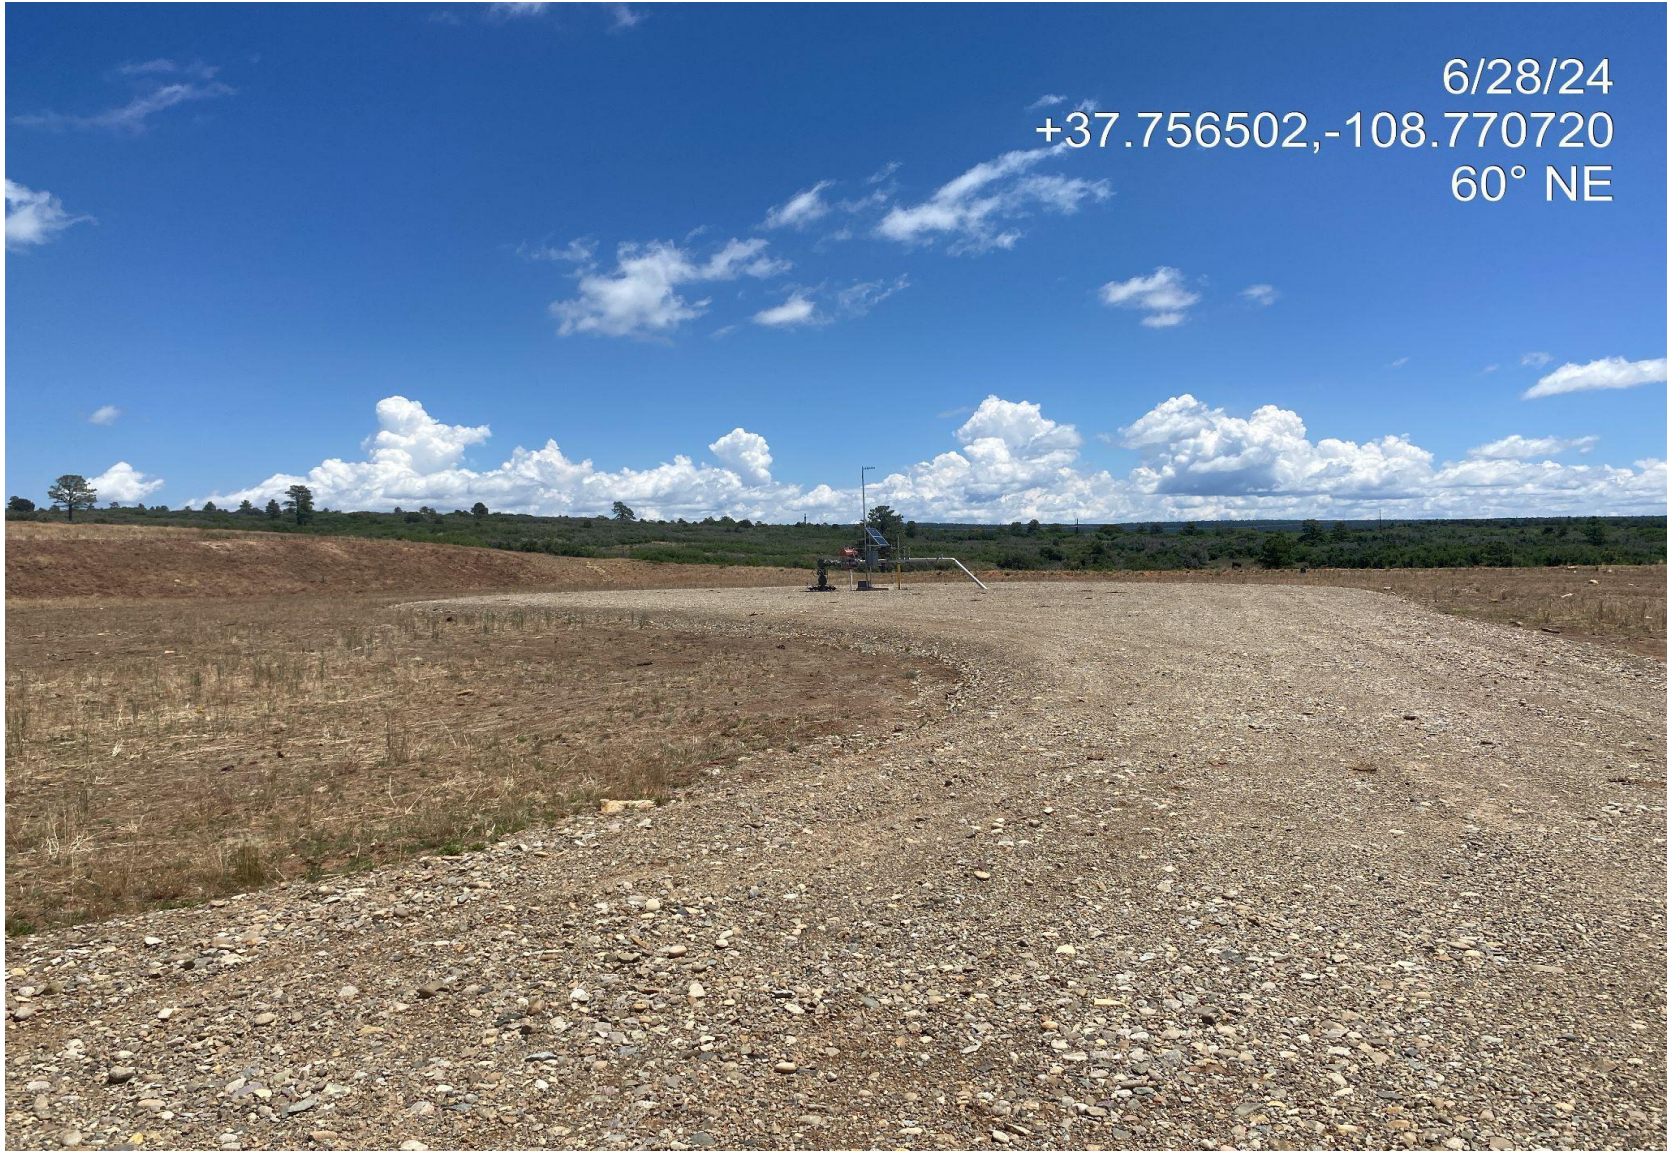
Photo 1. View of the disturbance taken from the access point facing center.

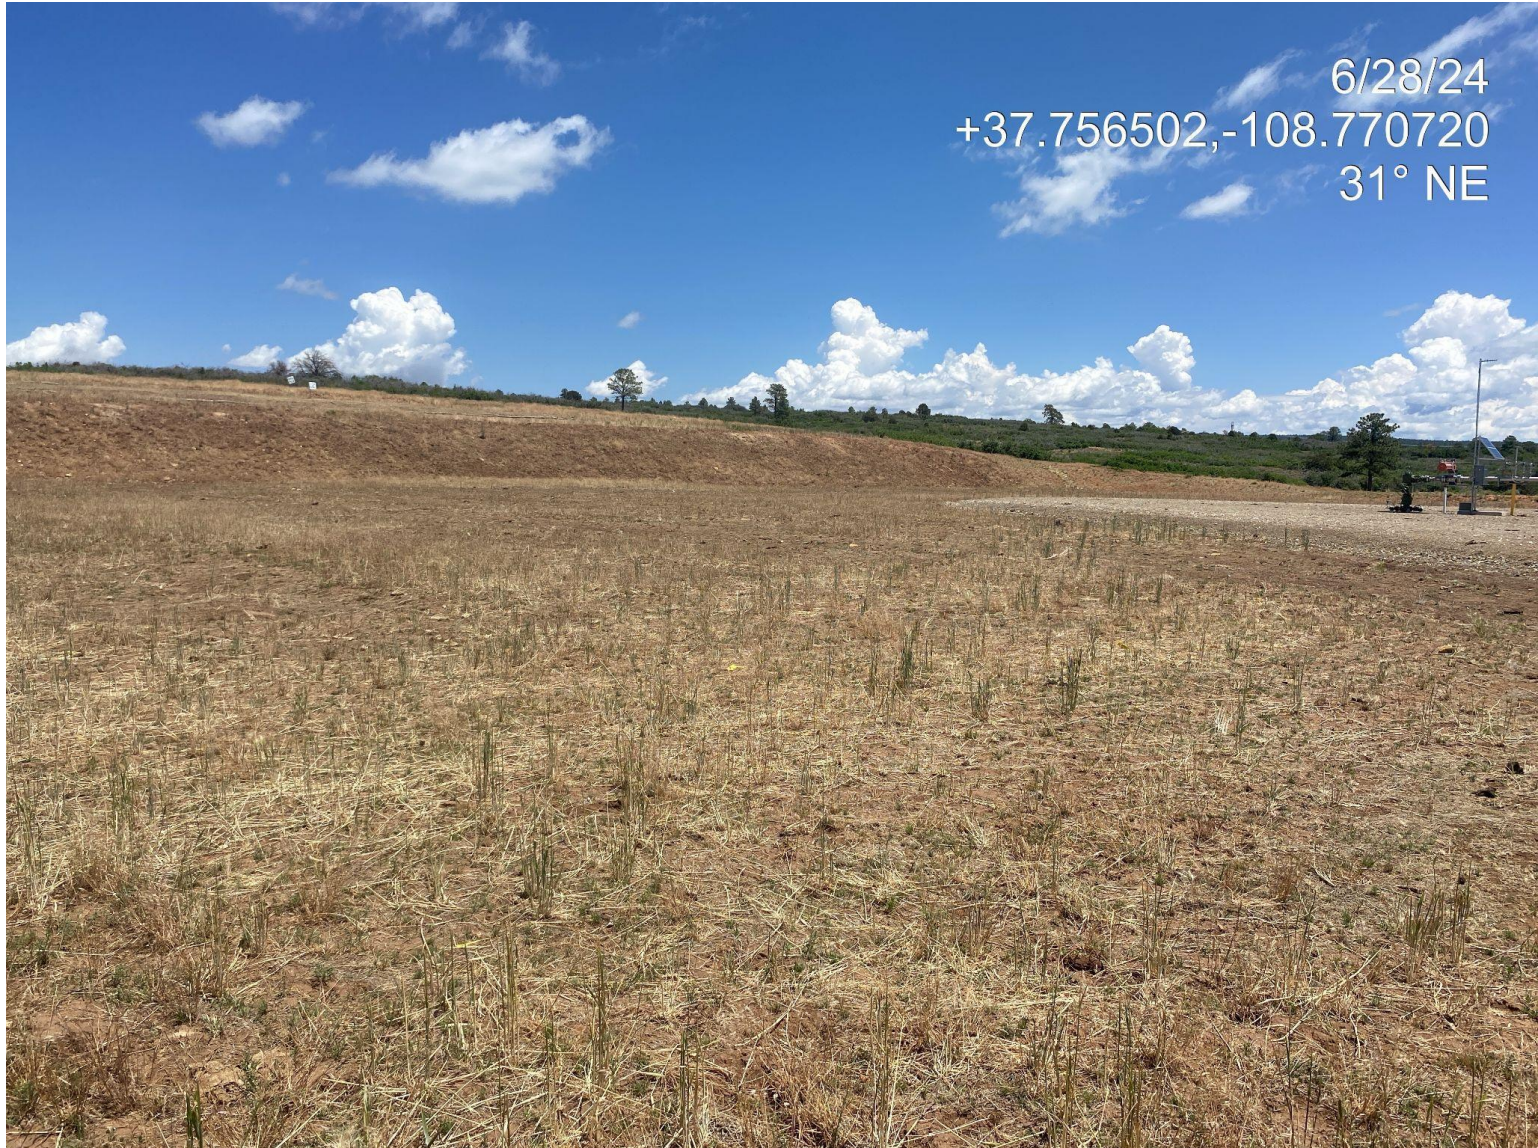
Photo 2. View of interim reclamation conducted, vegetation is progressing in these areas.

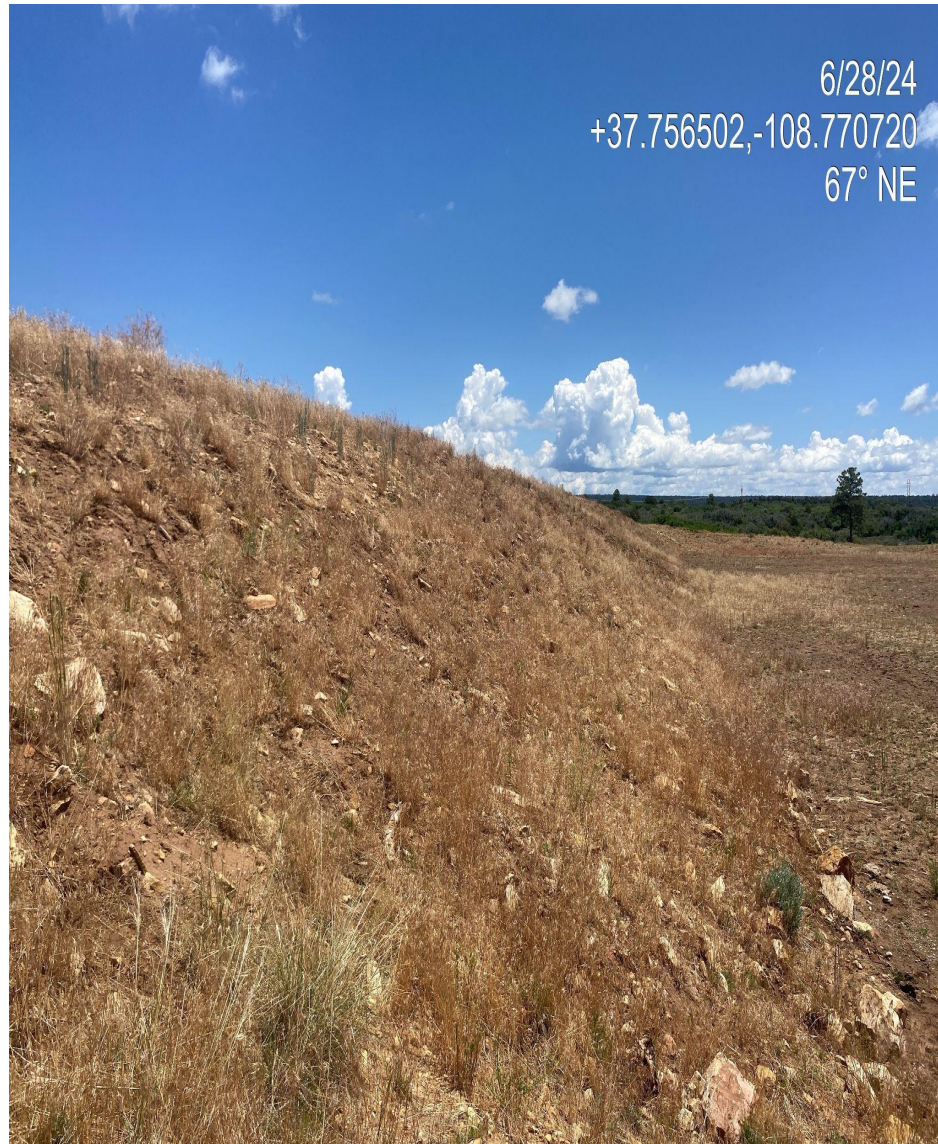
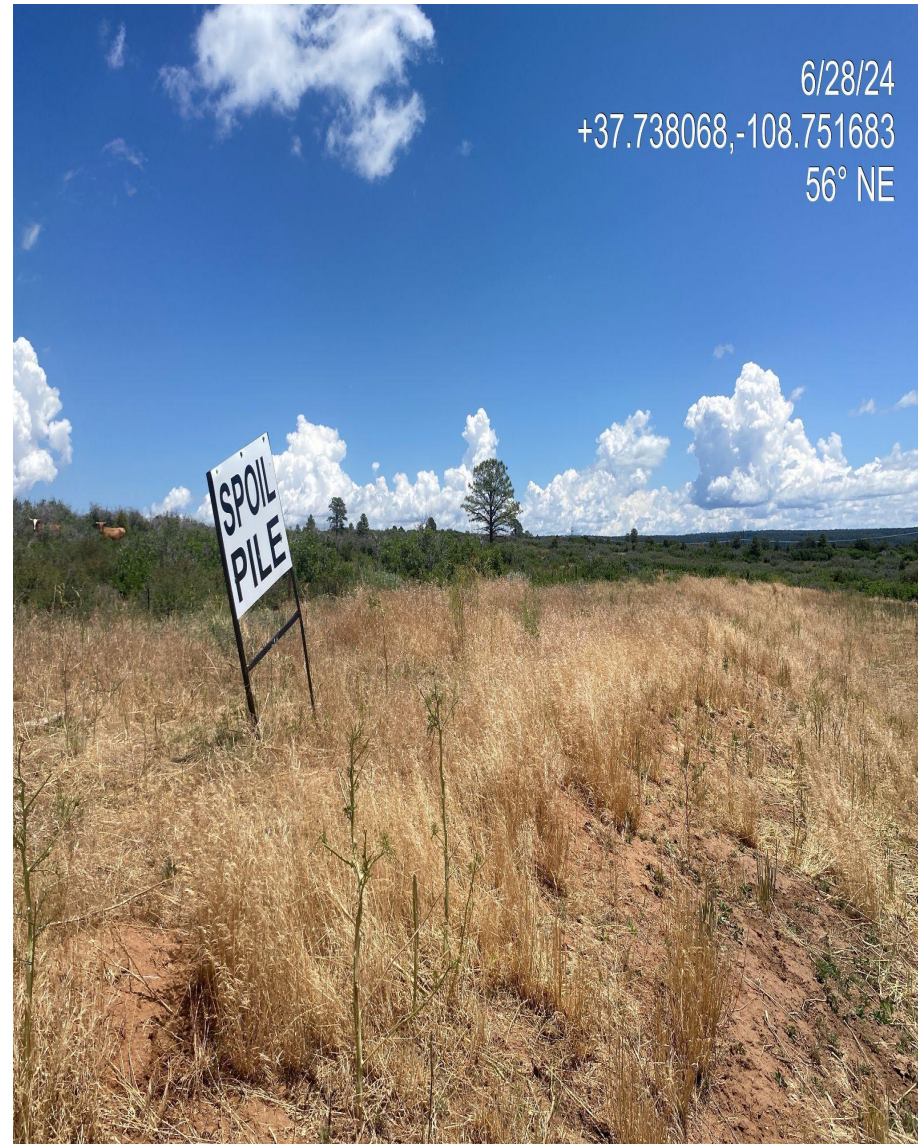
Photo 3. View of north cut slope and spoil pile which are covered in annual weeds, including Cheatgrass.

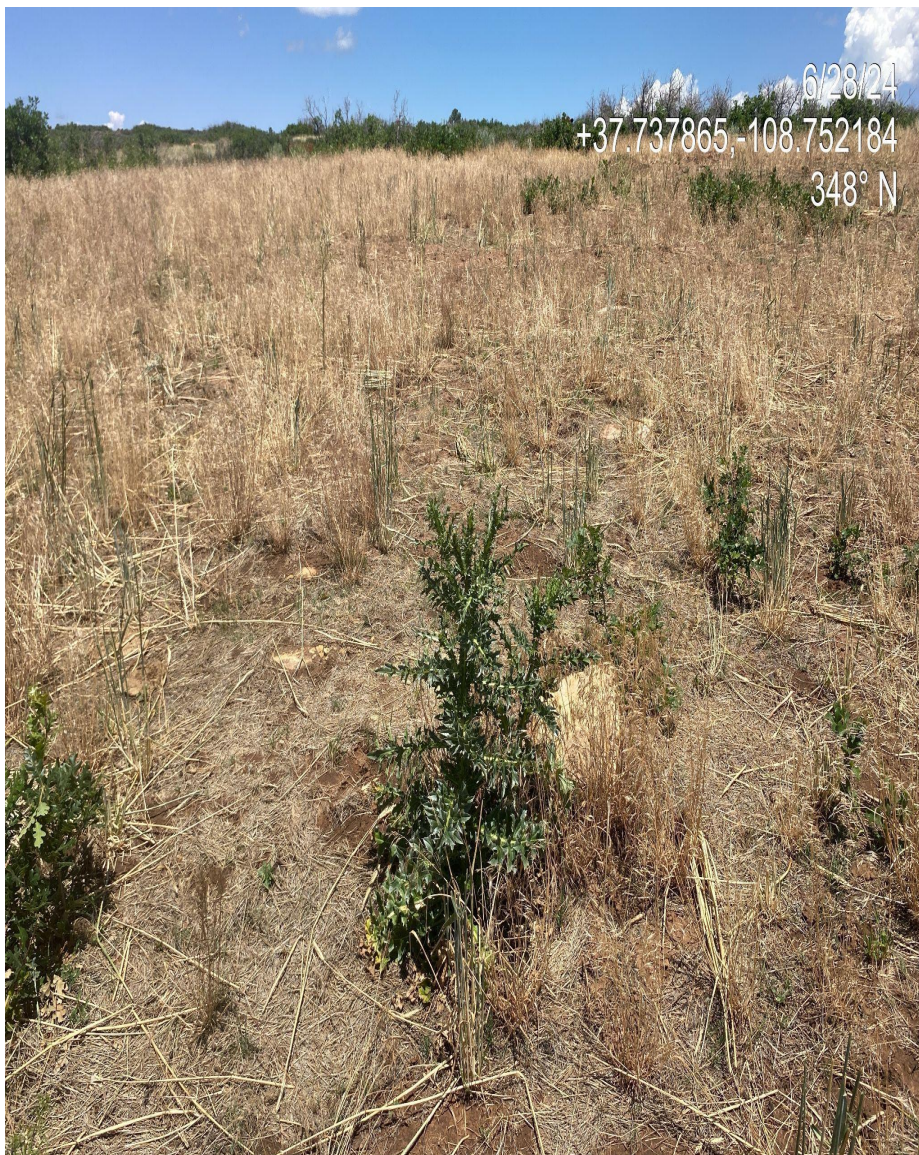
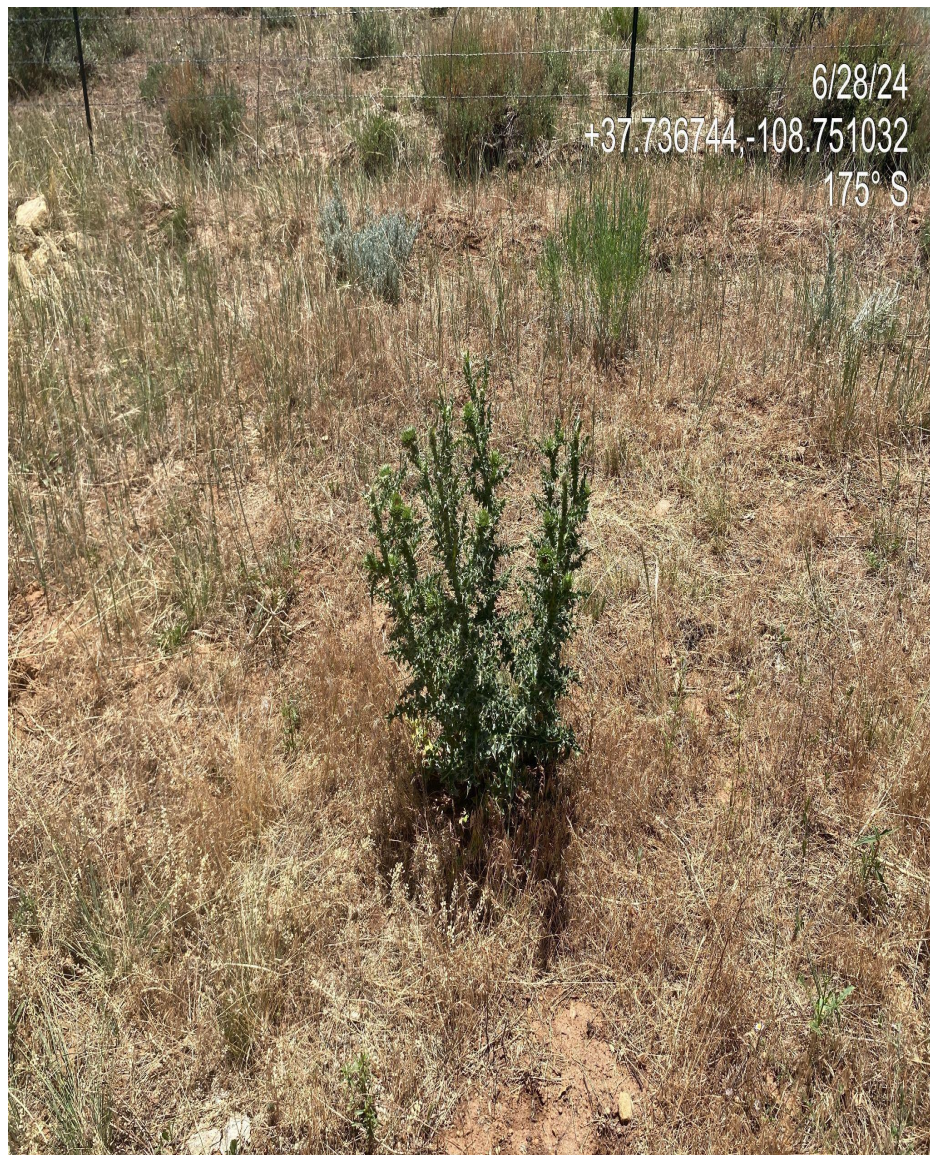
Photo 4. View of Musk thistle observed in both the northern and southern portions of the disturbance.

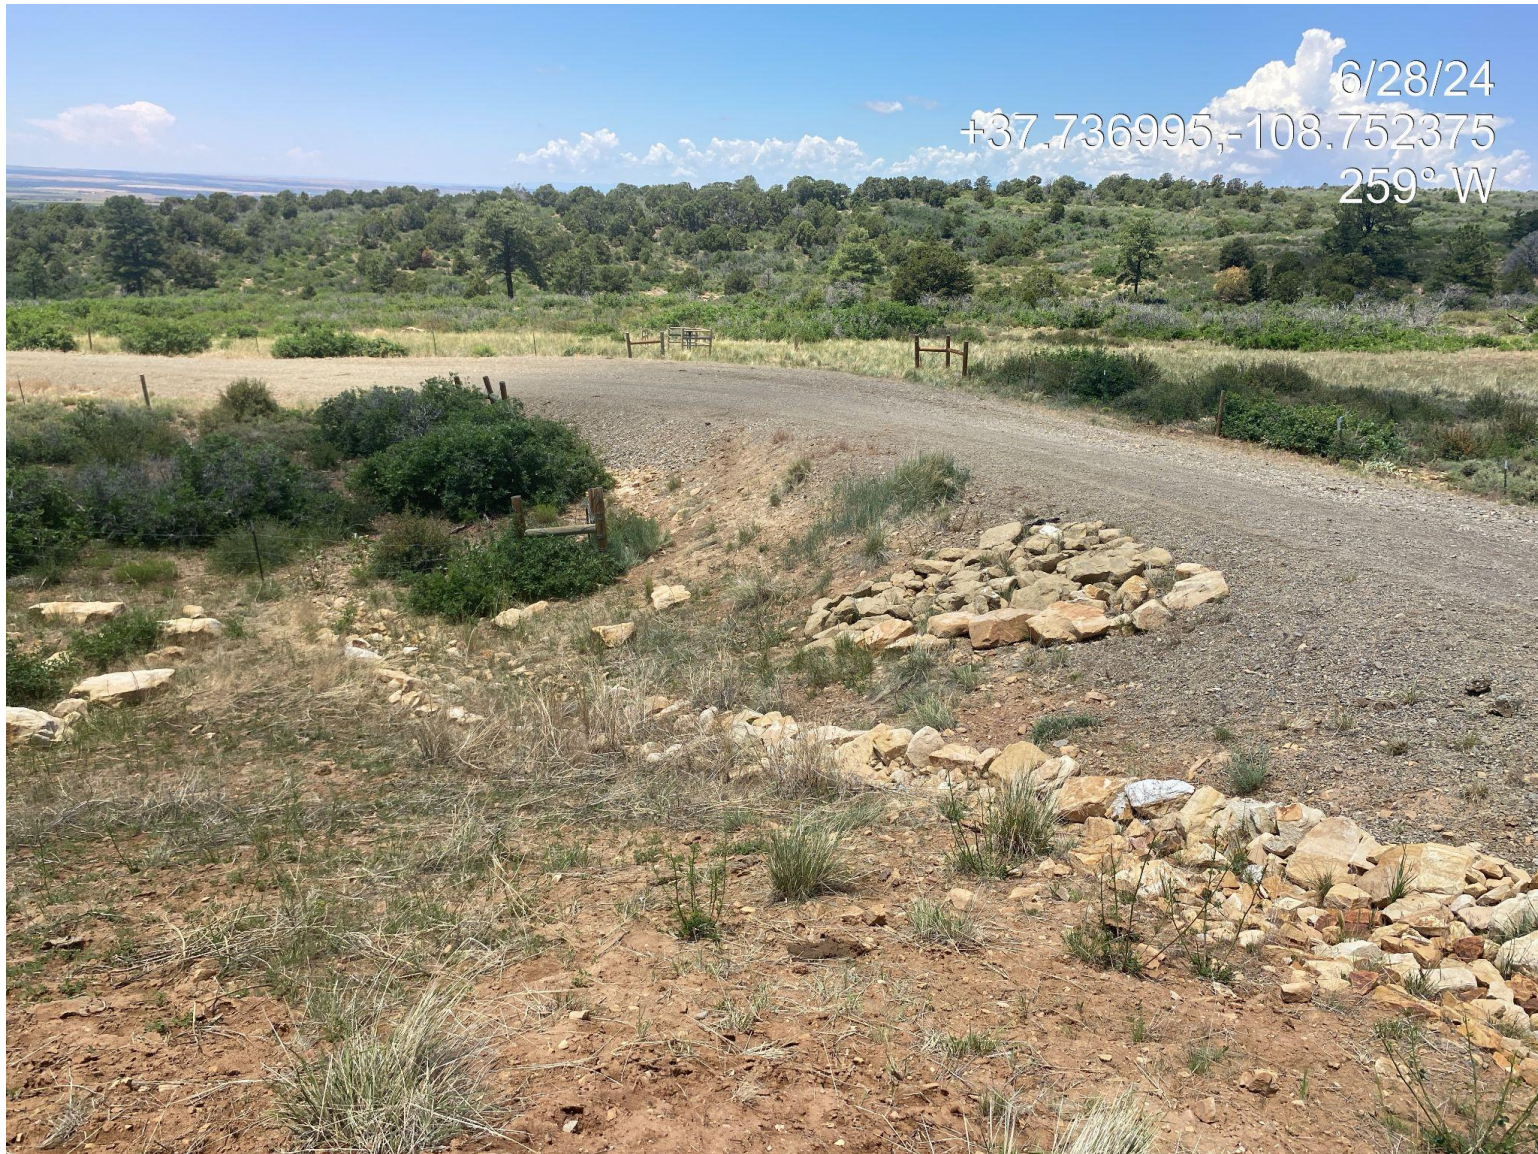
Photo 5. View of storm water BMPs that are functioning and have been properly maintained near the access point of the disturbance.

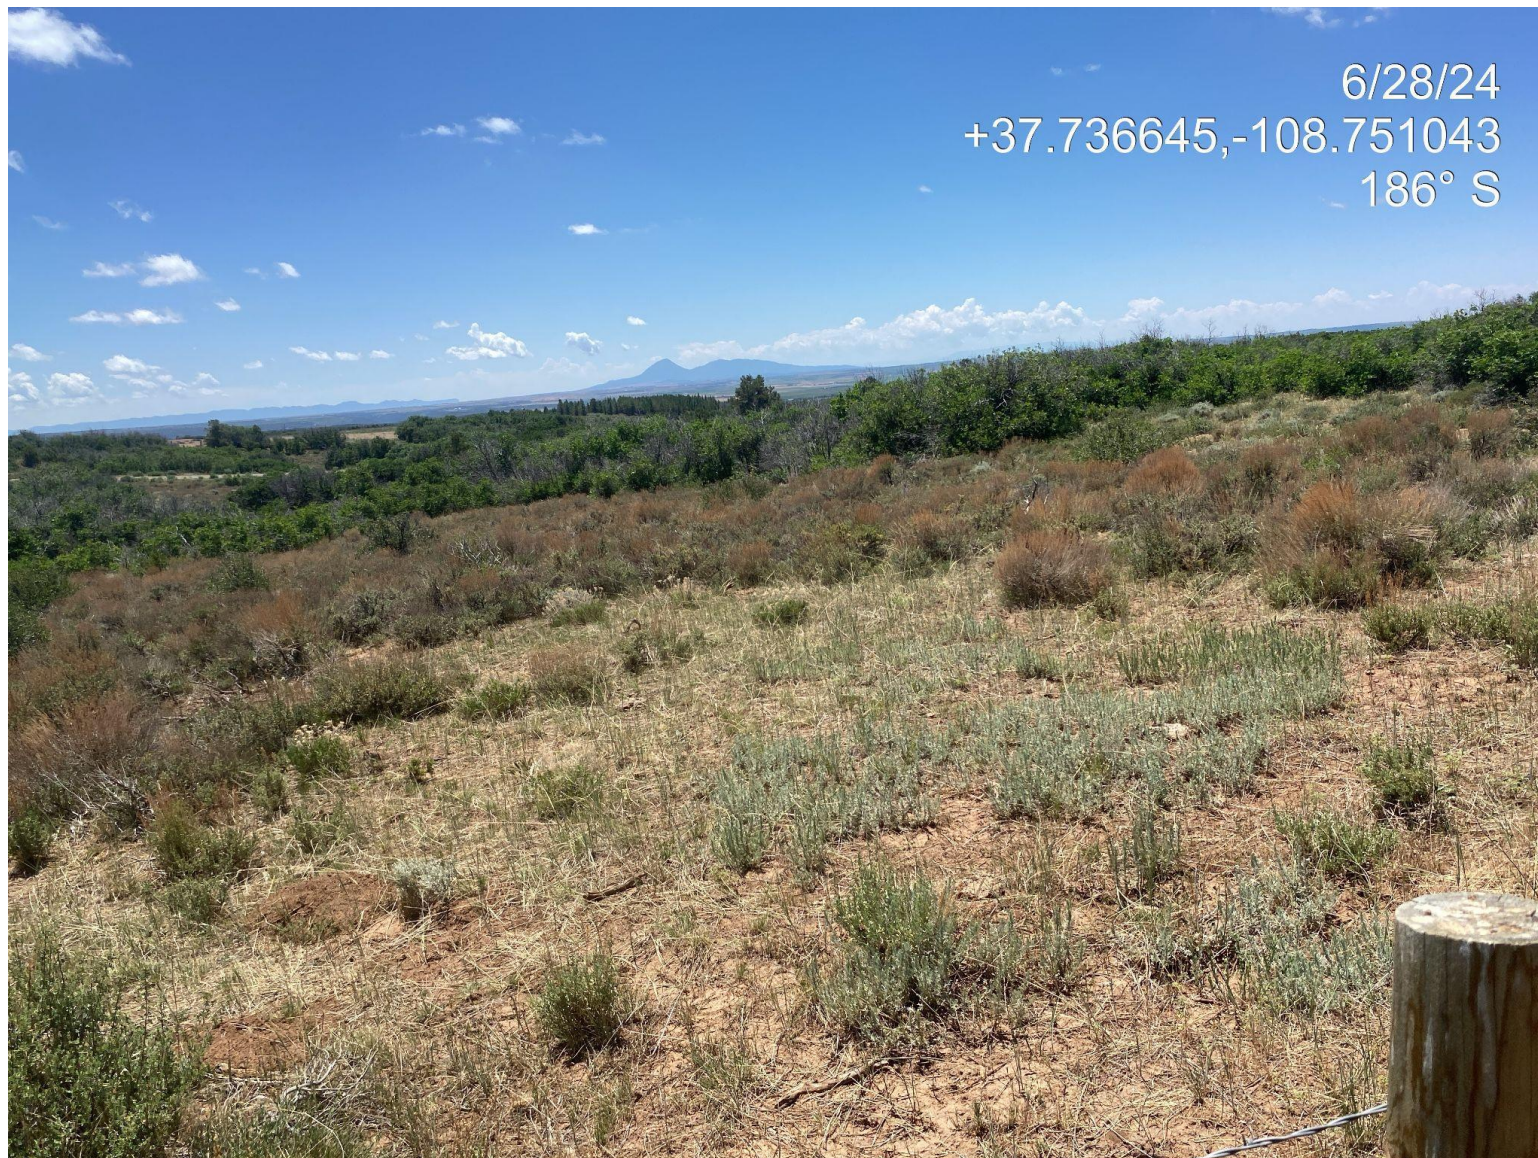
Photo 6. View of reference area comprised predominantly of Sage brush and Serviceberry.
