Inspection Photos

Location Name: TEP ROCKY MOUNTAIN LLC WEINREIS A Pad

Location ID: 335548

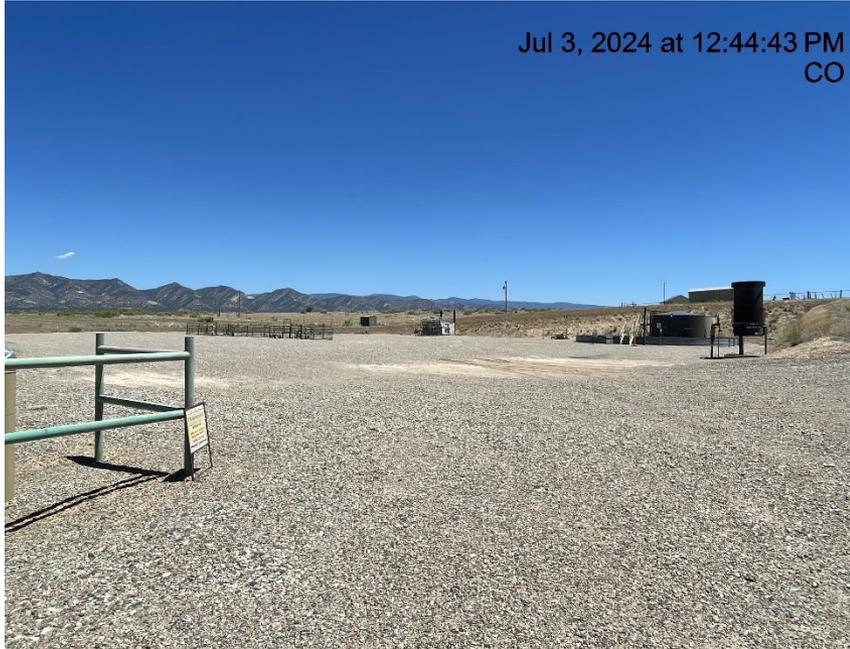
Photo # 2550 From entrance to location

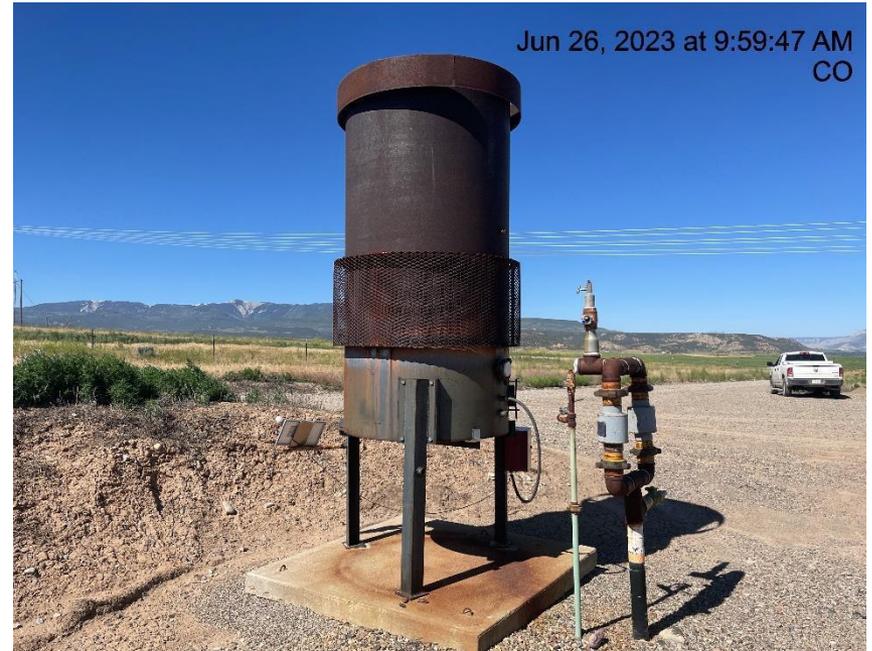
Photo # 1802 from inspection 708900877 conducted on
06/26/2023 - Unused equipment/ECD disconnected

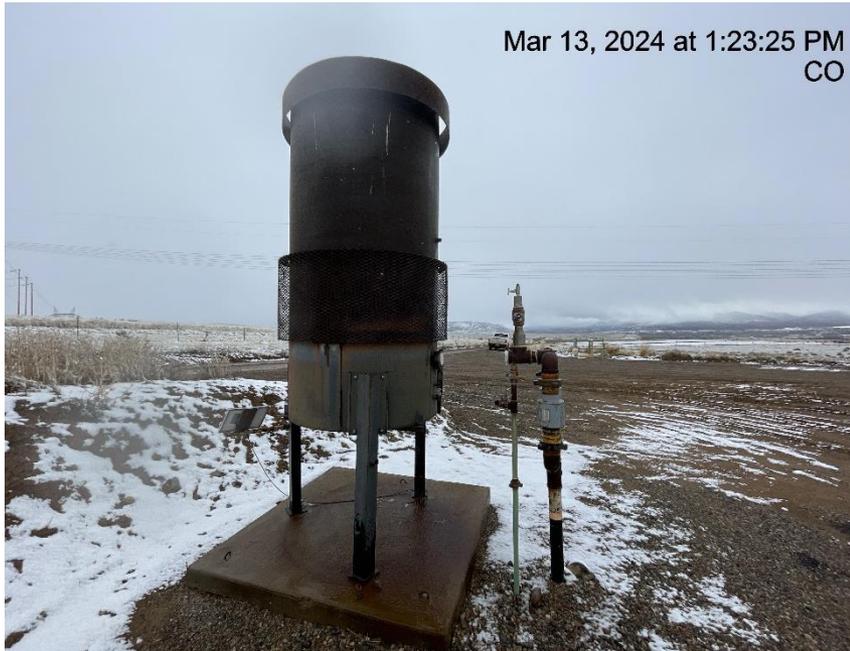
Photo # 9872 From inspection 708903328 conducted on 03/13/2024 Unused equipment/ECD disconnected

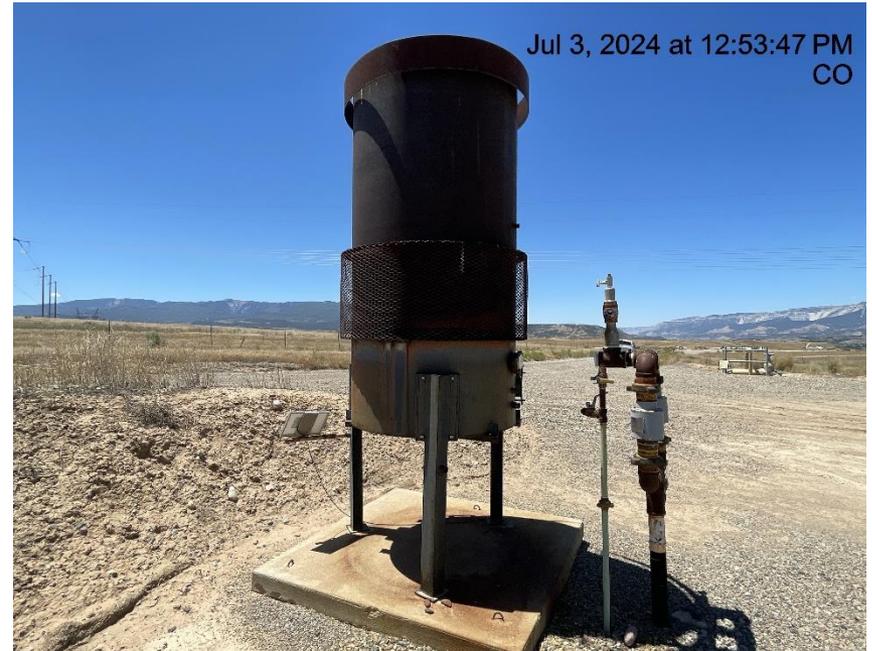
Photo # 2555 Unused equipment/ECD disconnected

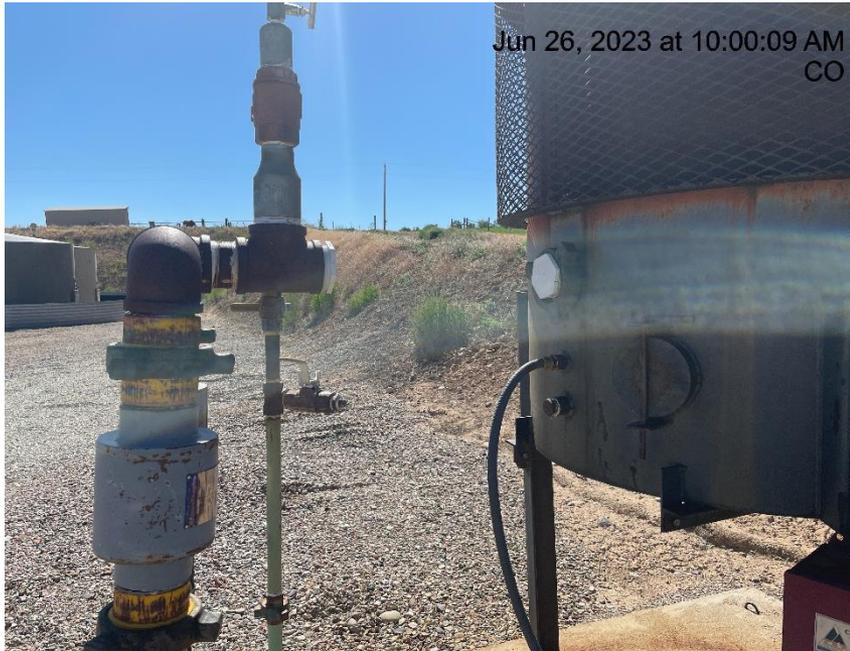
Photo # 1803 from inspection 708900877 conducted on 06/26/2023 - Unused equipment/ECD disconnected

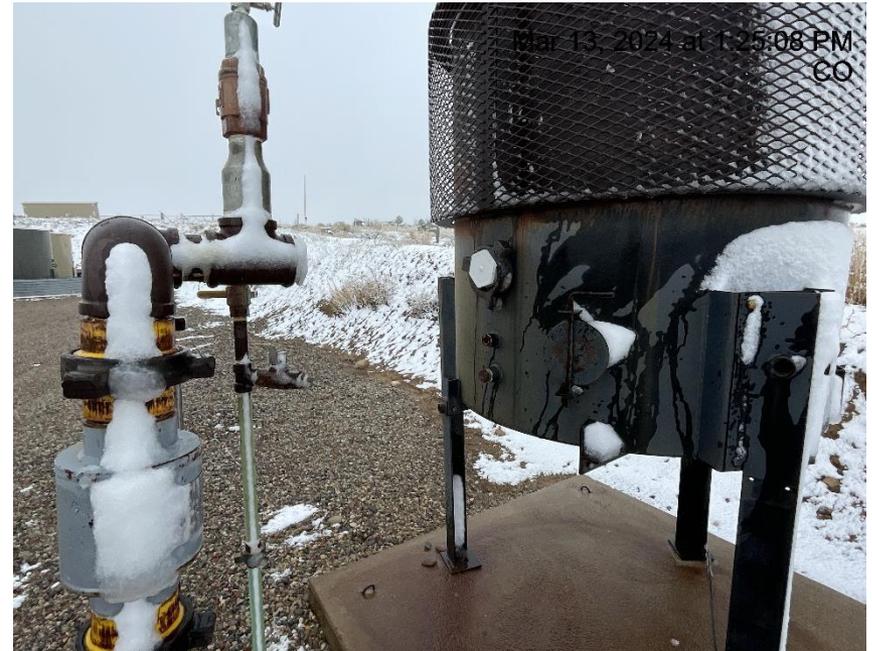
Photo # 9873 From inspection 708903328 conducted on 03/13/2024 Unused equipment/ECD disconnected

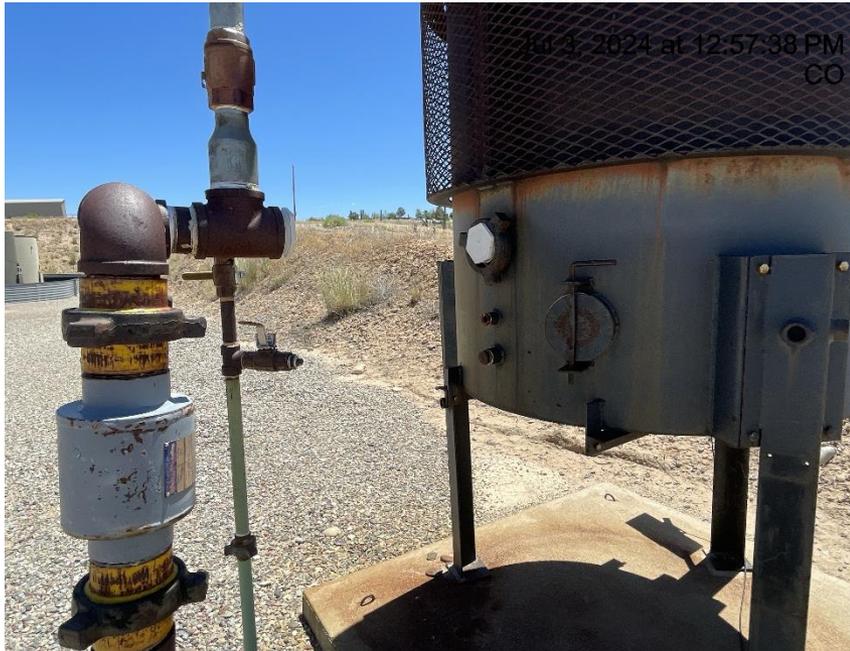
Photo # 2556 Unused equipment/ECD disconnected

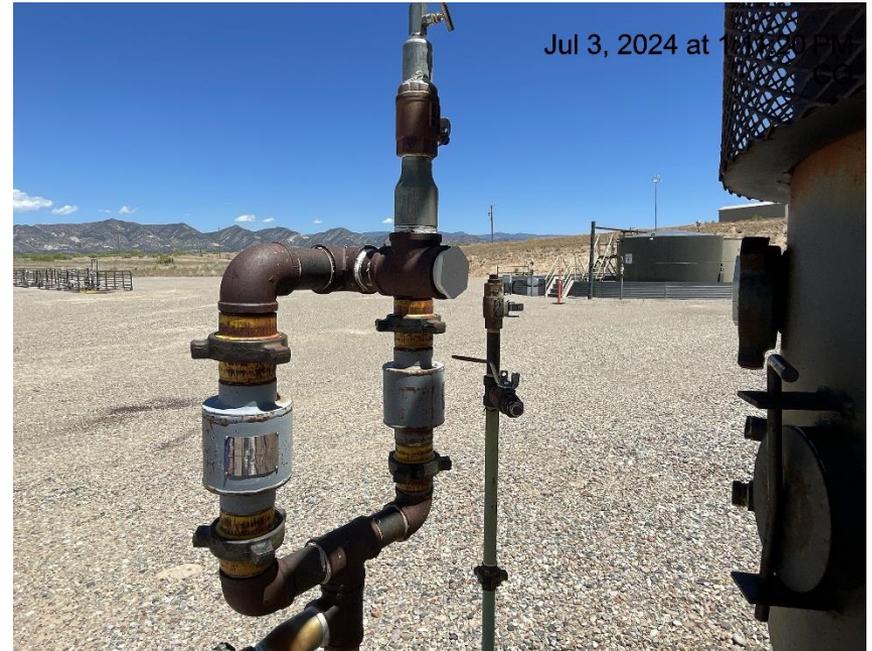
Photo # 2557 Unused equipment/ECD disconnected

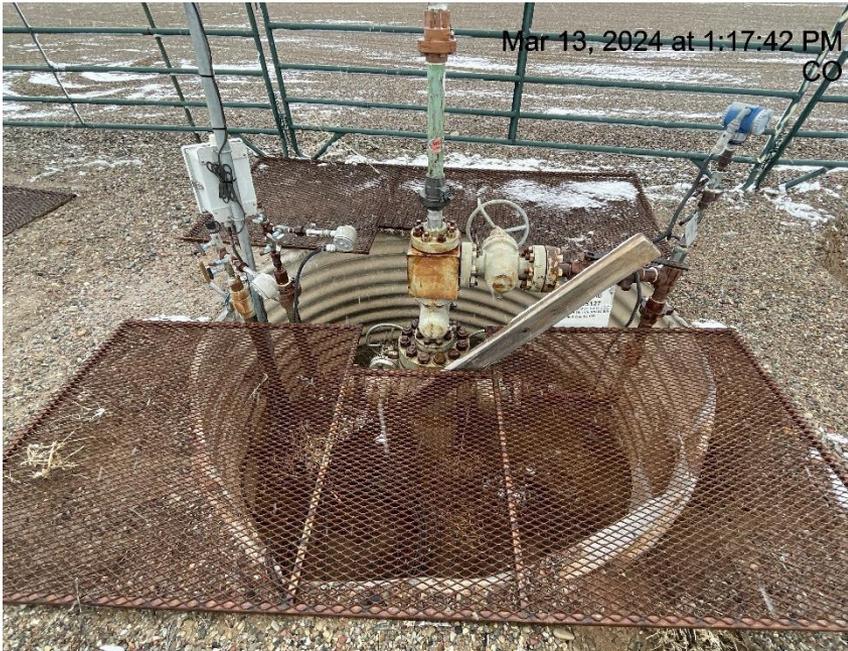
Photo # 9871 From inspection 708903328 conducted on 03/13/2024 Cellar cover not properly installed/wildlife & personnel hazard & wildlife egress not properly installed.

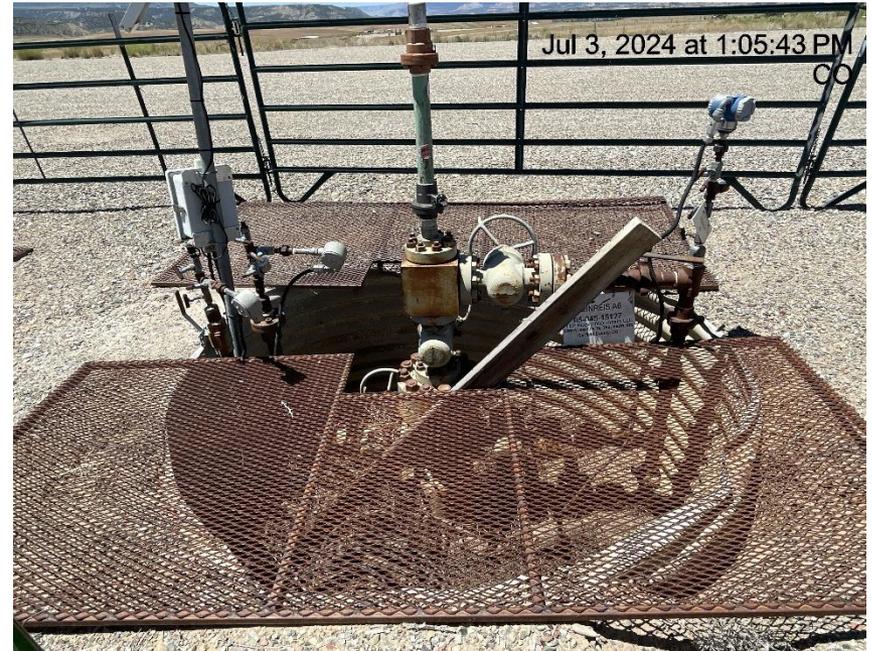
Photo # 2558 Cellar cover not properly installed/wildlife & personnel hazard & wildlife egress not properly installed.

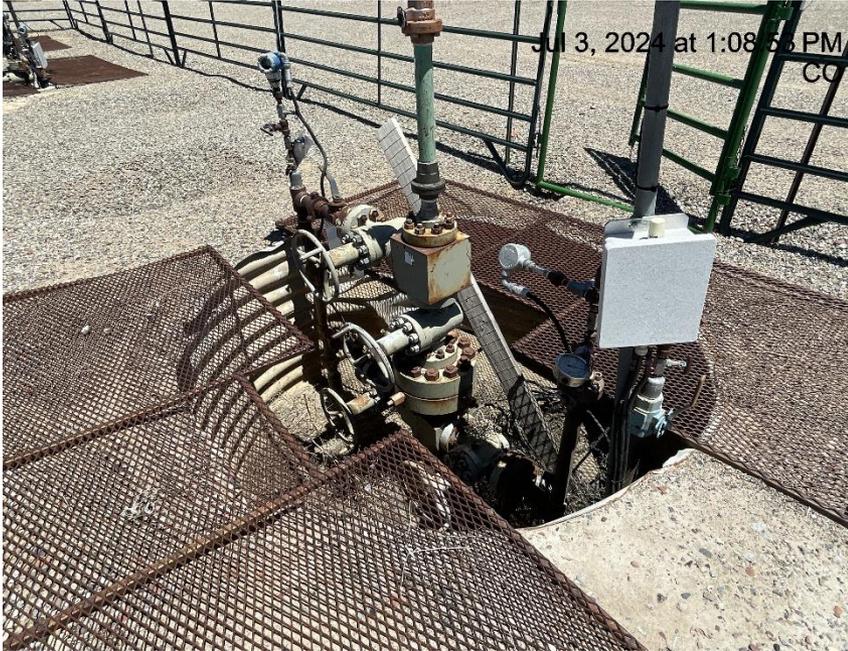
Photo # 2559 Cellar cover not properly installed/wildlife & personnel hazard & wildlife egress not properly installed.

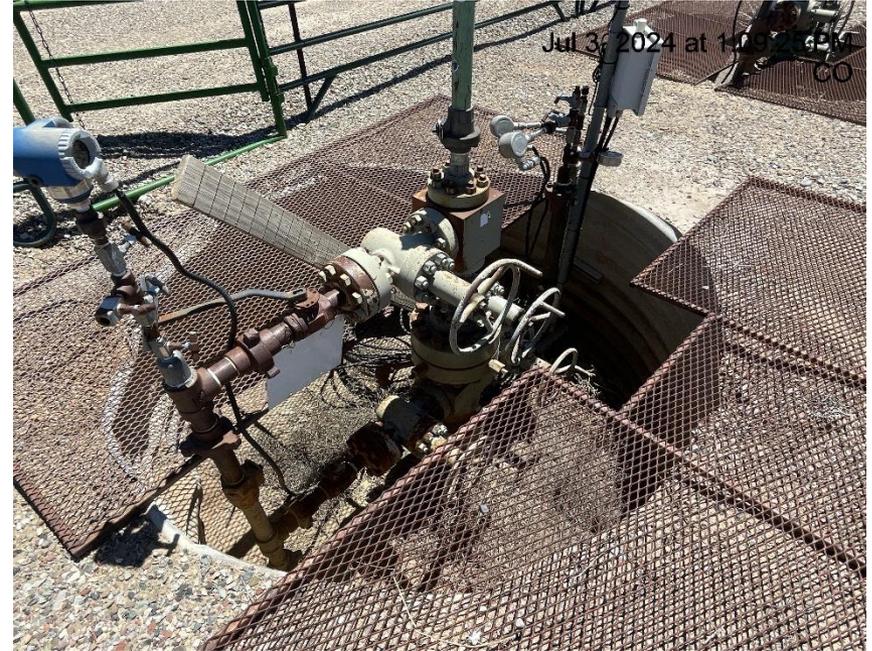
Photo # 2560 Cellar cover not properly installed/wildlife & personnel hazard & wildlife egress not properly installed.
