Hill 9-31

Pipeline Leak

API# 05-103-08021

Facility ID# 230359

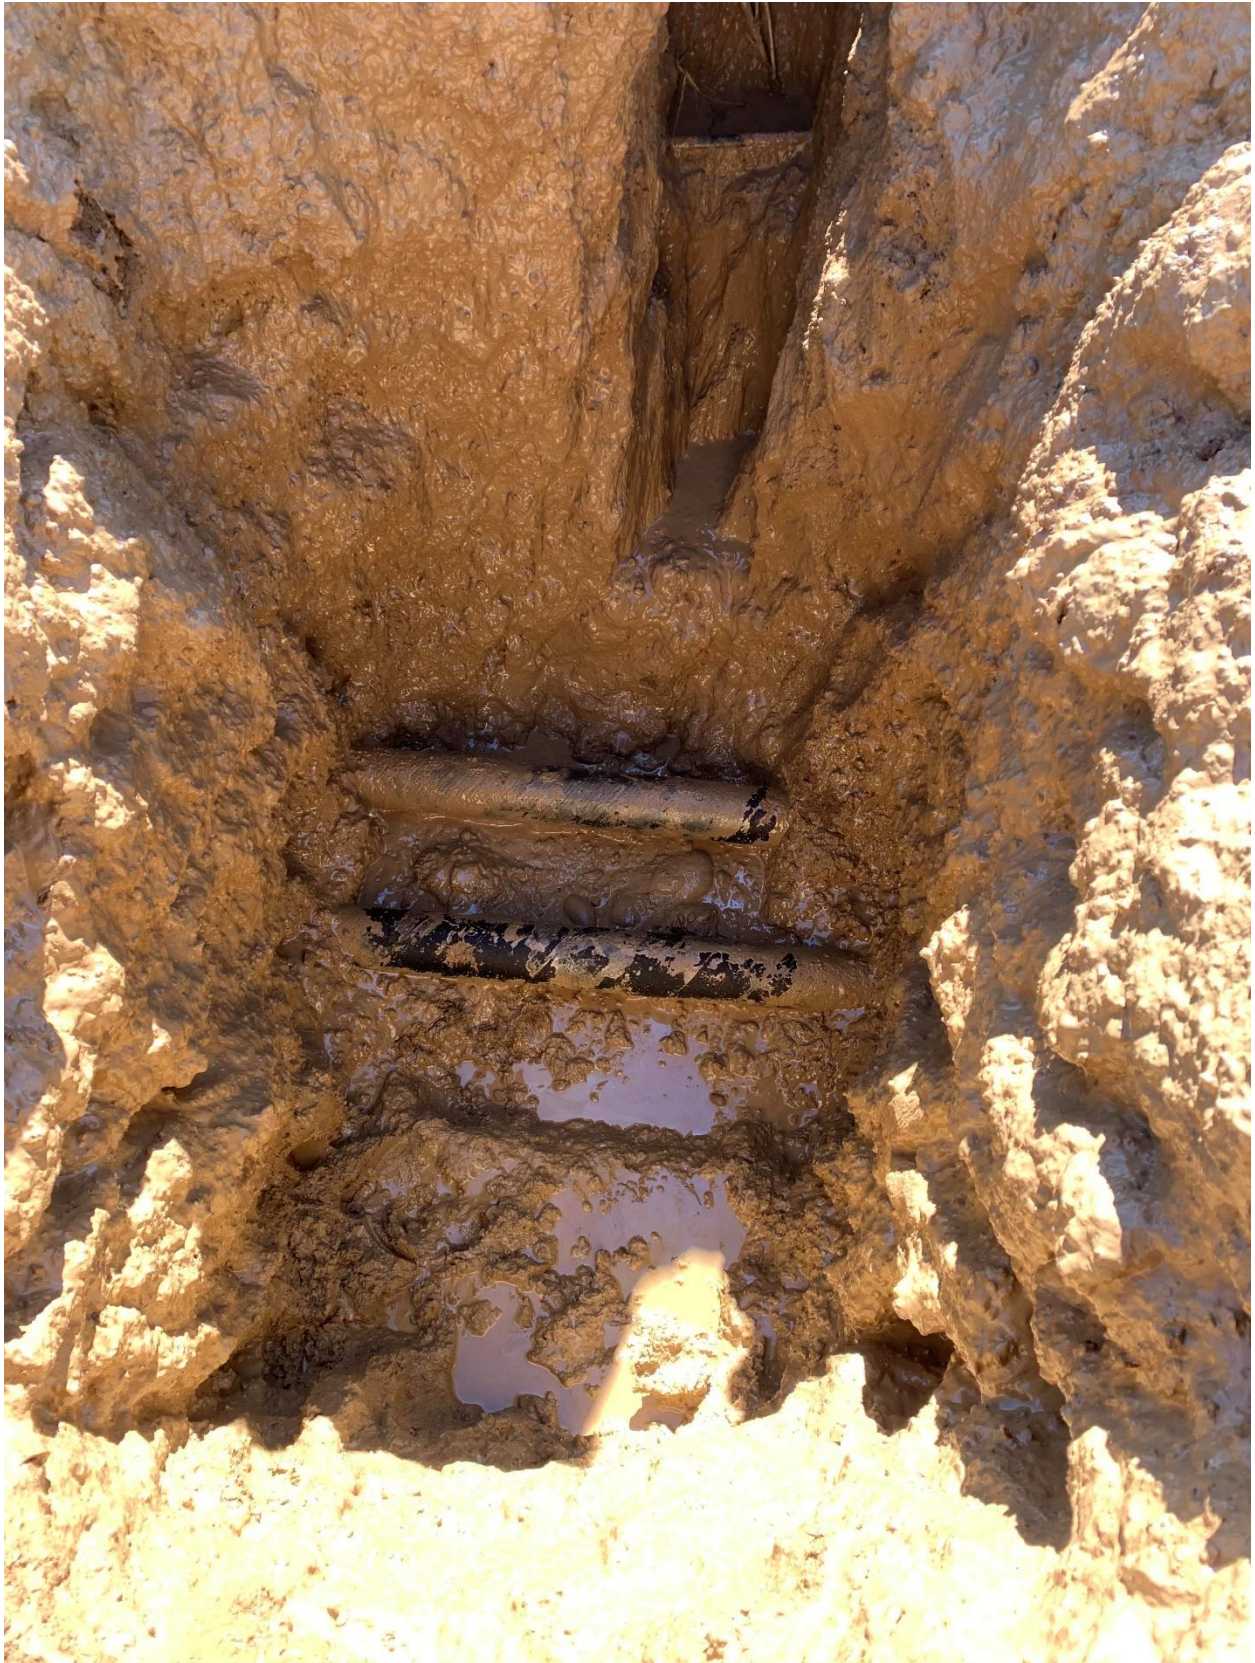
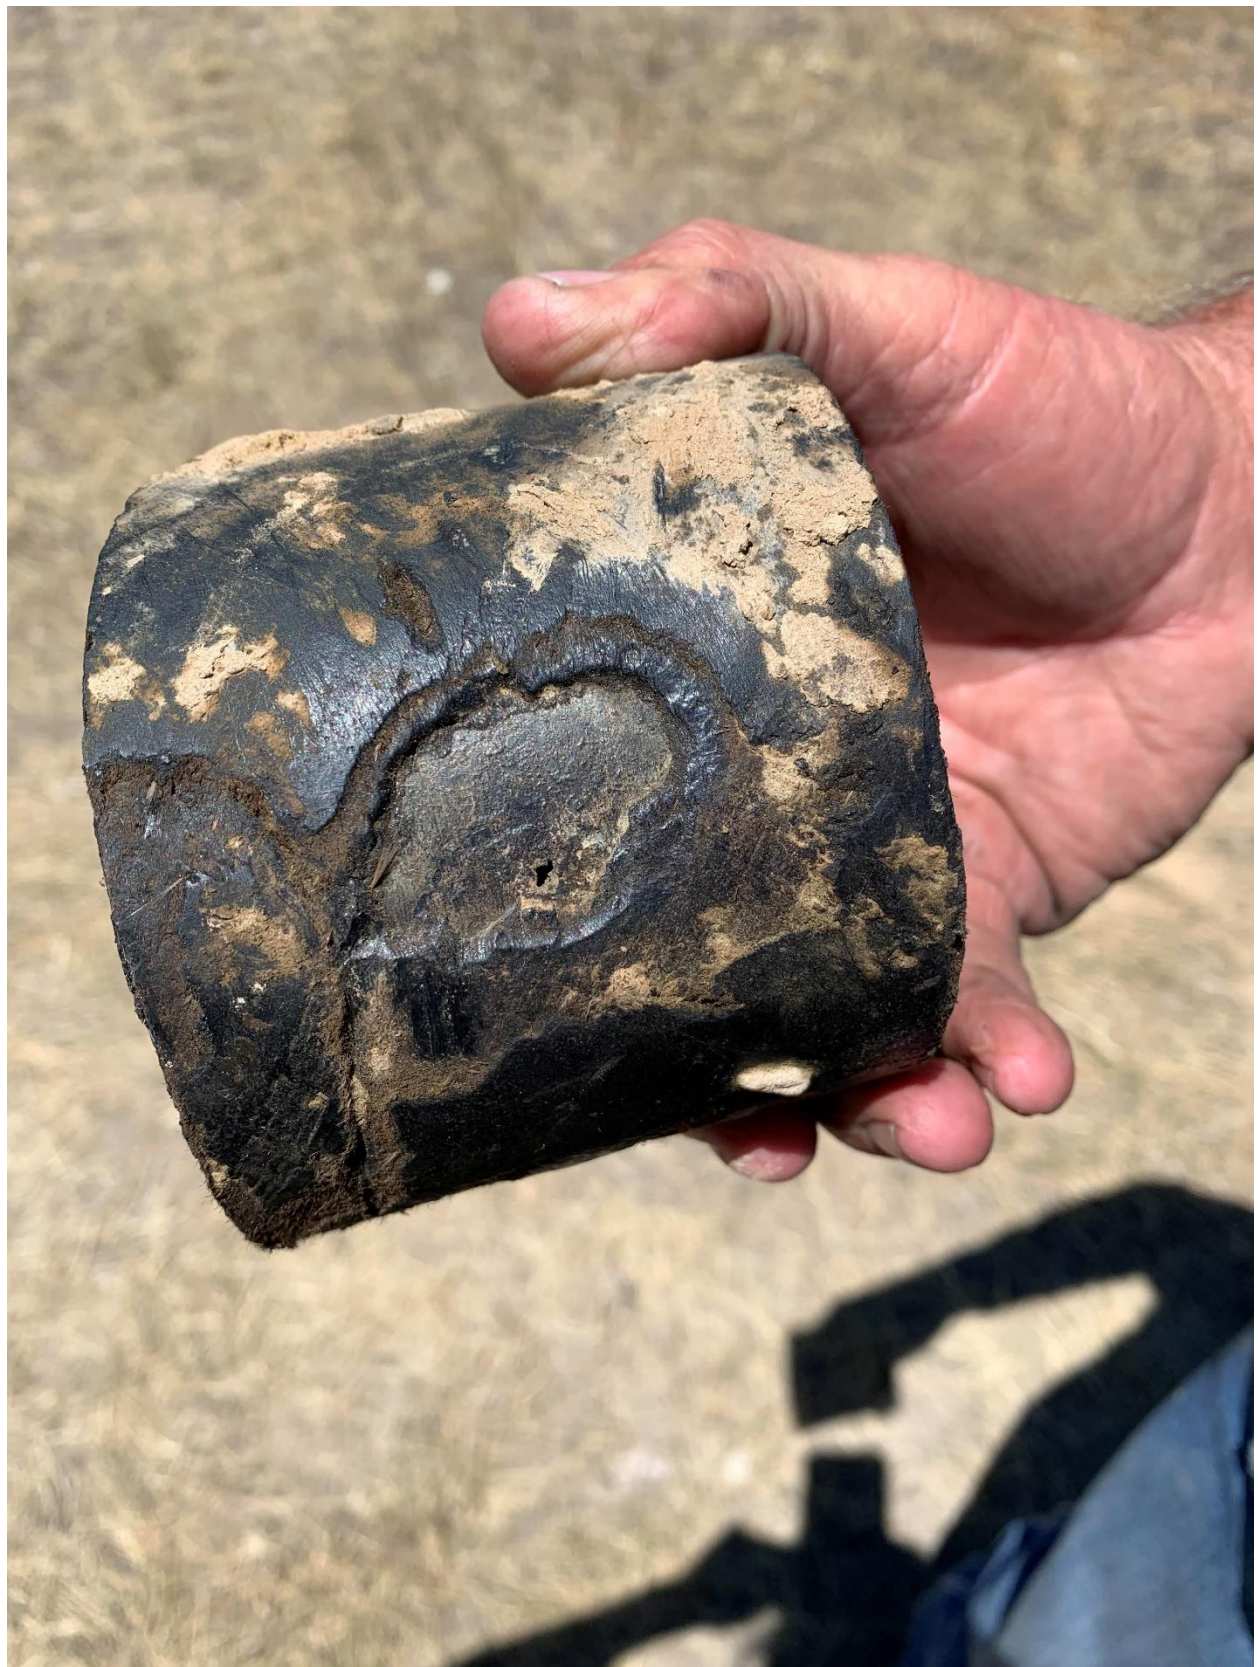
Photos From 7/8/2024

On 7/8/2024, UGC personnel arrive at the location of the pipeline leak with Badger Daylighting to further excavate the impacted area. Badger Daylighting (hydrovac) was used to carefully excavate the affected pipeline, as other lines were in the area. Once the affected line was opened, UGC utilized a backhoe to trench the line to find the hole in the pipeline. The hole was found in the east side of the pipe in the three o'clock orientation. The hole in the pipeline is about the size of a pen tip. During site excavation, dense clay was found at approximately 4-7ft depth. The excavation was opened to a total of 17ft in the north/south direction, 10ft in the east-west direction, and to a depth of 7ft. All material removed from the excavation and stockpiled nearby. The impacted section of pipeline was cut and removed, and a new segment of pipeline was welded into place.

5 soil samples were collected from the excavation walls (north, south, east, west, and bottom). No background samples were collected, as UGC has two other remediation projects within a 0.50mile radius. UGC is requesting the consideration of the nearby background samples for this project. No groundwater was encountered during site excavation, if groundwater is encountered, it will be sampled as part of this remediation project.

The excavation was fenced off and left open while UGC awaits soil sample results to determine if further excavation and delineation is required.
