# Inspection Photos

Loc: 386457

Operator: AMOCO PRODUCTION COMPANY

Inspection Date: 7/12/2024

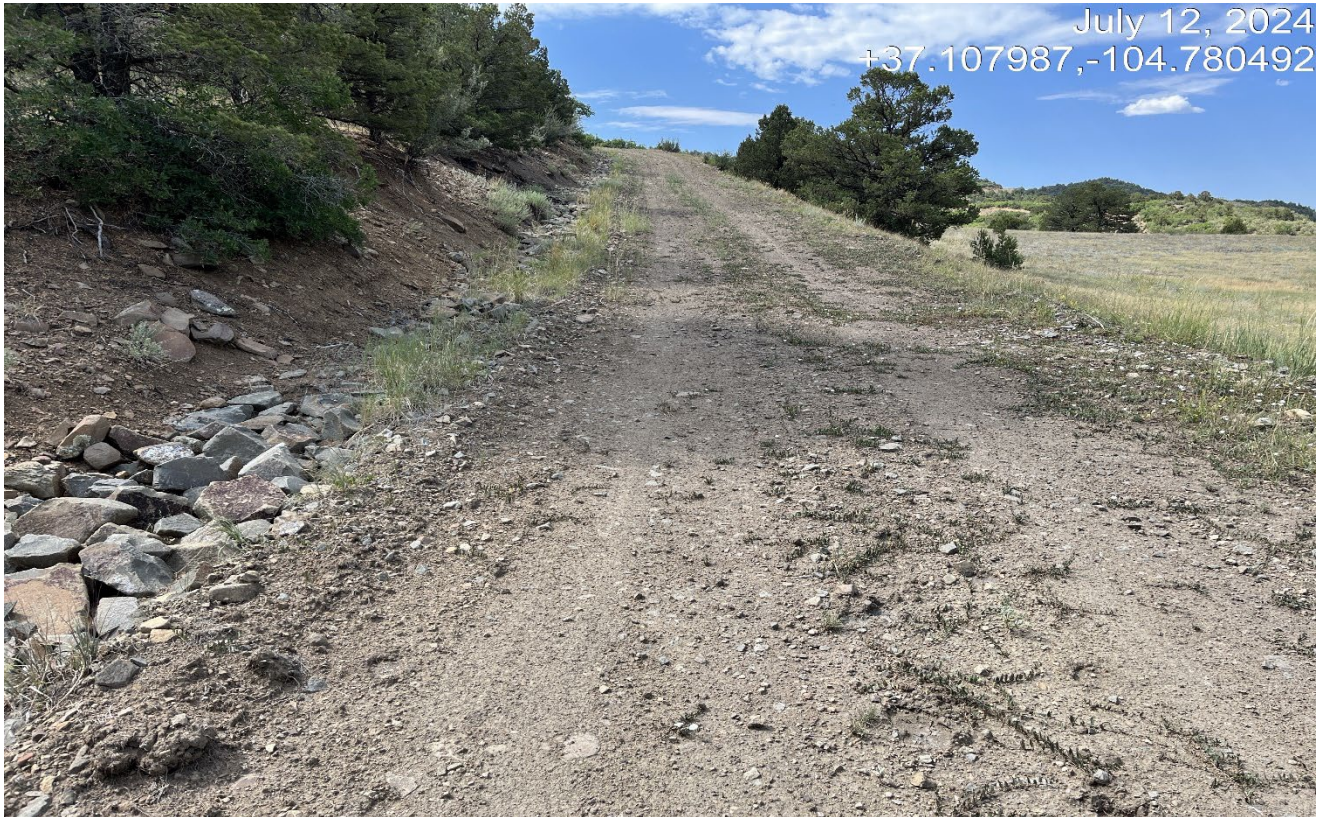
**Photo 1.** Facing south along the access road.

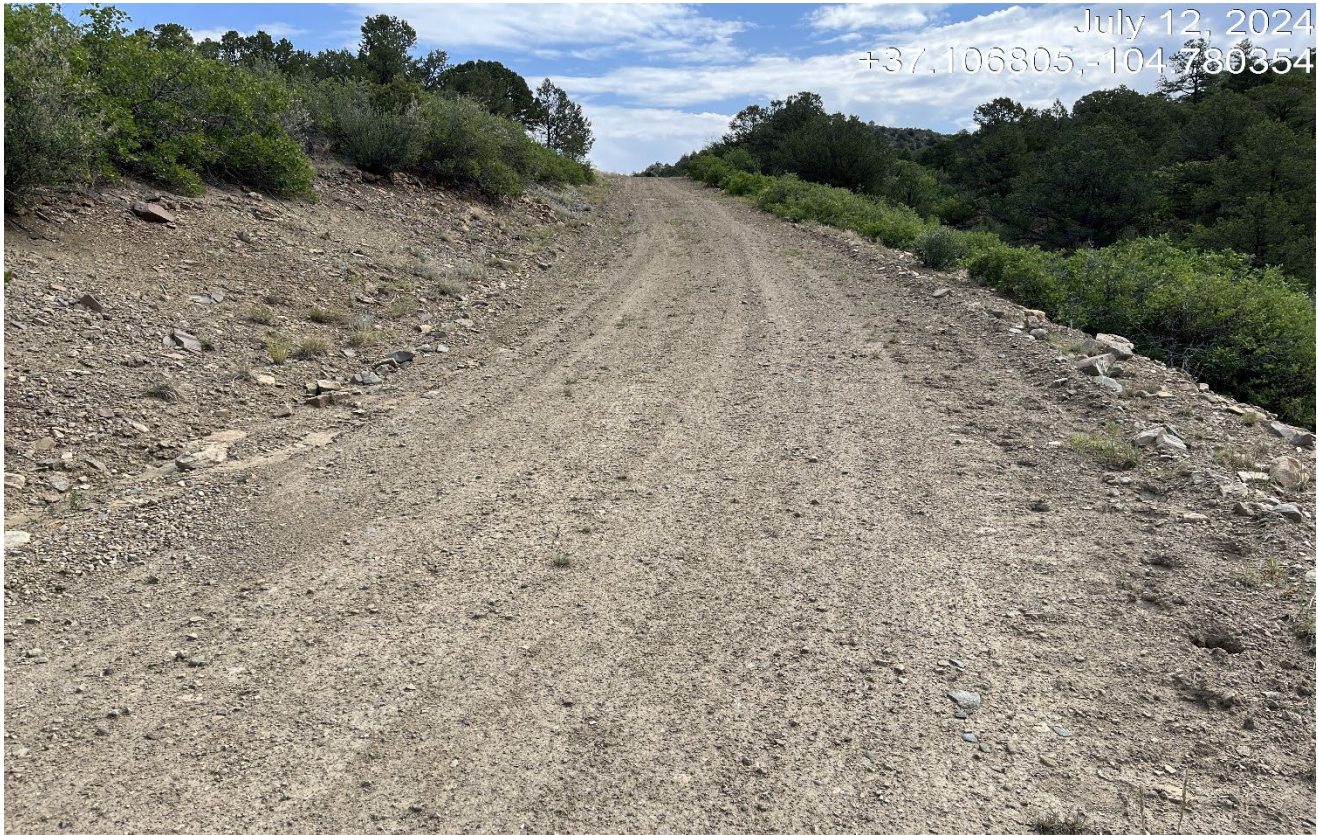
**Photo 2.** Facing northeast along the road.

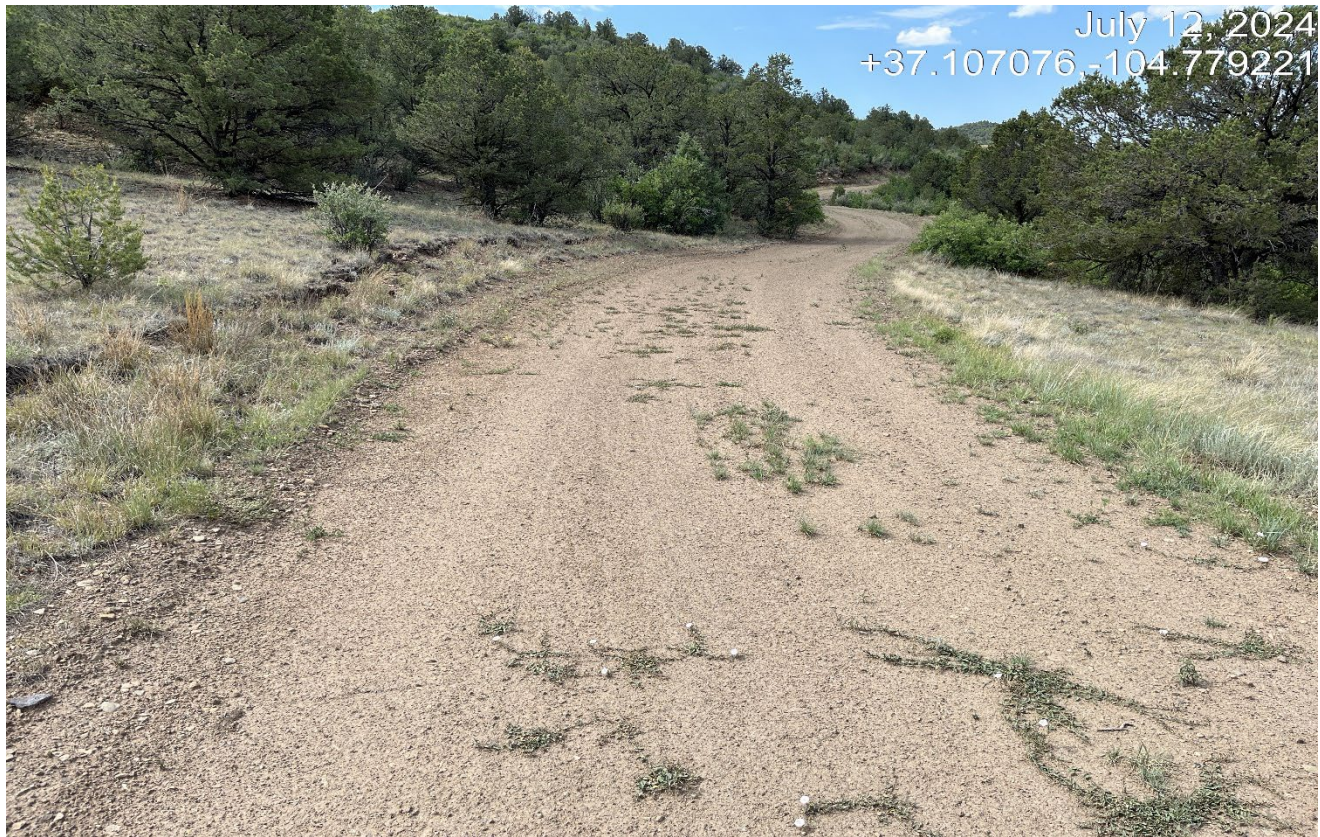
**Photo 3.** Further along the road back to the south traveling to the location.

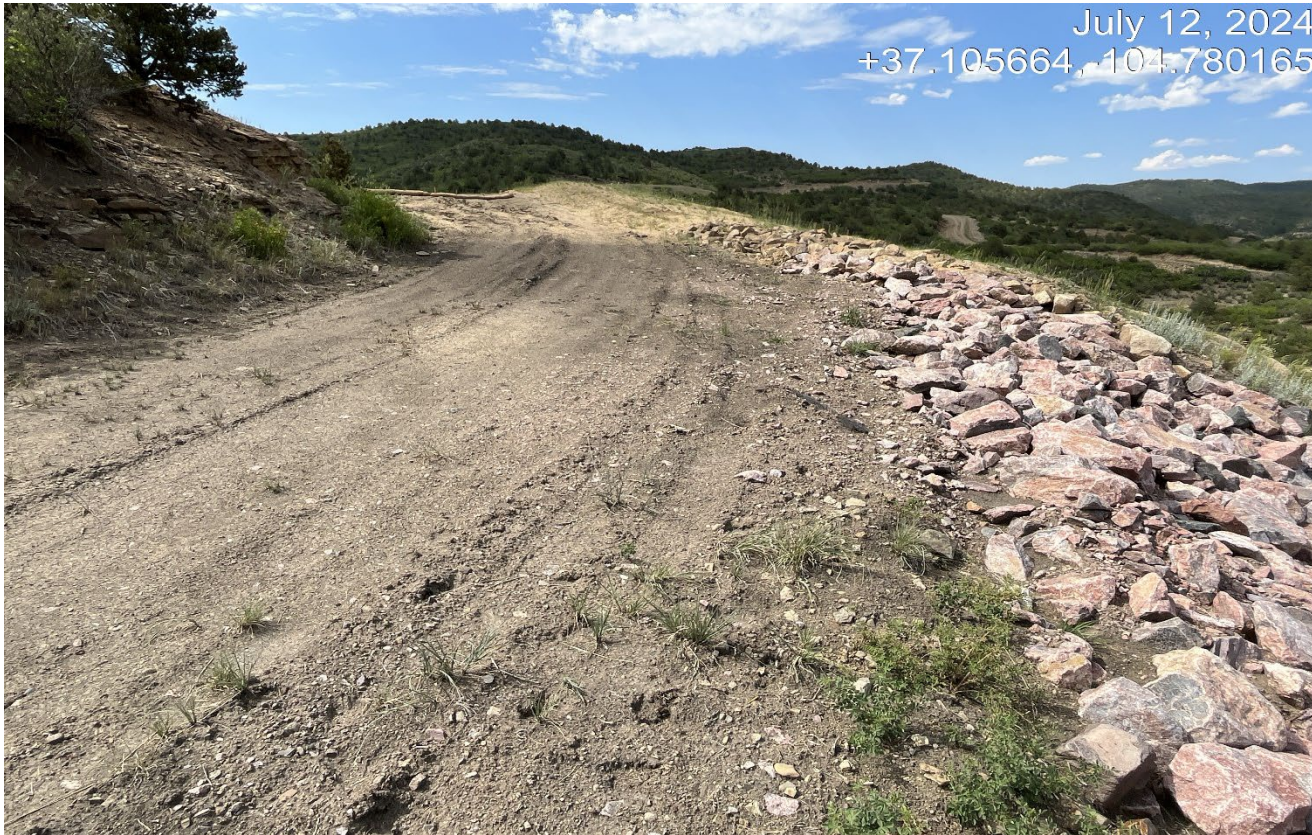
**Photo 4.** Facing southeast near the location. This area has rock rip along the road side.

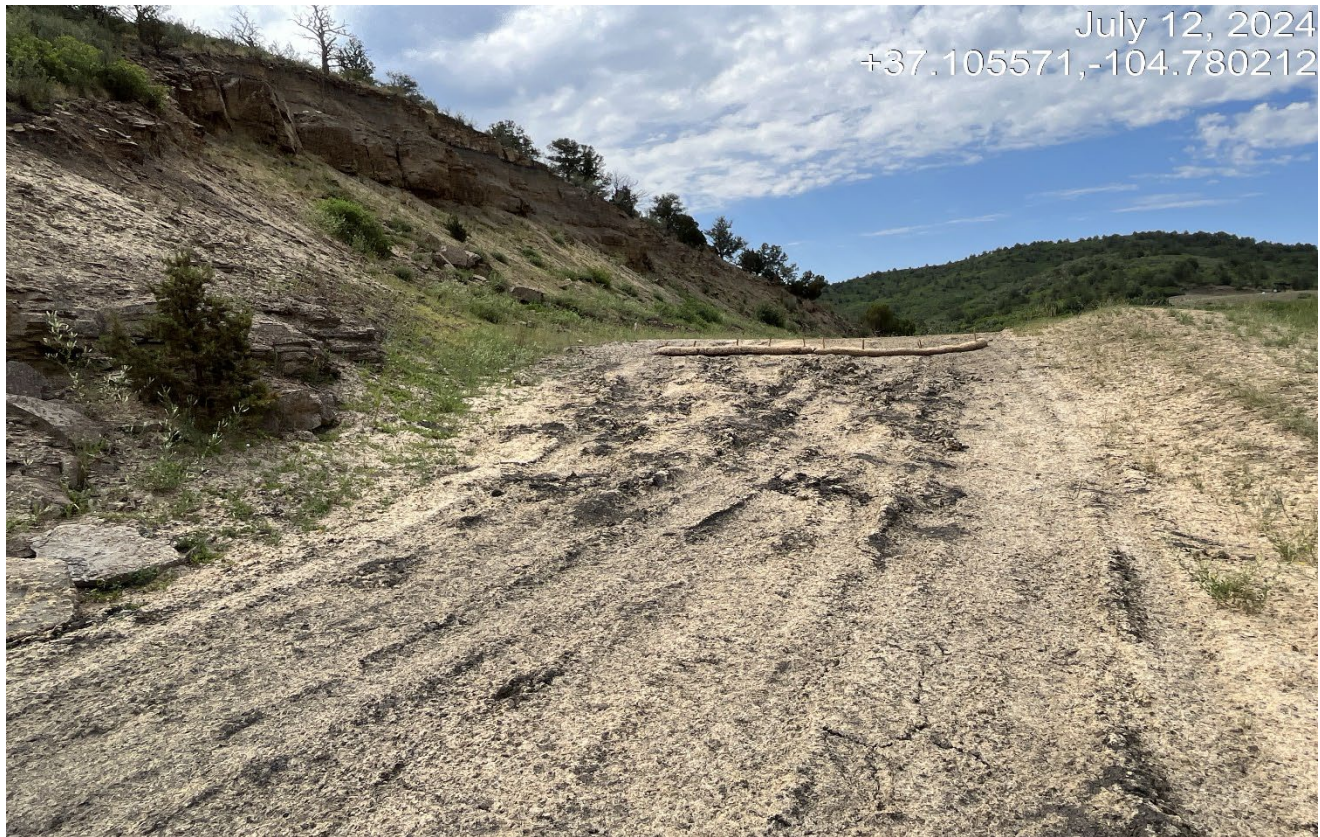
**Photo 5.** Facing southeast at the well pad location.

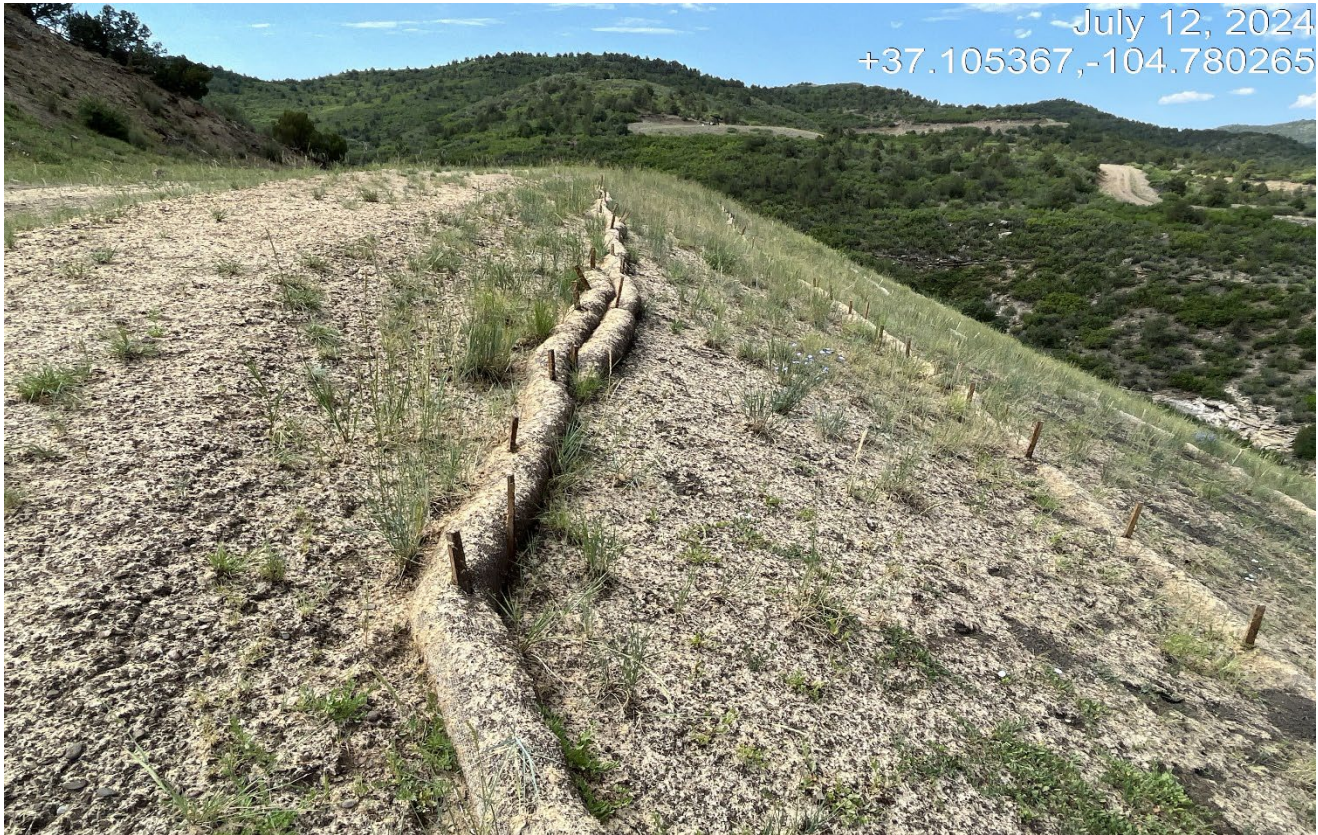
**Photo 6.** Facing toward the fill slope of the location. There has been additional work performed for stormwater control. The wattles have been replaced and hydromulch was applied.

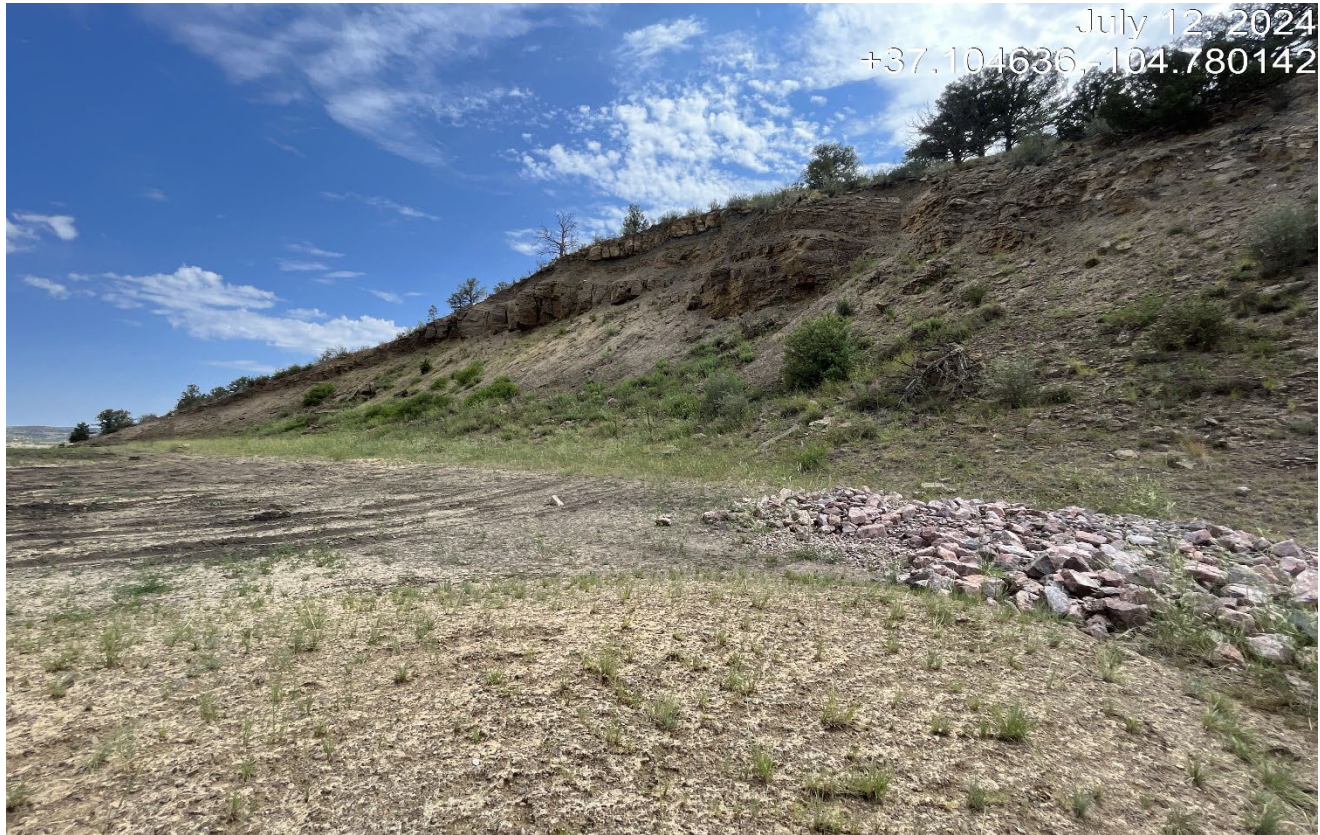
**Photo 7.** Facing northeast toward the cut slope.

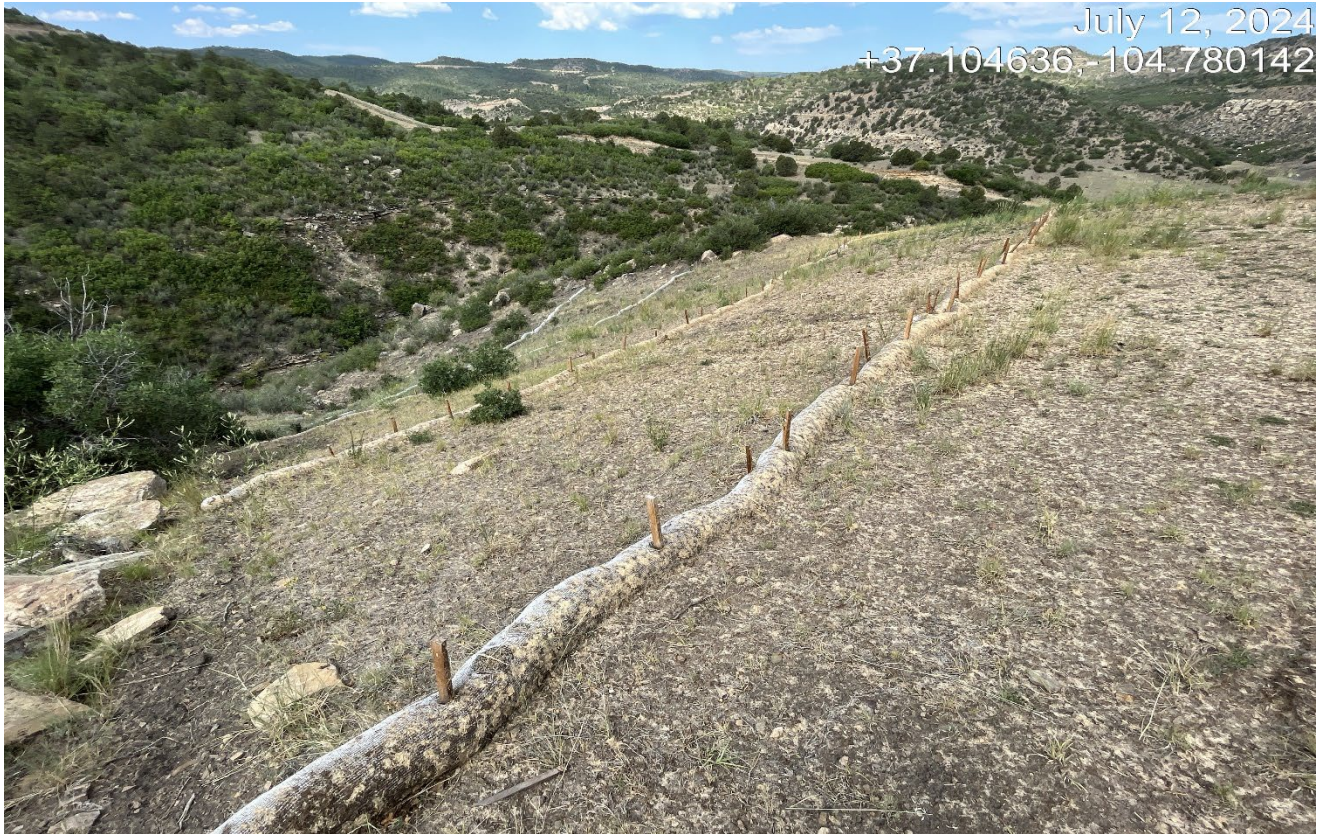
**Photo 8. Facing toward the south side of the location.** There has been additional work performed for stormwater control. The wattles have been replaced and hydromulch was applied.

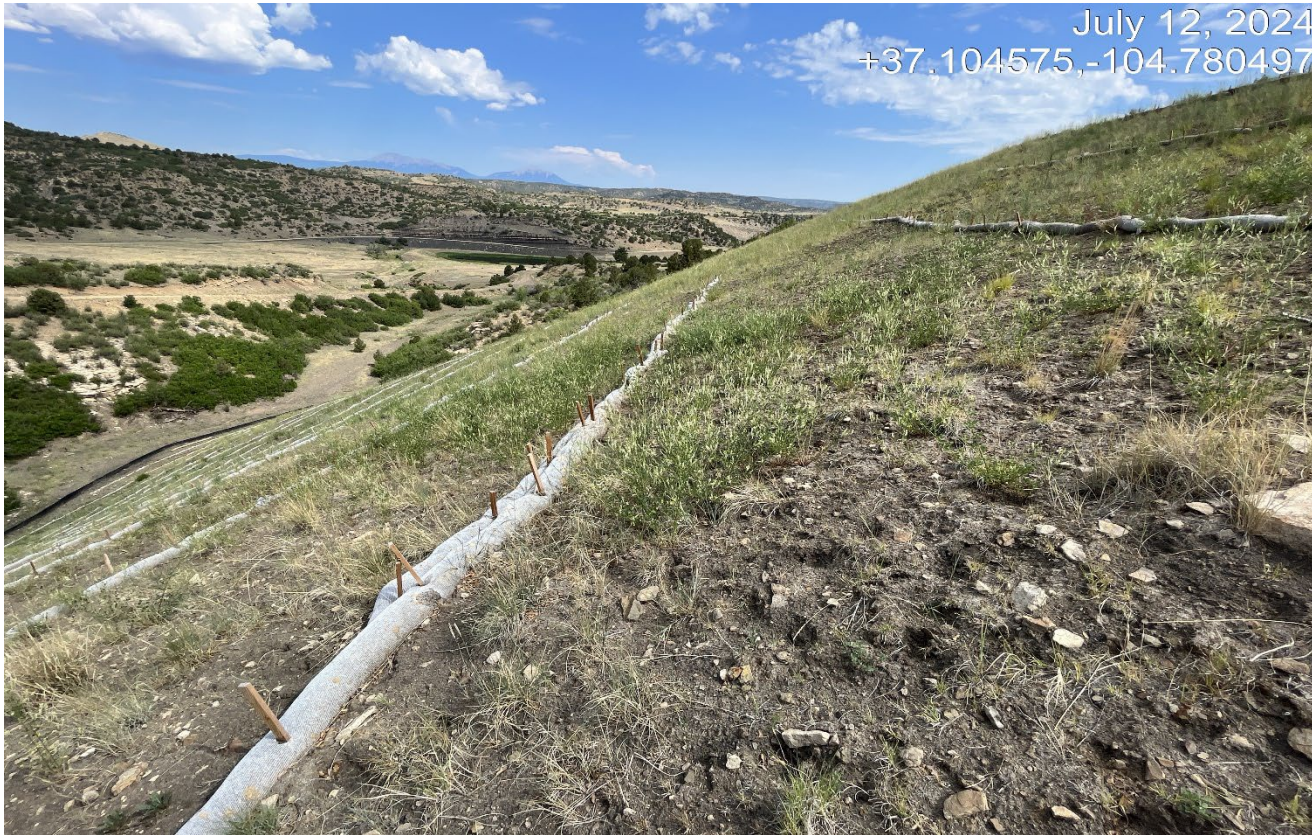
**Photo 9.** Facing north along the fill slope of the location. There are filter wattles installed along the slope.

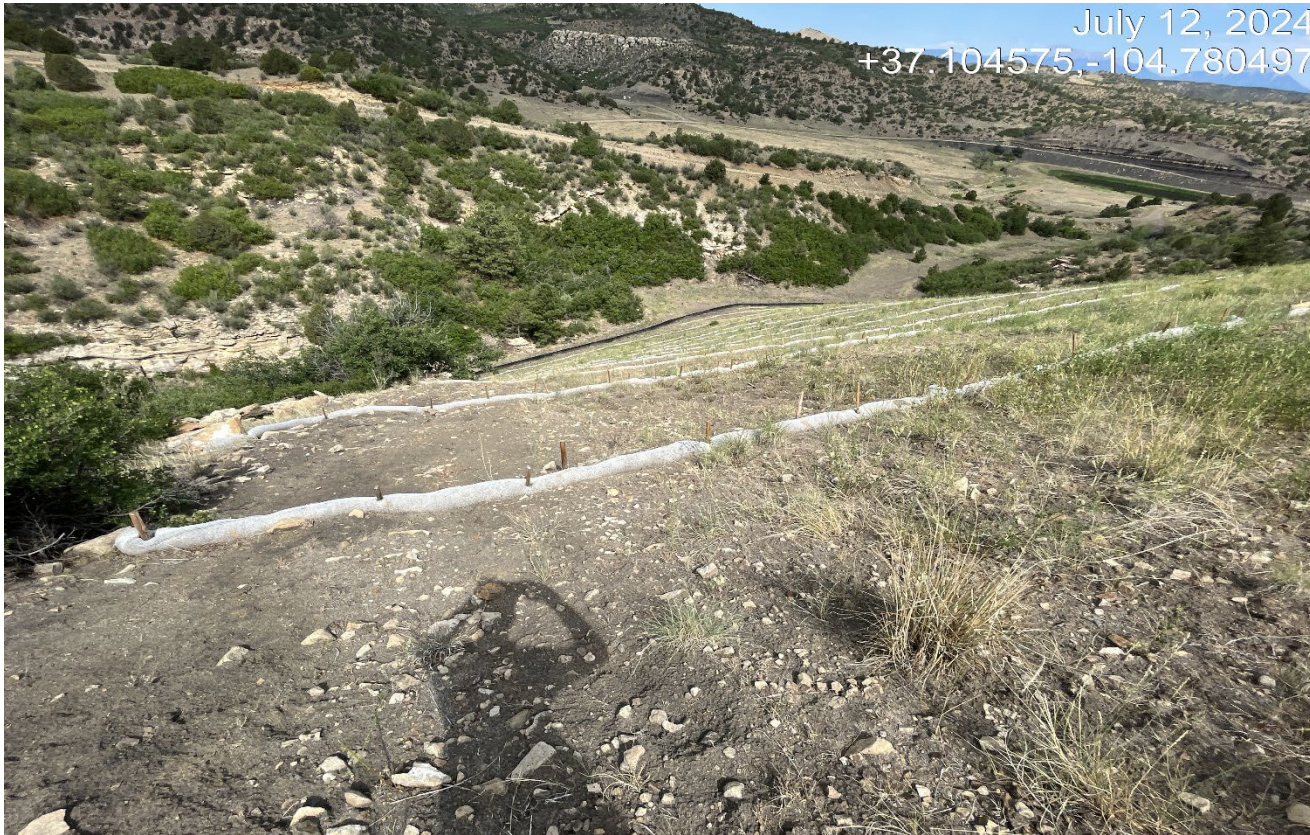
**Photo 10.** Facing down the fill slope to the west.

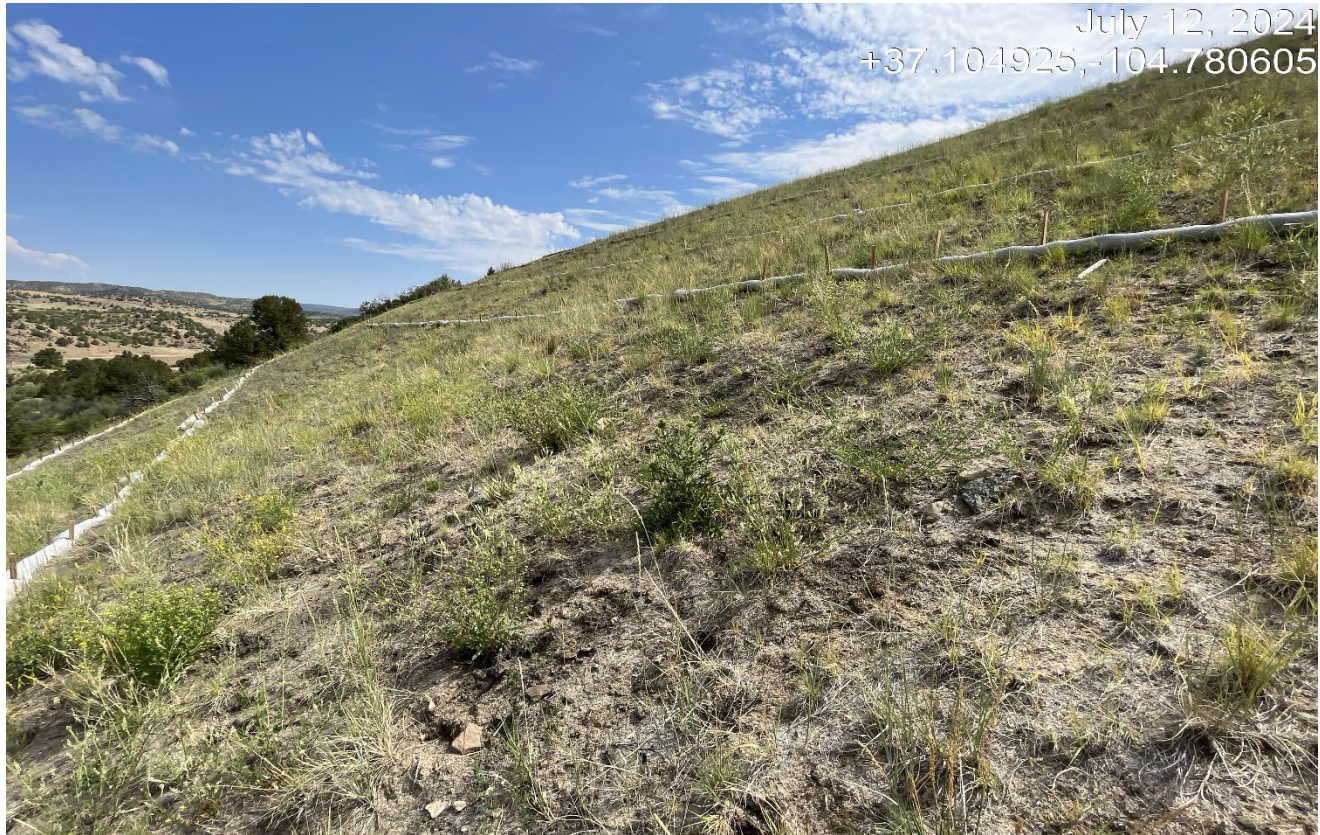
**Photo 11.** Center of the fill slope north.

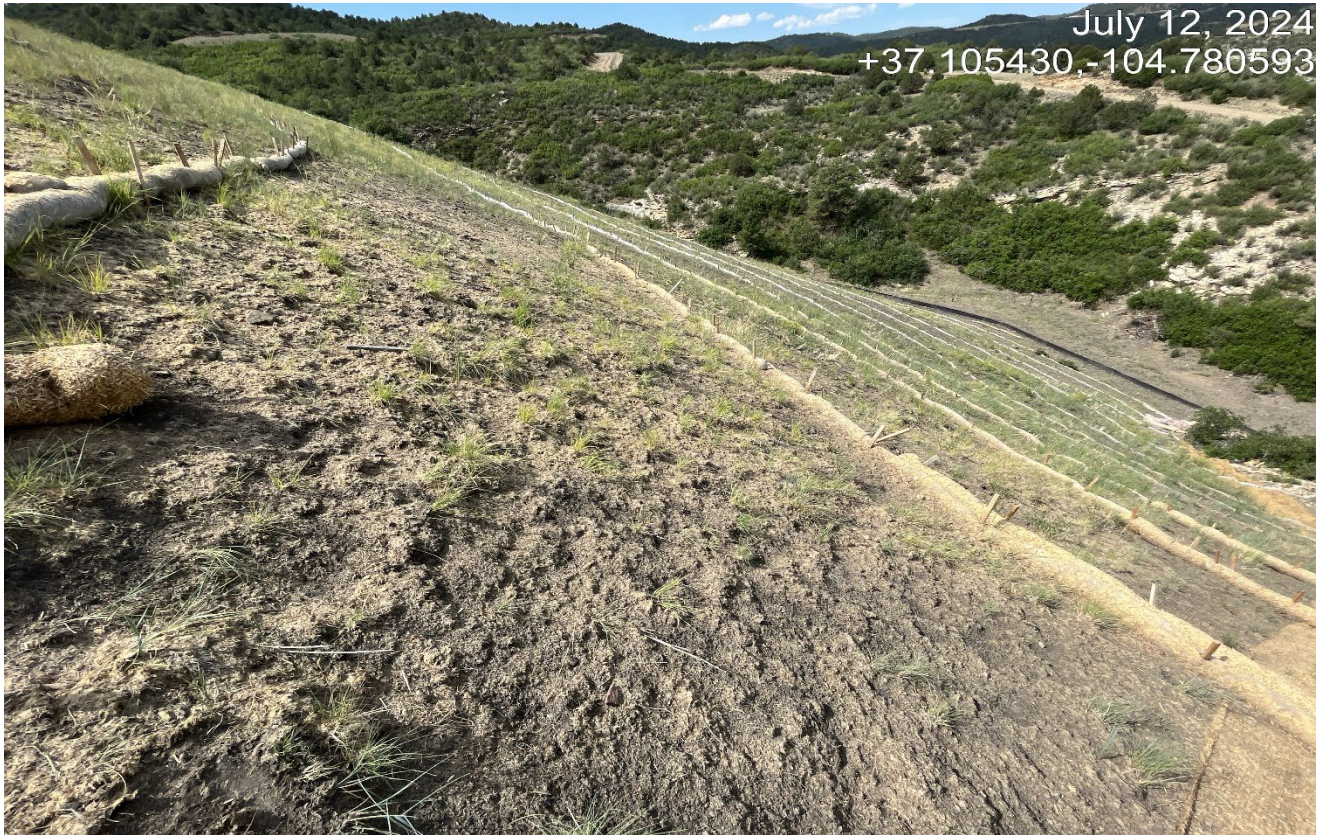
**Photo 12.** North side of the fill slope facing down to the southwest..

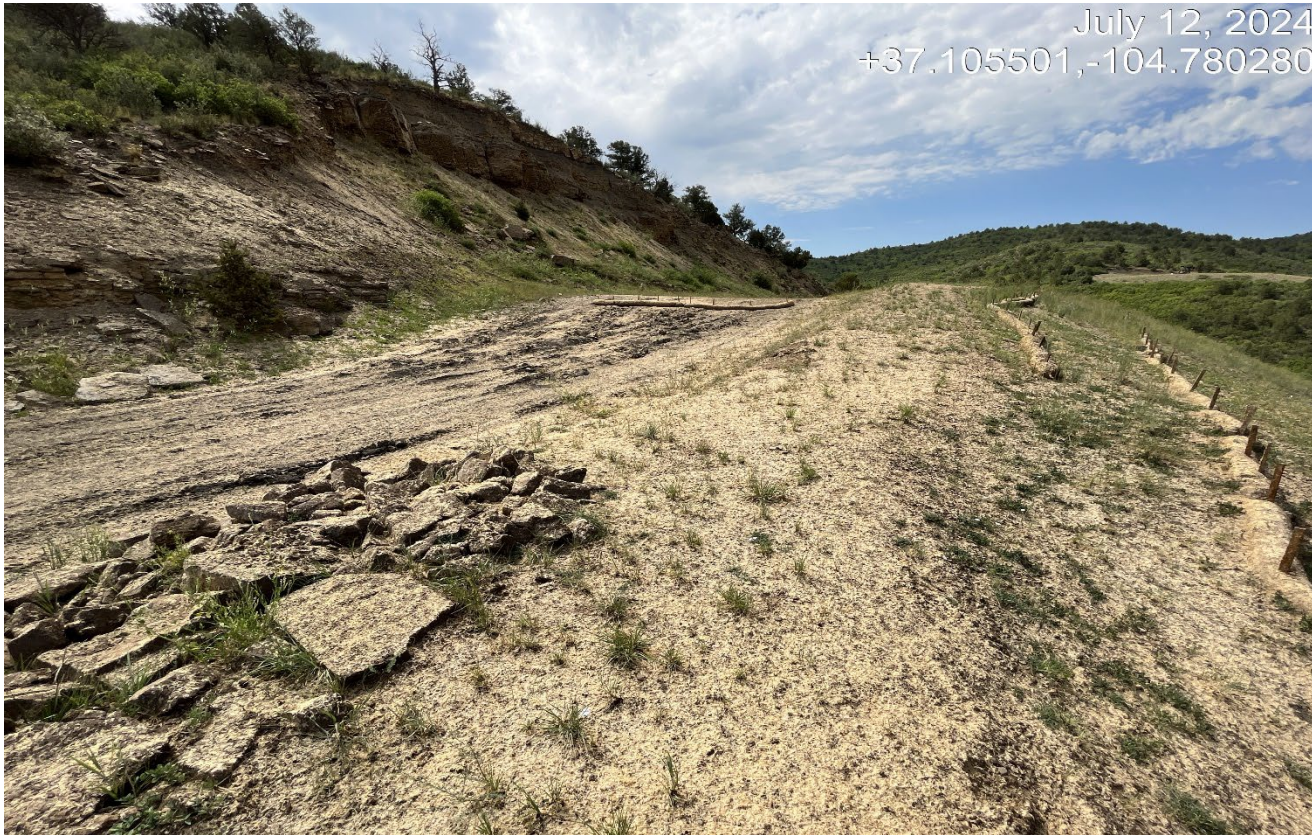
**Photo 13.** North side of the location facing south.

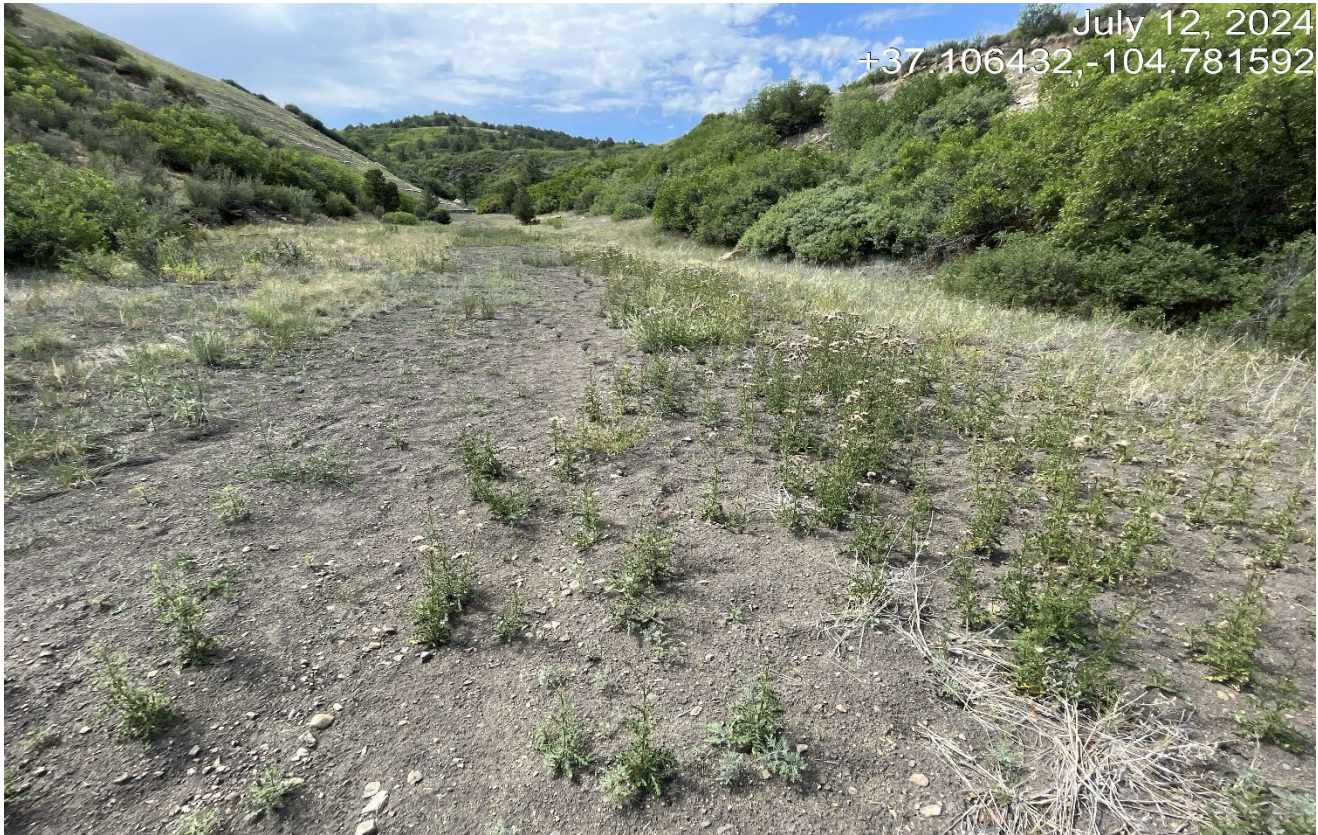
**Photo 14.** Facing south along the canyon drainage used to access the location bottom. There are noxious weeds (Canada thistle) that need to be controlled.

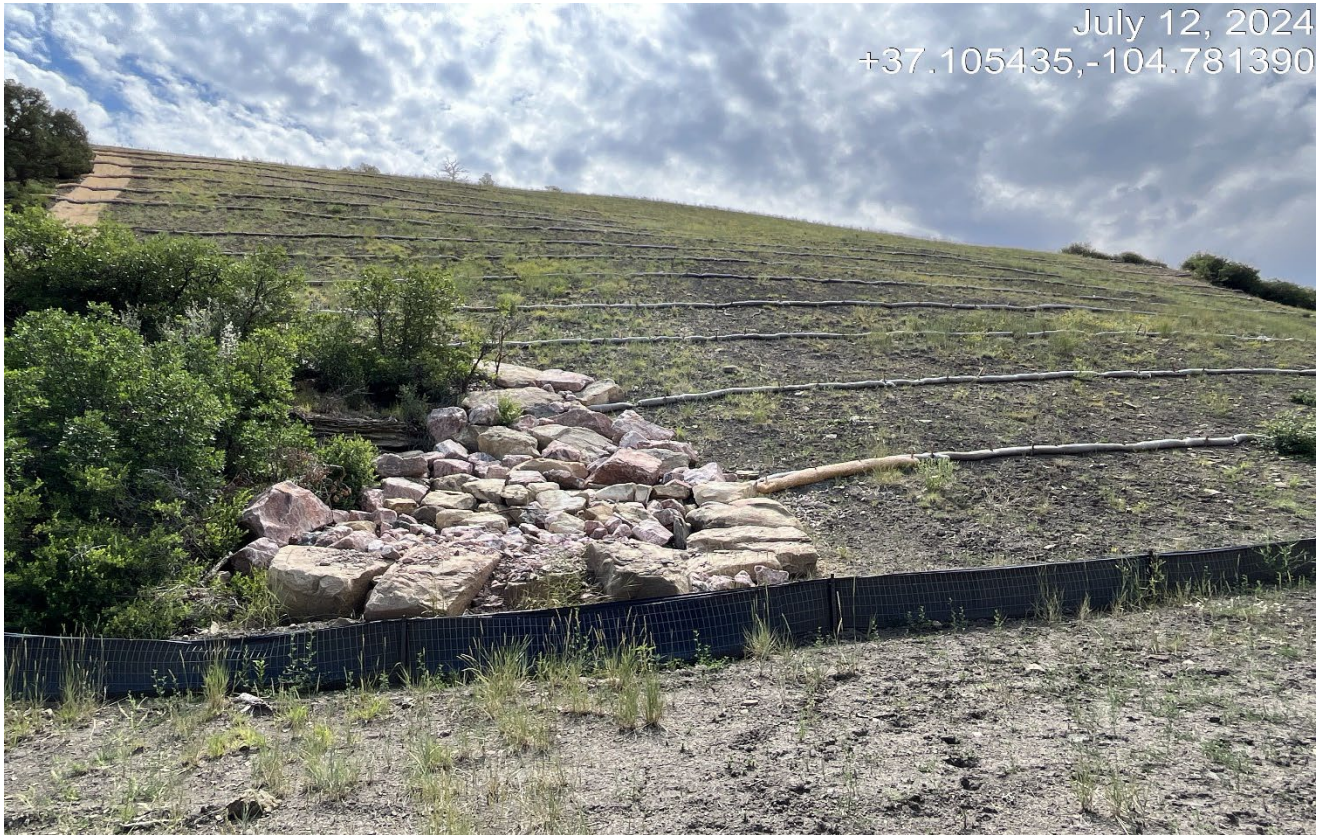
**Photo 15.** Facing east at the bottom of the slope of the well pad.

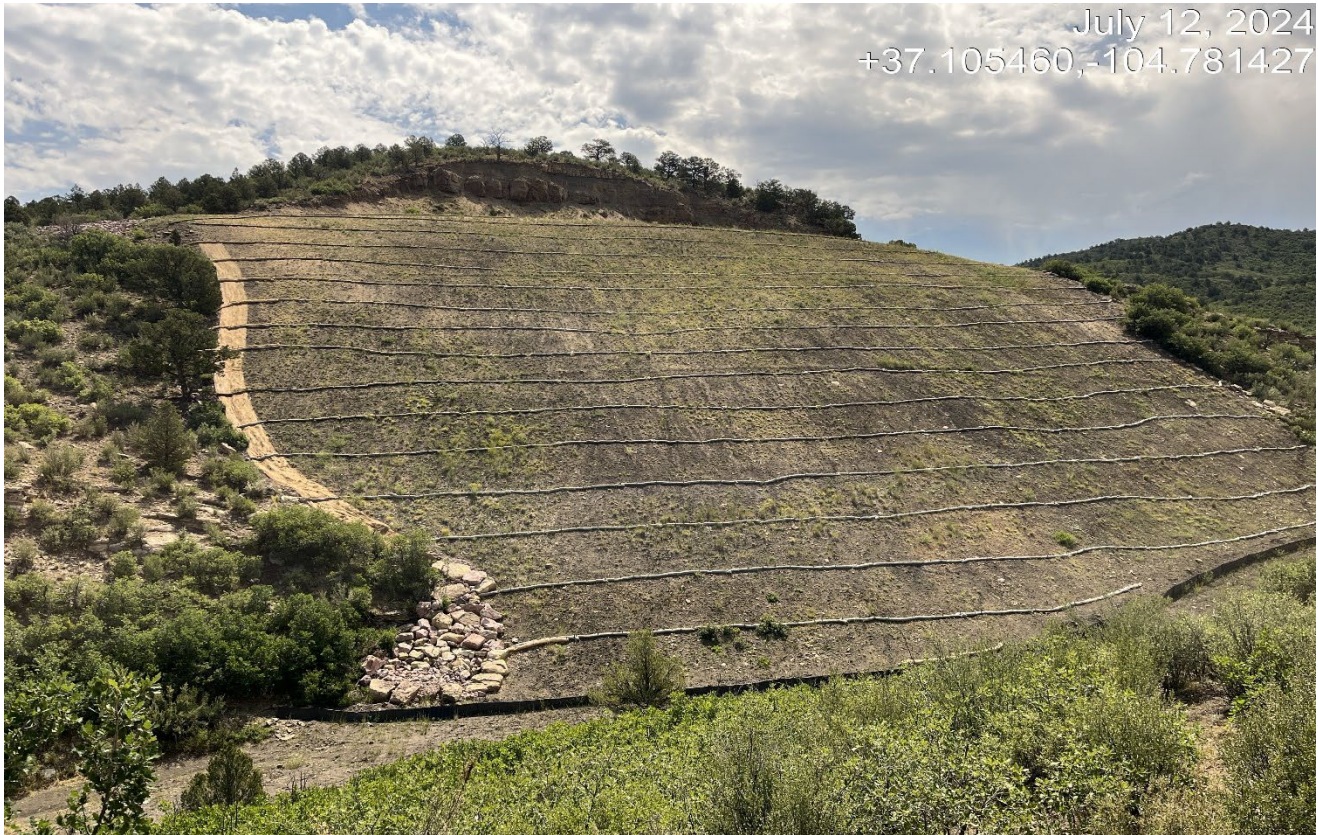
**Photo 16.** Facing east toward the location standing across the canyon.
