## Inspection Photos

Location Name: MUSTANG RESOURCES LLC MEAD 23-44-6S-94W Pad

Location ID: 323783

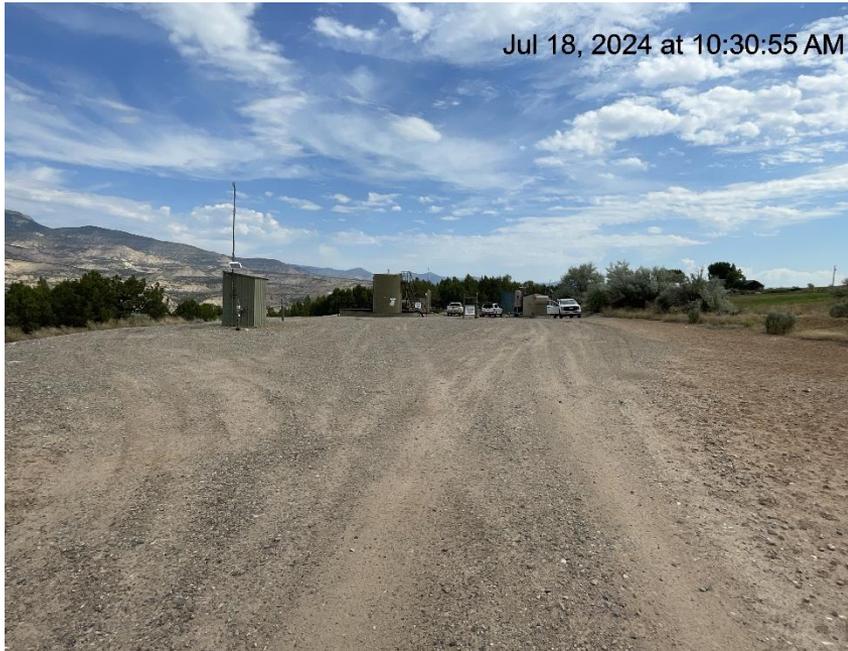
Photo # 2906 From entrance to location

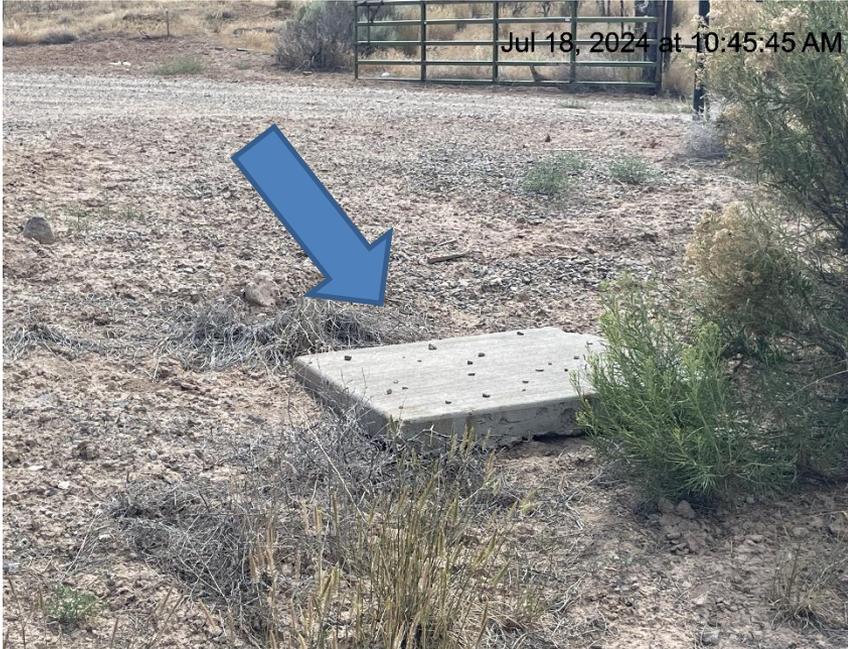
Photo # 2916 Debris
