Inspection Photos

Operator: ANSCHUTZ EXPLORATION CORP -
3104

Location ID: 430927

Inspection Doc: 696205993

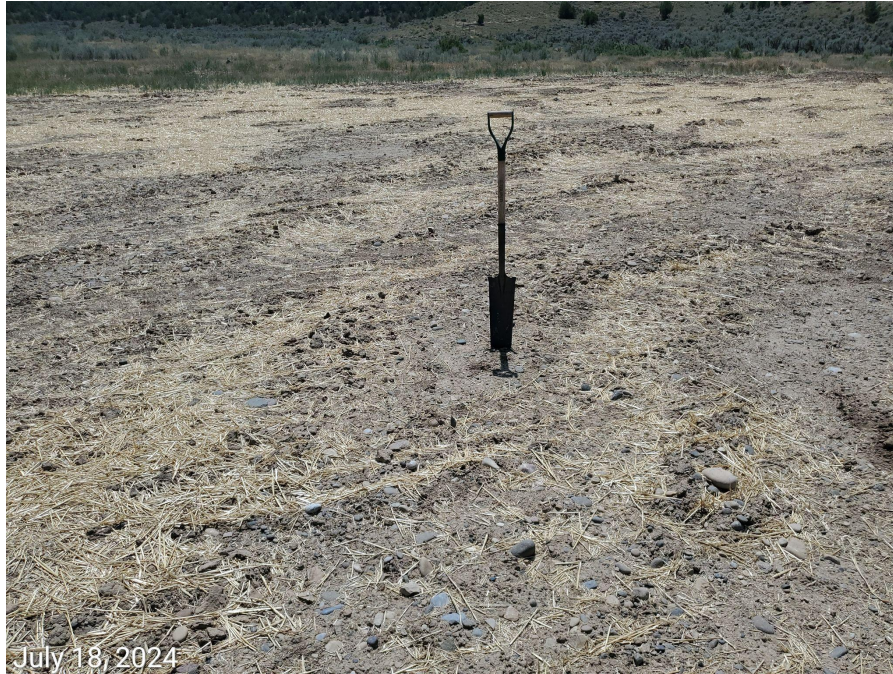
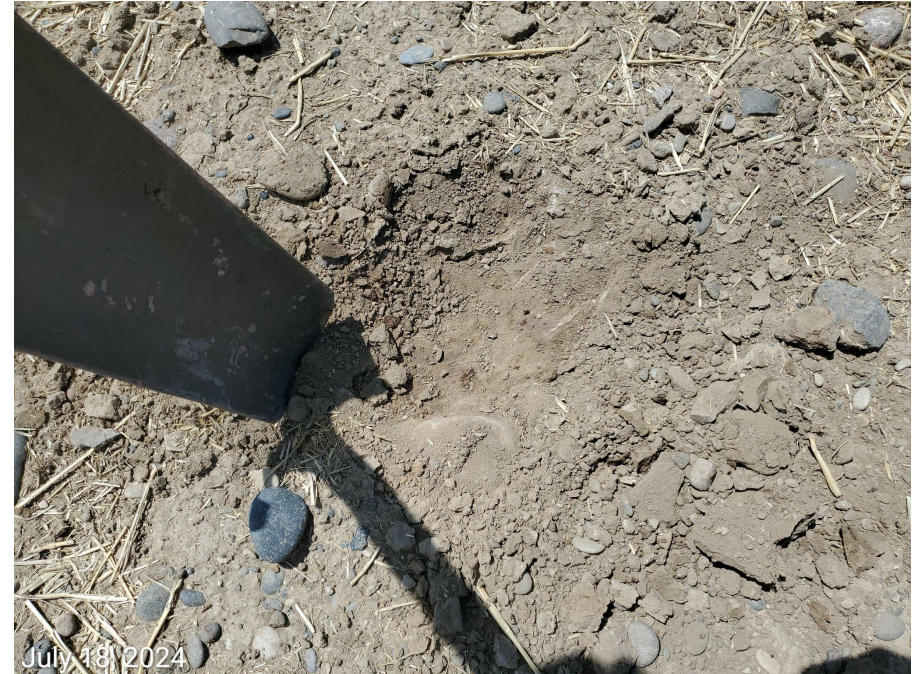
Photo 1: Photos taken from the interim areas on the south end of the Location. Photos examples showing compaction issues remain apparent; compaction alleviation (cross-ripping to a minimum of 18") has not been performed.

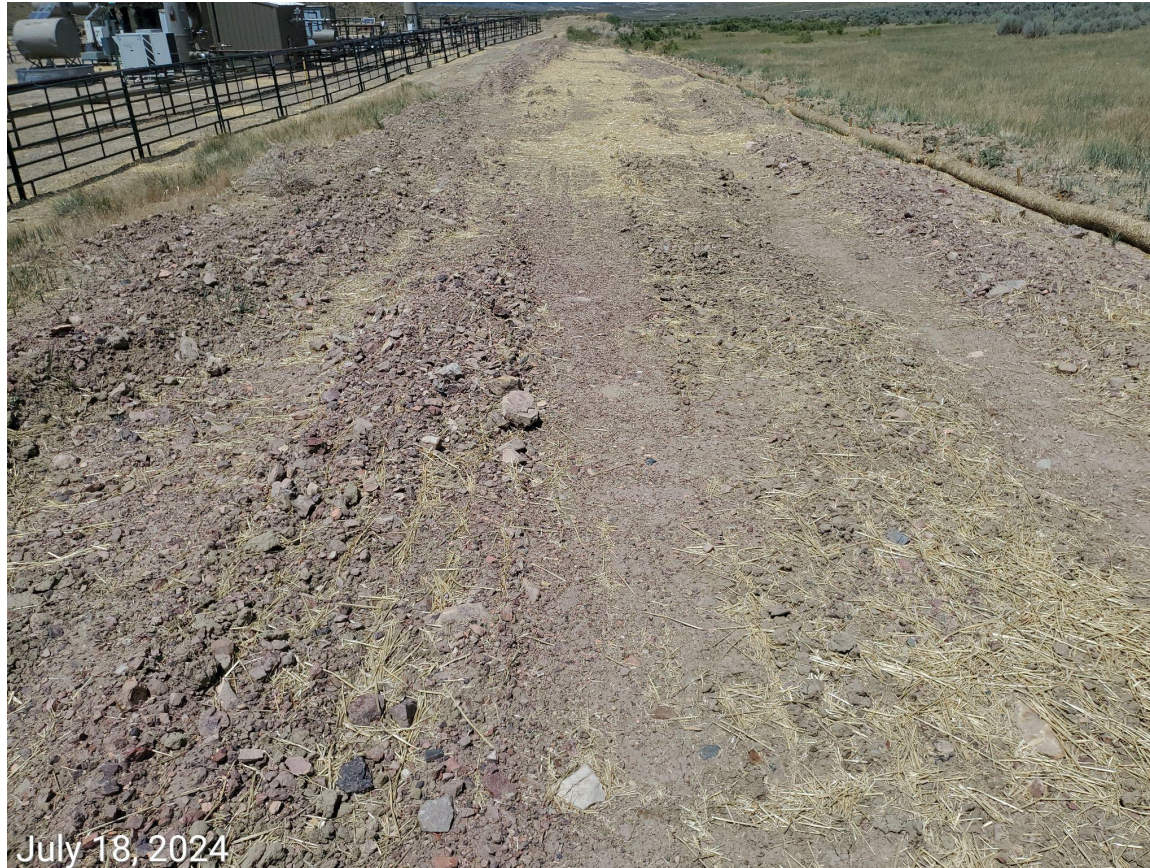
Photo 2: Photo taken from the access road on the east end of the Location. See comments under photo 1.

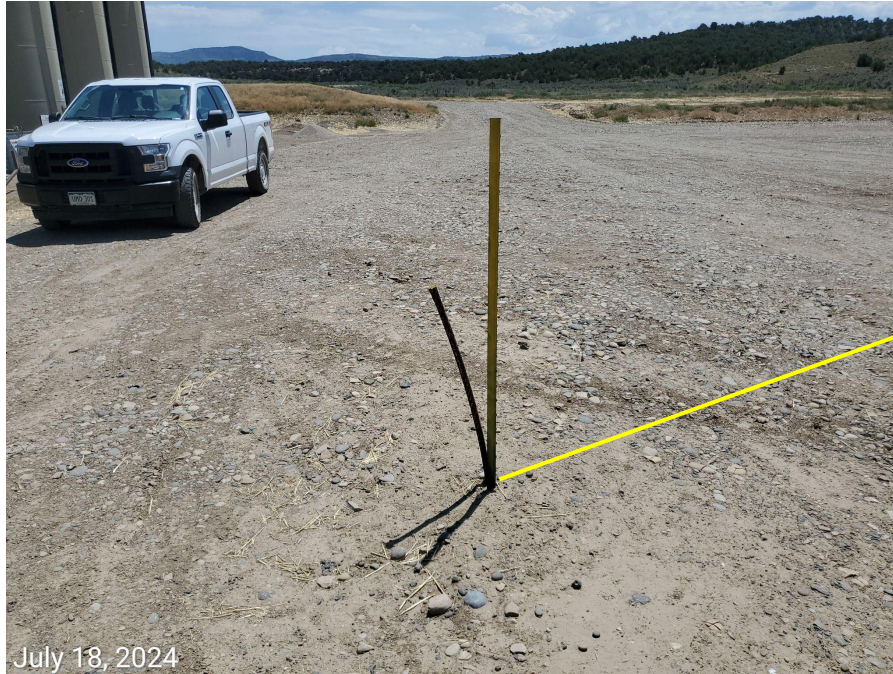
Photo 3: Photo left shows anchor on the northeast end of the Location- anchor has been marked. Photo right shows areas of the southeastern anchor; anchor appears to have been buried and has not been marked.

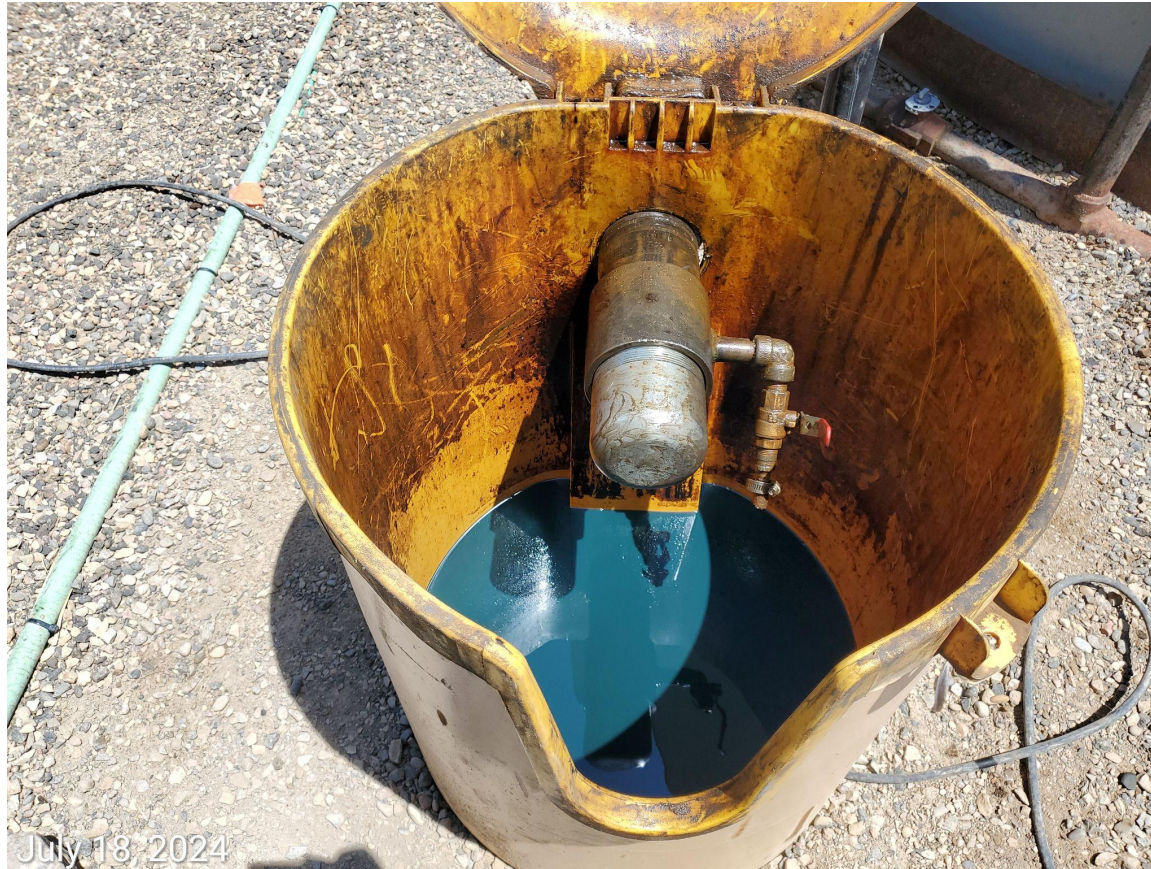
Photo 4: Fluids within honeypot.

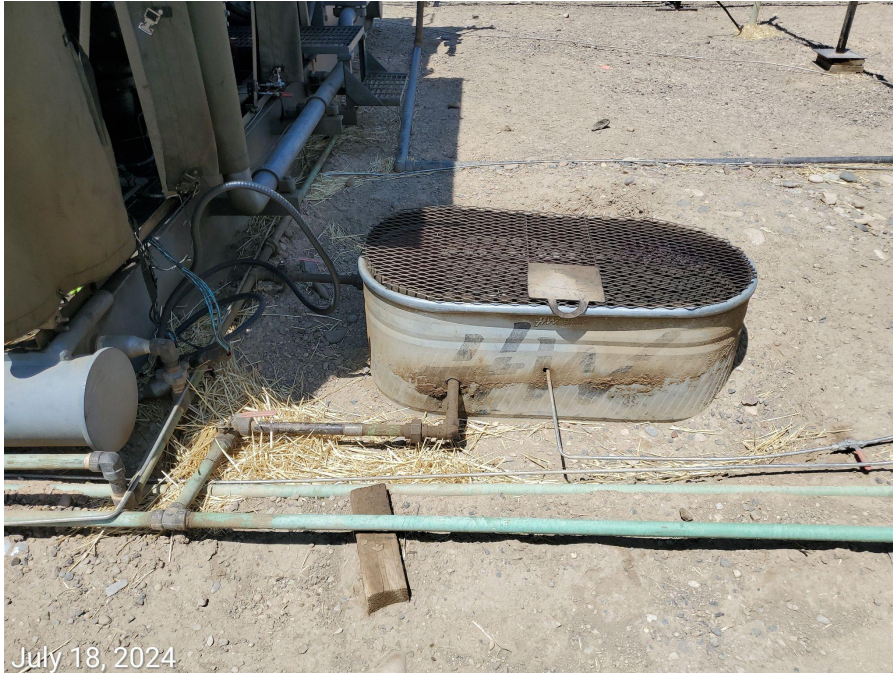
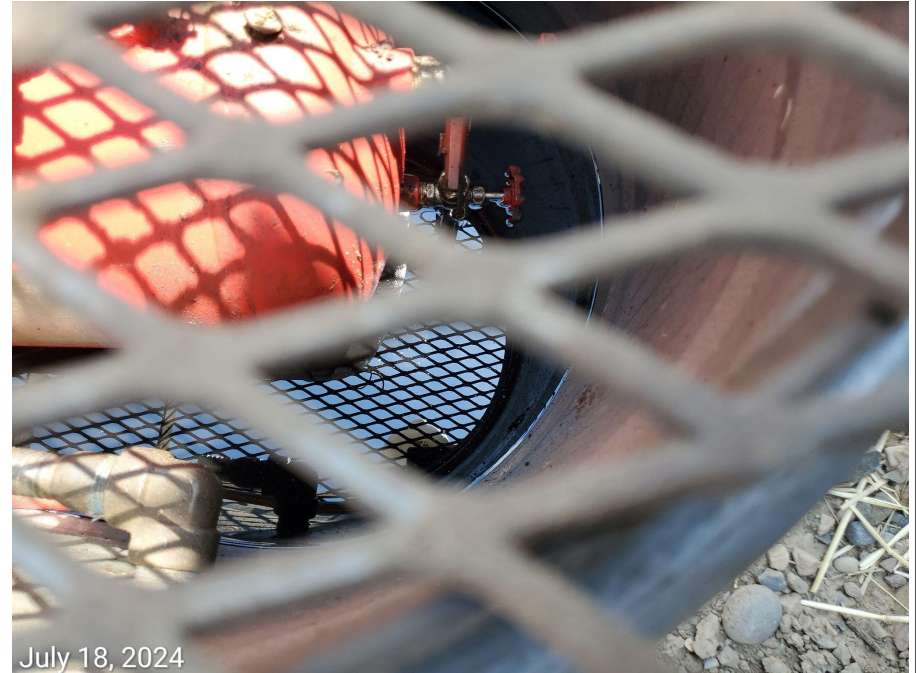
Photo 5: Photo shows secondary containment BMP remains inadequate to contain a spill or release. Photo right shows fluids have spilled within containment.

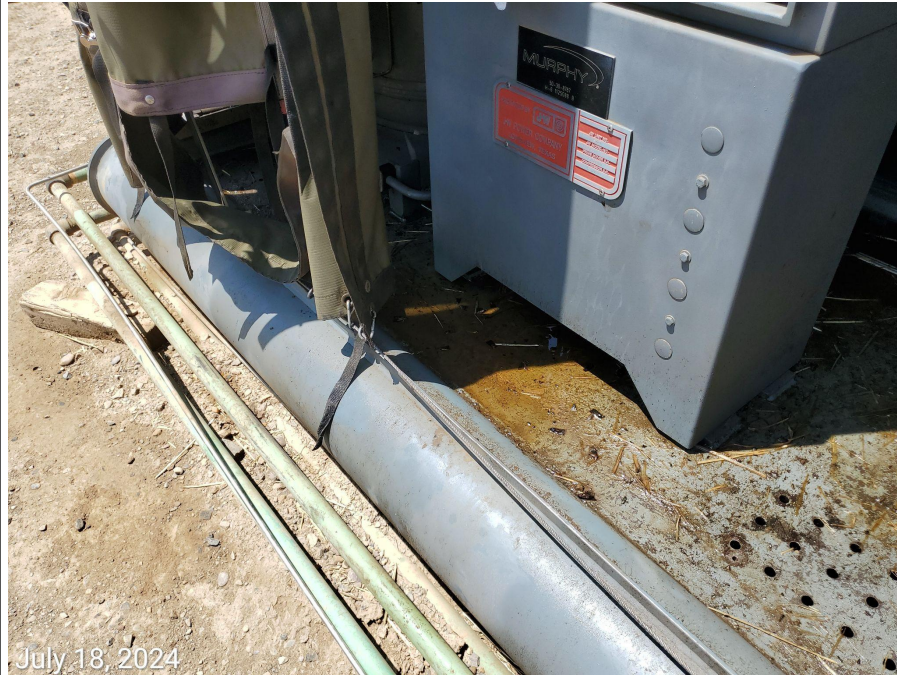
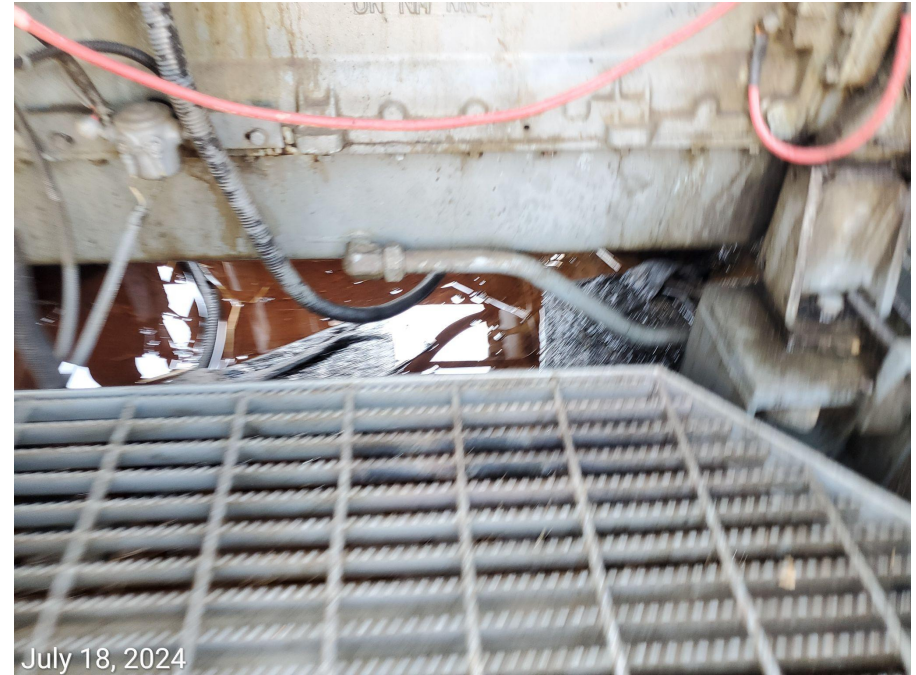
Photo 6: Photo shows fluids have spilled from the compressor equipment.

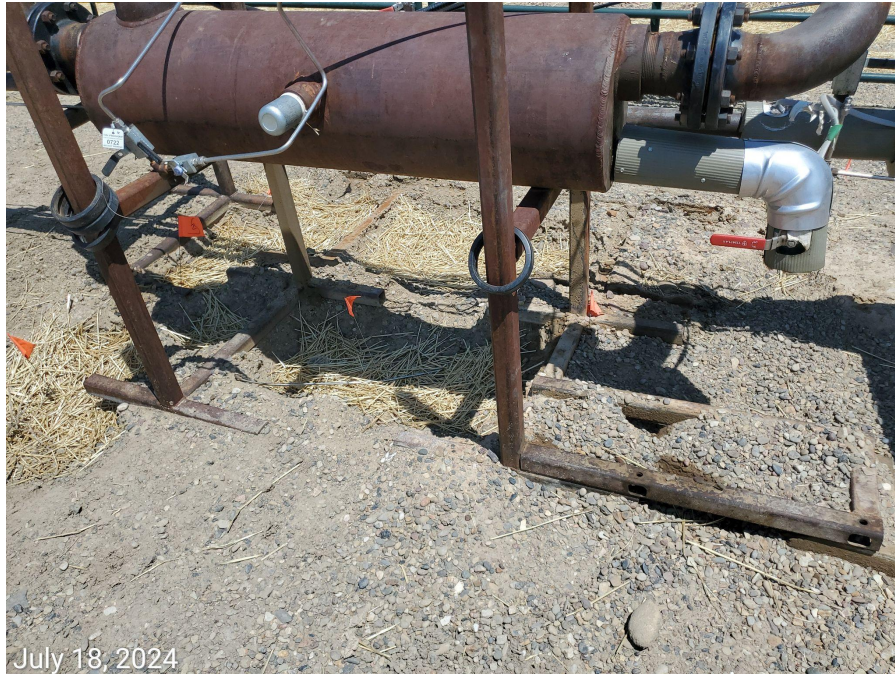
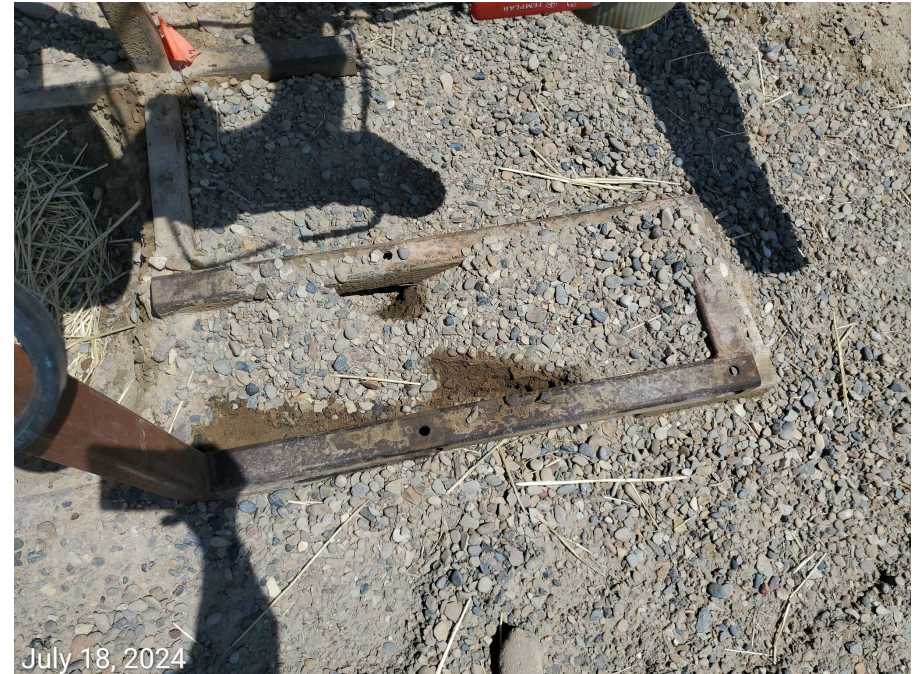
Photo 7: Spills on Location have not been cleaned.

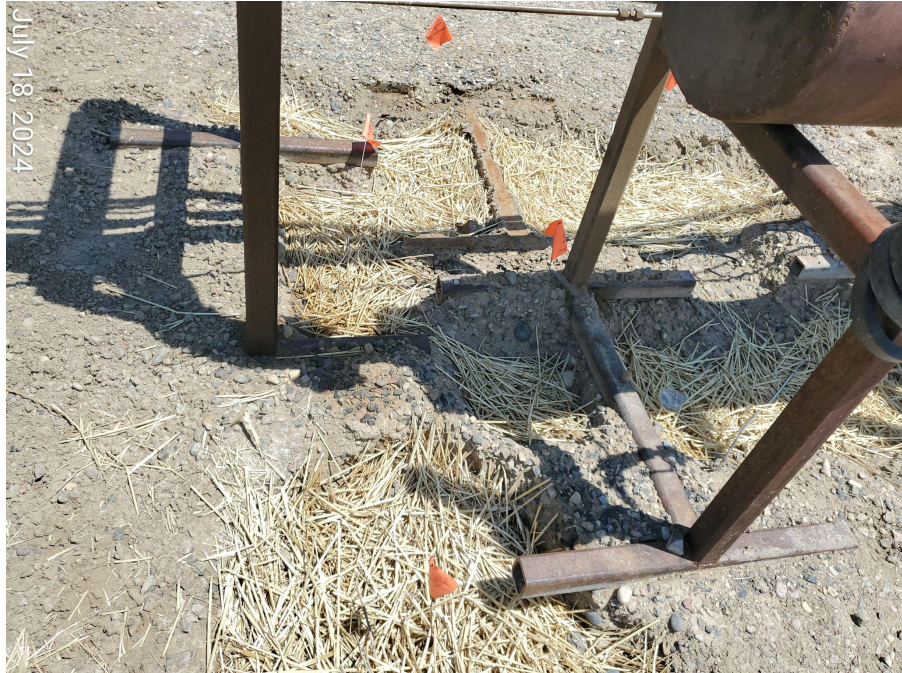
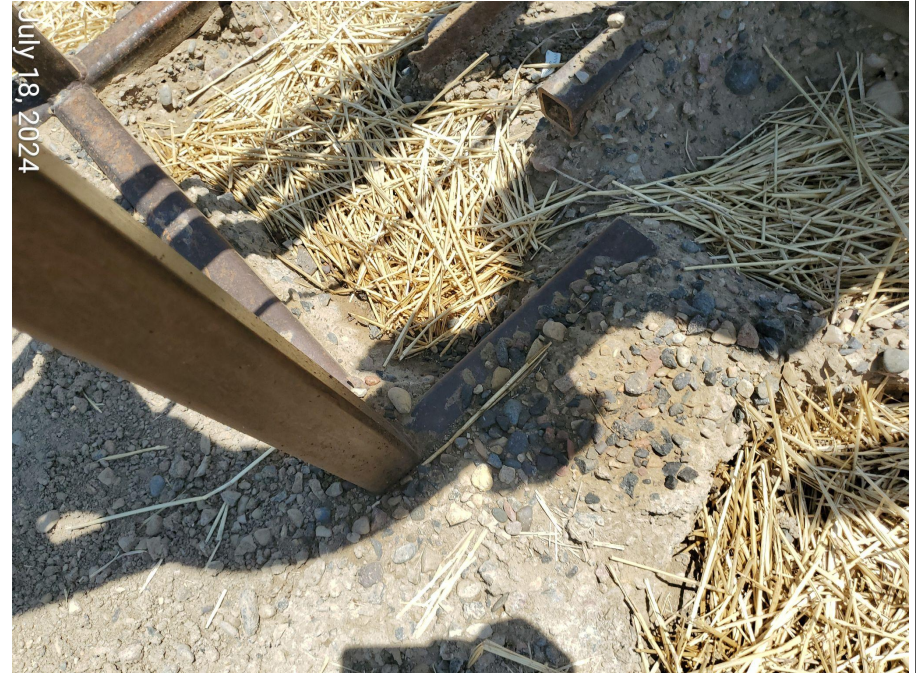
Photo 8: See comments under photo 7.

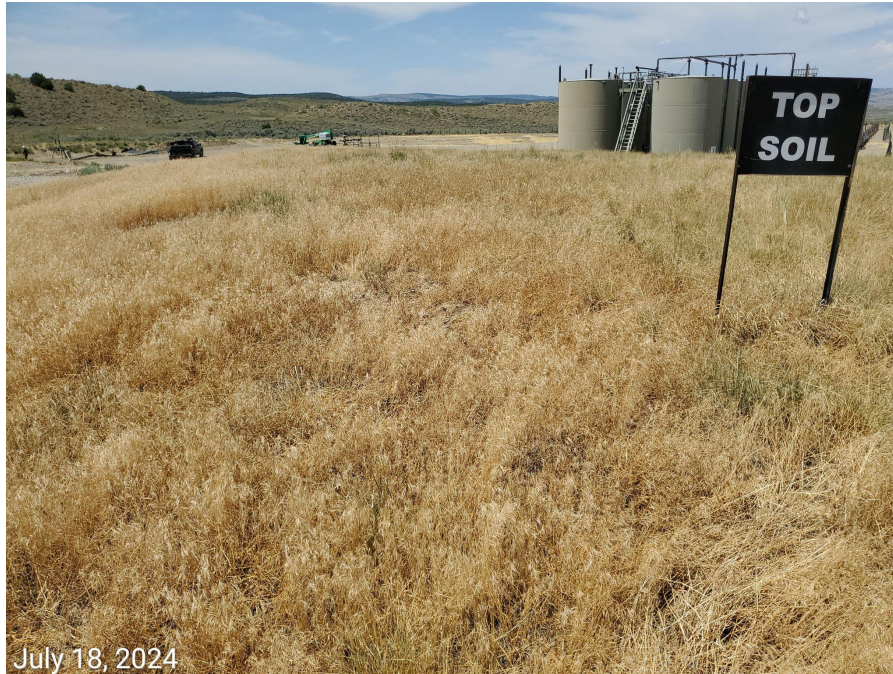
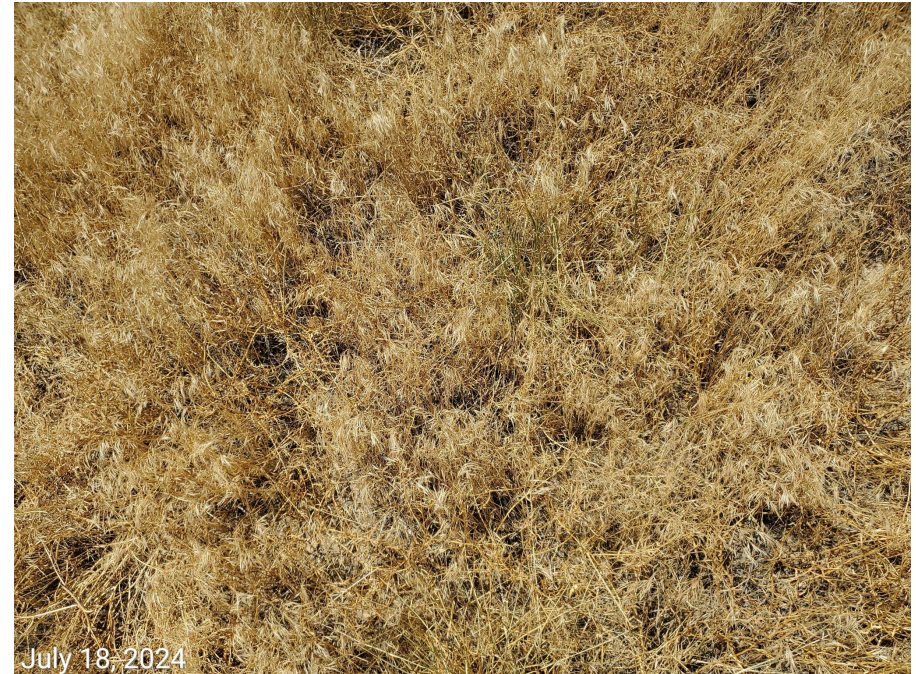
Photo 9: Photo taken from the topsoil stockpile. Stockpile is predominantly Undesirable Plant Species. Topsoil has also not been replaced during interim reclamation.
