Interim Reclamation and Stormwater Inspection

Operator: EXTRACTION OIL & GAS - 10459

Location ID: 440776

Inspection Photos
Location Name: Arellano 10-L Facility
Location ID: 440776

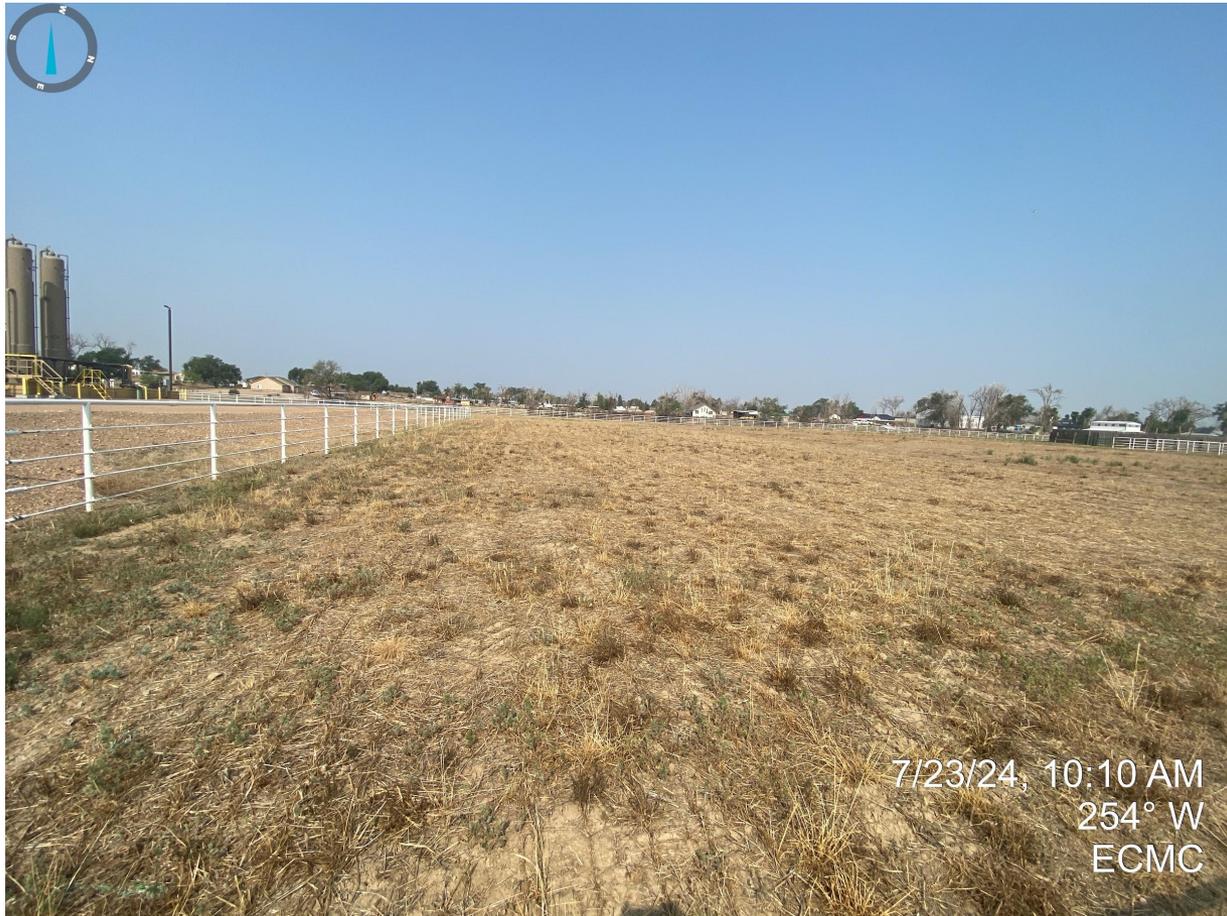
Photo 1. Northern interim areas appear to have been reclaimed with evidence of drill rows and crimped mulch.

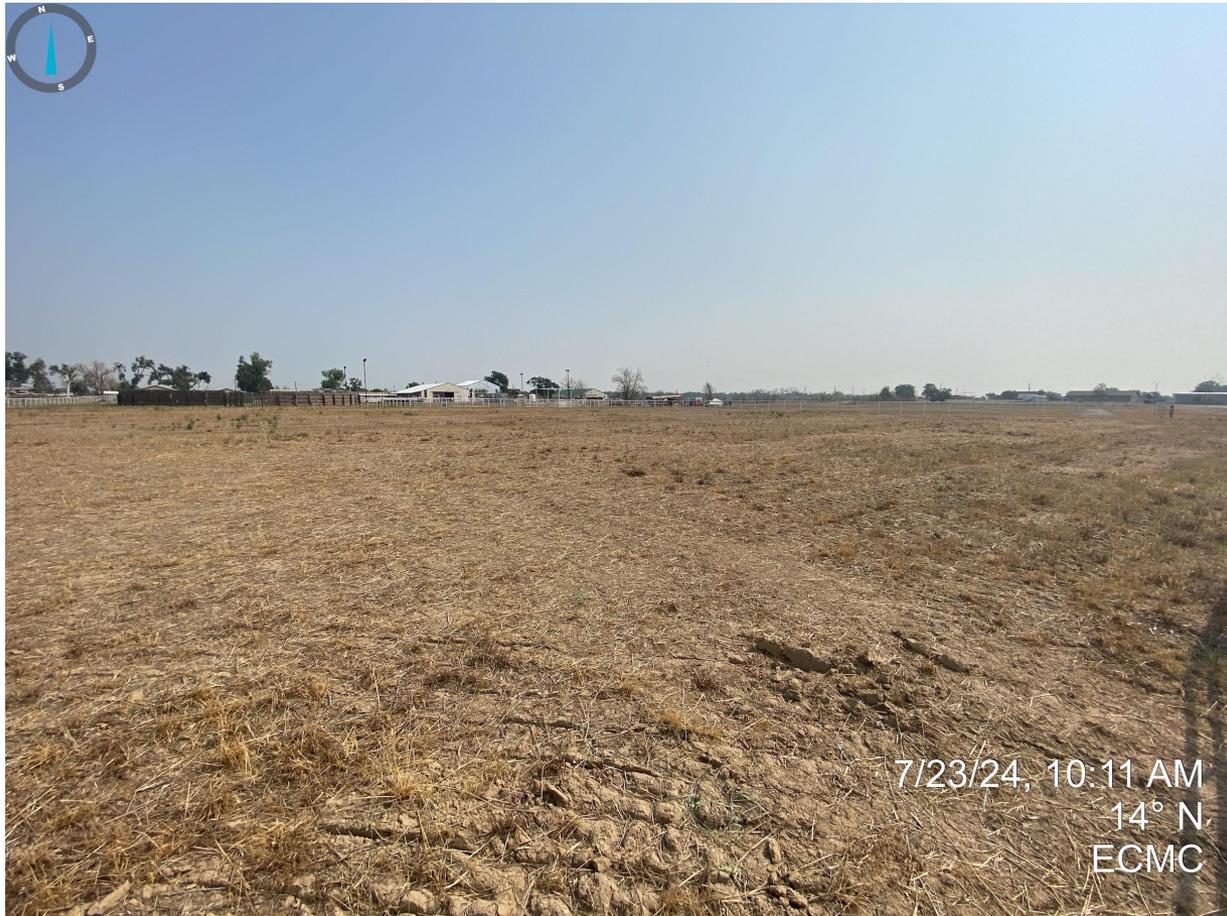
Photo 2. Northwest interim areas, facing north. See comments in Photo 1.

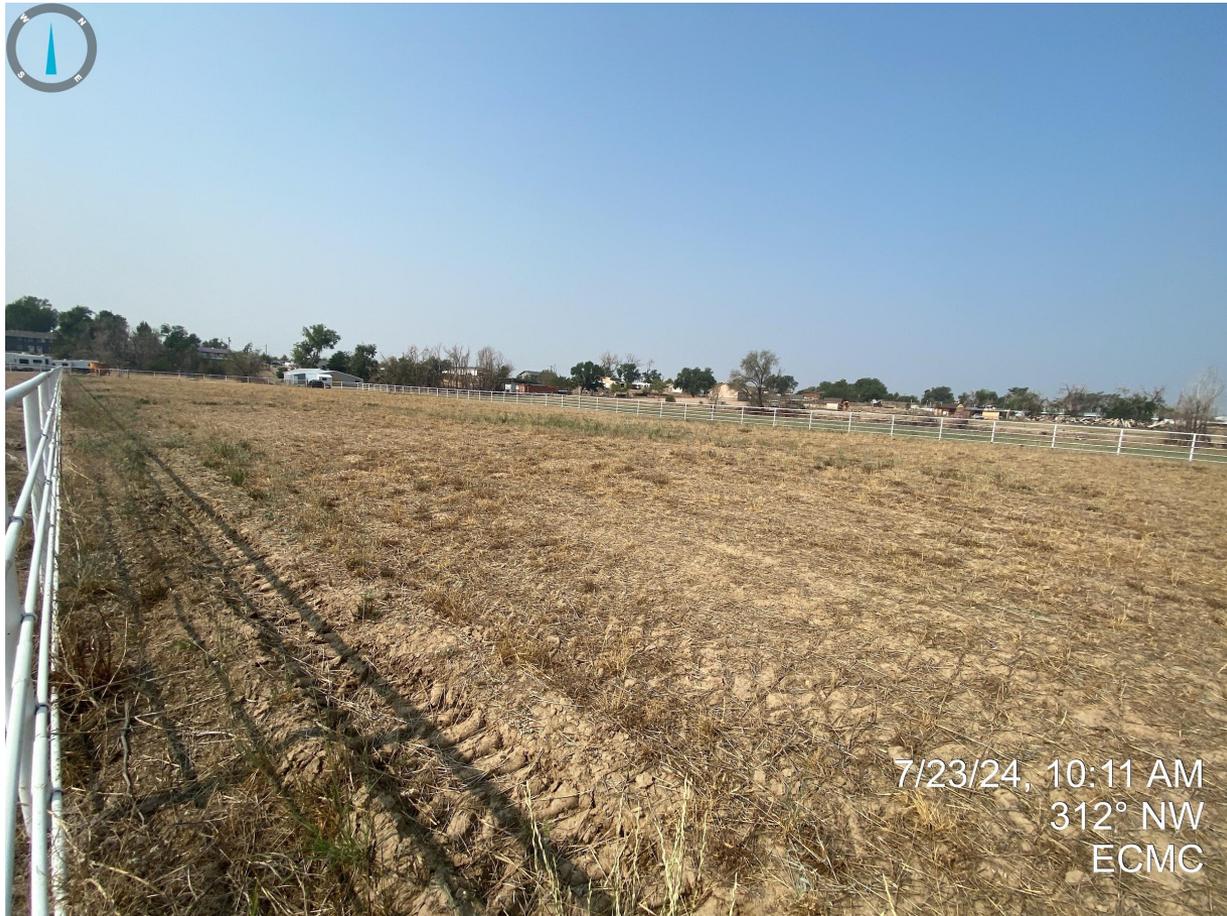
Photo 3. West interim areas, facing northwest. See comments in Photo 1.

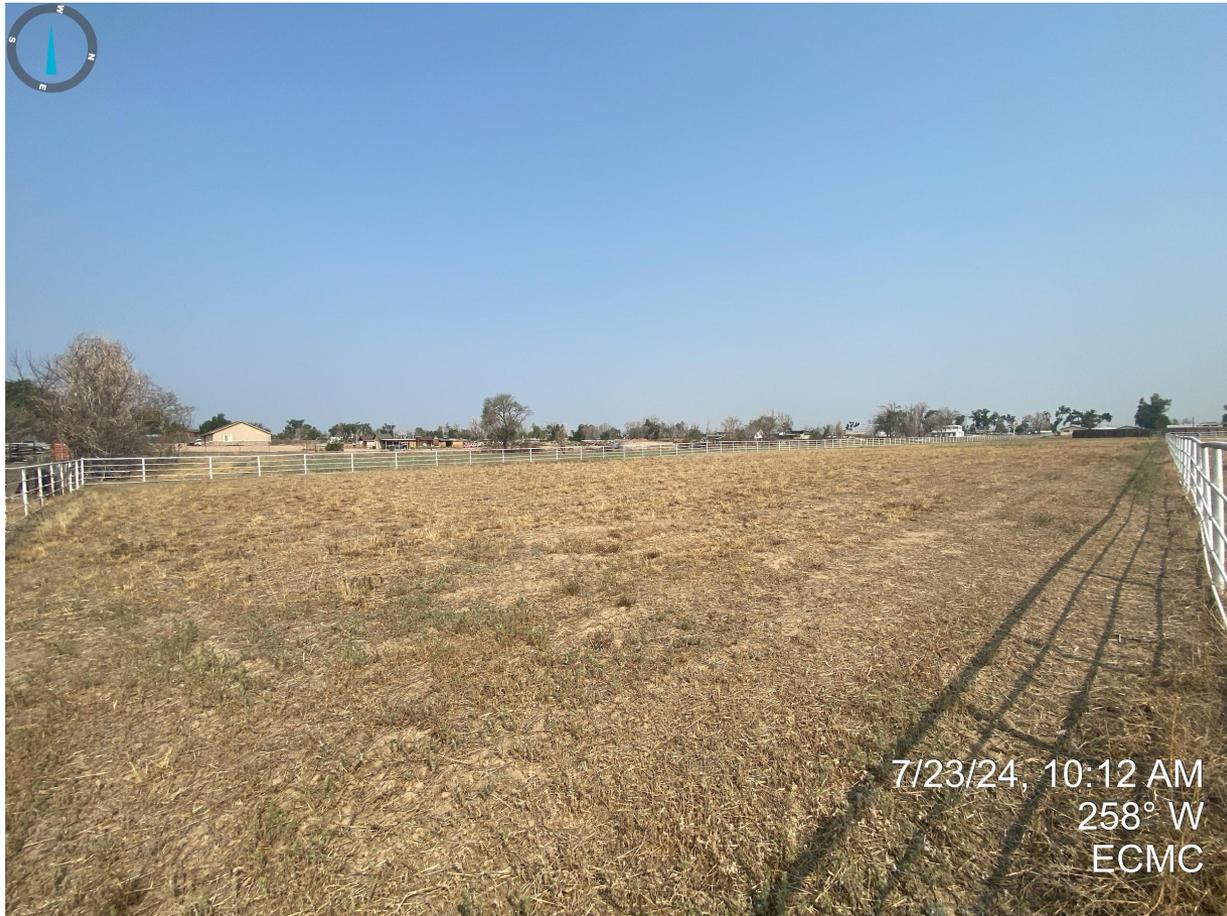
Photo 4. Southwest interim areas, facing west. See comments in Photo 1.

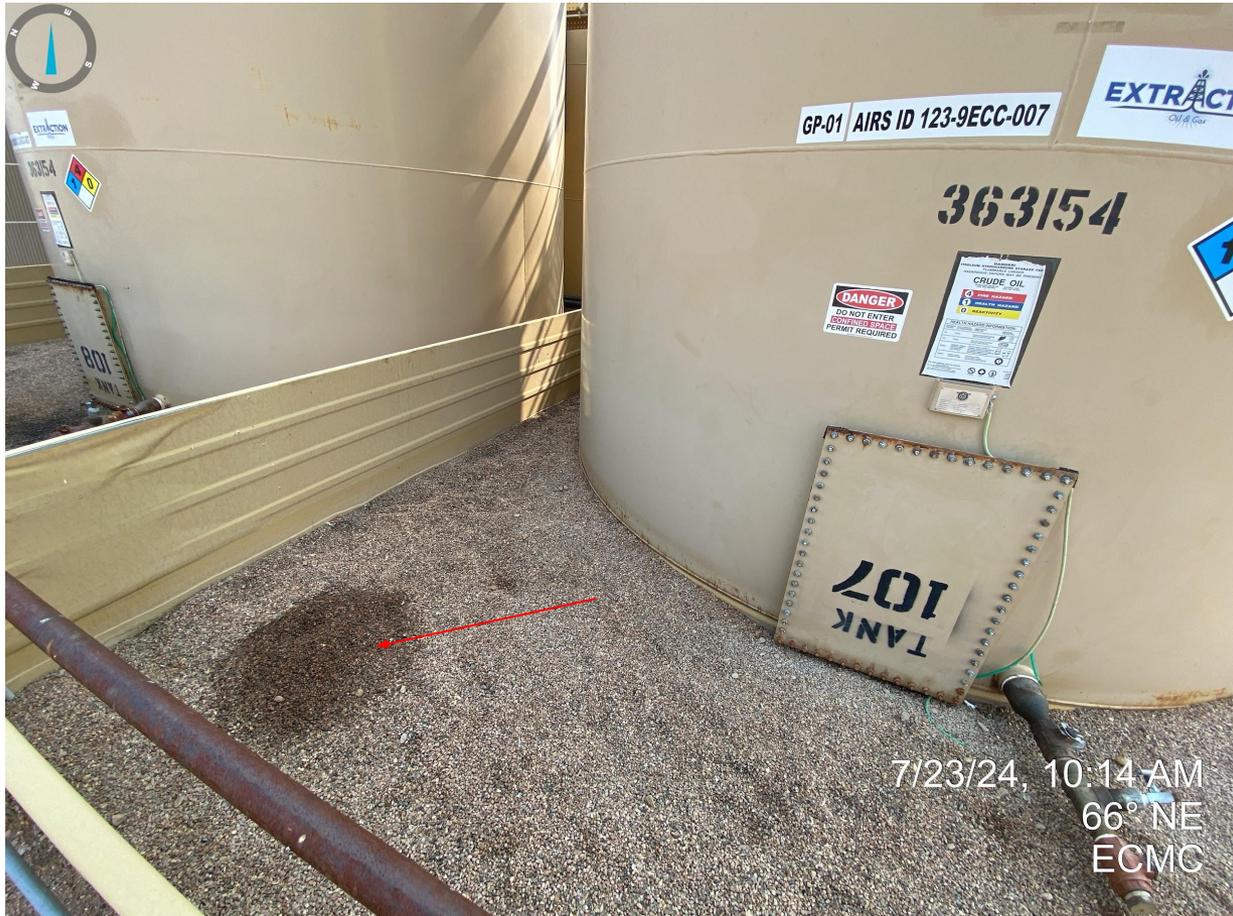
Photo 5. Stained soil within SW portion of tank battery.

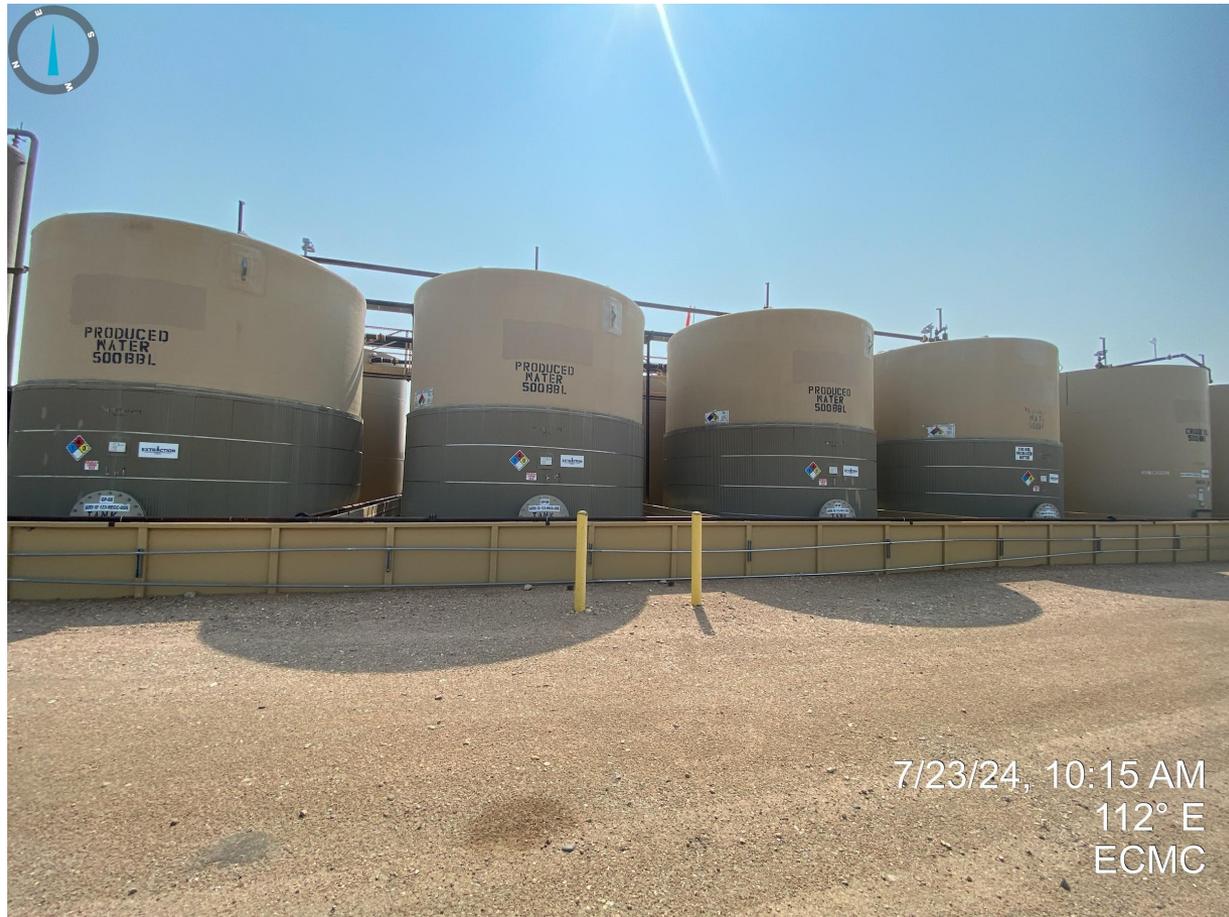
Photo 6. Tank labels have been replaced, west side of tank battery.

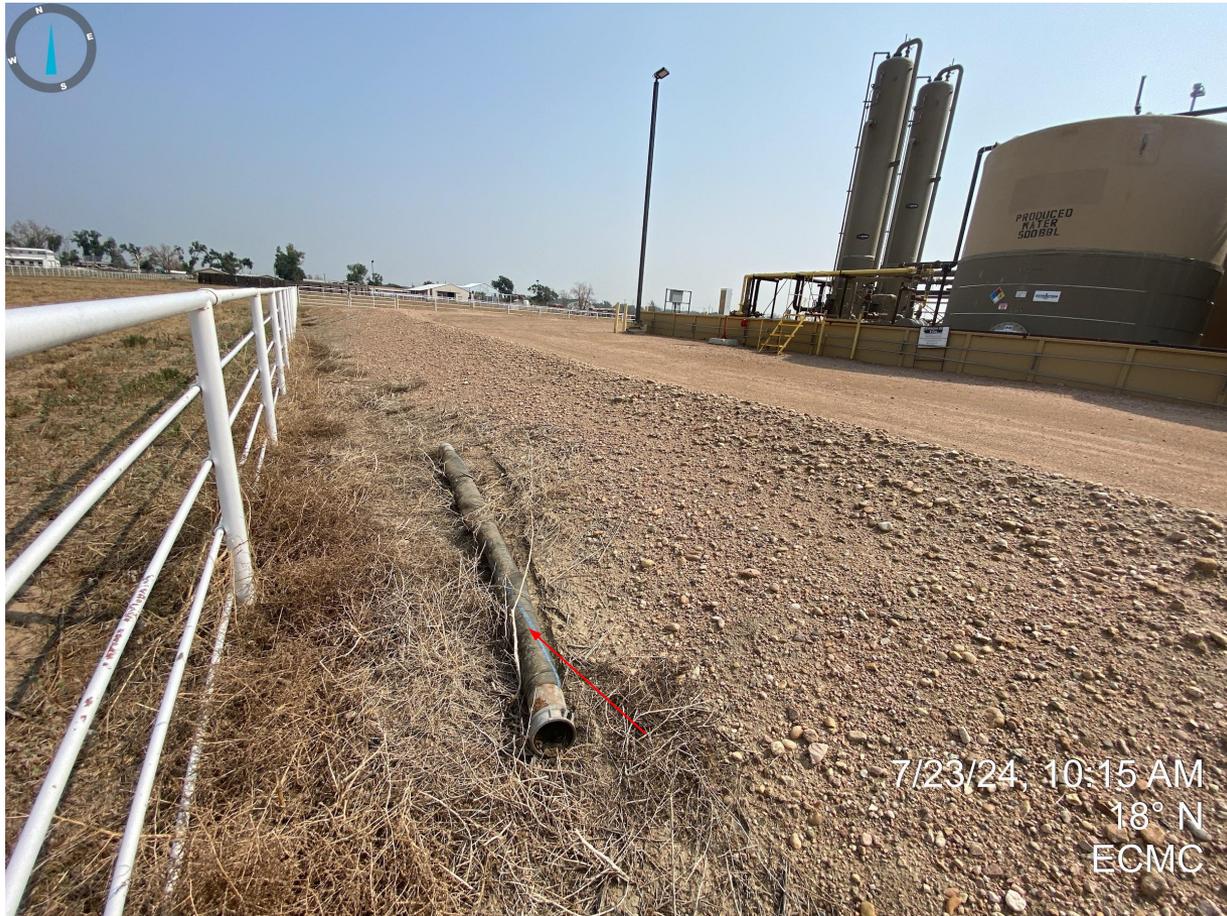
Photo 7. Unused equipment observed west of tank battery.

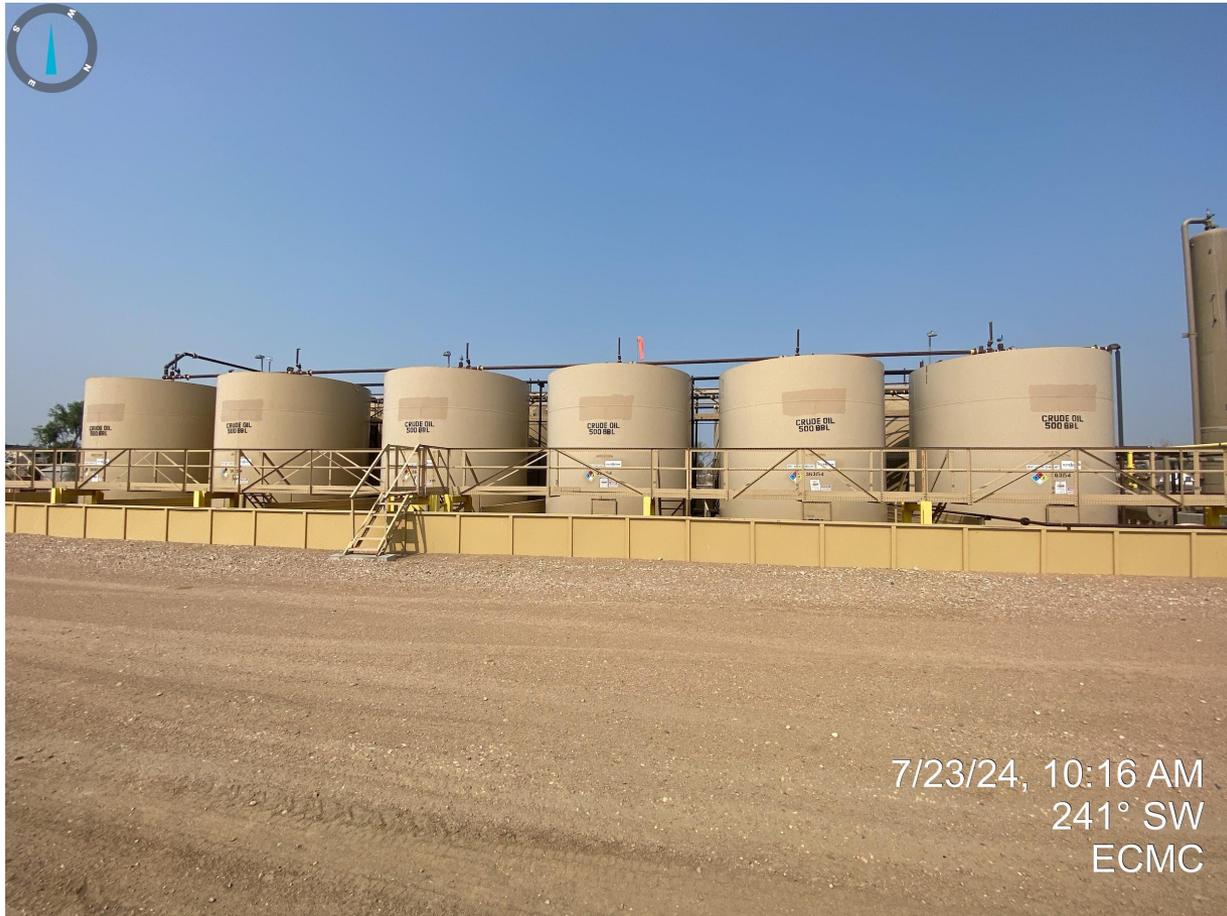
Photo 8. Tank labels have been replaced, east side of tank battery.

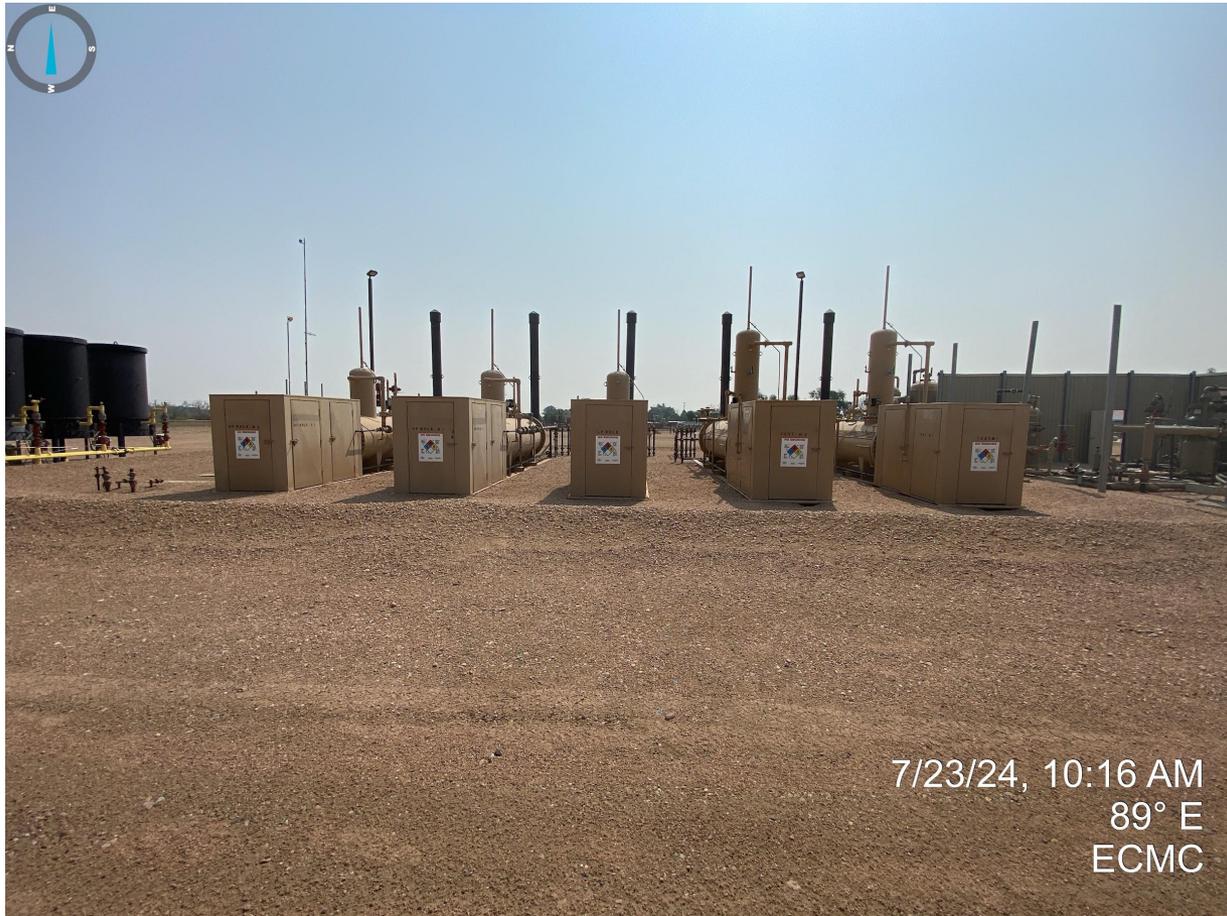
Photo 9. NFPA Placards and labels have been replaced.

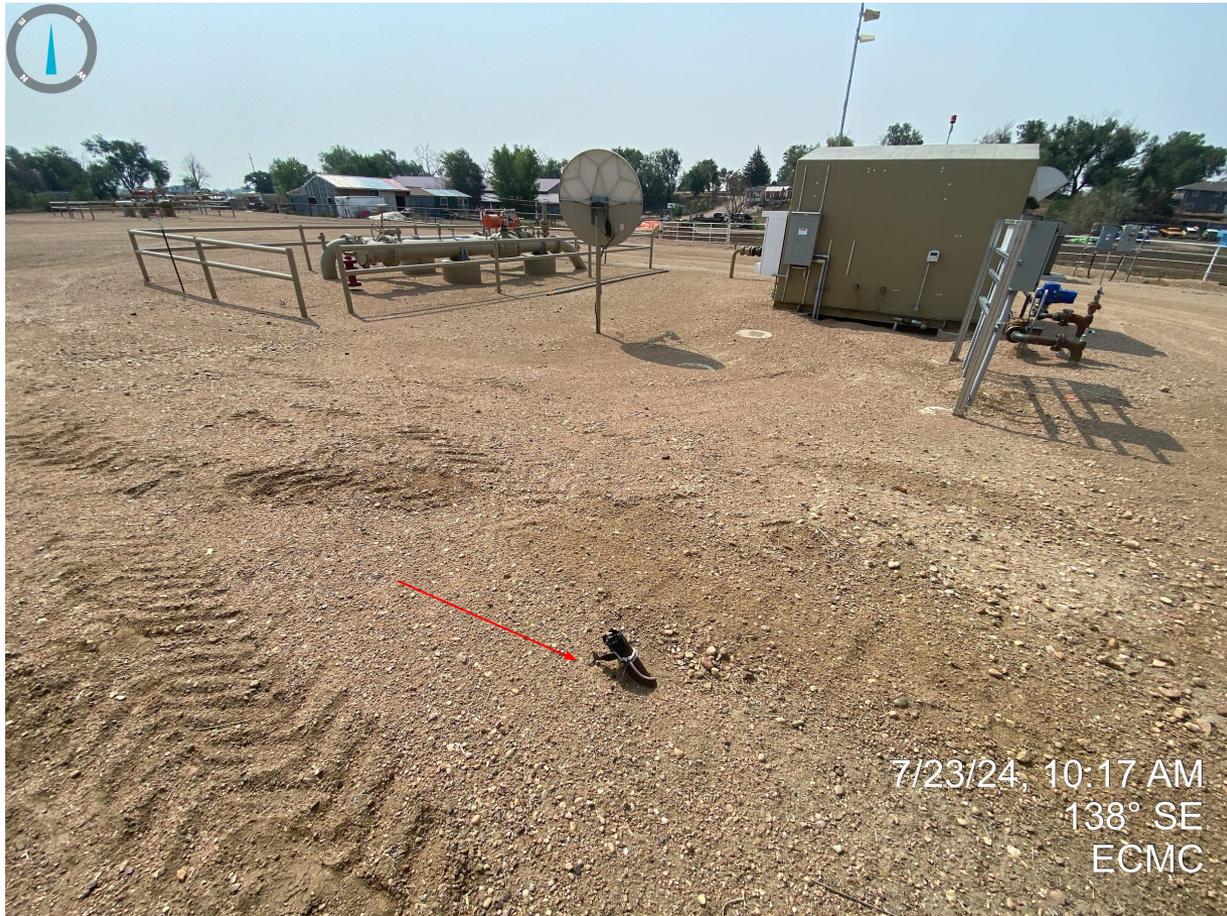
Photo 10. Unmarked riser/unused equipment, south of compressor station, remains on location.

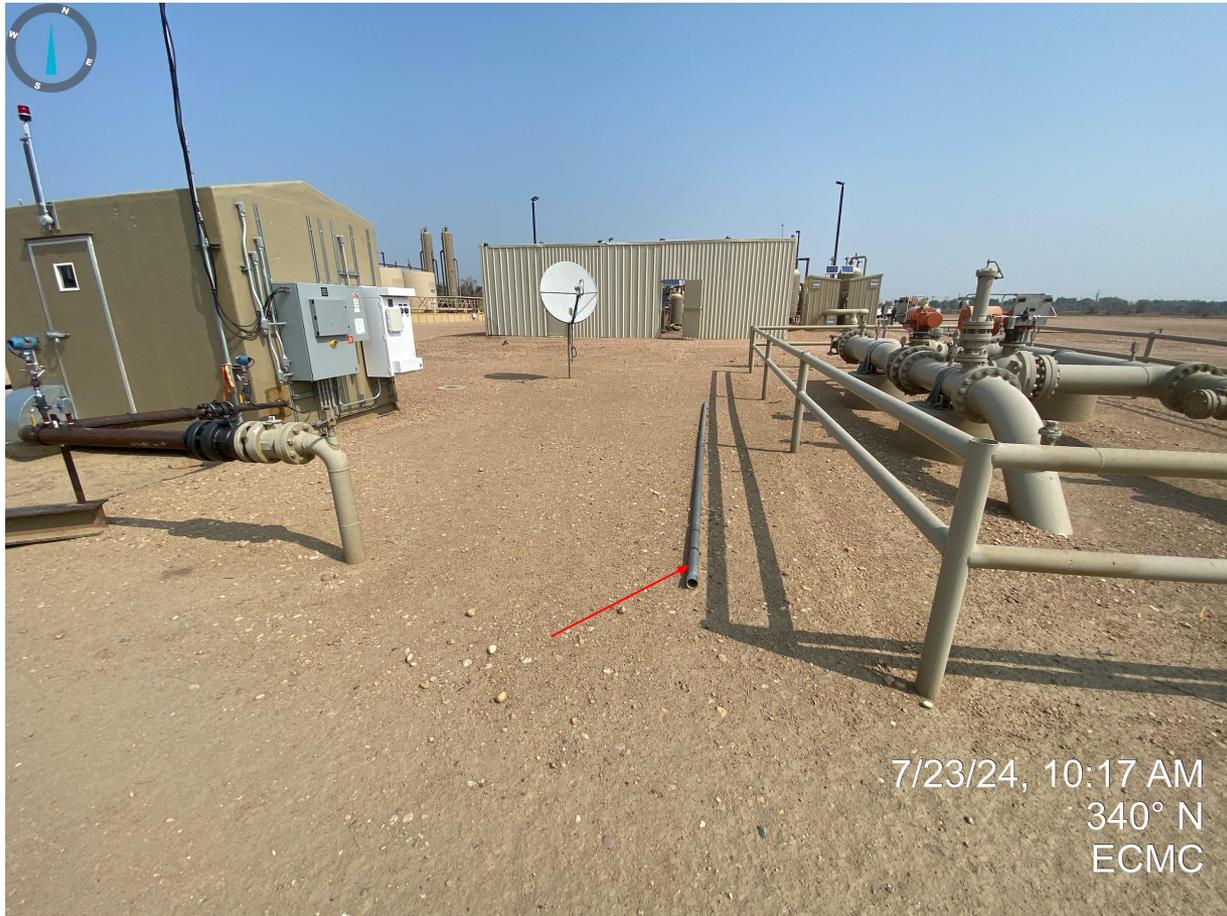
Photo 11. Unused equipment south of compressor station does not appear to have been removed or returned to service.

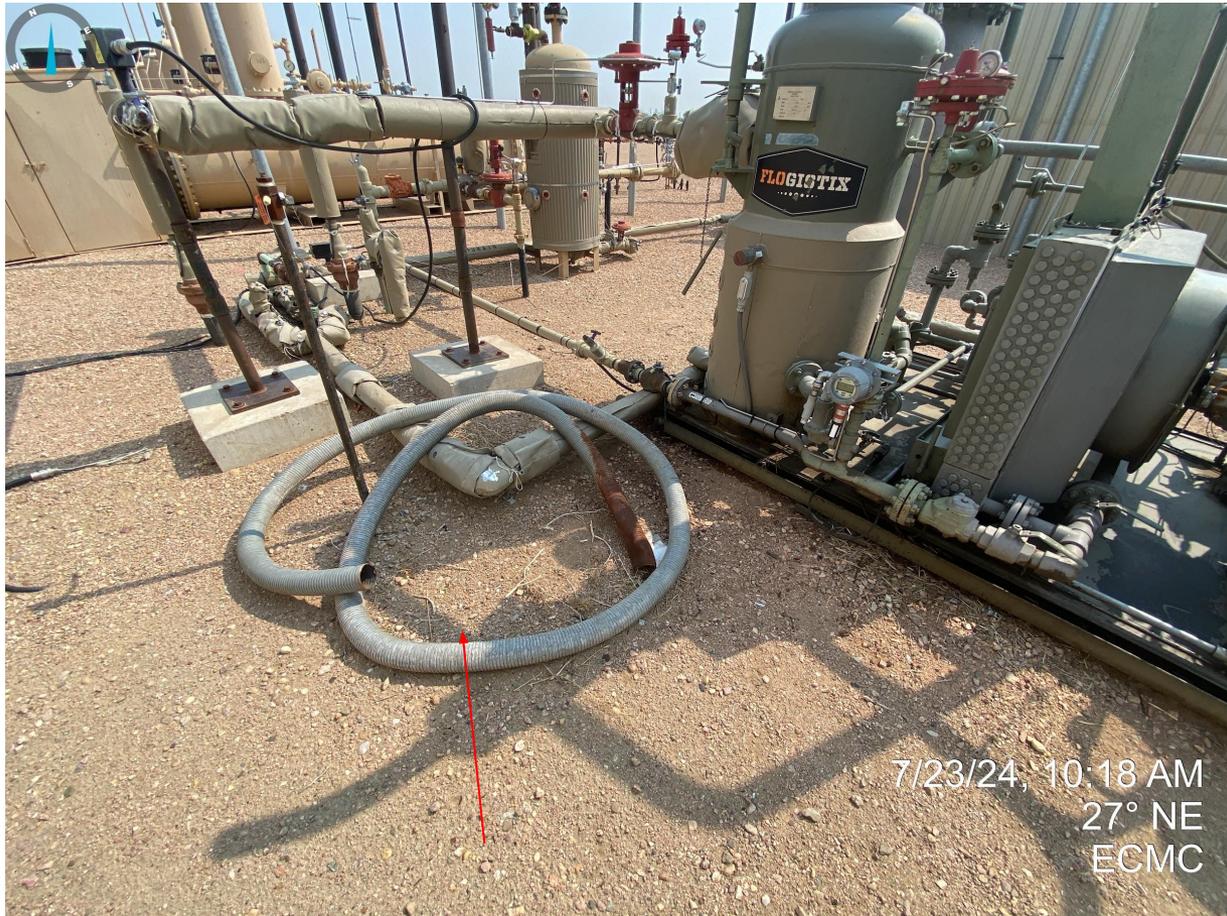
Photo 12. Unused equipment within compressor station does not appear to have been removed or returned to service.

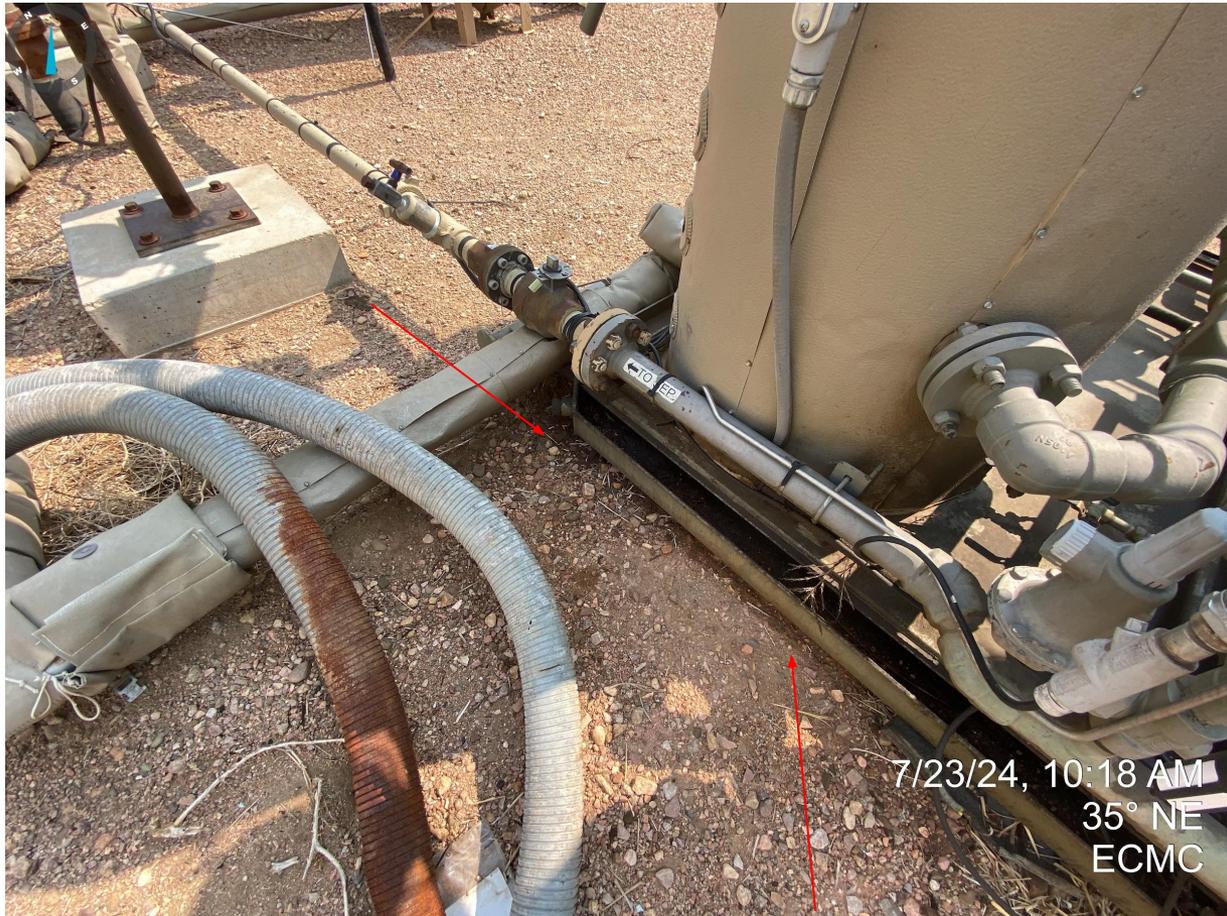
Photo 13. Stained soil does not appear to have been properly disposed of.

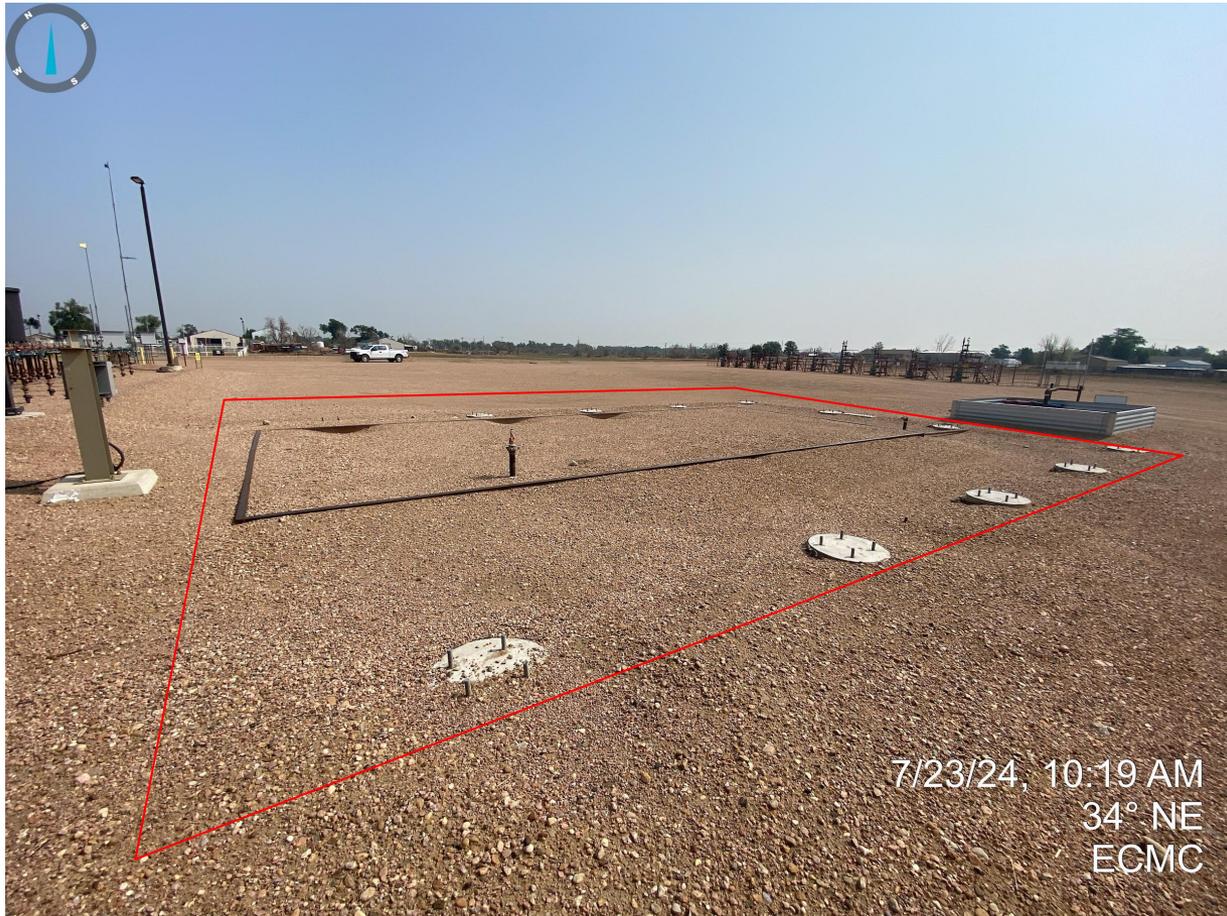
Photo 14. Unused equipment does not appear to have been removed or returned to service.

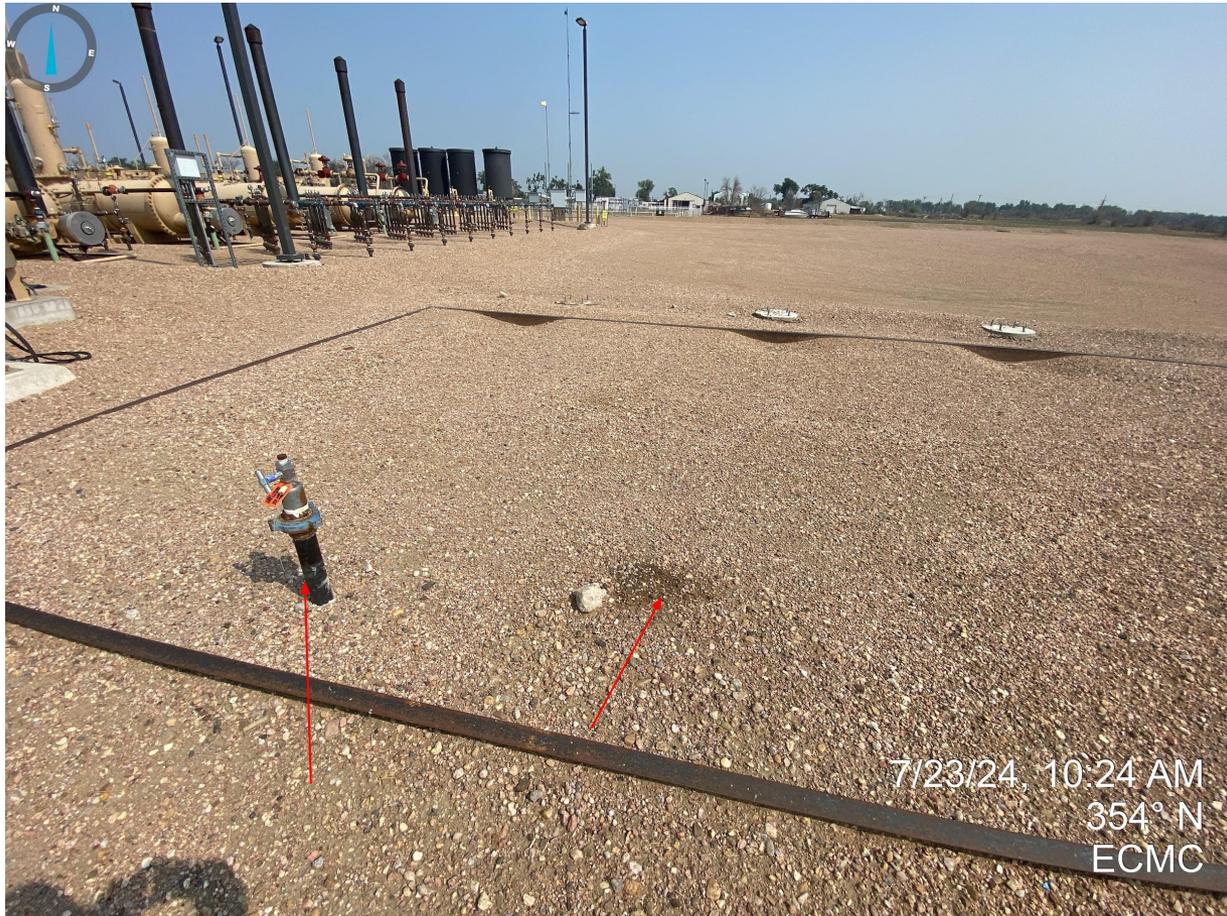
Photo 15. Unused equipment/unmarked riser and stained soil does not appear to have been removed or properly disposed of.
